MEMORANDUM

Subject: **SA-7 Sediment Remedy Long-Term Monitoring
Summary of Year 8 Monitoring & Proposed Year 8 Program**

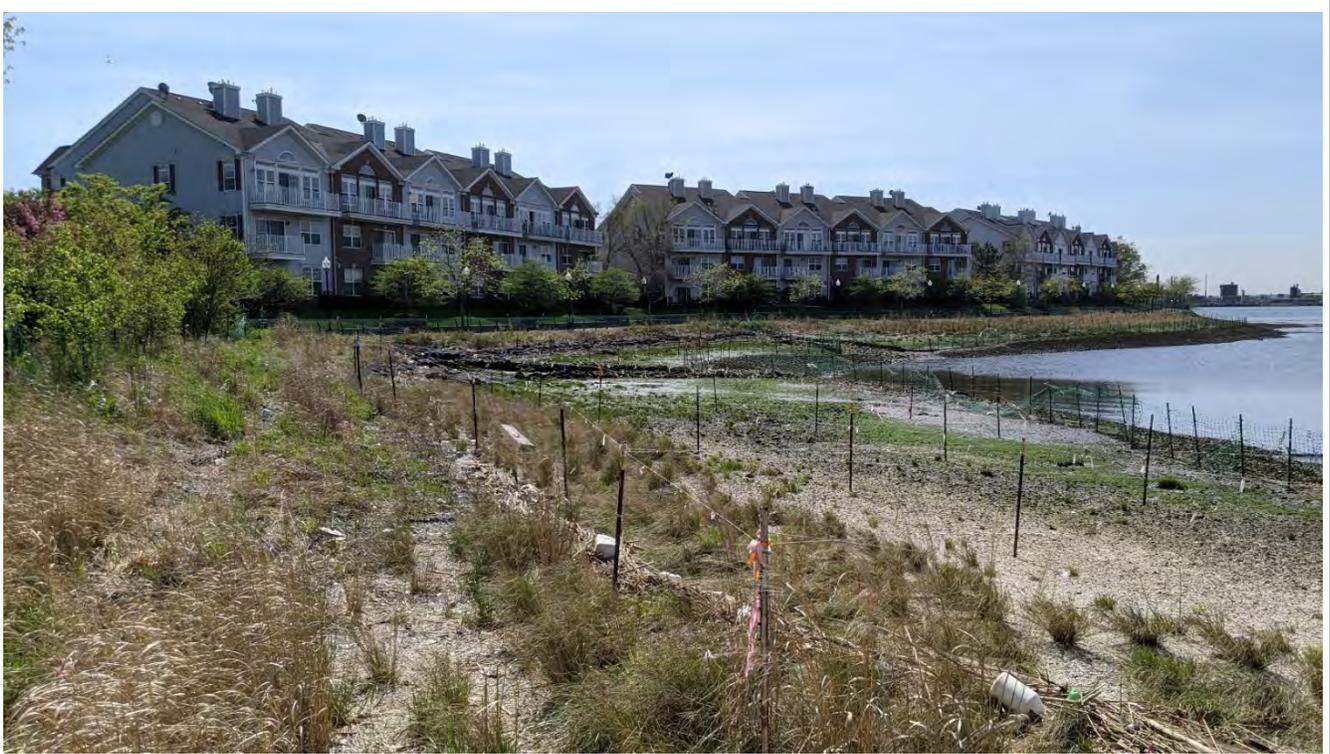
Photo 1: Northern end of Cap Area 16. Note largely dormant vegetation and intact waterfowl exclusion measures (facing west).

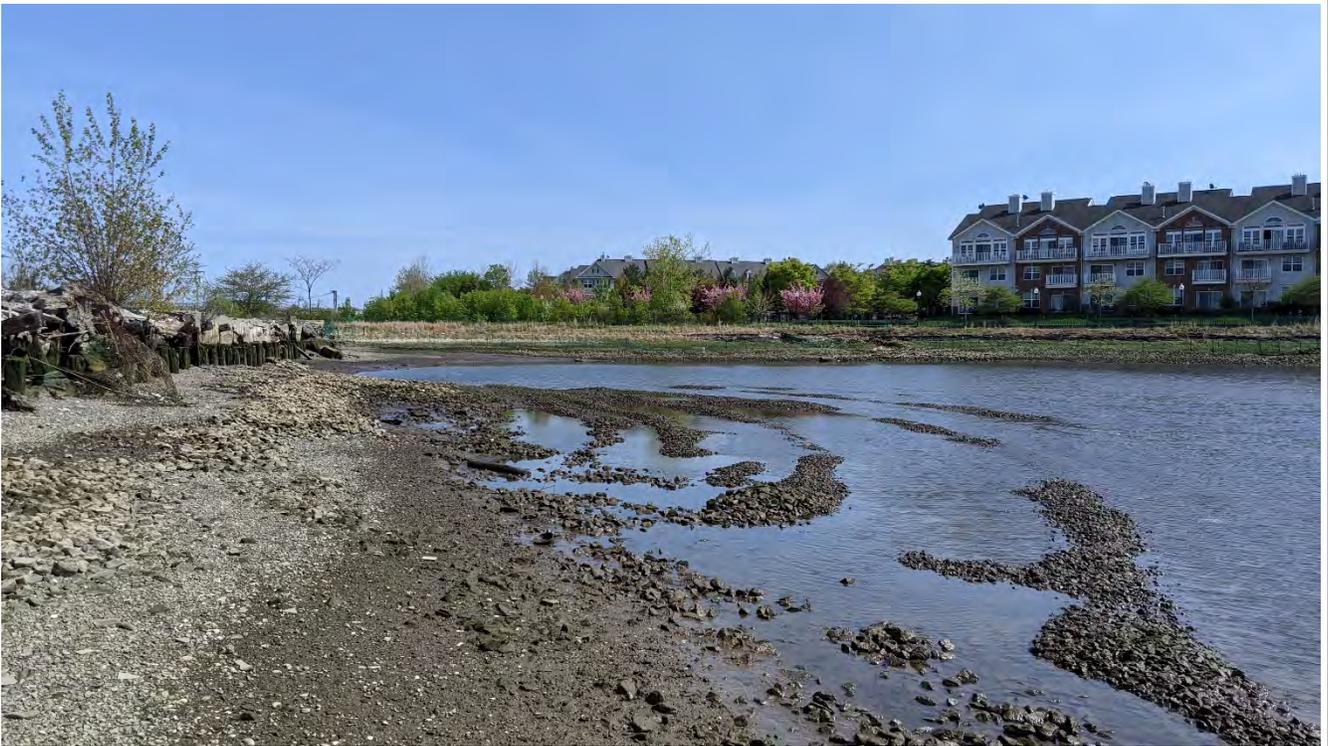
Photo 4: Cap Area 22. Note the Beneficial Environmental Project area located in the background (facing southeast).

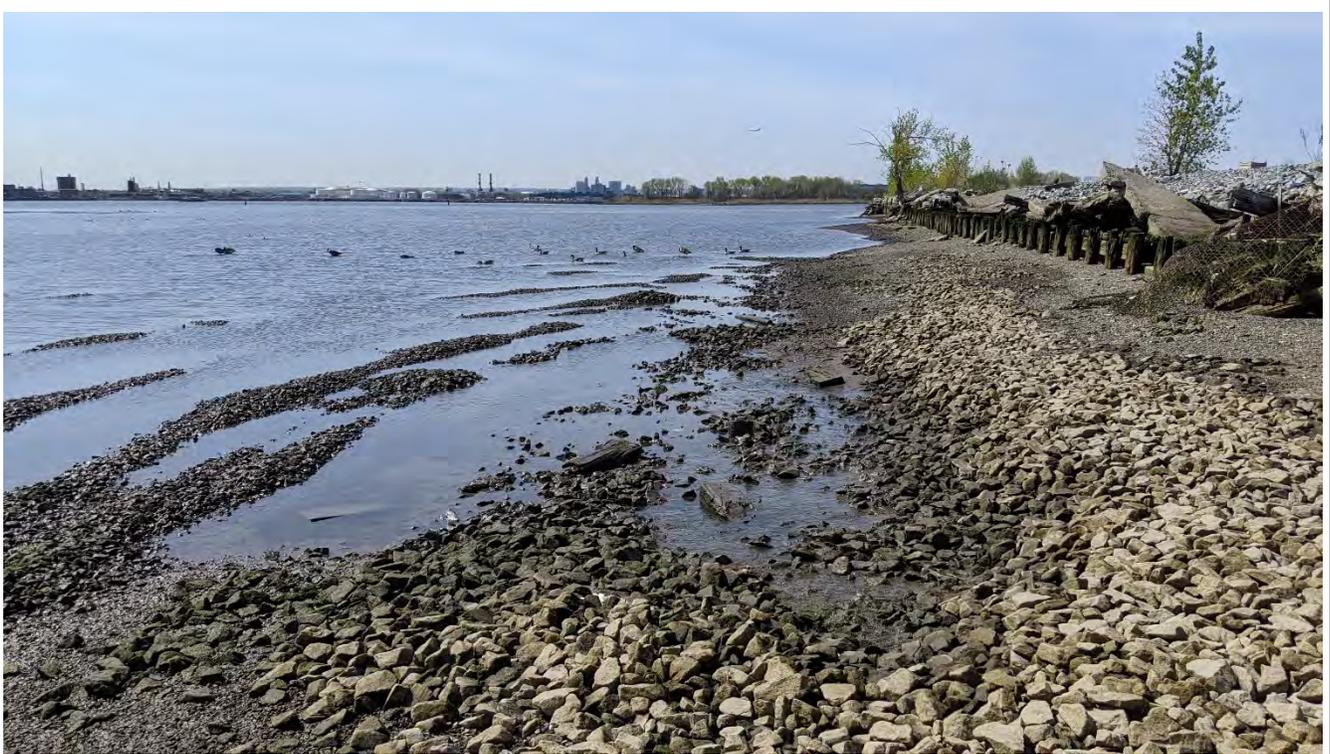
Photo 5: Cap Area 22. Note depressional areas on the armor stone (facing northwest).

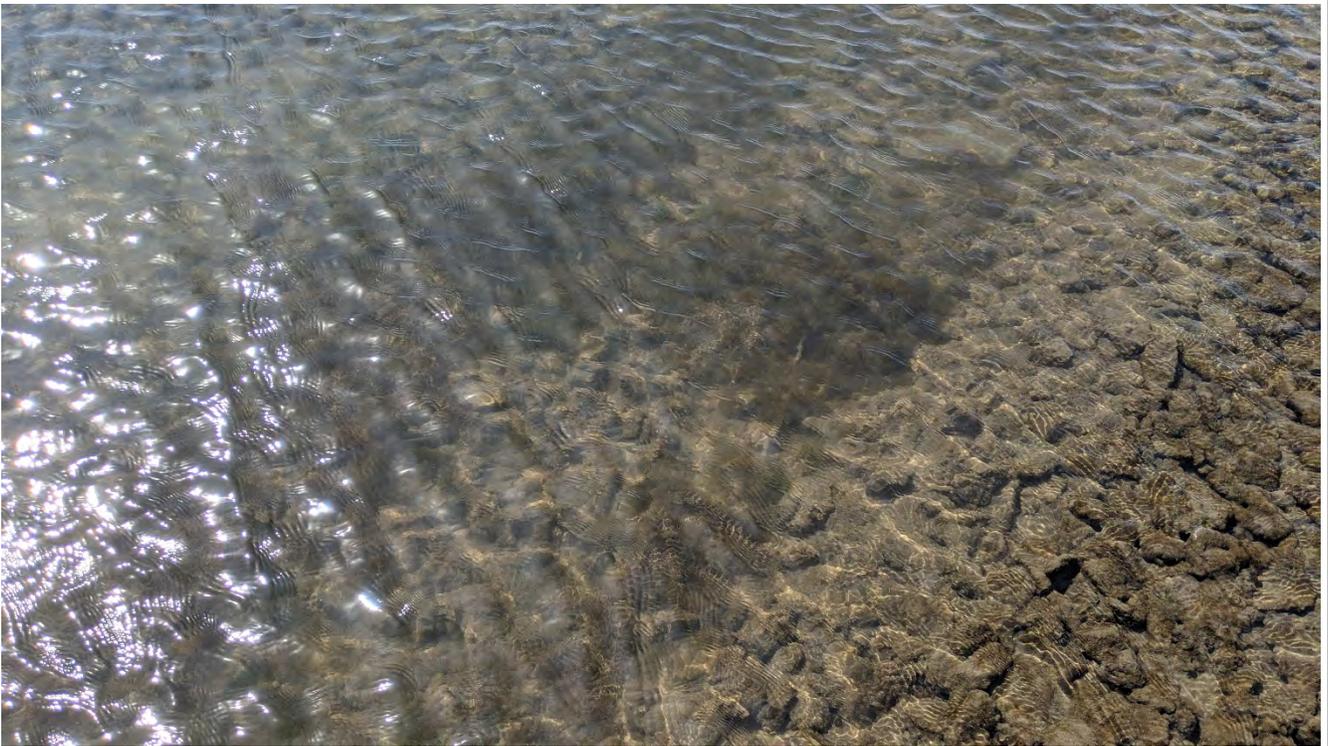
Photo 7: Sub-aquatic vegetation established in accumulated sediments located within depressional areas in the armoring stone of Cap Area 22.

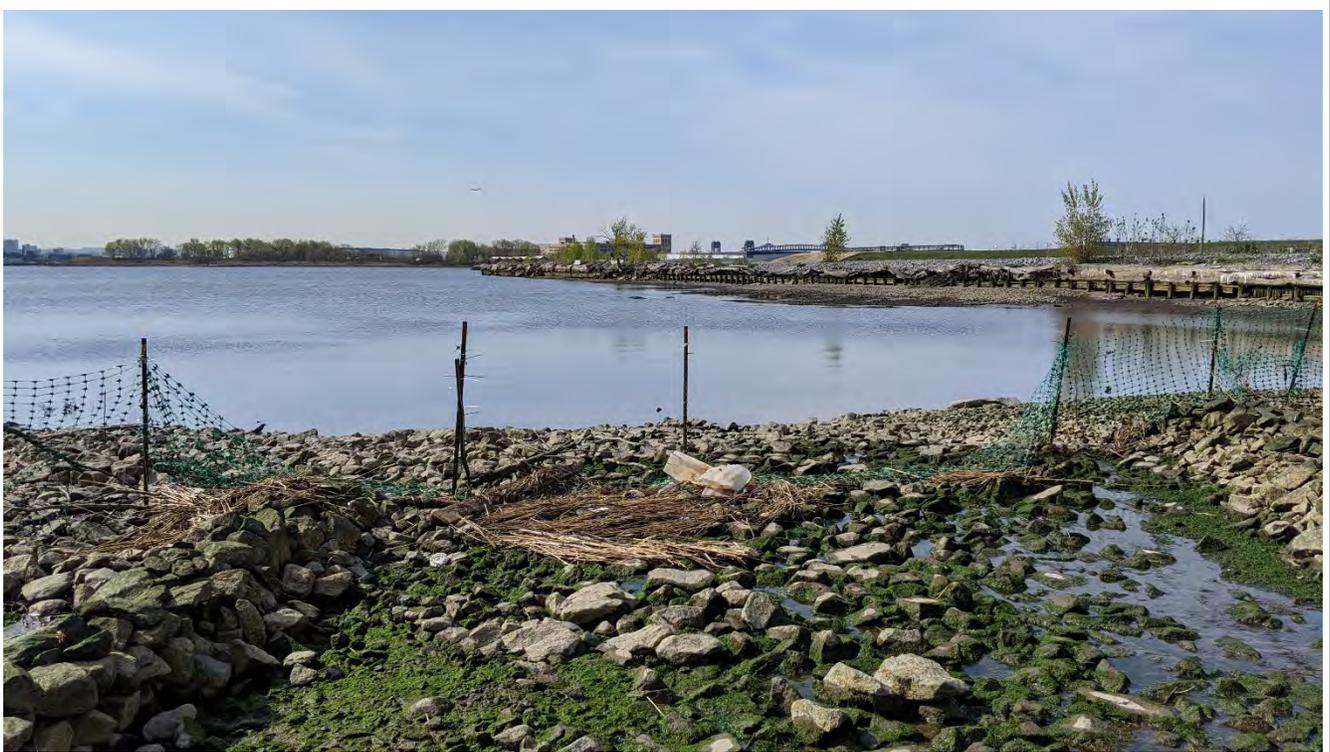
Photo 9: Shoreline stabilization at the end of Outfalls B and C. Note the compromised snow fence along the edge of the outfall apron (facing northwest).

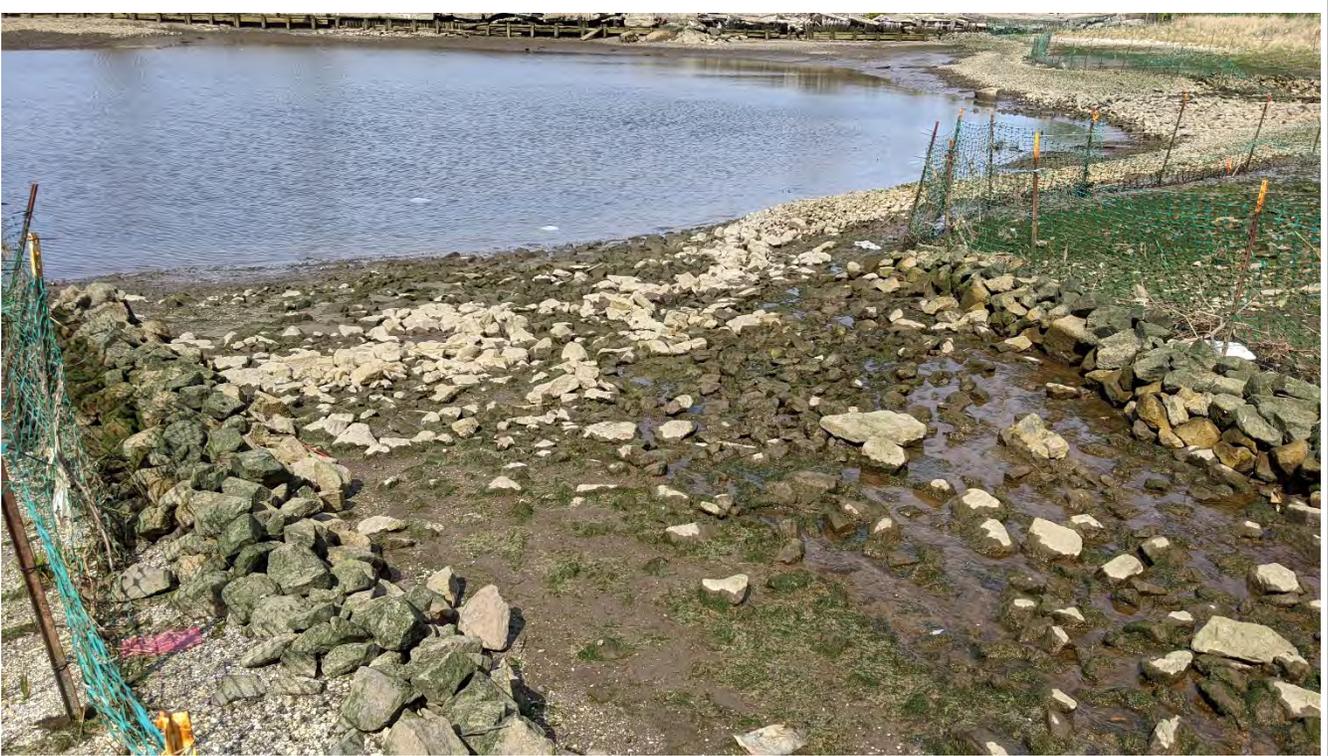
Photo 11: Outfall A discharge area. Note the accumulation of sediment in the foreground (facing northeast).

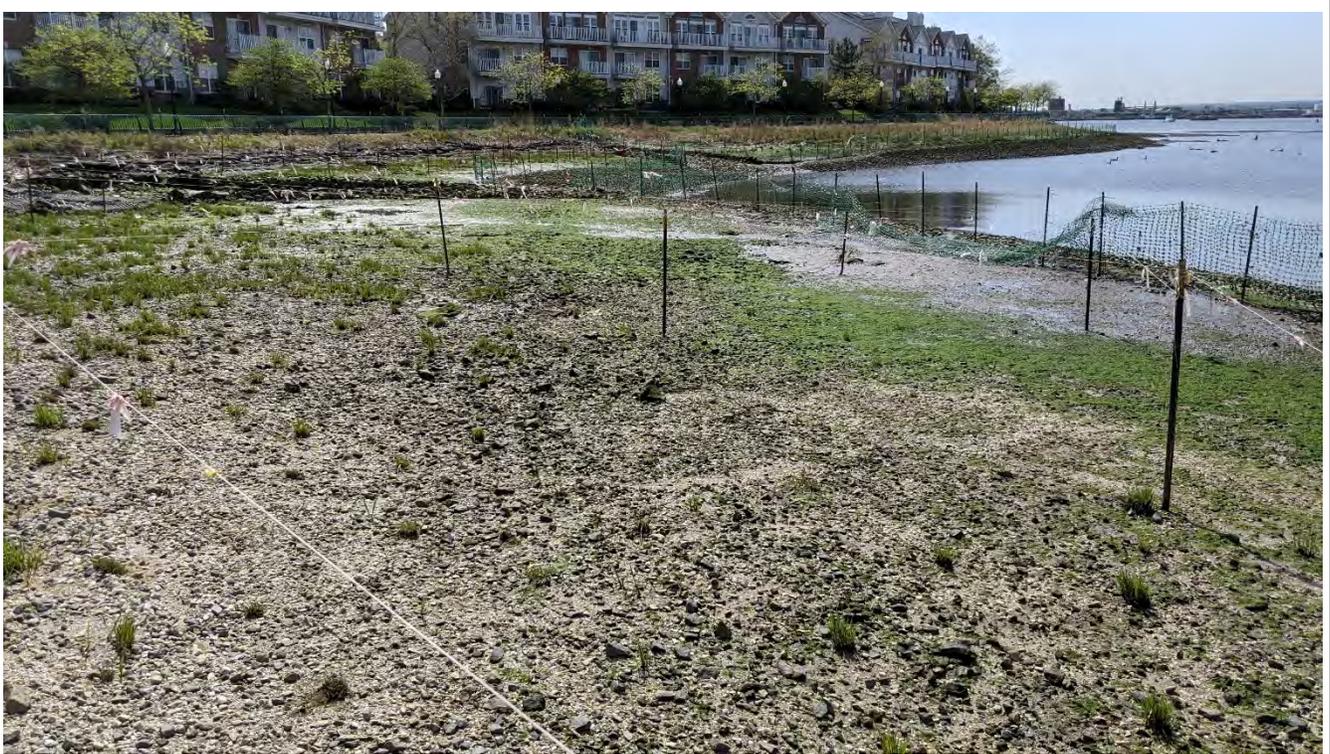
Photo 13: Limited vegetation present throughout the low marsh zone. Note tilted/loose waterfowl exclusion fencing (facing northwest).

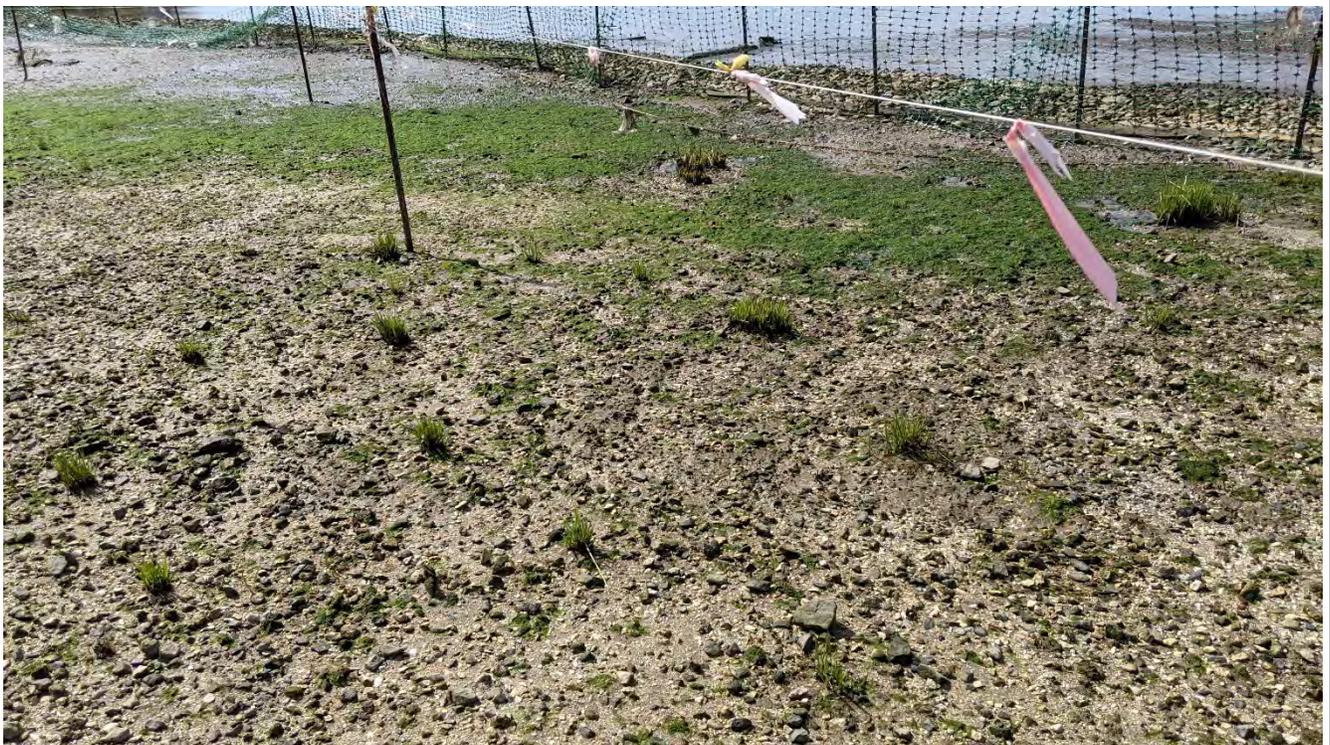
Photo 14: Limited vegetation present throughout the low marsh zone. Note tilted/loose waterfowl exclusion fencing (facing northwest).

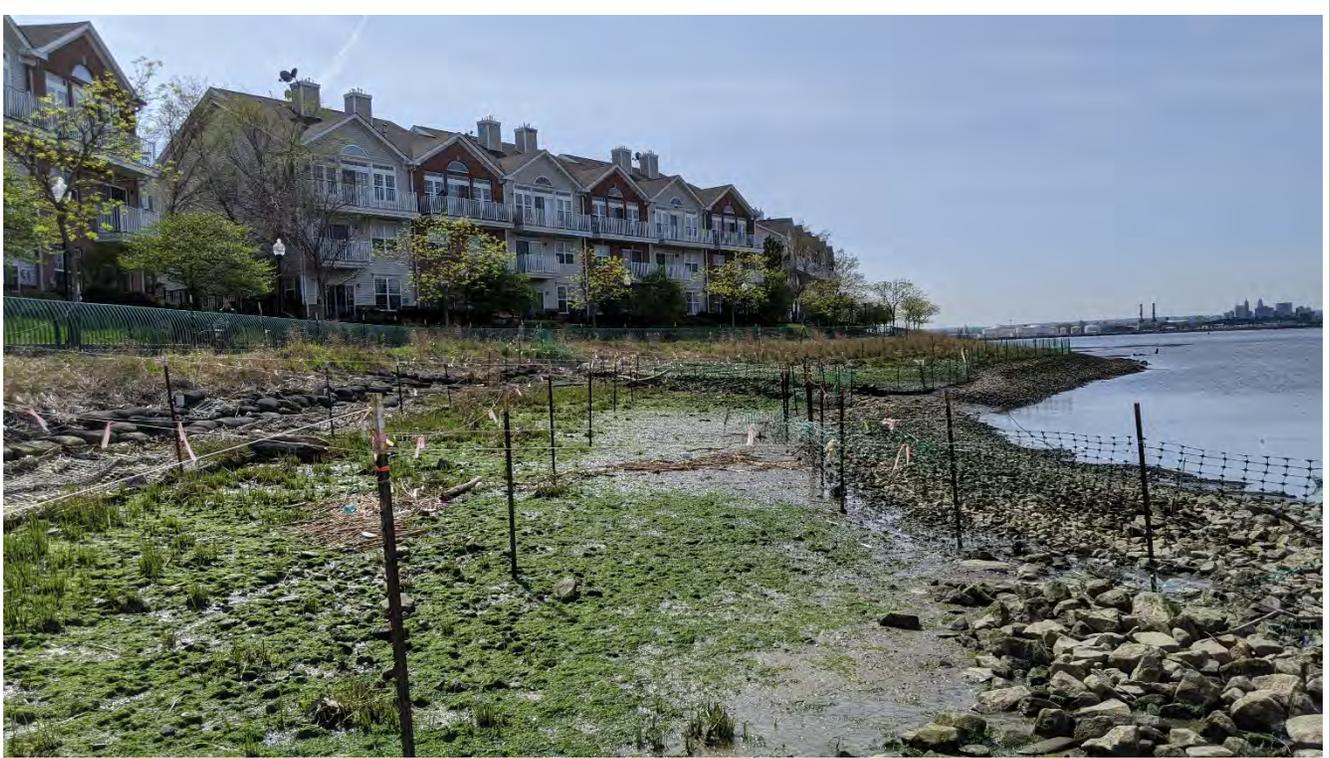
Photo 15: Limited vegetative growth present in the low marsh zone located between Outfalls A and B (facing west).

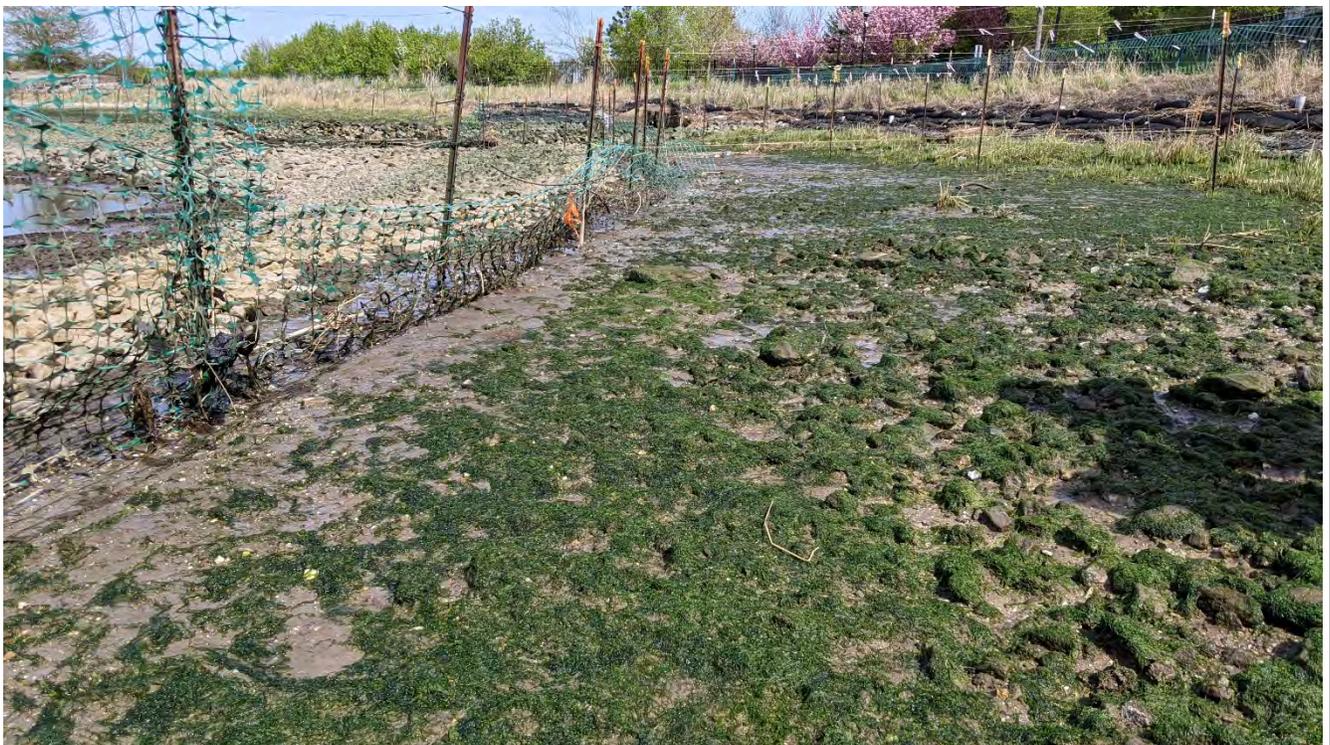
Photo 16: Limited vegetative growth present in the low marsh zone located between Outfalls A and B. Note tilted/loose waterfowl exclusion fencing (facing east).

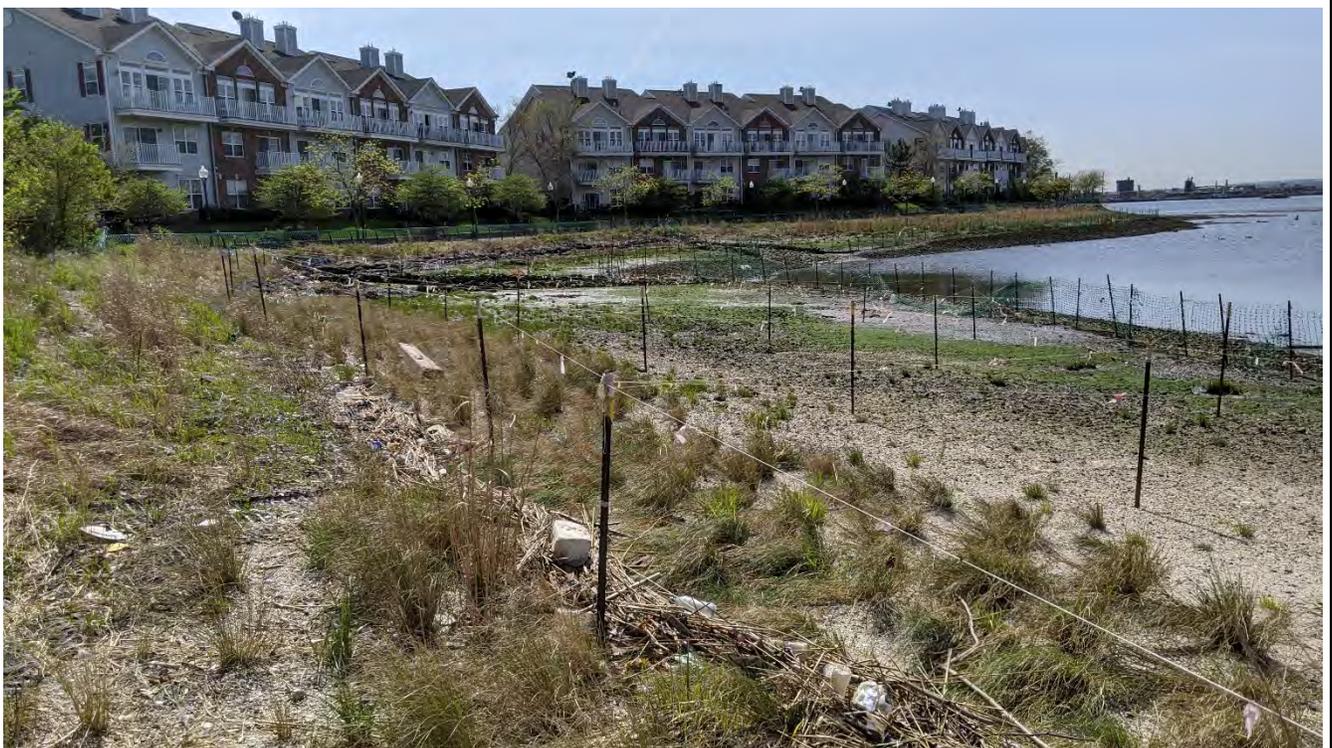
Photo 18: Vegetation on the eastern side of the BEP area. Note the healthy and vibrant vegetation in the uplands and high marsh zones, but limited growth in the low marsh (facing northwest).

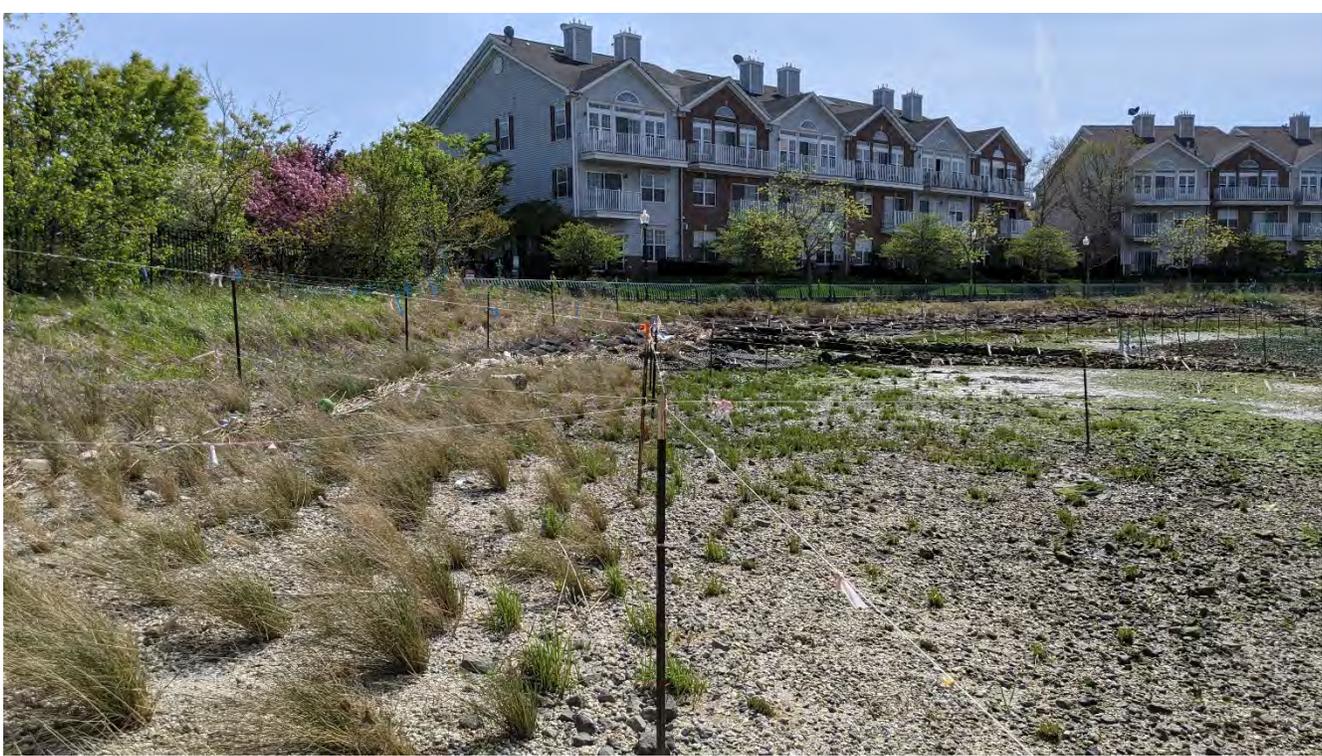
Photo 19: Vegetation on the eastern side of the BEP area. Note the healthy and vibrant vegetation in the uplands and high marsh zones, but limited growth in the low marsh (facing southwest).

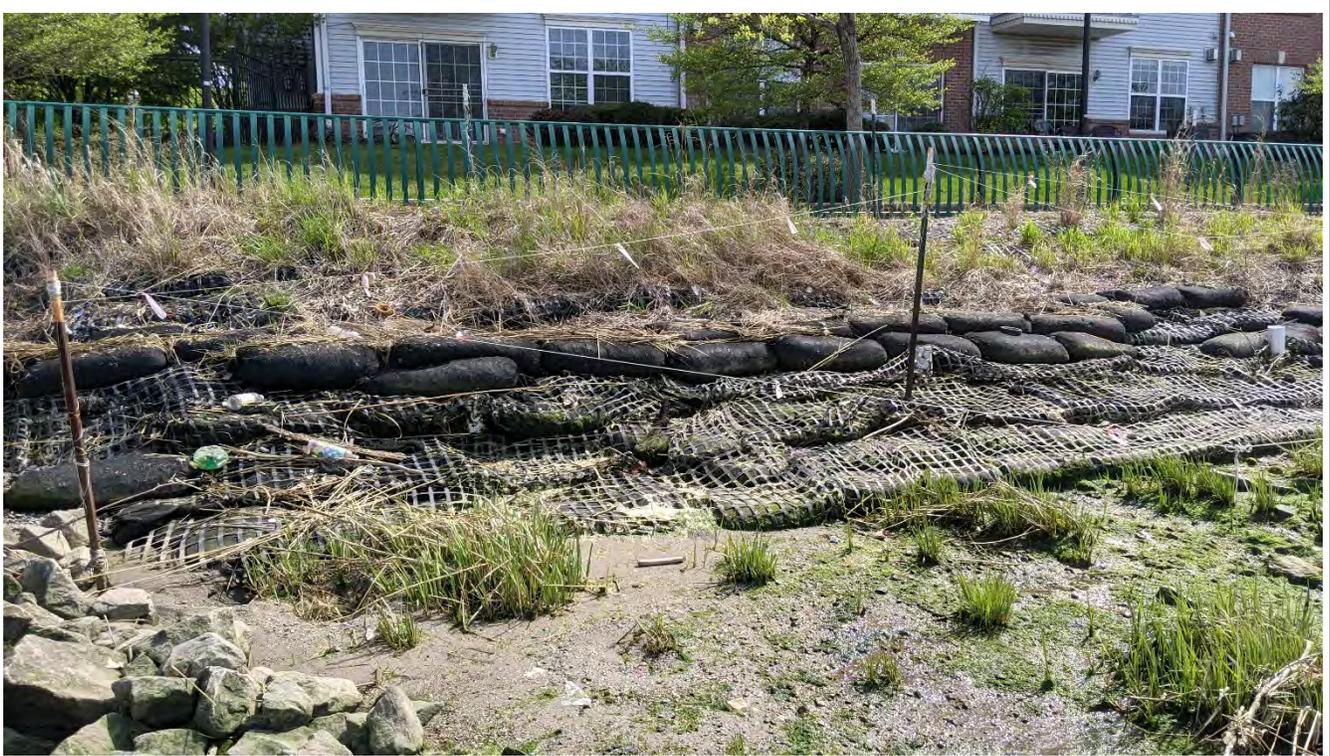
Photo 21: Sparse vegetation present near exposed geogrid and RockSoxx located adjacent to Outfall B (facing southwest).

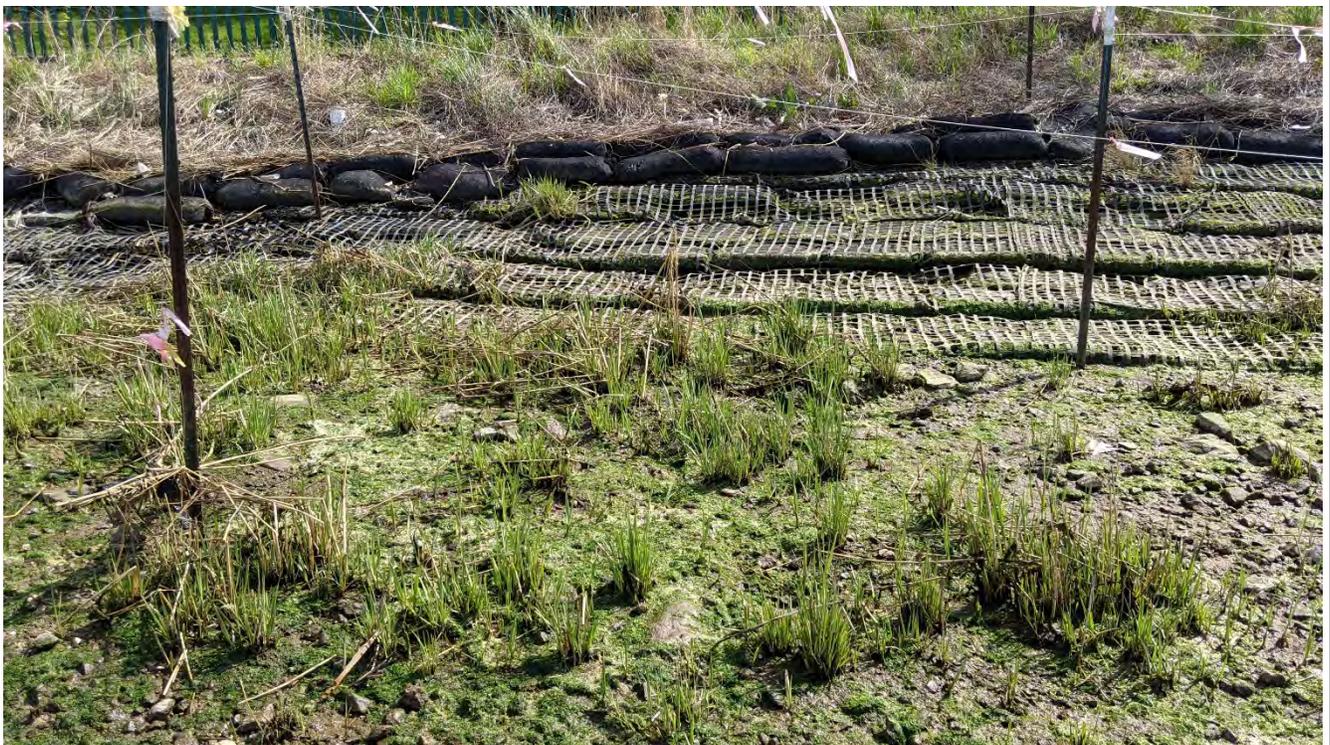
Photo 22: Sparse vegetation present near the exposed RockSoxx located in the central portion of the BEP area between Outfalls A and B (facing south).

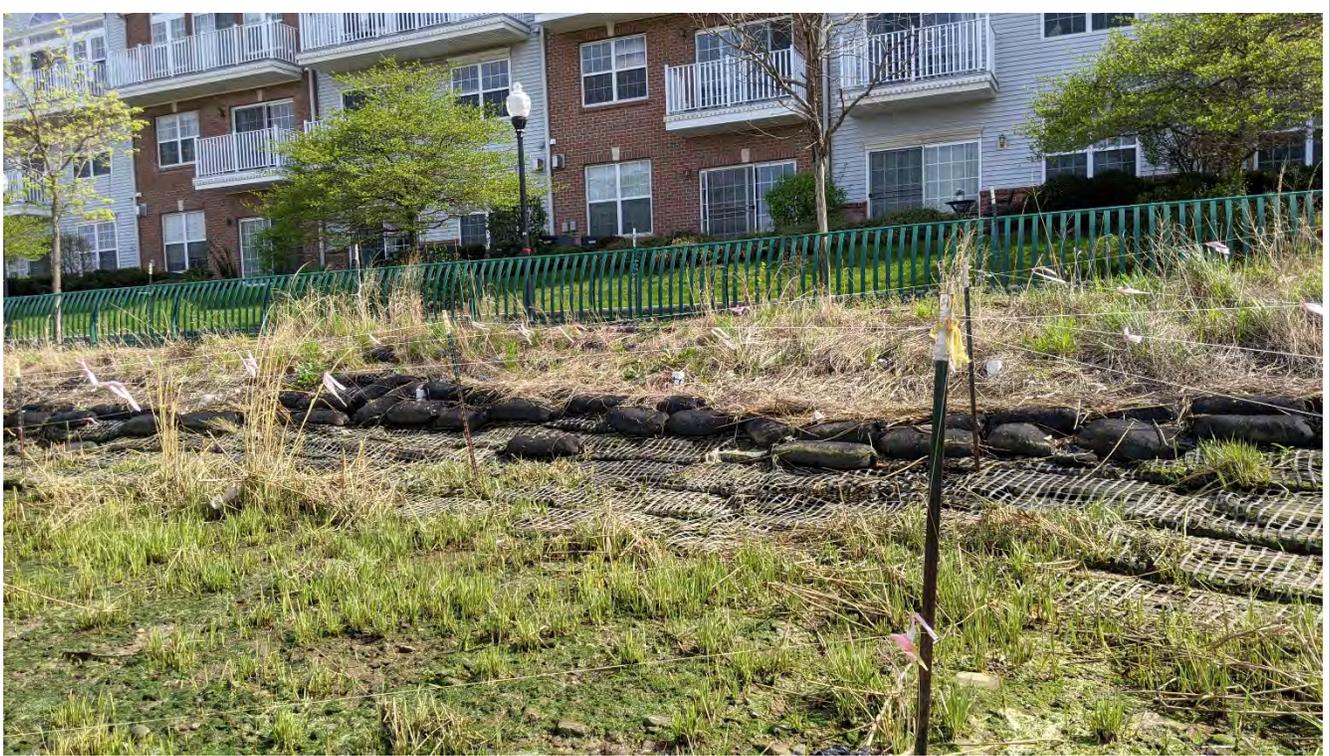
Photo 23: Sparse vegetation present near the exposed RockSoxx located in the central portion of the BEP area between Outfalls A and B (facing southeast).

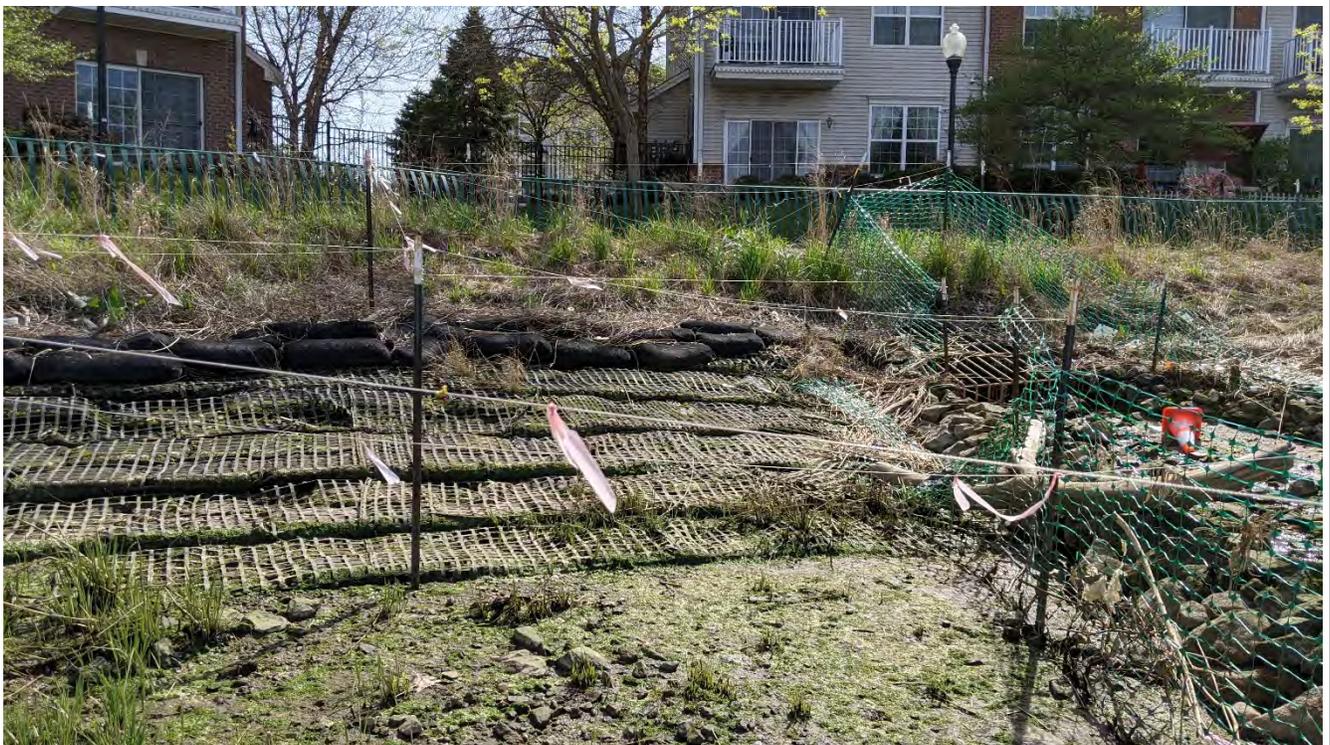
Photo 24: Sparse vegetation present on the exposed geogrid and RockSoxx located adjacent to Outfall A (facing southwest).

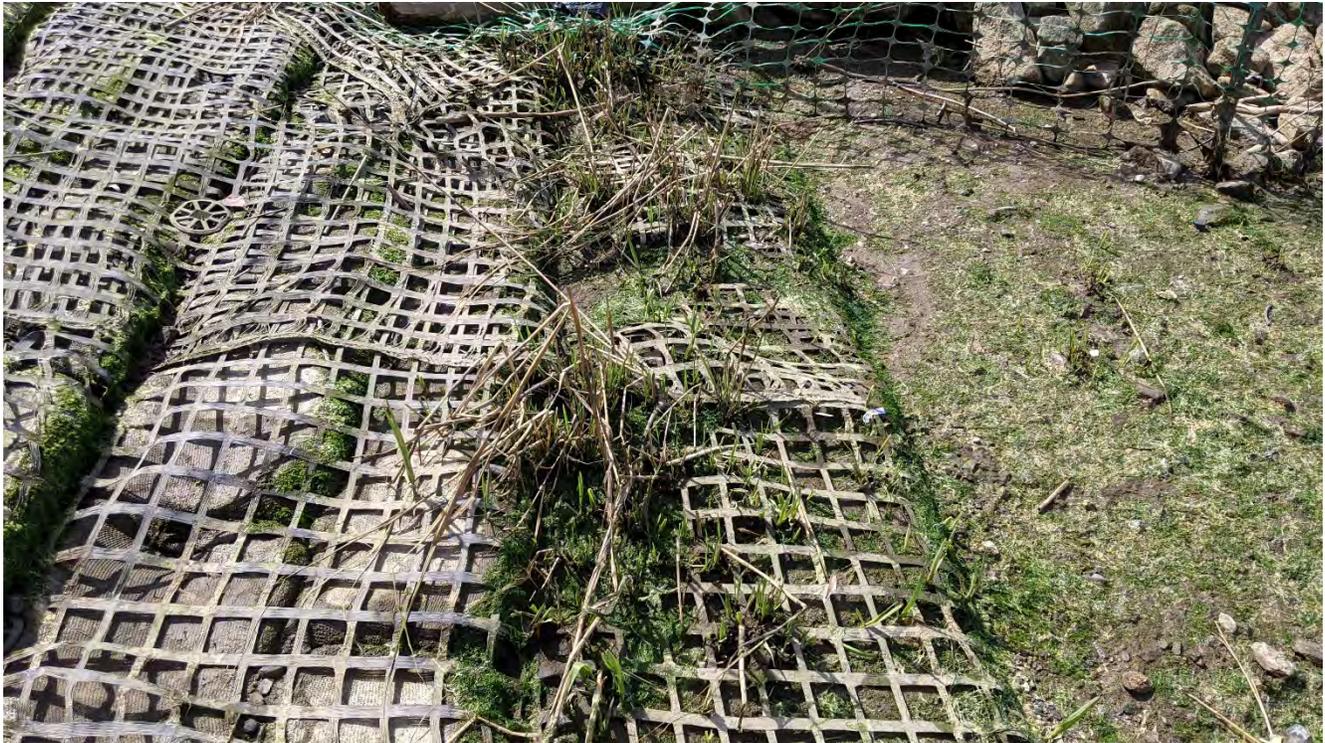
Photo 28: Partially buried and sparsely vegetated GroSoxx near Outfall A.

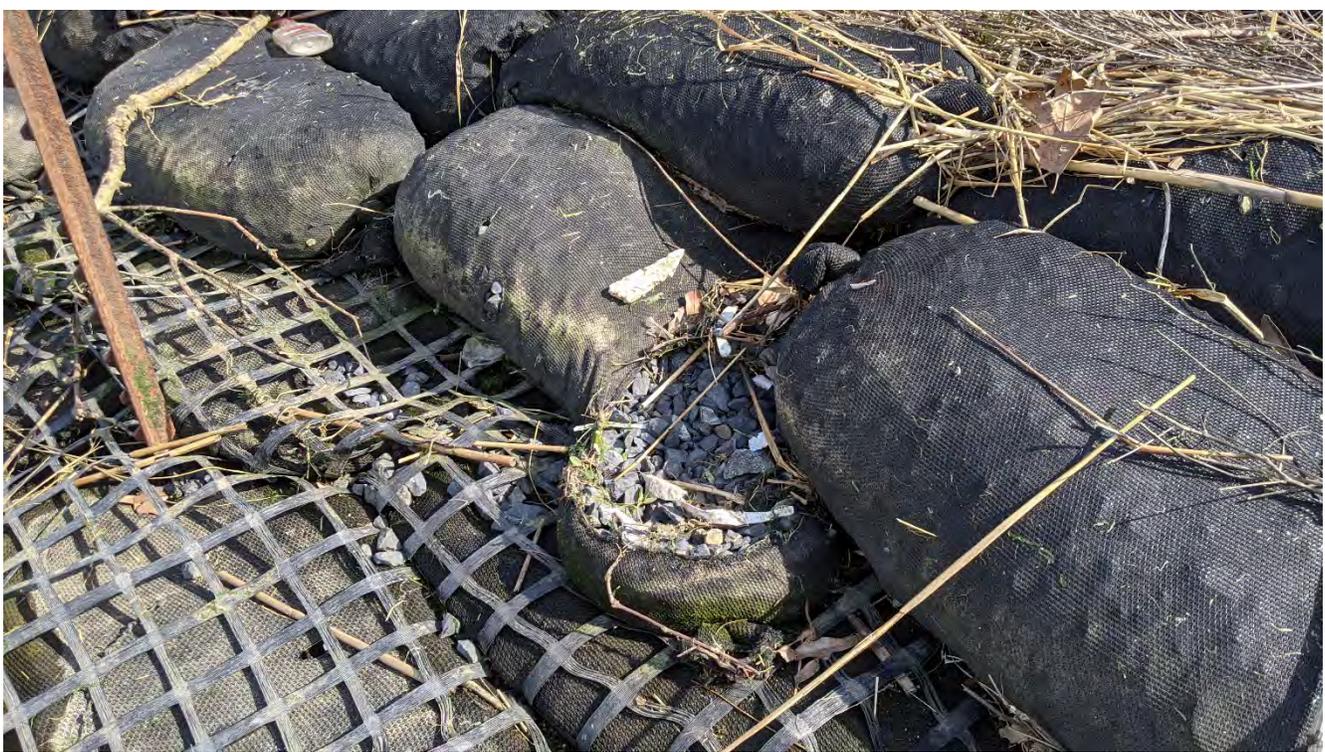
Photo 29: Typical damaged RockSoxx located along the drift line within the transition area between the high marsh and upland vegetative communities between Outfalls A and B.

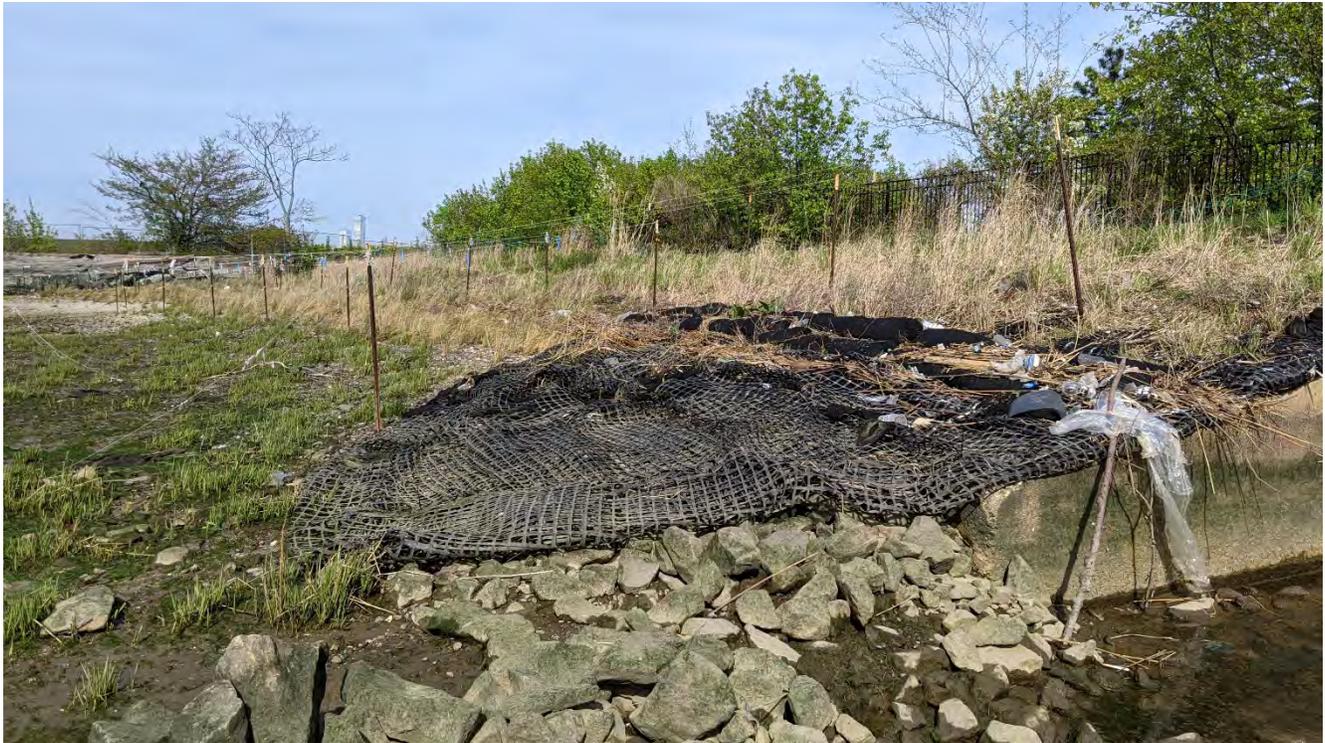
Photo 30: Sparse vegetation present near the exposed GroSoxx located adjacent to Outfall C (facing northeast).

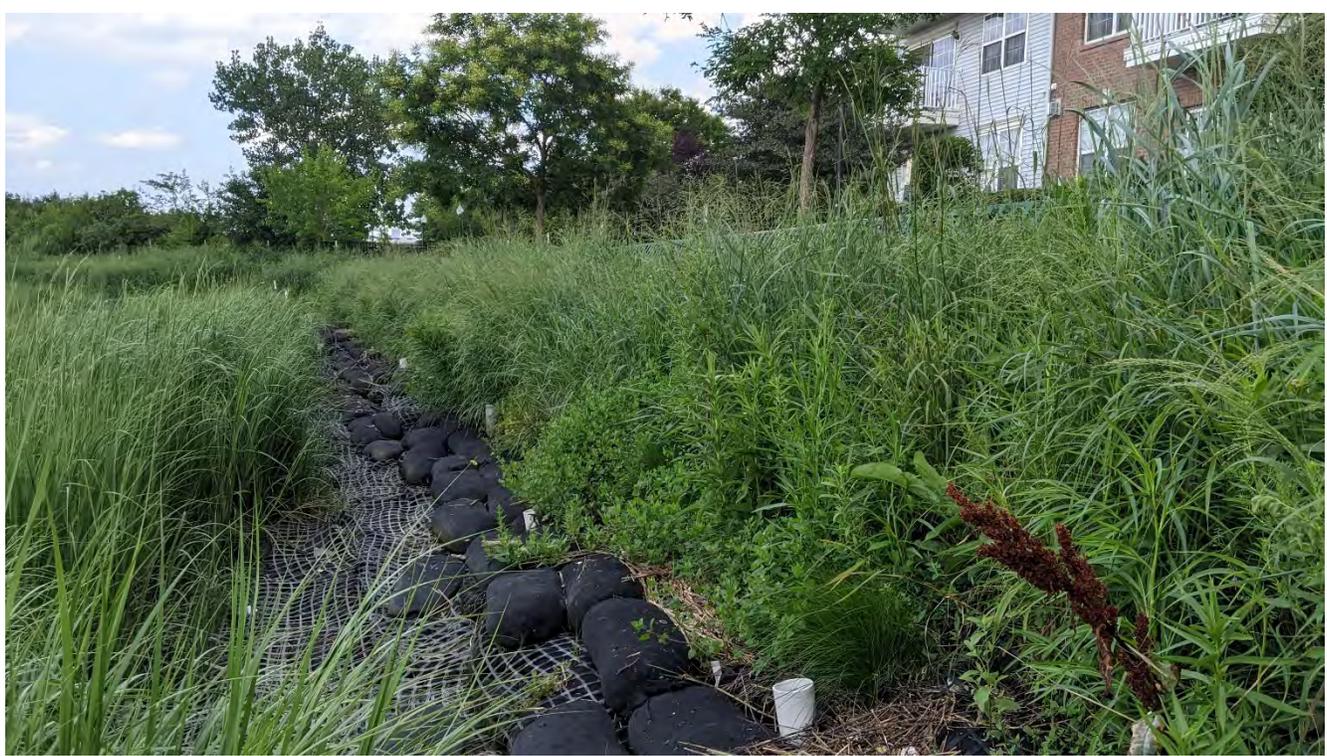
Photo 19: Exposed geogrid and RockSoxx in the high marsh zone of the central portion of the BEP area between Outfalls A and B (facing east).

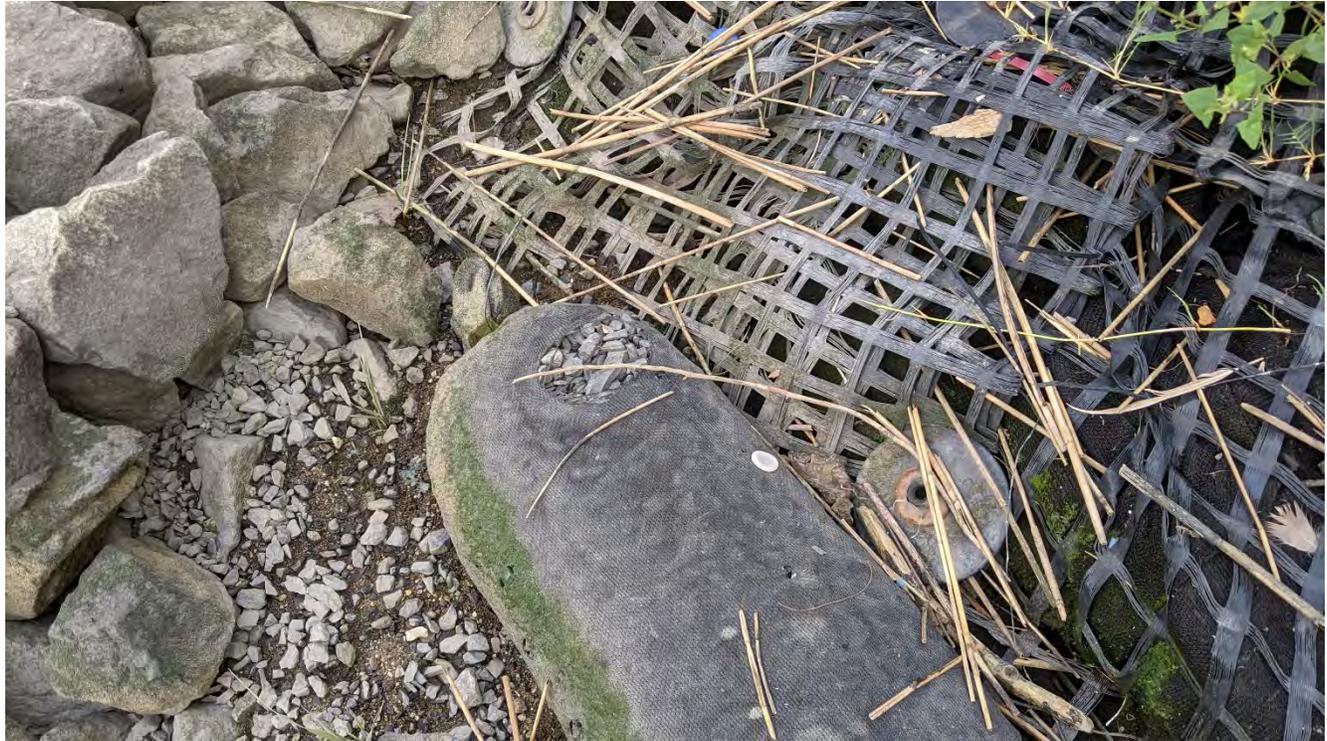
Photo 20: Sparse vegetation present near the exposed RockSoxx located in the central portion of the BEP area between Outfalls A and B. Note the damaged RockSoxx.

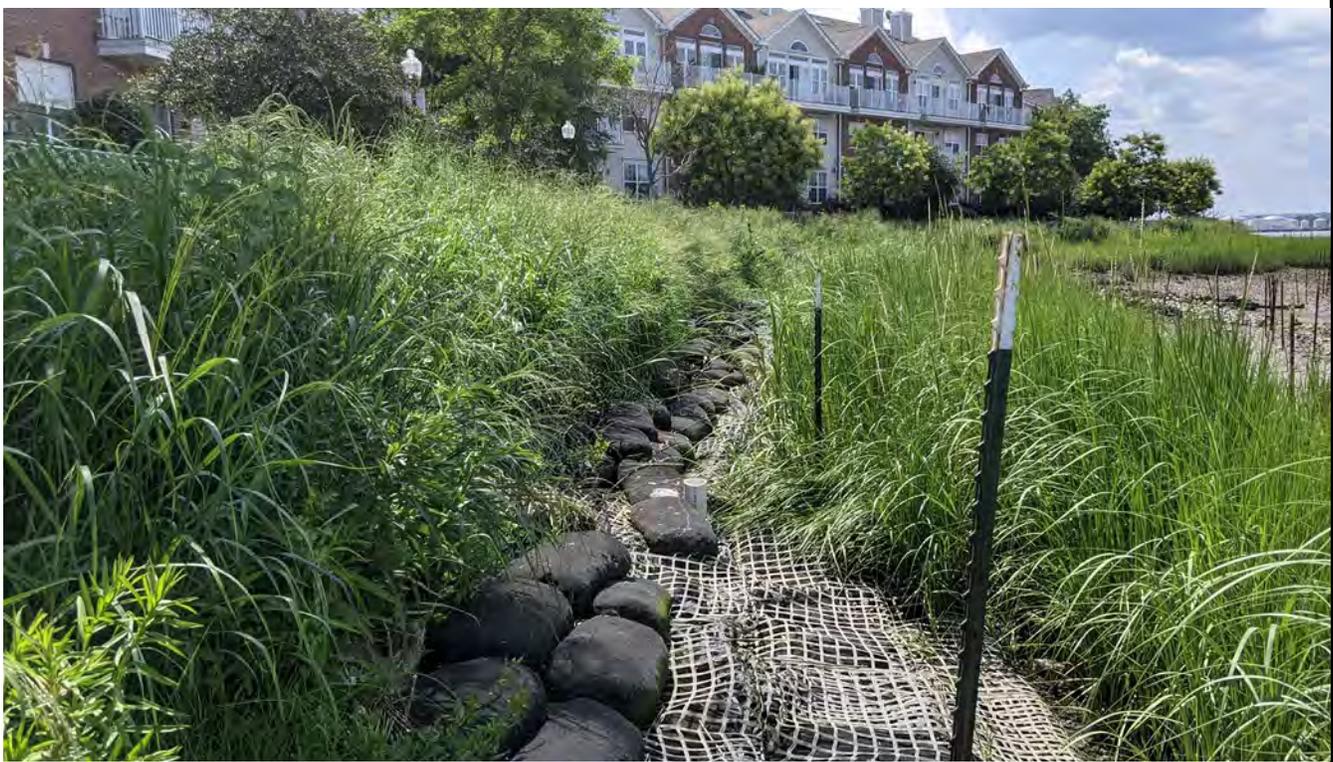
Photo 21: Exposed geogrid and RockSoxx in the high marsh zone of the central portion of the BEP area between Outfalls A and B (facing west).
