MEMORANDUM

Subject: **SA-7 Sediment Remedy Long-Term Monitoring
Summary of Year 8 Monitoring & Proposed Year 8 Program**

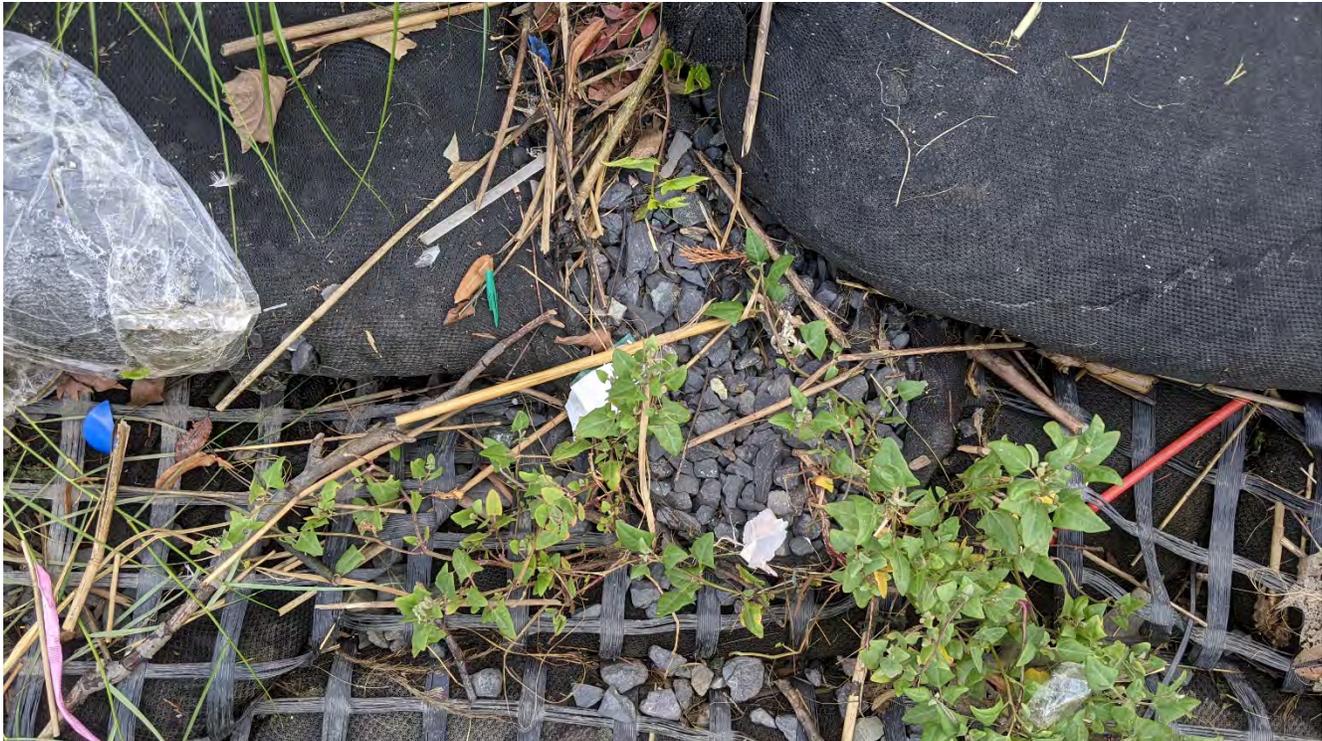
Photo 24: Typical damaged RockSoxx located along the drift line within the transition area between the high marsh and upland vegetative communities between Outfalls A and B.

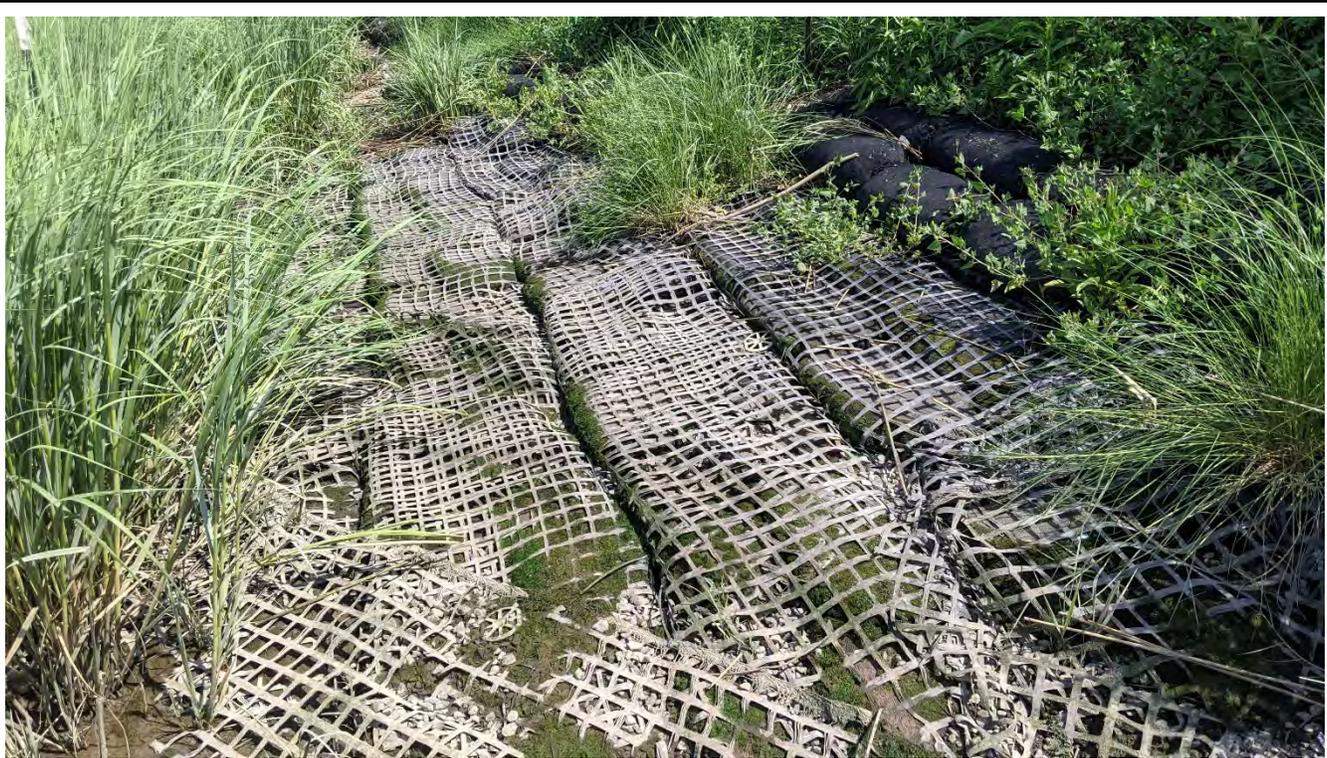
Photo 25: Sparse vegetation present near the exposed geogrid and RockSoxx located adjacent to Outfall C (facing southeast).

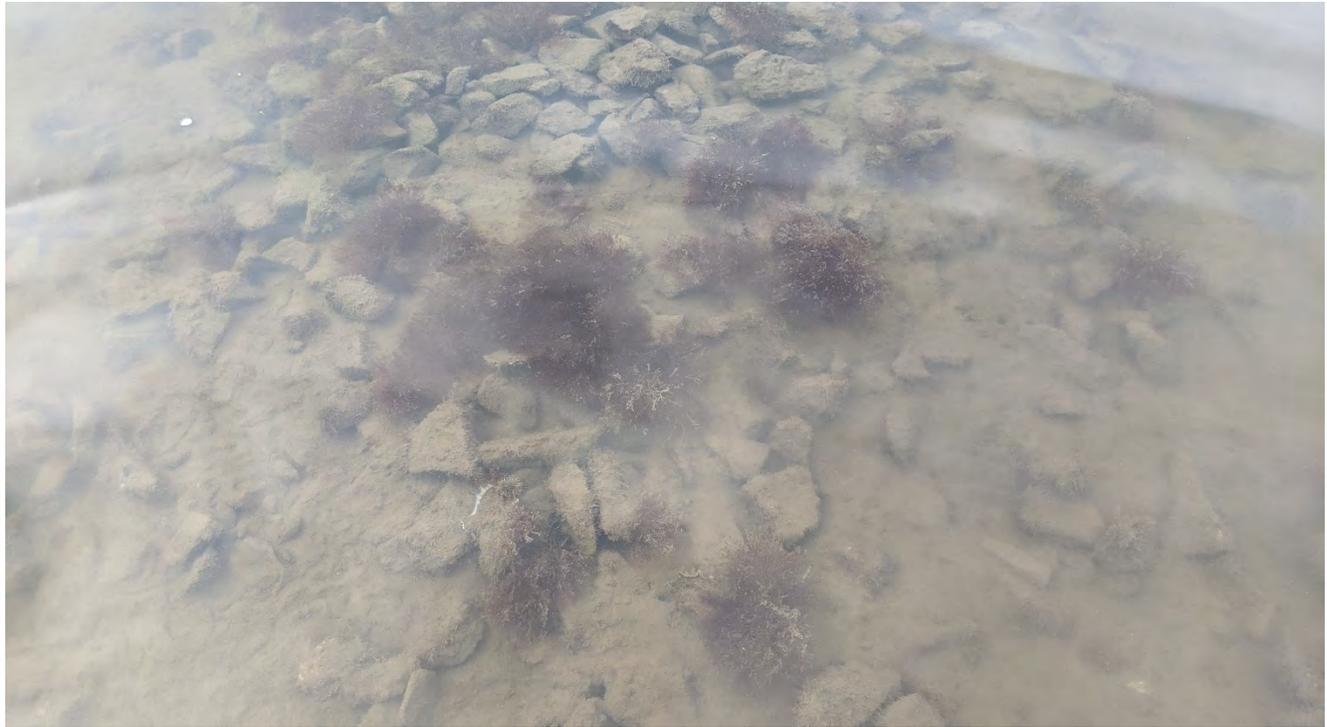
Photo 6: Siltation and subaquatic vegetation observed on Cap Area 22.

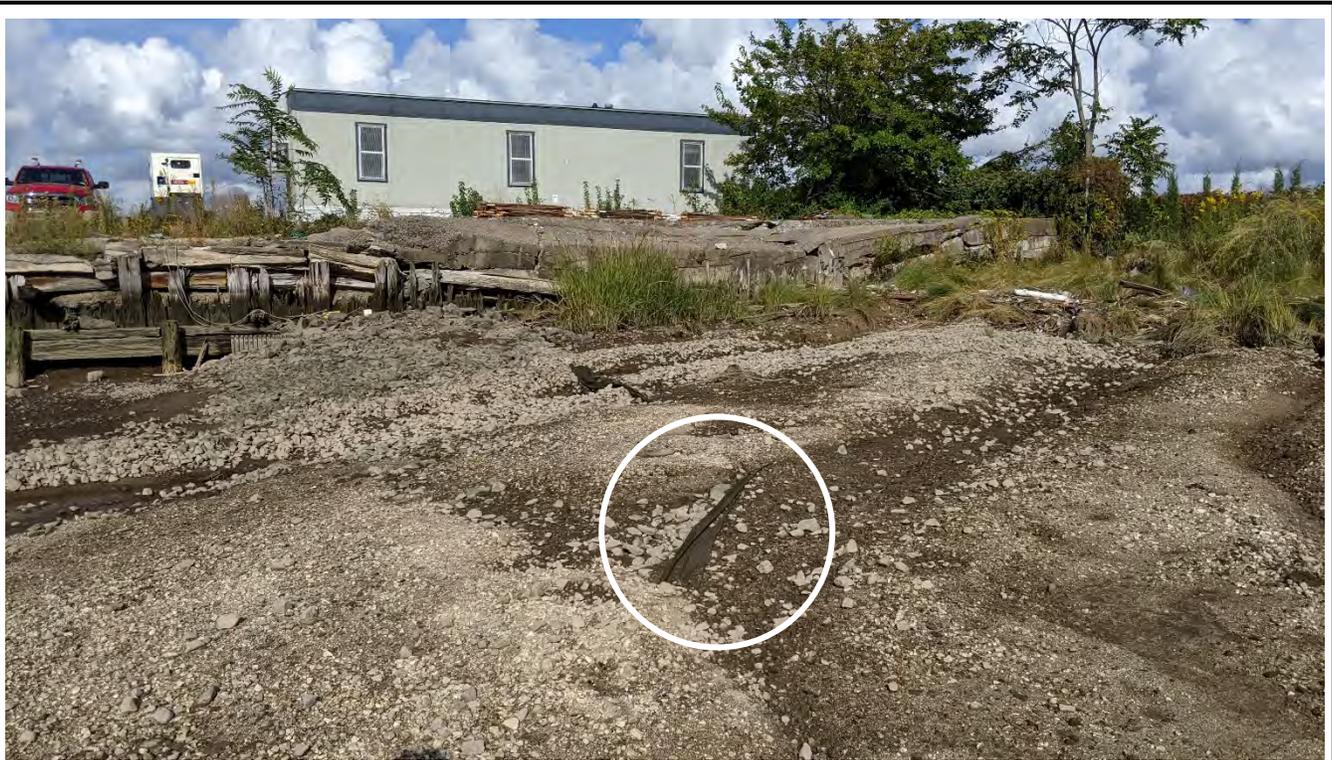
- Damage to approximately 60 linear feet of shoreline stabilization berm; and
 - Sediment scouring at the discharge of Outfall D. Beyond this area, small segments of the stone edge along the rip-rap aprons was displaced and some exposed geotextile was observed along the shoreline stabilization berm.

Photo 7: Eroded area located on the eastern side of the BEP near Outfall D (facing northeast). Note the shoreline stabilization stone scattered throughout and the exposed geotextile.

Damaged areas were repaired in March 2022 to prevent further erosional damage.

Repairs to the BEP area caused by the remnants of hurricane Ida will be completed in early 2022. The repairs will consist of the placement of stone along the shoreline stabilization berm on the eastern side of the BEP, regrading of the eroded areas located on the eastern side of the BEP, placement of stone armoring between the BEP area and Kellogg Street (to help prevent future erosional damage), and placement of additional stone armoring along the edges of the outfall aprons (where they connect to the shoreline stabilization berm).

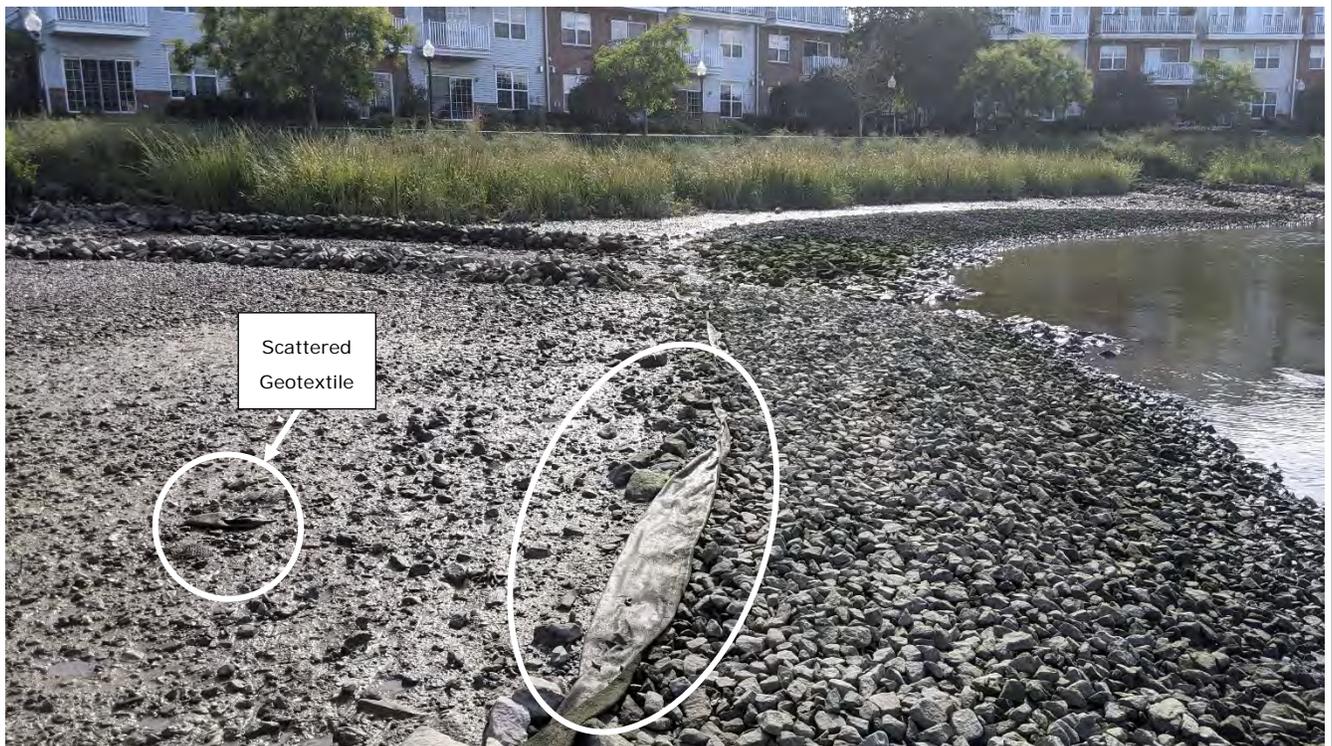
Photo 8: Shoreline stabilization stone located east of Outfalls B and C (facing southwest). Note the exposed geotextile fabric between the shoreline stabilization stone and the BEP fill material (facing southwest).

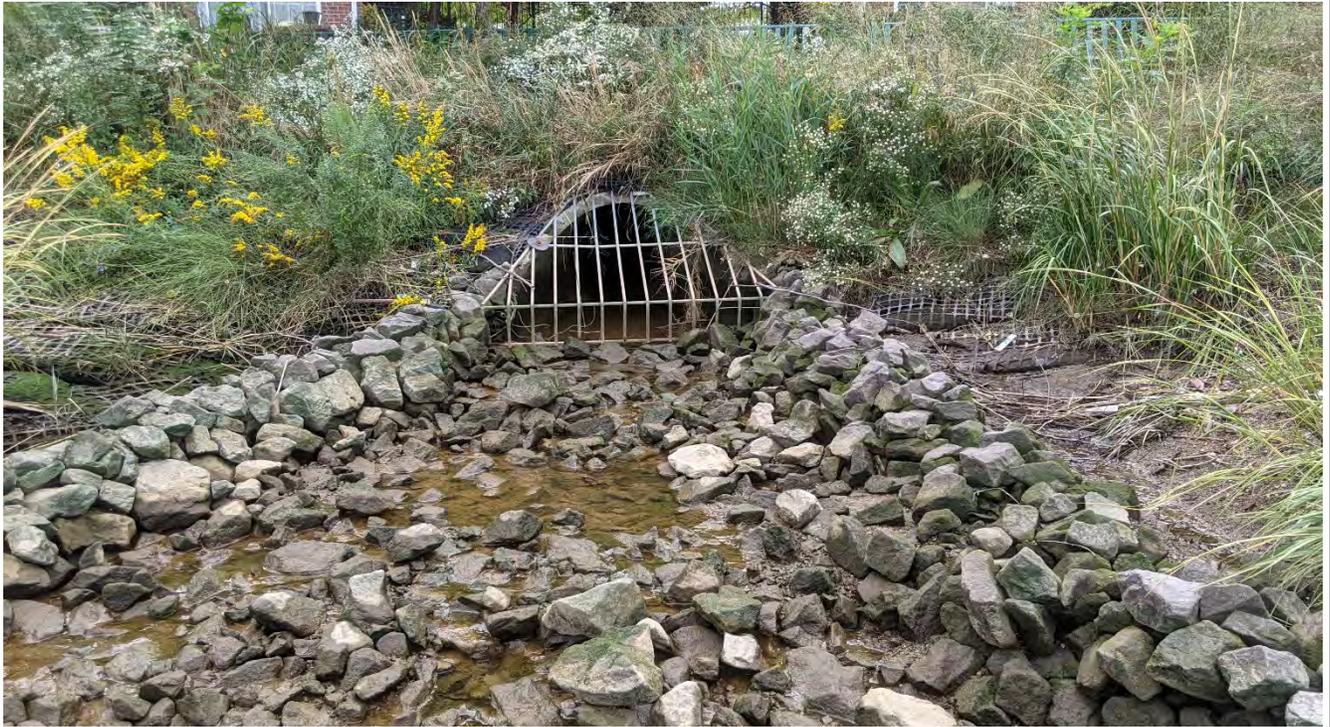
Photo 9: Moderate scouring observed in the western side (i.e., right side) of Outfall A (facing southwest)

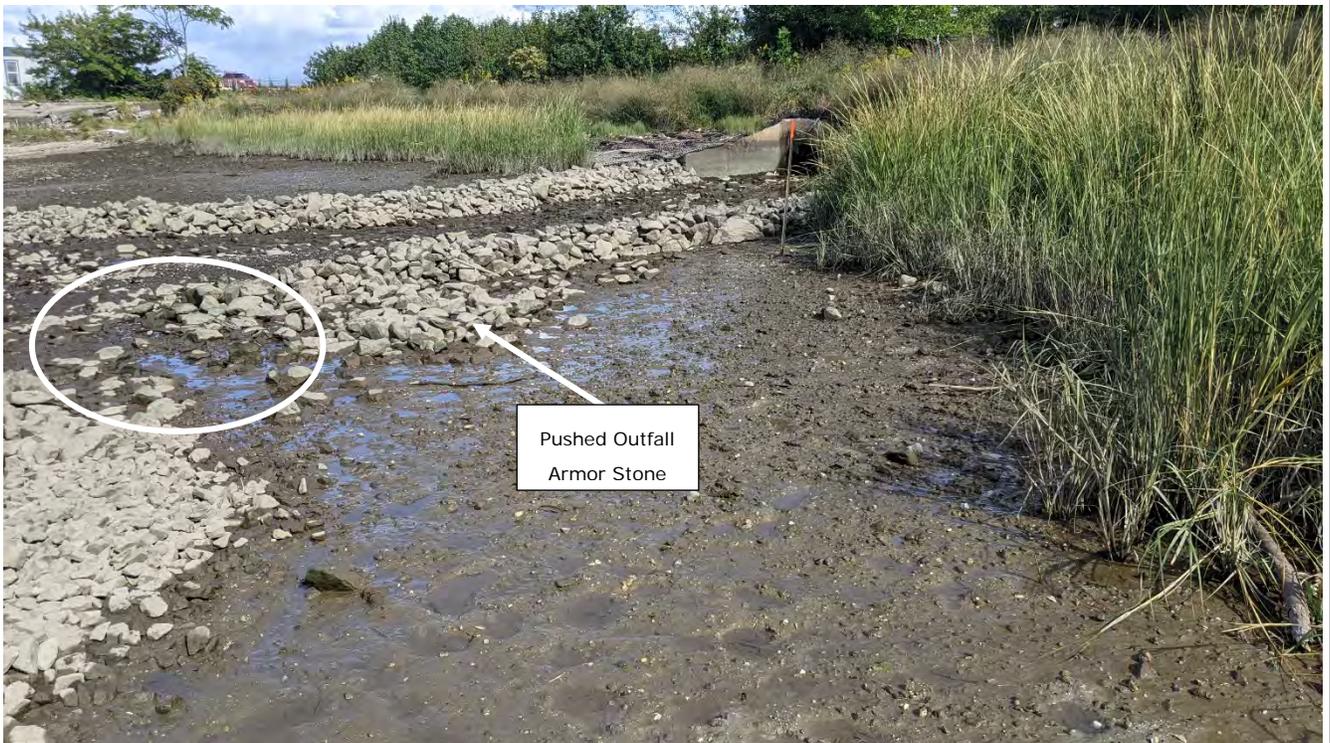
Photo 10: Missing armoring observed along the western edge if the apron for Outfalls B and C (facing northeast). Stone was pushed into the nearby BEP fill material..

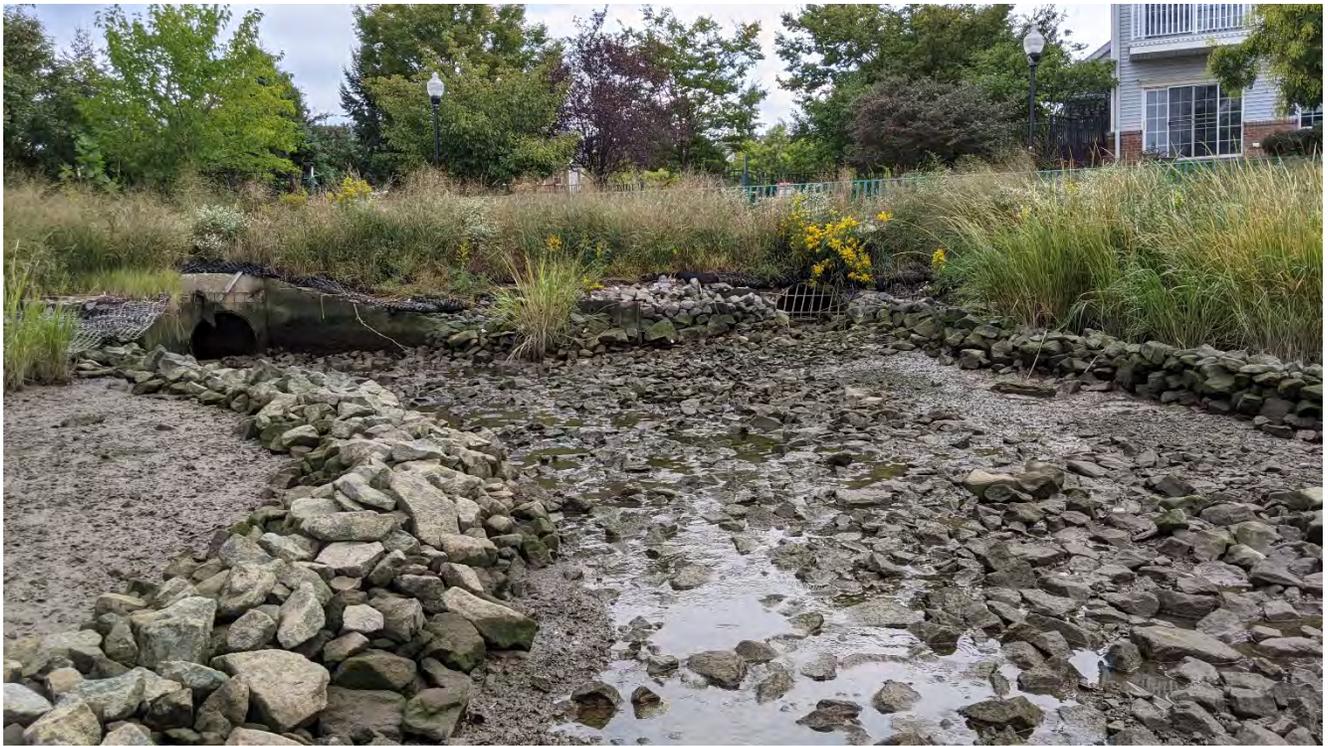
Photo 11: Outfalls B and C (facing southeast). Note the siltation present on the stone which lines the apron.

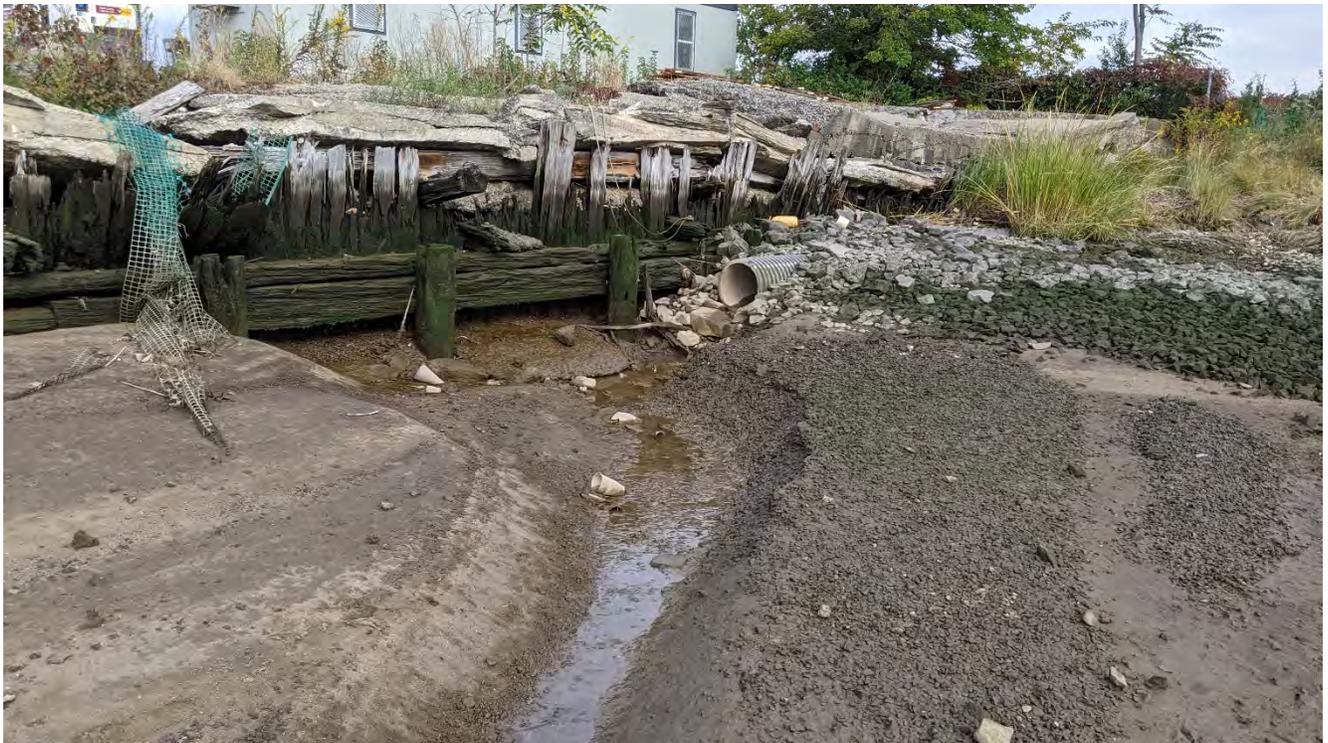
Photo 12: Scour channel was observed in sediments at the discharge of the Outfall D (facing east).

TABLE 2. BENEFICIAL ENVIRONMENTAL PROJECT AREA INSPECTION LOG			
BEP AREA ELEMENT	OBSERVATIONS	PHOTO(S) TAKEN	CORRECTIVE ACTION(S) REQUIRED
SHORELINE STABILIZATION	<ul style="list-style-type: none"> • Shoreline stabilization was damaged by the September 2020 storm event. Specifically, <ul style="list-style-type: none"> – Approximately 65 linear feet of shoreline stabilization stone, located on the eastern side of the BEP near Outfall D, washed out. – Several areas of exposed geofabric were observed between the BEP fill material and the shoreline stabilization stone. 	7 to 8	<ul style="list-style-type: none"> • Repair shoreline stabilization stone on the eastern side of the BEP (near Outfall D) . • Cut or cover exposed geofabric located between the BEP fill material and the shoreline stabilization stone.
OUTFALL RIPRAP APRONS	<ul style="list-style-type: none"> • The outfalls were damaged by the September 2020 storm event. Specifically, <ul style="list-style-type: none"> – Outfall A: Approximately 8 linear feet of the stone edge on the southwest side of the outfall's apron was displaced. – Outfalls B and C: Consistent with prior observations, approximately 1 to 3 inches of siltation (likely displaced shoreline fill) were observed throughout the riprap apron, especially in the vicinity of both outfalls. Approximately 3 to 4 inches of siltation was observed along the western edge of the Outfall B riprap apron. However, approximately 15 linear feet of the stone edge along the northwest corner of the apron was displaced. – Outfall D: The outfall makes a 90-degree turn near the southernmost corner of the bulkhead at the terminus of Kellogg Street. A significant area of erosion approximately 20 square feet and 4 feet deep was observed at this location, exposing the pipe. The stone around the pipe in this area was washed out and scatted in the low marsh planting zone on the eastern side of the BEP. <p>Although outside of the BEP area, an approximately 65 ft long, 1 to 1.5 feet deep and 1 to 2 feet wide scour channel was observed in sediments at the discharge of the outfall.</p>	9 to 15	<ul style="list-style-type: none"> • Repair the damages to outfall areas and fill scour hole at the elbow of Outfall D.

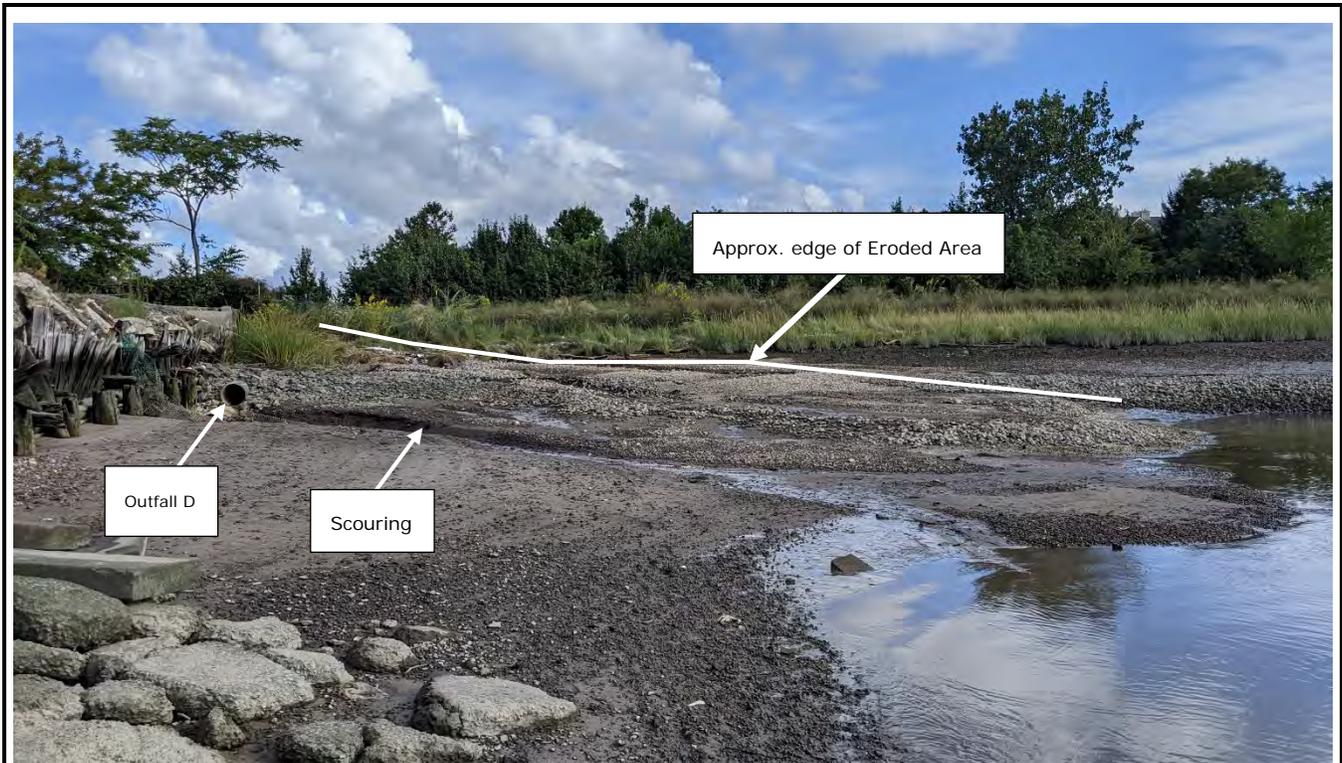
Photo 13: Eroded area located in the eastern corner of the BEP at the Outfall D (facing southeast). Note the displaced shoreline stabilization stone and erosion throughout.

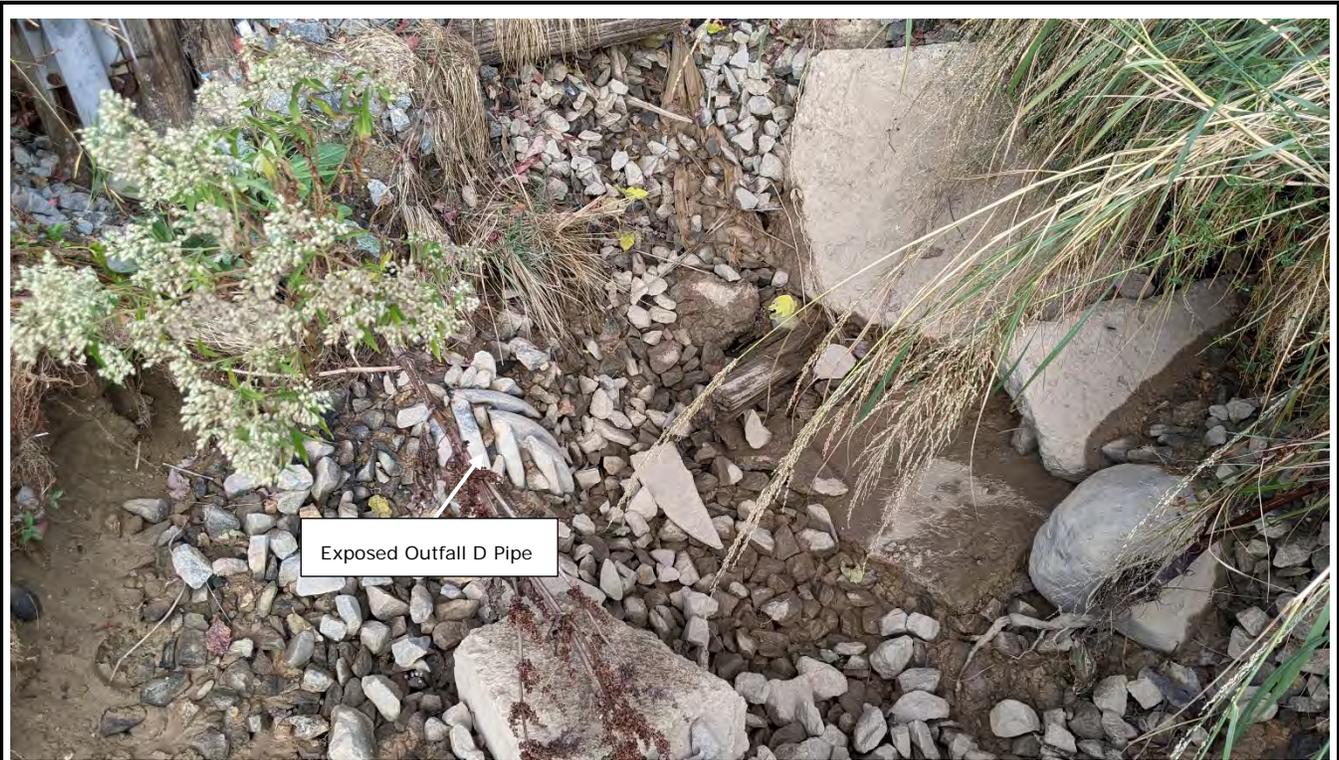
- An approximately 4-foot deep scour hole in the upland transition area in northeast corner;
 - Surface erosional damage across the northernmost portion of the low marsh and, to a lesser extent, the high marsh (approximately 1300 square feet);

Photo 15: Exposed Outfall D pipe within 4-foot-deep scour hole located near the southeast corner of the BEP along the bulkhead.

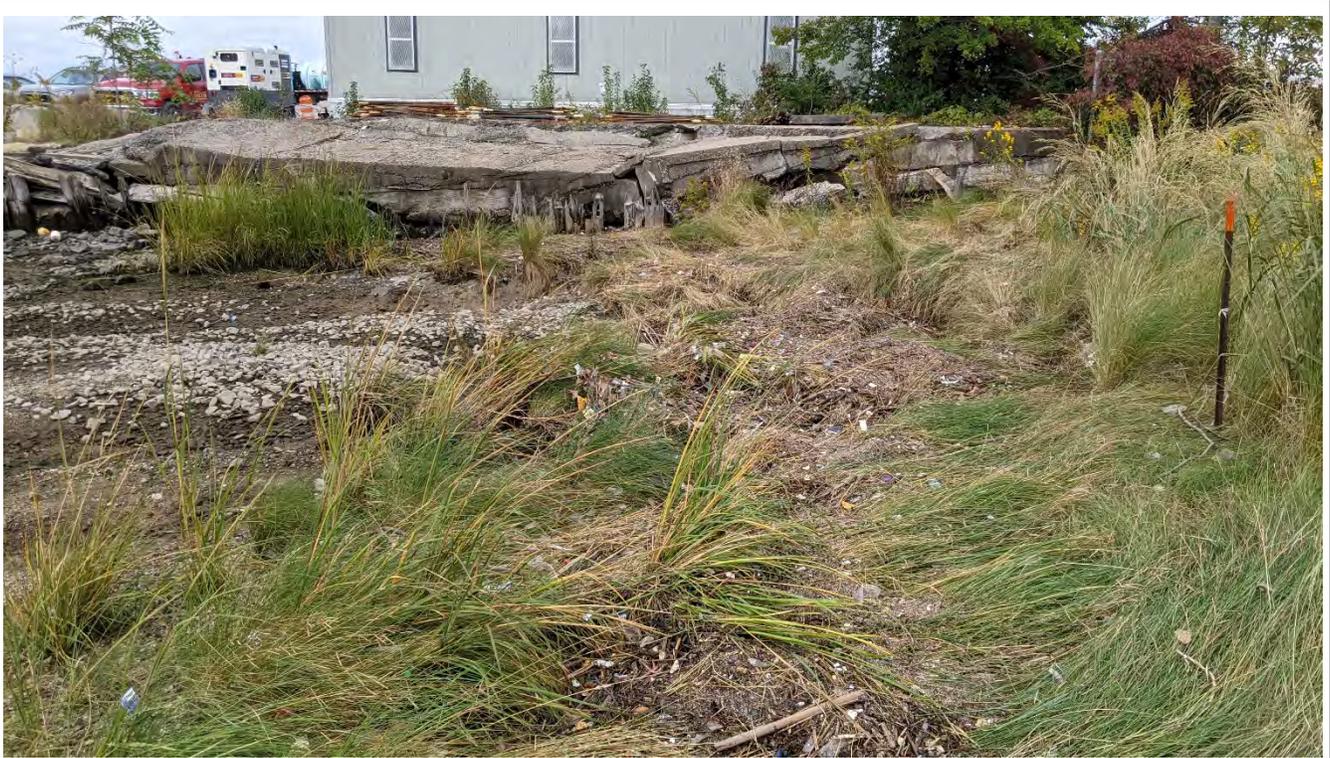
Photo 17: Area where the low marsh planting zone meets the high marsh planting zone within the eastern side of the BEP (facing northeast). Note the significant amount of debris and uprooted plant material.

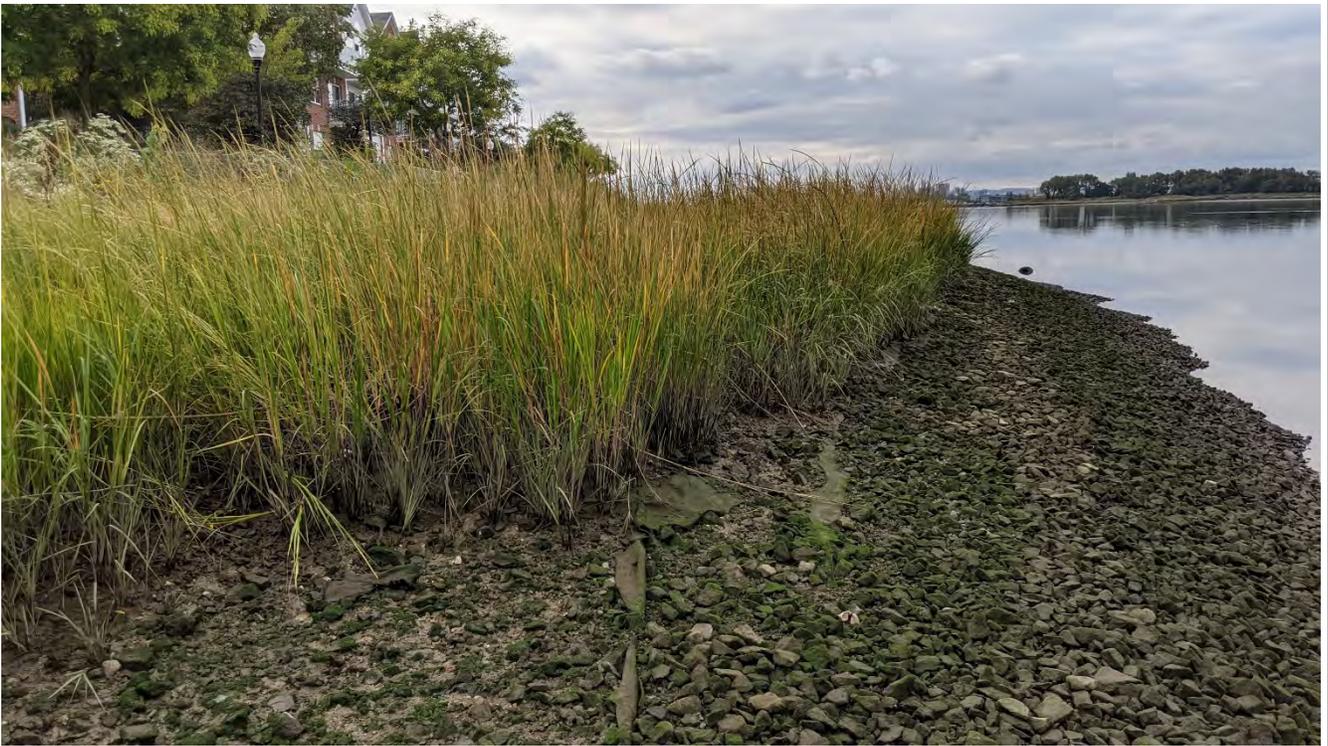
Photo 23: High marsh plantings on the western side of the BEP (facing west). Note the vibrant and health vegetation and exposed geotextile fabric between the shoreline stabilization stone and the BEP fill material.

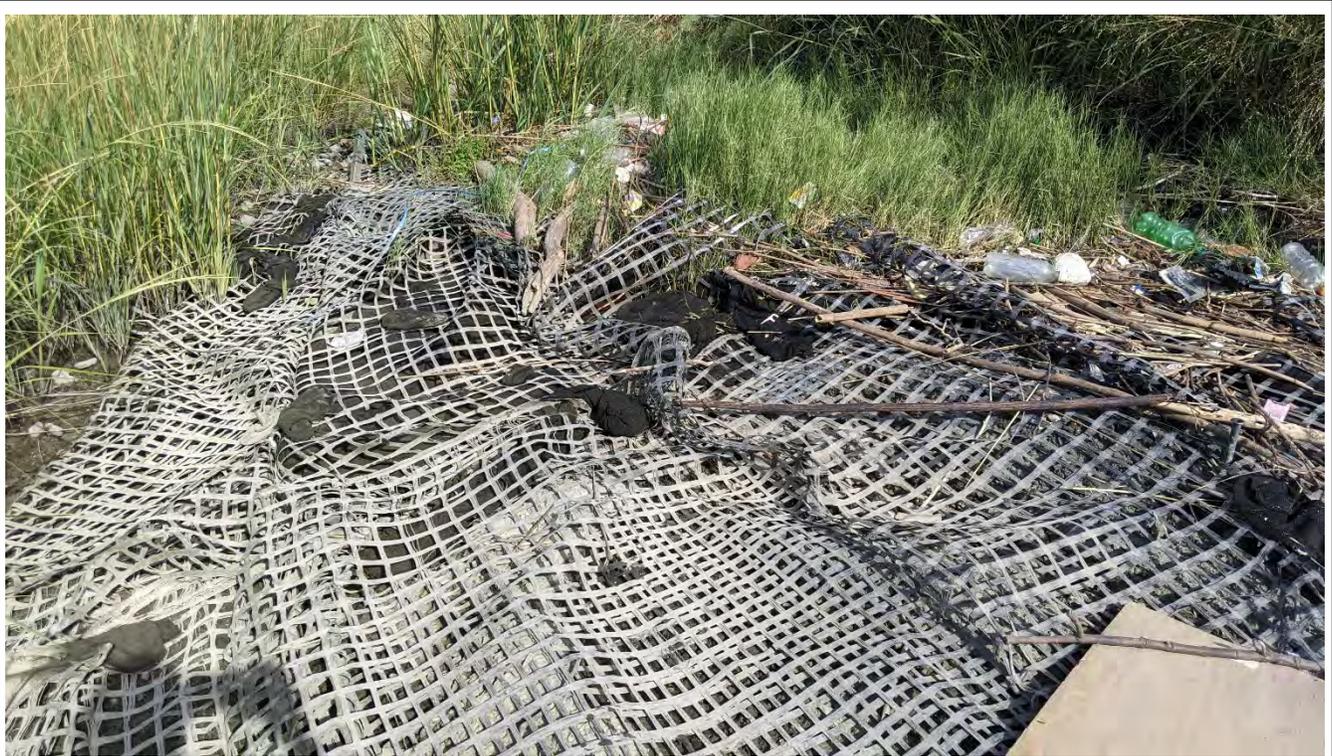
Photo 25: Area of exposed Grossoxx and geogrid located east of Outfall C (facing south).

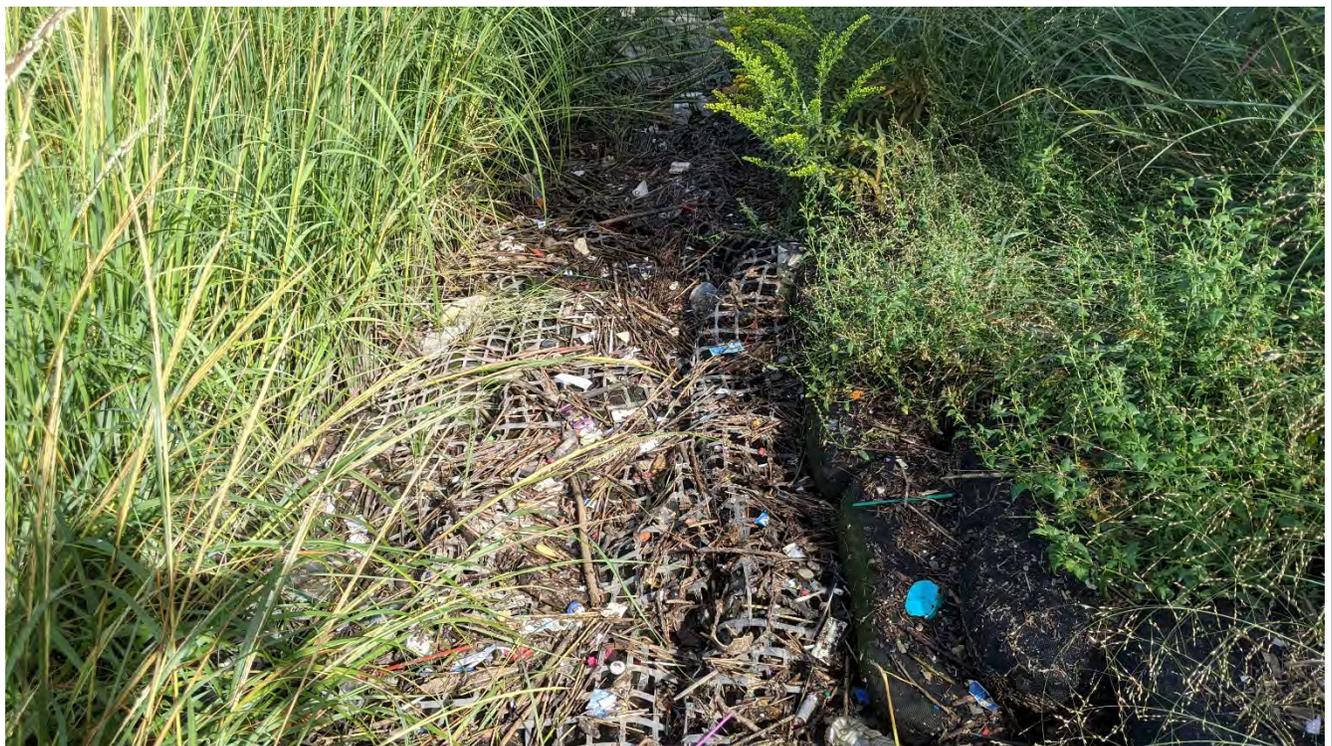
Photo 26: Area of exposed Grossoxx and geogrid between Outfalls A and B. Note the debris scattered throughout the geogrid.
