# MEMORANDUM

Subject: **SA-7 Sediment Remedy Long-Term Monitoring**  
**Summary of Year 9 Monitoring & Proposed Year 10 Program**

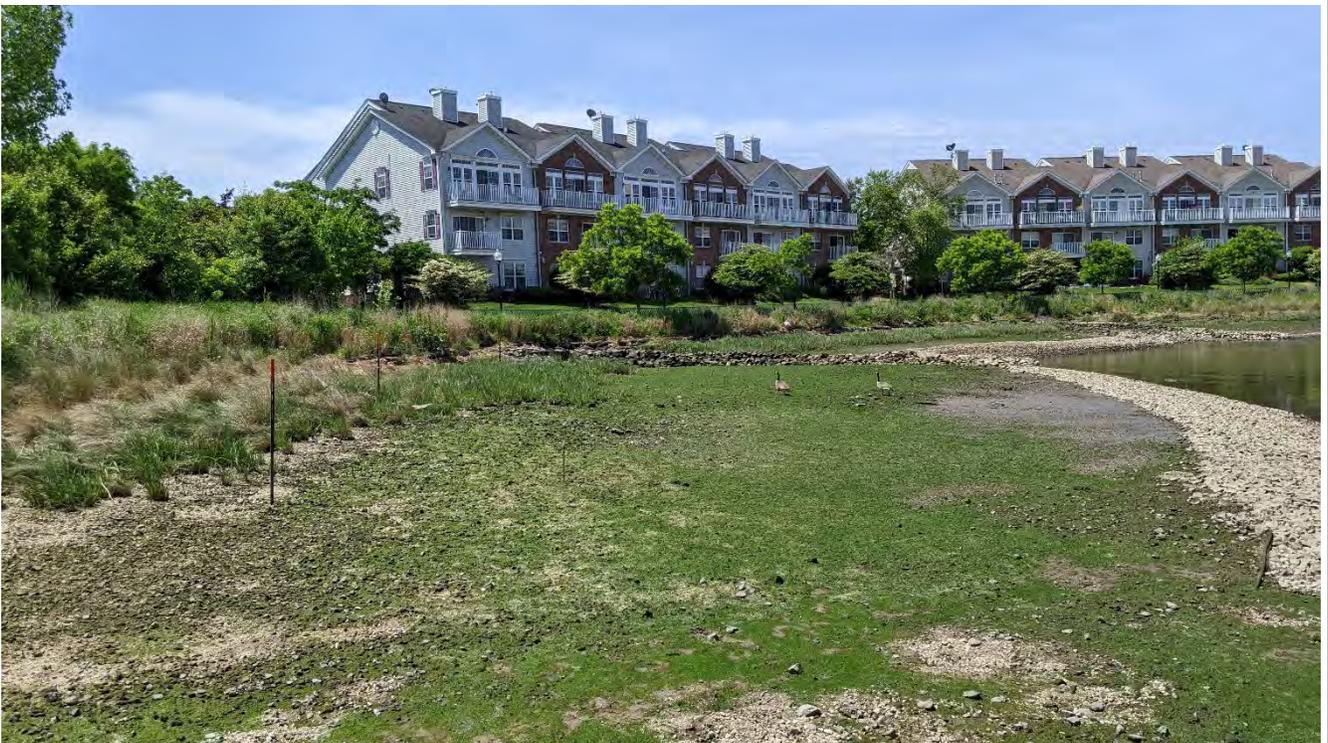
**Photo 2:** Central portion of Cap Area 16. Note presence of algae over the low marsh zone (facing southwest).

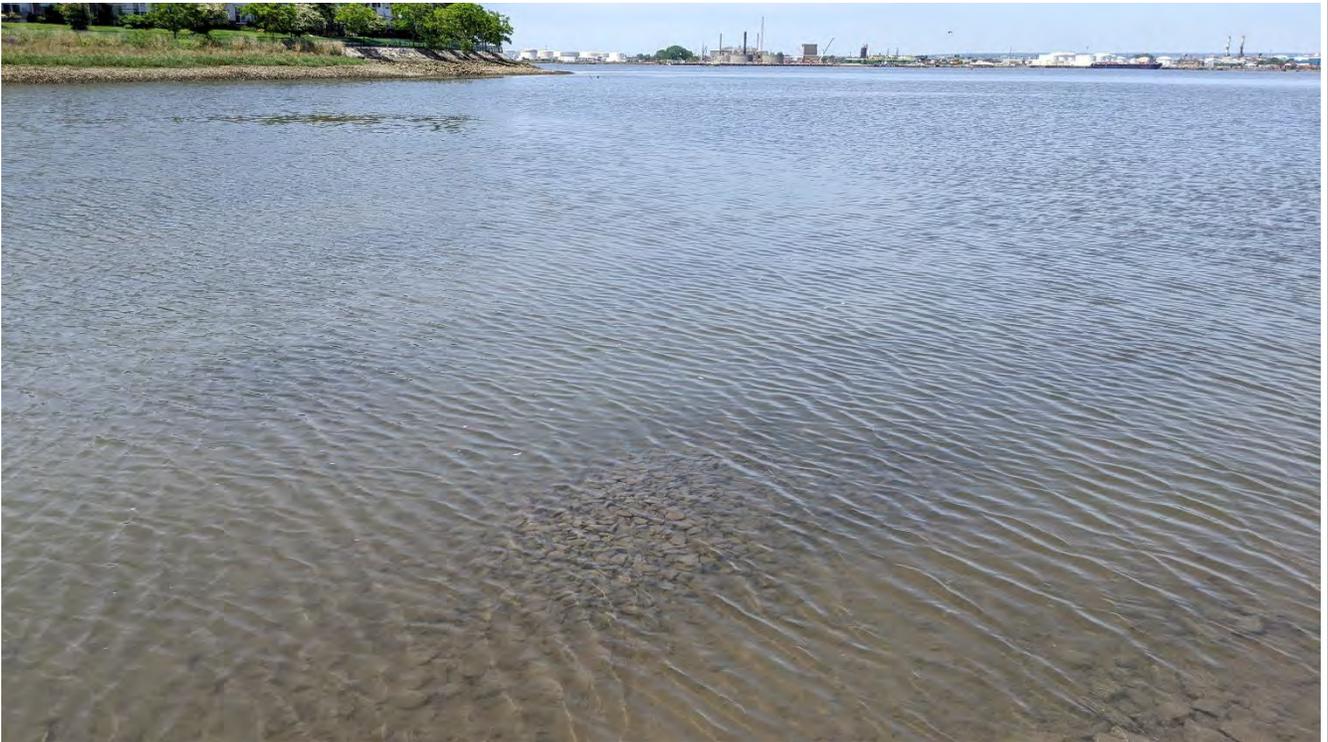
**Photo 4:** Siltation observed within Cap Area 22 (facing west).

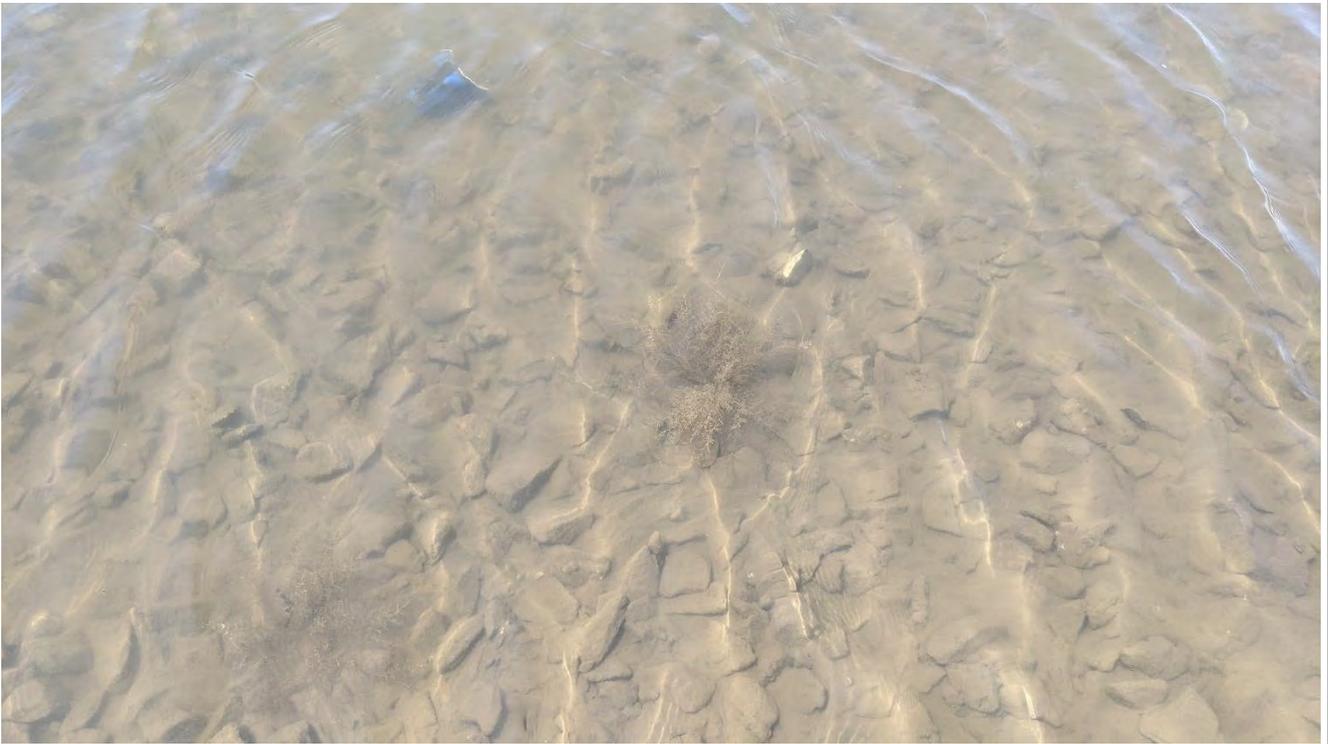
**Photo 5:** Siltation and subaquatic vegetation observed on Cap Area 22.

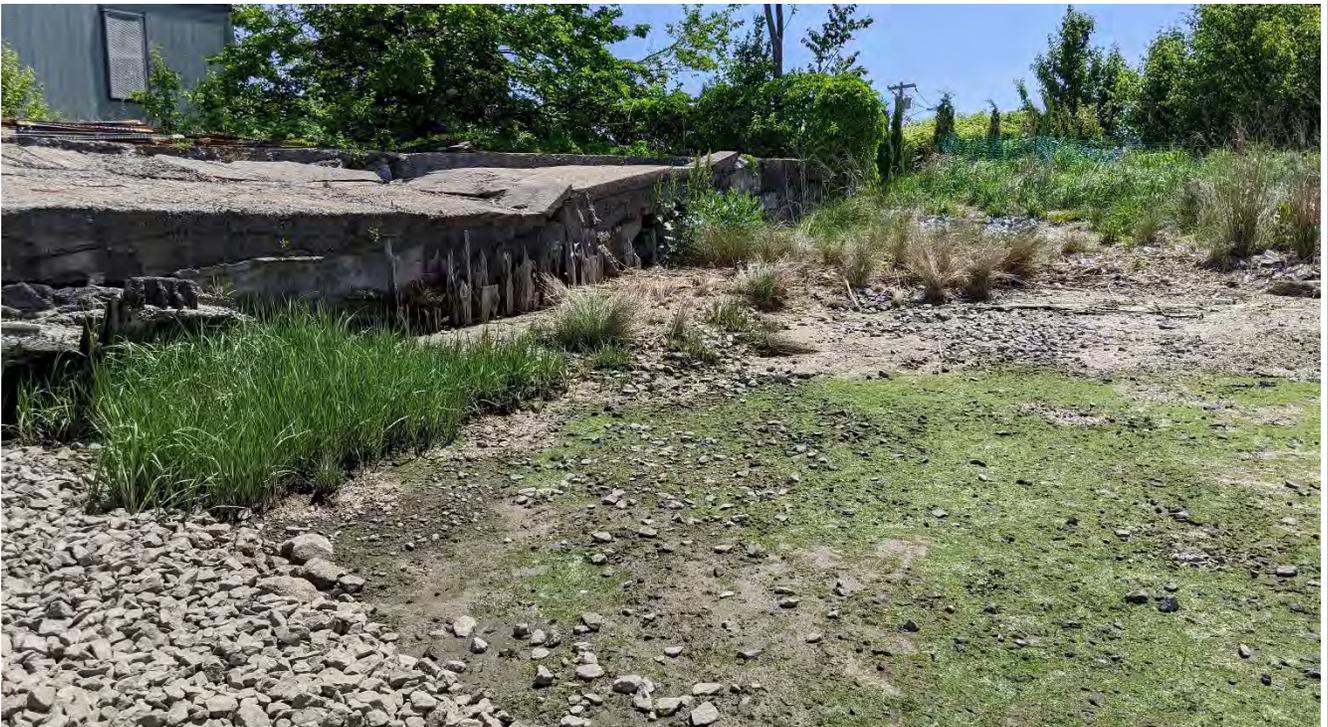
**Photo 6:** Repaired eroded area located on the eastern side of the BEP near Outfall D (facing southeast).

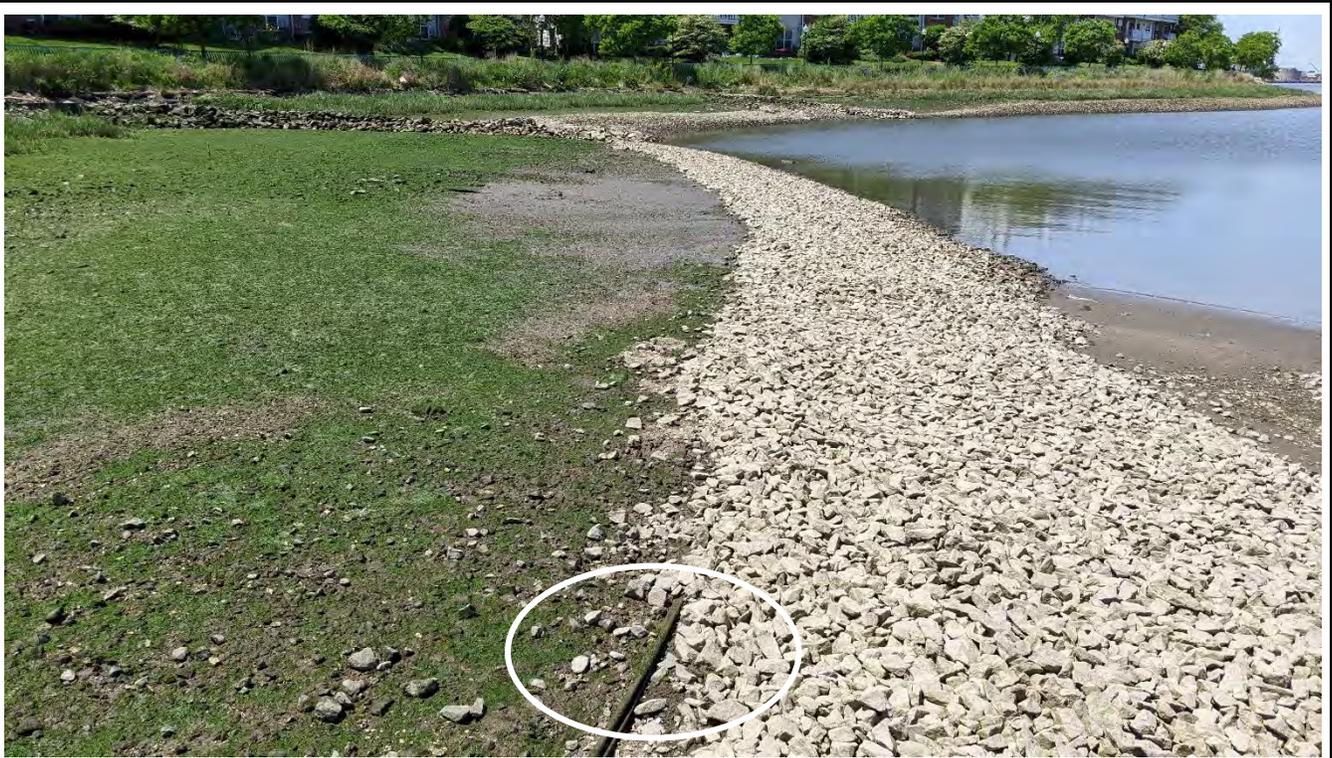
**Photo 7:** Repaired shoreline stabilization stone located west of Outfall D (facing southwest). Note the exposed geotextile fabric between the shoreline stabilization stone and the BEP fill material.

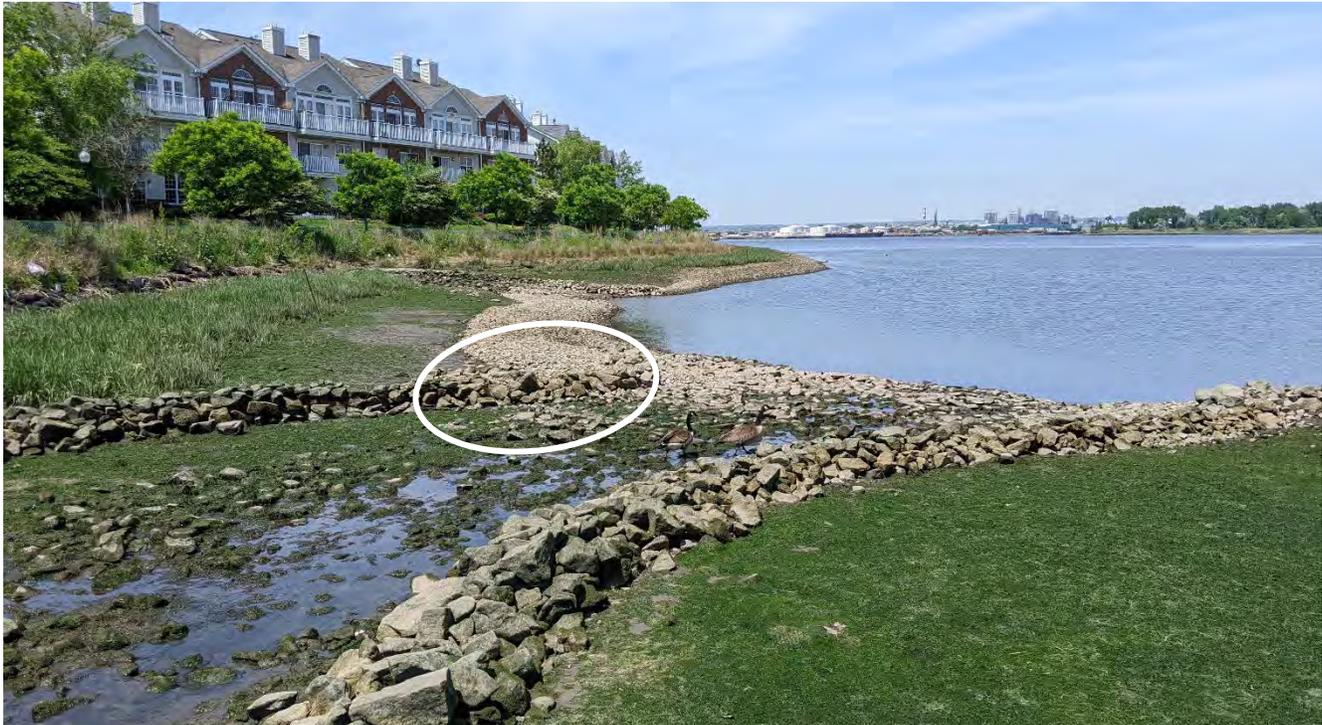
Photo 9: Repaired armor stone along the western edge of the apron for Outfalls B and C (facing west).

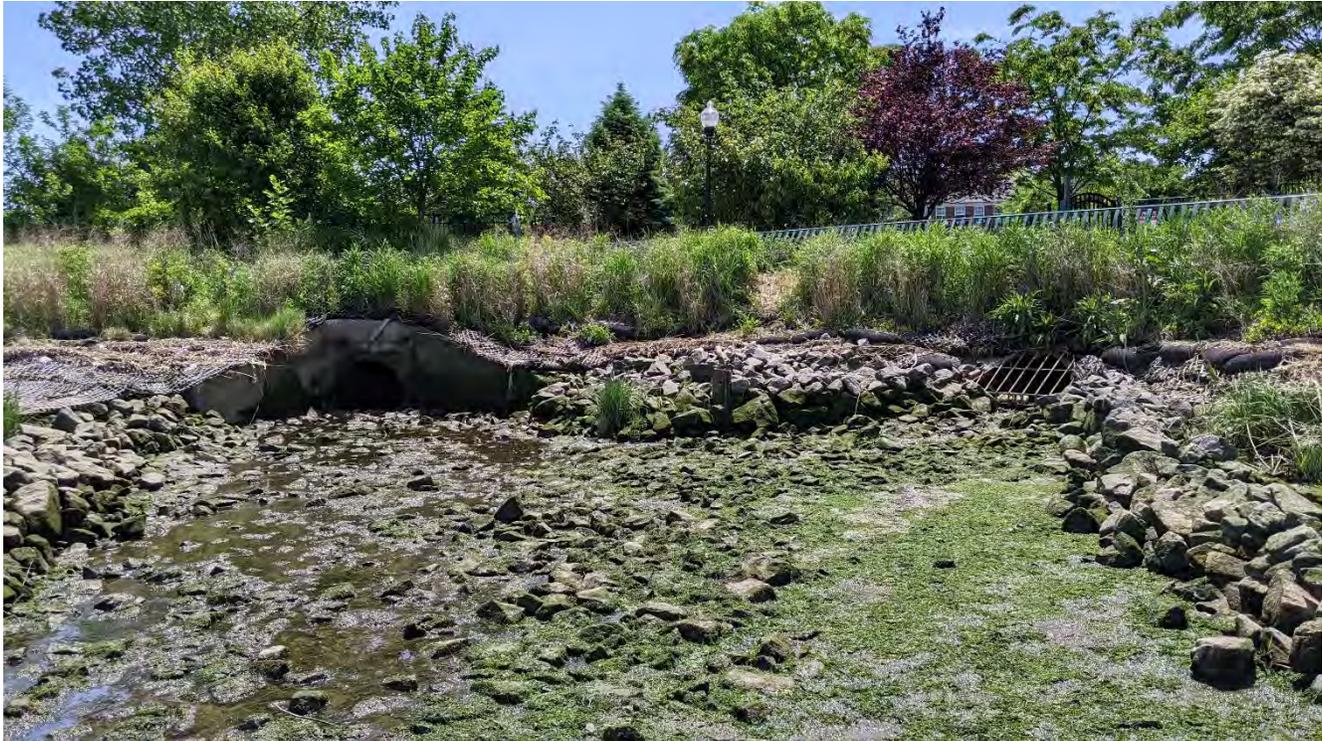
Photo 10: Outfalls B and C (facing southeast). Note the siltation and algae present on the apron stone.

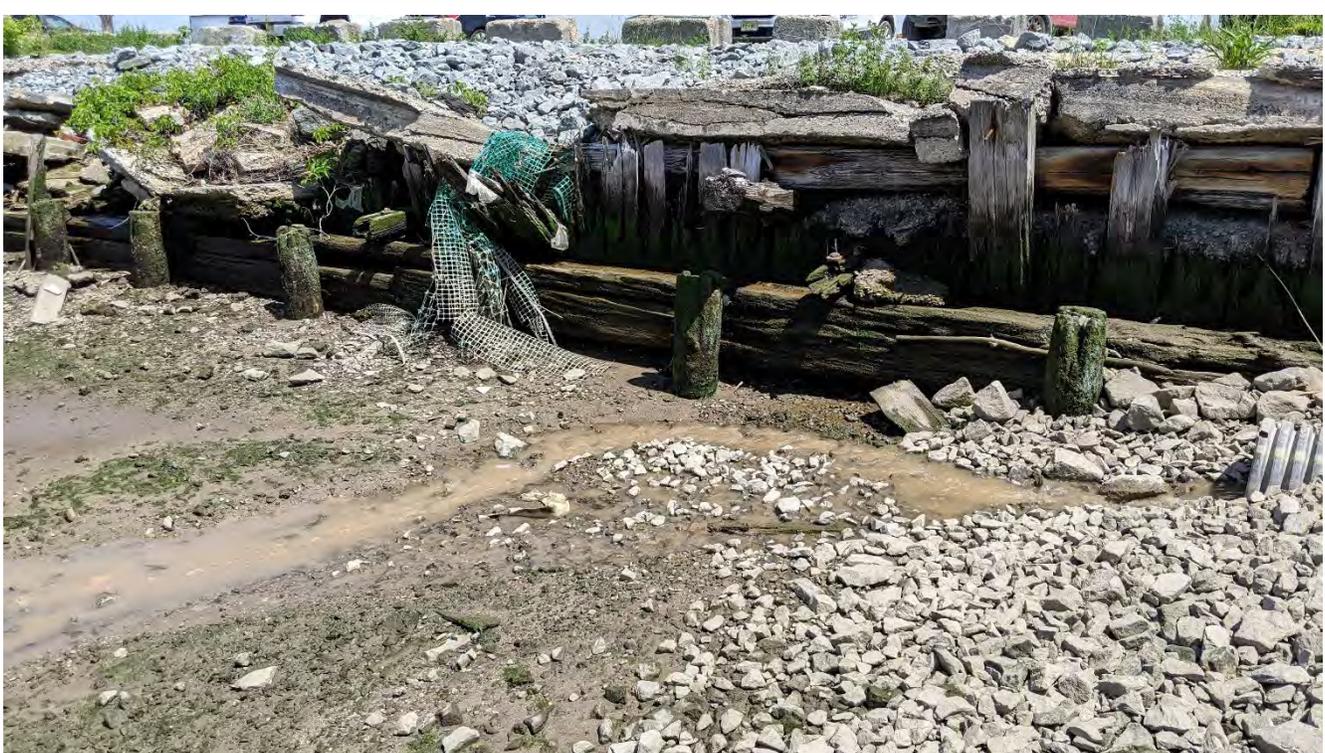
Photo 11: Minor scour channel was observed in sediments at the discharge of the Outfall D (facing east).

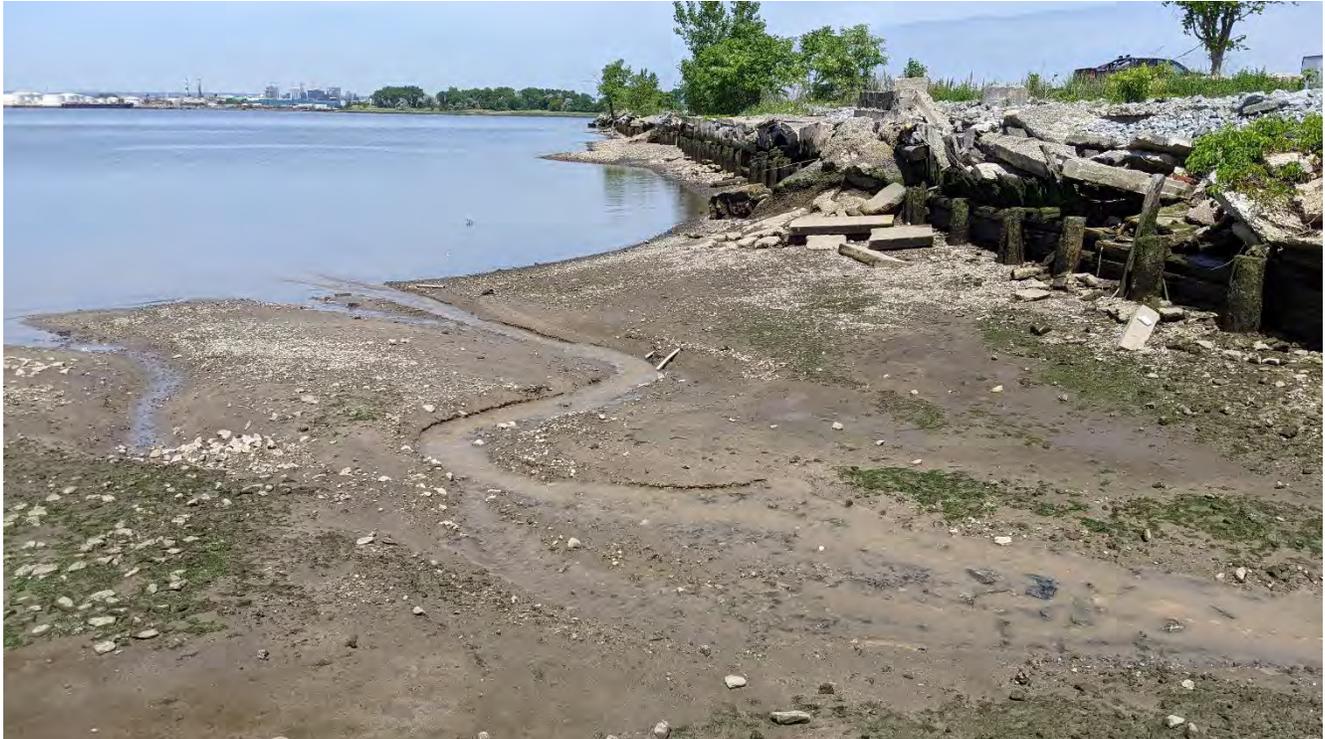
Photo 12: Scour channel observed at the discharge of Outfall D and Cap Area 22 in the background (facing northwest).

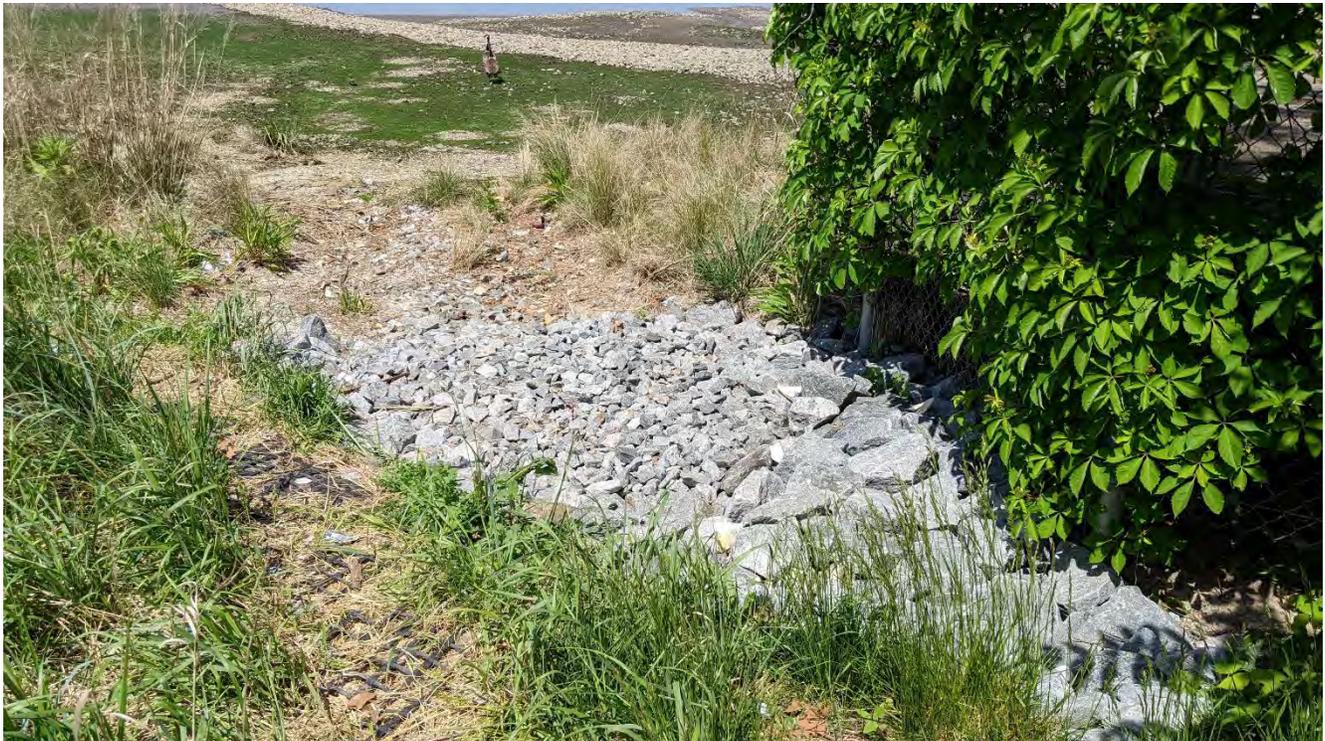
Photo 14: Repaired area located in the easternmost corner of the BEP area using ASTM #57 (0.75 inch) stone (facing northwest).

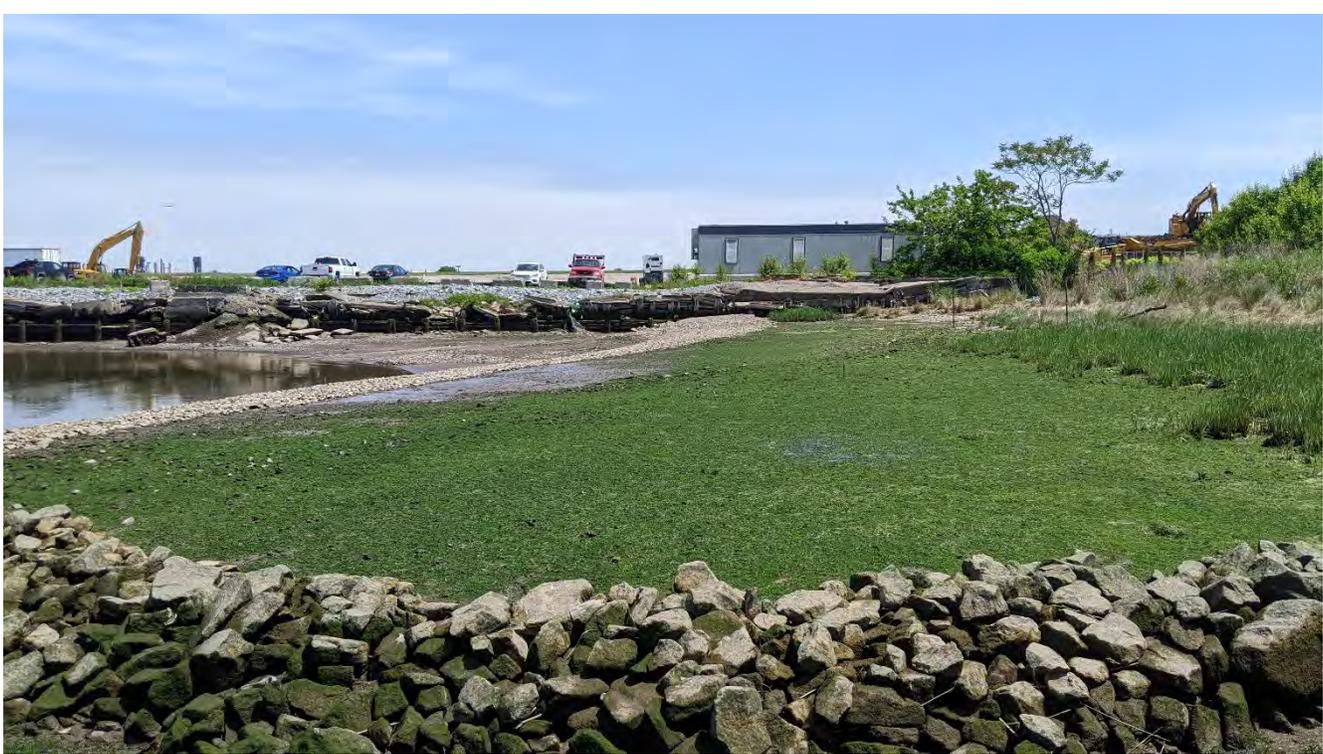
**Photo 17:** Low marsh planting zone within Cap Area 16 (facing northeast). Note the algae cover throughout the lower elevations of the low marsh area.

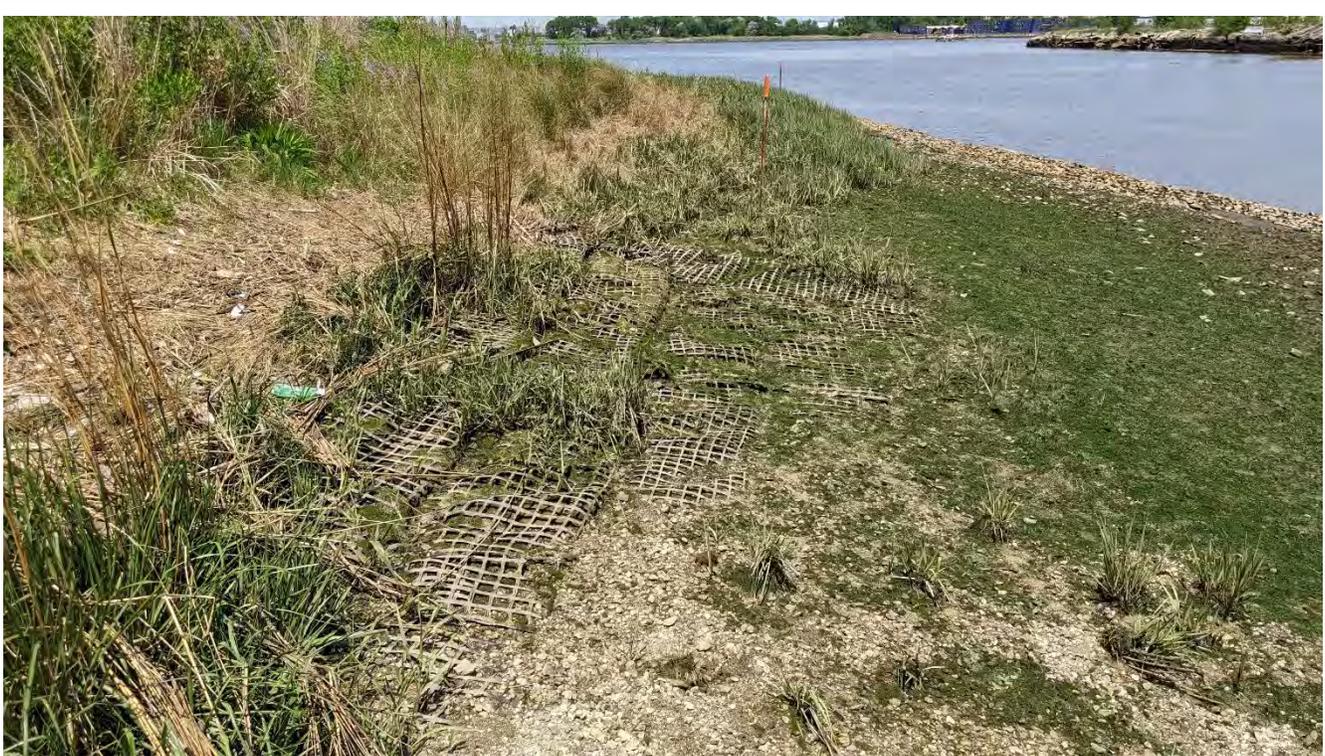
**Photo 19:** Stunted low marsh vegetation and exposed partially geogrid immediately west of Outfall A (facing northwest).

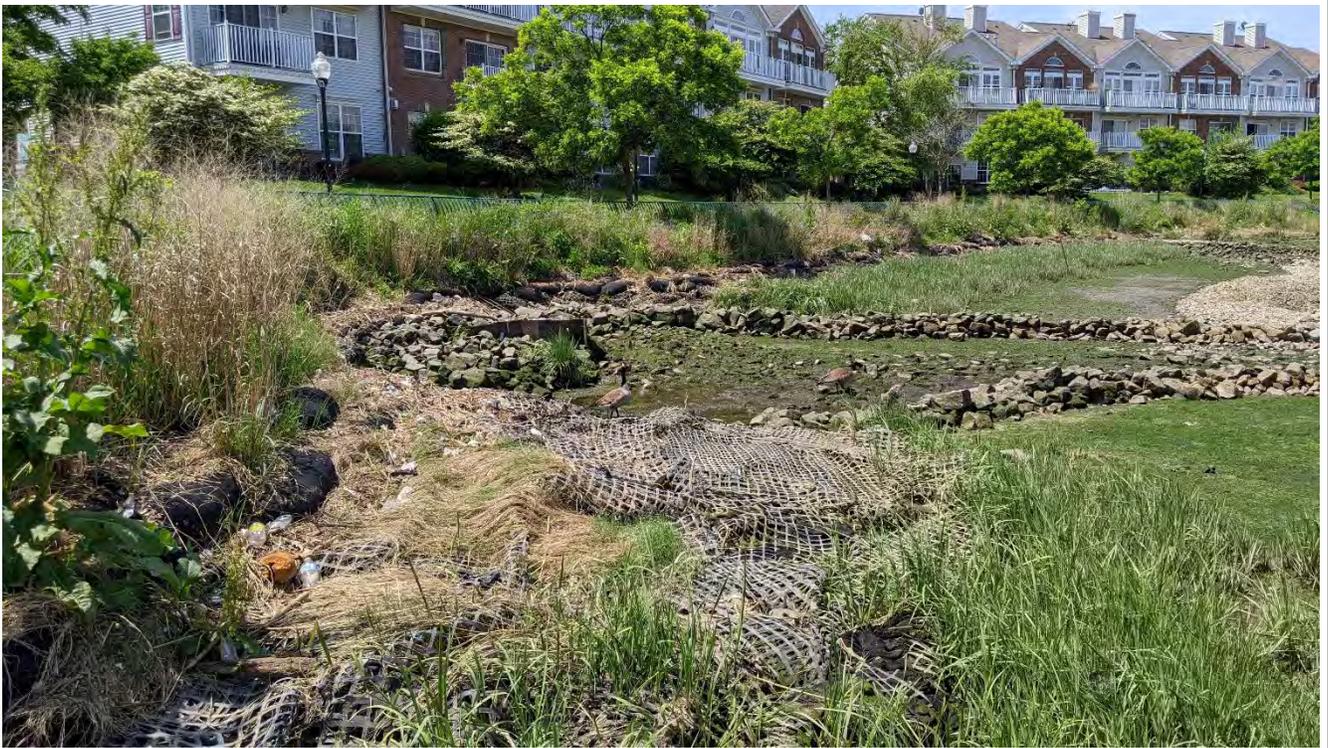
**Photo 23:** Vibrant and healthy vegetation within the high marsh and the upland transition area within Cap Area 16 (facing southwest). Debris present along the drift line and exposed geogrid in the high marsh planting zone.

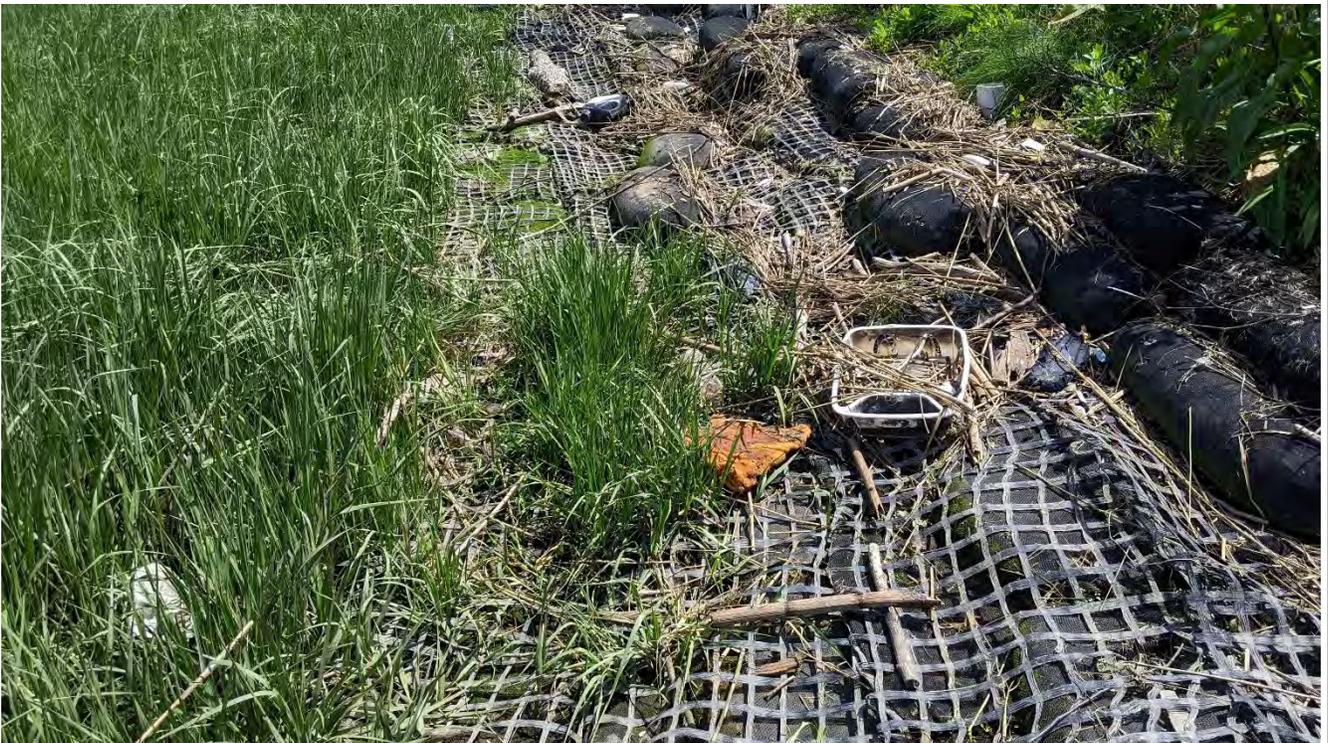
**Photo 24:** Area of exposed GroSoxx and geogrid with some debris, located east of Outfall A (facing southwest). Note the presence healthy and vibrant vegetation and emergent growth within the GroSoxx area.

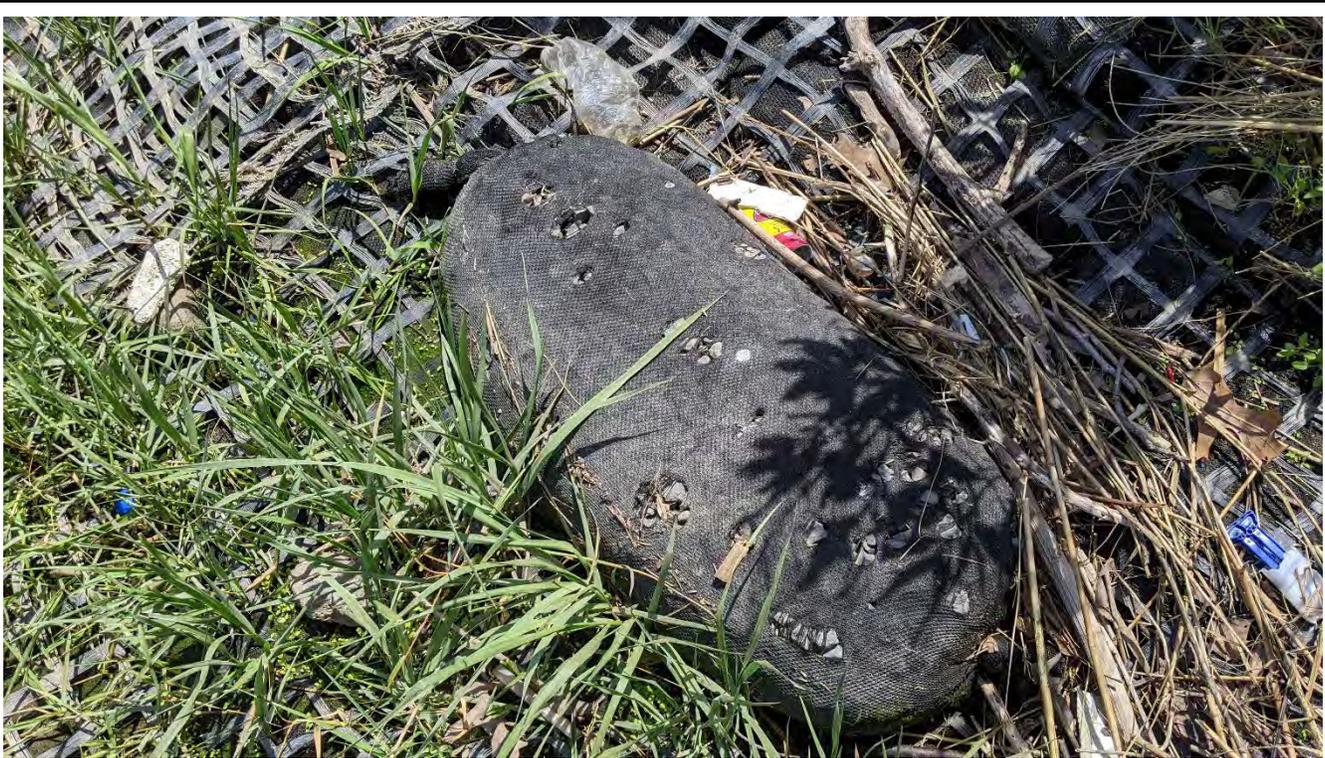
**Photo 25:** Punctured RockSoxx east of Outfall A. Note the debris scattered throughout the geogrid.

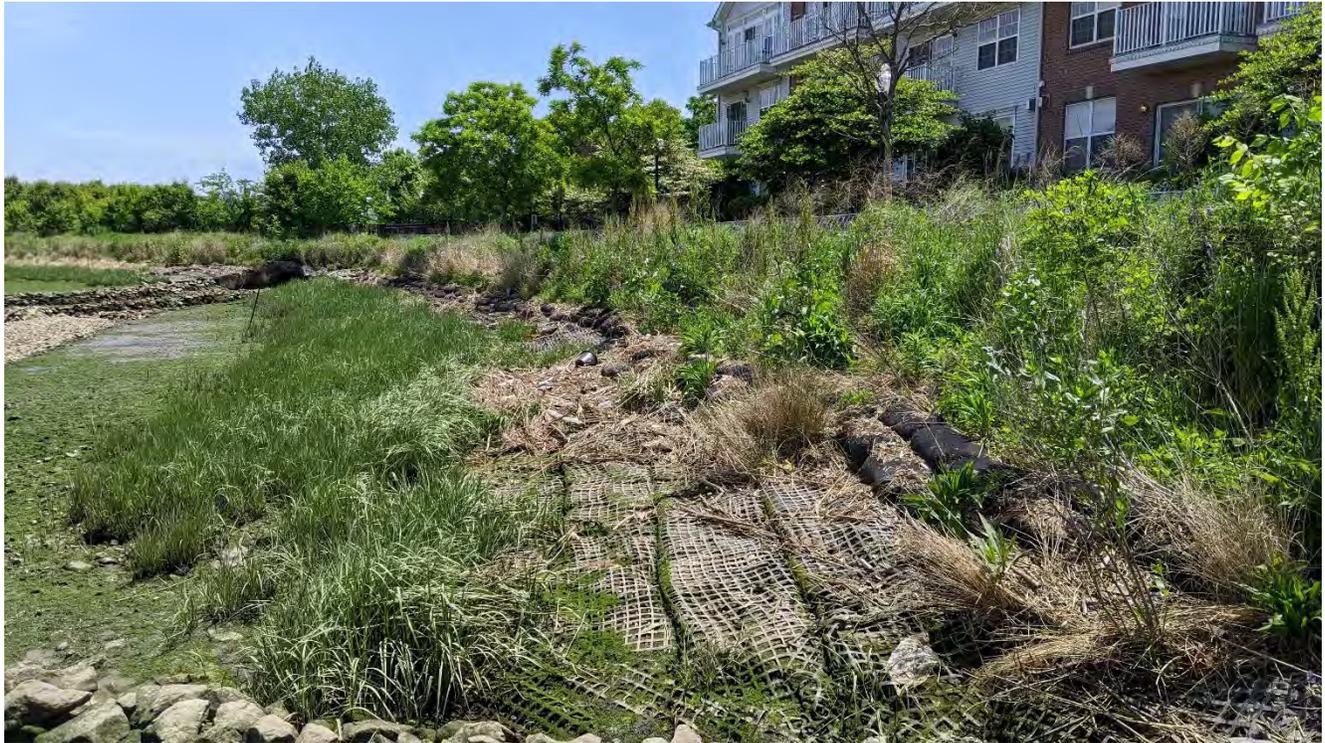
**Photo 26:** Vibrant and healthy upper low marsh, lower high marsh, and upland vegetation between Outfalls A and B (facing east). Note the exposed GroSoxx and geogrid.

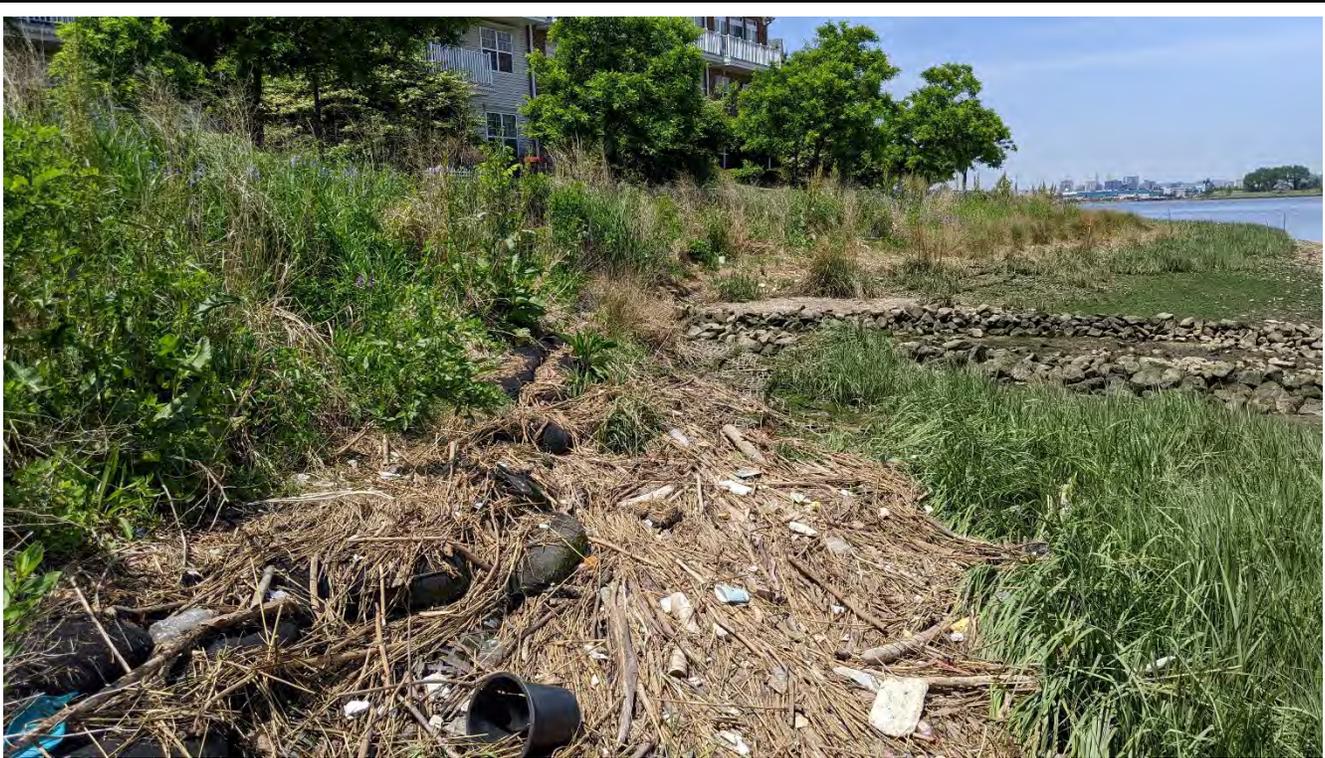
**Photo 27:** Vibrant and healthy upland transitional and high marsh vegetation near Outfall A (facing west). Note the exposed GroSoxx and significant amount of debris.

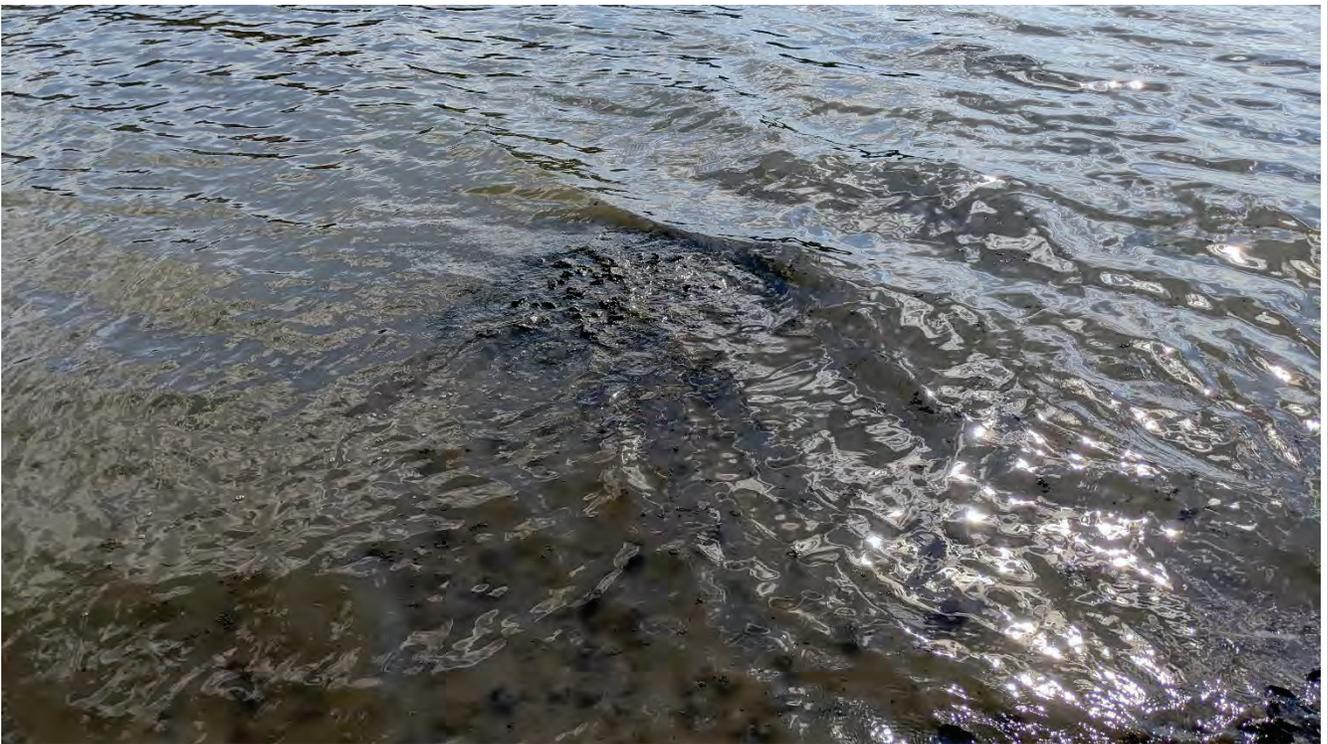
**Photo 4:** Siltation observed within Cap Area 22 (facing west).

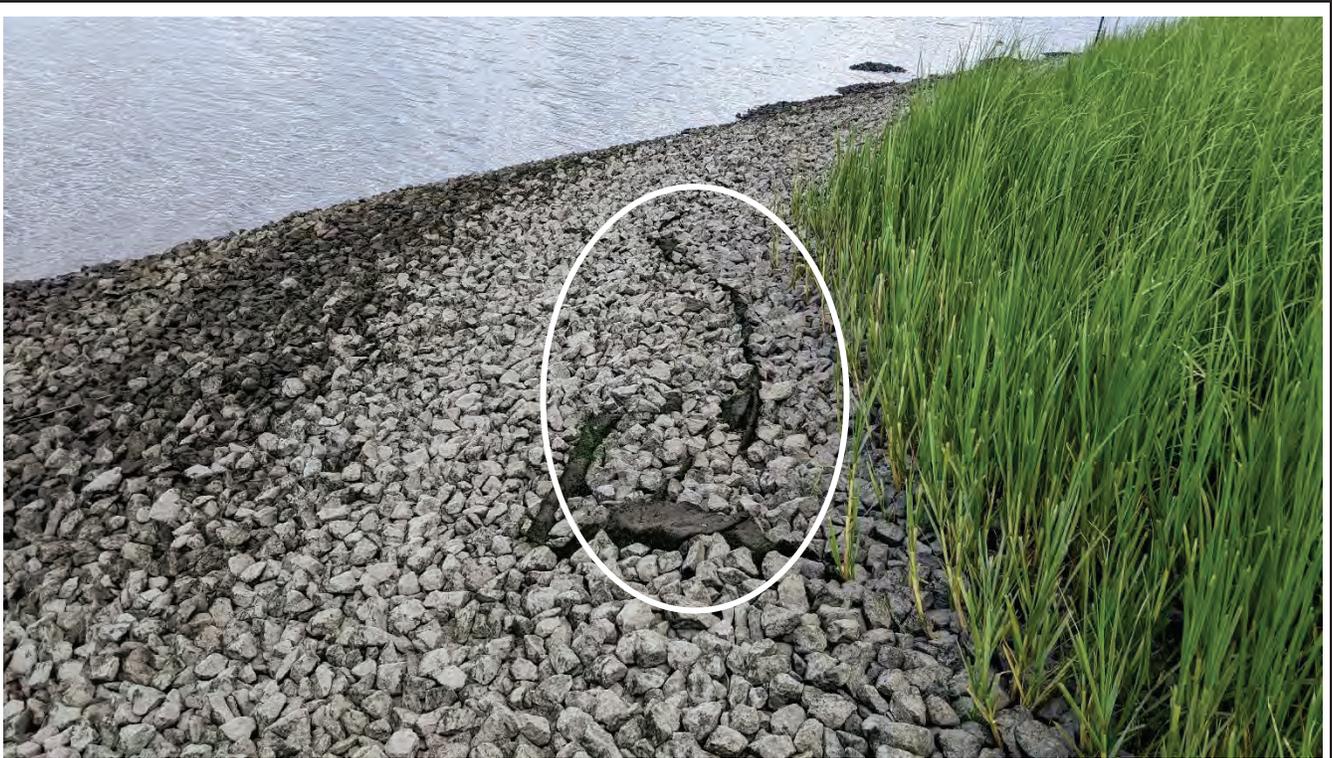
**Photo 7:** Exposed geotextile fabric between the shoreline stabilization stone and the BEP fill material west of Outfall A (facing northeast).

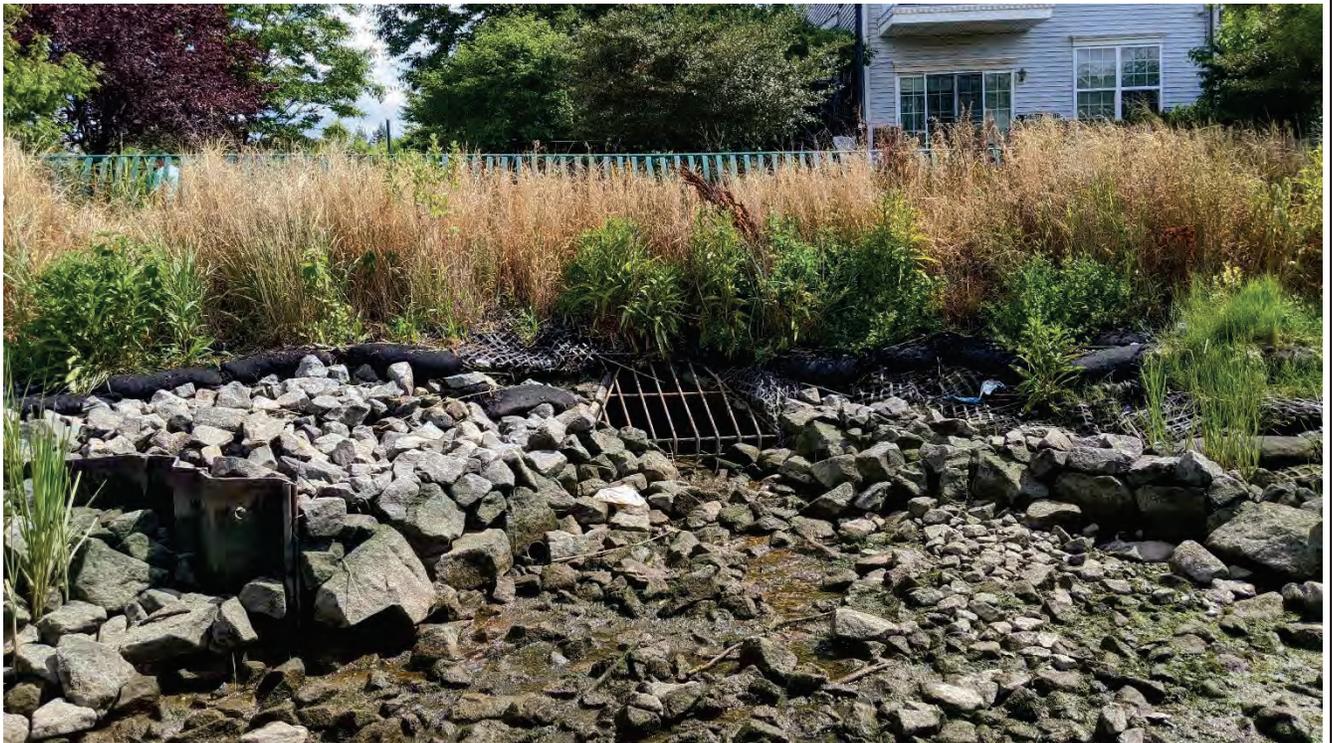
**Photo 8:** Outfall B and surrounding armor stone (facing south). Note the leaf burn and dehydrated vegetation within the uplands area.

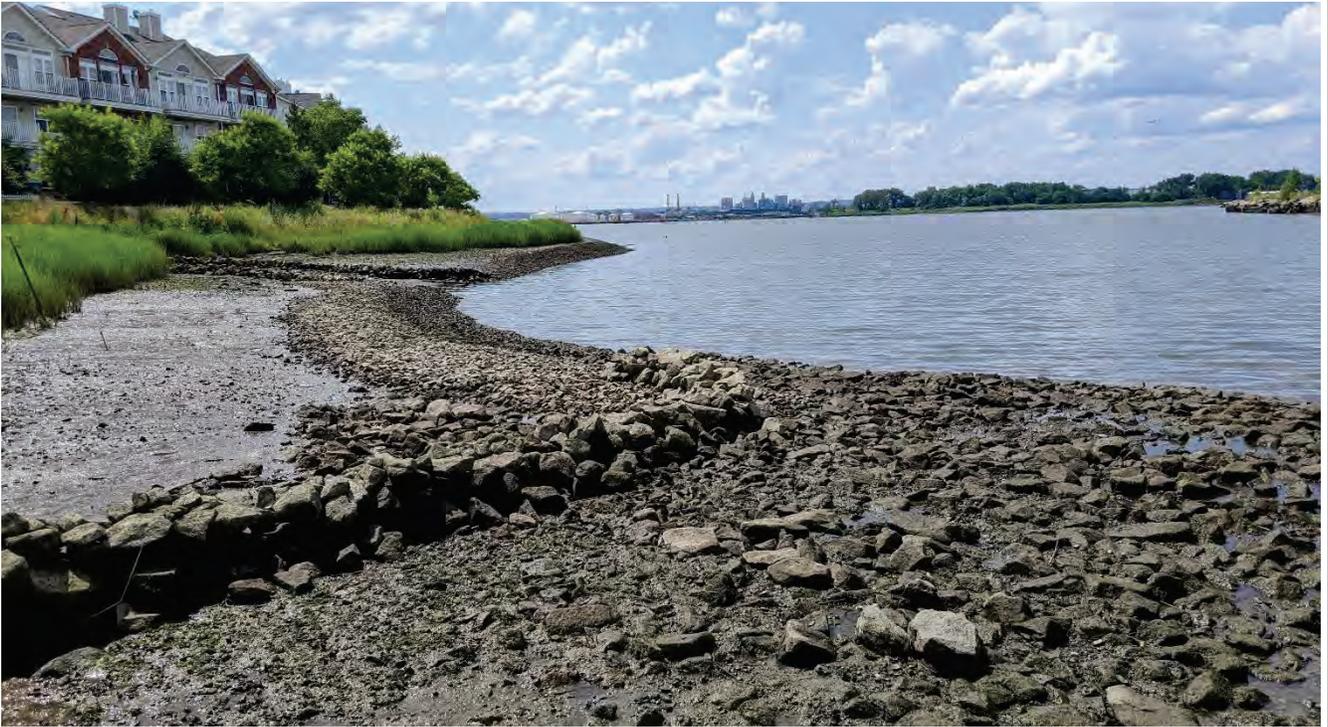
**Photo 9:** Repairs to the armor stone remain effective along the western edge of the apron for Outfalls B and C (facing west). Note the siltation present on the apron stone.

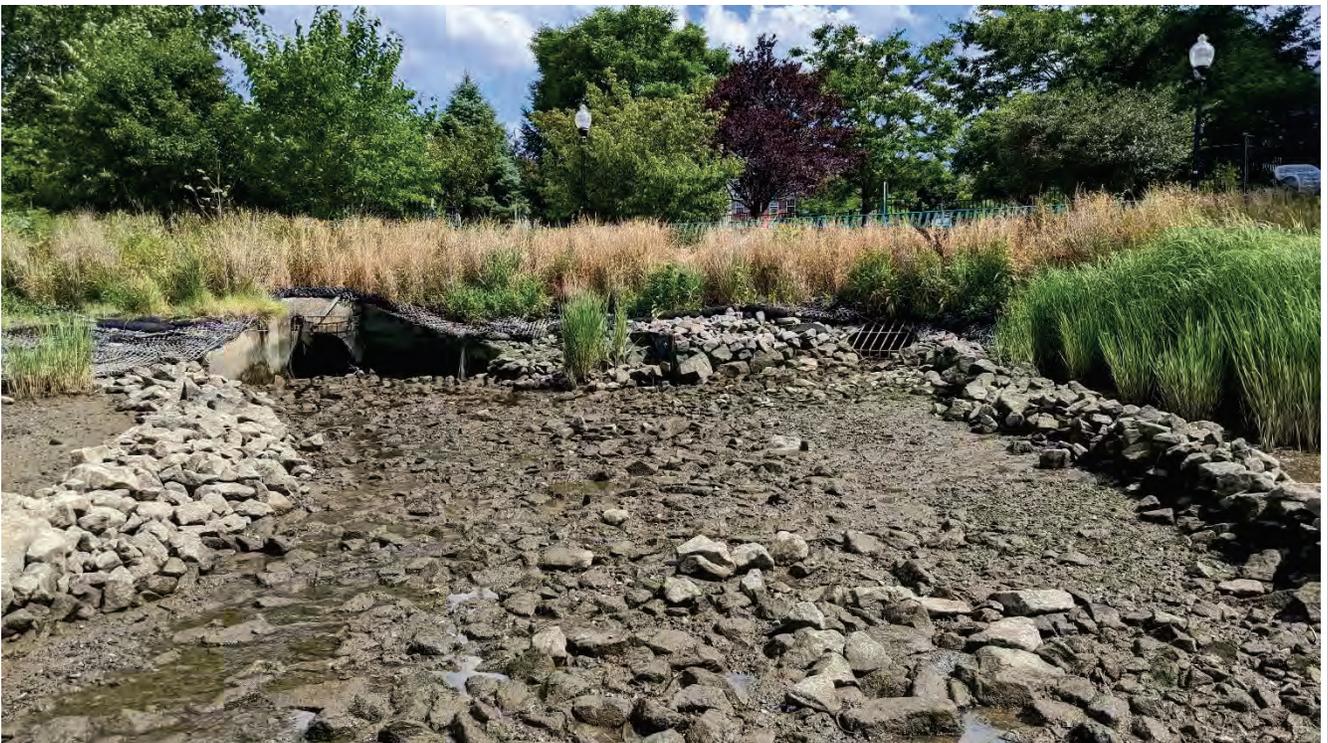
**Photo 10:** Outfalls B and C (facing southeast). Note the siltation present on the apron stone.
