# MEMORANDUM

Subject: **SA-7 Sediment Remedy Long-Term Monitoring**  
**Summary of Year 9 Monitoring & Proposed Year 10 Program**

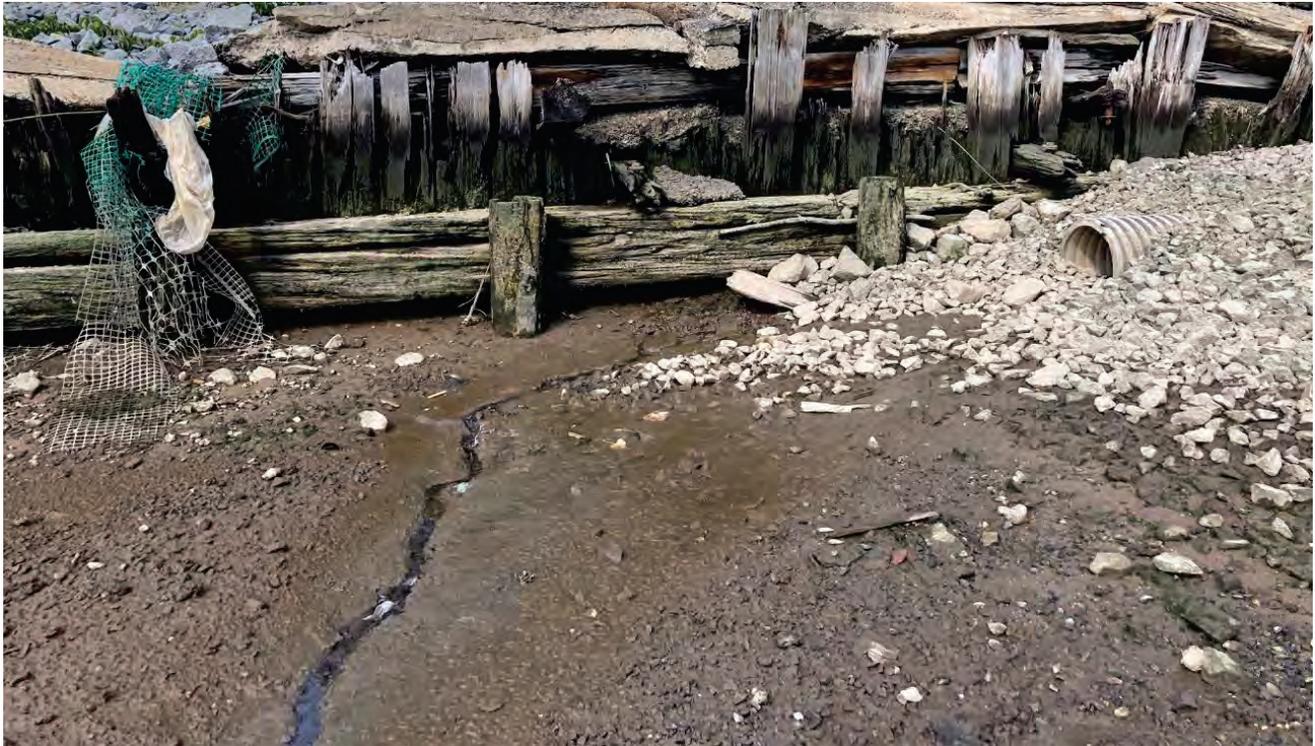
Photo 11: Minor flow channel observed in sediments at the discharge of the Outfall D (facing northeast).

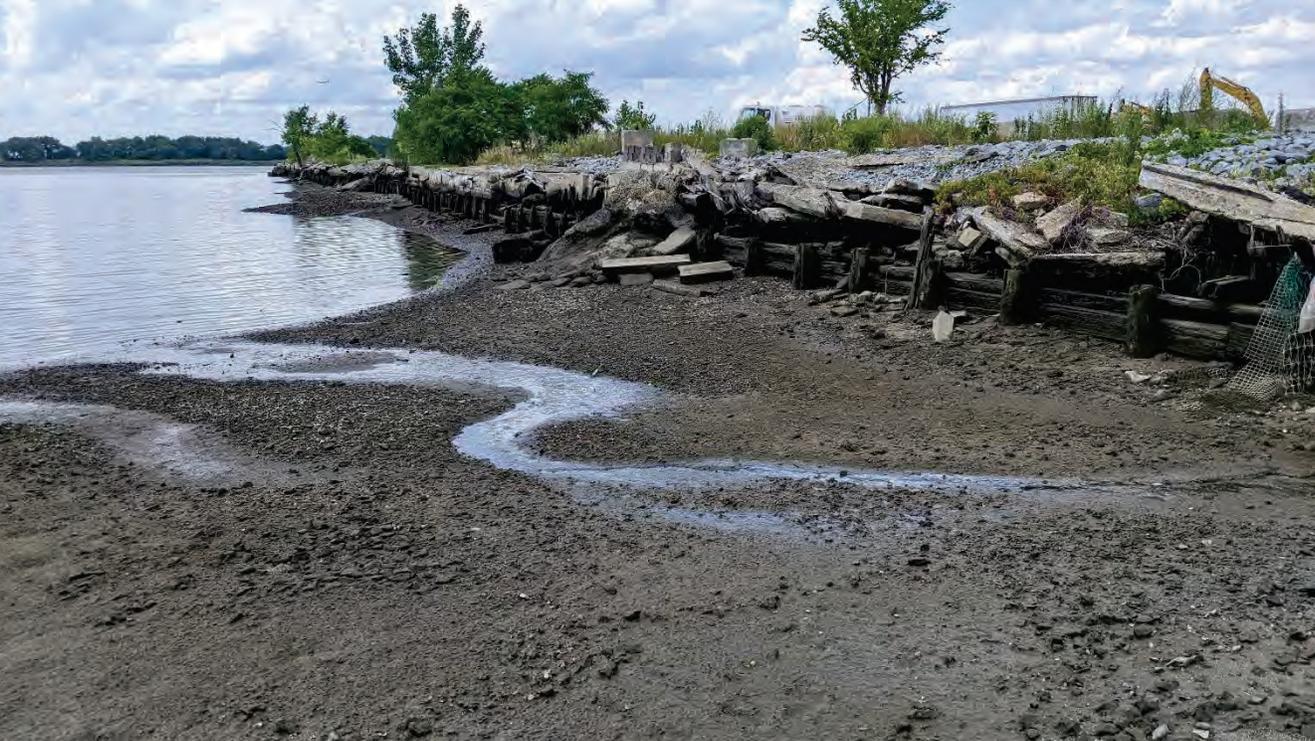
Photo 12: Flow channel observed at the discharge of Outfall D and Cap Area 22 in the background (facing northwest).

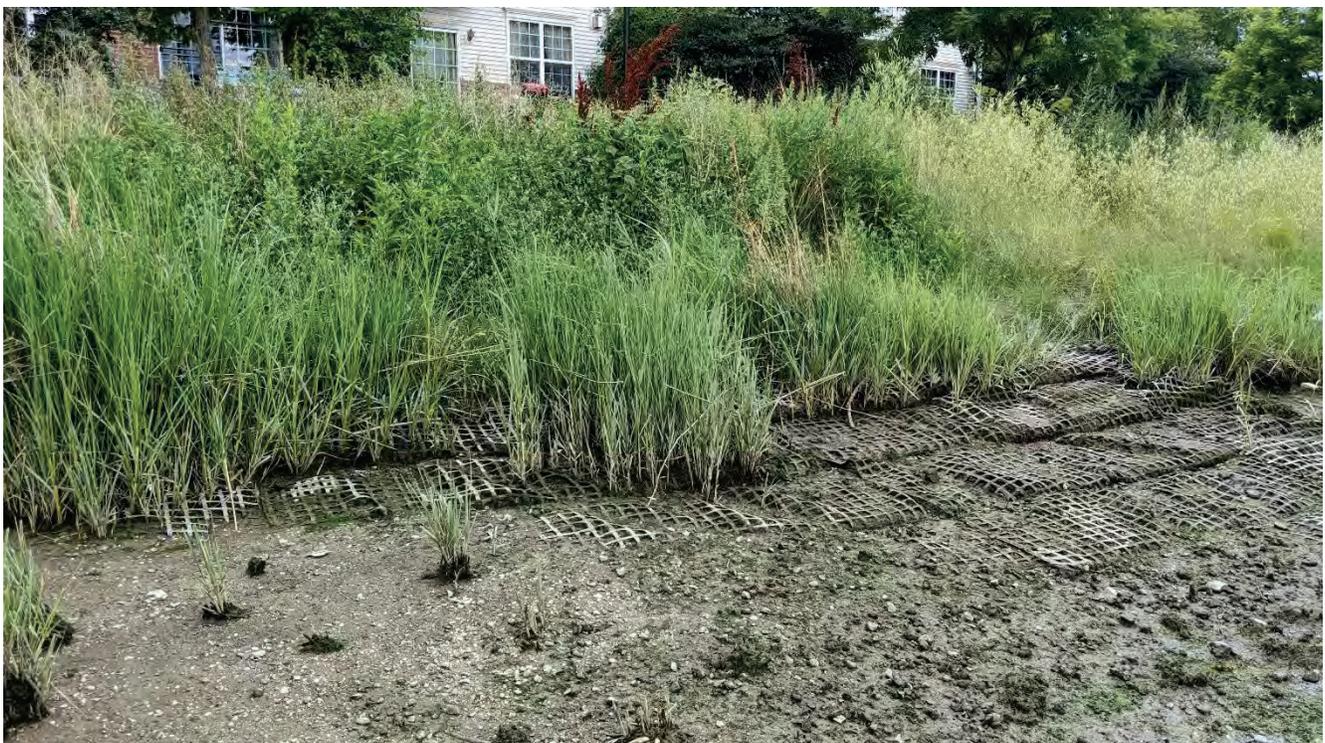
**Photo 22:** Vibrant and healthy upper low marsh zone, high marsh, and uplands transition area west of Outfall A (facing southwest). Note the exposed geogrid and absence of GroSoxx in the bottom of the low marsh zone.

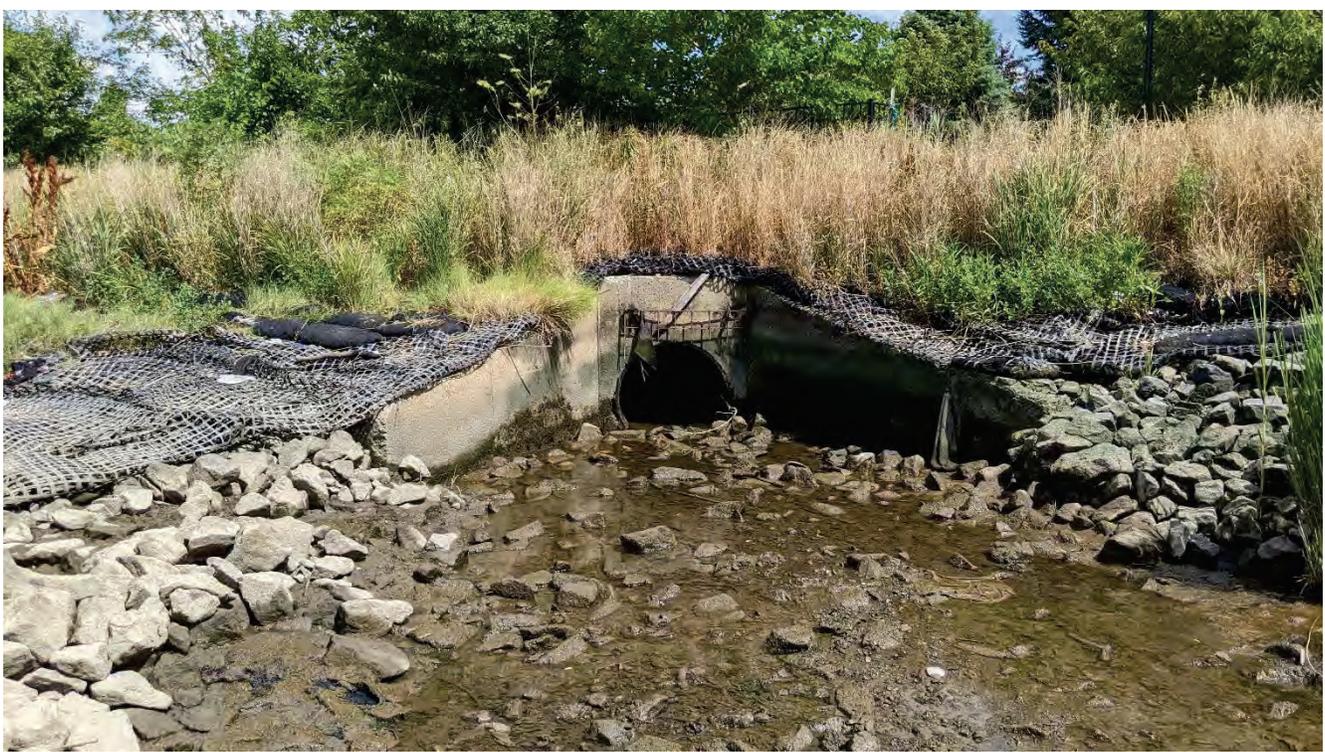
**Photo 23:** Exposed geogrid over the ledge of the Outfall B structure (facing south).

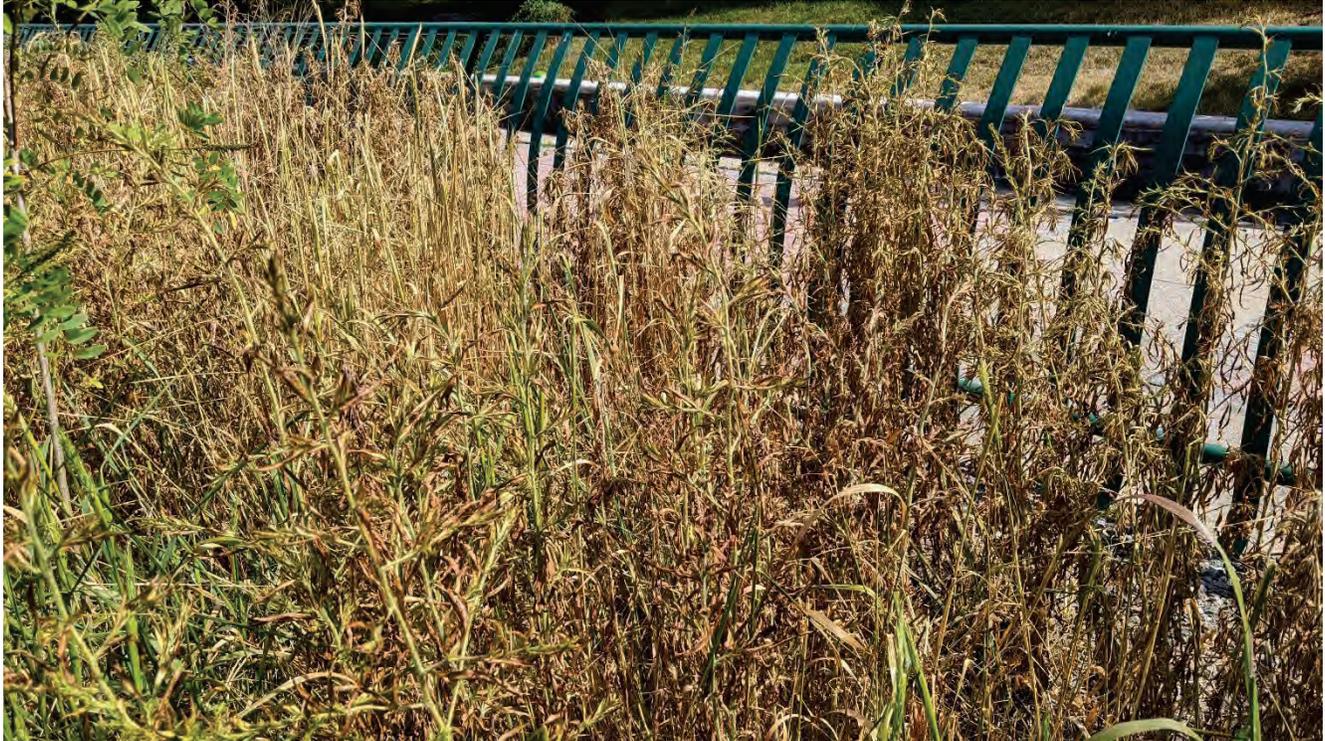
Photo 30: Leaf burn on invasive species curly dock and common mugwort located within the upland transitional planting zone of the BEP.

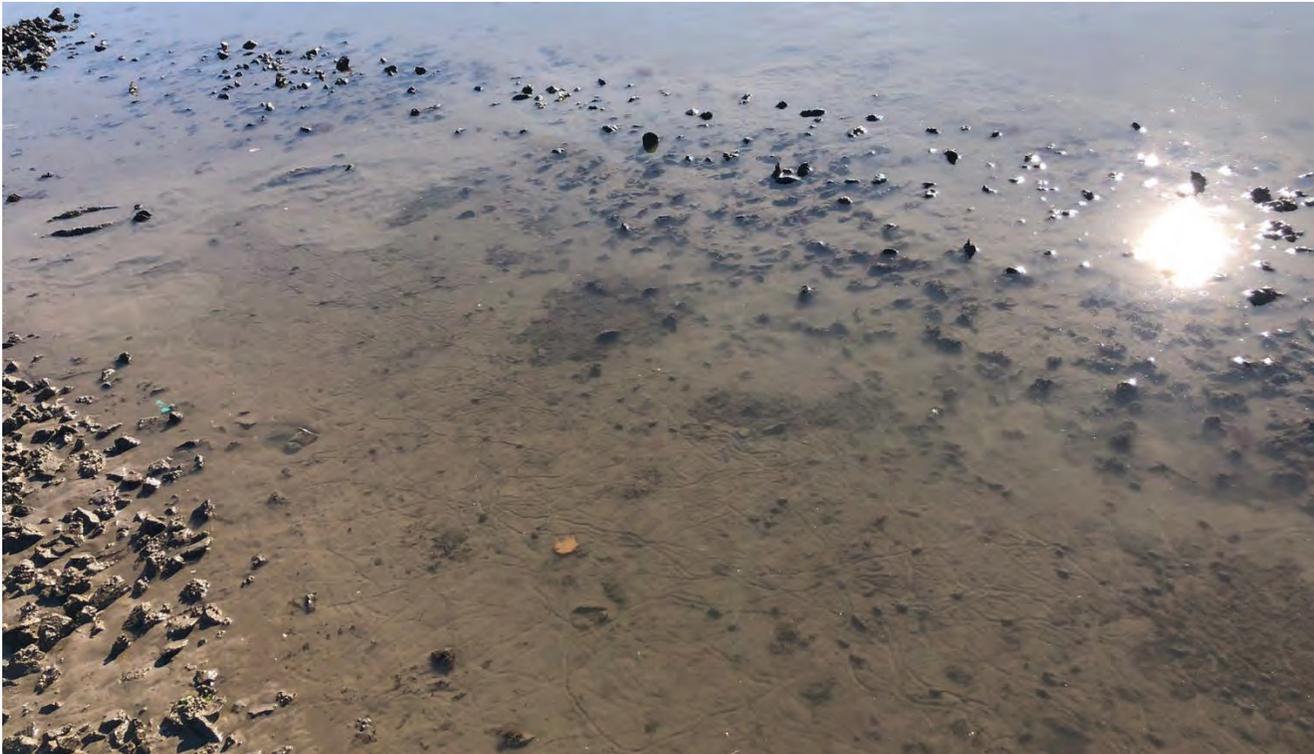
**Photo 4:** Siltation observed within Cap Area 22.

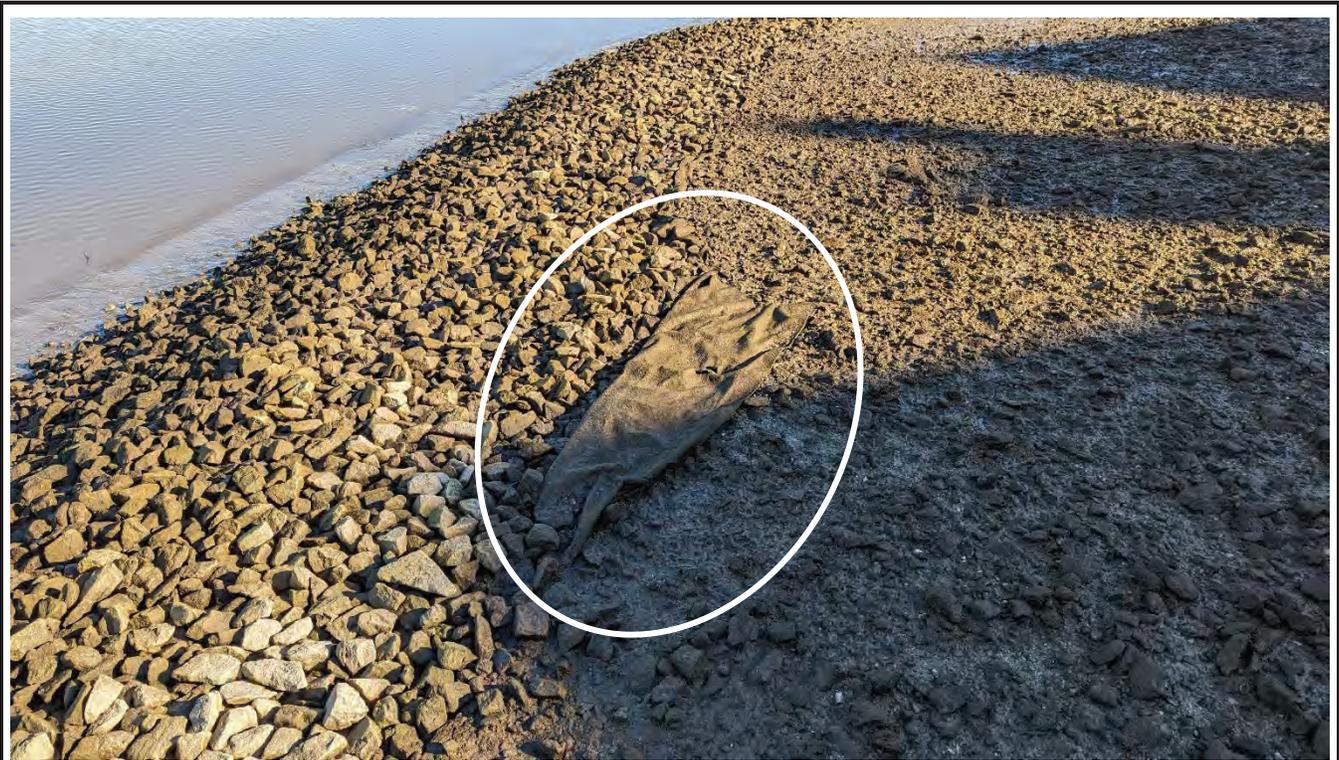
**Photo 7:** Exposed geotextile fabric between the shoreline stabilization stone and the BEP fill material west of Outfall A.

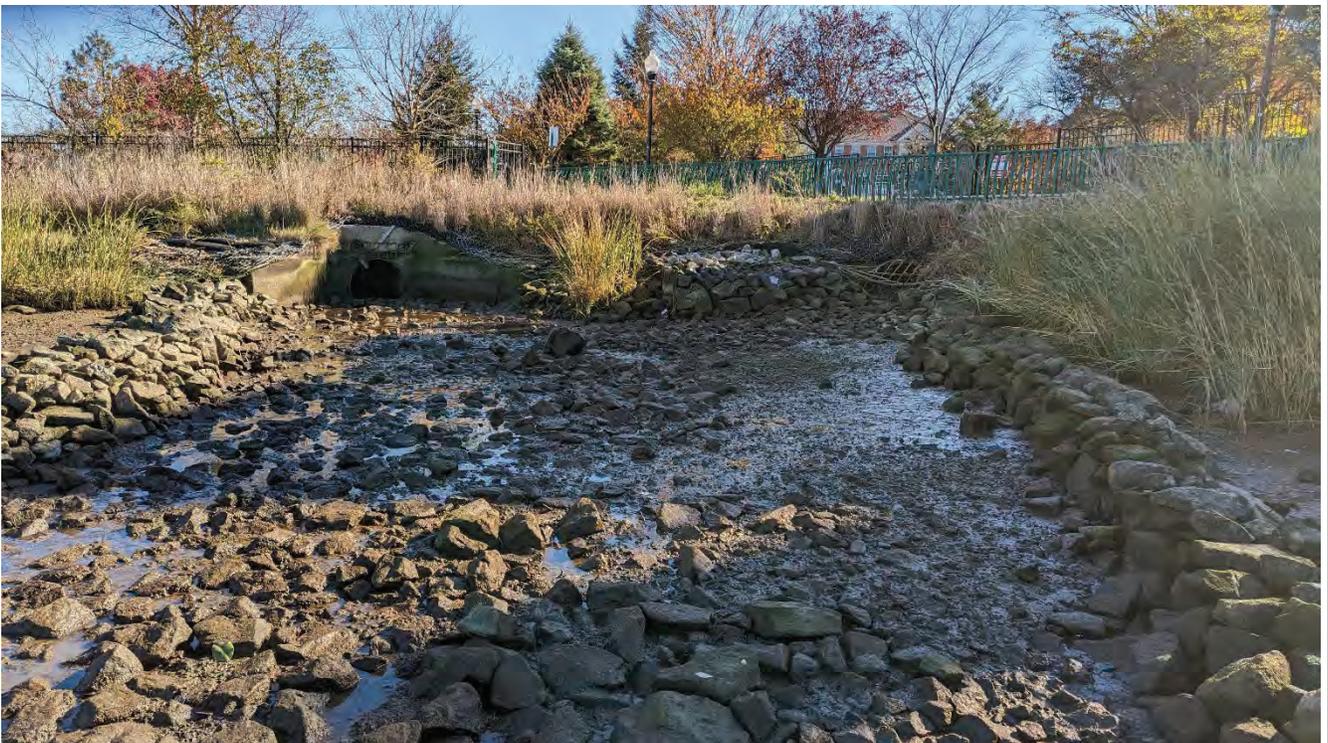
**Photo 10:** Outfalls B and C (facing southeast). Note the siltation present on the apron stone.

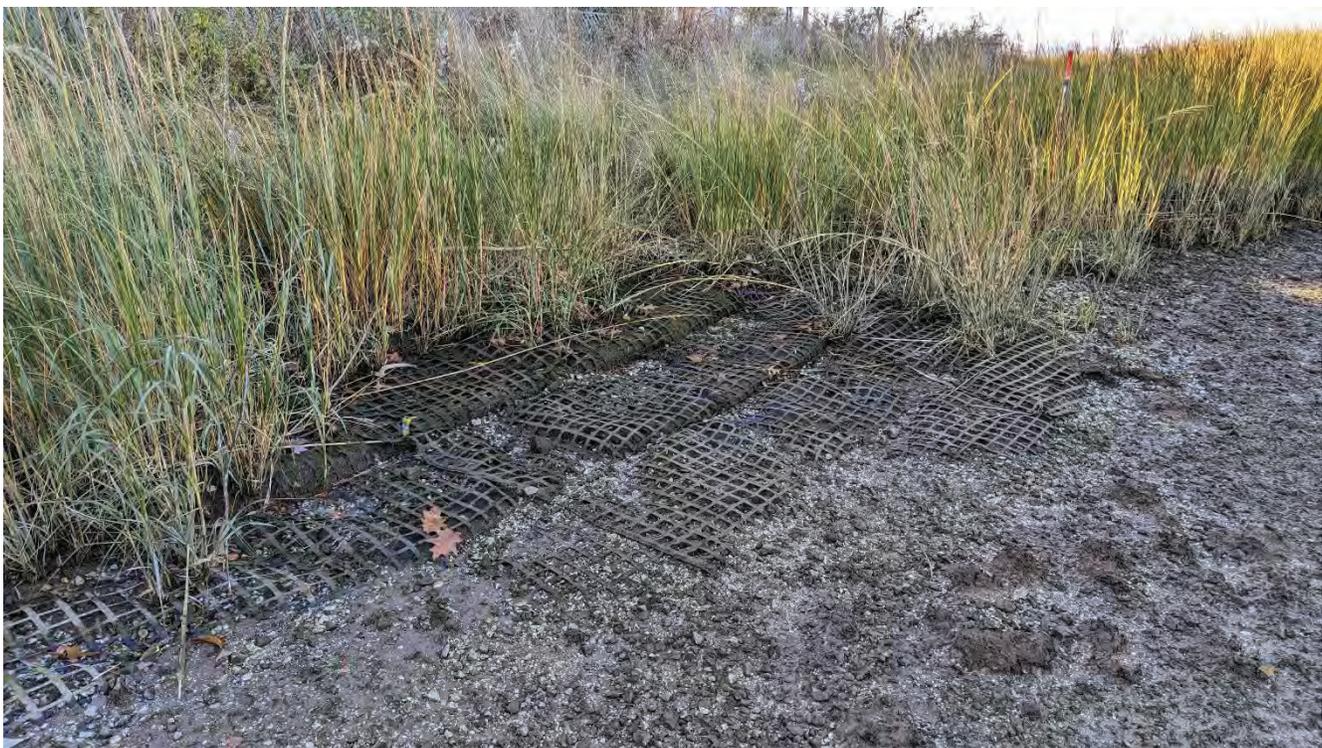
**Photo 21:** Vibrant and healthy low marsh zone west of Outfall A (facing southwest). Note the exposed geogrid and absence of GroSoxx at the bottom of the low marsh zone.

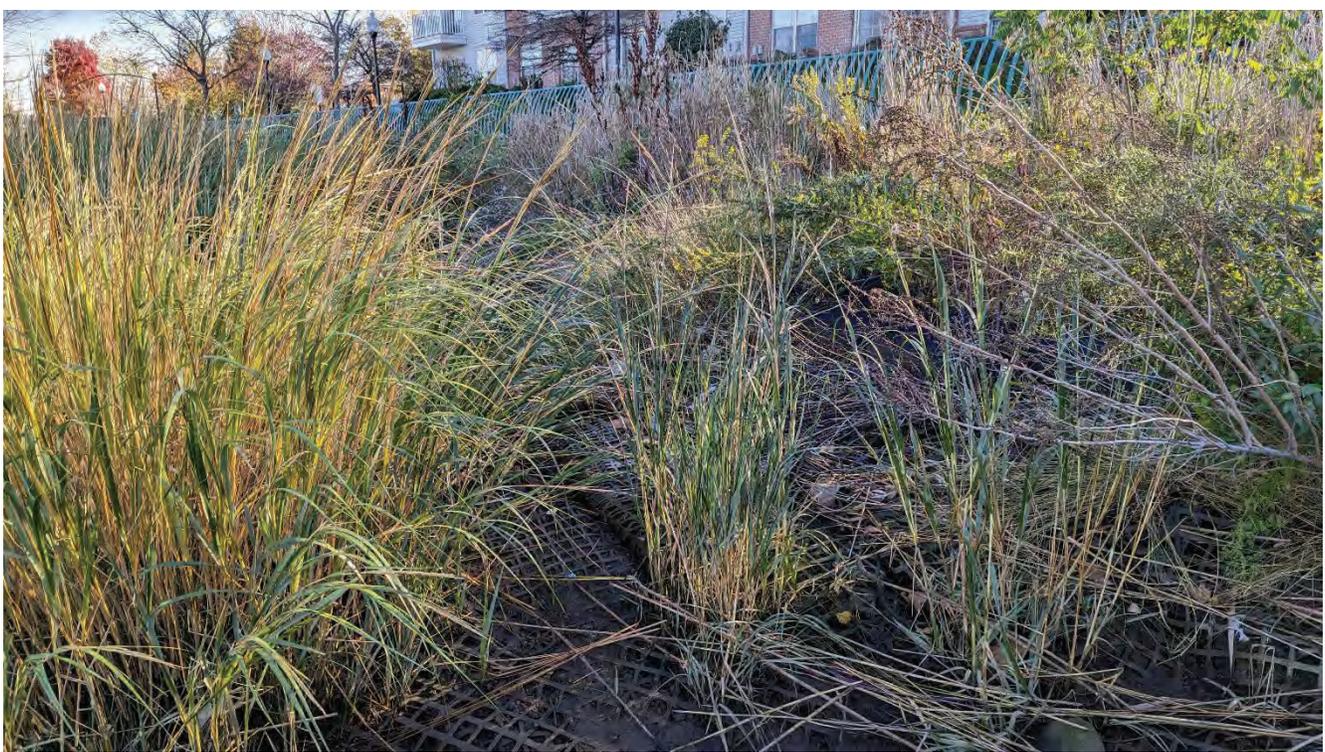
**Photo 25:** Vibrant and healthy upland transitional and high marsh vegetation near Outfall A (facing west). Note the exposed geogrid.

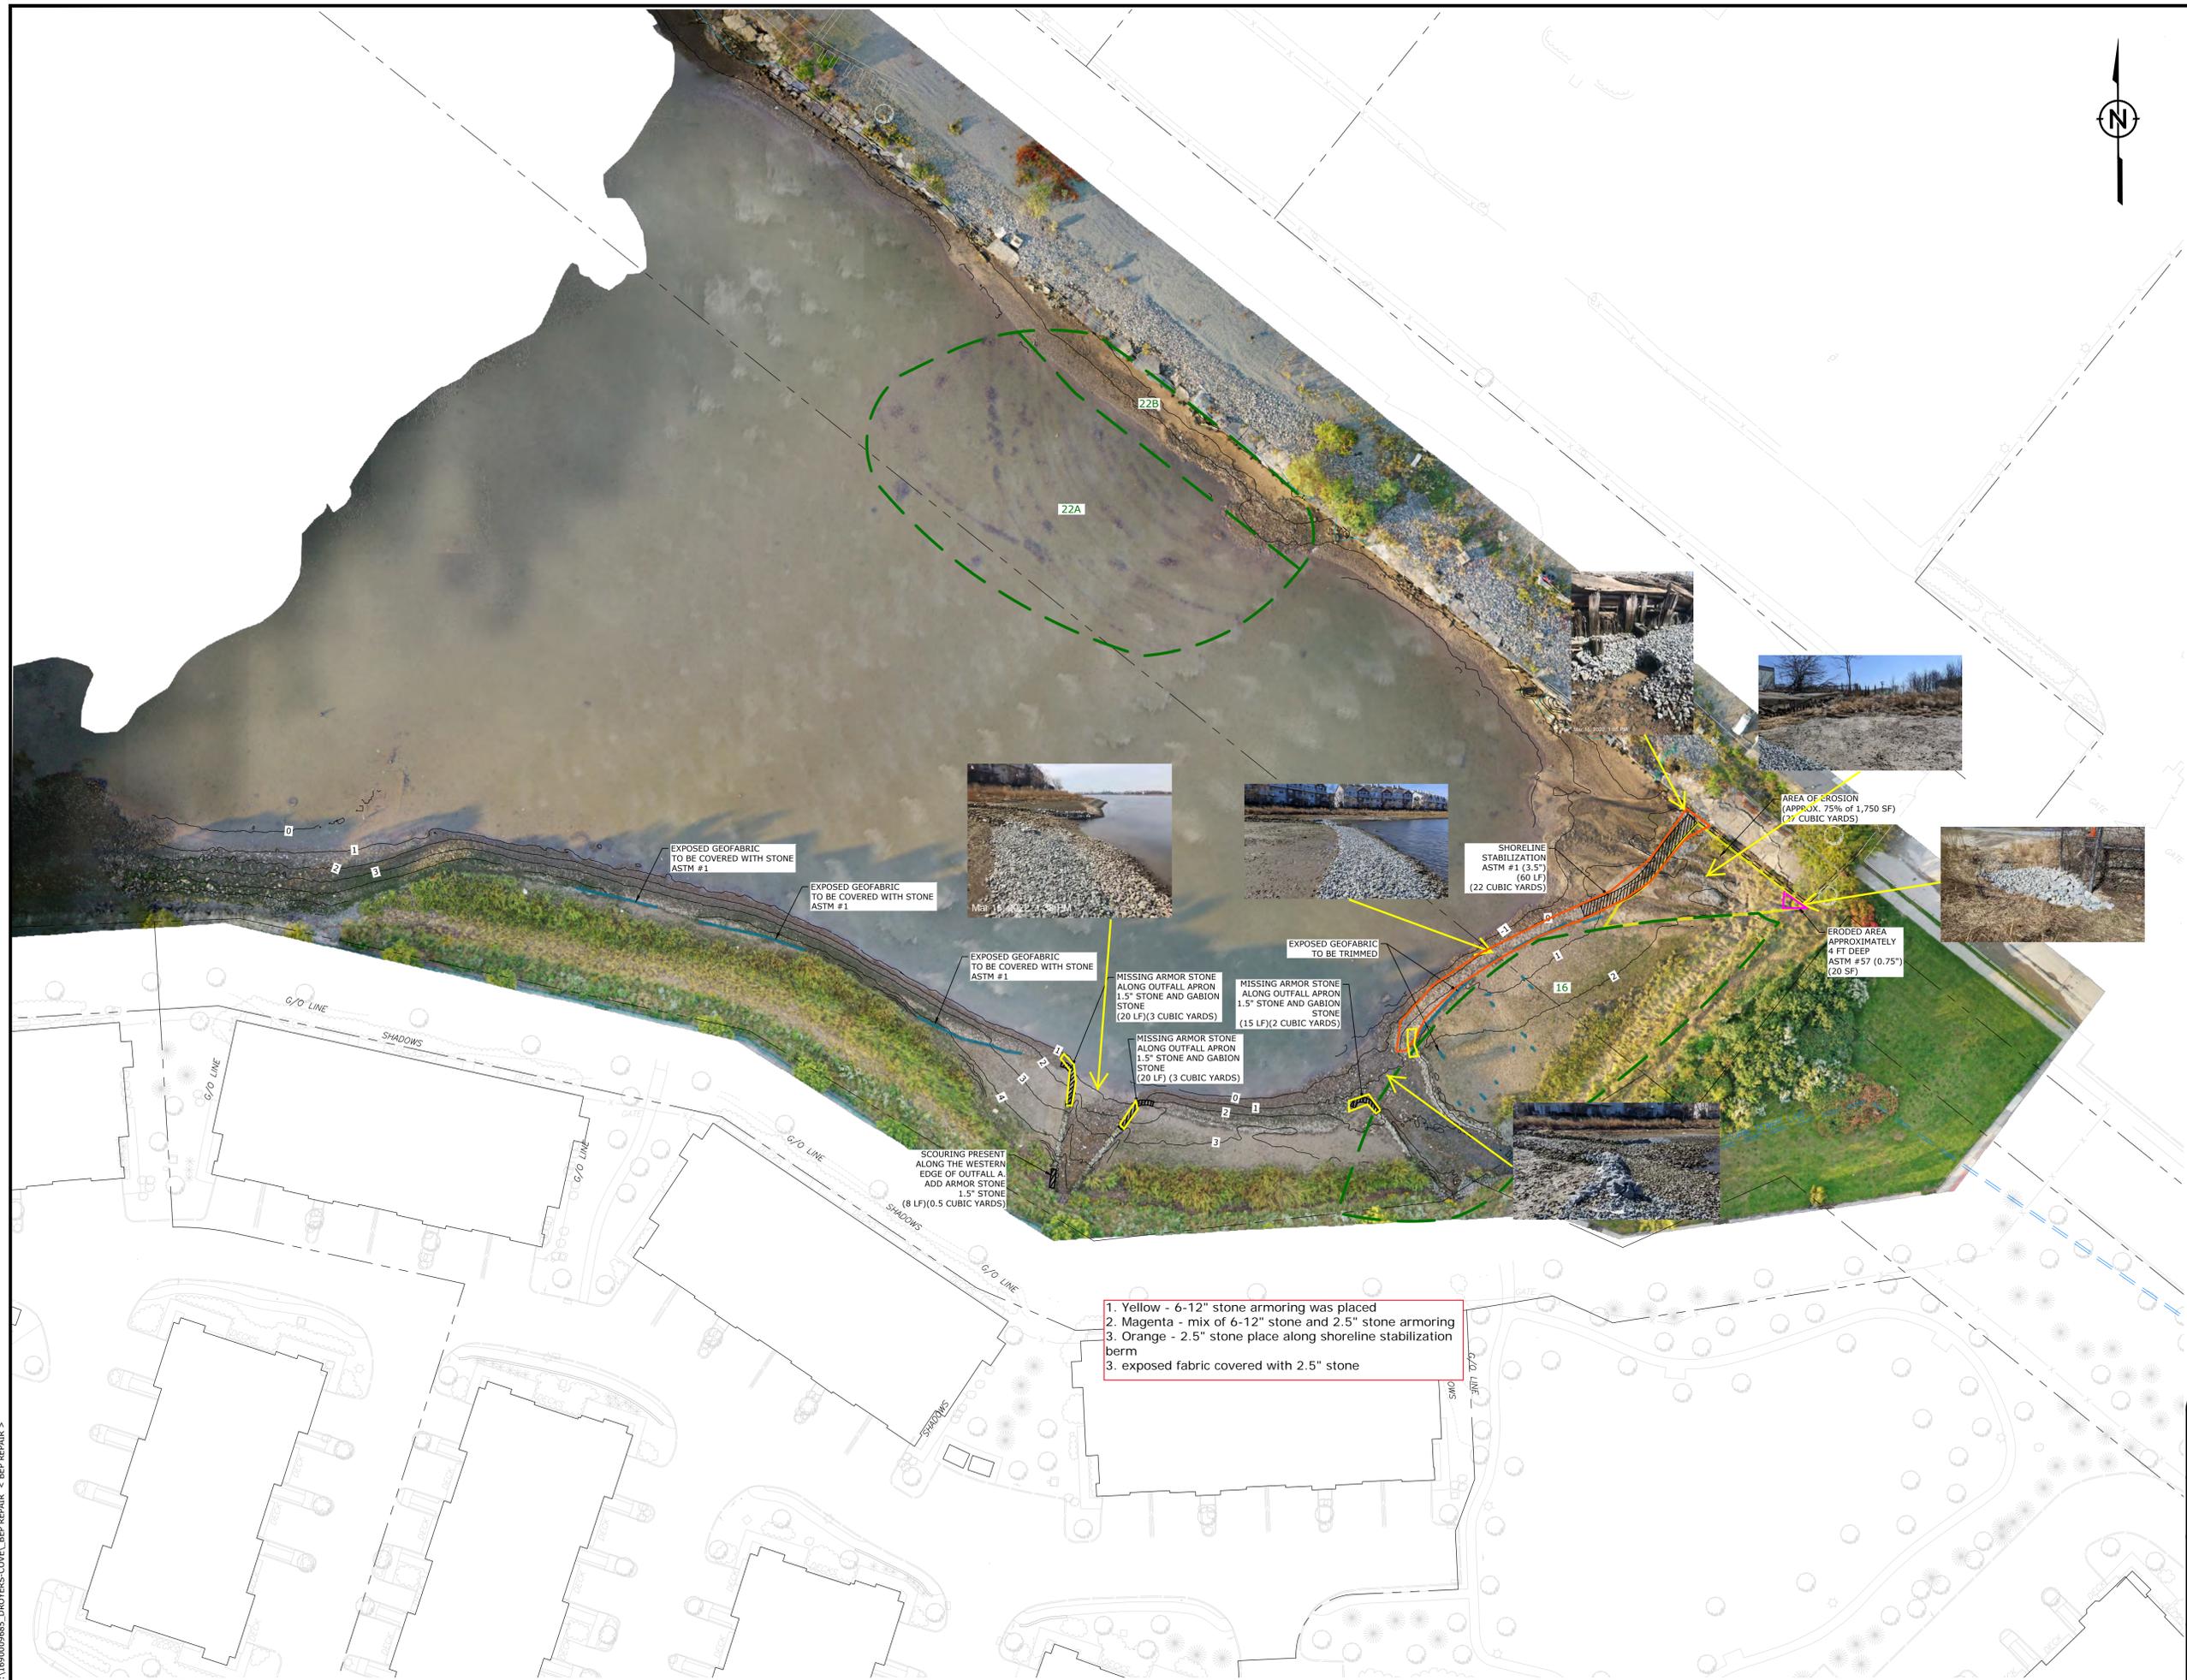
**PROPOSED PHASE 1 REPAIRS TO BEP**

MISSING ARMOR STONE ALONG OUTFALL APRON 1.5" STONE AND GABION STONE (20 LF)(3 CUBIC YARDS)

MISSING ARMOR STONE ALONG OUTFALL APRON 1.5" STONE AND GABION STONE (15 LF)(2 CUBIC YARDS)

MISSING ARMOR STONE ALONG OUTFALL APRON 1.5" STONE AND GABION STONE (20 LF) (3 CUBIC YARDS)

EXPOSED GEOFABRIC TO BE COVERED WITH STONE ASTM #1
