**MEMORANDUM**

Subject: **SA-7 Sediment Remedy Long Term Monitoring – Summary of**  
**Year 6 Activities and Proposed Activities for Year 7**

**ATTACHMENT A  
YEAR 6 INSPECTION LOGS**

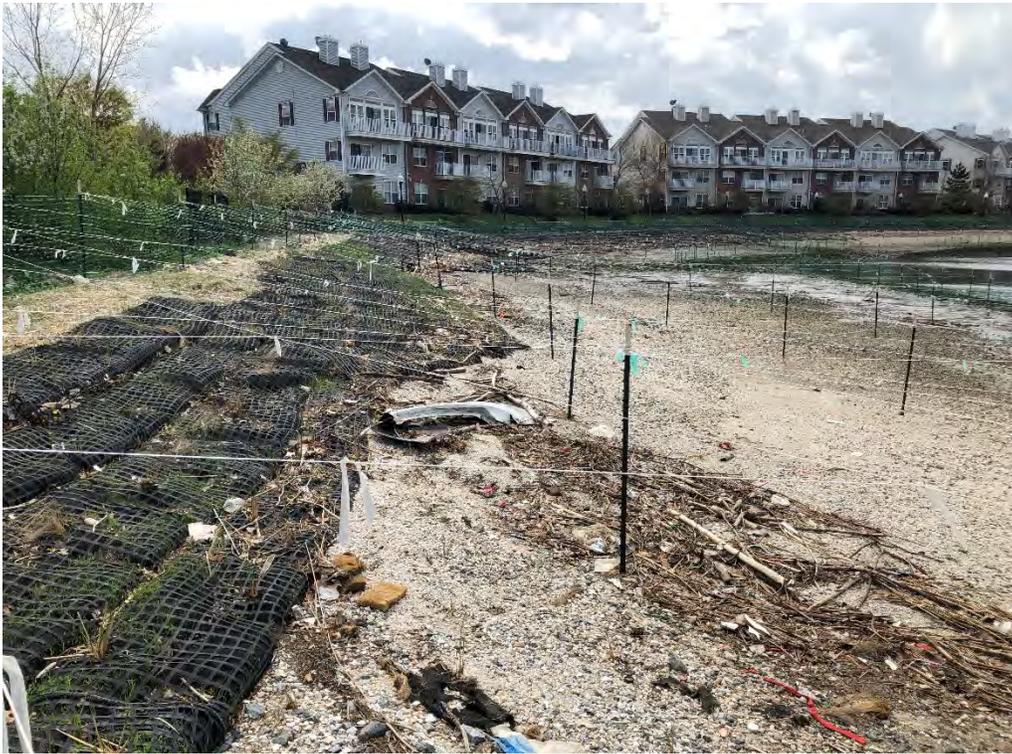
**Photo 1:** Northern end of Cap Area 16. Note lack of vegetative growth and accumulation of debris in 8-ft swath (facing south). The surface materials contain a large quantity of gravel, suggesting possible tidal erosion of fines from shoreline fill.

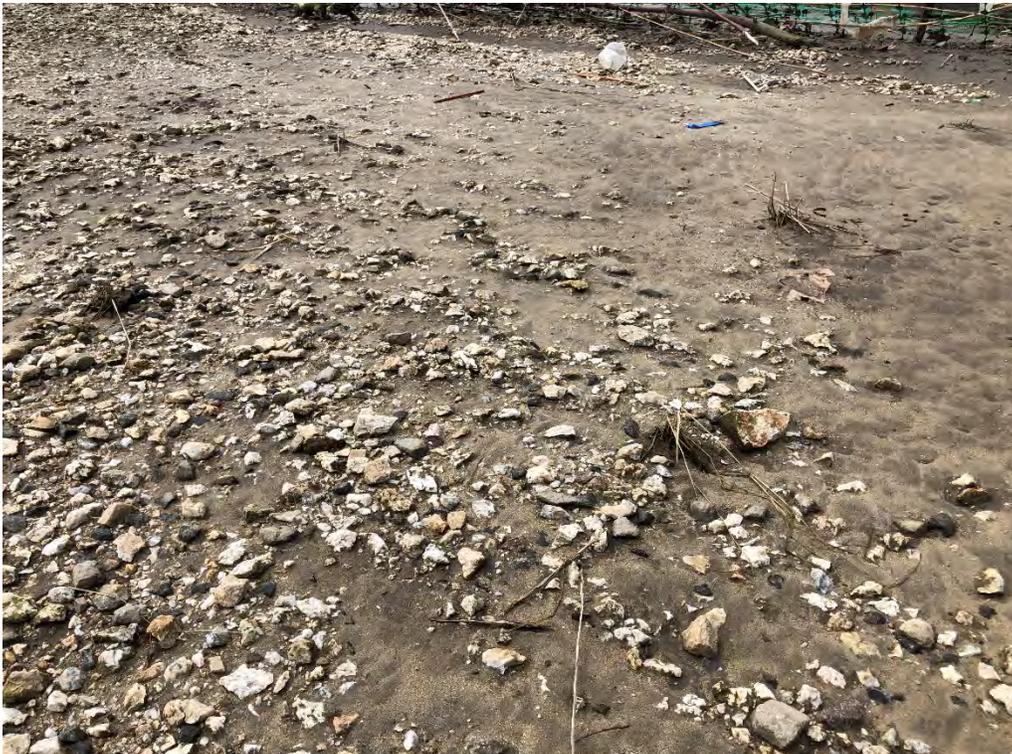
**Photo 2:** Central portion of Cap Area 16. Sedimentation on low marsh areas of lower elevation and exposed gravel on areas of higher elevation, due to tidal erosion of the shoreline fill material (facing west).

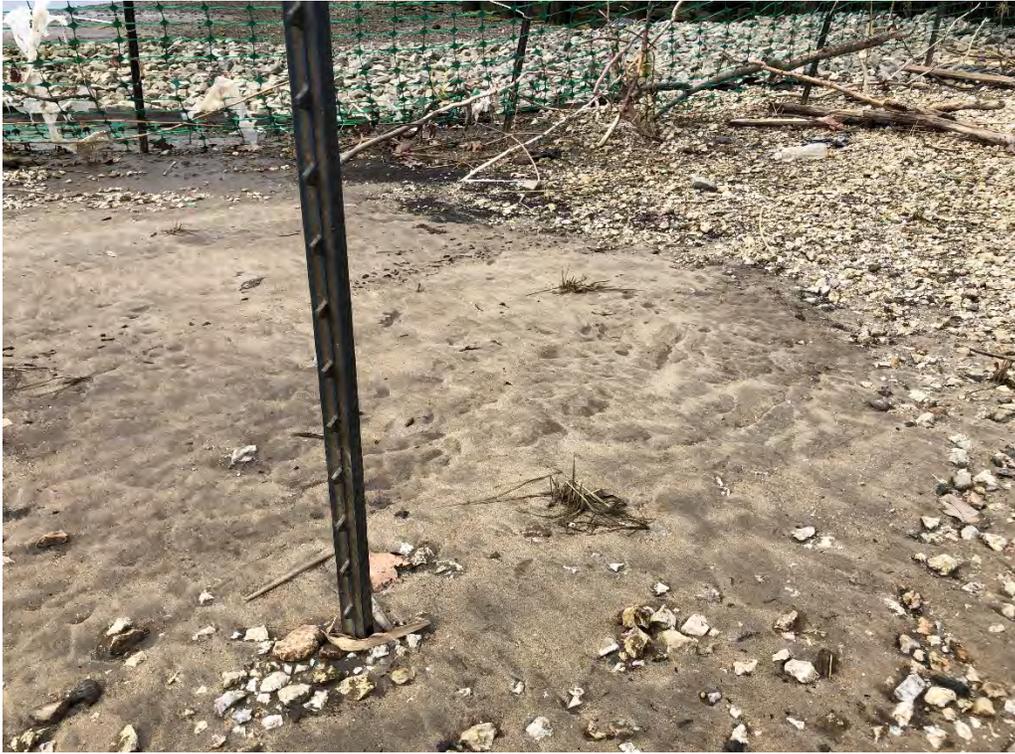
**Photo 3:** Central portion of Cap Area 16. Sedimentation on low marsh areas of lower elevation and exposed gravel on areas of higher elevation, due to tidal erosion of the shoreline fill material. Note accumulation of vegetative and trash debris along the perimeter waterfowl exclusion measures (facing west).

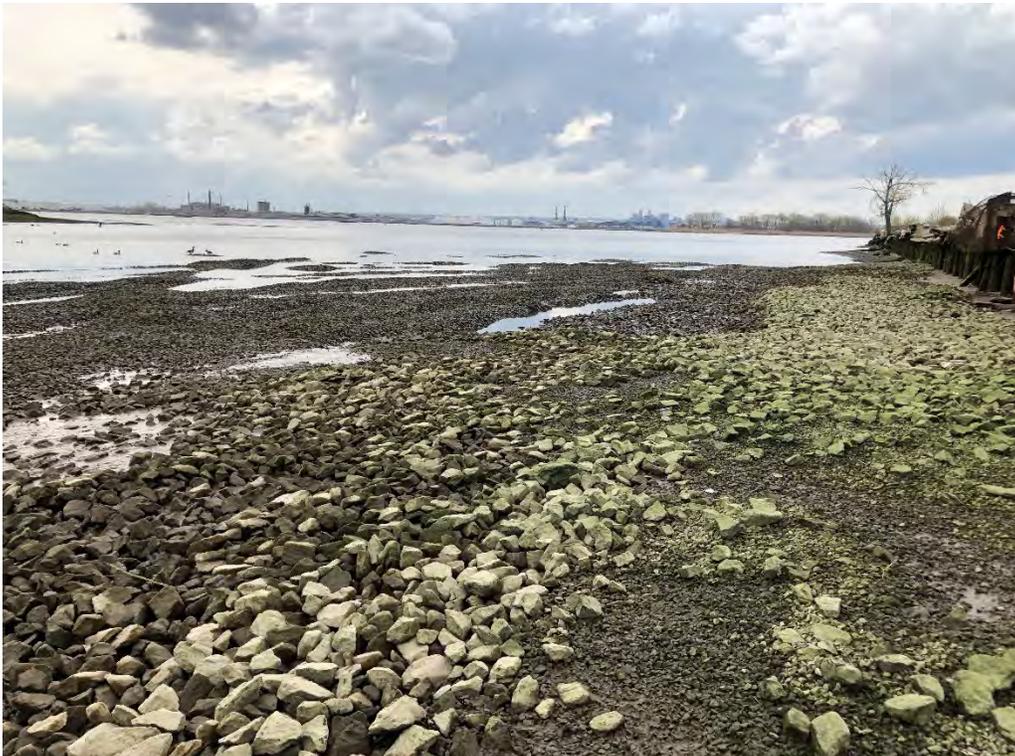
**Photo 4:** Northeastern portion of Cap Area 22. Note that 3/4 -inch stone overlies the 3 to 6 inch armor material in two approximately three-foot-long by two foot wide areas in the northeastern corner of Cap Area 22(facing southwest).

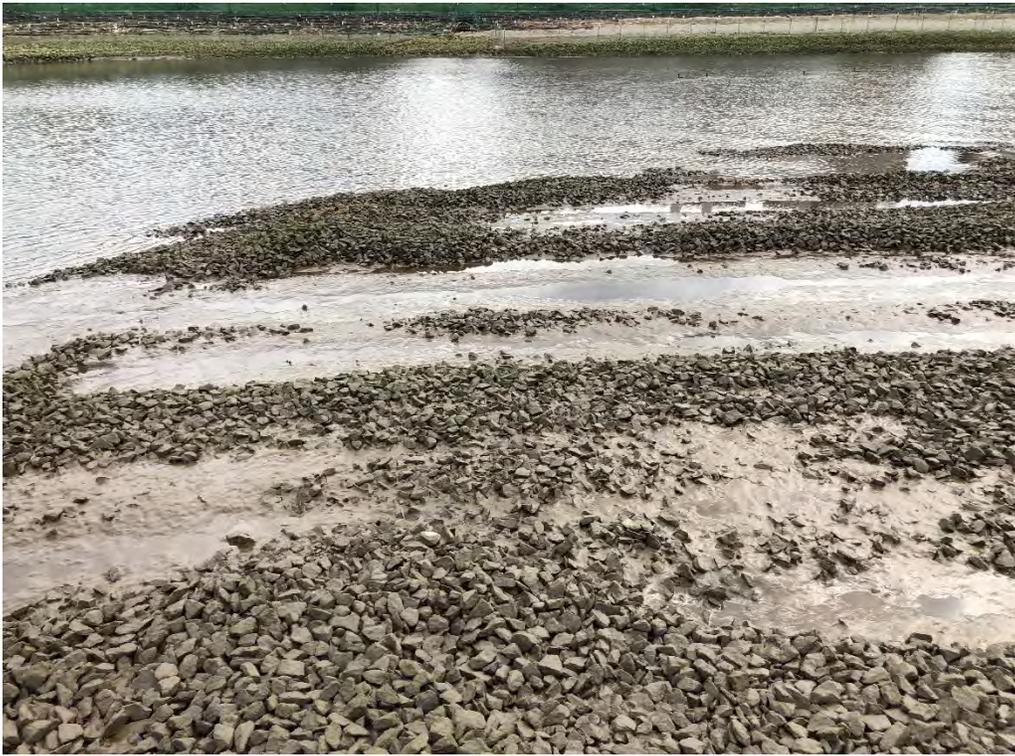
**Photo 5:** Sediment deposition on the eastern portion of Cap Area 22a (facing south).

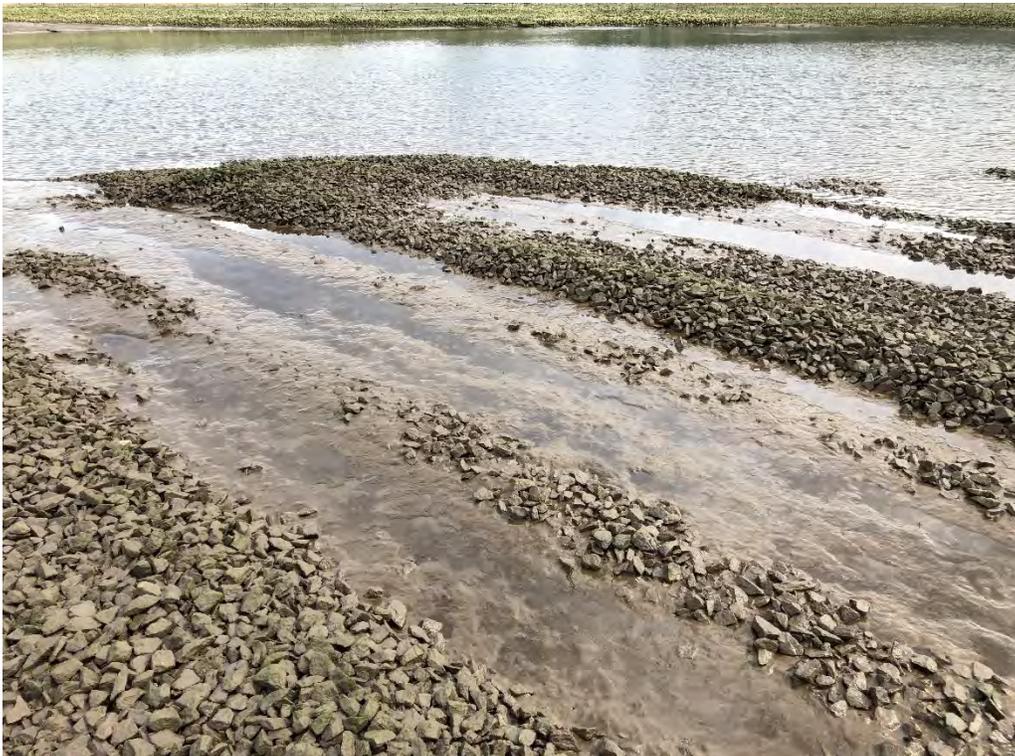
**Photo 6:** Sediment deposition on the southeastern portion of Cap Area 22a (facing southeast).

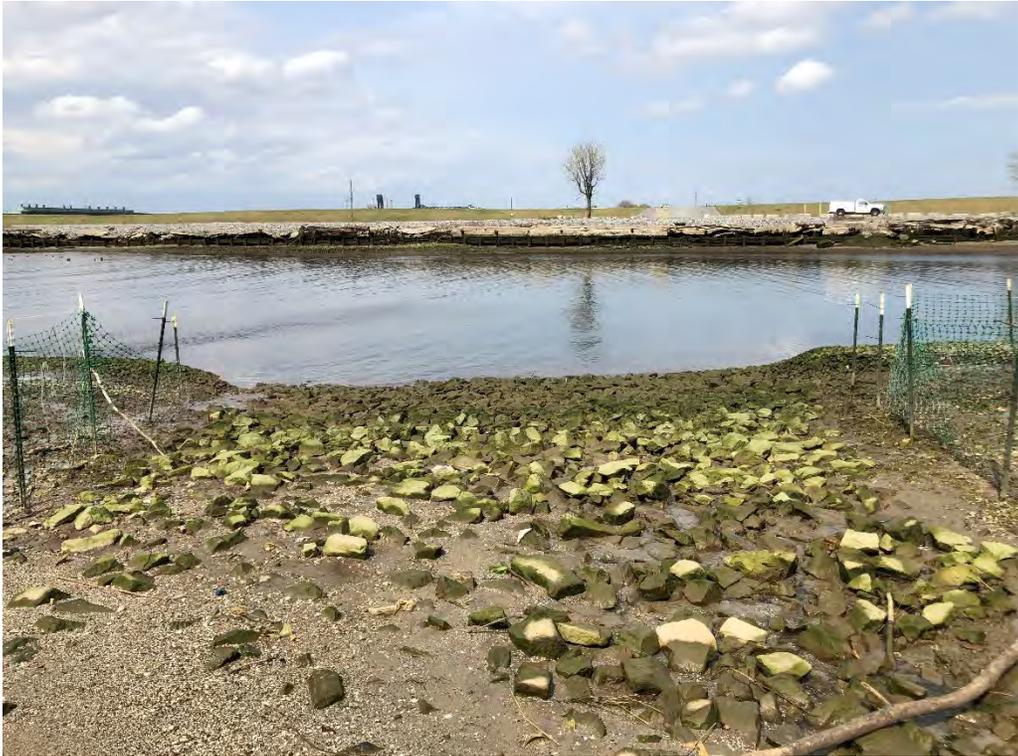
**Photo 14:** Deposition of shoreline fill material in the western portion of the Outfall A riprap apron due to tidal currents (facing north). Note that riprap apron is present under the deposited material.

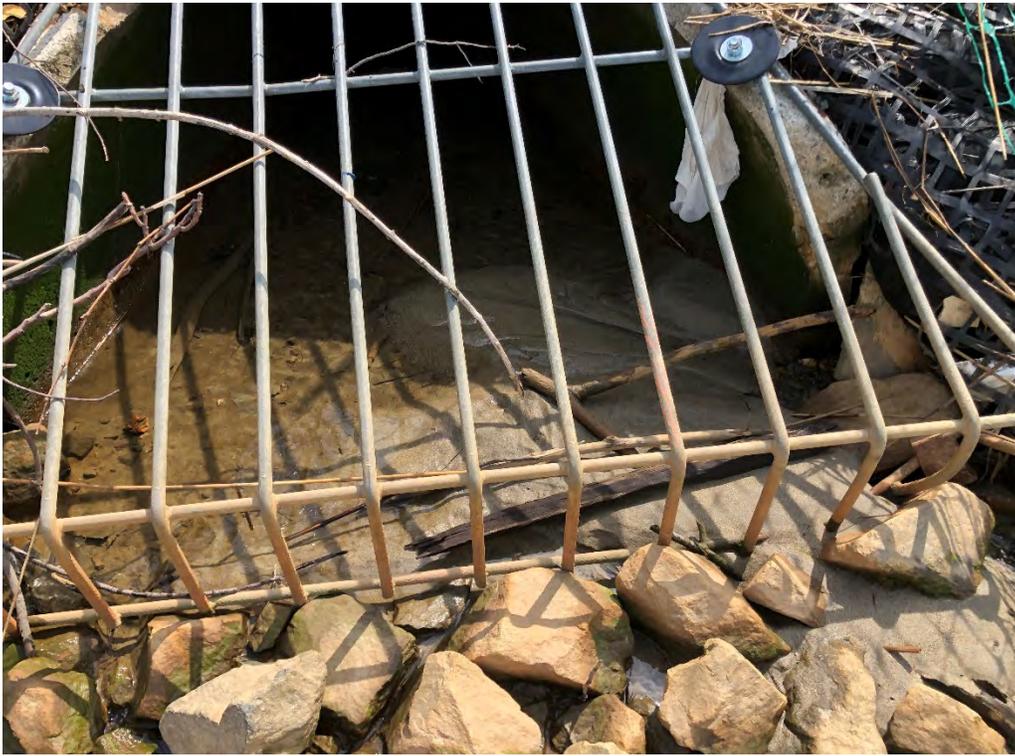
**Photo 15:** Shoreline fill material deposition within Outfall A (facing south).

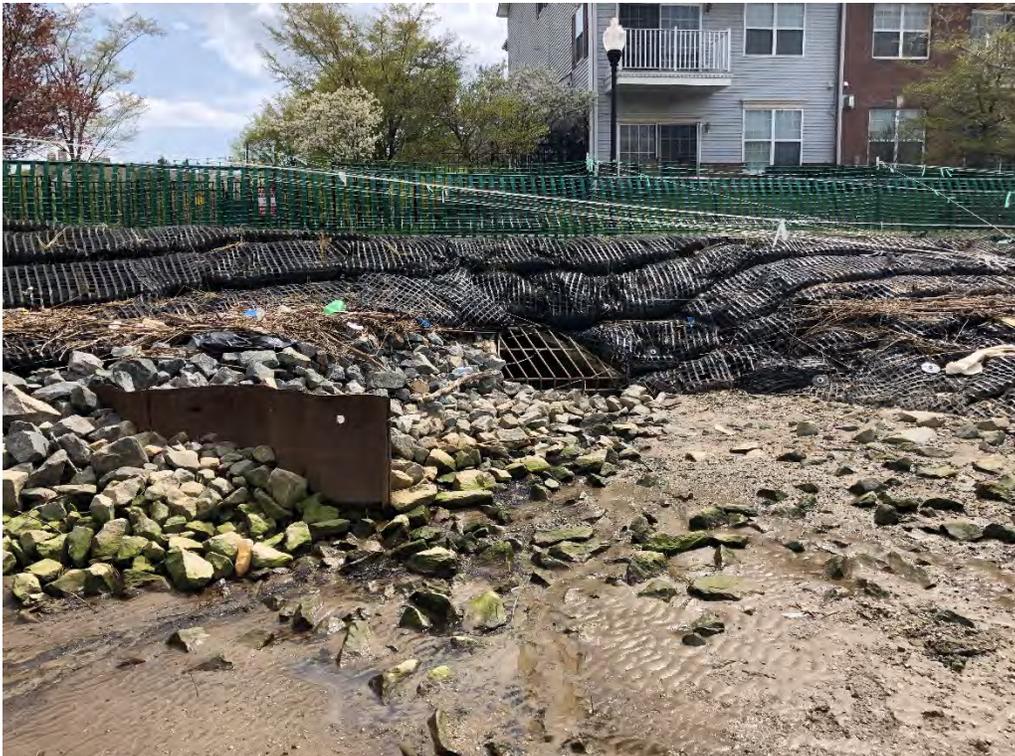
**Photo 16:** Outfall B and surrounding area with sediment deposition over the central portion of the riprap apron and accumulated debris along slope (facing southeast).

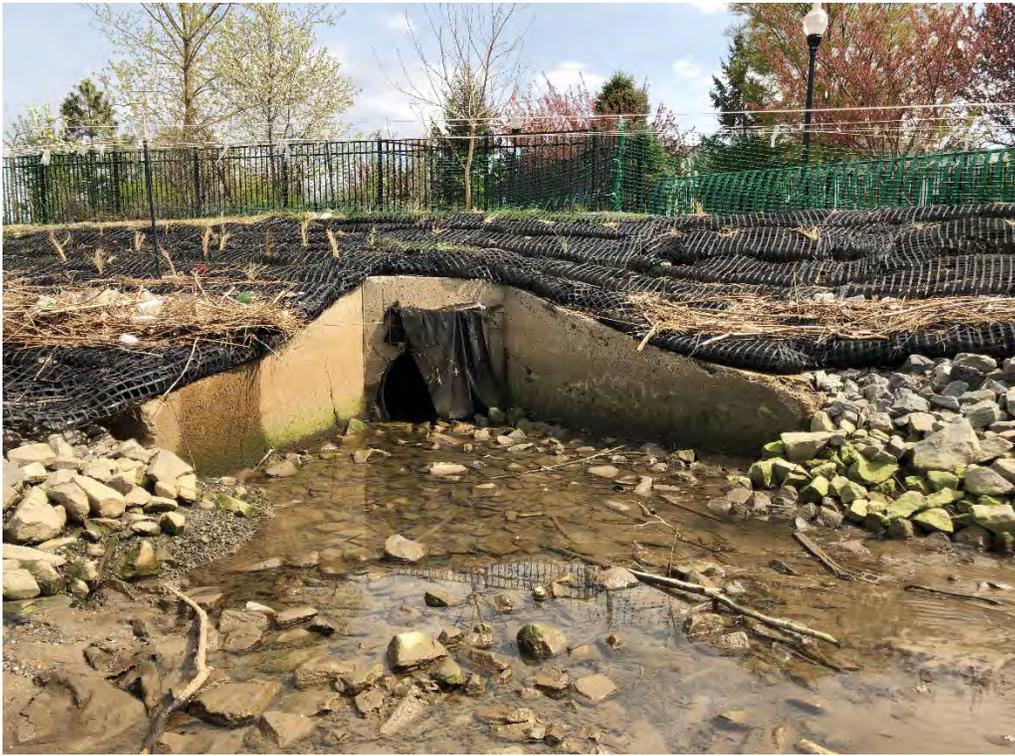
**Photo 17:** Sediment deposition at Outfall C and surrounding area, and accumulated debris over the riprap surface (facing east).

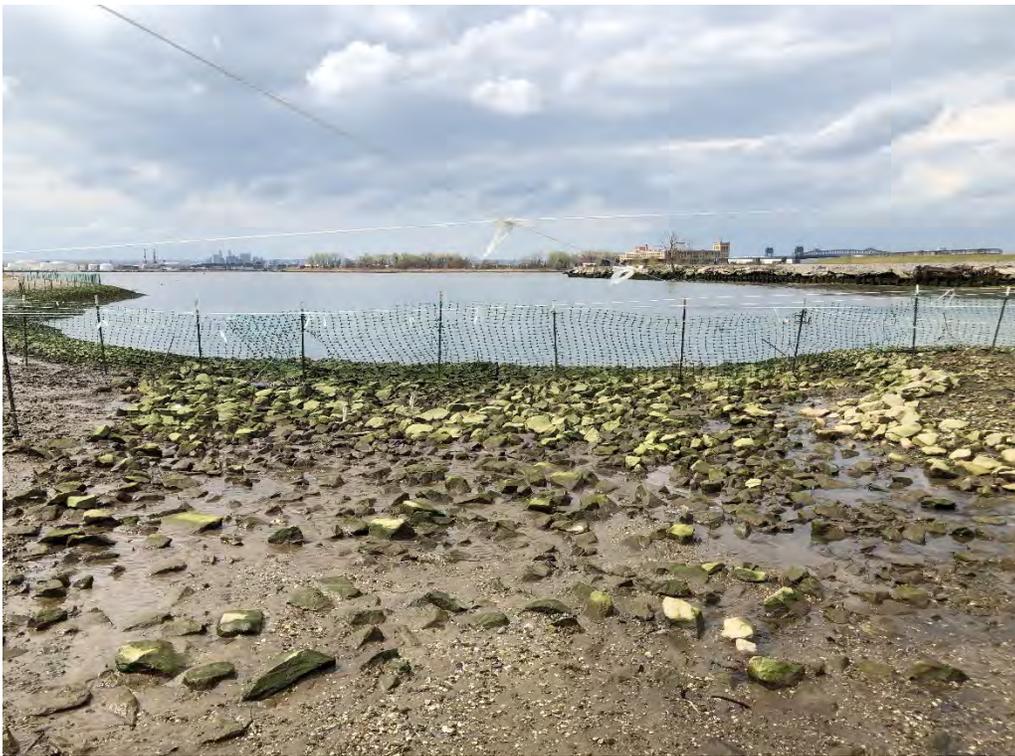
**Photo 19:** Sediment deposition over the underlying riprap apron of Outfalls B and C (facing west).

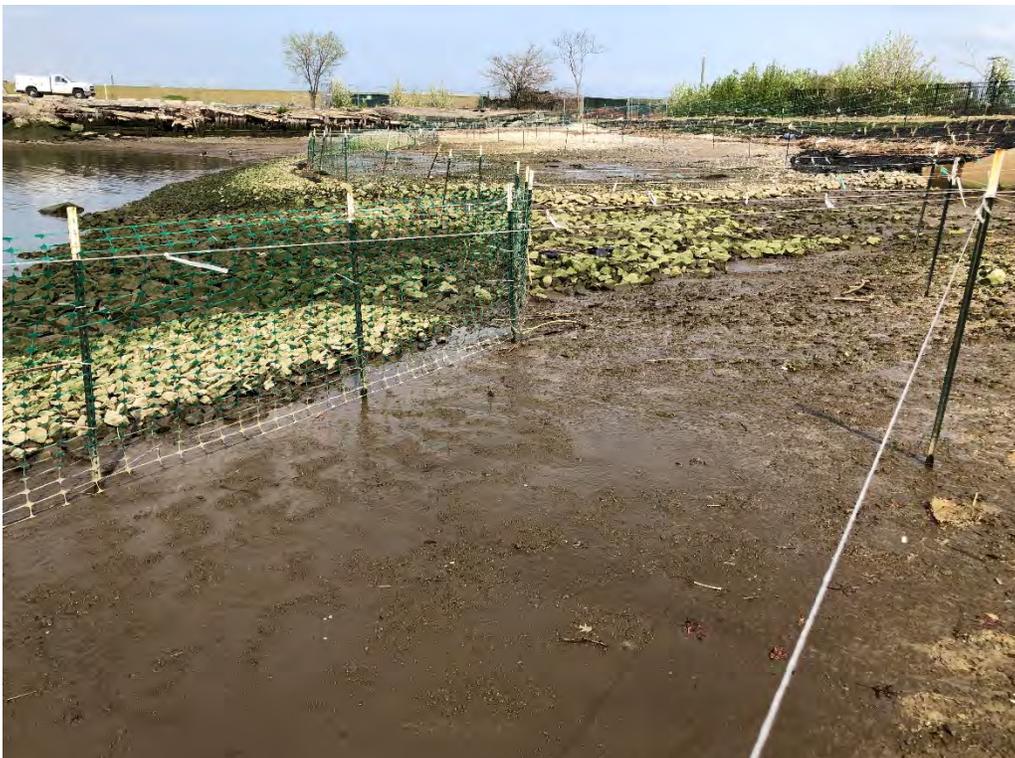
**Photo 20:** Riprap apron of Outfalls B and C with sediment deposition over the low marsh planting zone (facing northeast).

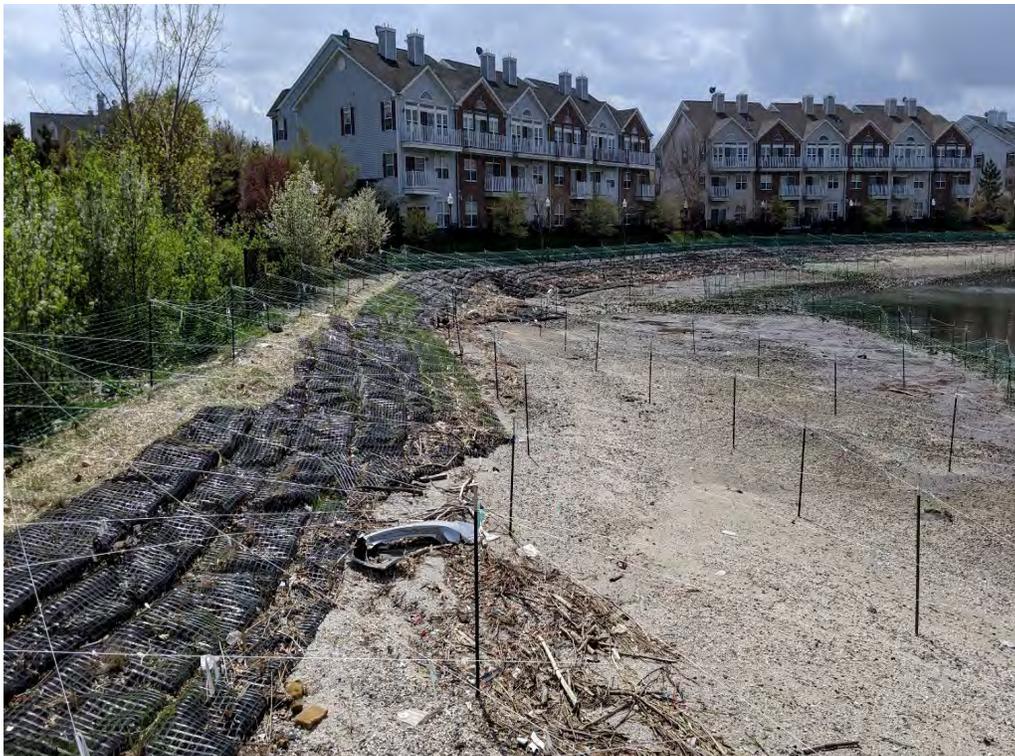
Photo 22: Northern portion of the BEP area with accumulated debris along the slope of the GroSoxx areas and the upper portion of the high marsh planting zone (facing southwest).

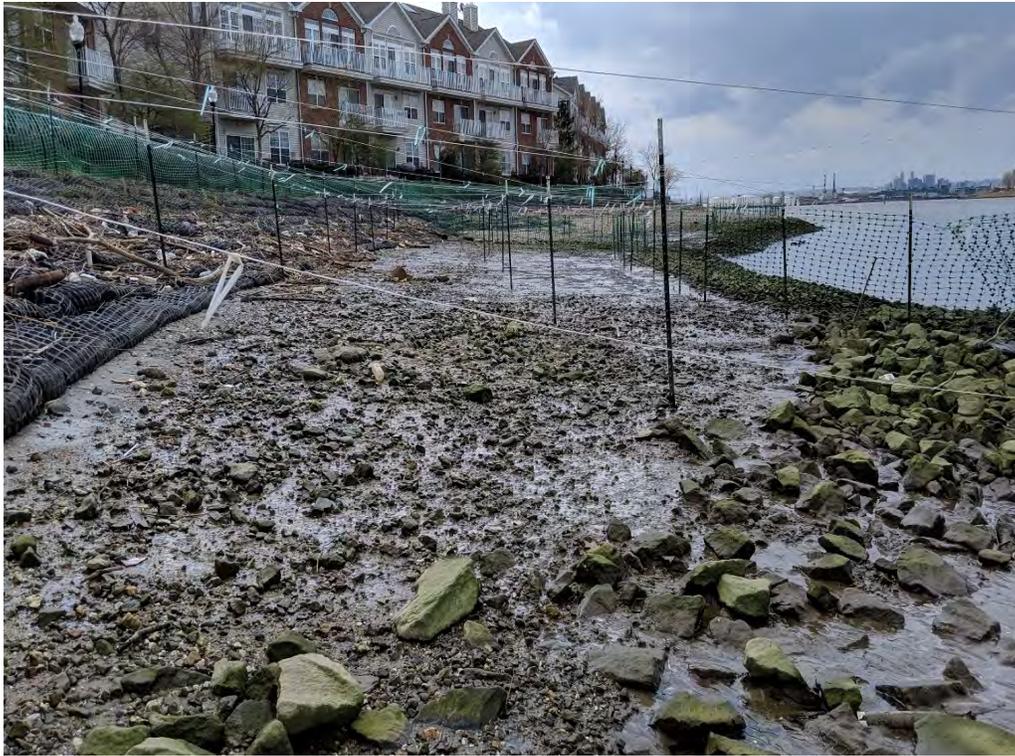
**Photo 23:** Central portion of the BEP area, east of Outfall A, with sediment deposition over riprap apron of Outfall B and accumulated debris along the slope of the GroSoxx area (facing west).

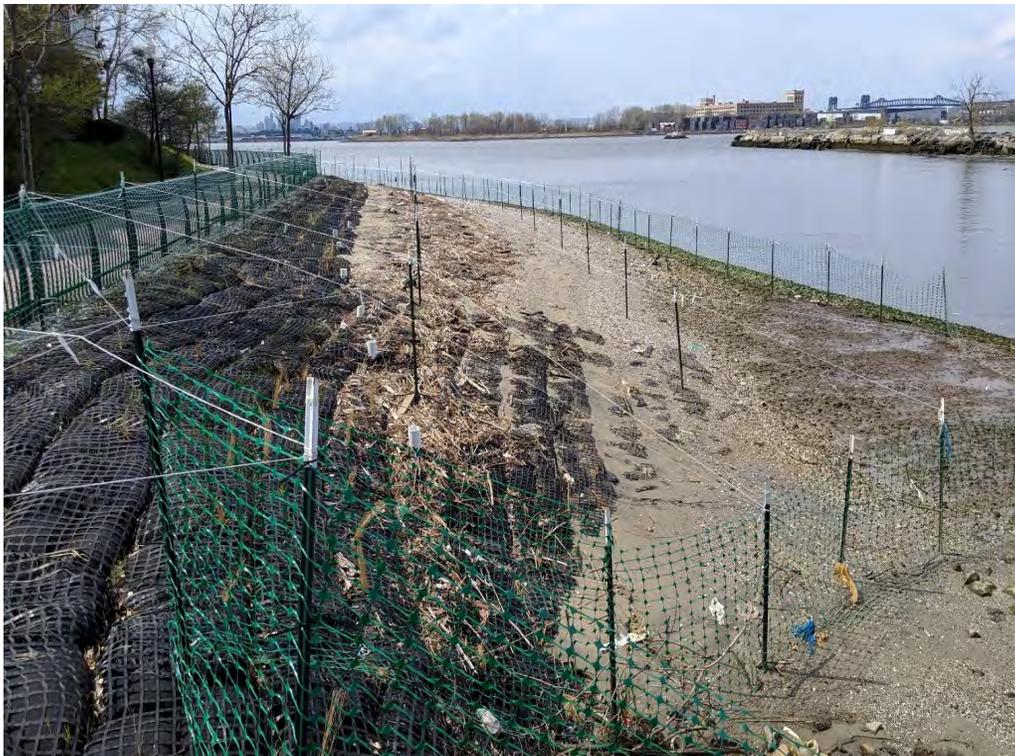
**Photo 24:** Central portion of the BEP area, west of Outfall A, with sediment deposition on the lower rows of GroSoxx, and 4-foot wide accumulated debris on the high marsh and upland planting zones (facing northwest).

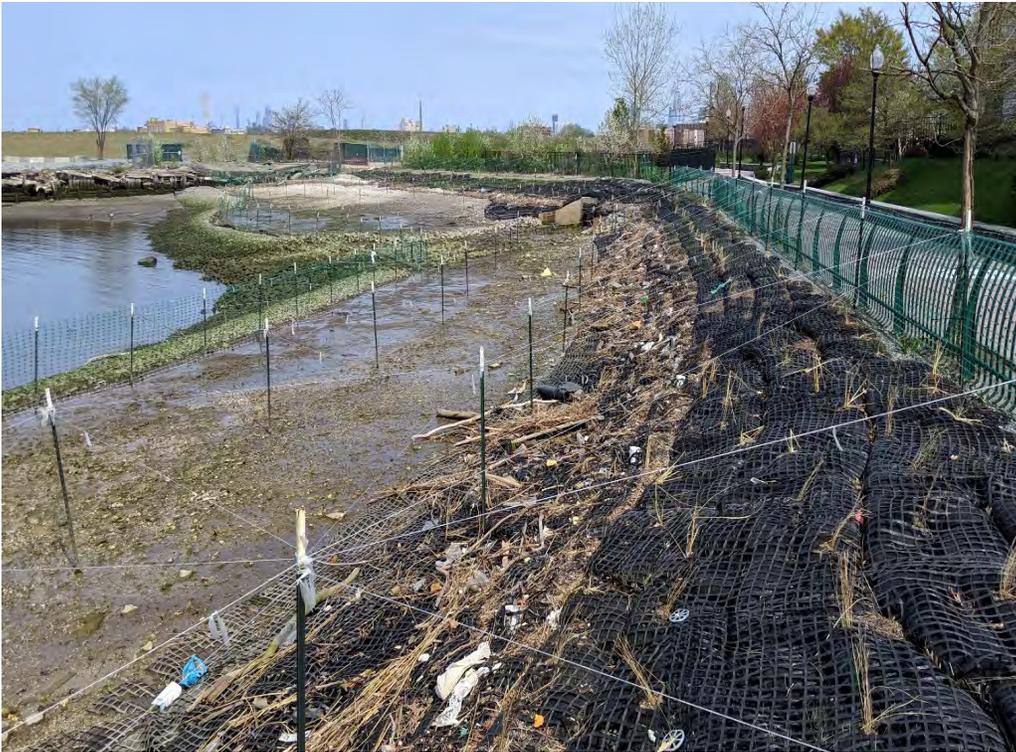
**Photo 25:** Central portion of the BEP area, east of Outfall A, with accumulated debris on the high marsh and upland planting zones (facing southeast).

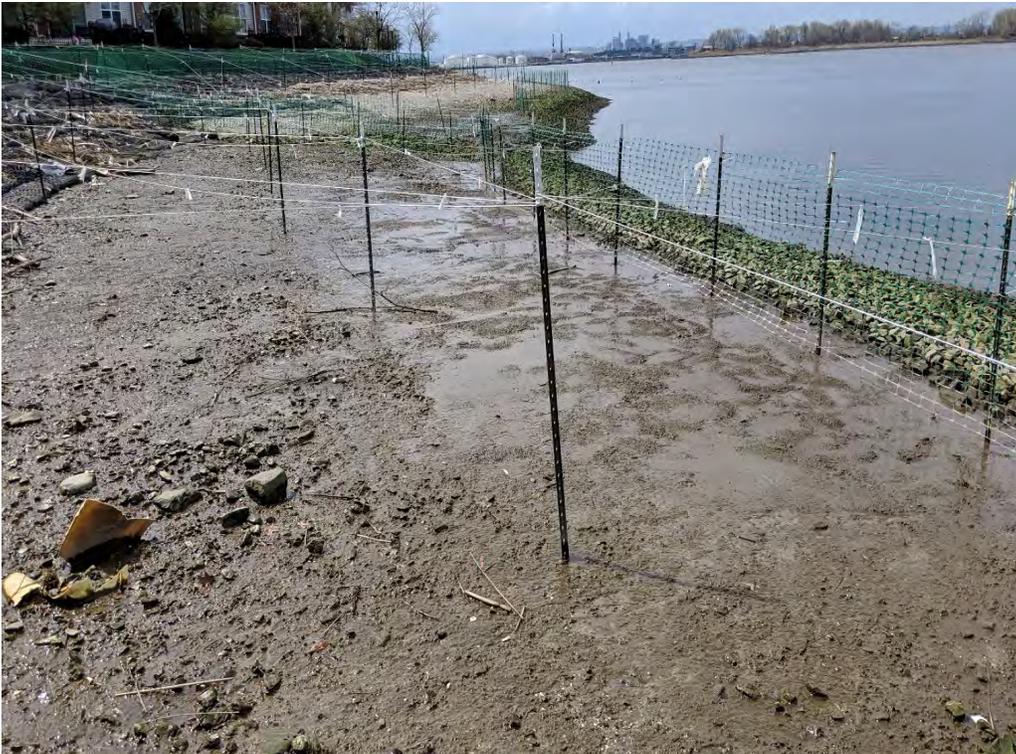
**Photo 26:** Low marsh and high marsh planting zones in the central portion of the BEP area, east of Outfall A, with sediment deposition in the low marsh planting zone and scattered debris along the GroSoxx slope (facing west).

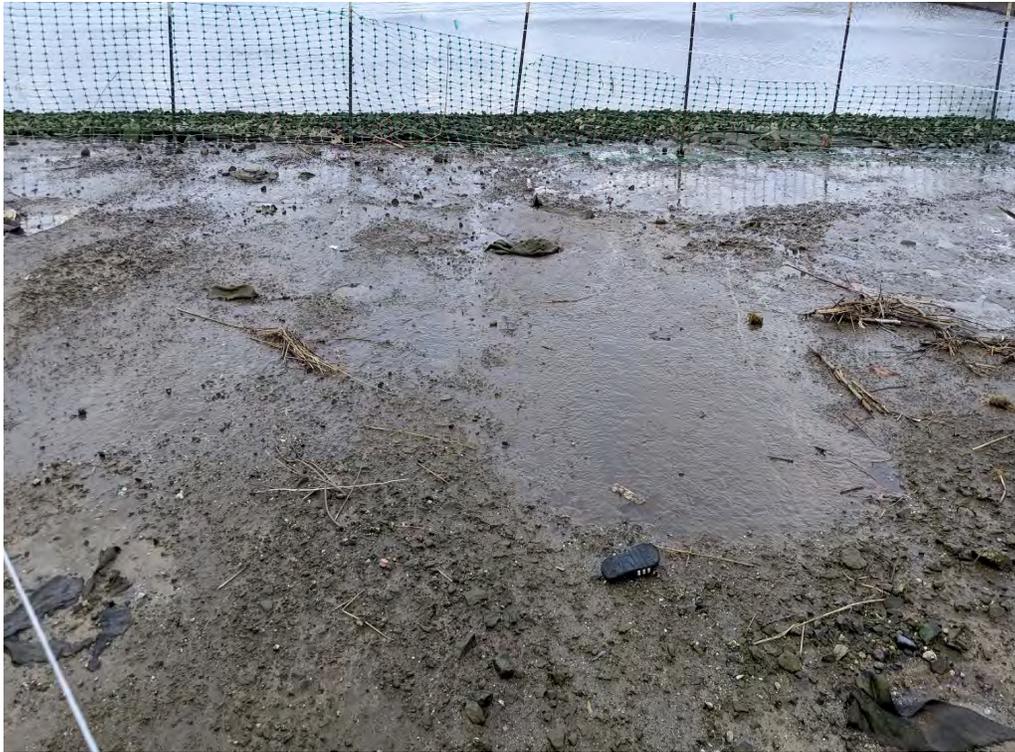
**Photo 27:** Low marsh planting zone in the central portion of the BEP area, just west of Outfall A, with sediment deposition in the low marsh planting zone and scattered debris over the surface (facing northwest).

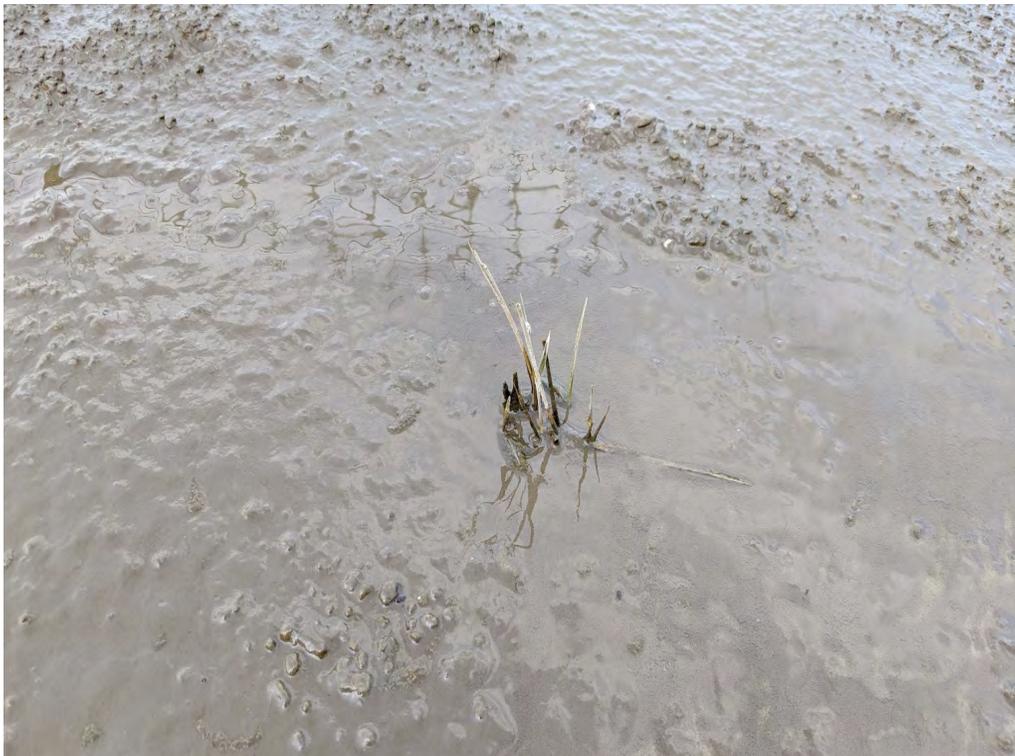
**Photo 28:** A partially buried plug in the low marsh planting zone in the central portion of the BEP area, just west of Outfall A.

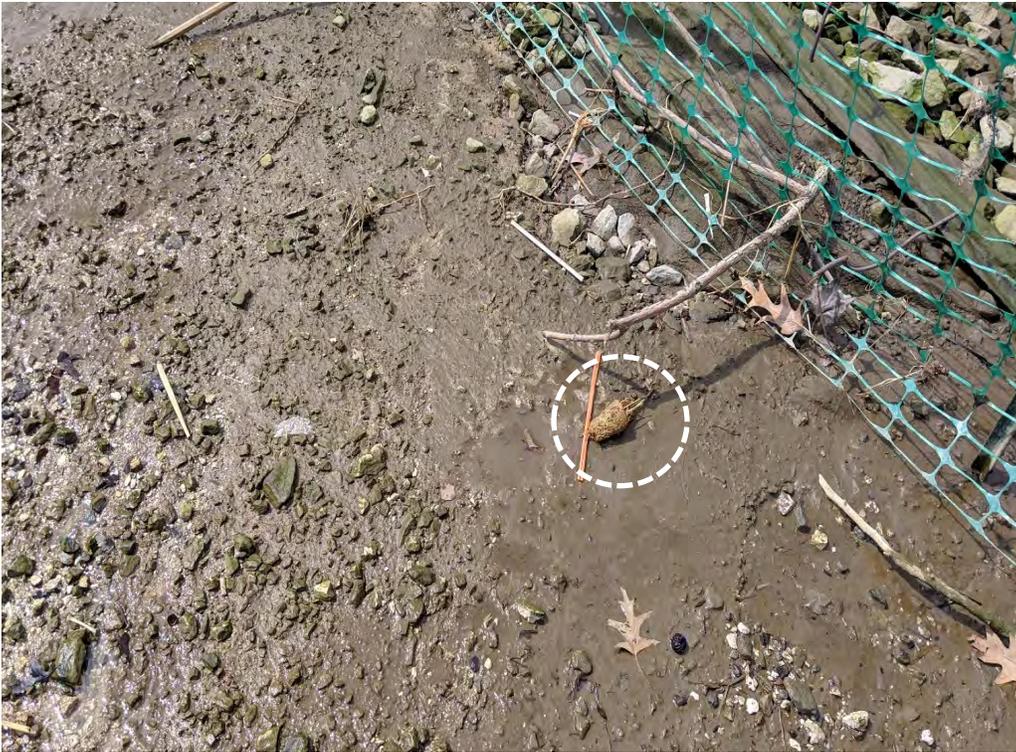
Photo 29: Example of a loose plug scattered throughout the low marsh planting zone.

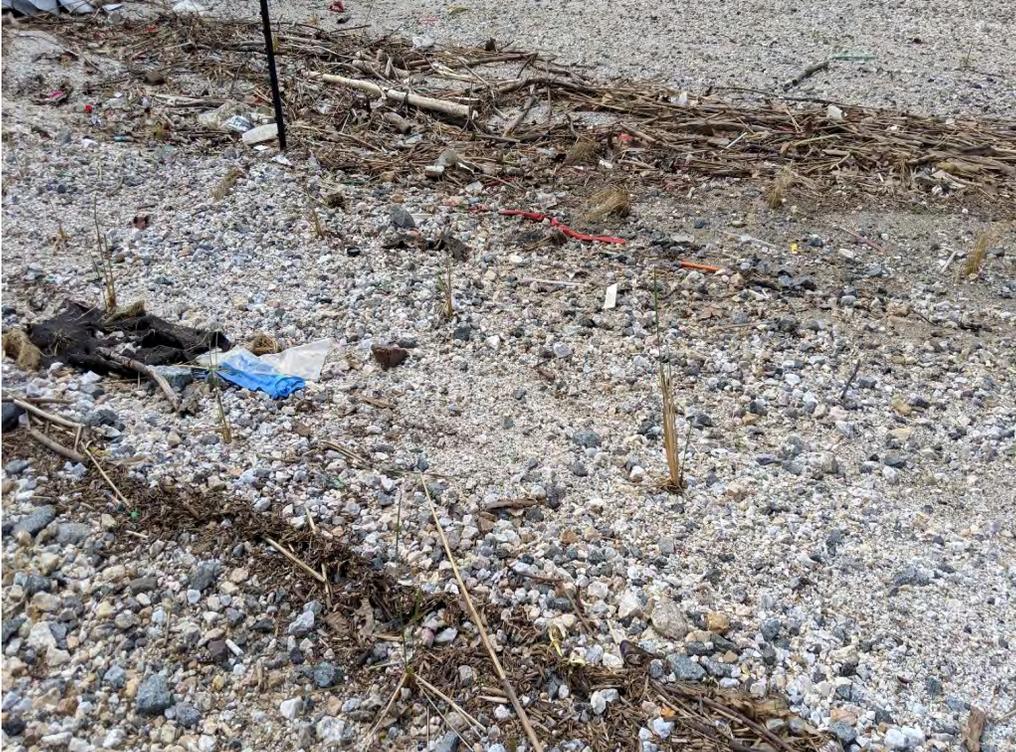
Photo 30: Plugs with new growth in the high marsh planting zone on the east side of the BEP area (facing northwest). Note exposed gravel due to tidal erosion of fines, scattered debris throughout the high marsh area, and 2-foot wide accumulated debris on the low marsh and high marsh planting zones.

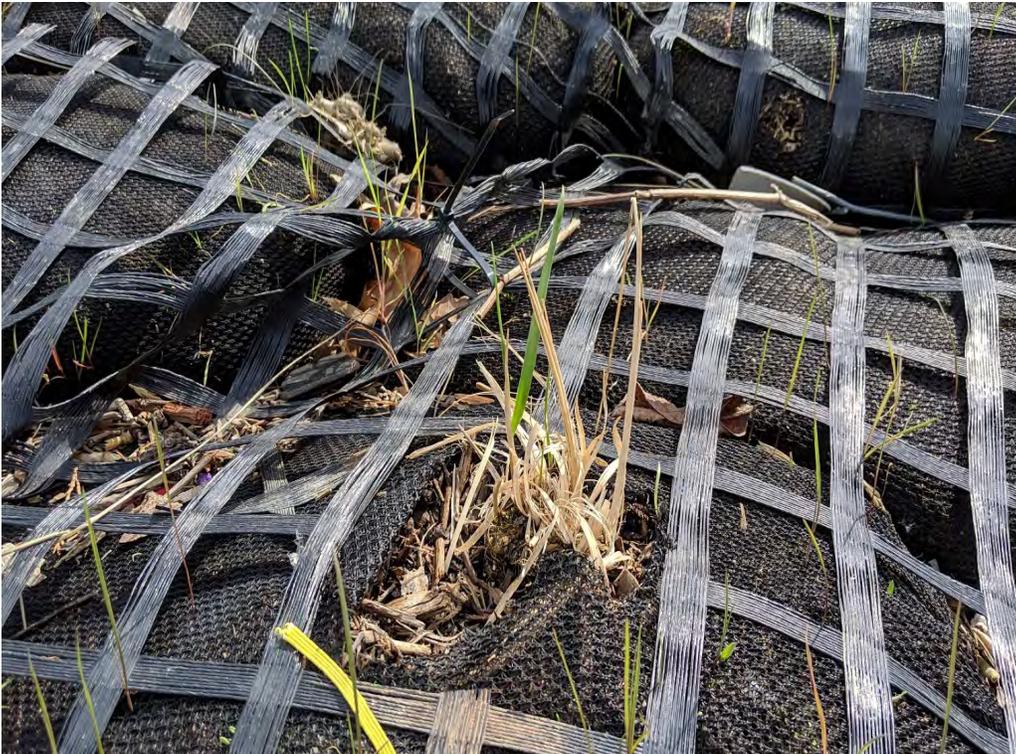
**Photo 34:** New growth on plugs within the upland transition area of the BEP area.

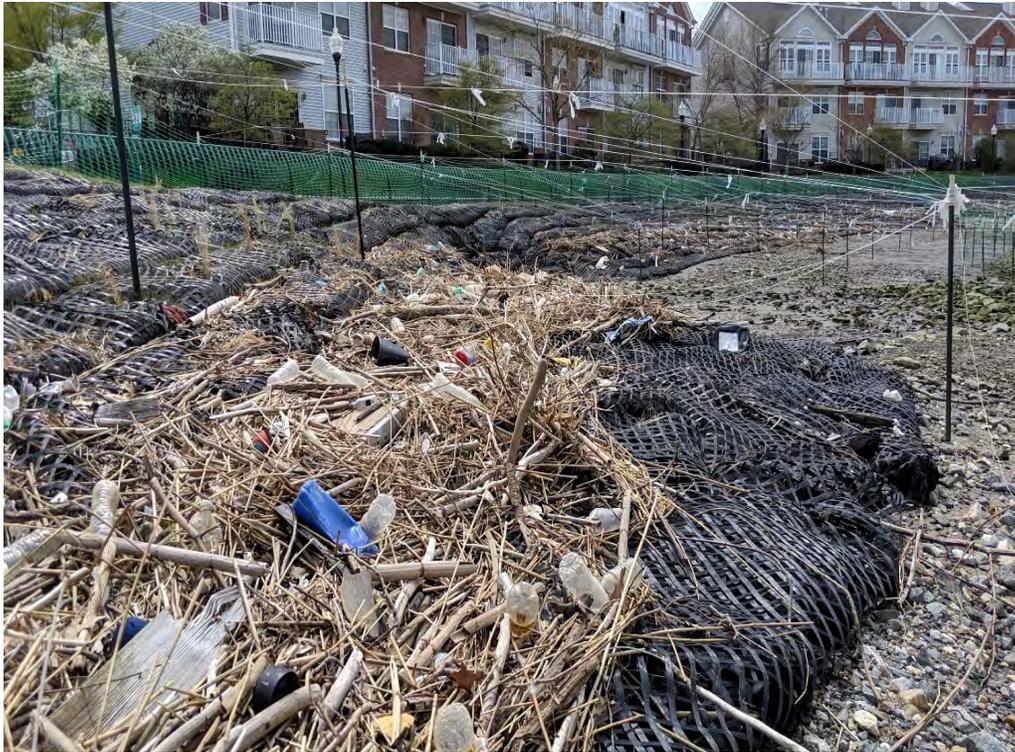
**Photo 35:** Upper and lower extent of the GroSoxx and tidal drift deposit on the GroSoxx in the northern portion of the BEP area, north of Outfall C. Note exposed gravel just below the toe of the GroSoxx, indicating tidal erosion of fines from the shoreline fill material (facing southwest).

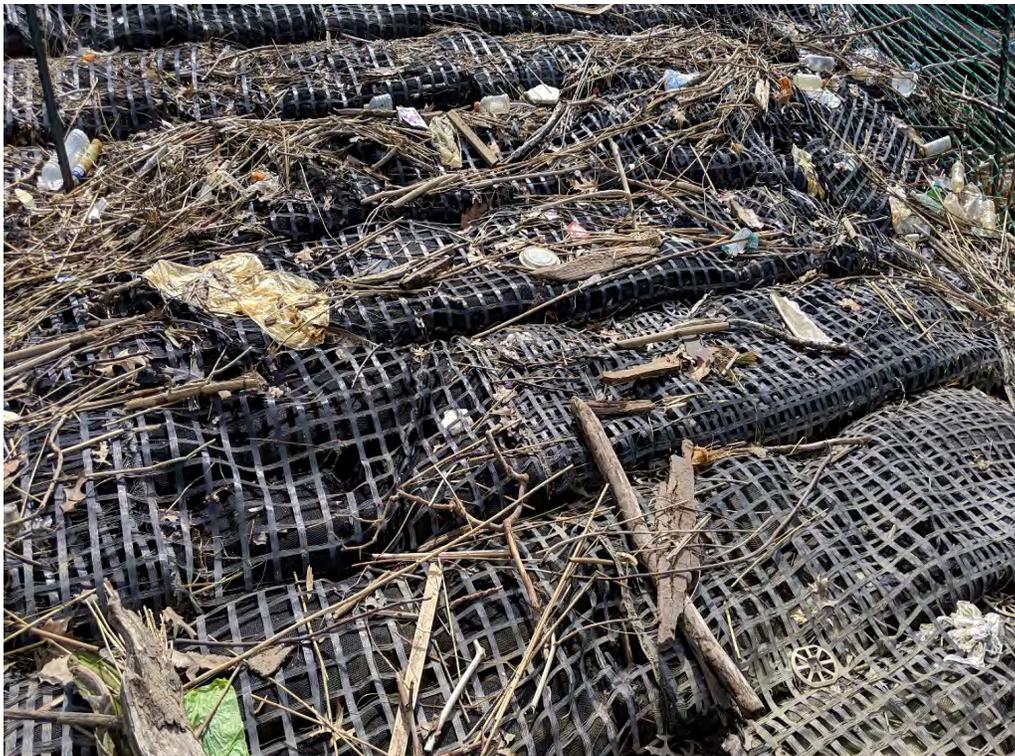
**Photo 36:** GroSoxx section below the tidal drift deposit line in the northern portion of the BEP area, just north of Outfall C (facing east). Note scattered debris throughout the area.

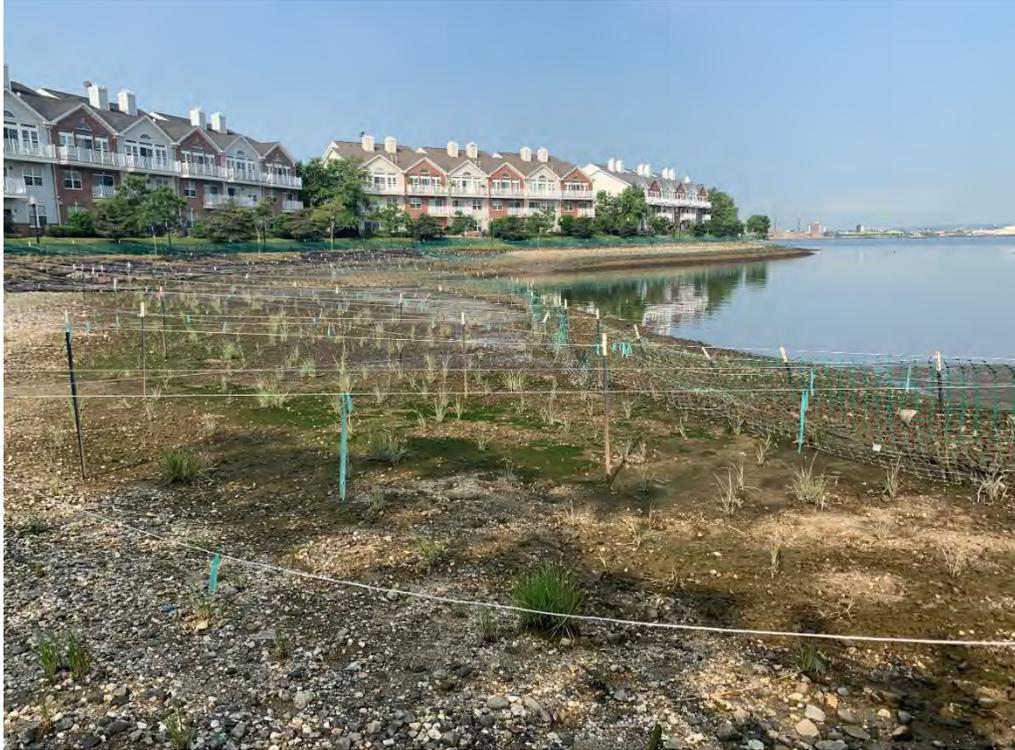
**Photo 1:** Northern end of Cap Area 16 and far extent of BEP area. Note healthy vegetative growth, exposed sand and gravel, and intact waterfowl exclusion measures (facing southwest).

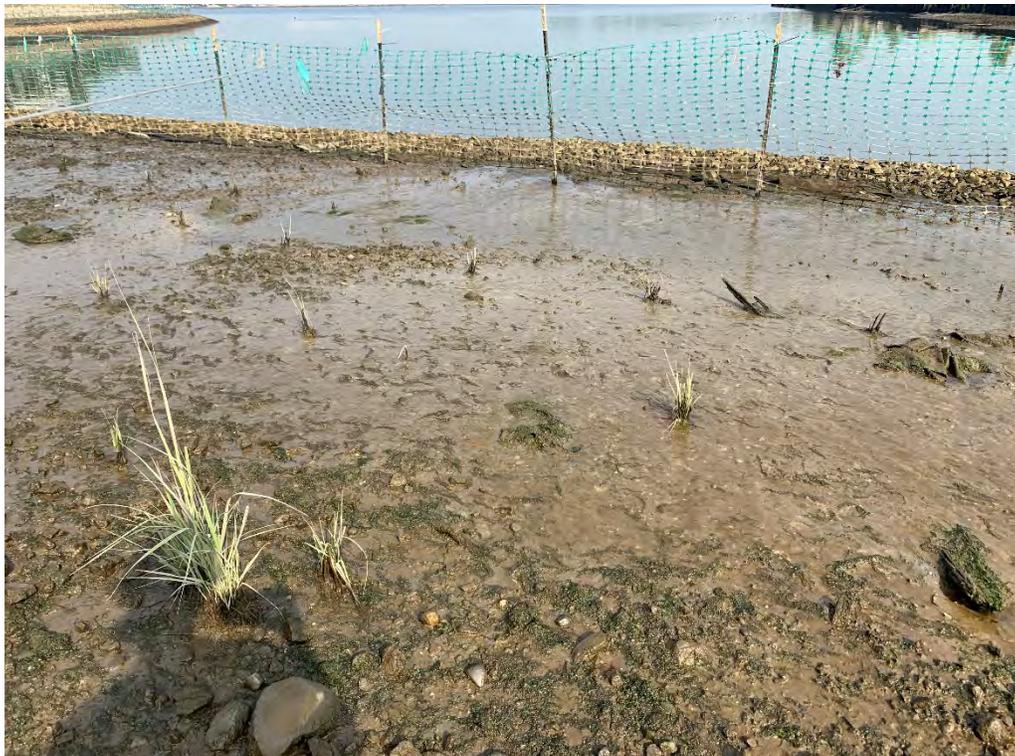
**Photo 14:** Somewhat stressed (likely due to frequent inundation) plugs and plug clusters near the armored shoreline in the low marsh planting zone northeast of Outfall C (facing northwest).

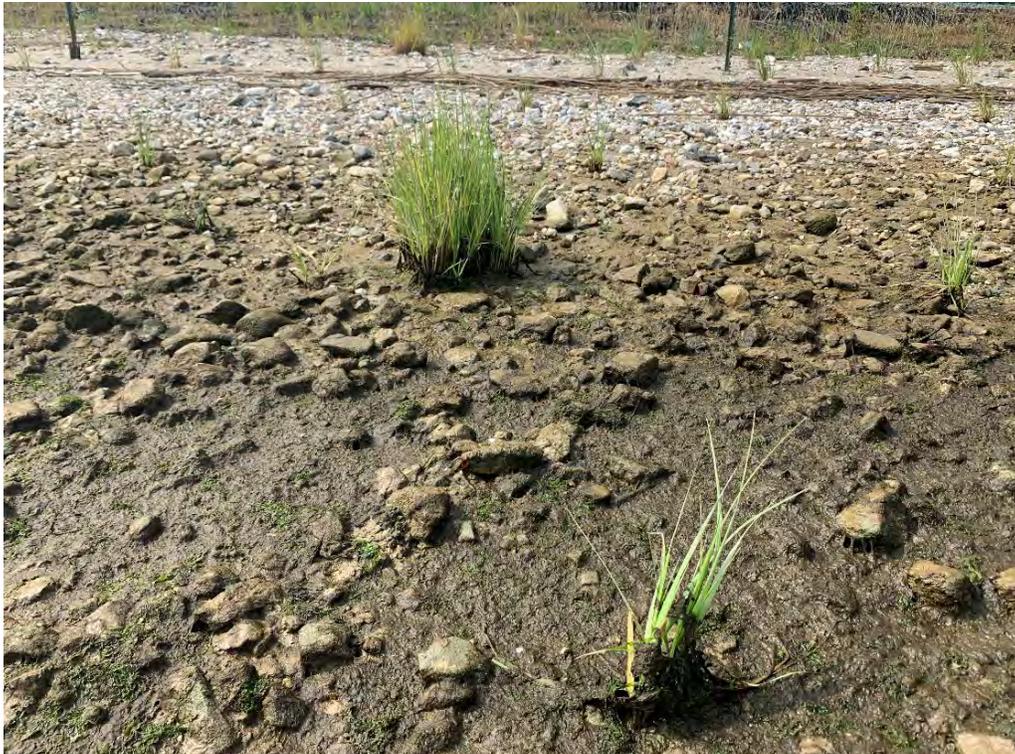
**Photo 18:** Healthy plugs and plug clusters in the high marsh planting zone in the southwestern BEP area (facing southwest). Note the exposed gravel and drift deposit line noticeable in the upper extent of the high marsh zone.

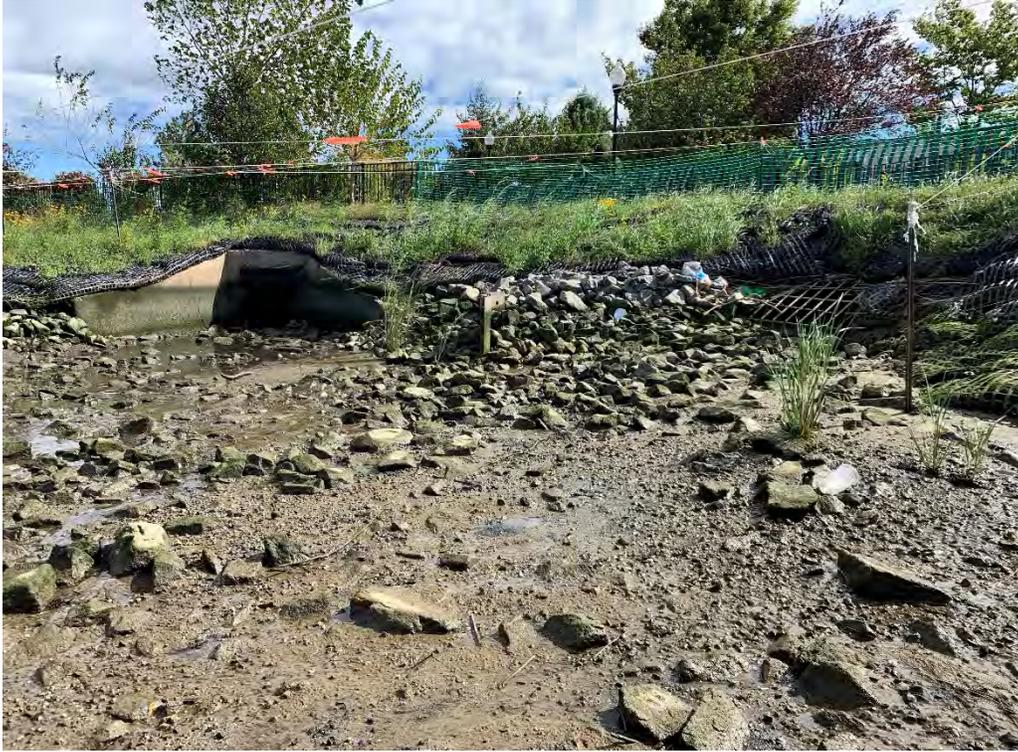
**Photo 5:** Areas of shoreline fill material deposition at Outfalls B and C (facing southeast).
