**MEMORANDUM**

Subject: **SA-7 Sediment Remedy Long Term Monitoring – Summary of**  
**Year 6 Activities and Proposed Activities for Year 7**

**ATTACHMENT A  
YEAR 6 INSPECTION LOGS**

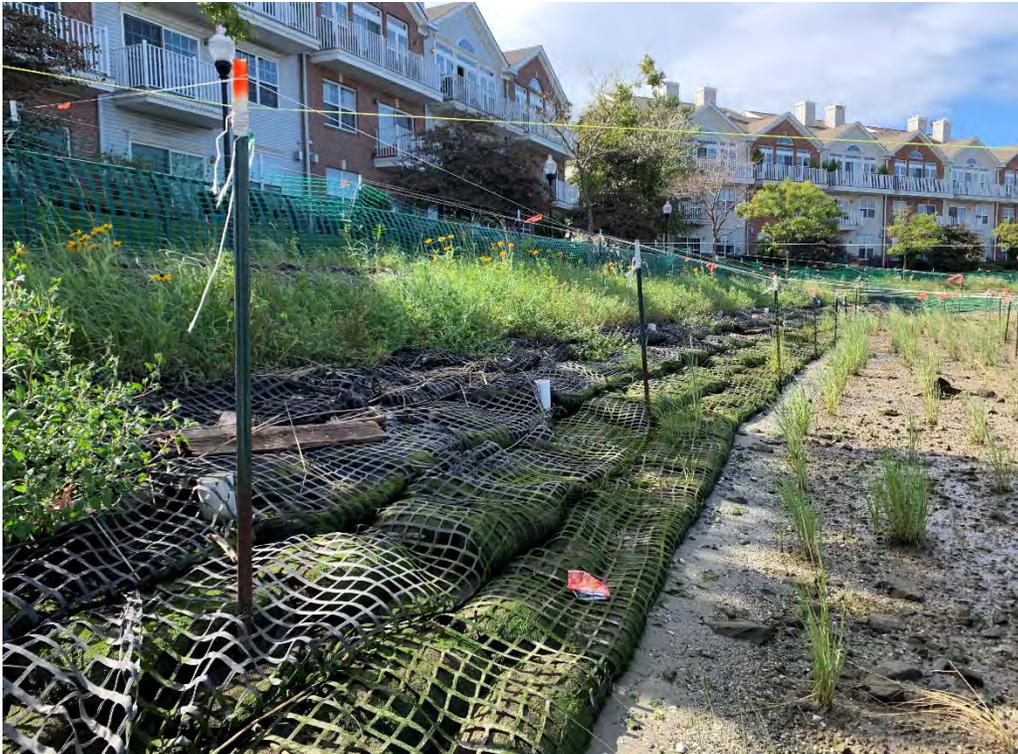
**Photo 12:** Sparsely vegetated high marsh zone, west of Outfall B where GroSoxx were installed (facing west).

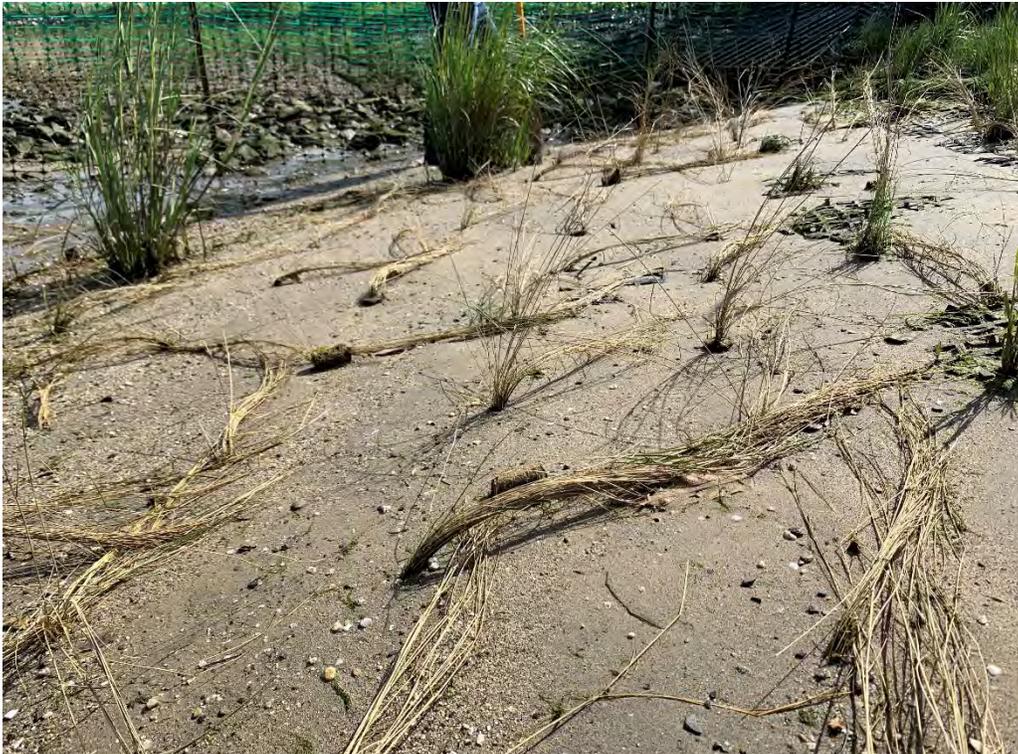
**Photo 13:** Uprooted plugs in the high marsh zone west of Outfall A, replanted at the time of inspection (viewing east).

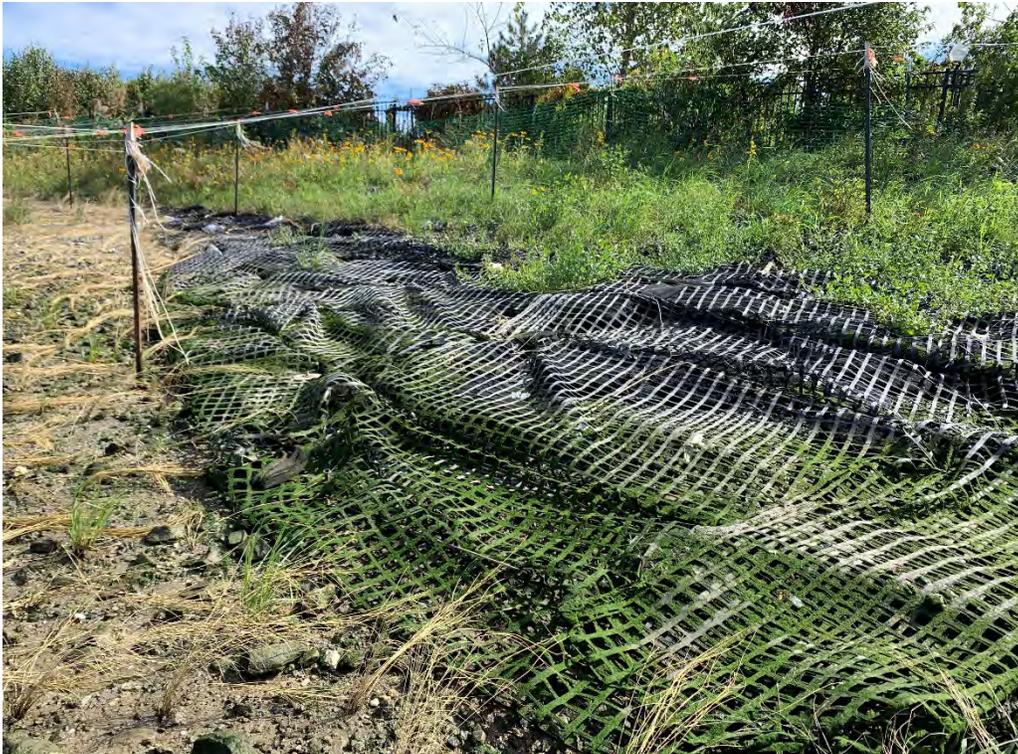
**Photo 14:** Sparsely vegetated high marsh zone, east of Outfall C where GroSoxx were installed (facing southeast).

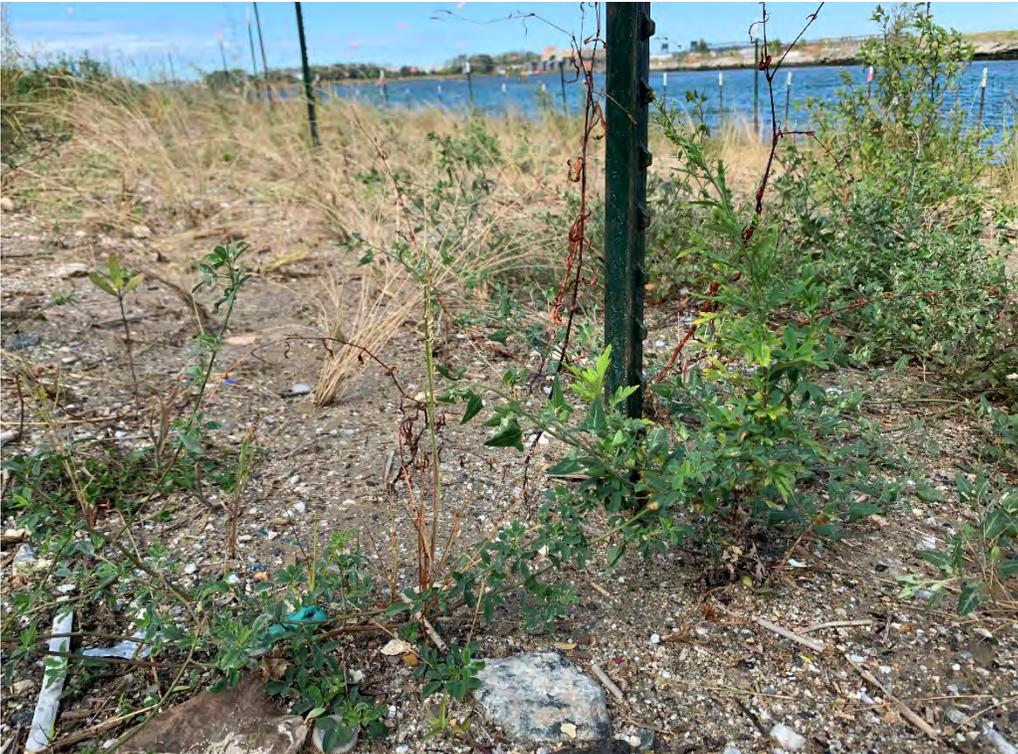
**Photo 15:** Small cluster of invasive species (European mugwort) around erosion measurement Pole 10 (facing west).

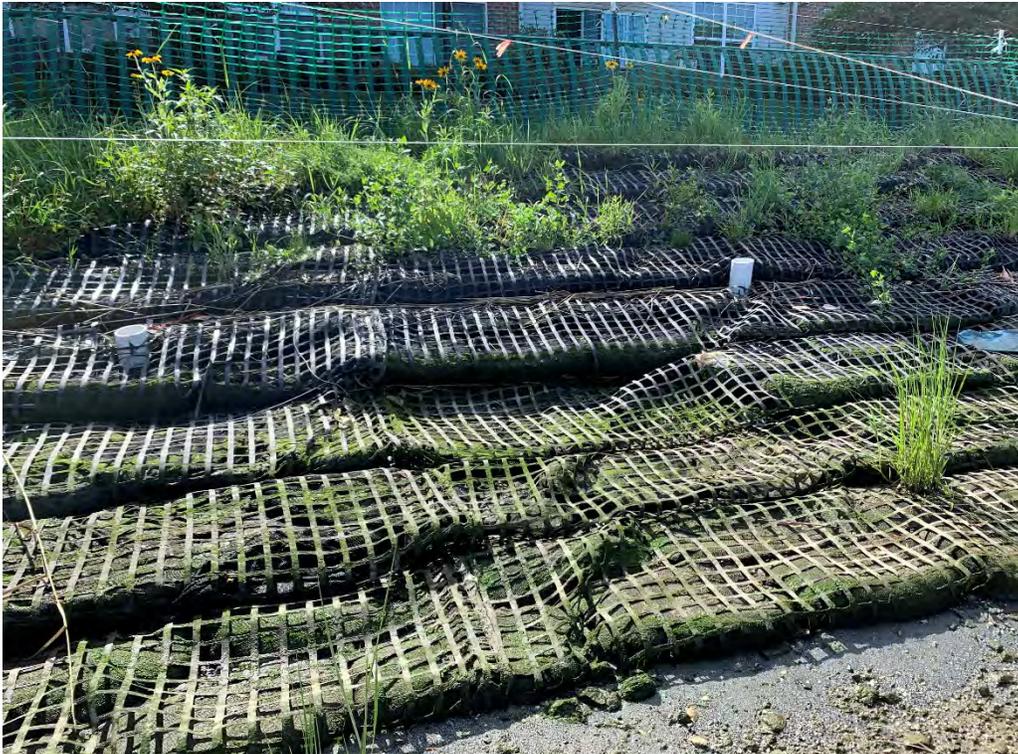
**Photo 17:** Sparsely vegetated upland transition area and high marsh zone between Outfalls A and B (facing south).

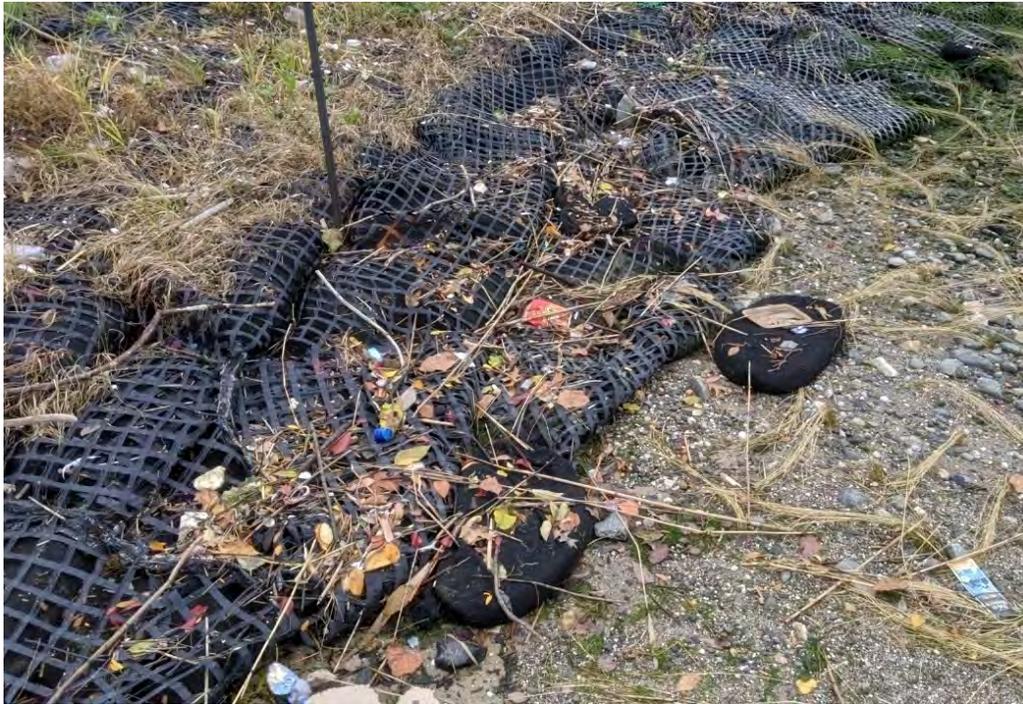
**Photo 19:** Loose and ripped geogrid, with GroSoxx either missing or outside of the geogrid east of Outfalls B and C.

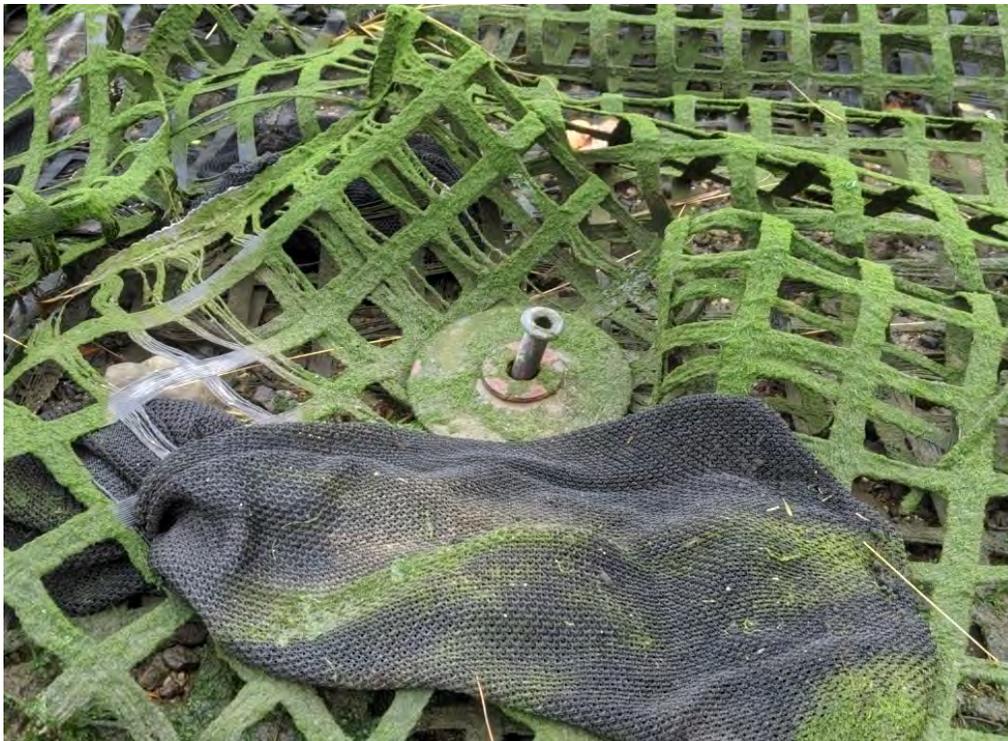
**Photo 20:** An uplifted anchor bolt and an emptied GroSoxx observed outside of the geogrid east of Outfalls B and C.

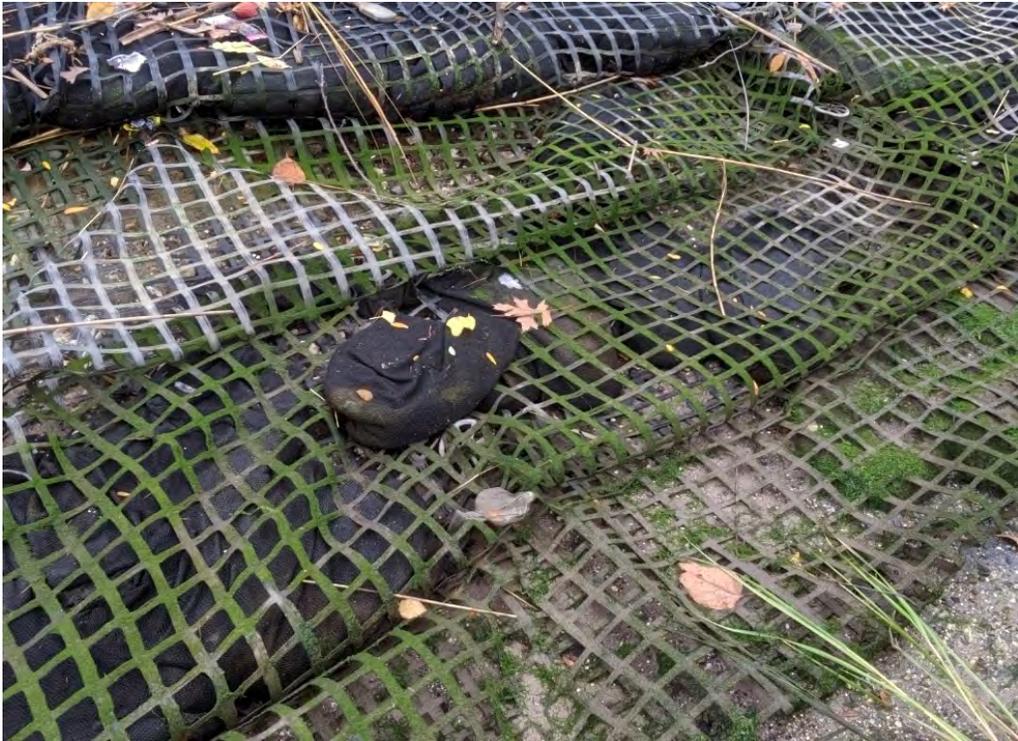
**Photo 21:** Missing row of GroSoxx (third from the bottom) with loose geogrid and GroSoxx outside the geogrid between Outfalls A and B.

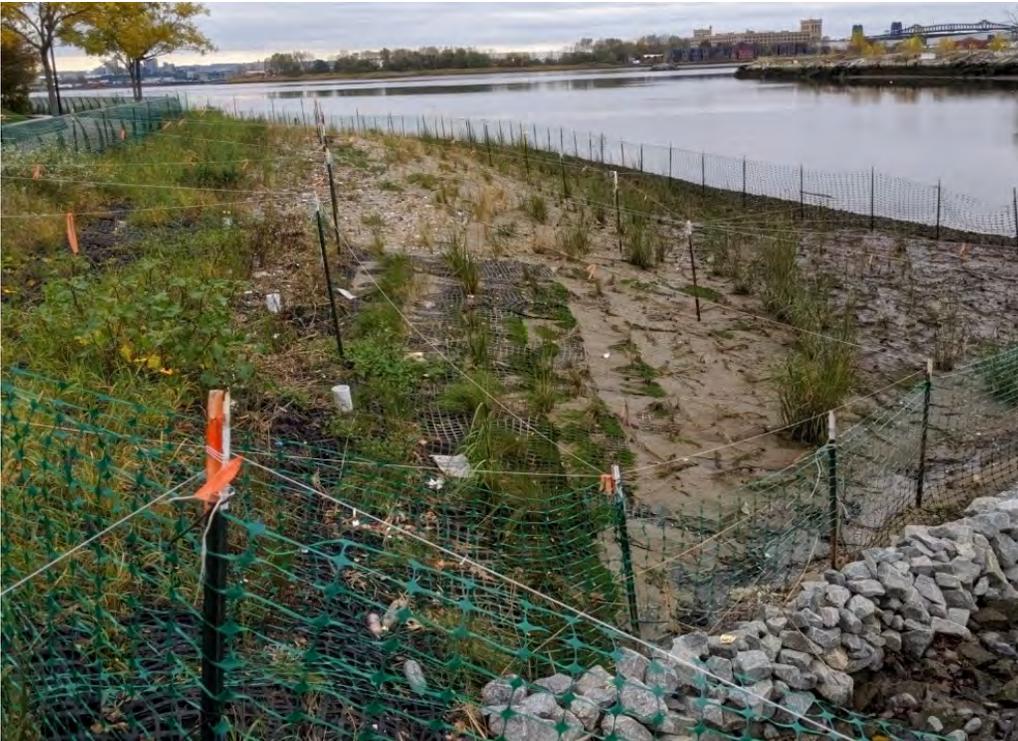
**Photo 22:** Partially vegetated high marsh area west of Outfall A. Note siltation on the GroSoxx (facing northwest).

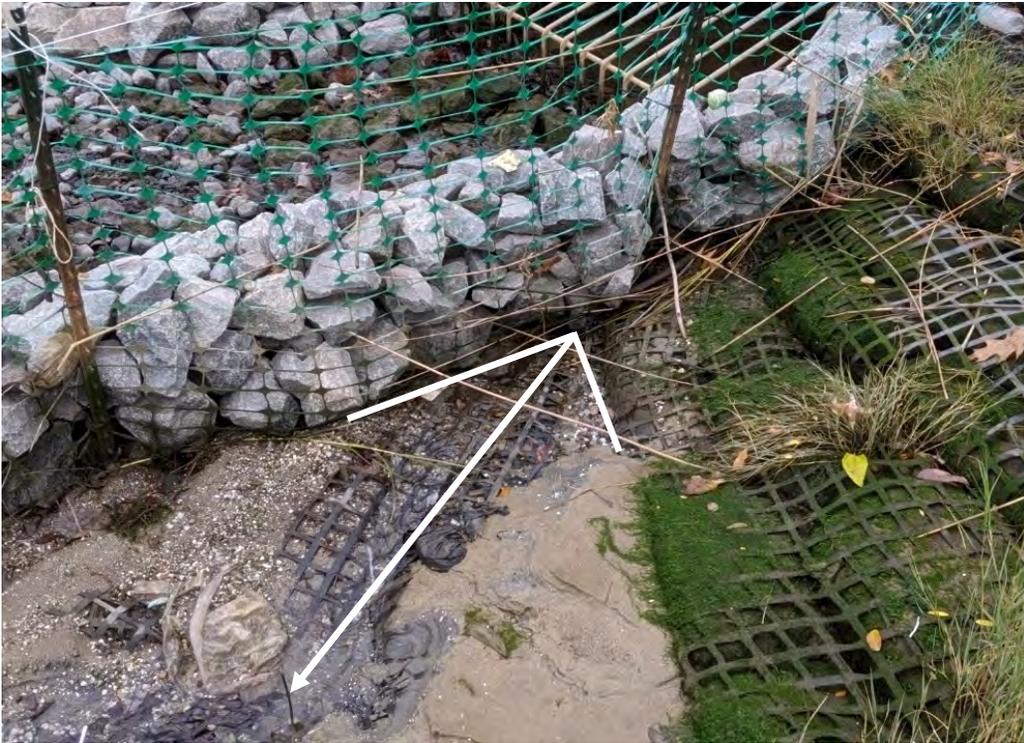
**Photo 24:** Water draining through the riprap apron modification and from underneath the GroSoxx on the west side of Outfall A (facing southeast). Note large size of riprap and riprap leaning on the waterfowl exclusion measures.

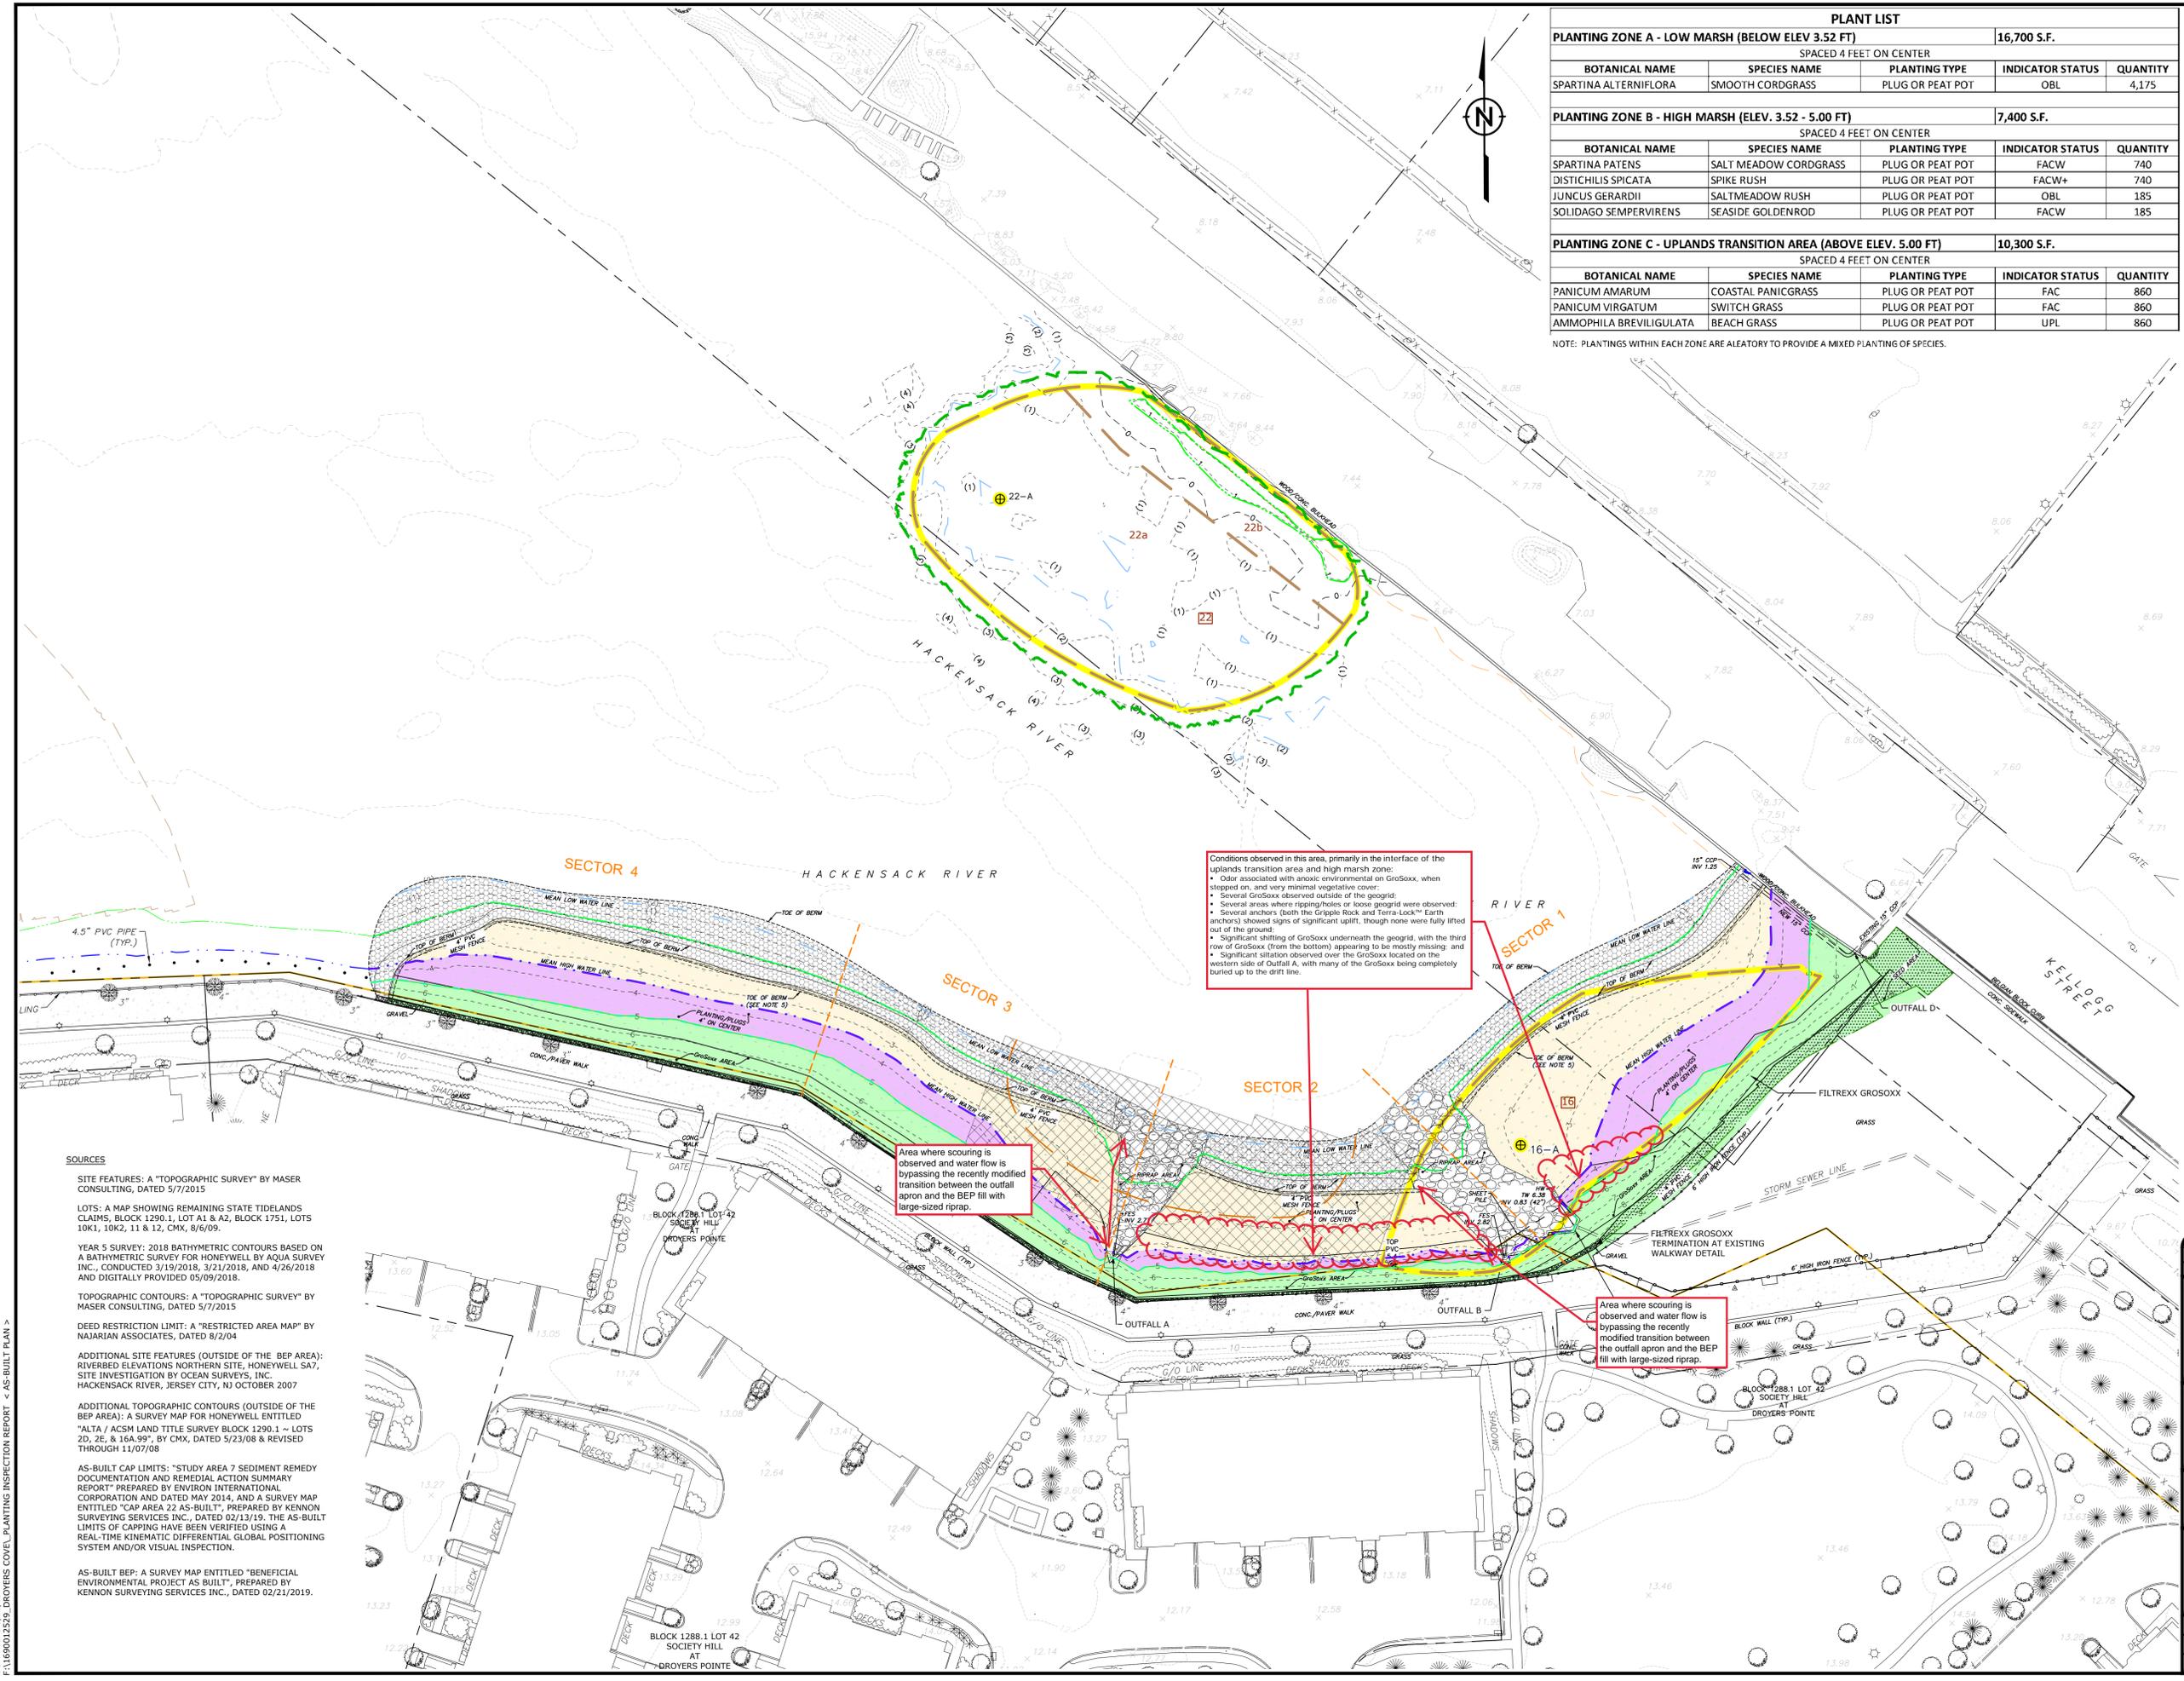
Conditions observed in this area, primarily in the interface of the uplands transition area and high marsh zone:

- Odor associated with anoxic environmental on Grosoxx, when stepped on, and very minimal vegetative cover.
- Several Grosoxx observed outside of the geogrid.
- Several areas where rippings/holes or loose geogrid were observed.
- Several anchors (both the Gripple Rock and Terra-Lock™ Earth anchors) showed signs of significant uplift, though none were fully lifted out of the ground.
- Significant shifting of Grosoxx underneath the geogrid, with the third row of Grosoxx (from the bottom) appearing to be mostly missing; and
- Significant siltation observed over the Grosoxx located on the western side of Outfall A, with many of the Grosoxx being completely buried up to the drift line.

Area where scouring is observed and water flow is bypassing the recently modified transition between the outfall apron and the BEP fill with large-sized riprap.
