MEMORANDUM

Subject: **SA-7 Sediment Remedy Long-Term Monitoring**
Summary of Year 10 Monitoring & Proposed Year 11
Program

**ATTACHMENT A.2
AUGUST 30, 2023 INSPECTION LOG**

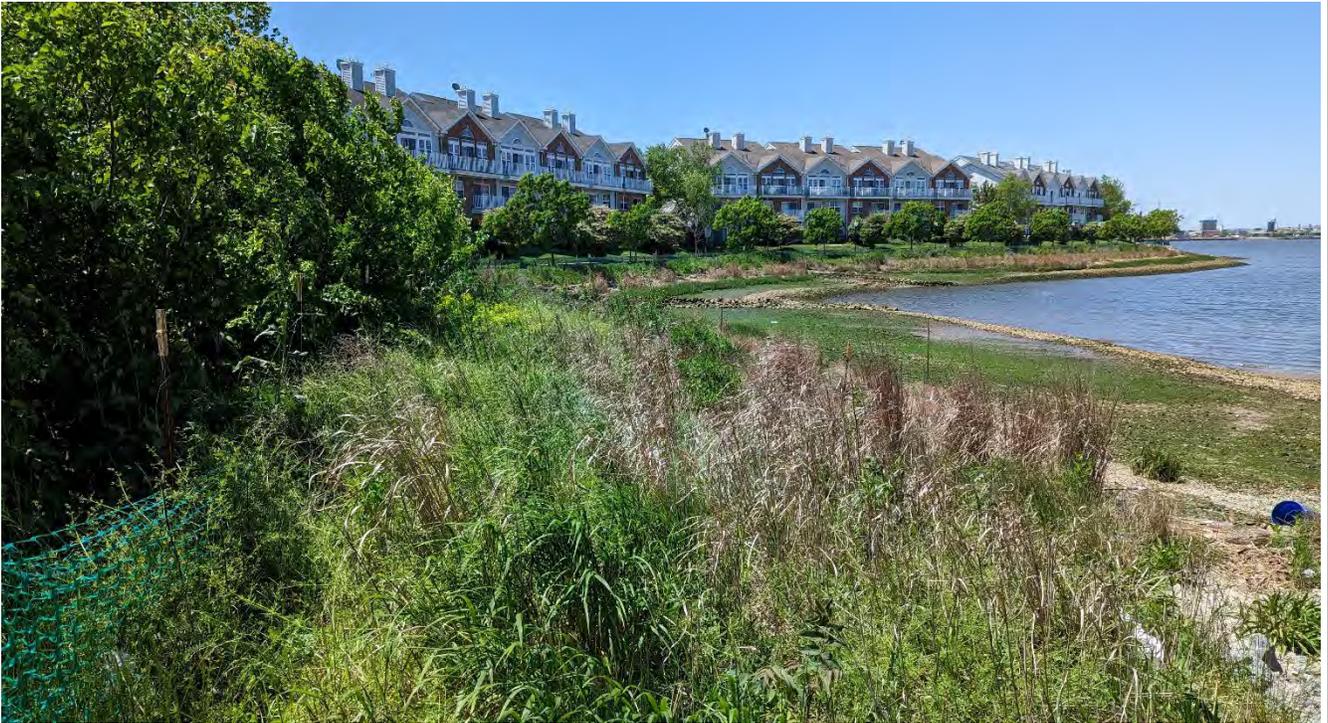
Photo 1: Northern end of Cap Area 16 (facing west). Note vibrant and healthy vegetation present in high marsh planting and upland zones.

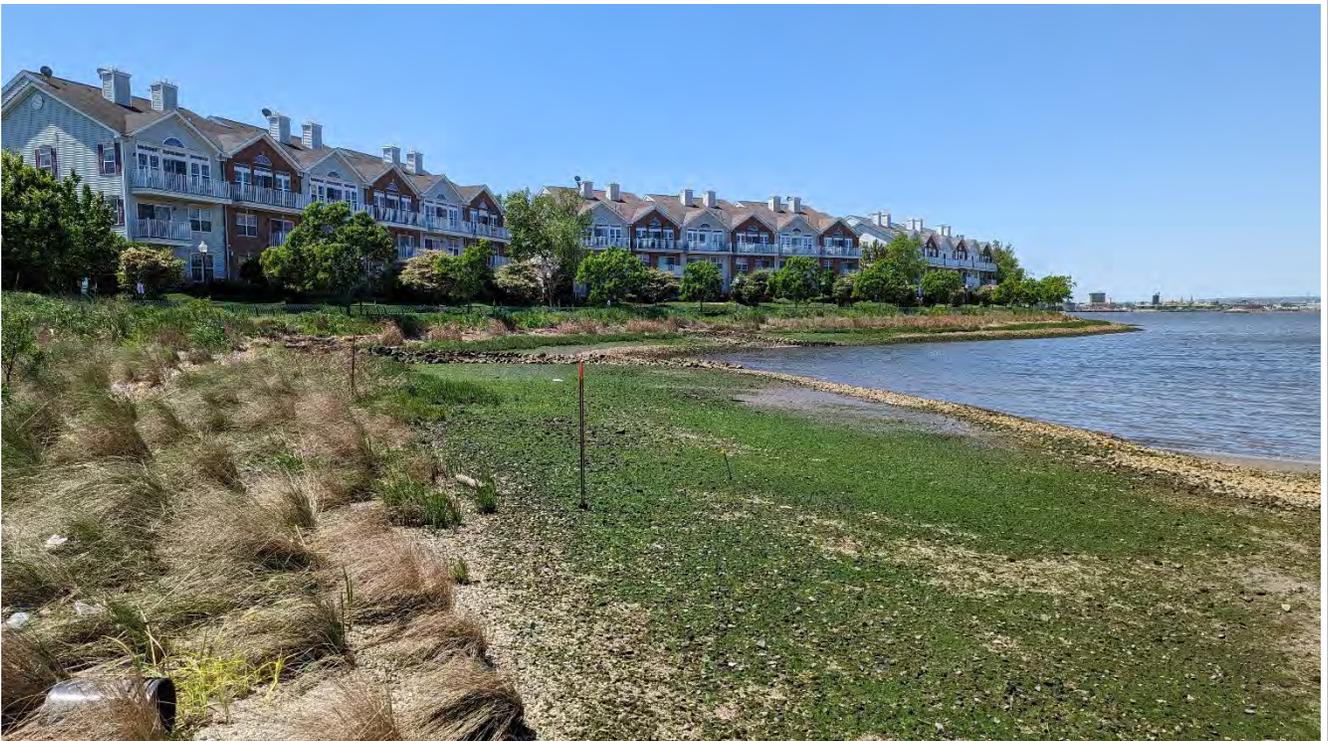
Photo 2: Central portion of Cap Area 16 (facing west). Note algae resembling sea lettuce (*Ulva intestinalis*) throughout the low marsh planting zone and reference posts used to assess sediment surface changes.

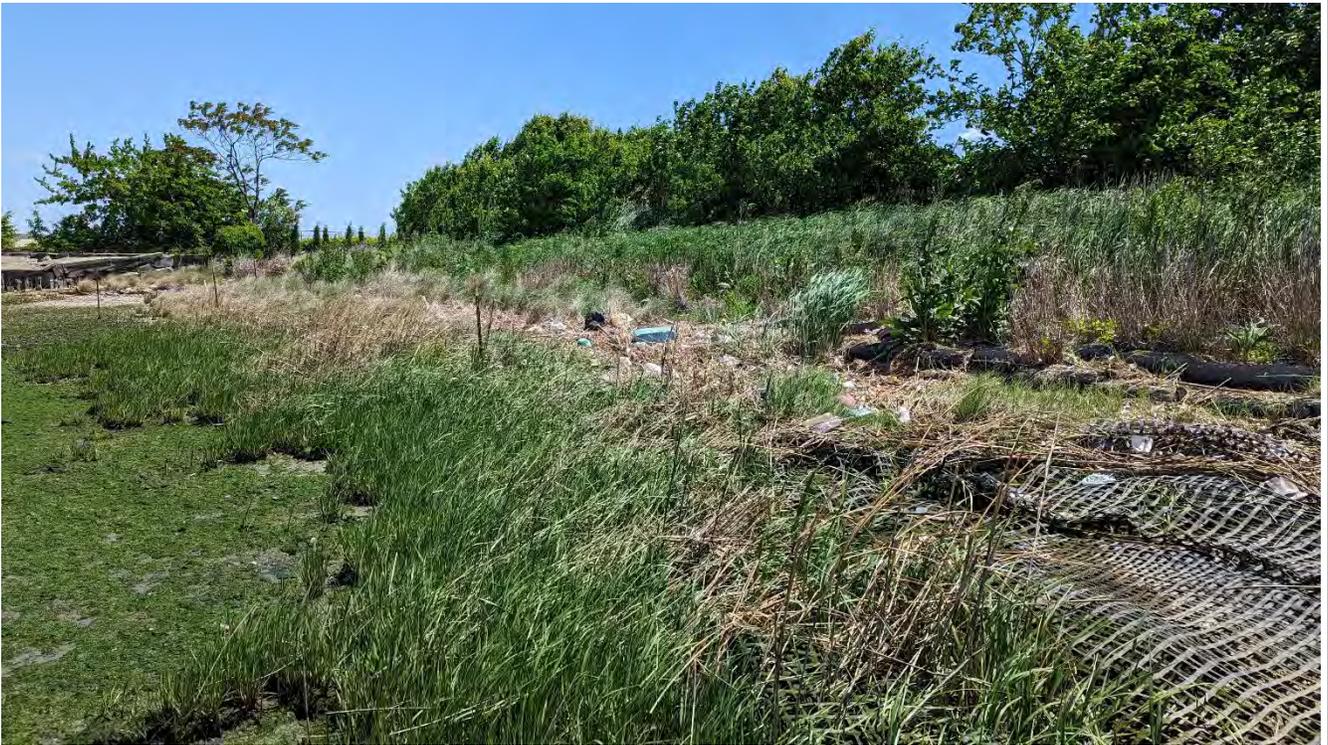
Photo 3: Western end of Cap Area 16 (facing east). Note the vibrant and healthy vegetation in the low and high marsh planting zones.

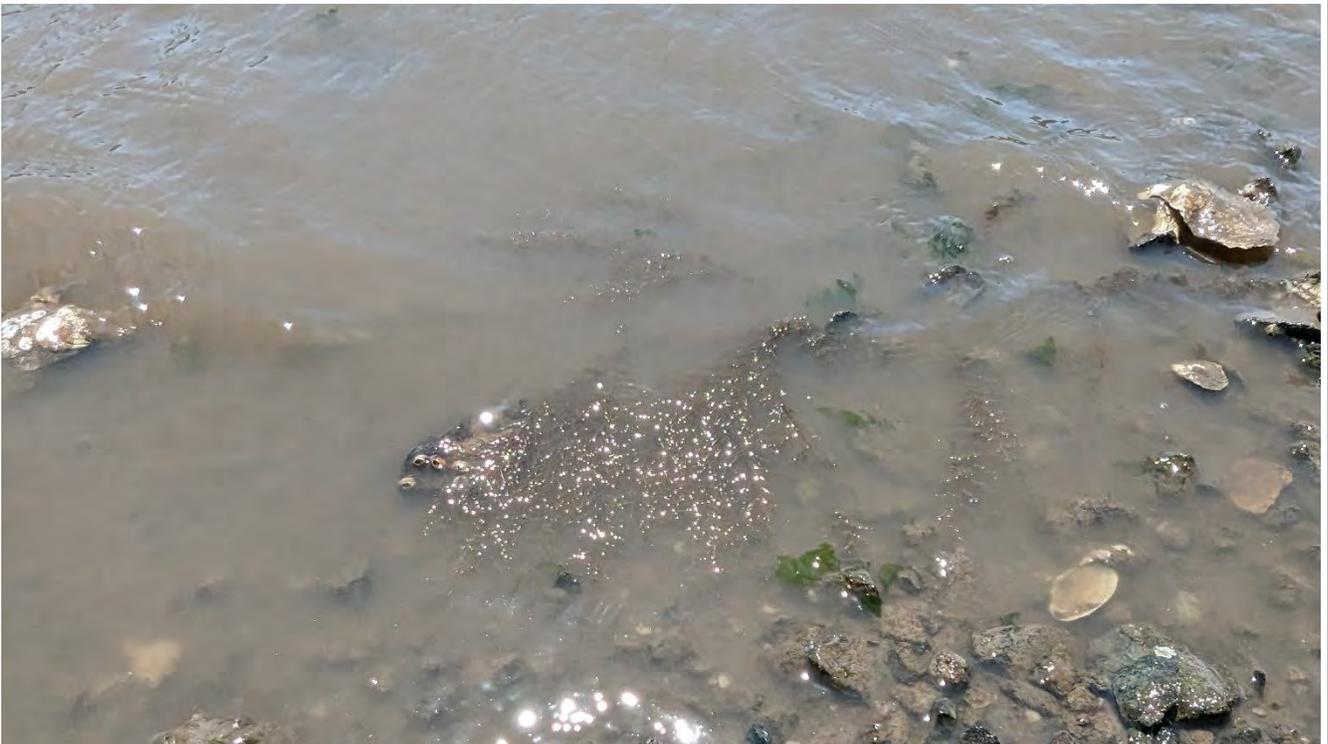
Photo 4: Siltation and aquatic plants observed within Cap Area 22.

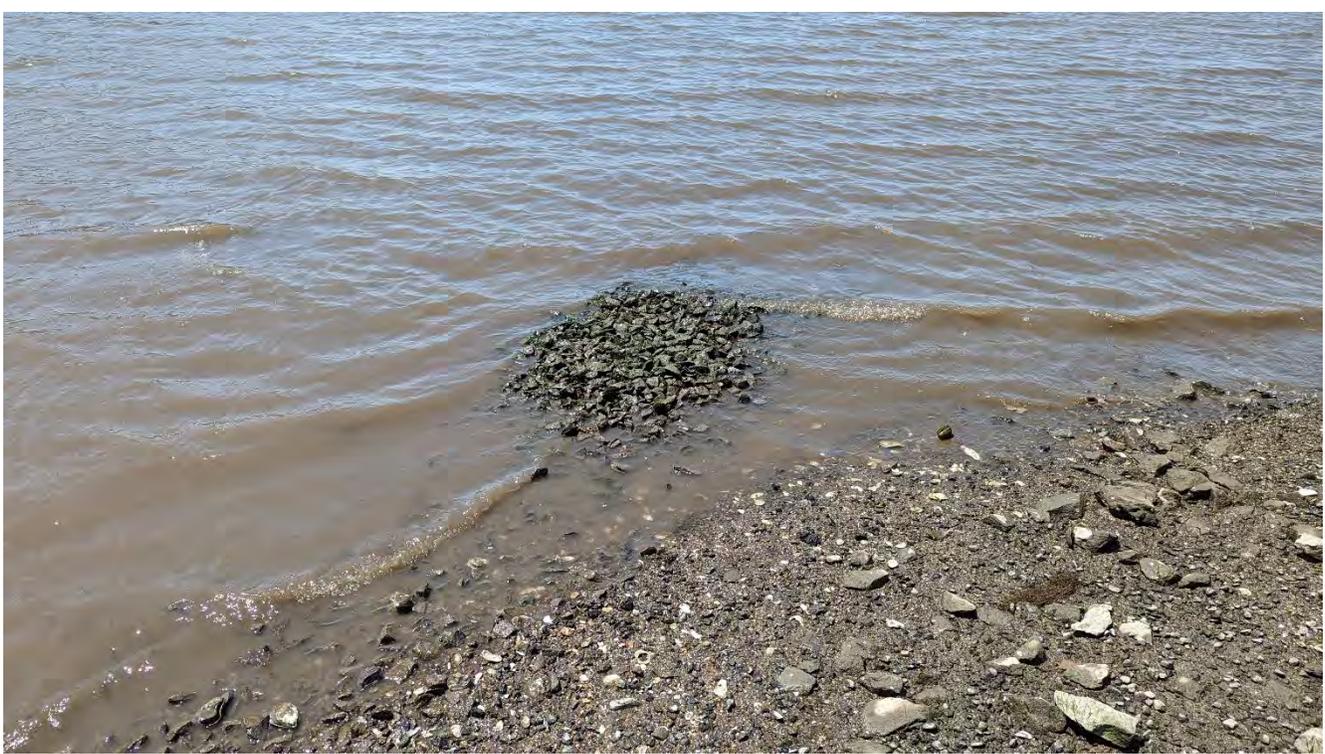
Photo 5: Partially exposed edge of Cap Area 22 during low tide (facing west).

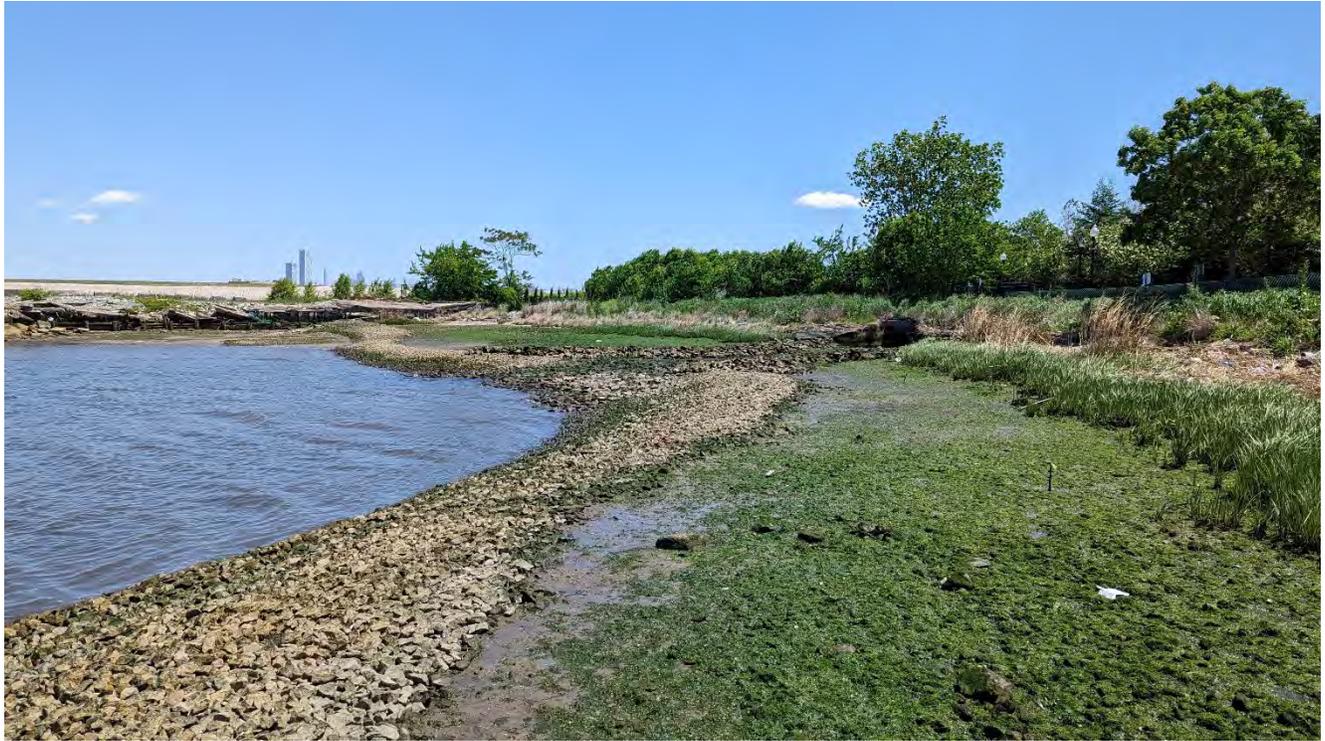
Photo 6: Central portion of the BEP, between Outfalls A and B (facing east). Note algae throughout the low marsh planting zone.

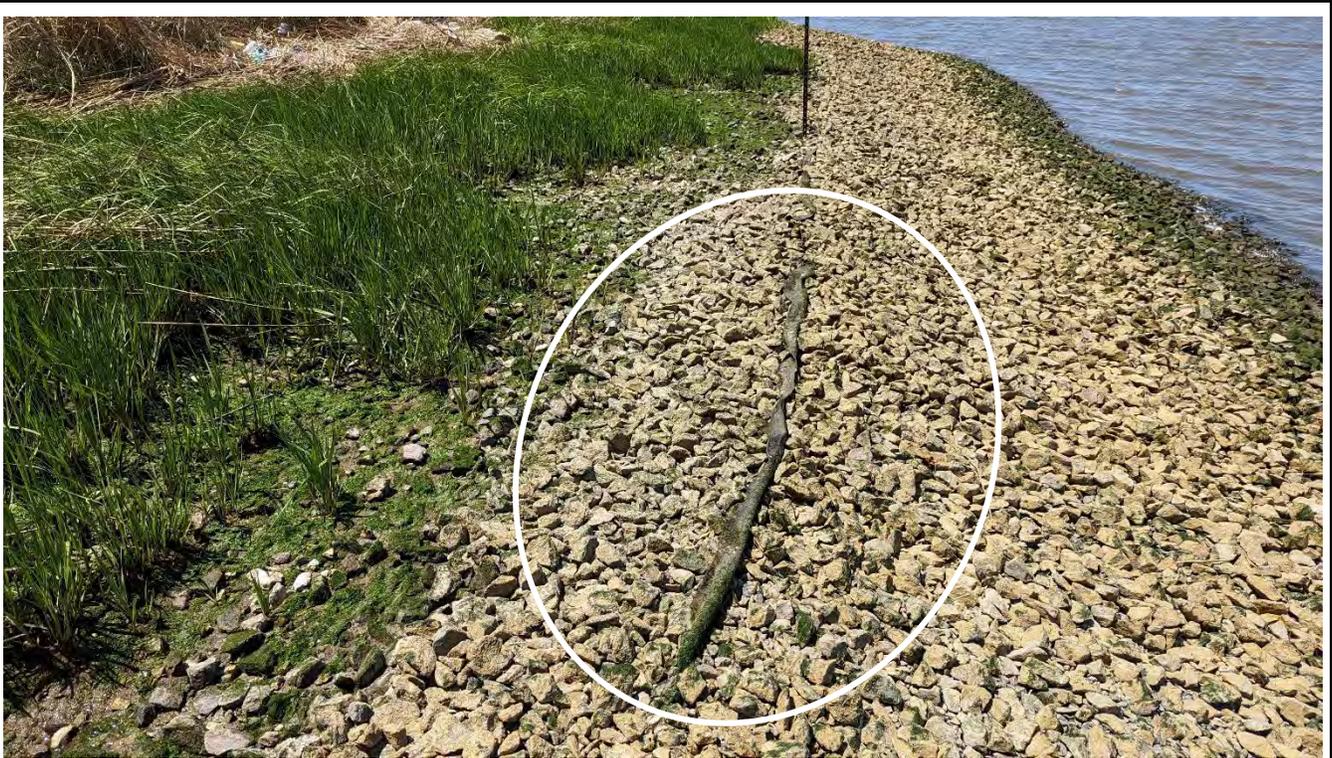
Photo 7: Exposed geotextile fabric between the shoreline stabilization berm and the BEP fill material west of Outfall A.

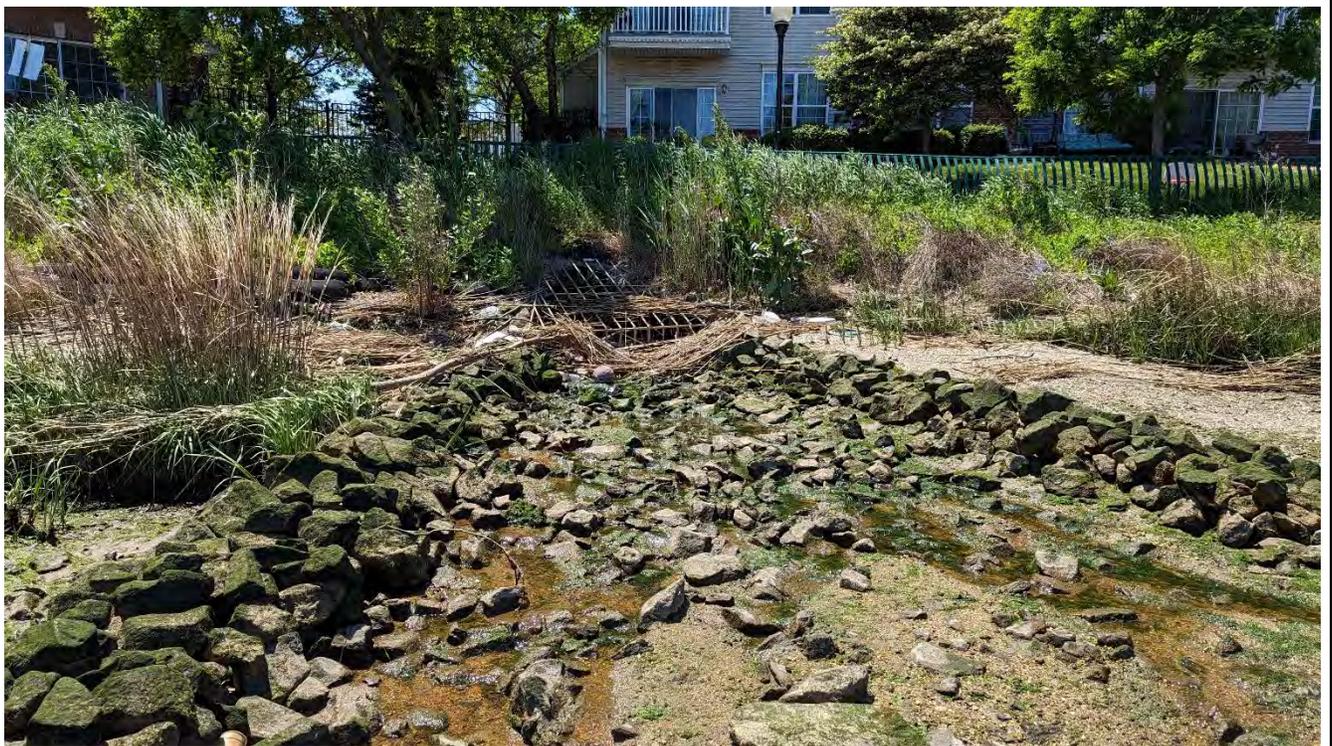
Photo 8: Outfall A and surrounding armor stone (facing southwest). Note drift deposits in front of the outlet.

TABLE 2. BENEFICIAL ENVIRONMENTAL PROJECT AREA INSPECTION LOG			
BEP AREA ELEMENT	OBSERVATIONS	PHOTO(S) TAKEN	CORRECTIVE ACTION(S) REQUIRED
SHORELINE STABILIZATION	<ul style="list-style-type: none"> Shoreline stabilization appeared to be in good condition. Several areas of exposed geofabric were observed between the BEP fill material and the shoreline stabilization berm west of Outfall A. 	6 to 7	<ul style="list-style-type: none"> Cut exposed geofabric or cover it with stone.
OUTFALL RIPRAP APRONS	<ul style="list-style-type: none"> Outfall A: Appeared in good condition. Siltation within the rip rap apron ranged from approximately 1 to 3 inches, especially in the vicinity of the outfall. Outfalls B and C: Appeared in good condition. Consistent with prior observations, approximately 1 to 3 inches of siltation was observed throughout the rip rap apron, especially in the vicinity of both outfalls. Outfall D: Appeared in good condition. The previously observed minor flow channel at the discharge of Outfall D was partially filled with displaced stone. Other than at Outfall D, drift deposits were observed in front of the outfalls; however, water was actively flowing at the time of the inspection. 	8 to 12	<ul style="list-style-type: none"> Monitor drift deposits and debris at the Outfalls; if persistent, arrange for removal.

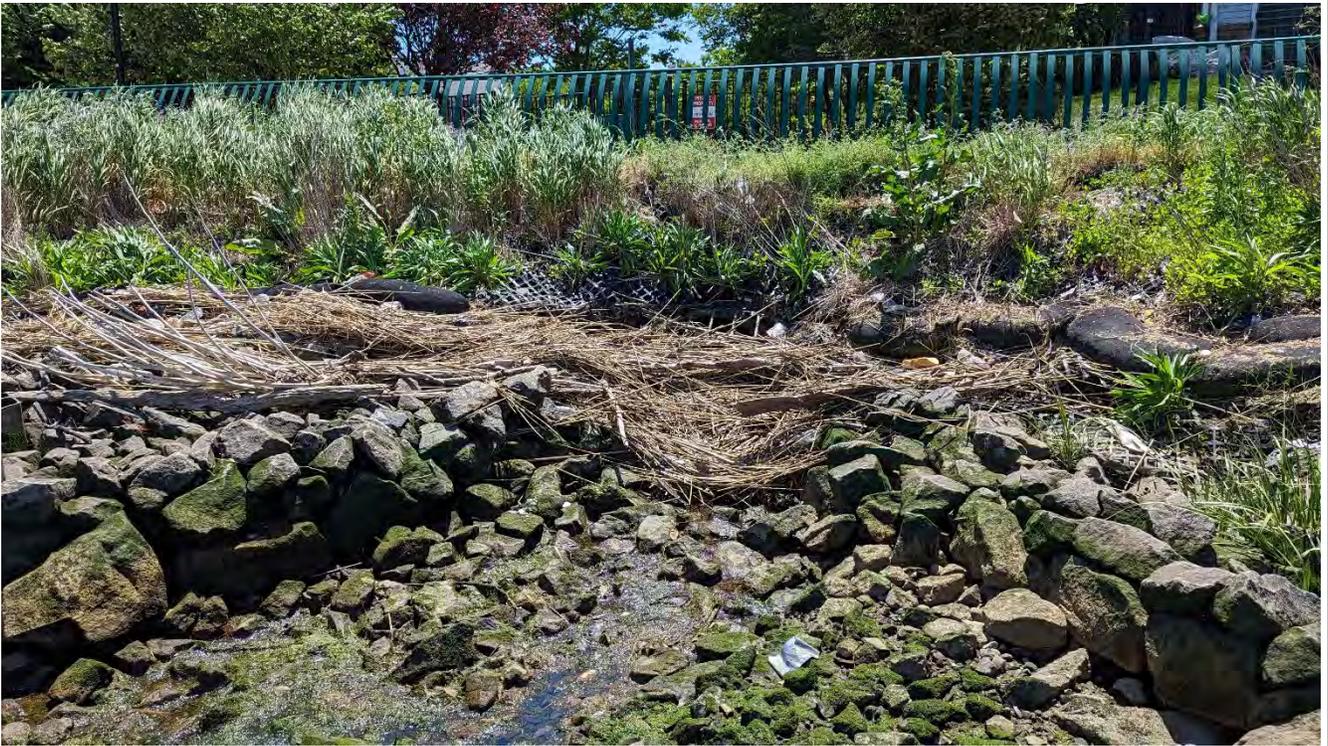
Photo 9: Outfall B and surrounding armor stone (facing south). Note drift deposits in front of the outlet.

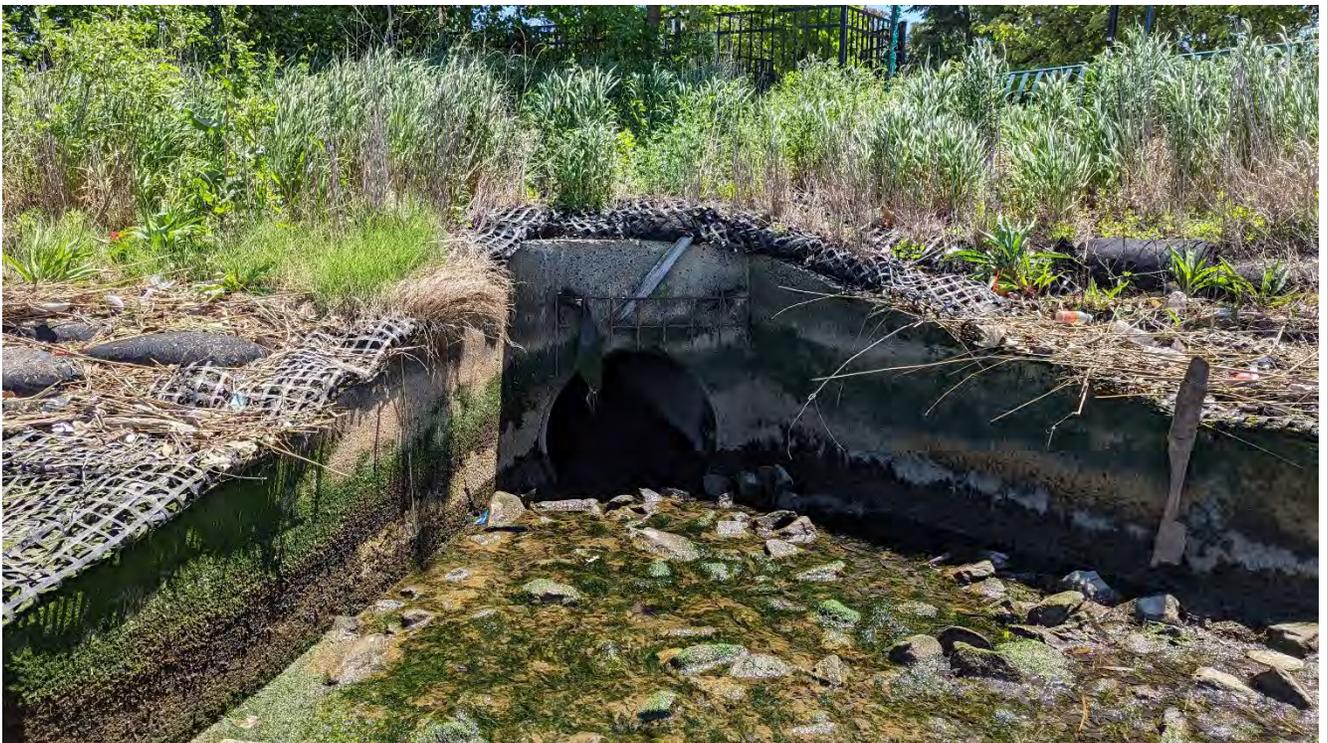
Photo 10: Outfall C and surrounding armor stone (facing southeast).

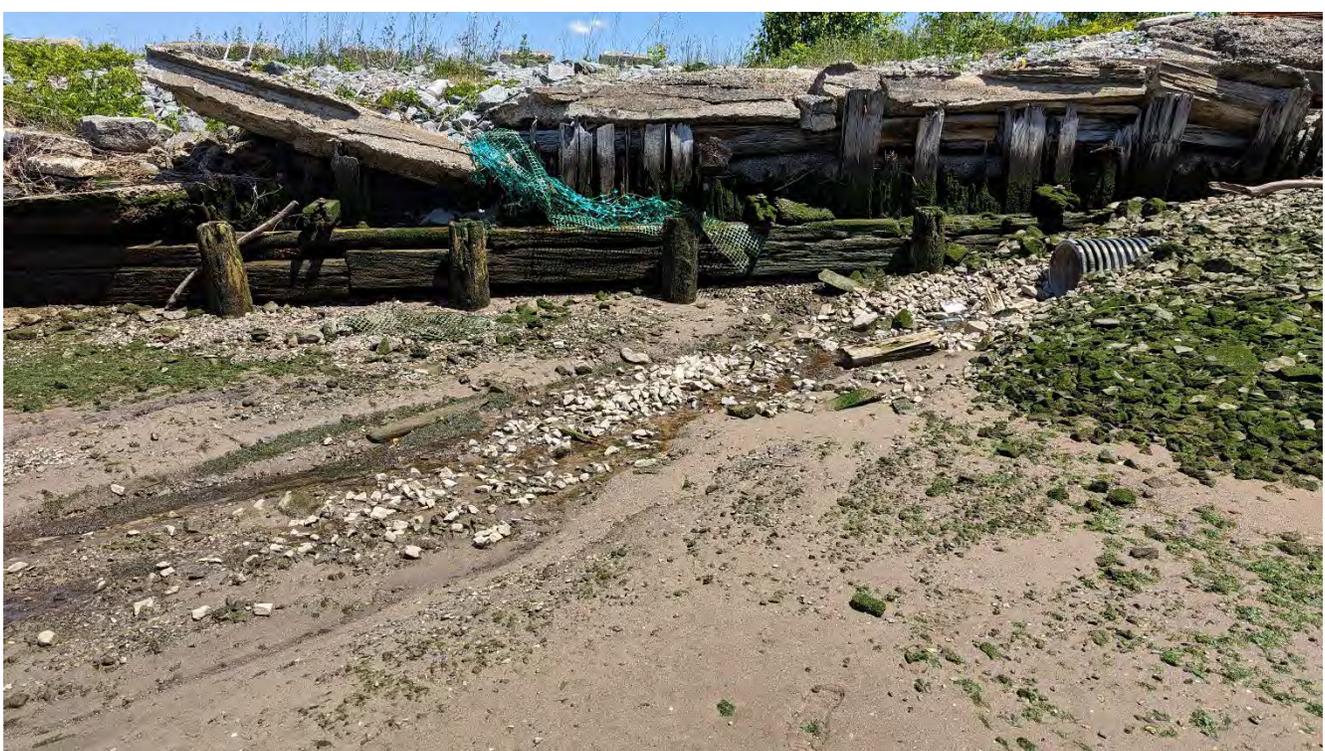
Photo 11: Outfall D discharge area where previously observed minor flow channel is overlain by displaced stone (facing east).

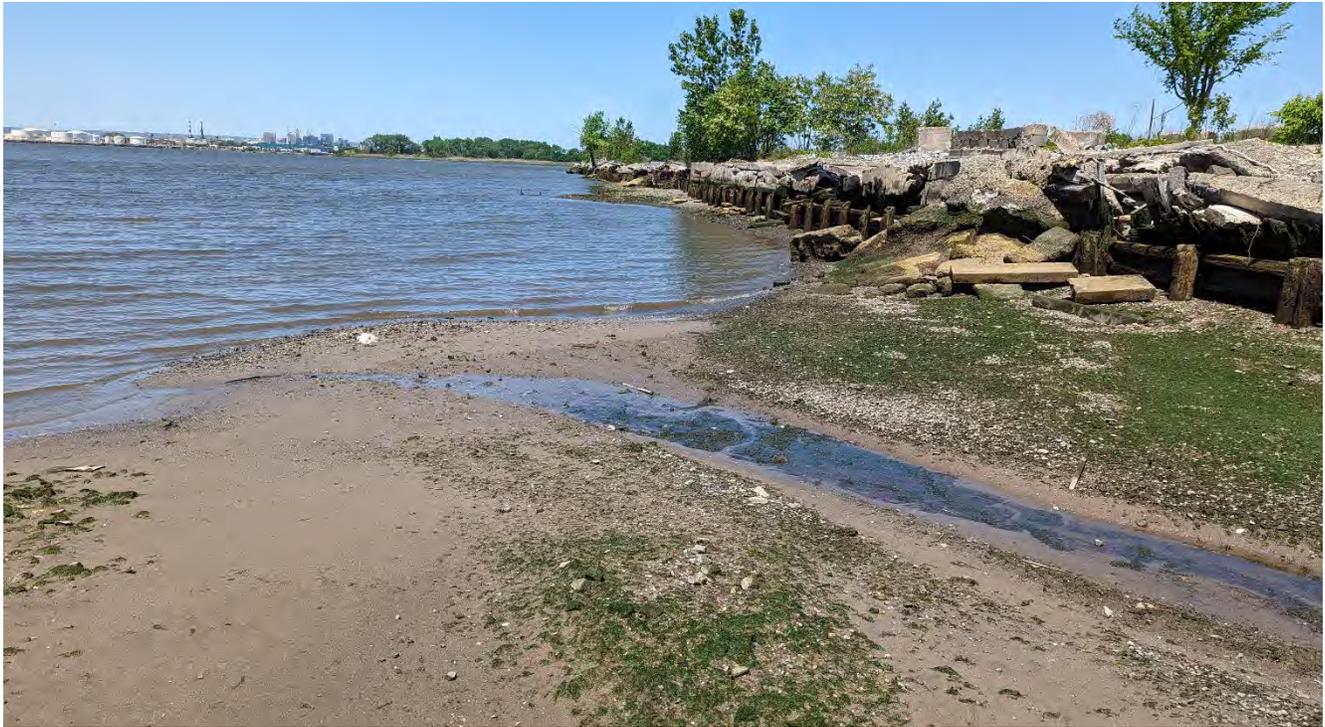
Photo 12: Area beyond the shoreline stabilization berm near Outfall D with Cap Area 22 in the background (facing north).

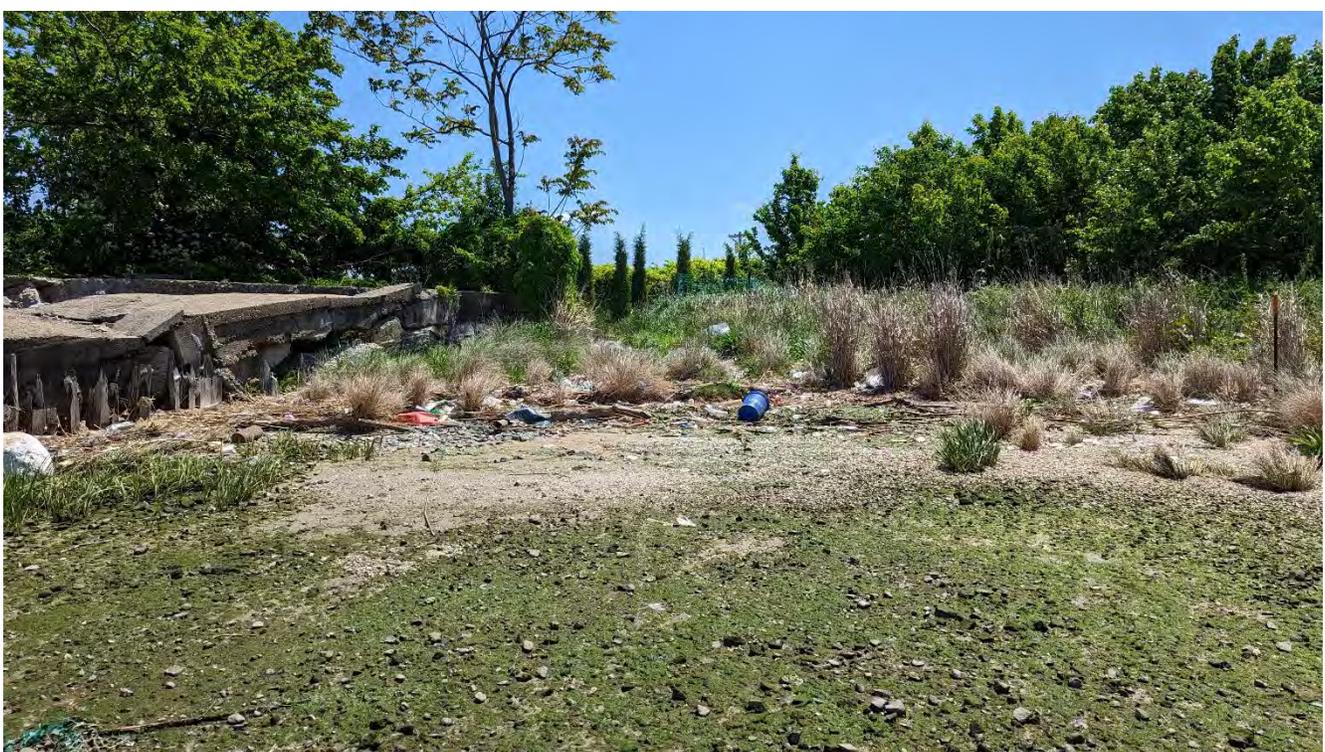
Photo 13: Low marsh zone in the eastern corner of the BEP near Outfall D (facing southeast). Note algae throughout the low marsh planting zone.

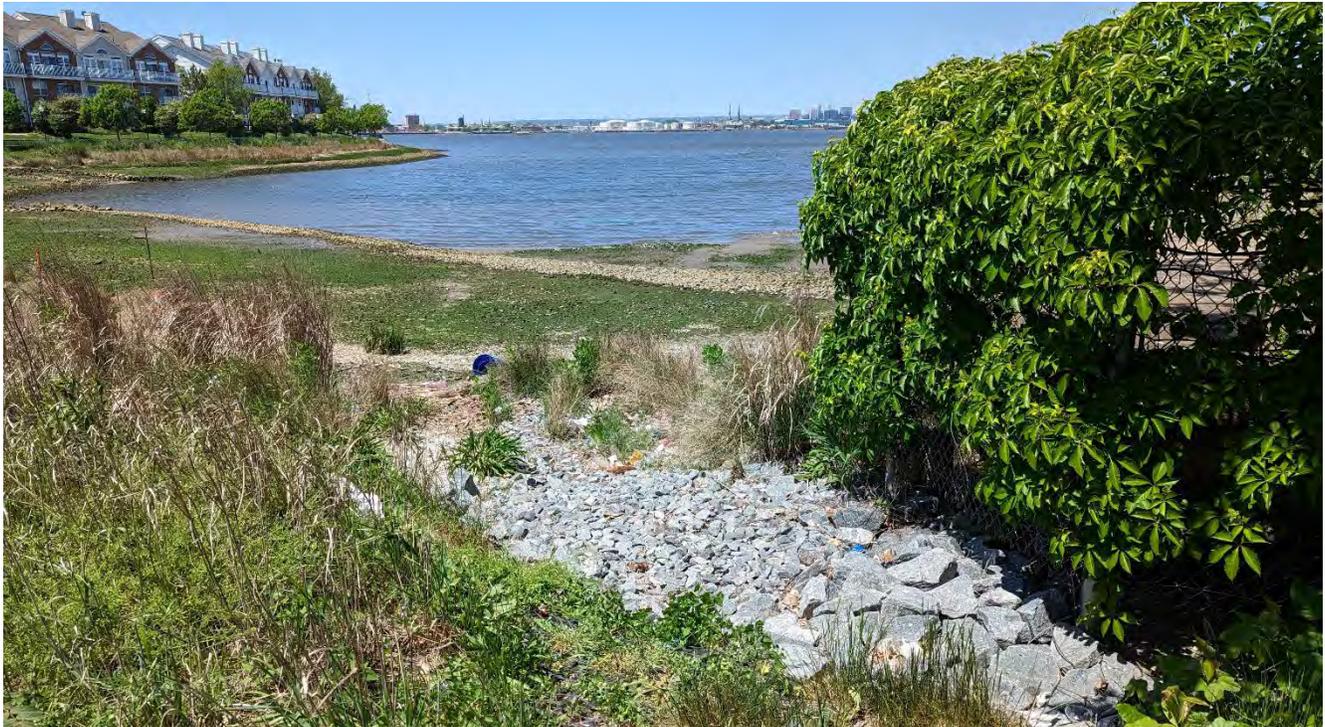
Photo 14: Transition from upland to low marsh zone in the easternmost corner of the BEP area (facing west).

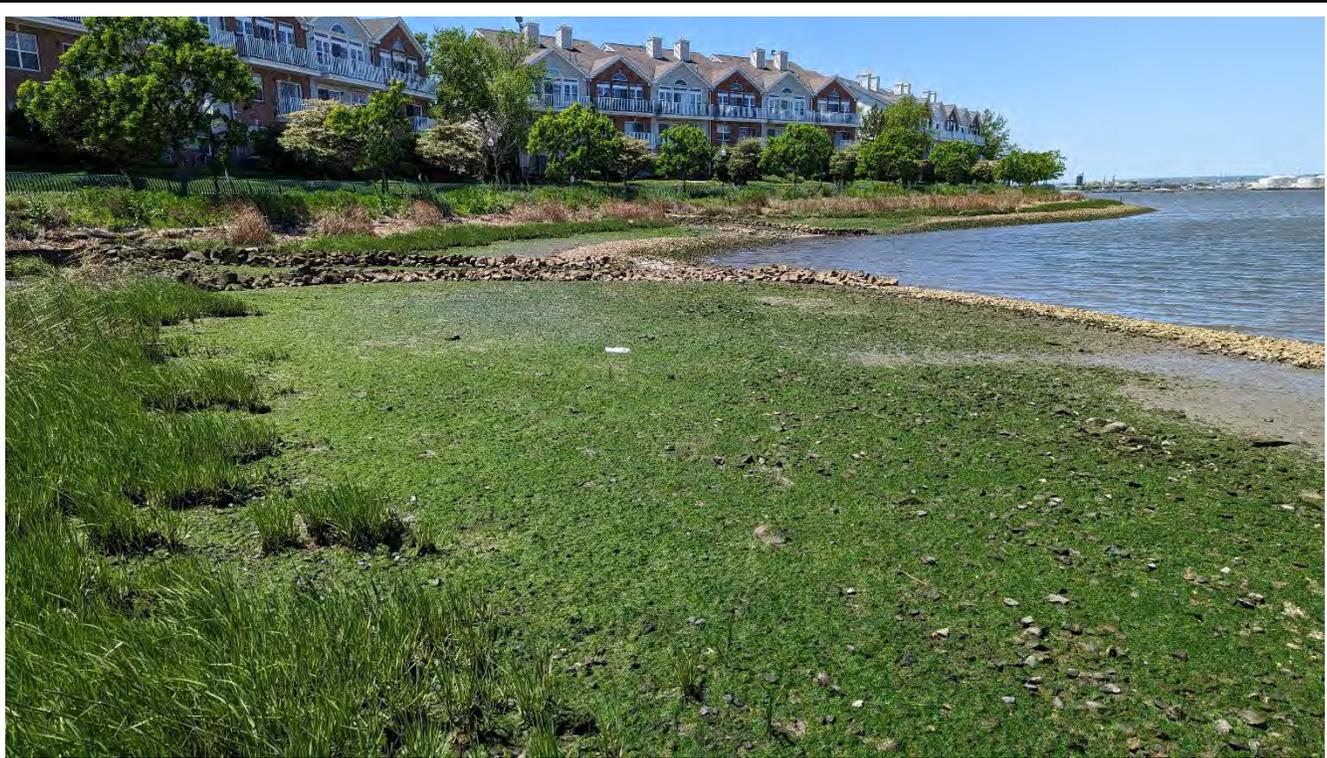
Photo 15: Low marsh planting zone on the eastern side of the BEP (facing west). Note algae throughout the low marsh planting zone.

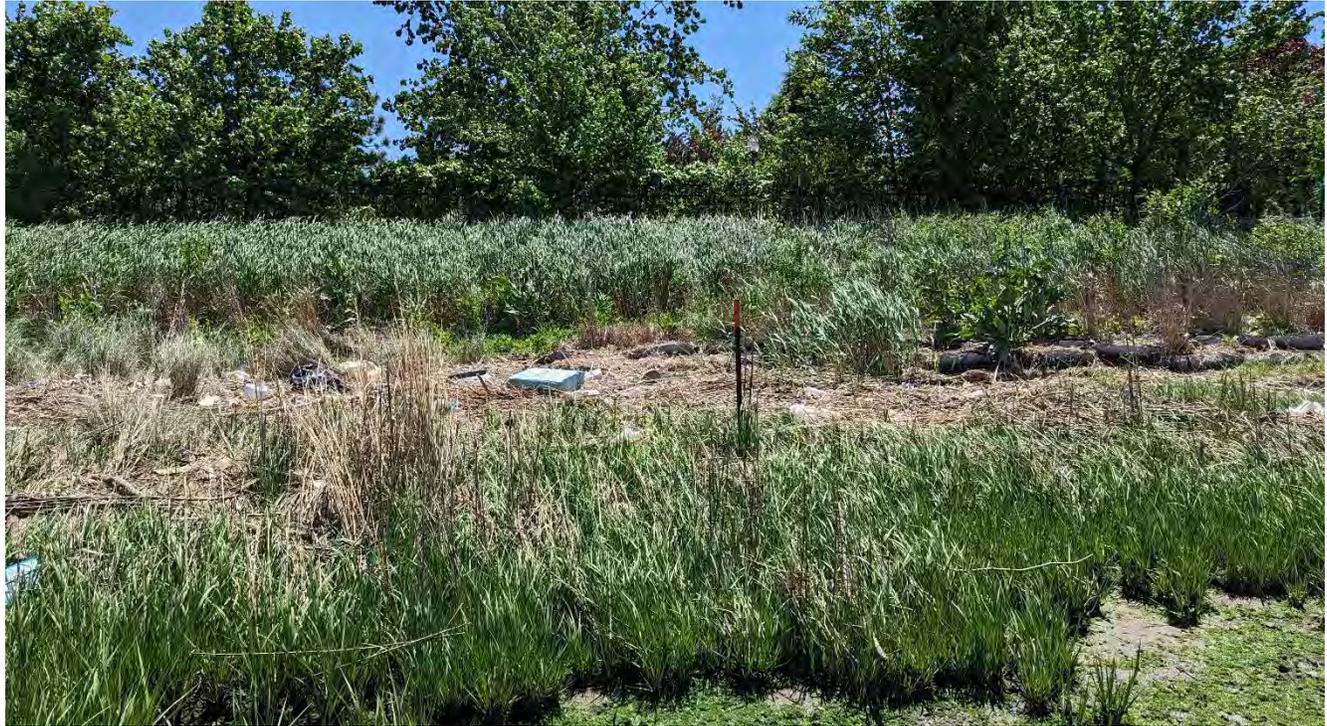
Photo 16: Transition area between low marsh planting zone and high marsh planting zone within the eastern side of the BEP (facing southeast). Note the low marsh vegetation appears vibrant and healthy.

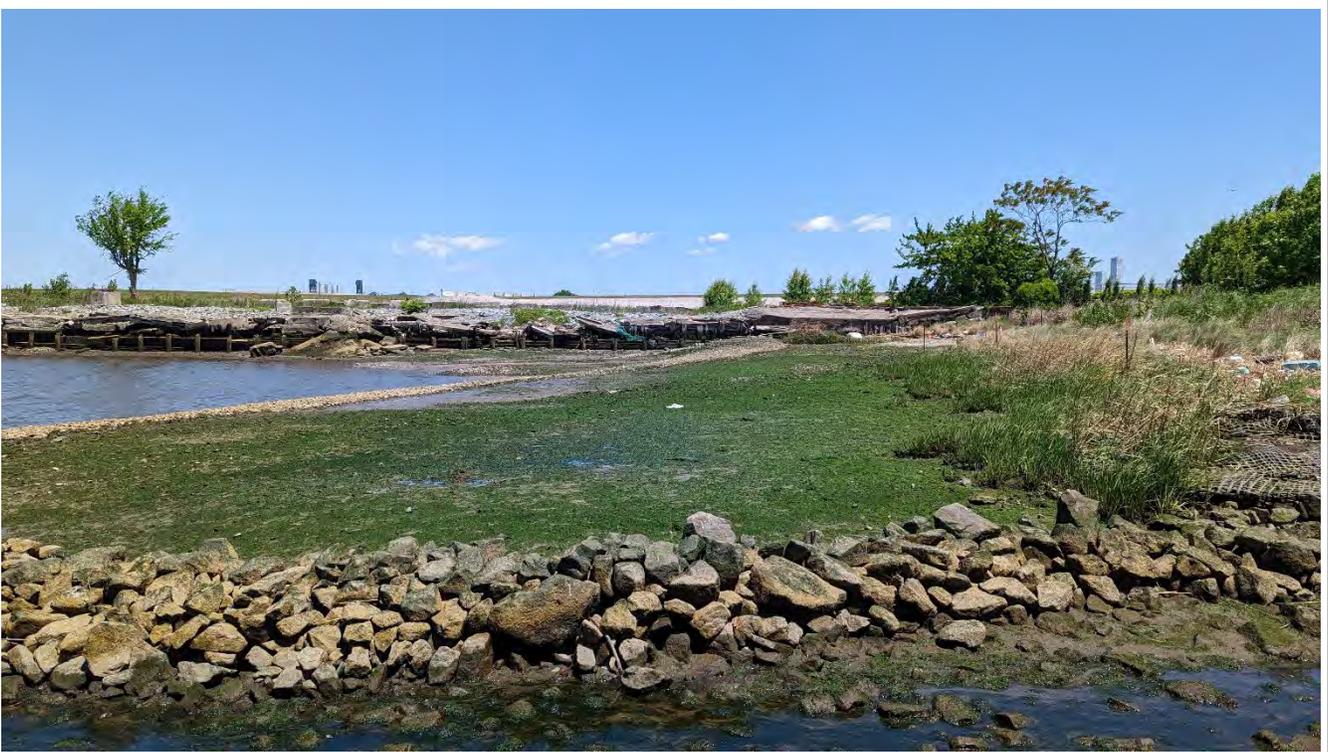
Photo 17: Low marsh planting zone within eastern portion of the BEP (facing northeast). Note the algae throughout the low marsh area.

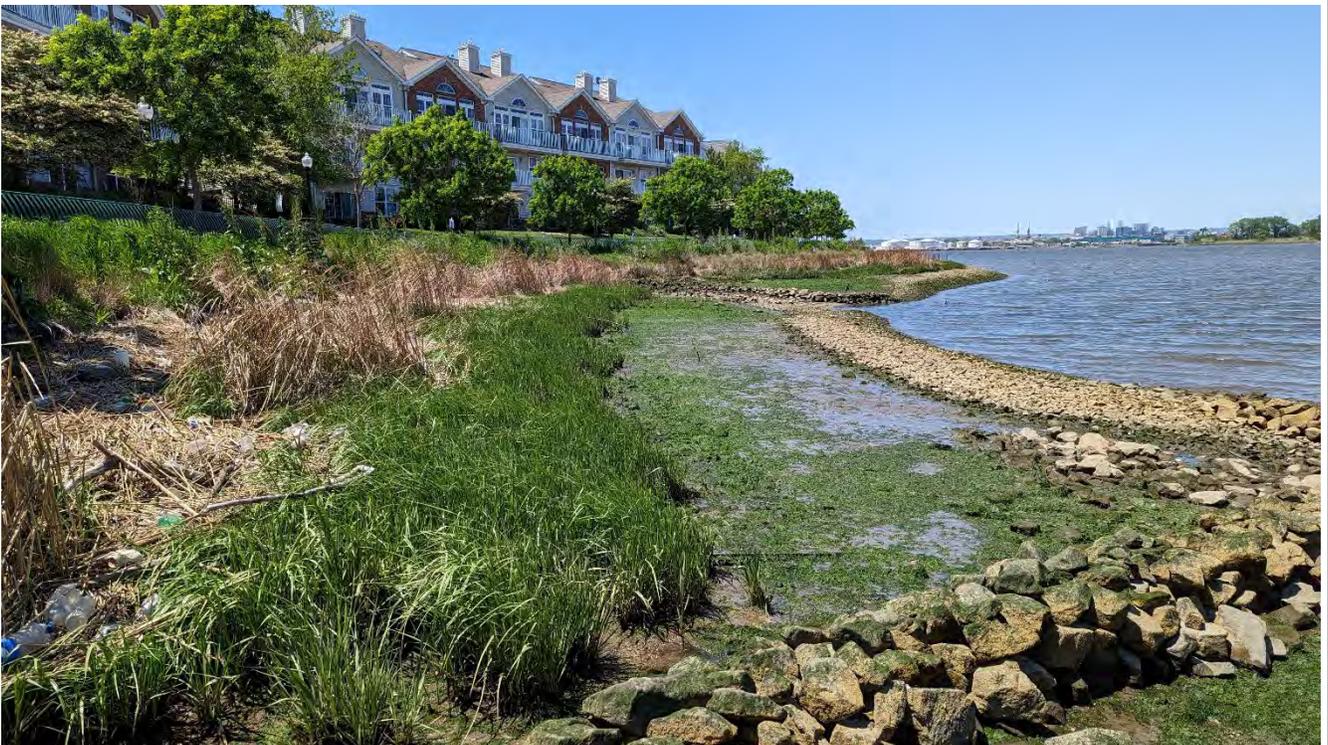
Photo 18: Low marsh planting zone between Outfalls A and B (facing west). Note the vibrant and healthy vegetation in the higher elevations of the low marsh area and algae in the lower elevations.

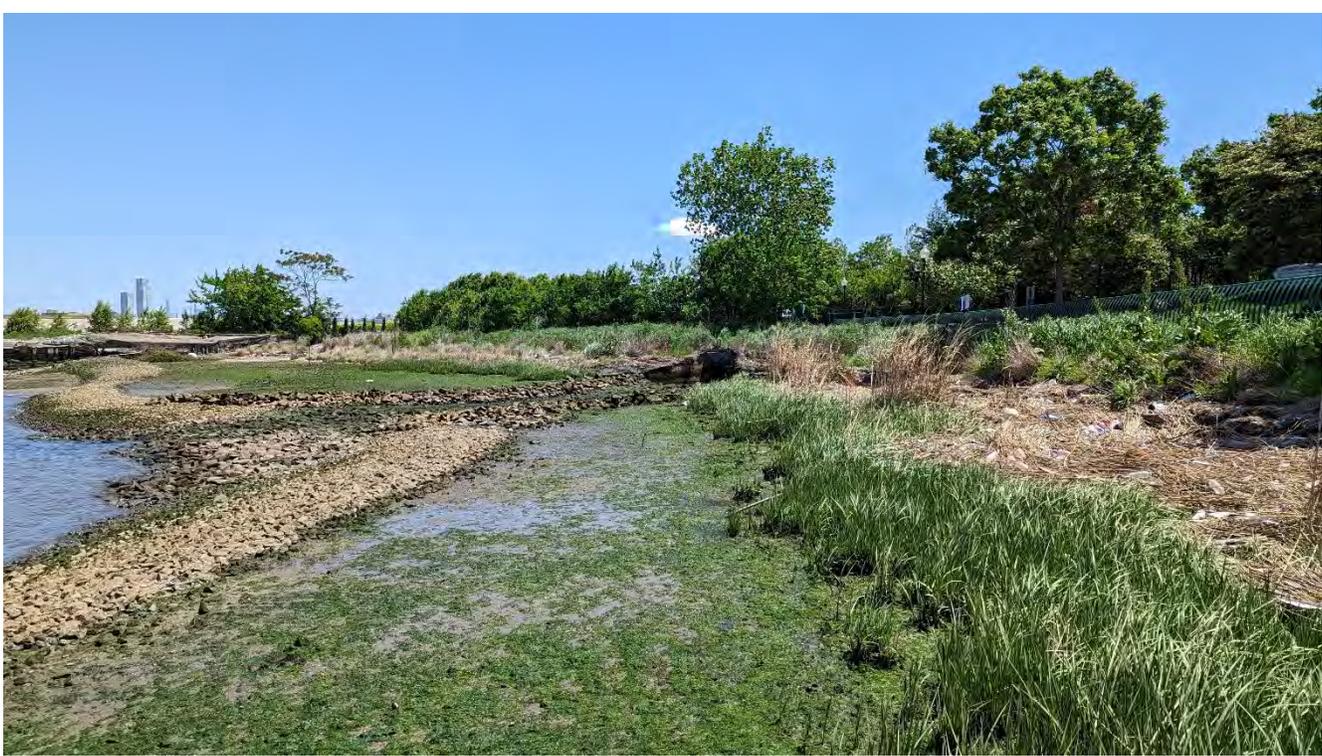
Photo 19: Vibrant and healthy vegetation in the higher elevations of the low marsh zone and high marsh zones, and algae in the lower elevations of the low marsh zone in the eastern BEP area (facing southeast).

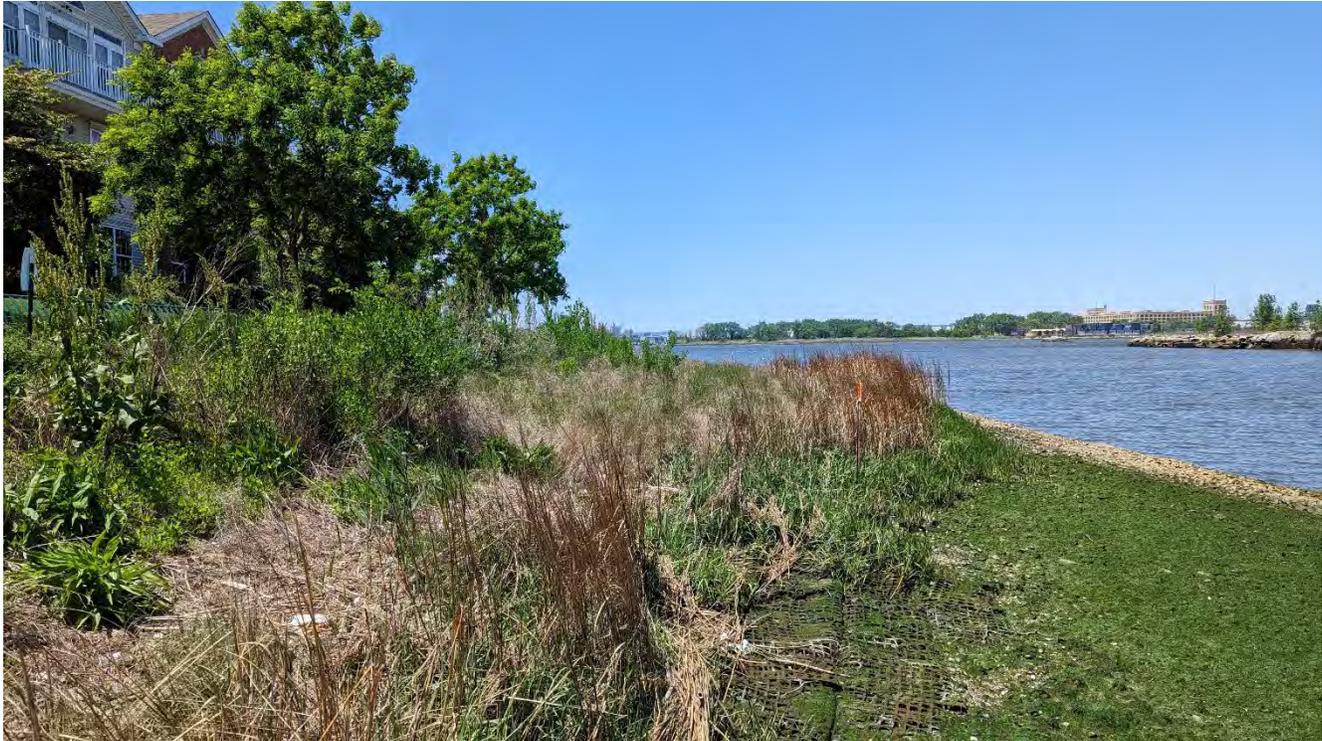
Photo 20: Vibrant and healthy vegetation in the high marsh zone in the area west of Outfall A (facing north). Note partially exposed geogrid in the low marsh planting area.

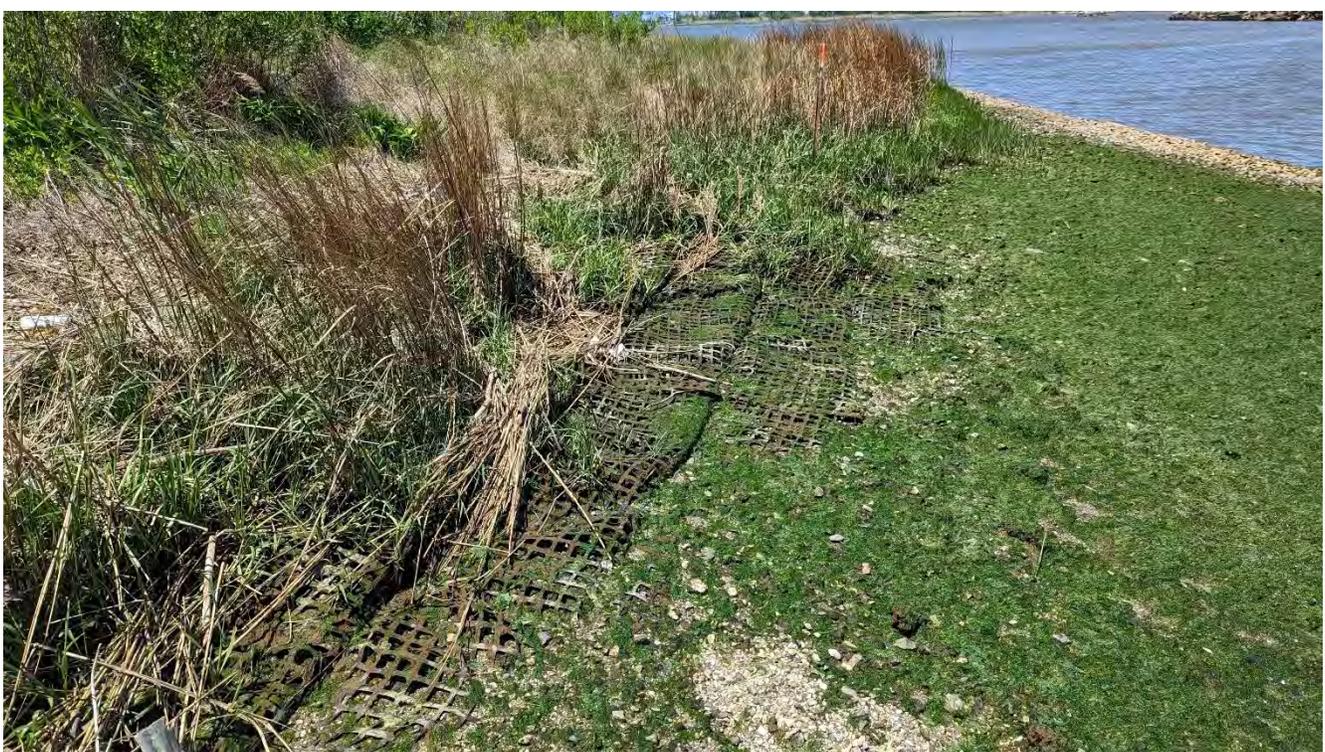
Photo 21: Vibrant and healthy low and high marsh zones west of Outfall A (facing southwest). Note the exposed geogrid and absence of GroSoxx at the bottom of the high marsh zone and algae on the low marsh zone.

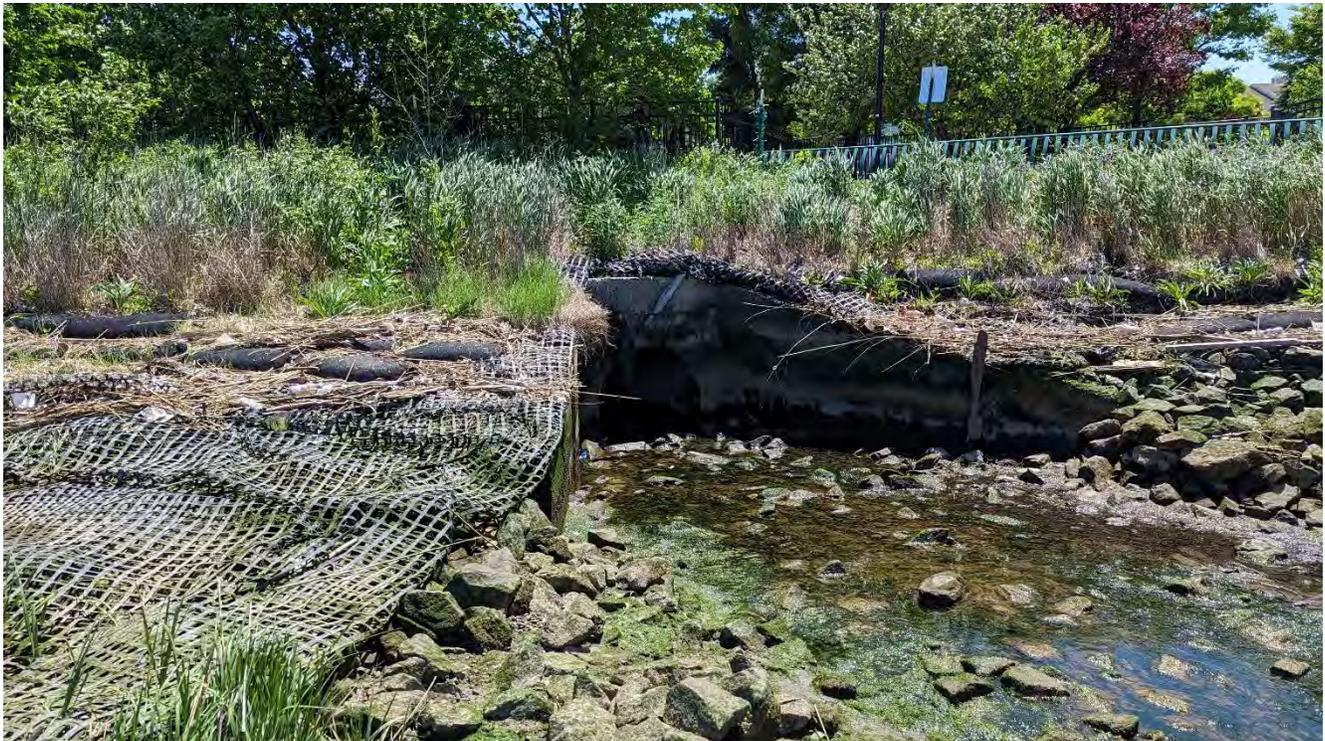
Photo 22: Exposed geogrid over and around the Outfall C structure and within the high marsh planting zone (facing south).
