MEMORANDUM

Subject: **SA-7 Sediment Remedy Long-Term Monitoring**
Summary of Year 10 Monitoring & Proposed Year 11
Program

**ATTACHMENT A.2
AUGUST 30, 2023 INSPECTION LOG**

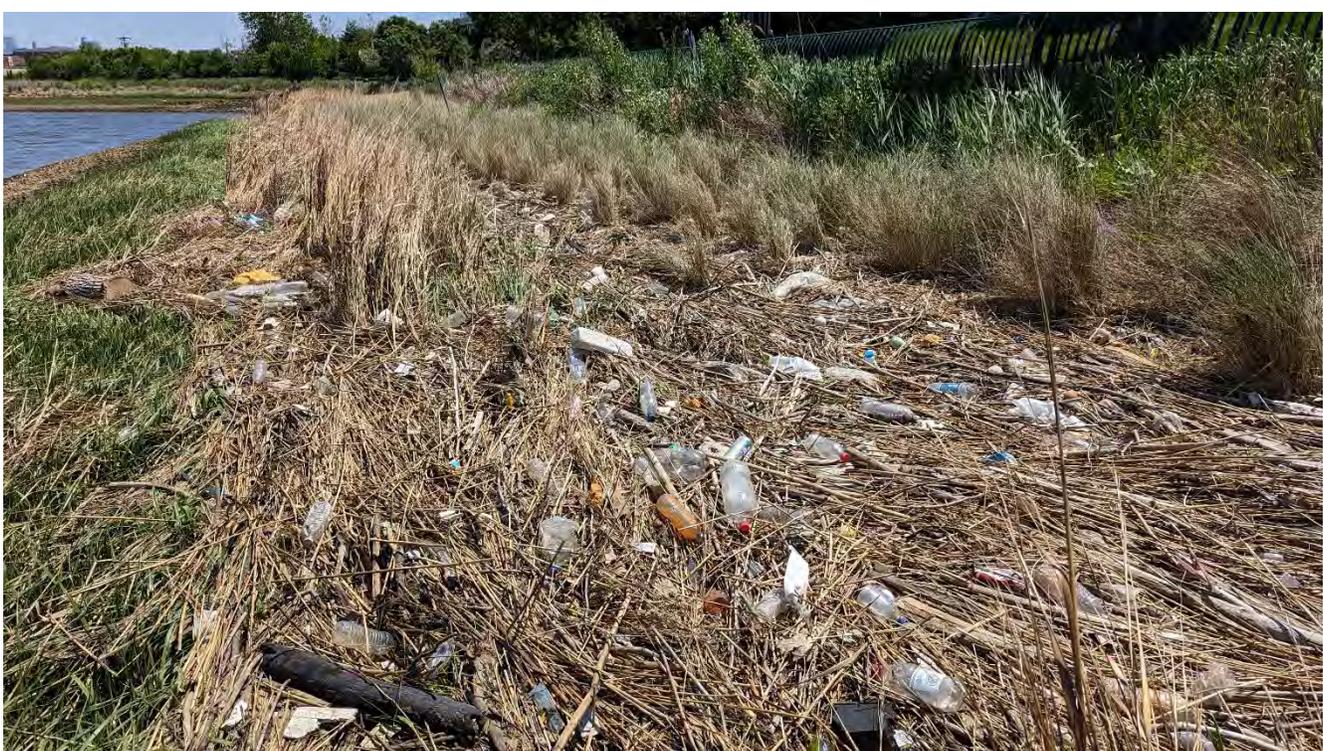
Photo 23: Healthy low and high marsh vegetation west of Outfall A (facing southeast). Note the heavy presence of tidal drift deposits and debris within the high marsh areas.

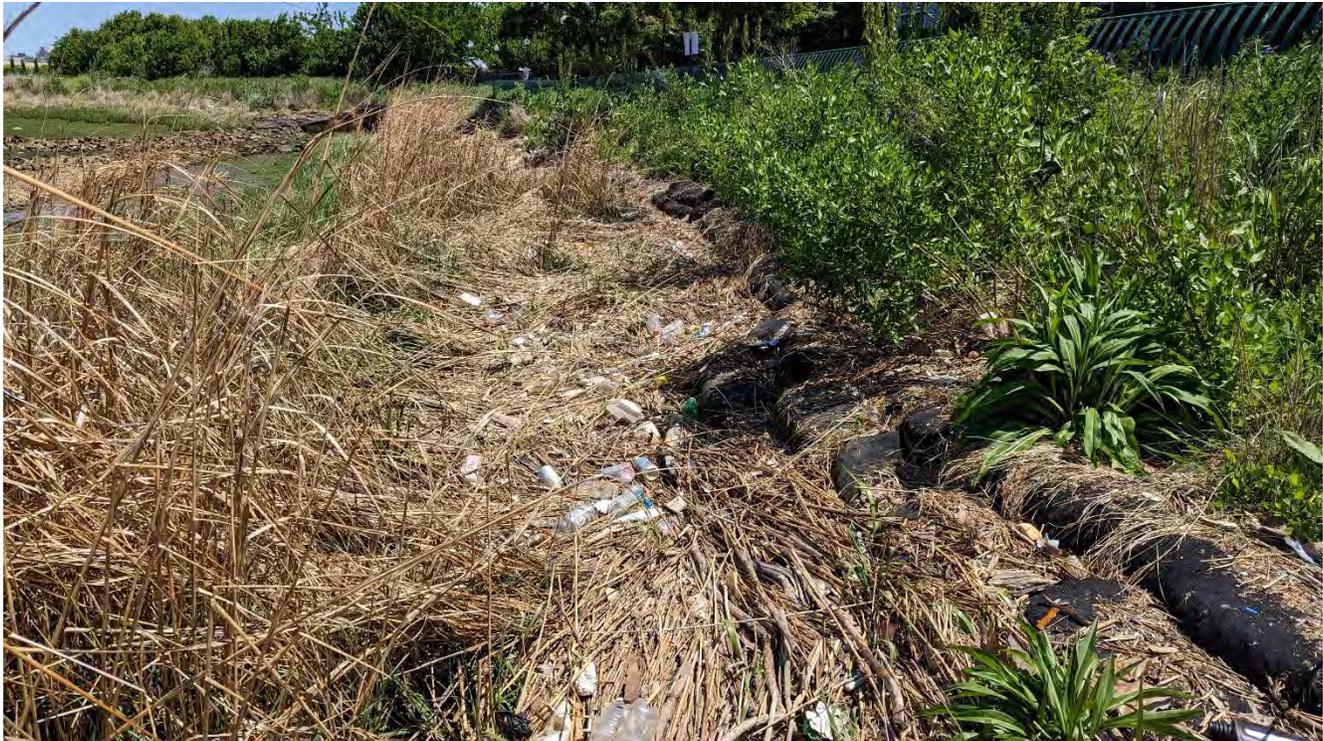
Photo 24: Healthy vegetation in the upland transition area and interface between the low and high marsh between Outfalls A and B (facing east). Note the heavy amount of tidal drift deposits and debris within the high marsh areas.

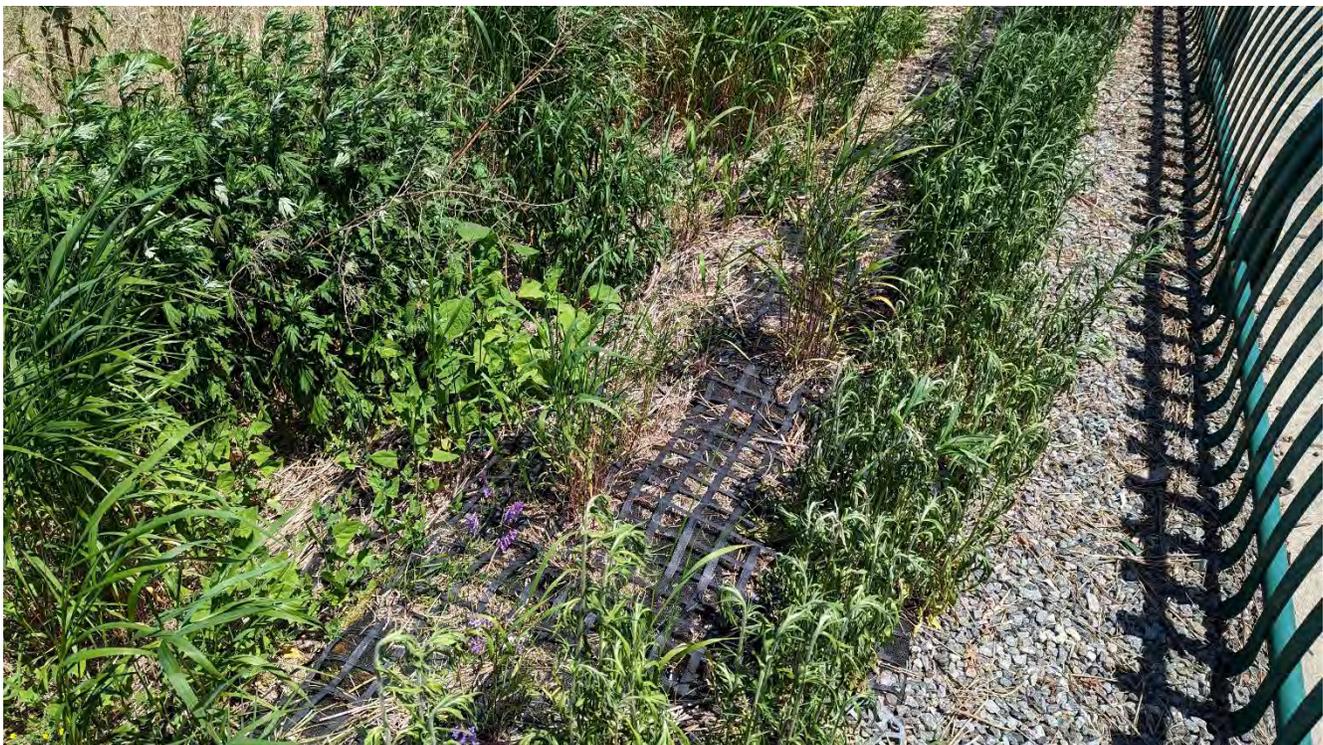
Photo 25: Area of exposed GroSoxx and geogrid located within the upper edge of the upland transitional area east of Outfall A (facing southeast).

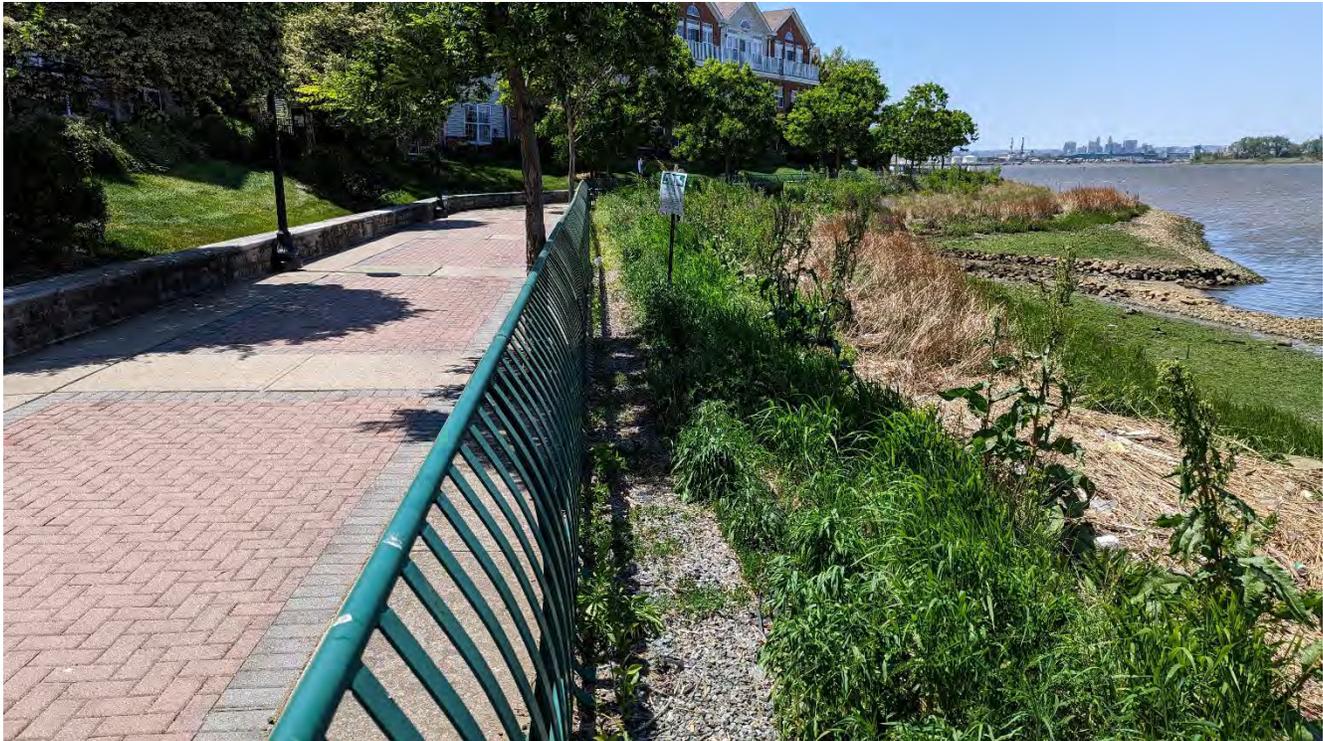
Photo 26: Previously mowed section of the upland planting area in the western portion of the BEP (facing west).

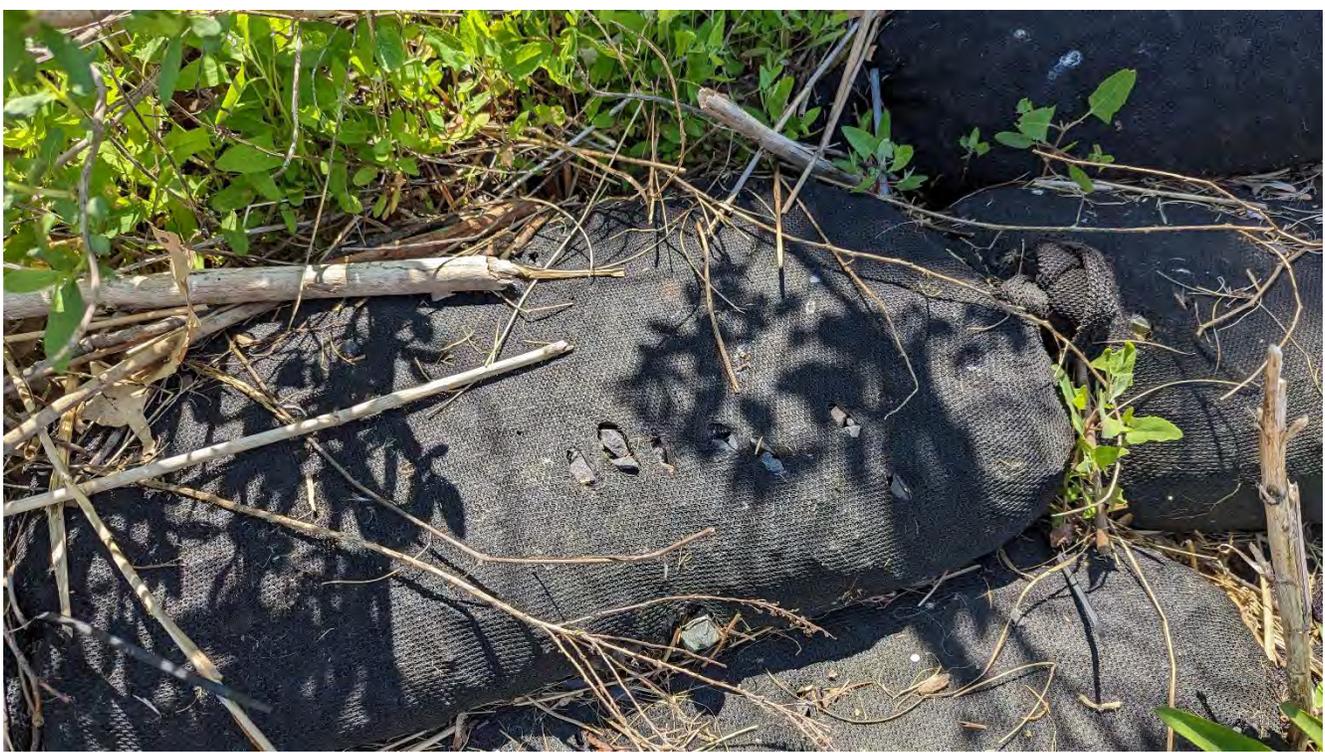
Photo 27: Damaged RockSox in upland transition area east of Outfall A.

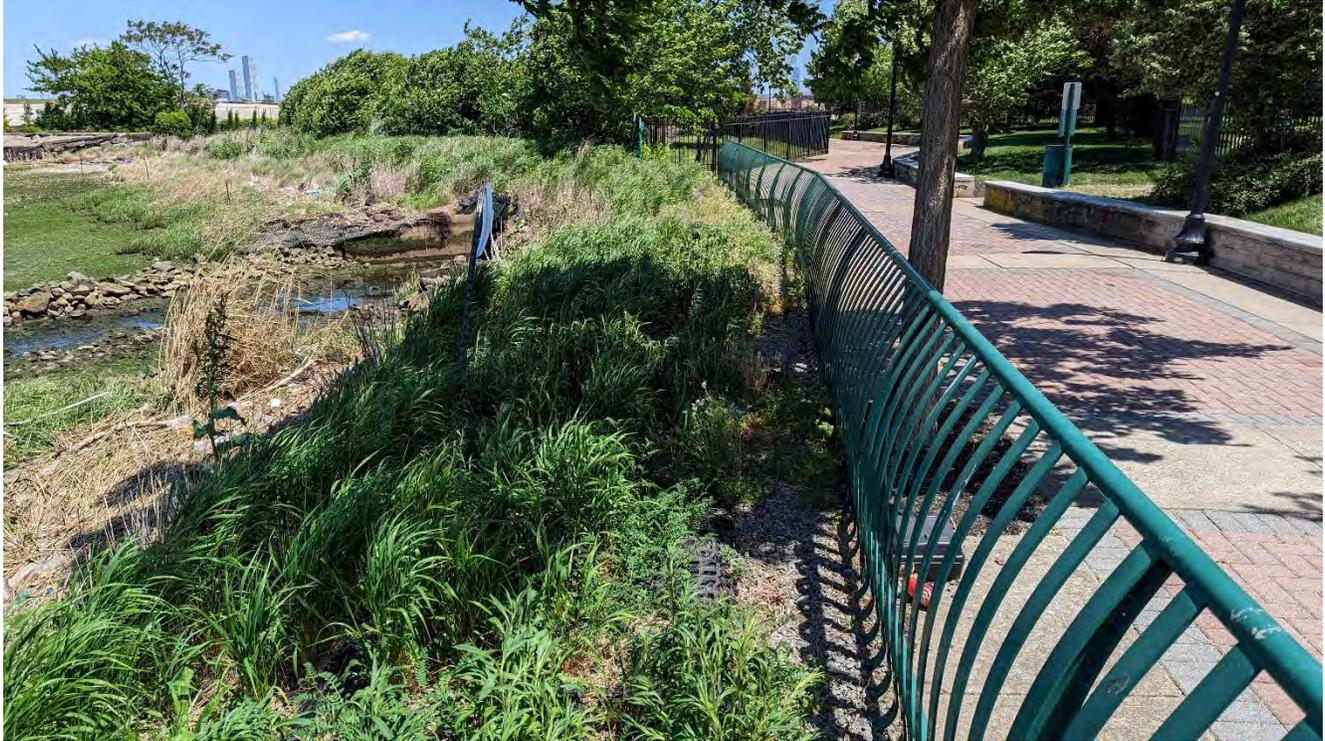
Photo 28: Previously mowed section of the upland planting area in the western portion of the BEP between Outfalls A and B (facing east).

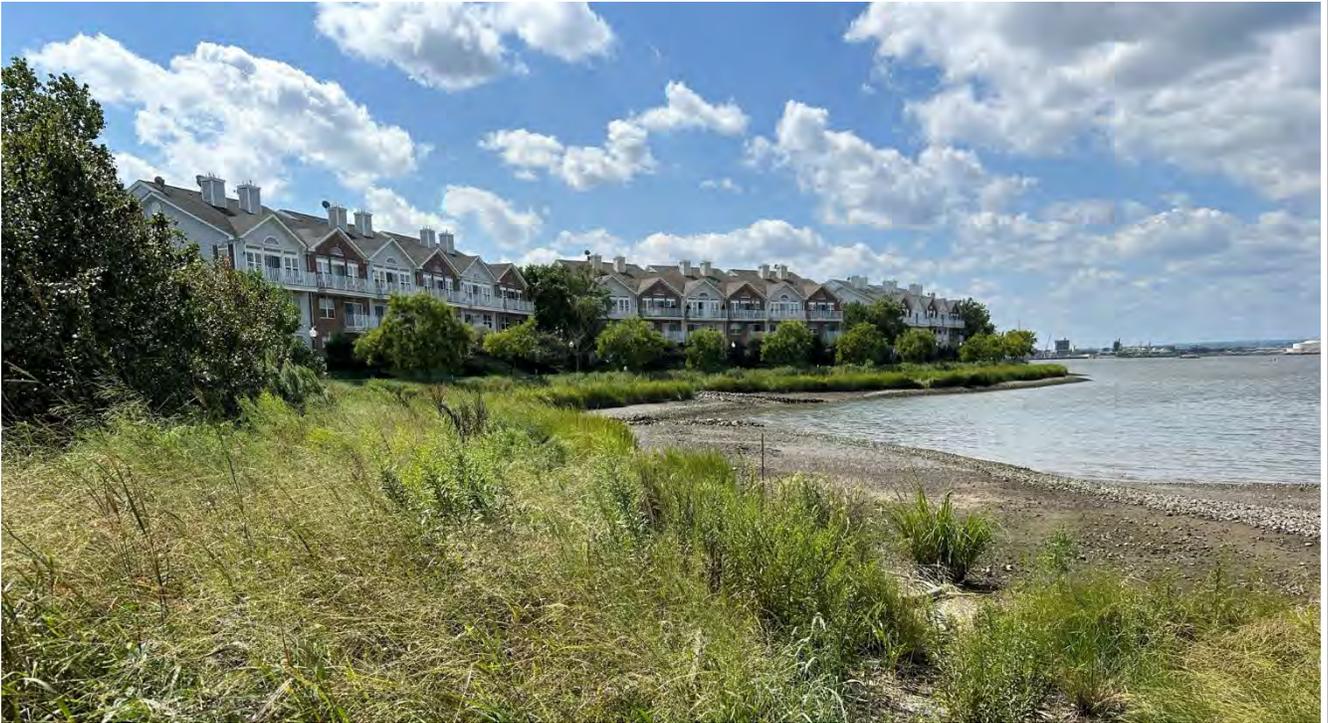
Photo 1: Northern end of Cap Area 16 (facing west). Note vibrant and healthy vegetation present in high marsh planting and upland zones.

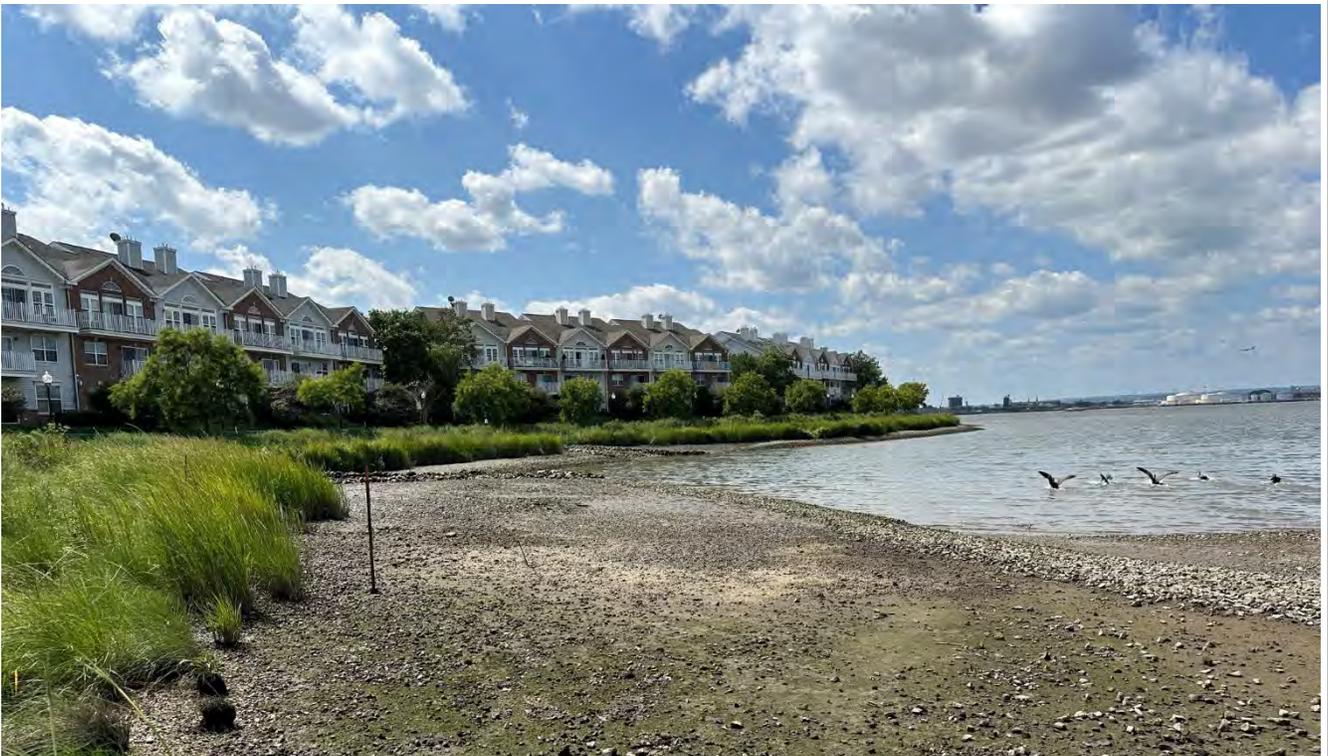
Photo 2: Central portion of Cap Area 16 (facing west). Note reference posts used to assess sediment surface changes.

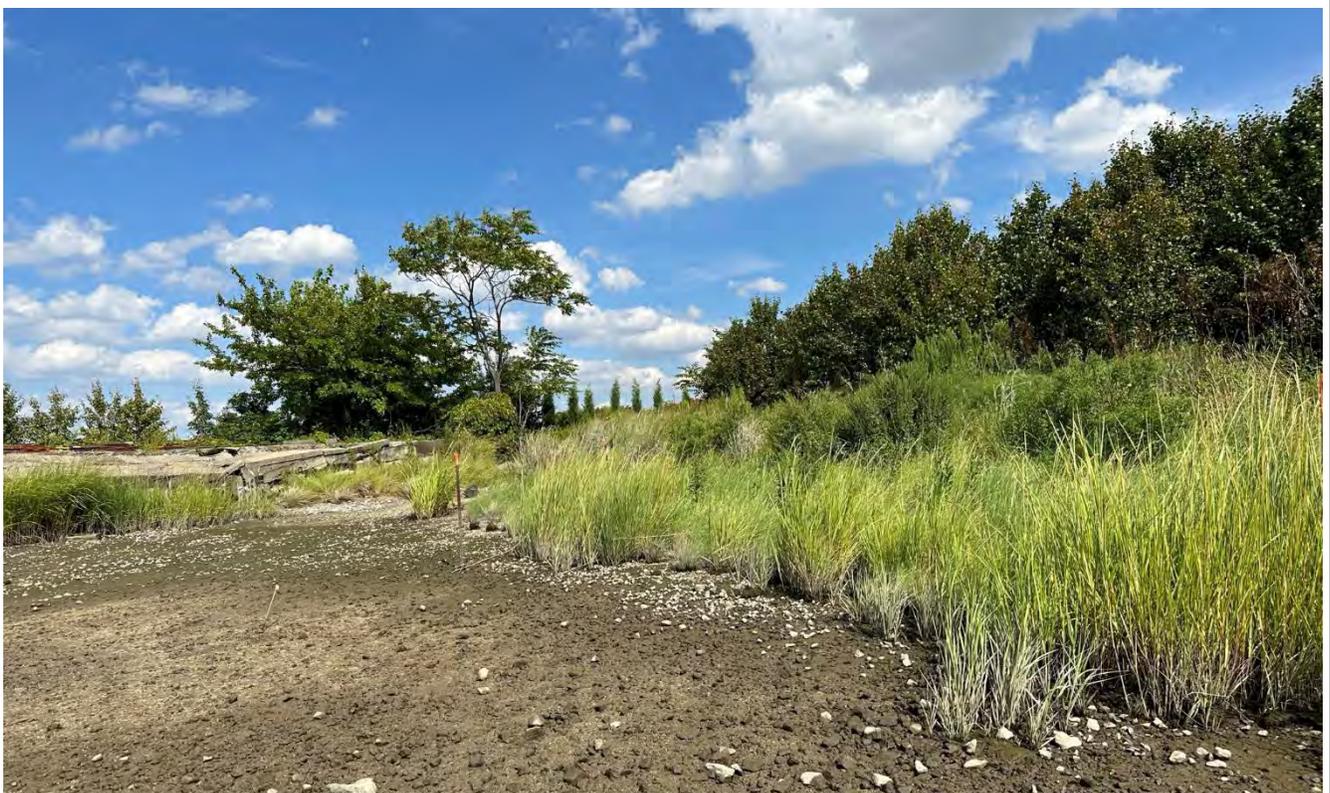
Photo 3: Western end of Cap Area 16 (facing east). Note the vibrant and healthy vegetation in the low and high marsh planting zones.

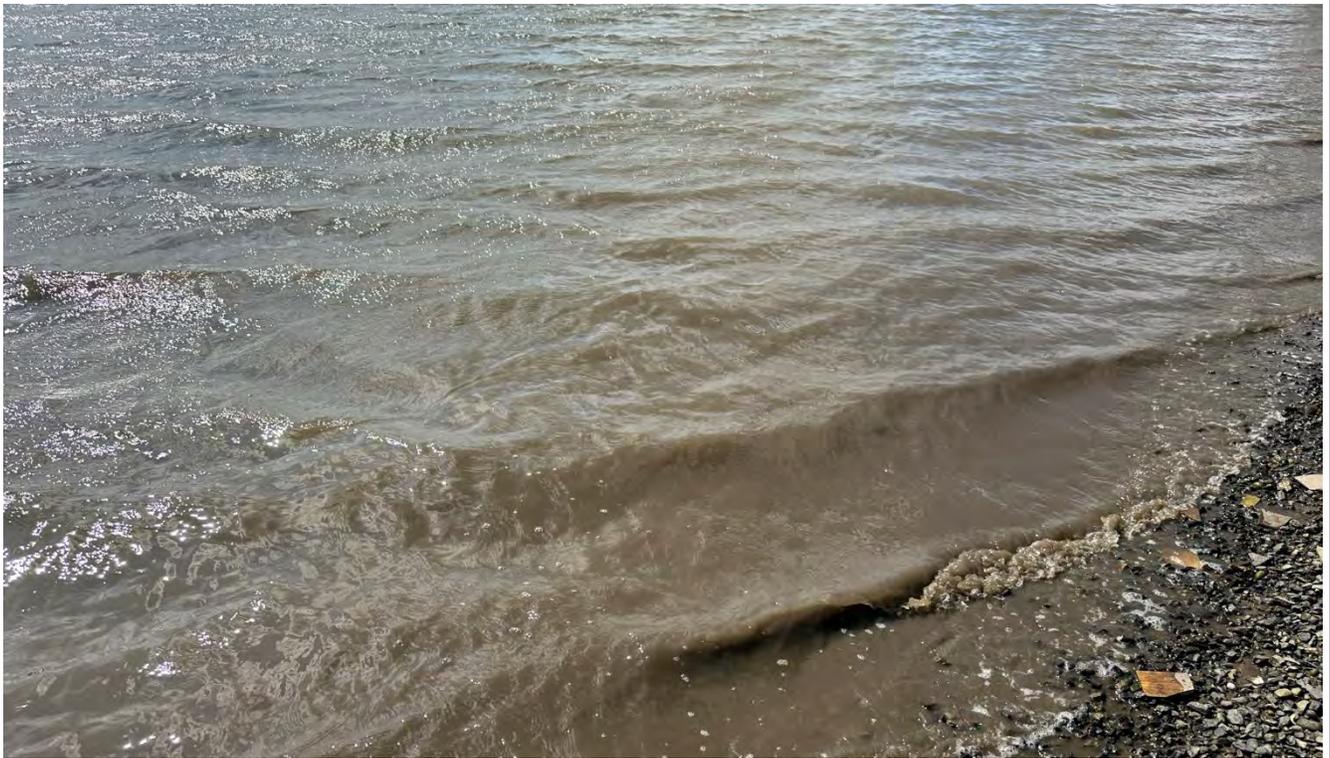
Photo 4: Subaquatic vegetation not observed within Cap Area 22 (facing northwest).

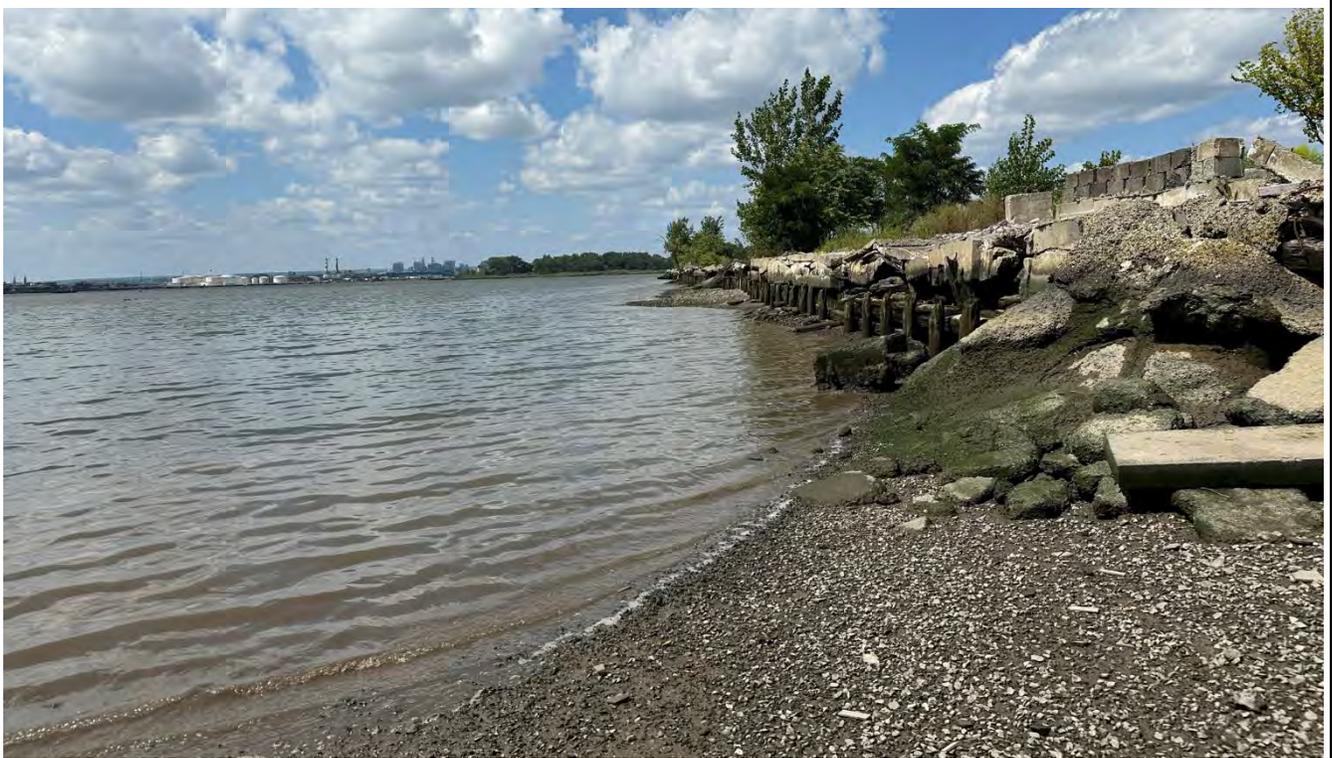
Photo 5: Cap Area 22 partially exposed during low tide (facing west).

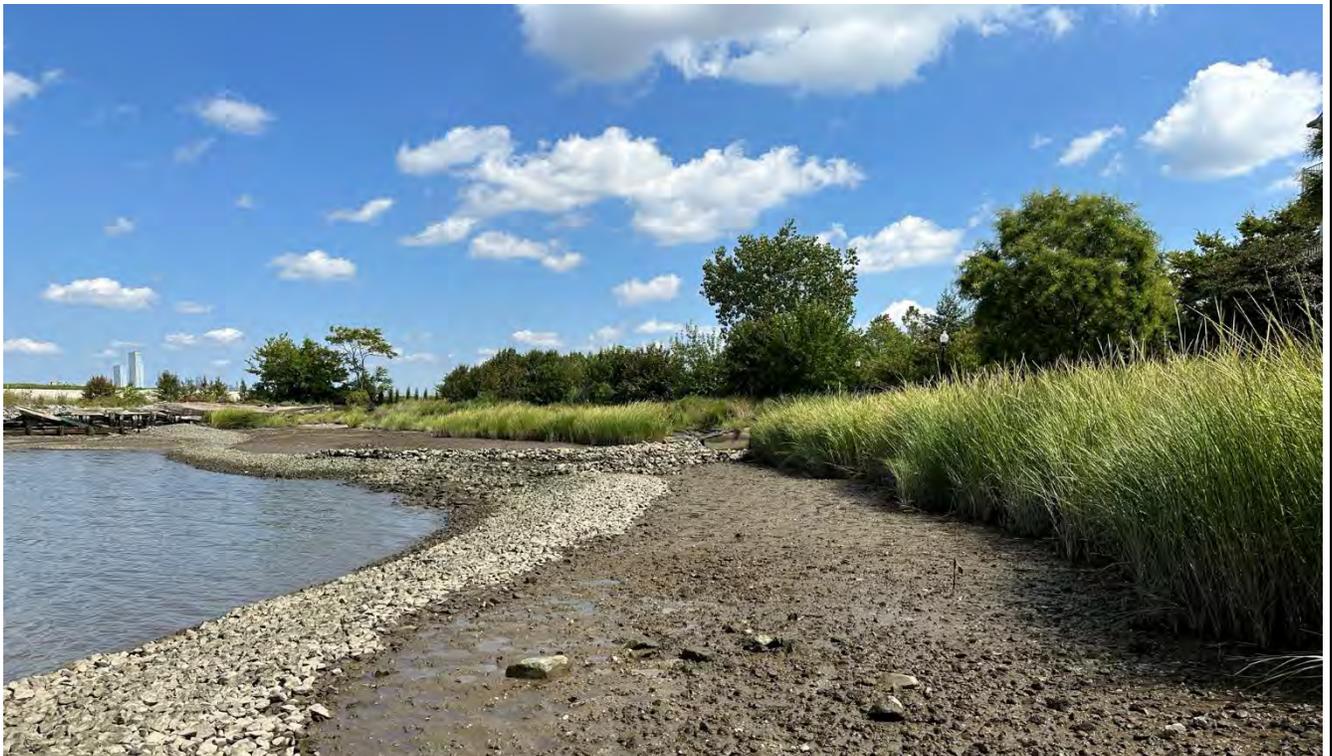
Photo 6: Central portion of the BEP, between Outfalls A and B (facing east). Note vibrant and healthy vegetation in the low marsh planting zone.

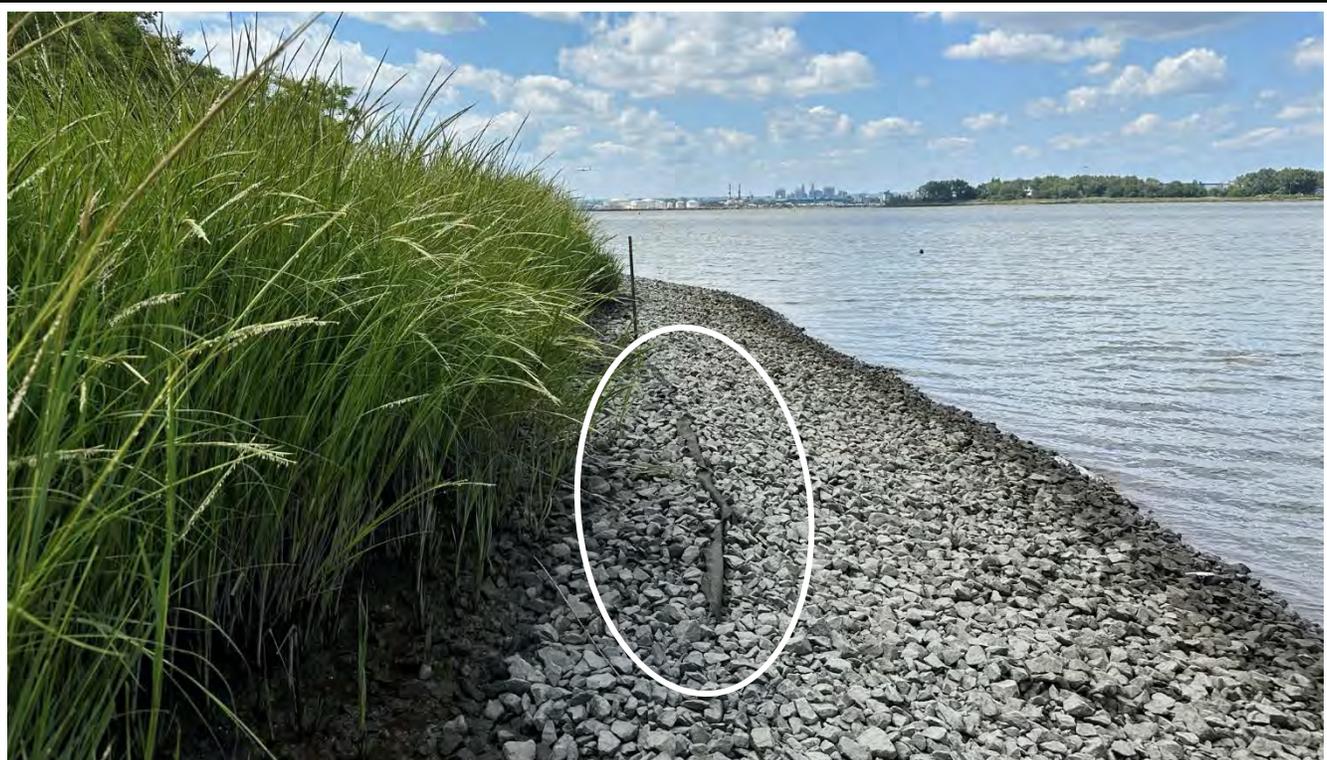
Photo 7: Exposed geotextile fabric between the shoreline stabilization berm and the BEP fill material west of Outfall A (facing west).

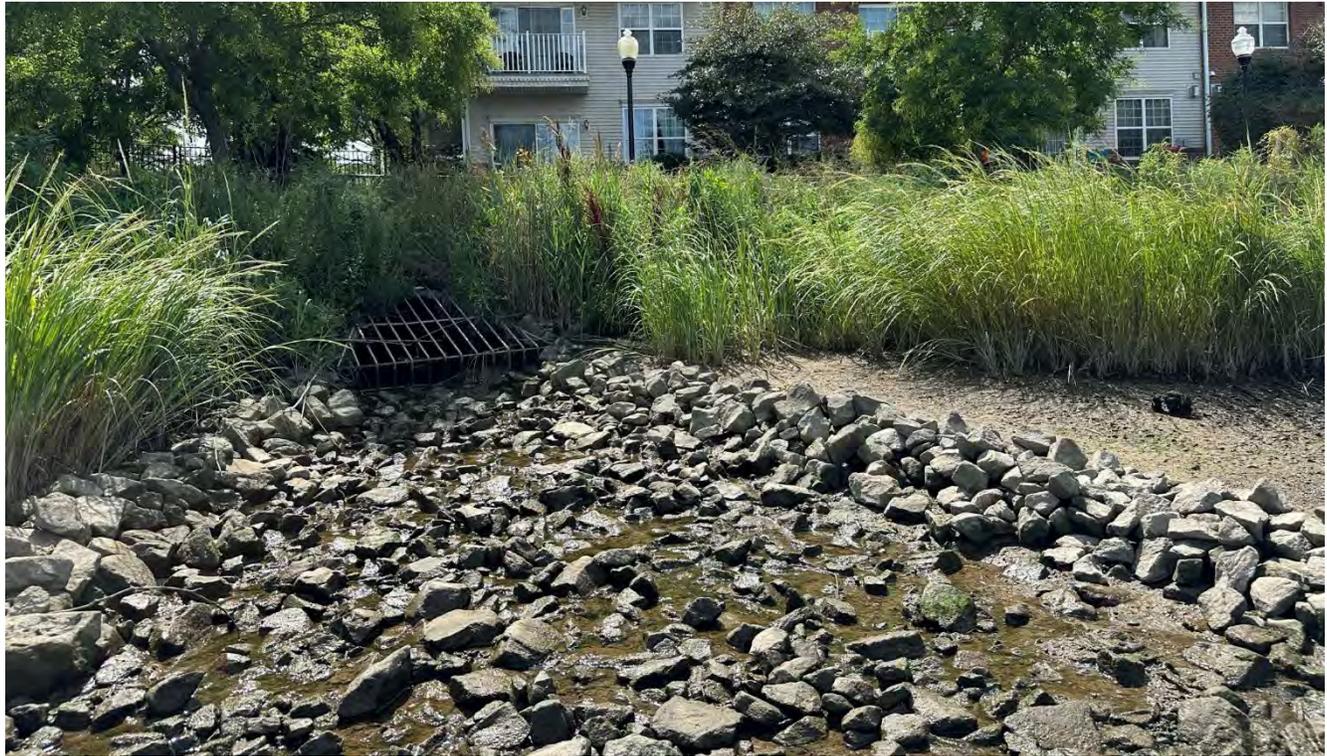
Photo 8: Outfall A and surrounding armor stone (facing southwest). Note vibrant and healthy vegetation in the low marsh and high marsh planting zones.

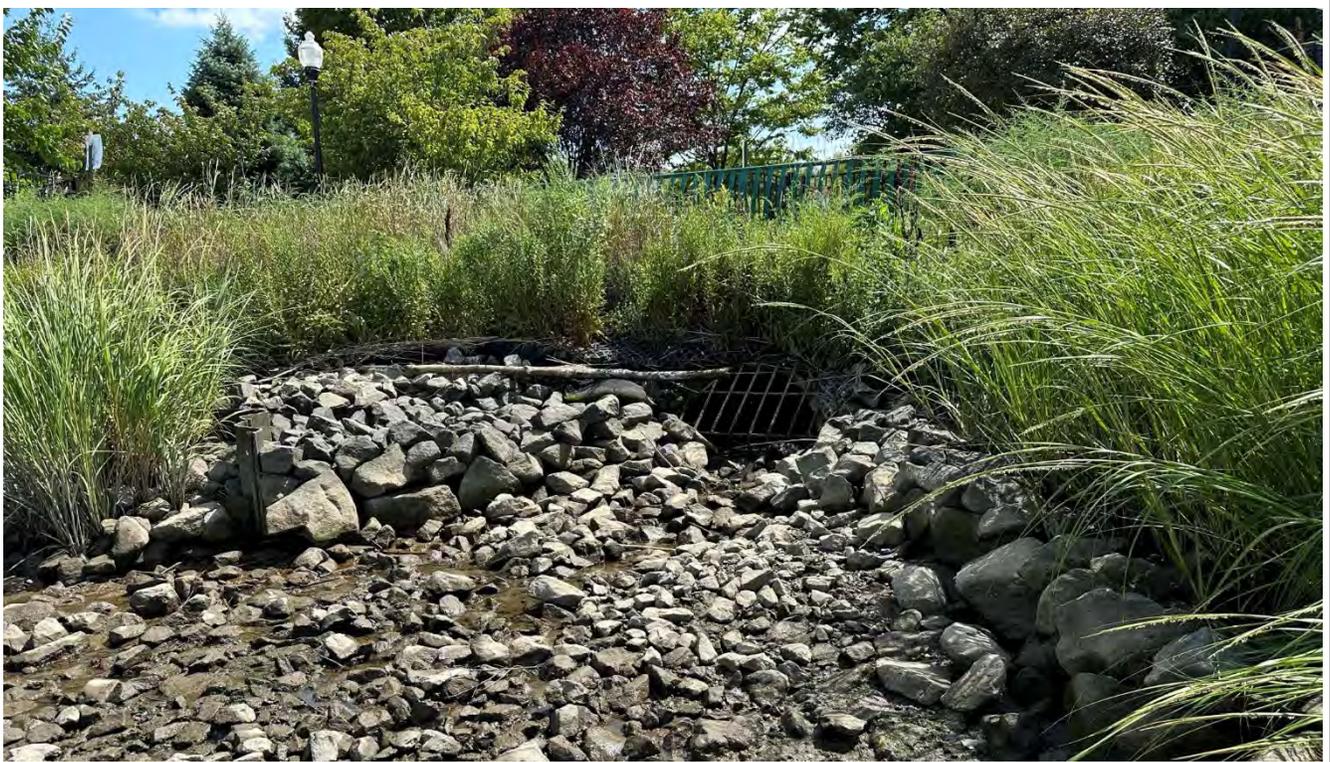
Photo 9: Outfall B and surrounding armor stone (facing south).

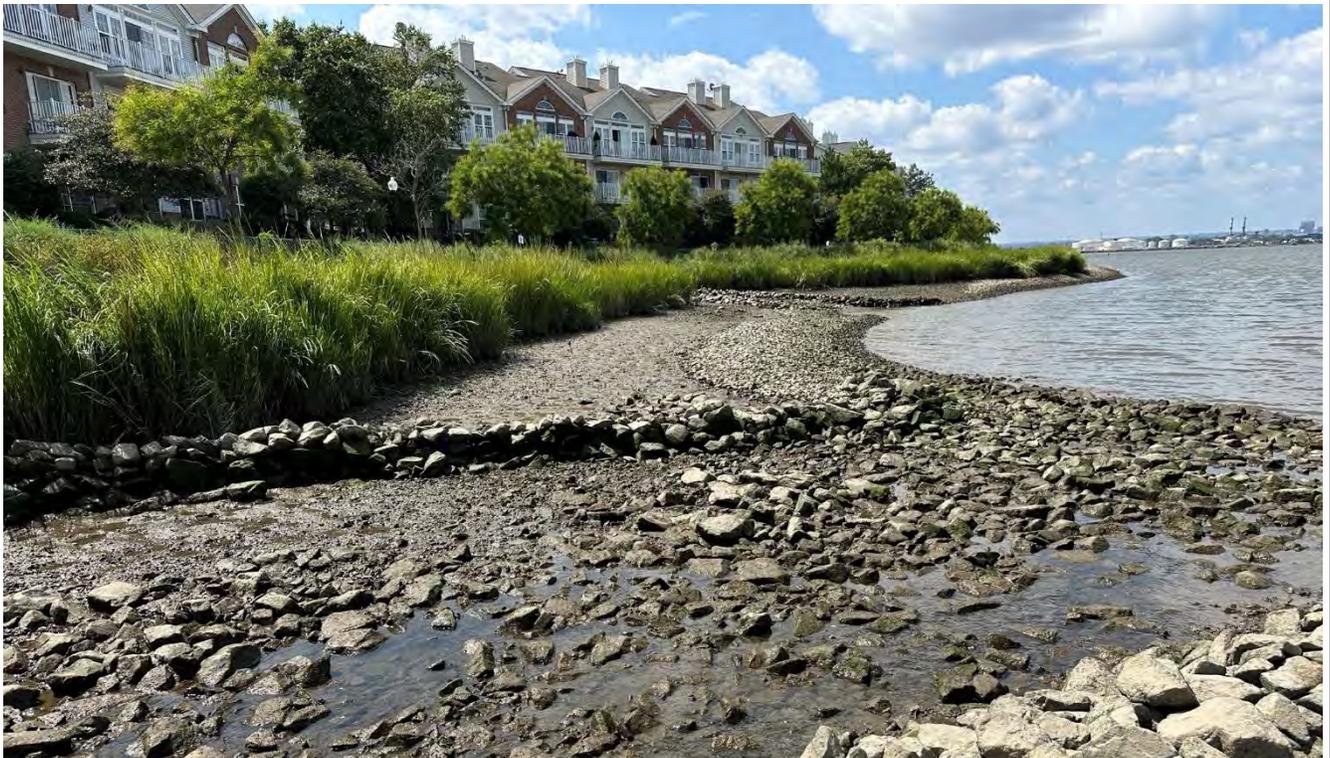
Photo 10: Armor stone along the western edge of the apron for Outfalls B and C (facing west). Note the siltation present on the apron stone.

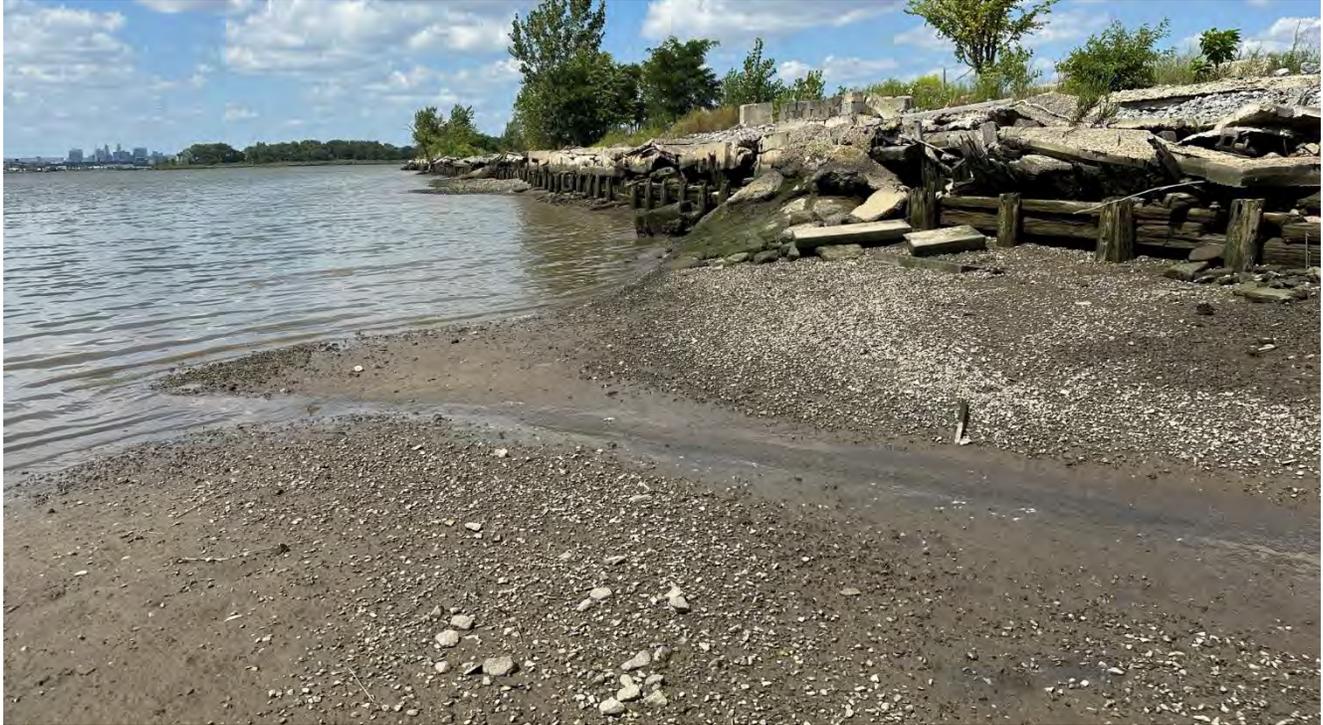
Photo 12: Area beyond the shoreline stabilization berm near Outfall D with Cap Area 22 partially exposed in the background (facing north).

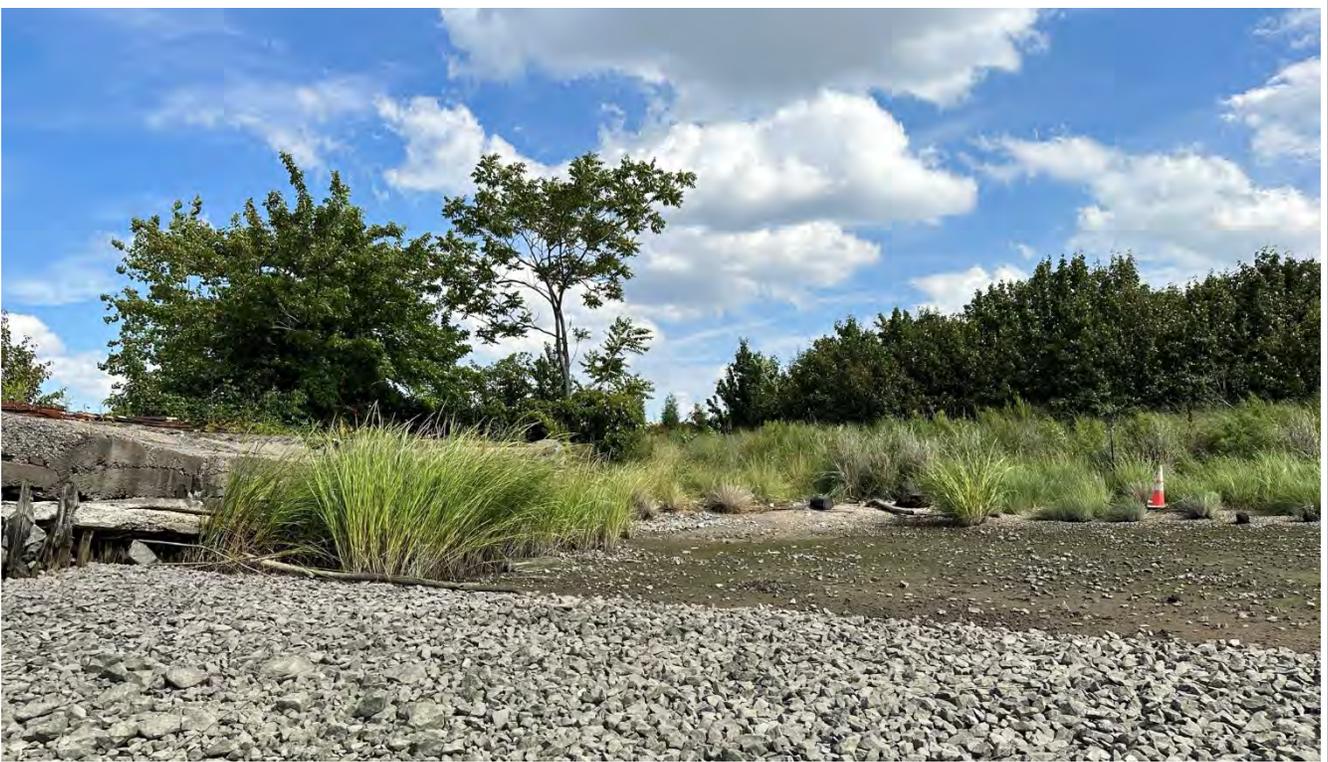
Photo 13: Low marsh zone in the eastern corner of the BEP near Outfall D (facing southeast). Note vibrant and healthy vegetation throughout the low marsh planting zone.

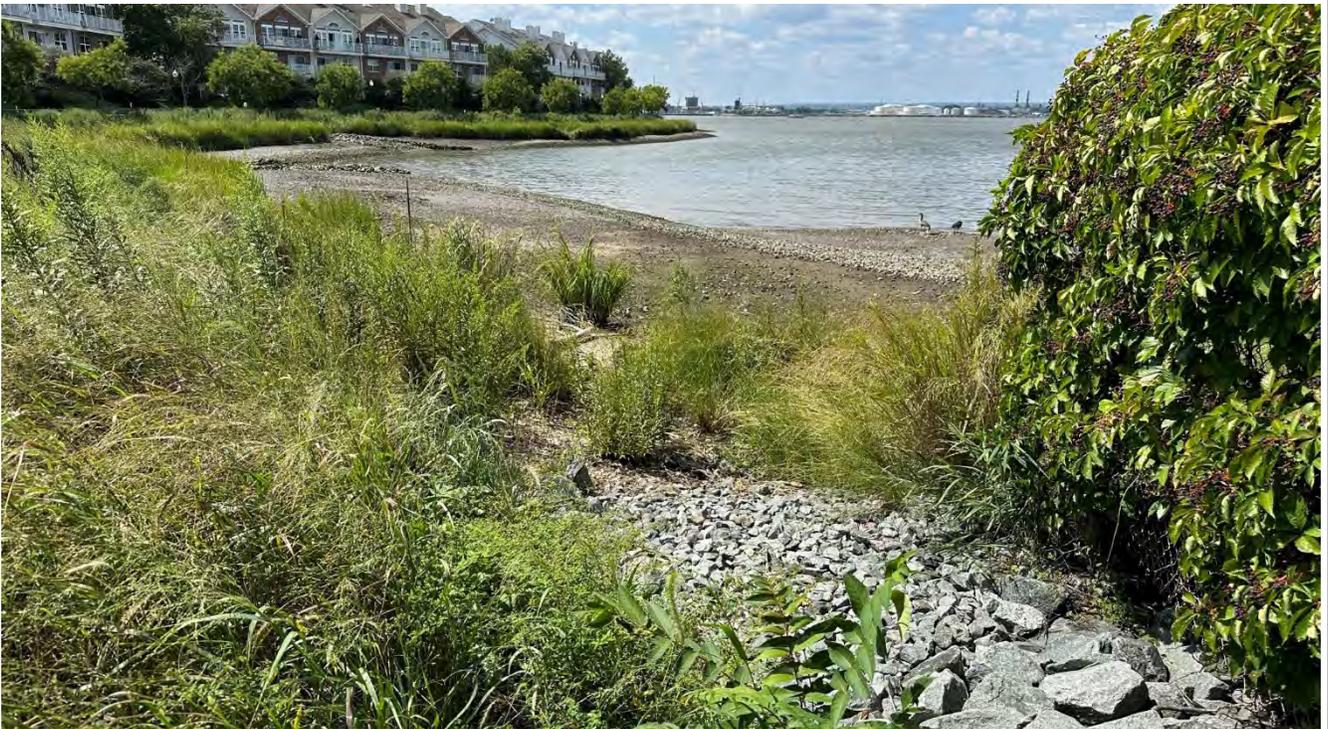
Photo 14: Transition from upland to low marsh zone in the easternmost corner of the BEP area (facing west).

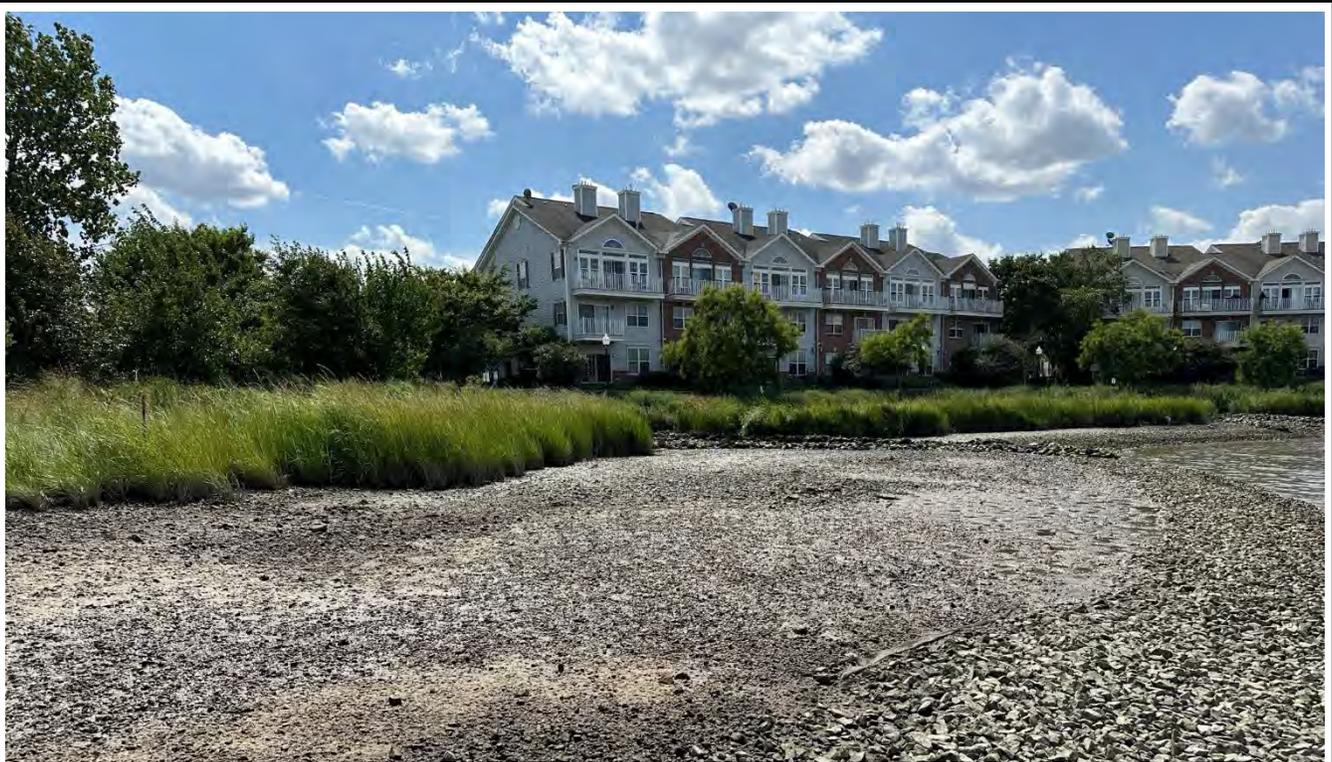
Photo 15: Low marsh planting zone on the eastern side of the BEP (facing west).

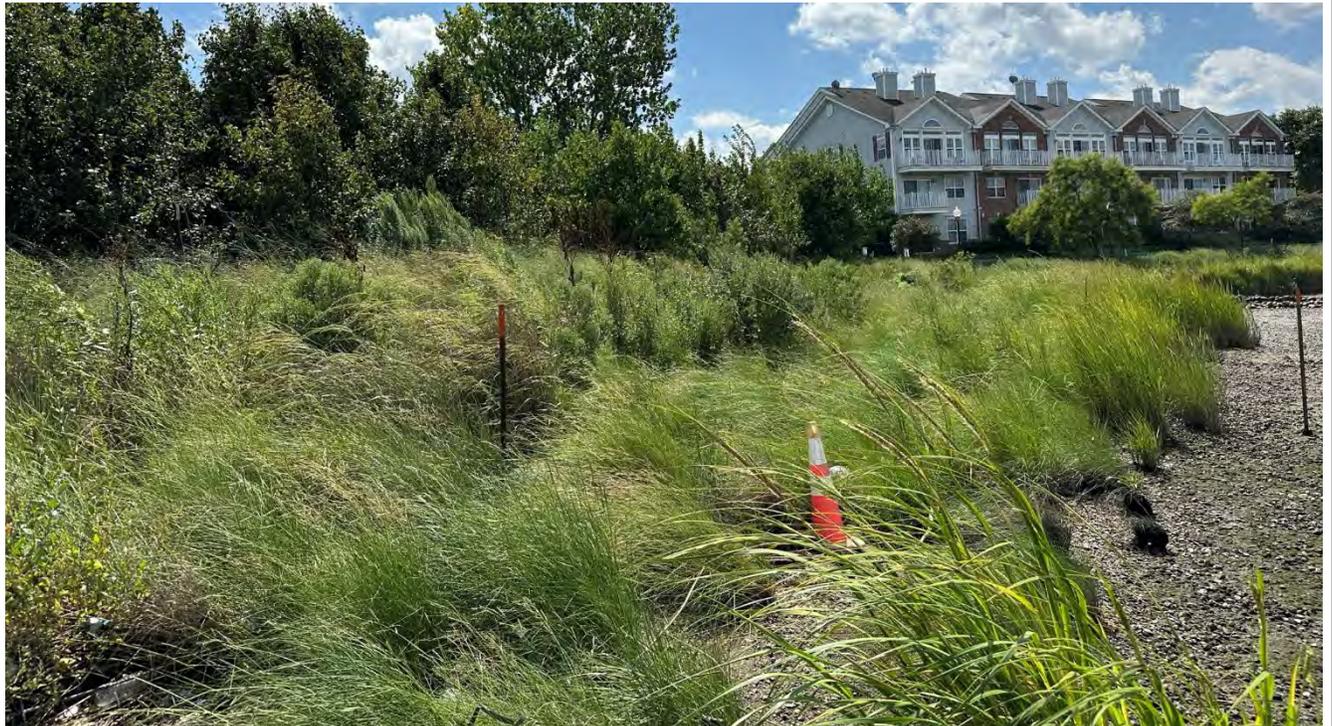
Photo 16: Transition area between low marsh planting zone and high marsh planting zone within the eastern side of the BEP (facing southeast). Note the vibrant and healthy low marsh and high marsh vegetation.

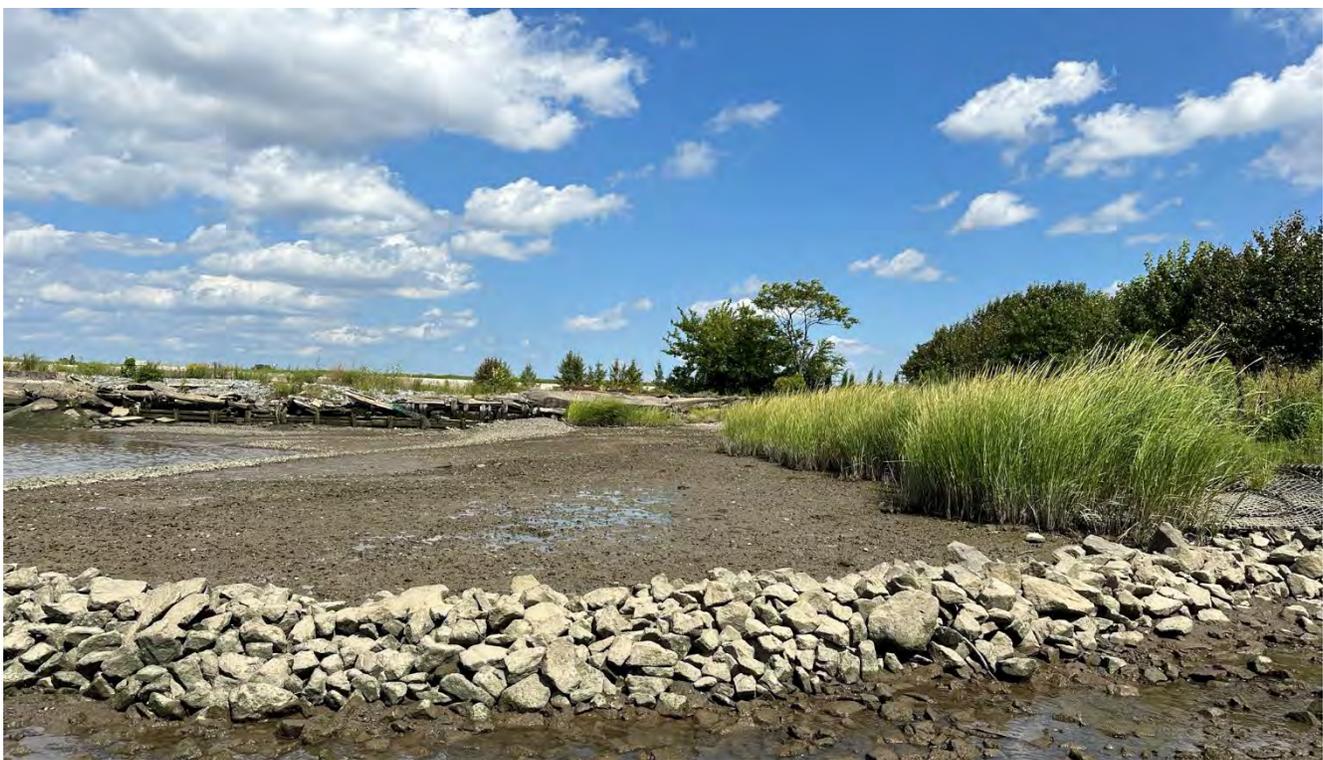
Photo 17: Low marsh planting zone within eastern portion of the BEP (facing northeast).
