MEMORANDUM

Subject: **SA-7 Sediment Remedy Long-Term Monitoring**
Summary of Year 10 Monitoring & Proposed Year 11
Program

**ATTACHMENT A.2
AUGUST 30, 2023 INSPECTION LOG**

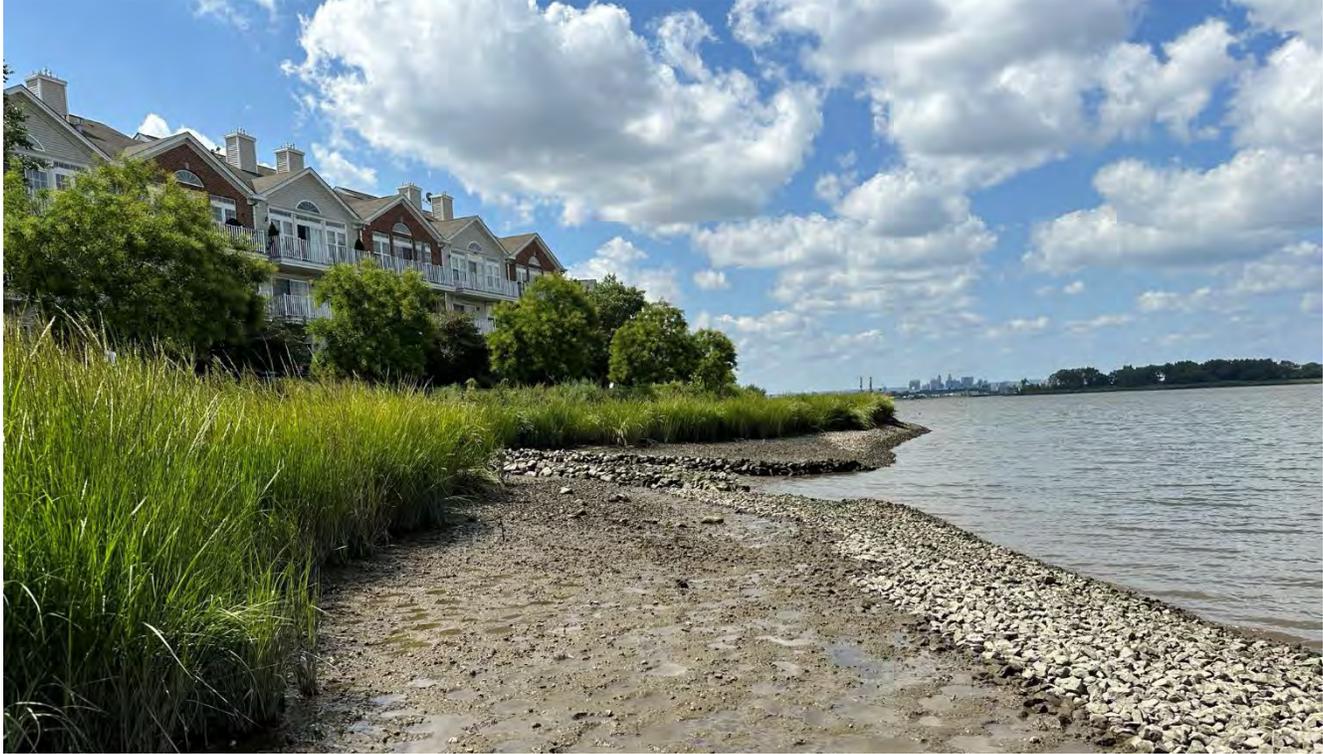
Photo 18: Low marsh planting zone between Outfalls A and B (facing west). Note the vibrant and healthy vegetation in the higher elevations of the low marsh area.

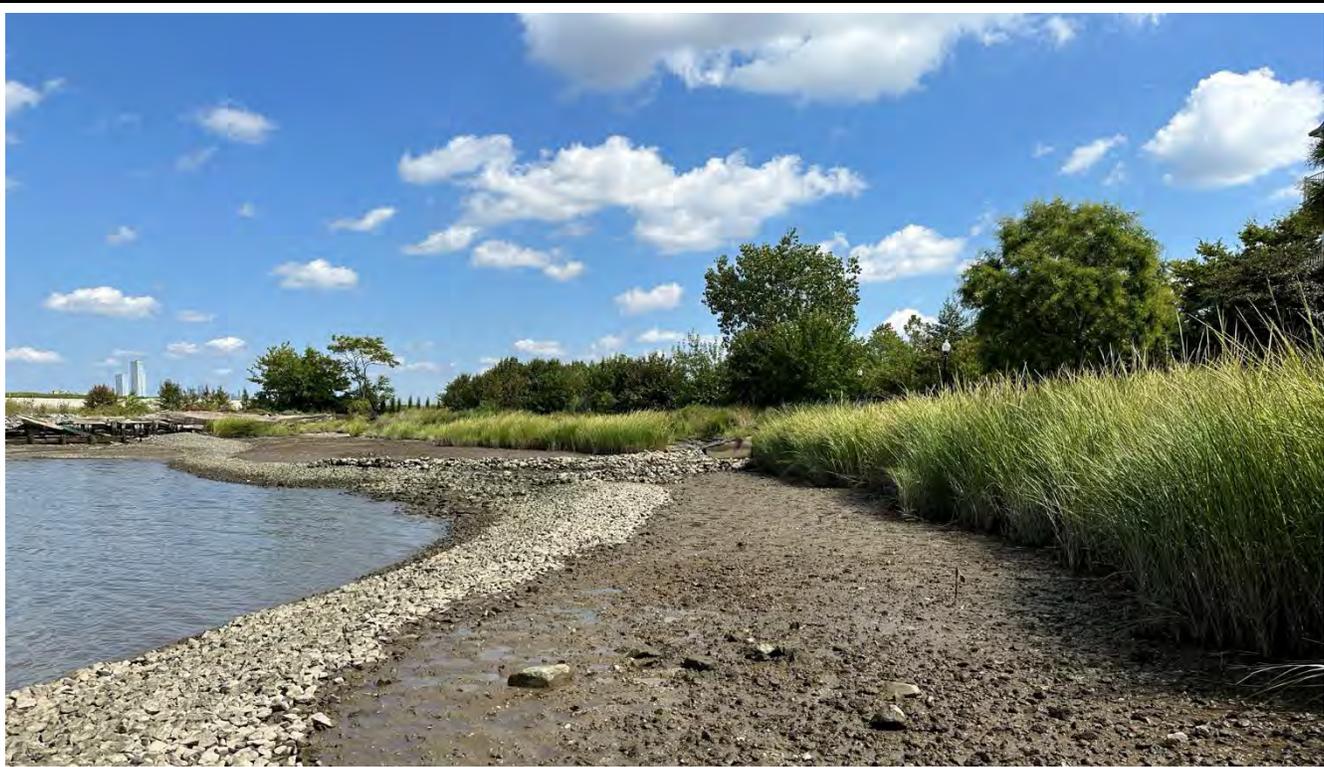
Photo 19: Vibrant and healthy vegetation in the higher elevations of the low marsh zone and high marsh zones in the eastern BEP area (facing southeast).

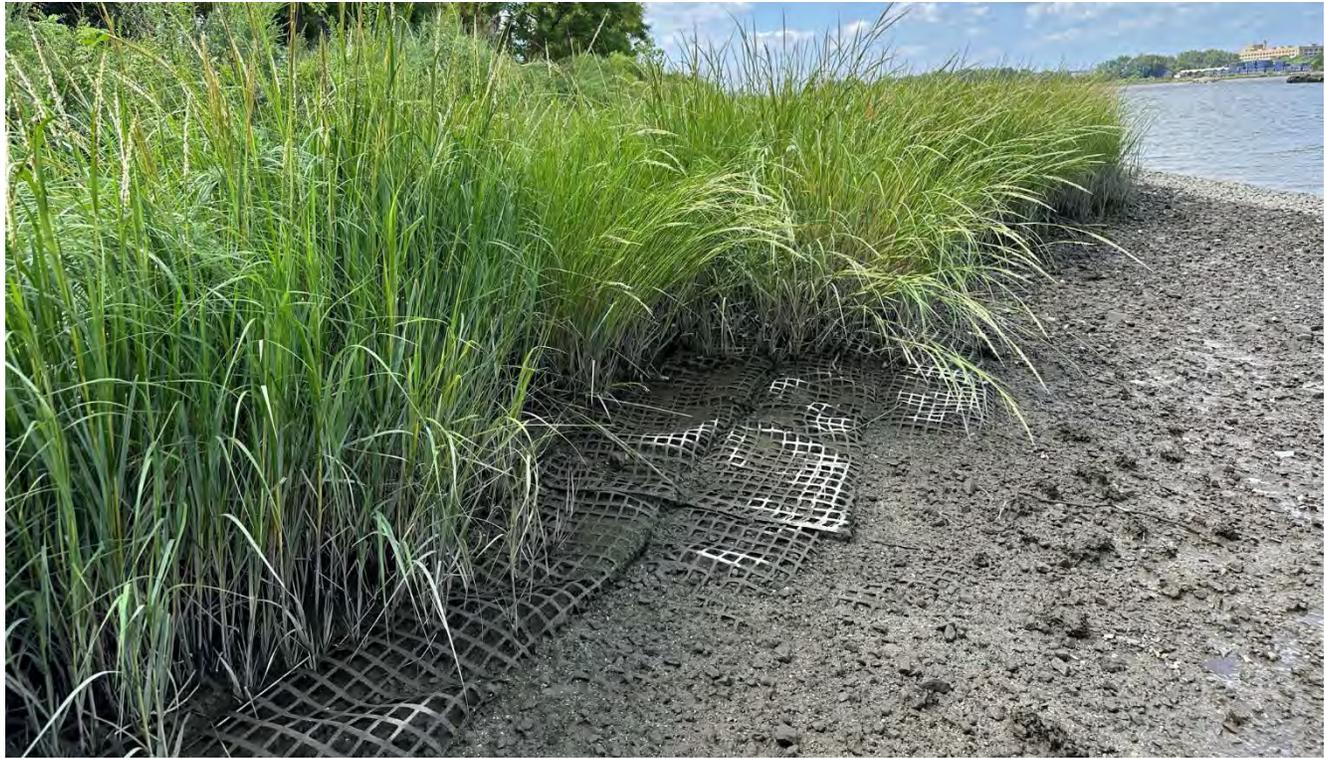
Photo 20: Vibrant and healthy low and high marsh zones west of Outfall A (facing southwest). Note the exposed geogrid and absence of GroSoxx at the bottom of the low marsh zone.

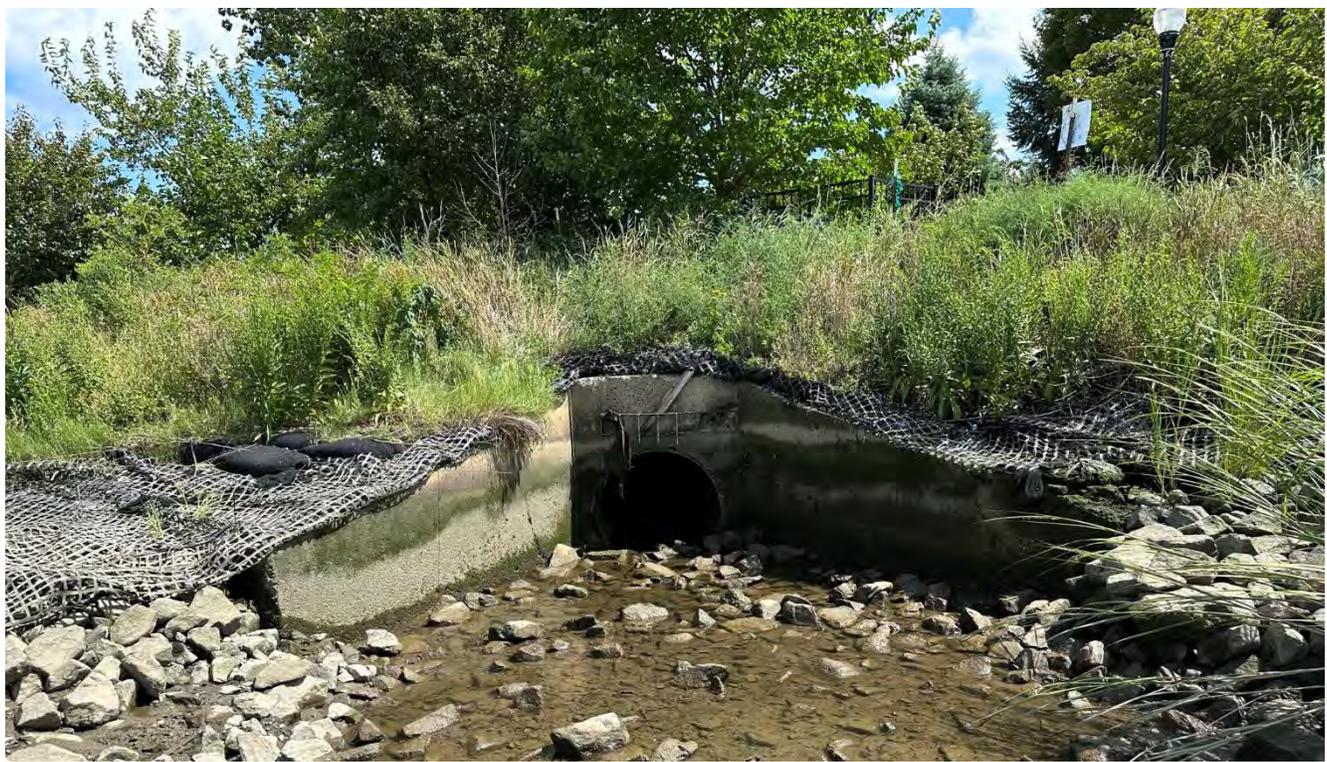
Photo 21: Exposed geogrid over and around the Outfall C structure and within the high marsh planting zone (facing south).

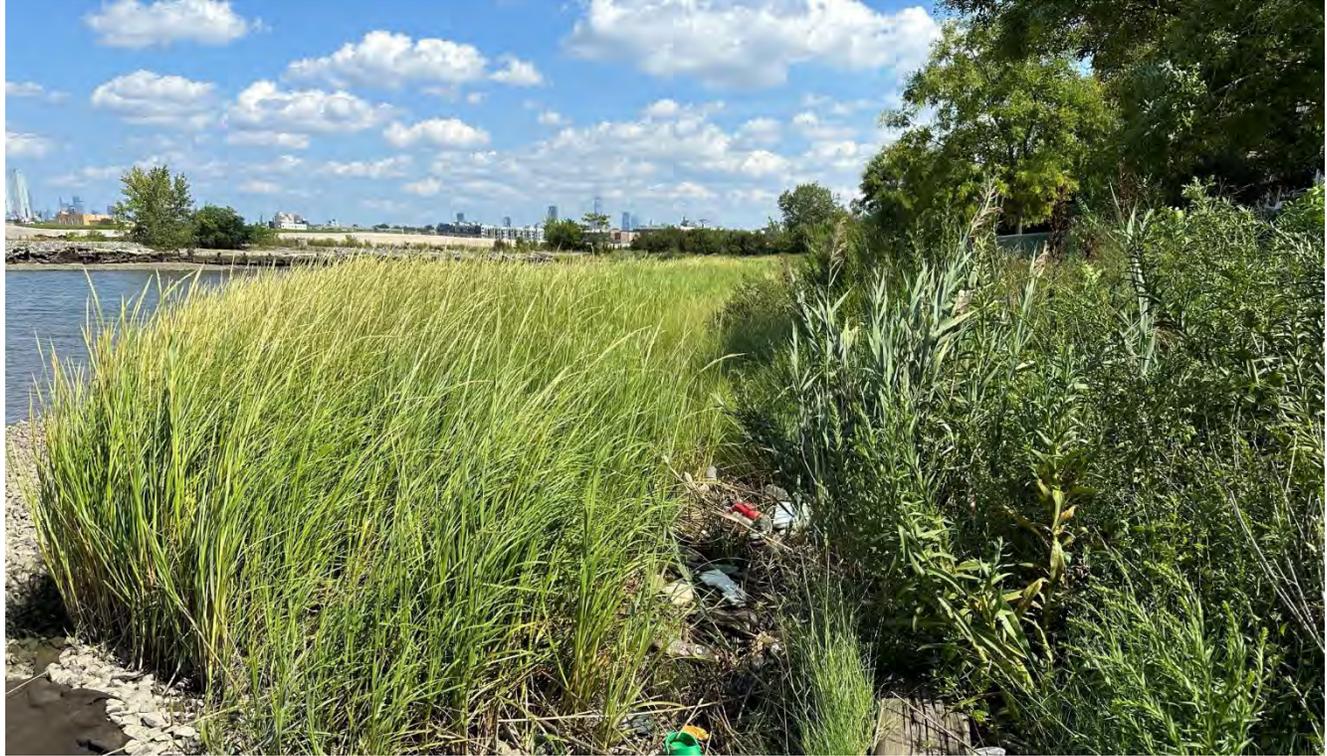
Photo 22: Healthy low and high marsh vegetation west of Outfall A (facing east). Note the presence of tidal drift deposits and debris within the high marsh areas.

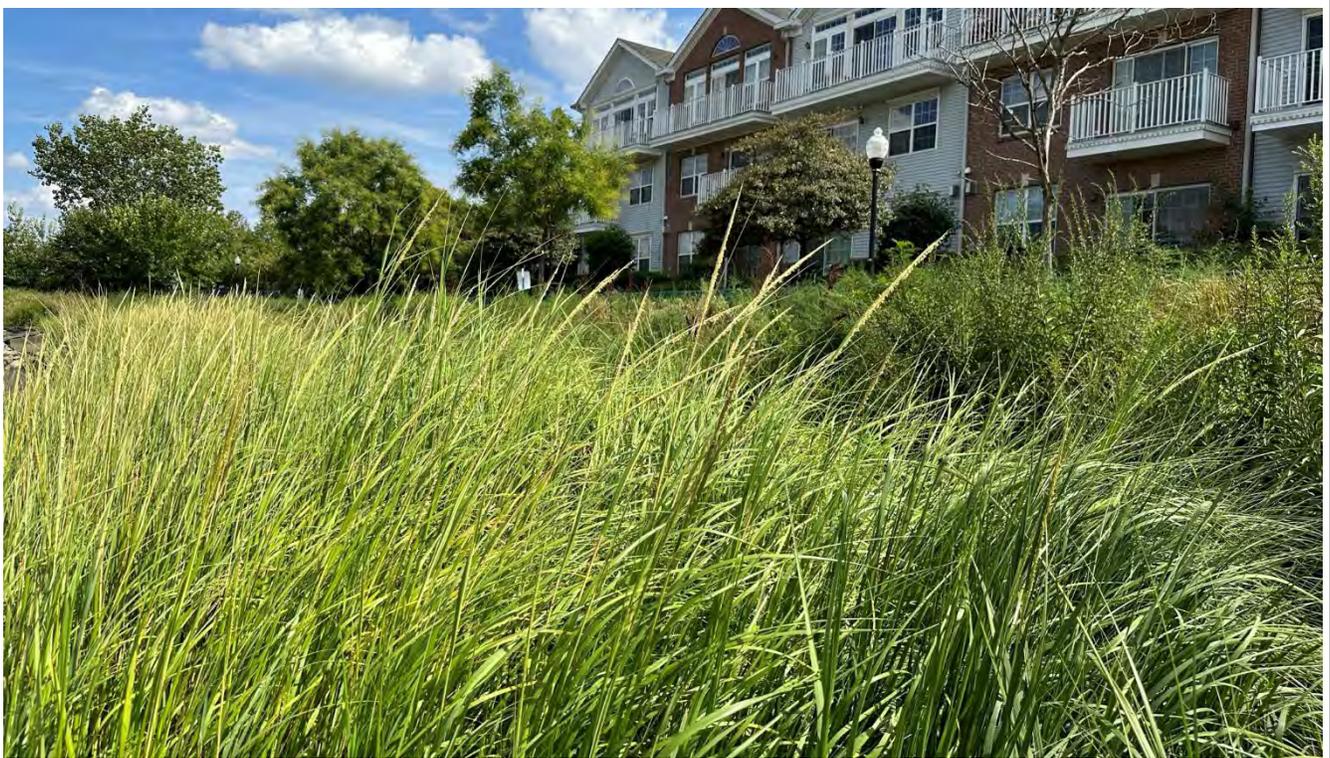
Photo 23: Healthy vegetation in the upland transition area and interface between the low and high marsh between Outfalls A and B (facing southeast).

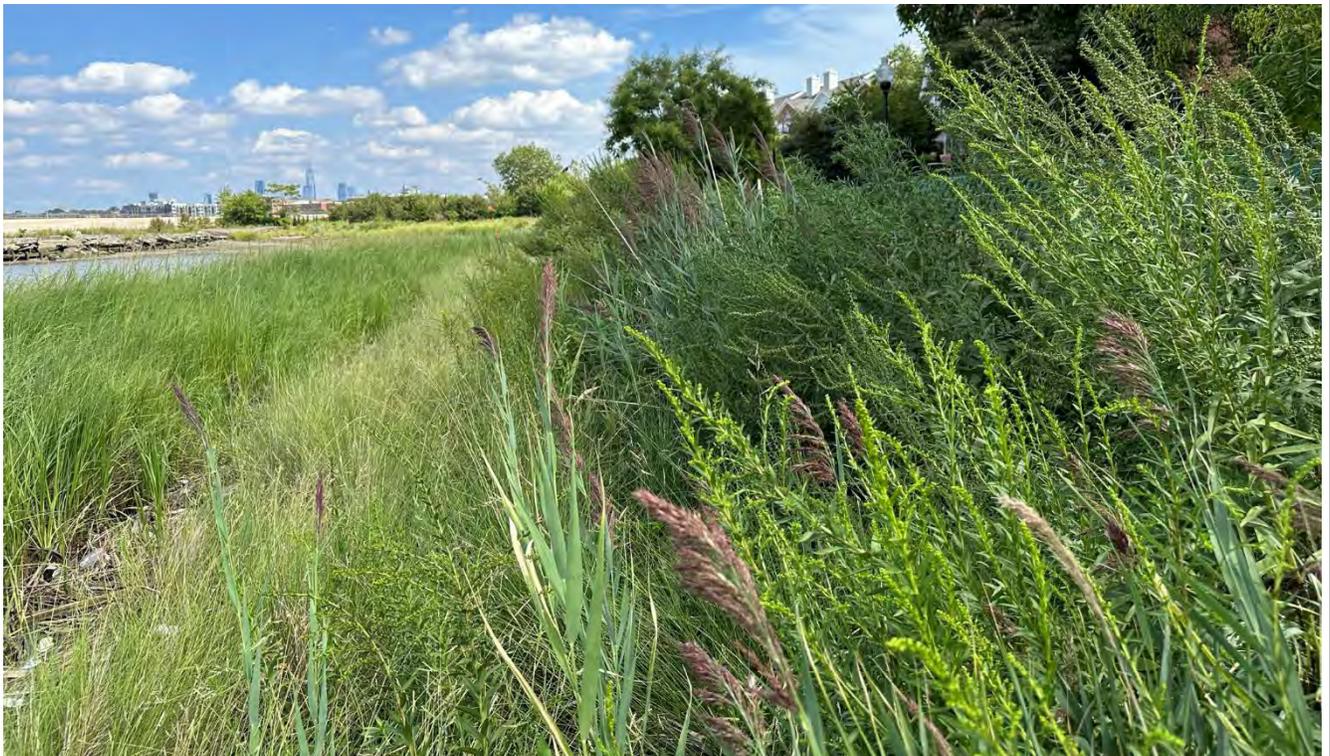
Photo 24: Healthy vegetation in the upland transitional area and interface between the low and high marsh west of Outfall A (facing east).

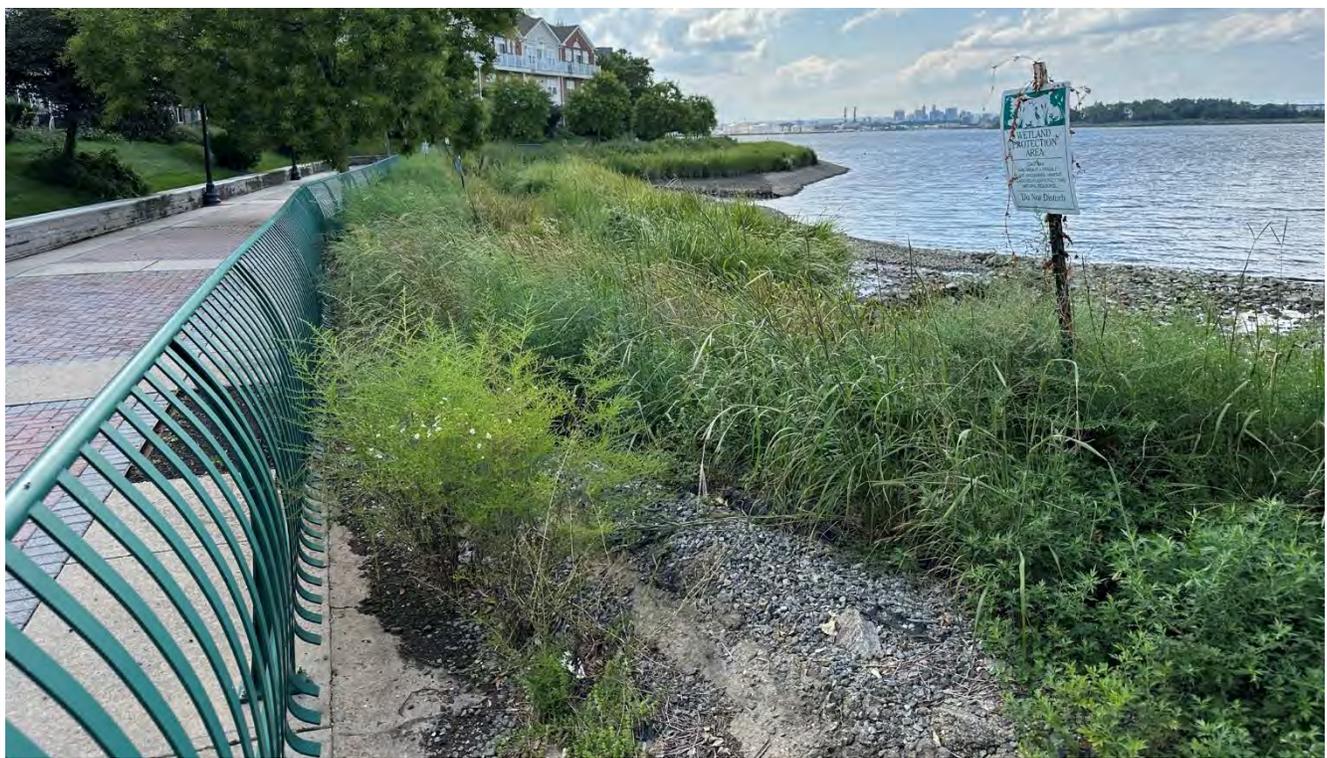
Photo 25: Previously mowed section of the upland planting area in the western portion of the BEP (facing west).

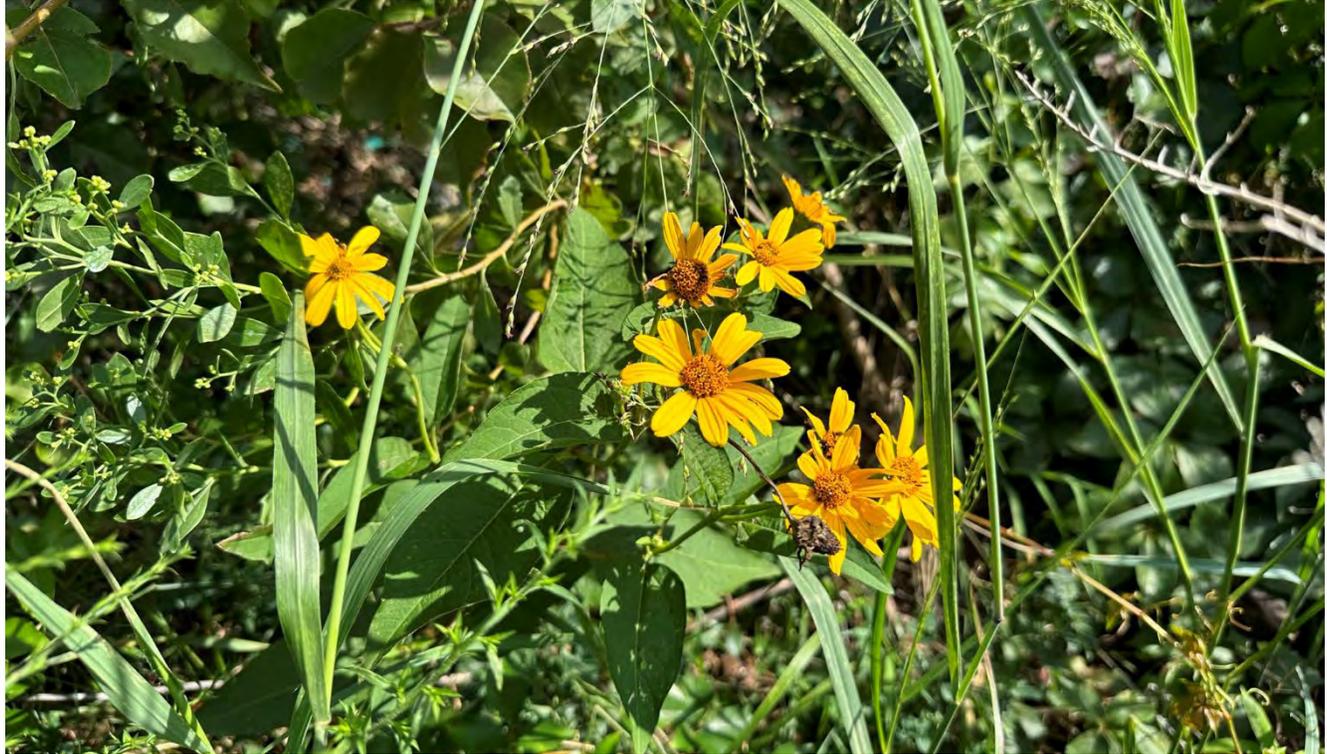
Photo 26: Native species black-eyed susan located within the upland transitional planting zone of the BEP.

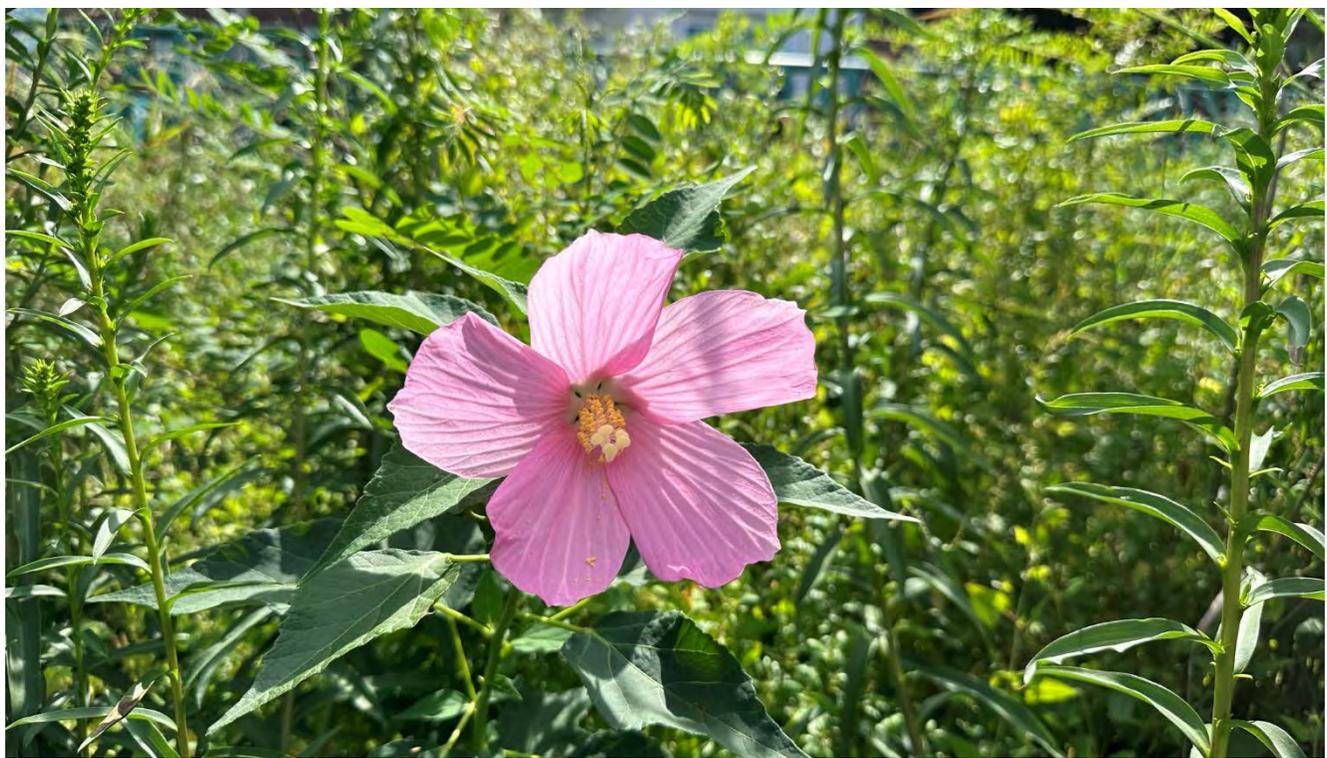
Photo 27: Native species swamp rose mallow located within the upland transitional planting zone of the BEP.

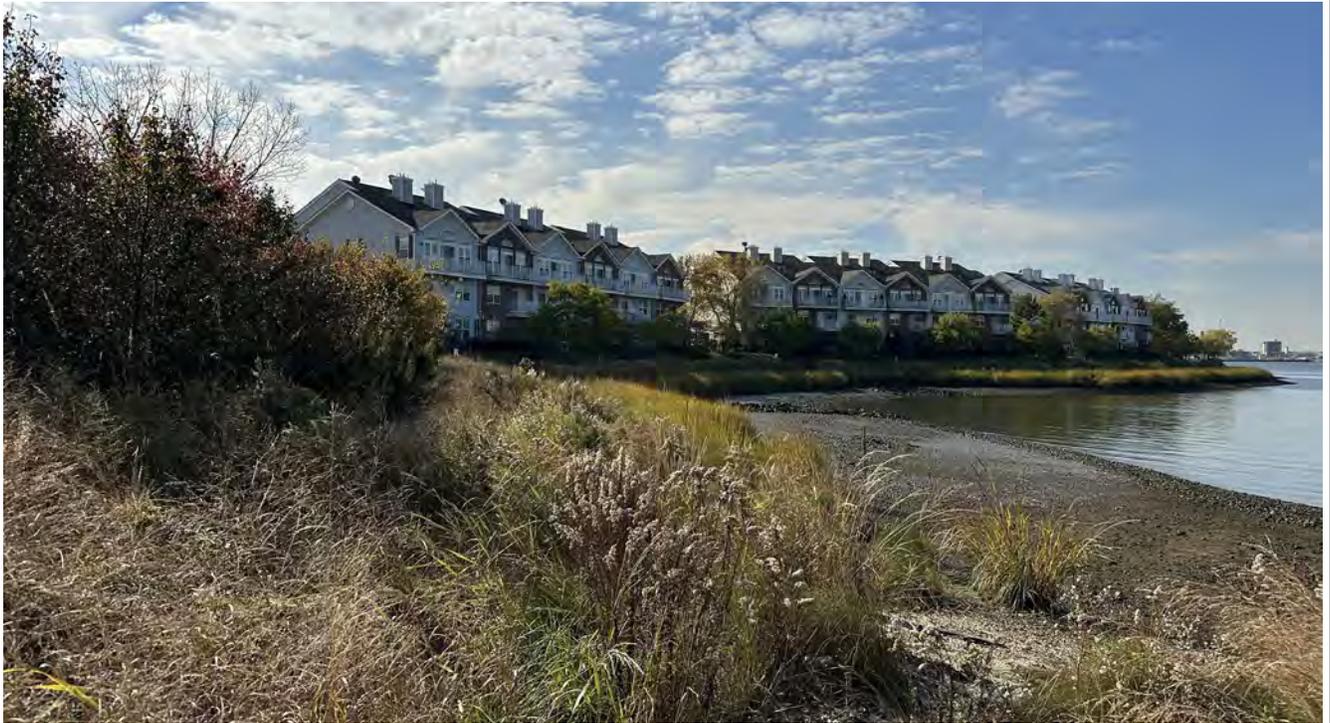
Photo 1: Northern end of Cap Area 16 (facing west). Note vibrant and healthy vegetation present in high marsh planting and upland zones.

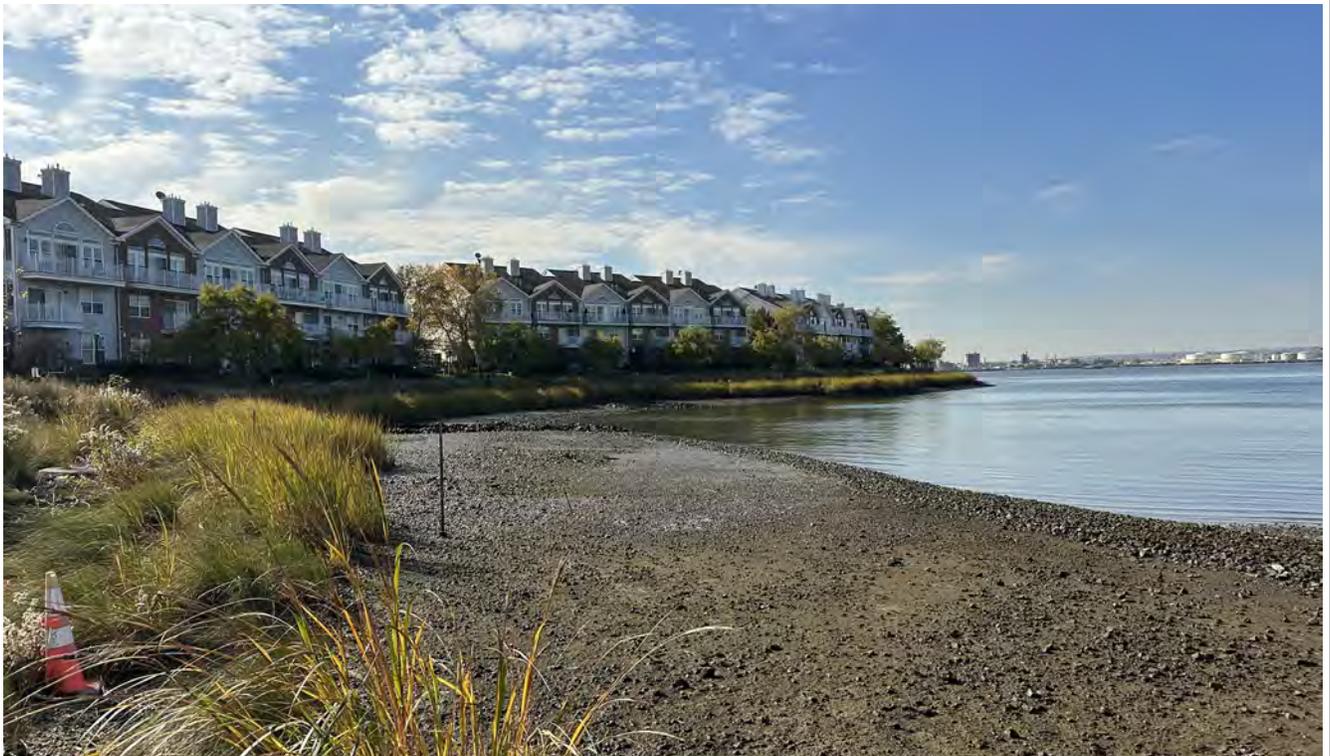
Photo 2: Central portion of Cap Area 16 (facing west). Note reference posts used to assess sediment surface changes.

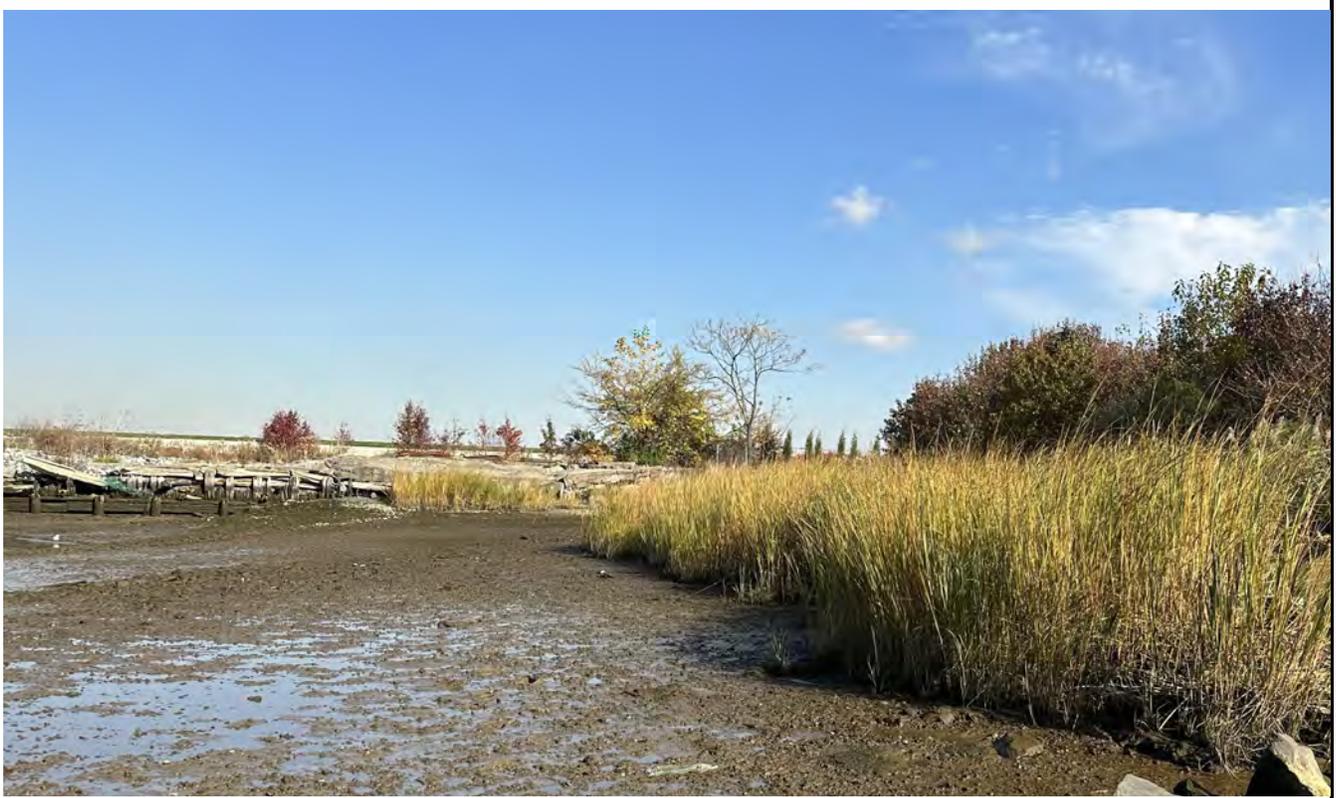
Photo 3: Western end of Cap Area 16 (facing east). Note the vibrant and healthy vegetation in the low marsh planting zone.

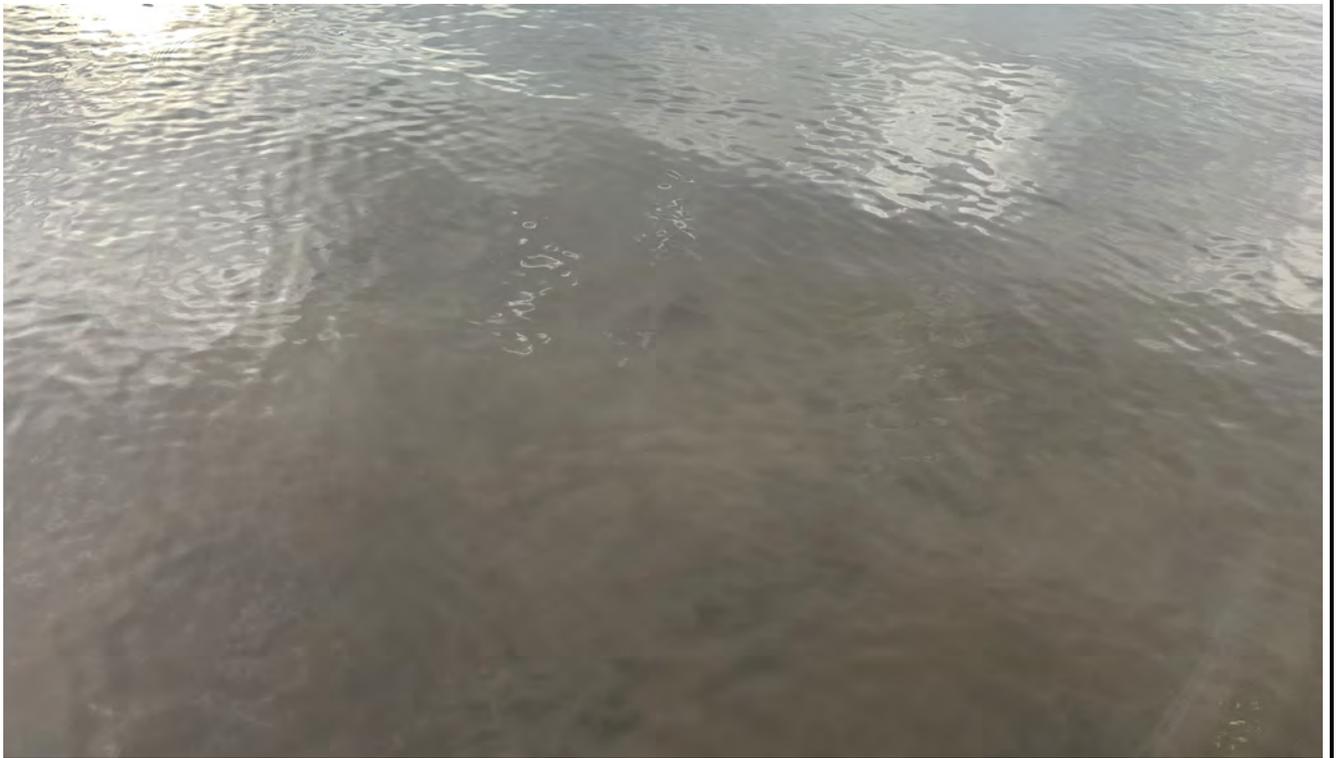
Photo 4: Subaquatic vegetation not observed within Cap Area 22 (facing west).

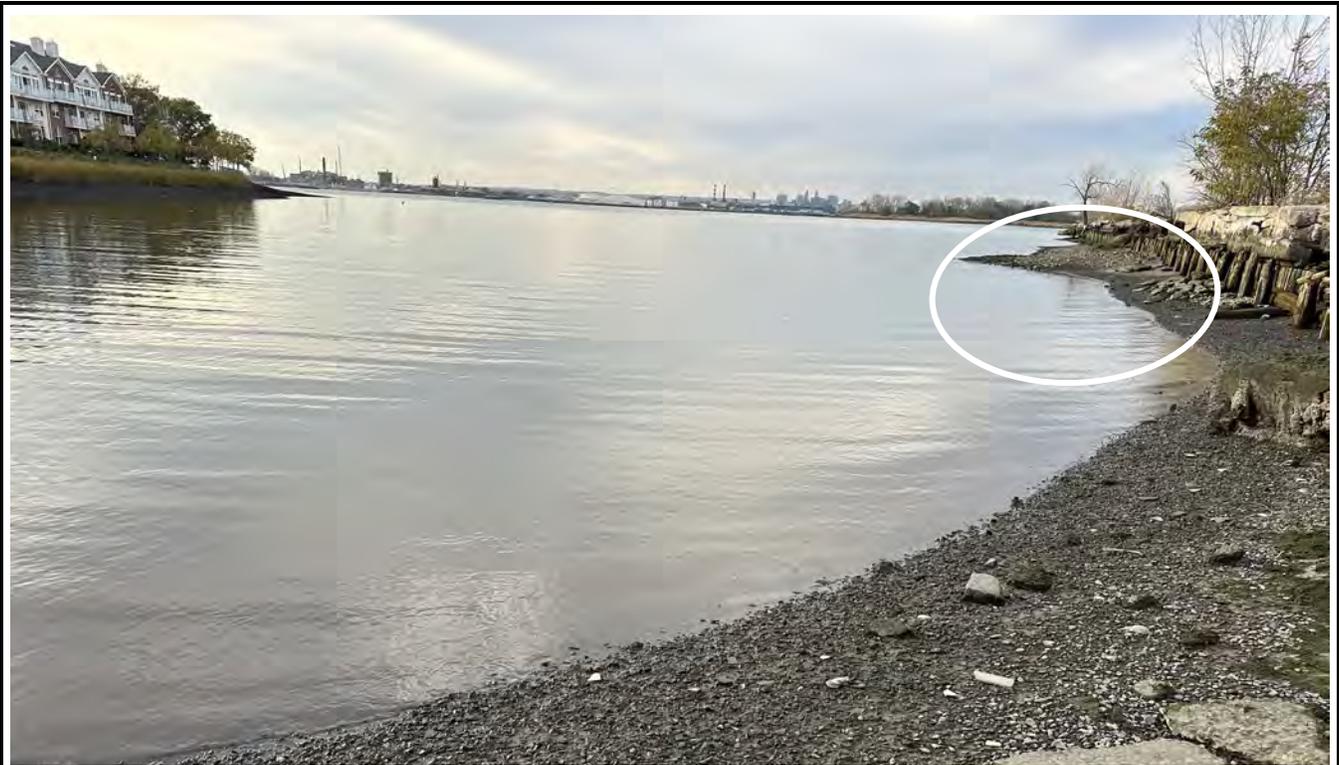
Photo 5: Partially exposed Cap Area 22 during low tide (facing west).

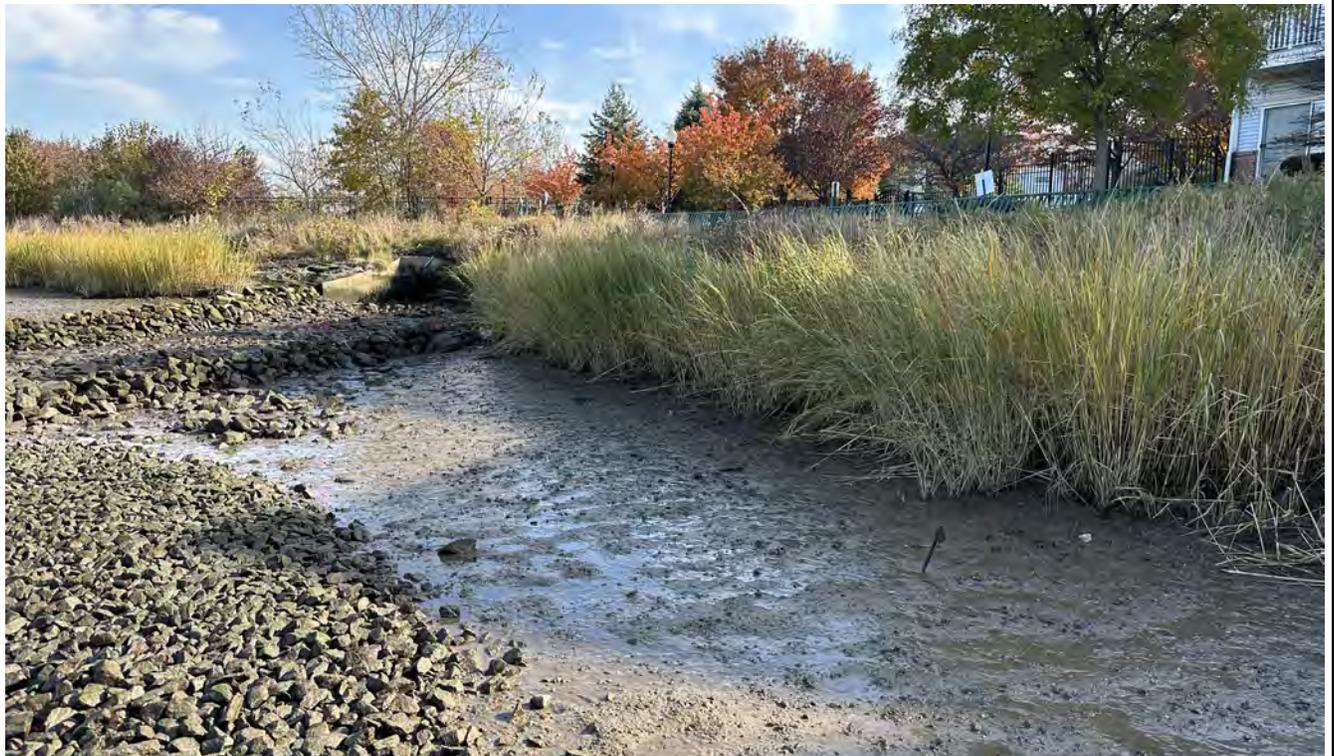
Photo 6: Central portion of the BEP, between Outfalls A and B (facing southeast). Note vibrant and healthy vegetation in the low marsh planting zone.

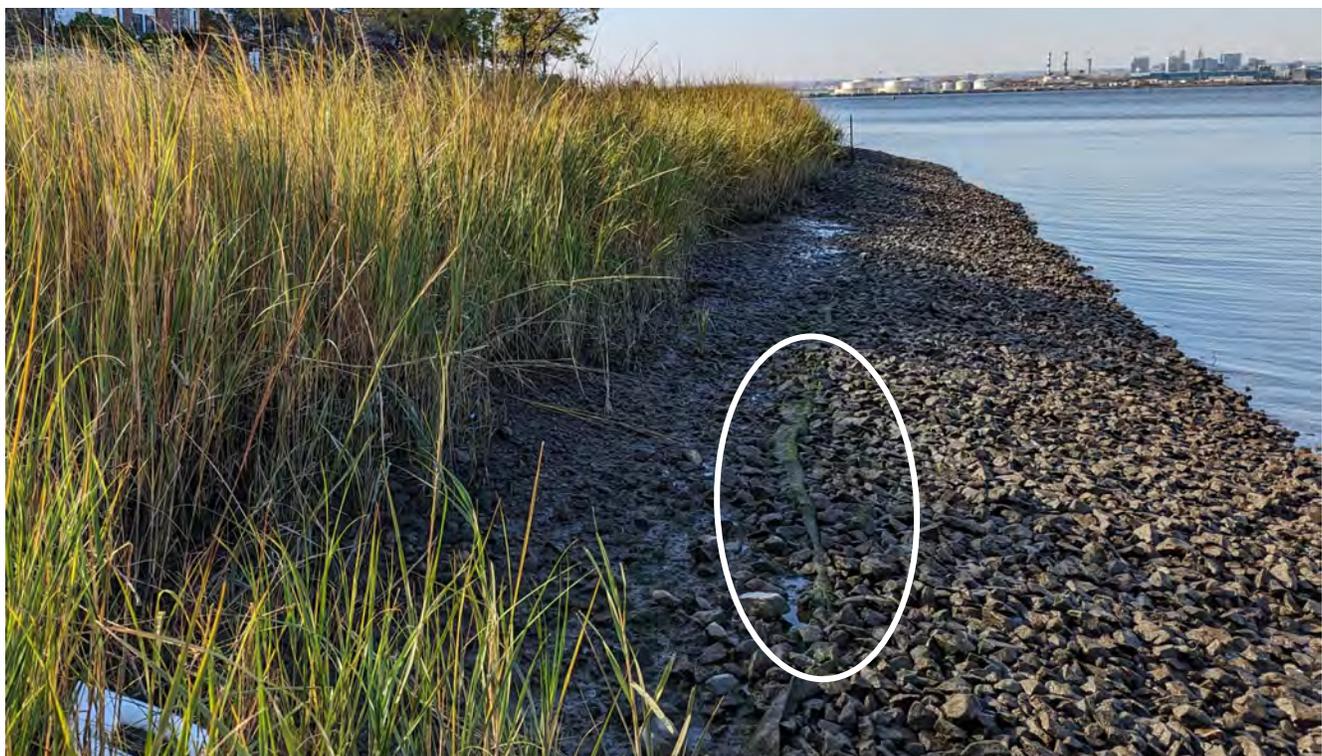
Photo 7: Exposed geotextile fabric between the shoreline stabilization berm and the BEP fill material west of Outfall A (facing west).

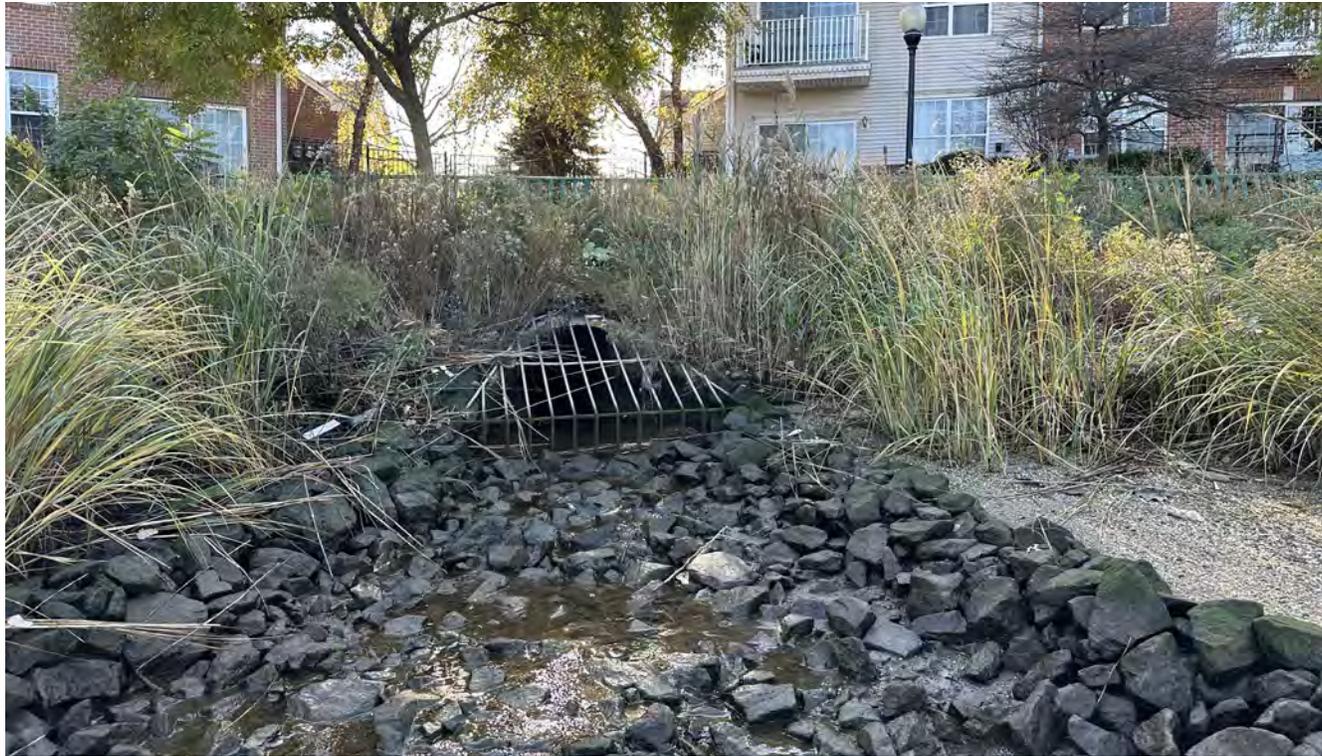
Photo 8: Outfall A and surrounding armor stone (facing southwest). Note vibrant and healthy vegetation in the low marsh and high marsh planting zones.

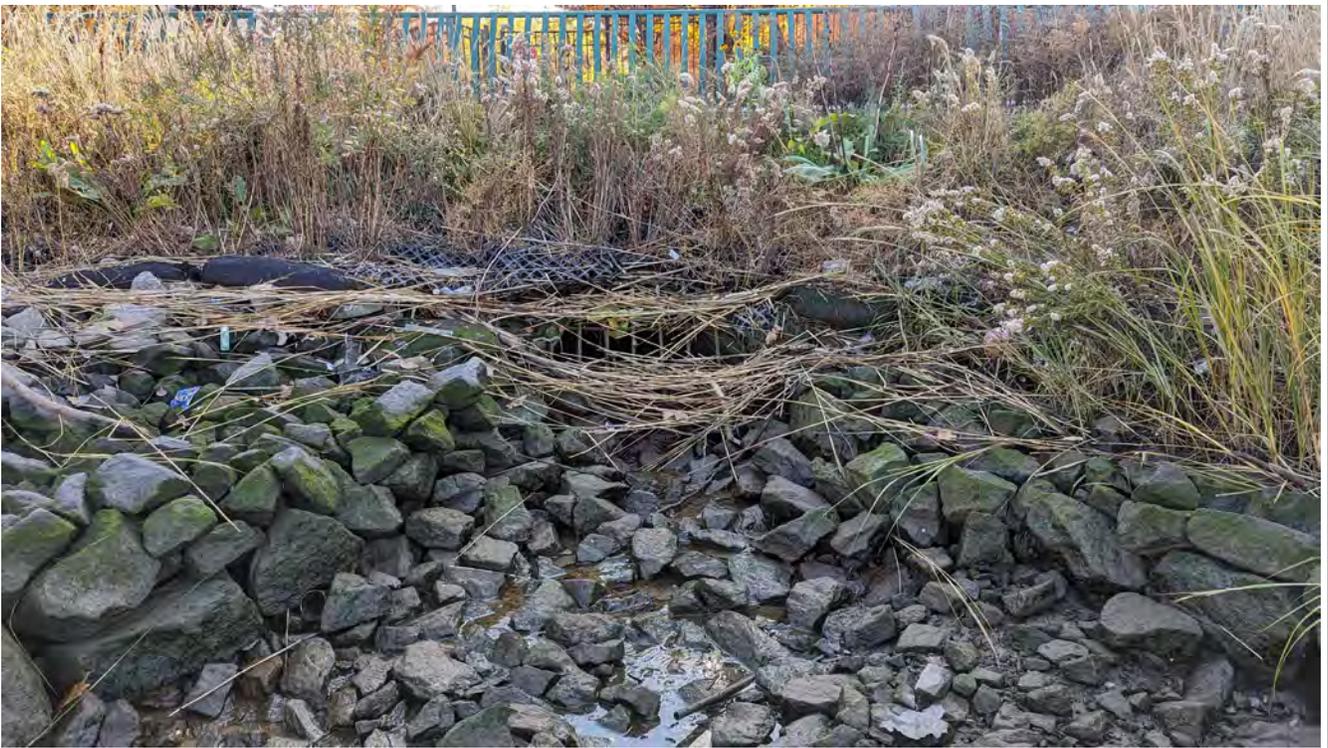
Photo 9: Outfall B and surrounding armor stone (facing southwest). Note the tidal drift deposits and debris in front of the outlet.

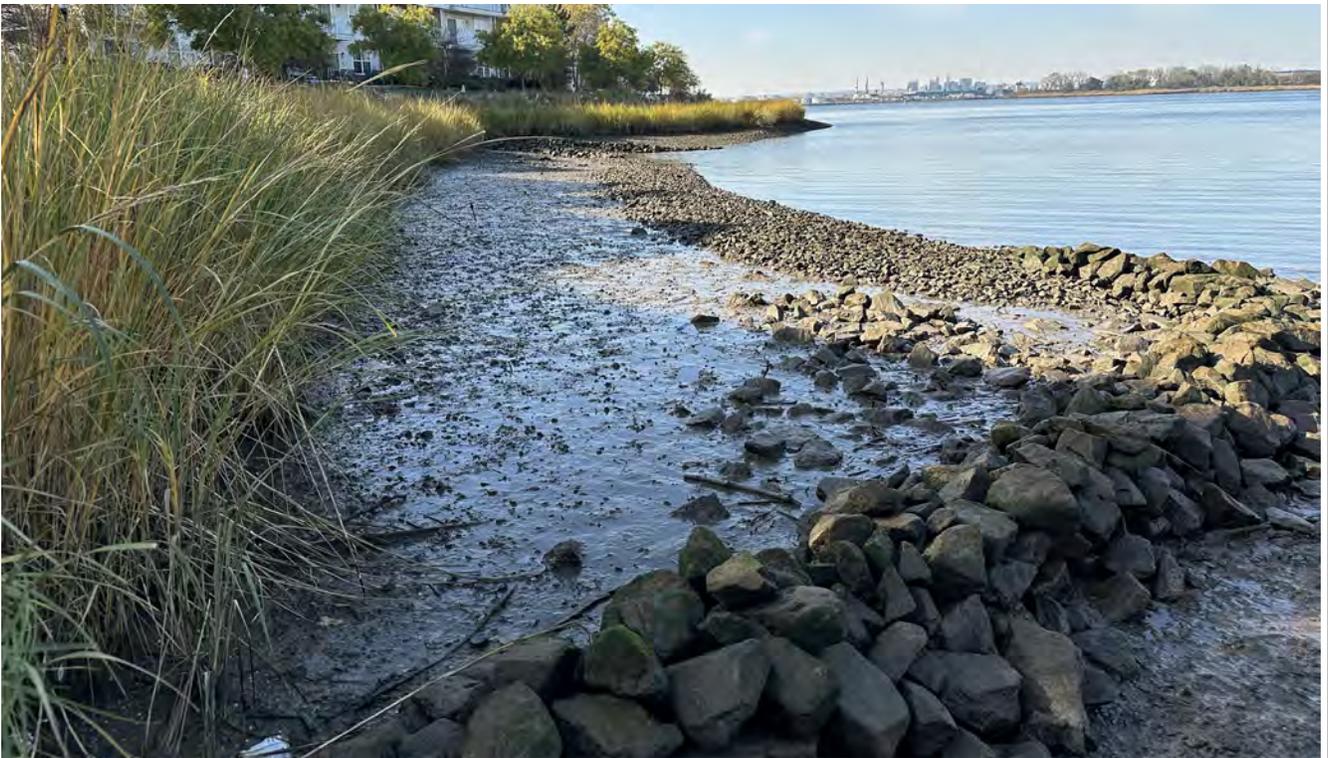
Photo 10: Armor stone along the western edge of the apron for Outfalls B and C (facing west). Note the siltation present on and behind the apron stone.

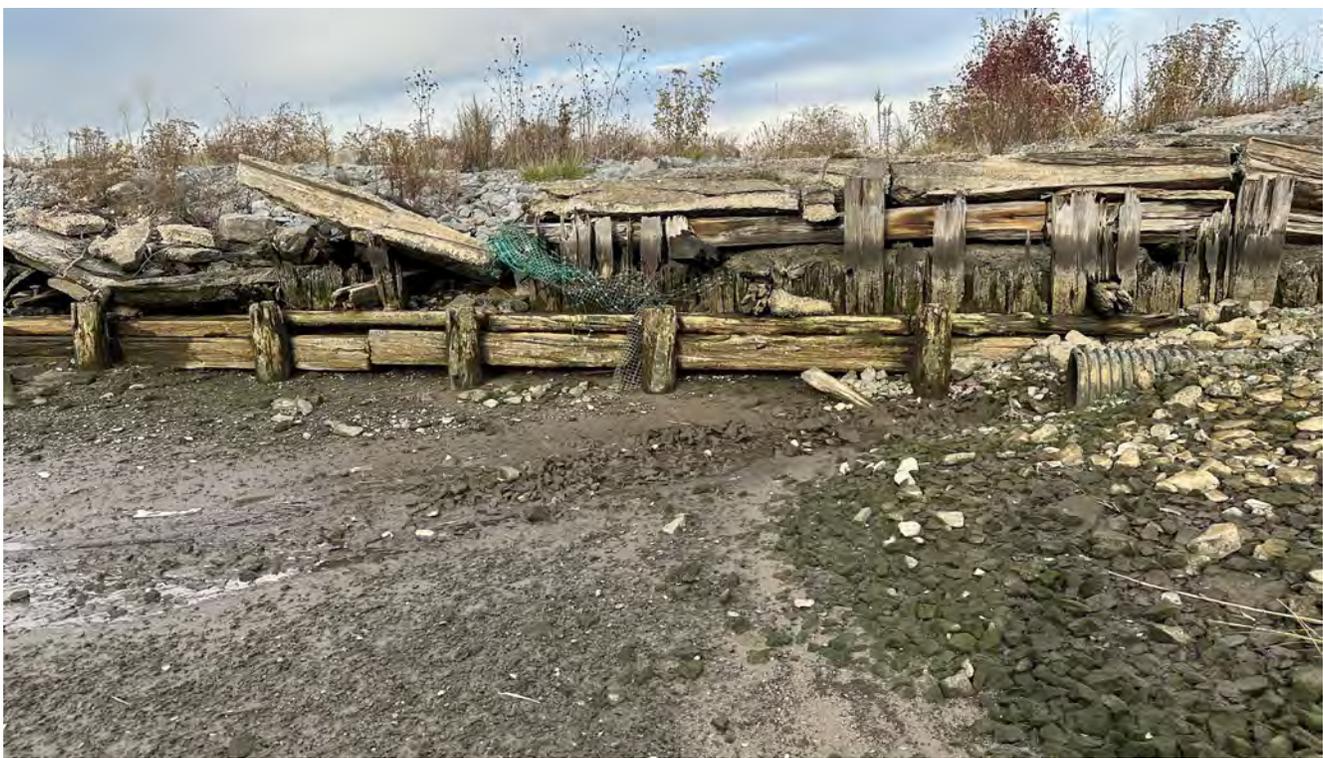
Photo 11: Outfall D discharge area where previously observed minor flow channel is overlain by displaced stone (facing east).

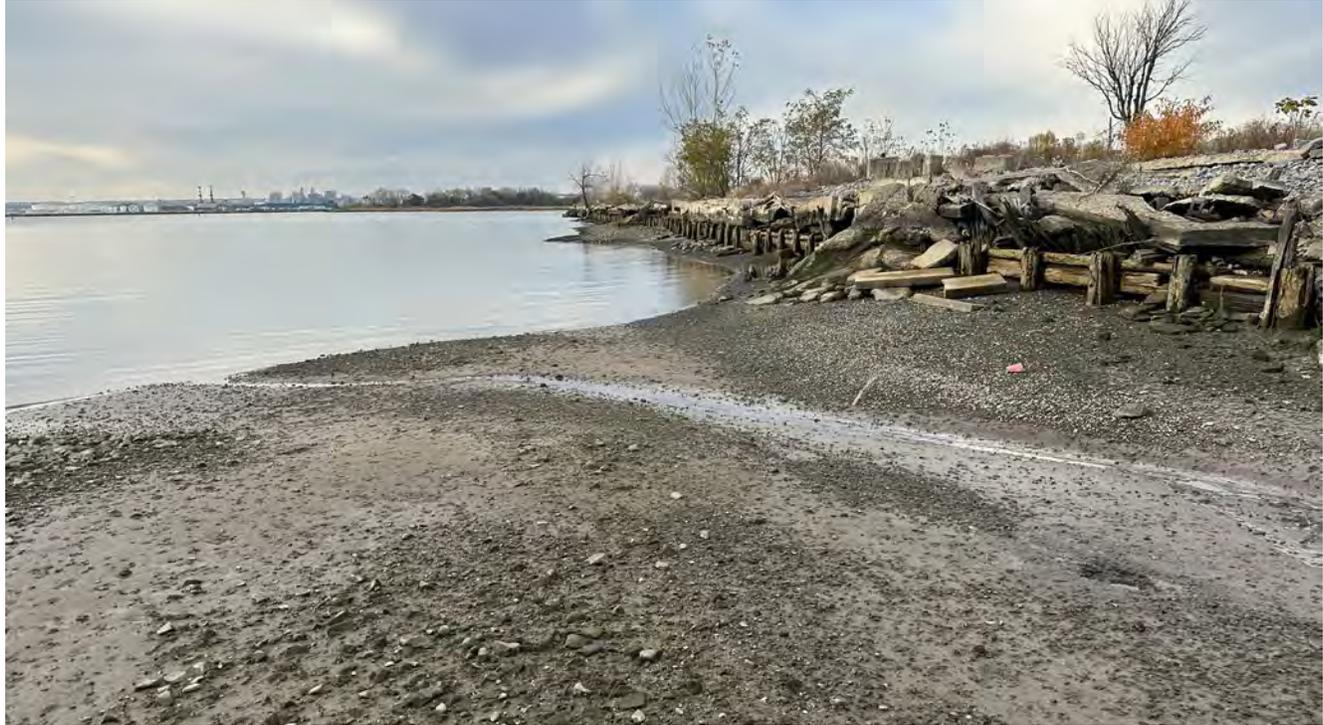
Photo 12: Area beyond the shoreline stabilization berm near Outfall D with Cap Area 22 partially exposed in the background (facing north).
