MEMORANDUM

Subject: **SA-7 Sediment Remedy Long-Term Monitoring**
Summary of Year 10 Monitoring & Proposed Year 11
Program

**ATTACHMENT A.2
AUGUST 30, 2023 INSPECTION LOG**

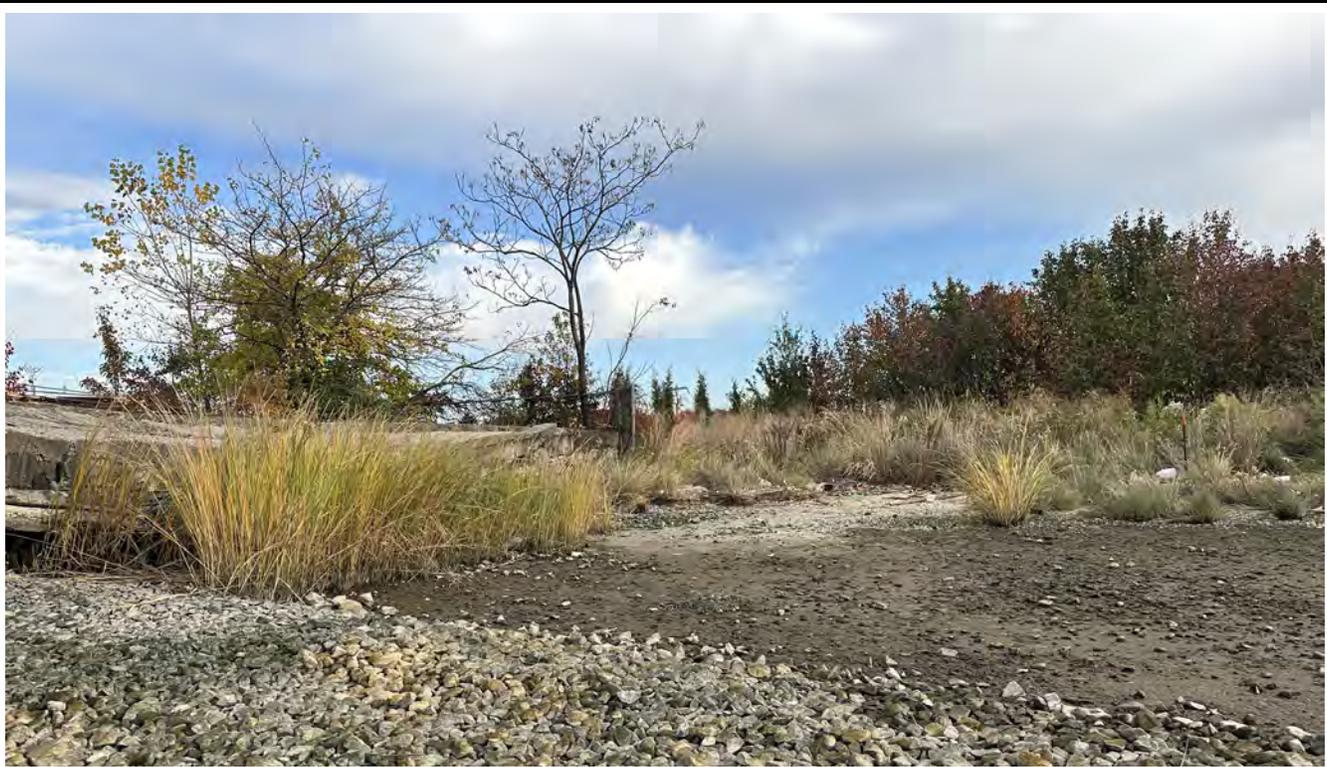
Photo 13: Low marsh zone in the eastern corner of the BEP near Outfall D (facing southeast). Note vibrant and healthy vegetation throughout the low marsh planting zone.

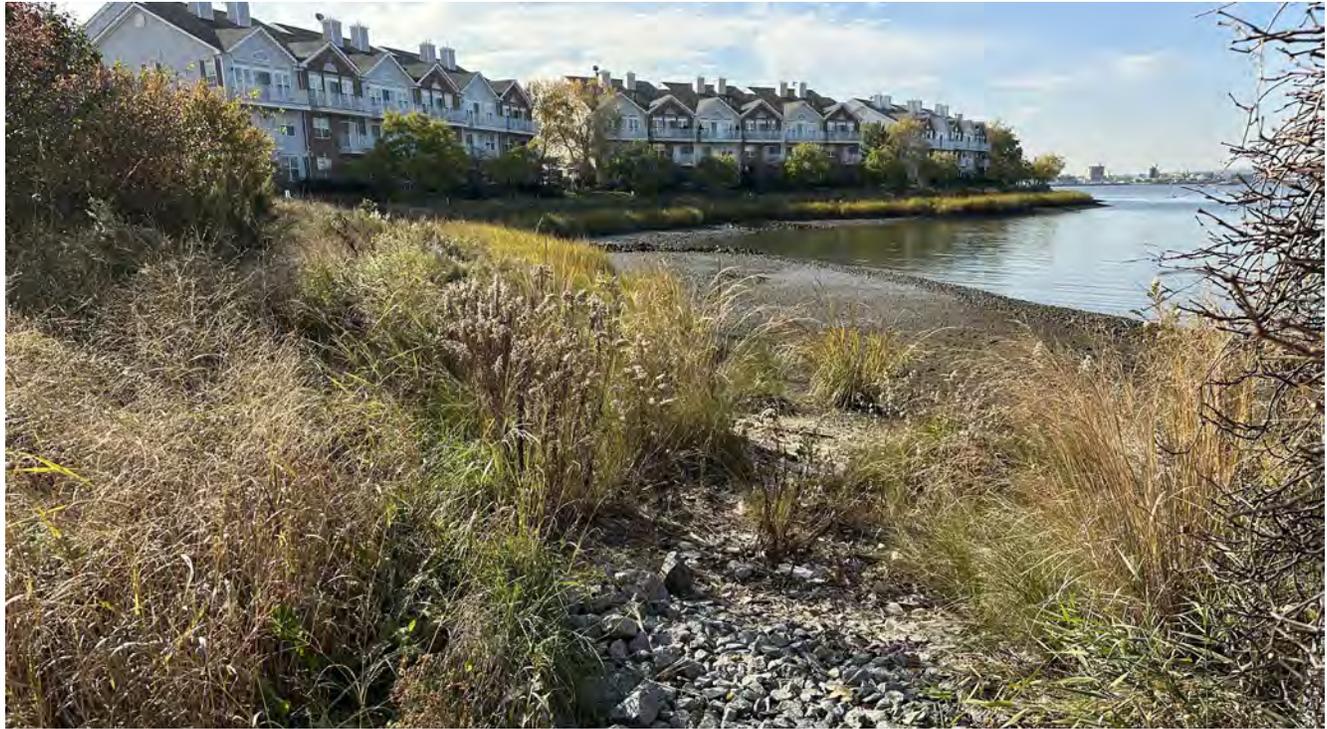
Photo 14: Transition from upland to low marsh zone in the easternmost corner of the BEP area (facing west).

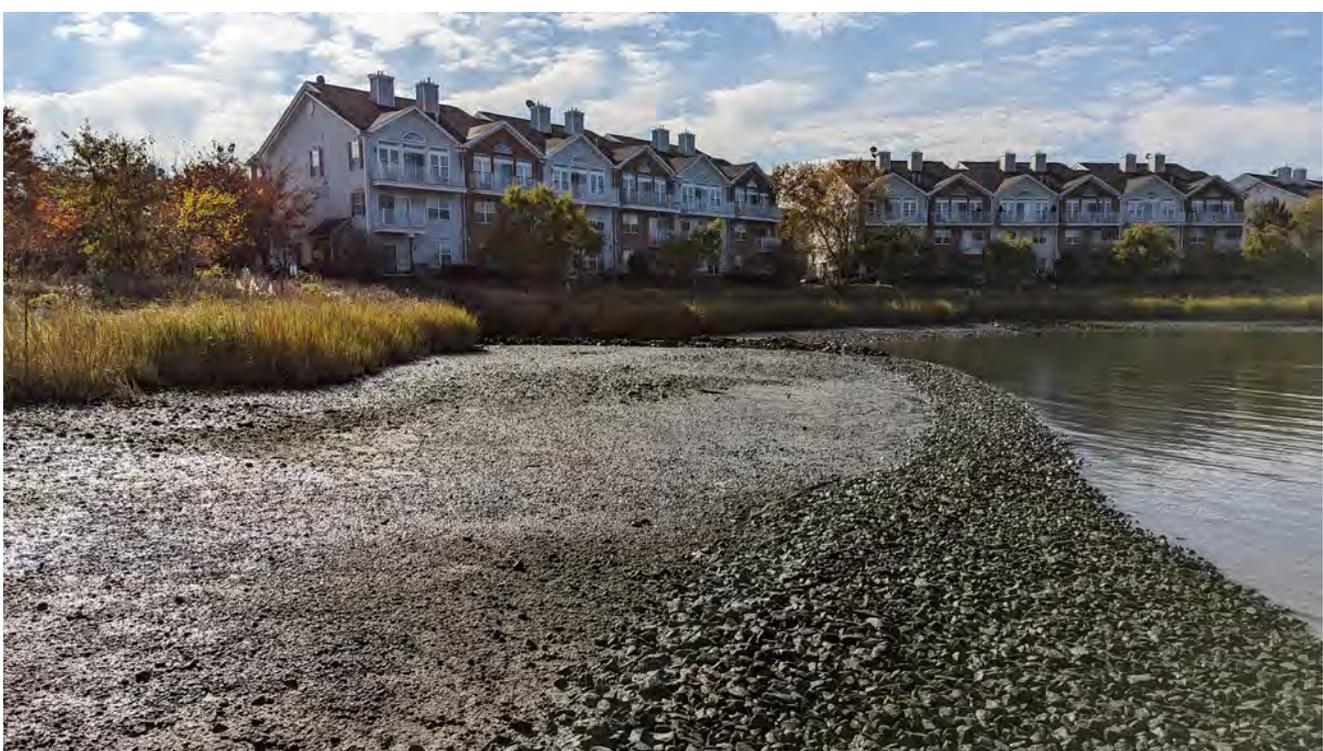
Photo 15: Low marsh planting zone on the eastern side of the BEP (facing west).

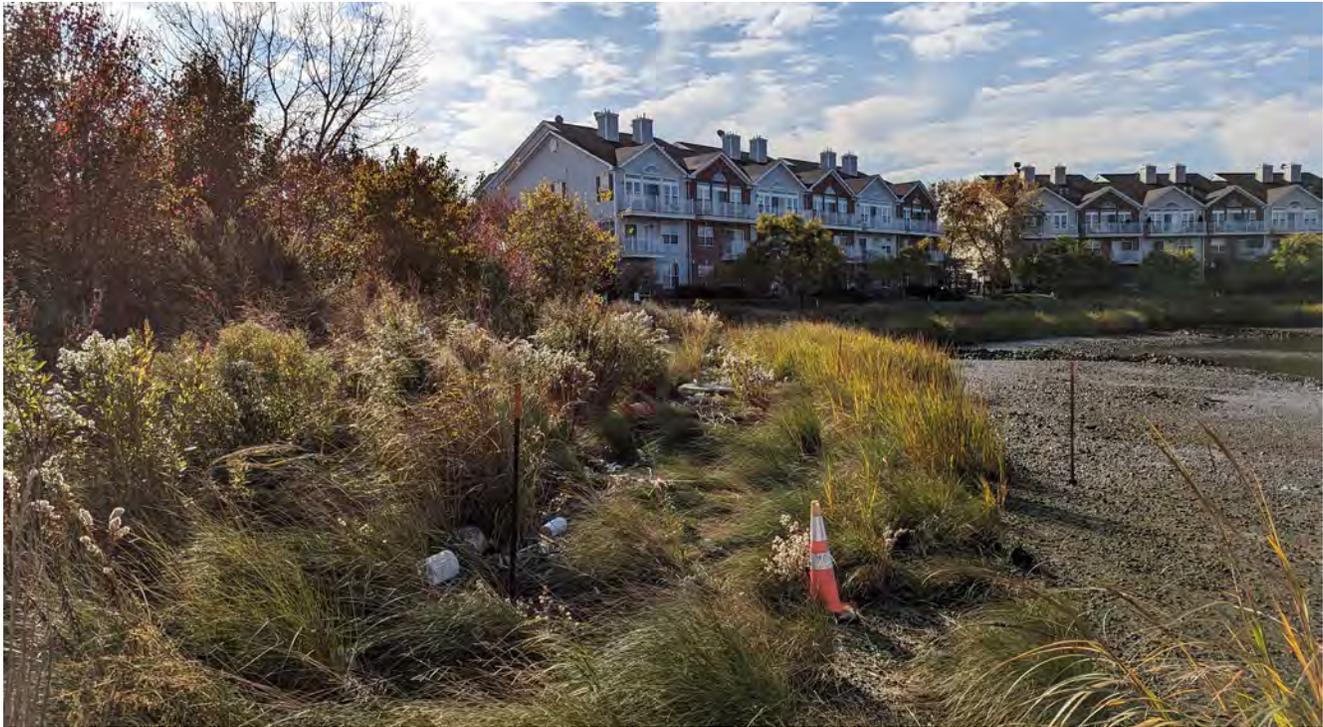
Photo 16: Transition area between low marsh planting zone and high marsh planting zone within the eastern side of the BEP (facing southeast). Note the vibrant and healthy low marsh and high marsh vegetation appears and tidal drift deposits and debris.

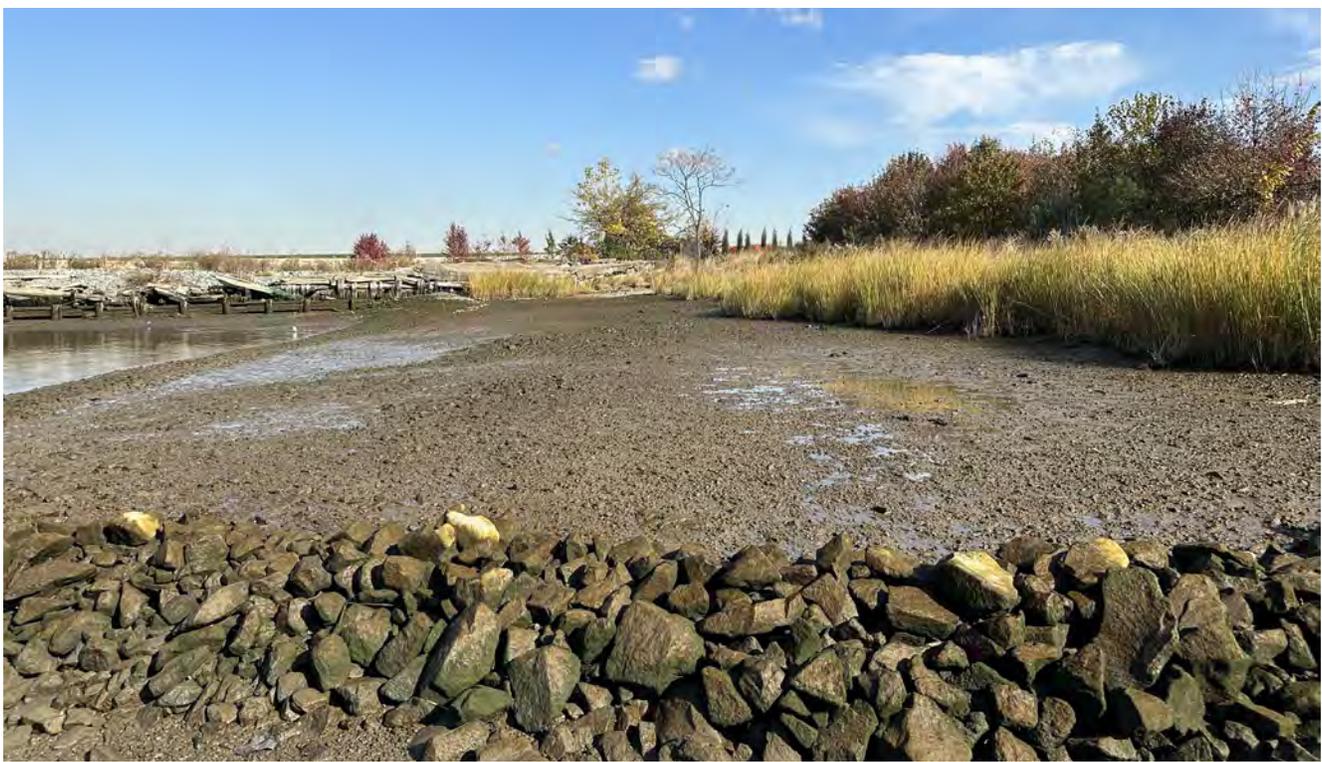
Photo 17: Low marsh planting zone within eastern portion of the BEP (facing northeast). Note the small amount of algae coating stabilization stone in the low marsh area.

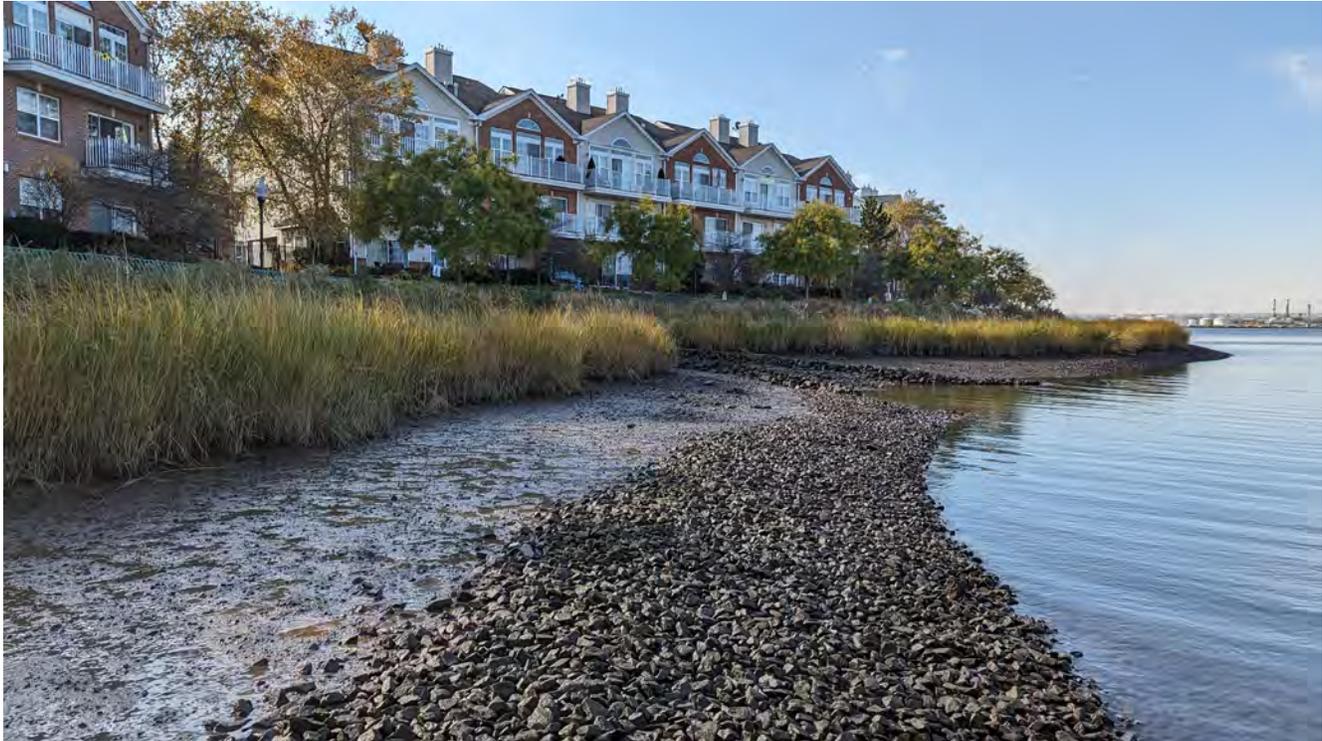
Photo 18: Low marsh planting zone between Outfalls A and B (facing west). Note the vibrant and healthy vegetation in the higher elevations of the low marsh area.

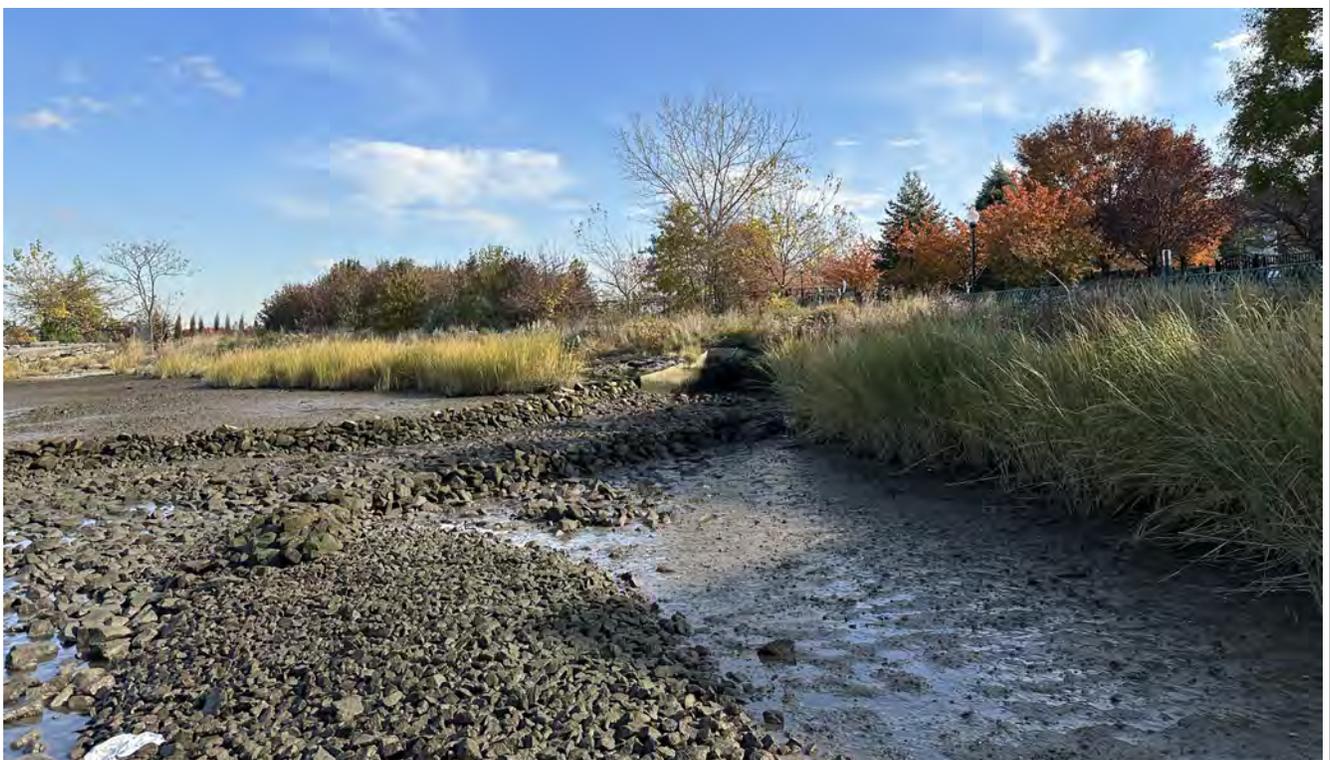
Photo 19: Vibrant and healthy vegetation in the higher elevations of the low marsh zone and high marsh zones in the eastern BEP area (facing southeast).

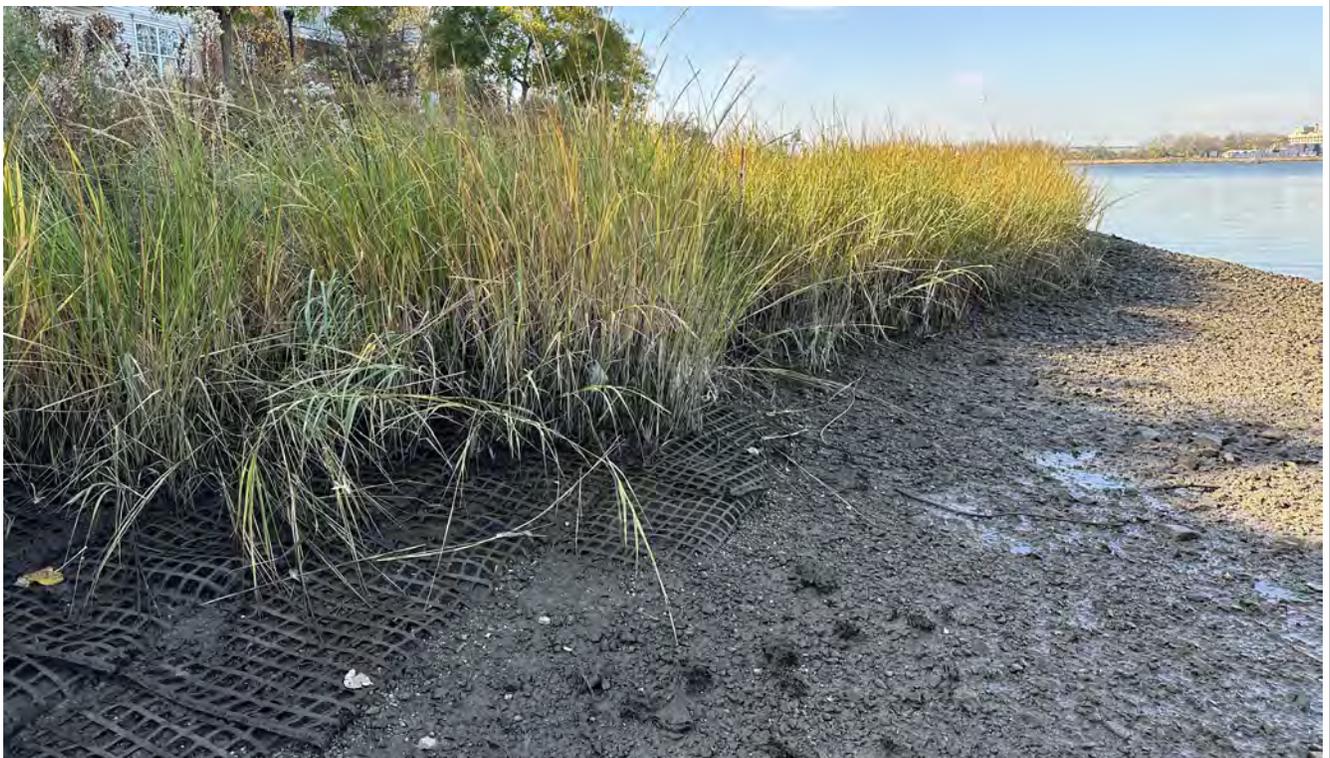
Photo 20: Vibrant and healthy low and high marsh zones west of Outfall A (facing southwest). Note the exposed geogrid and absence of GroSoxx at the bottom of the low marsh zone.

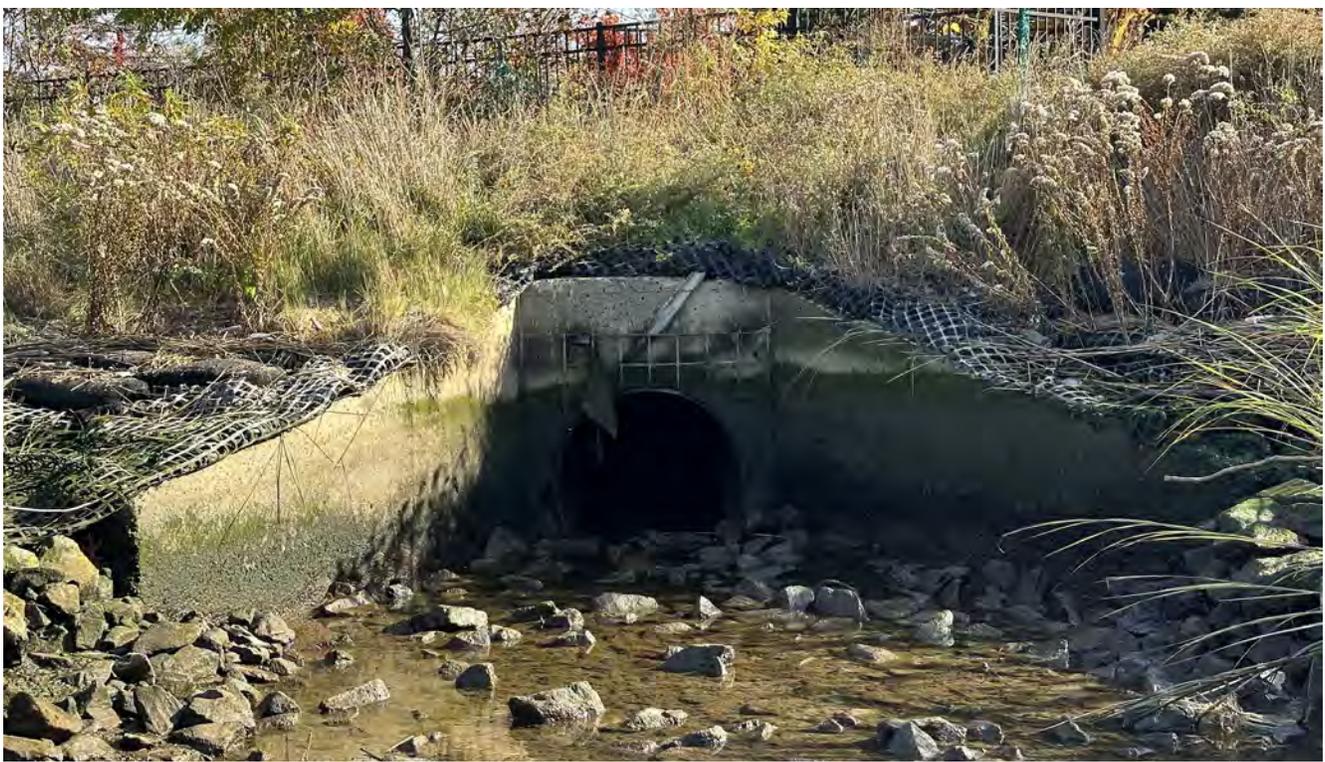
Photo 21: Exposed geogrid over and around the Outfall C structure and within the high marsh planting zone (facing south).

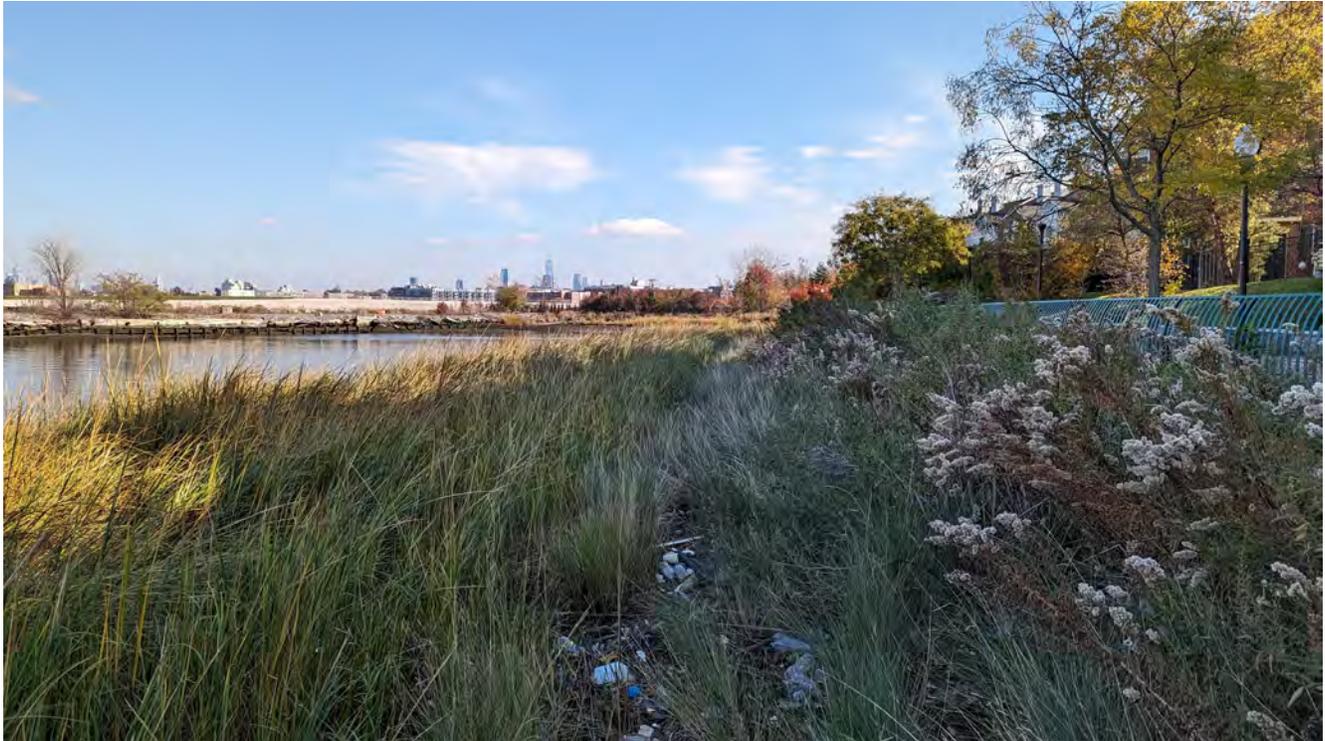
Photo 22: Healthy low and high marsh vegetation west of Outfall A (facing east). Note the presence of tidal drift deposits and debris, and invasive species Canada goldenrod within the upland transition zone.

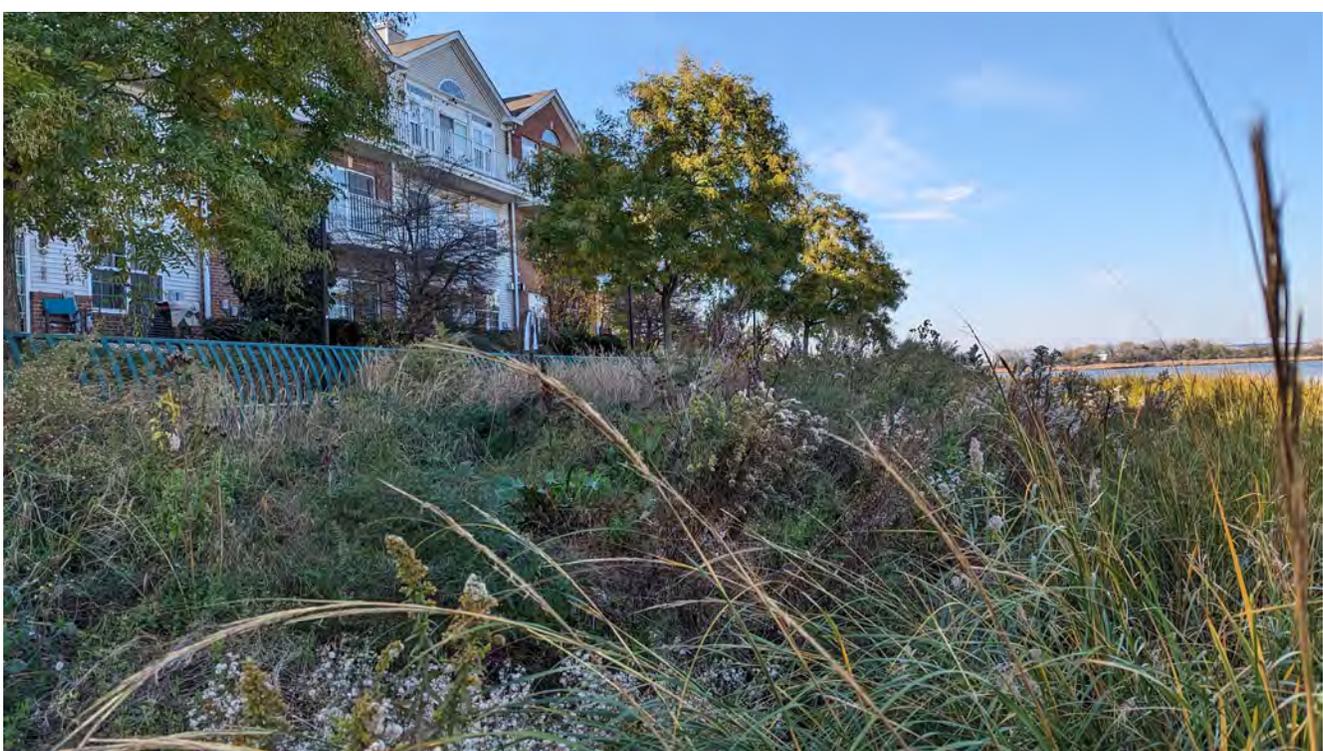
Photo 23: Healthy vegetation in the upland transition area and interface between the low and high marsh between Outfalls A and B (facing southeast). Note presence of invasive Canada goldenrod in upland transition zone.

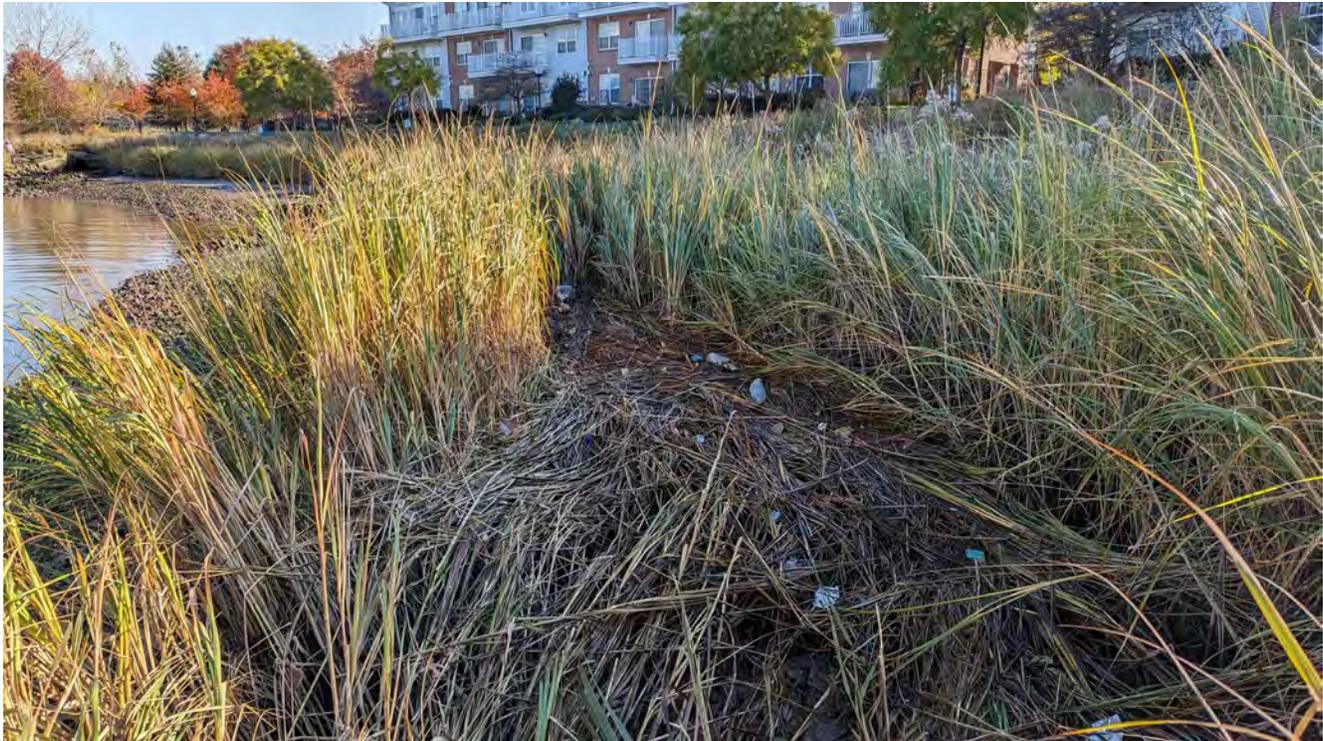
Photo 24: Healthy vegetation in the upland transitional area and interface between the low and high marsh west of Outfall A (facing southeast). Note the presence of tidal drift deposits and debris within the high marsh areas.

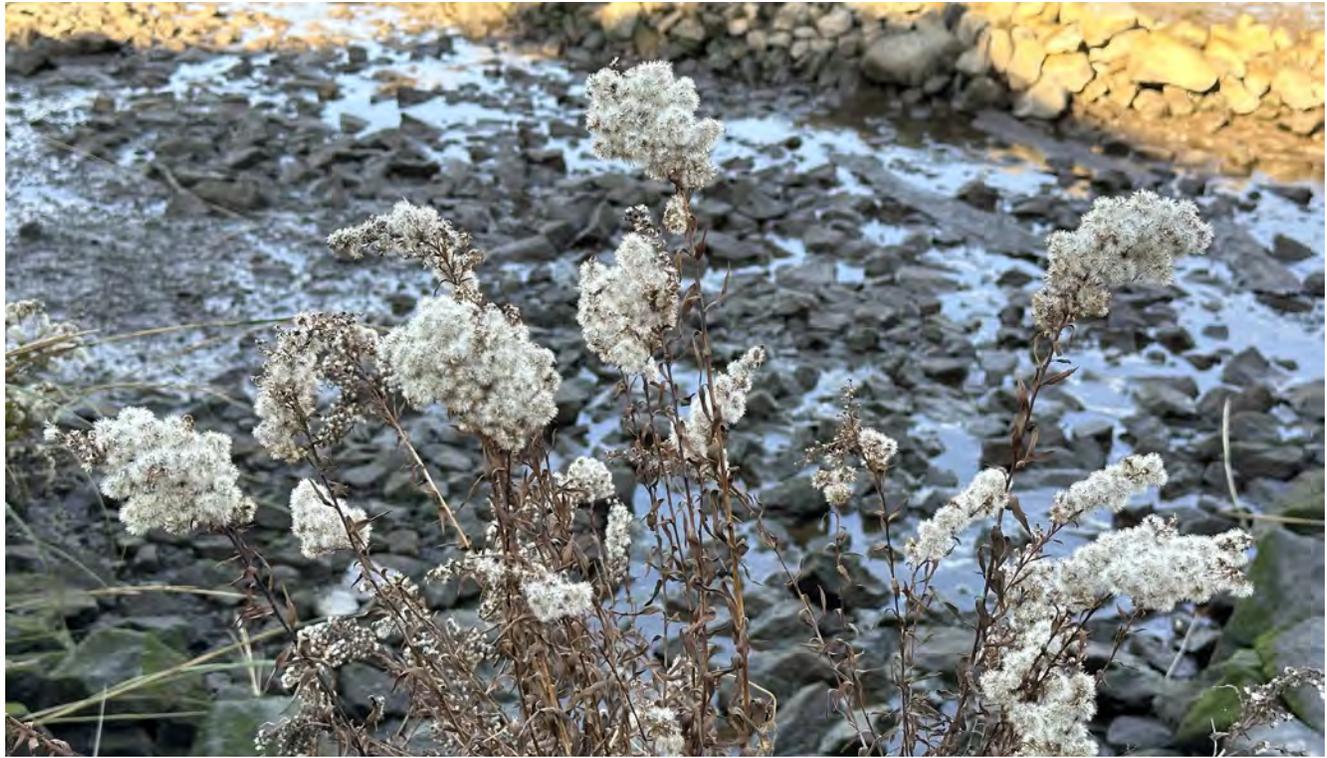
Photo 26: Invasive species Canada goldenrod located within the upland transitional planting zone of the BEP.

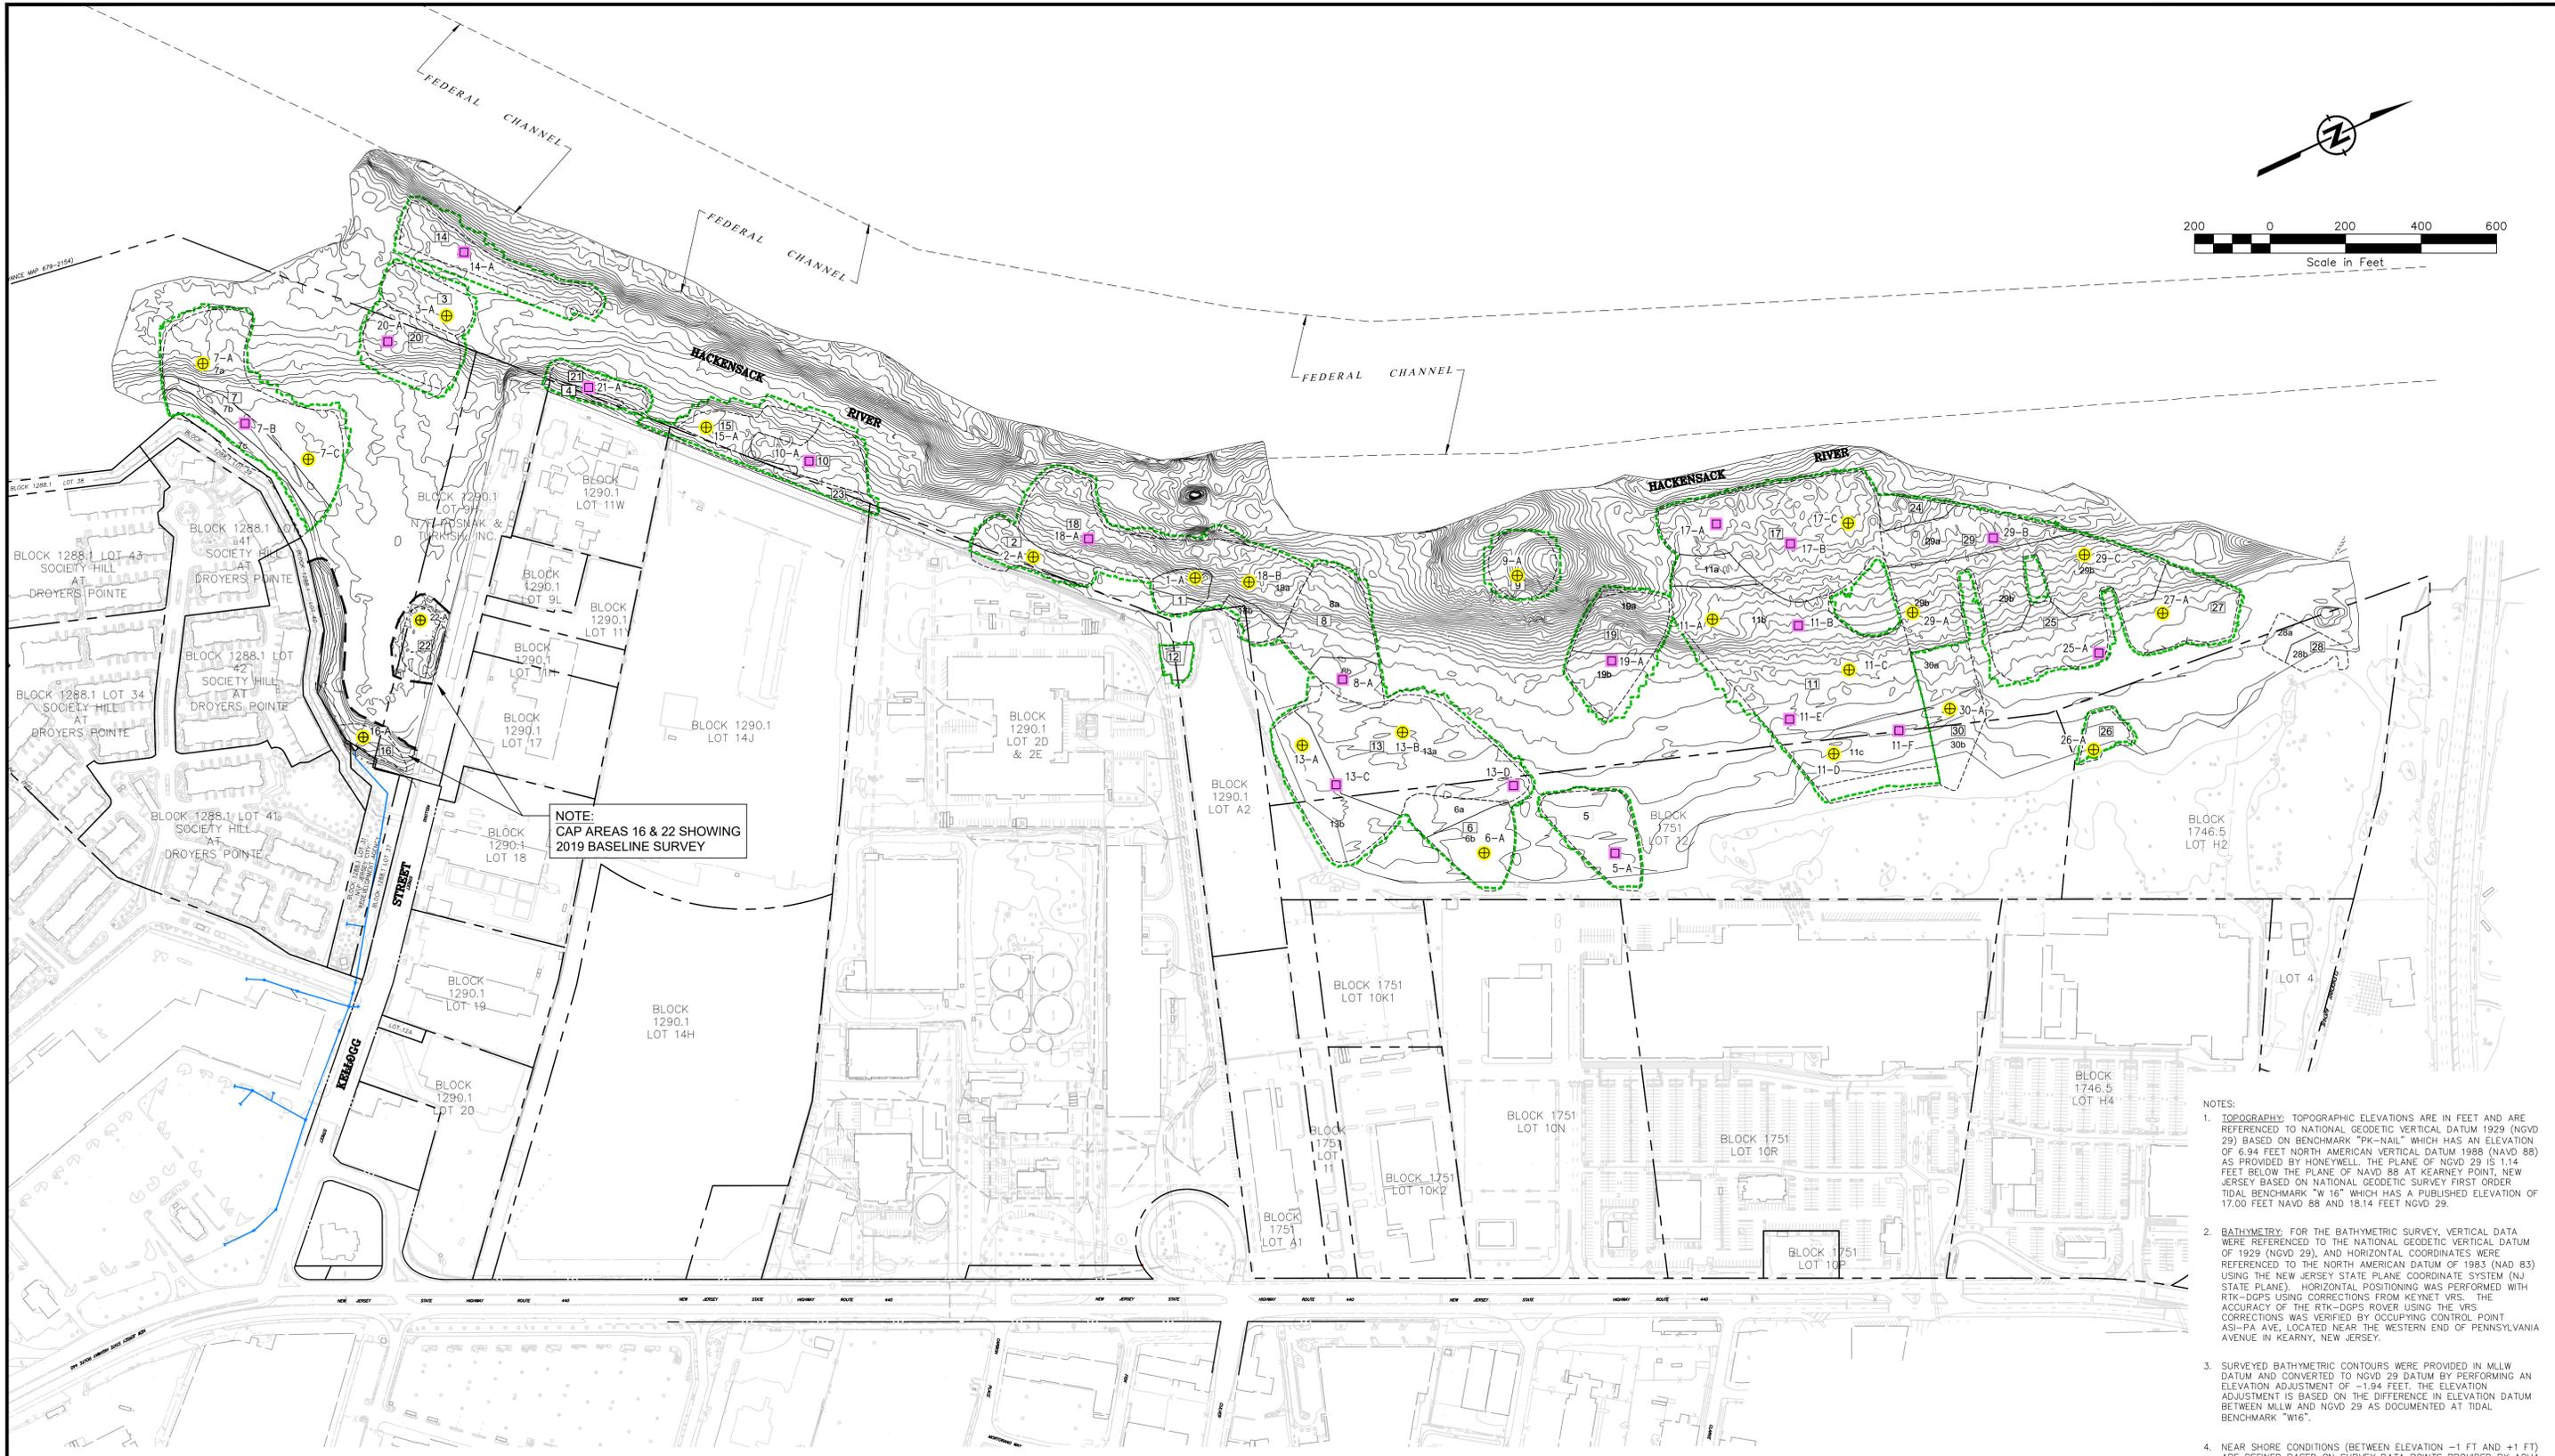
DATE: 4/4/24
DRAWING: 001

NOTE:
CAP AREAS 16 & 22 SHOWING
2019 BASELINE SURVEY

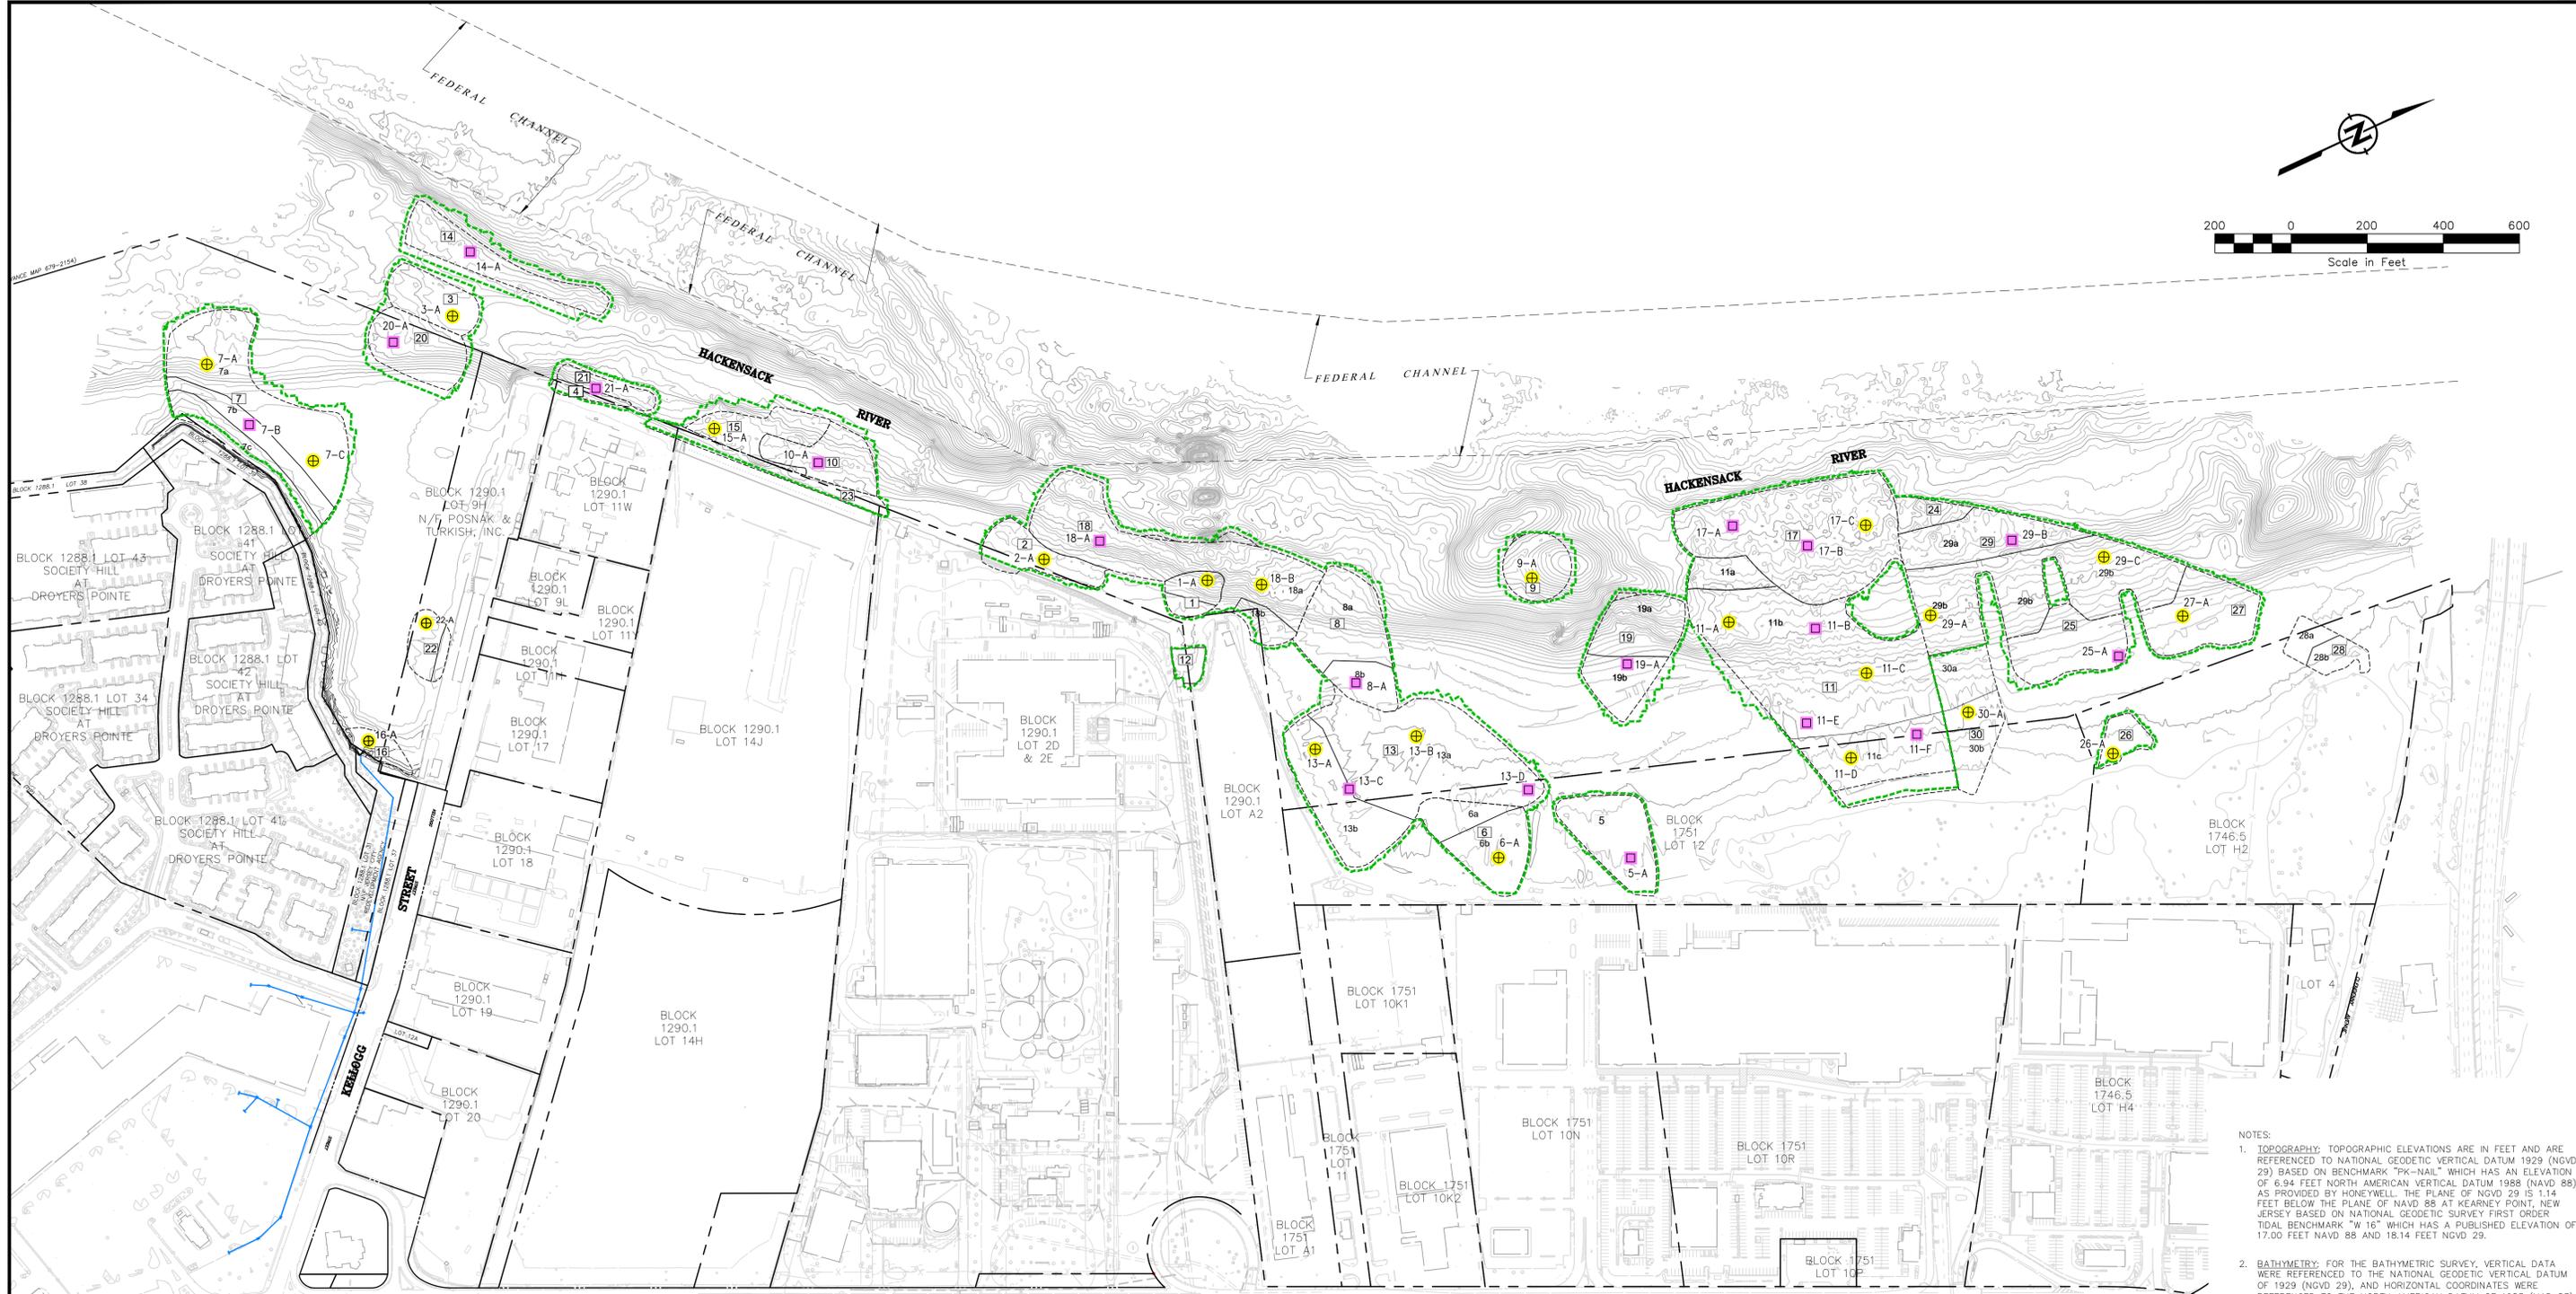
2014 BATHYMETRIC BASE MAP			
HONEYWELL INTERNATIONAL, INC. SA7 SEDIMENT REMEDIATION PROJECT JERSEY CITY, HUDSON COUNTY, NJ		PREPARED BY: ECP/PRM DATE: 4/4/2024	DRAWING 1
		DRAFTED BY: PRM APPROVED BY: JSJ/MN	SCALE: AS SHOWN PROJECT: 169000484
