# MEMORANDUM

Subject: **SA-7 Sediment Remedy Long-Term Monitoring**  
**Summary of Year 11 Monitoring & Proposed Year 12**  
**Program**

**ATTACHMENT A  
YEAR 11 INSPECTION LOGS**

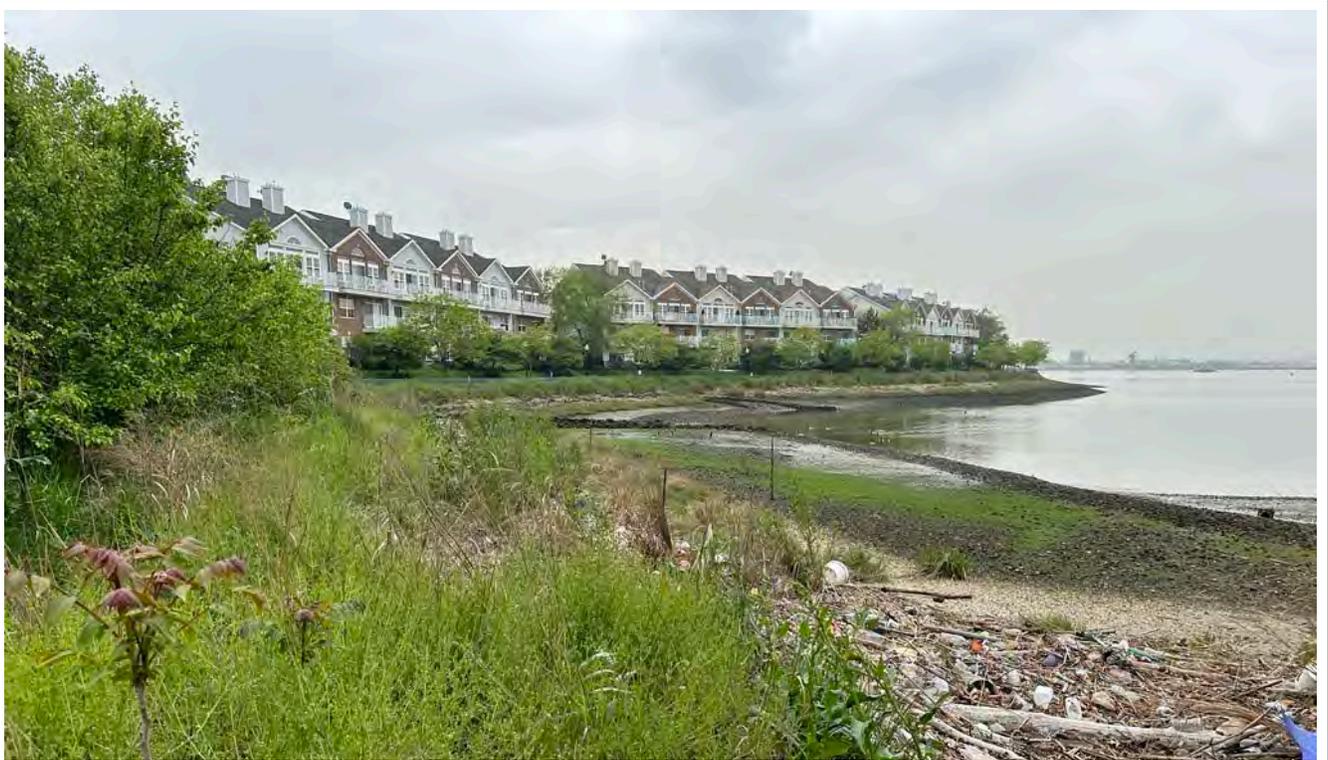
**Photo 1:** Northern end of Cap Area 16 (facing west). Note vibrant and healthy vegetation present in high marsh planting and upland zones.

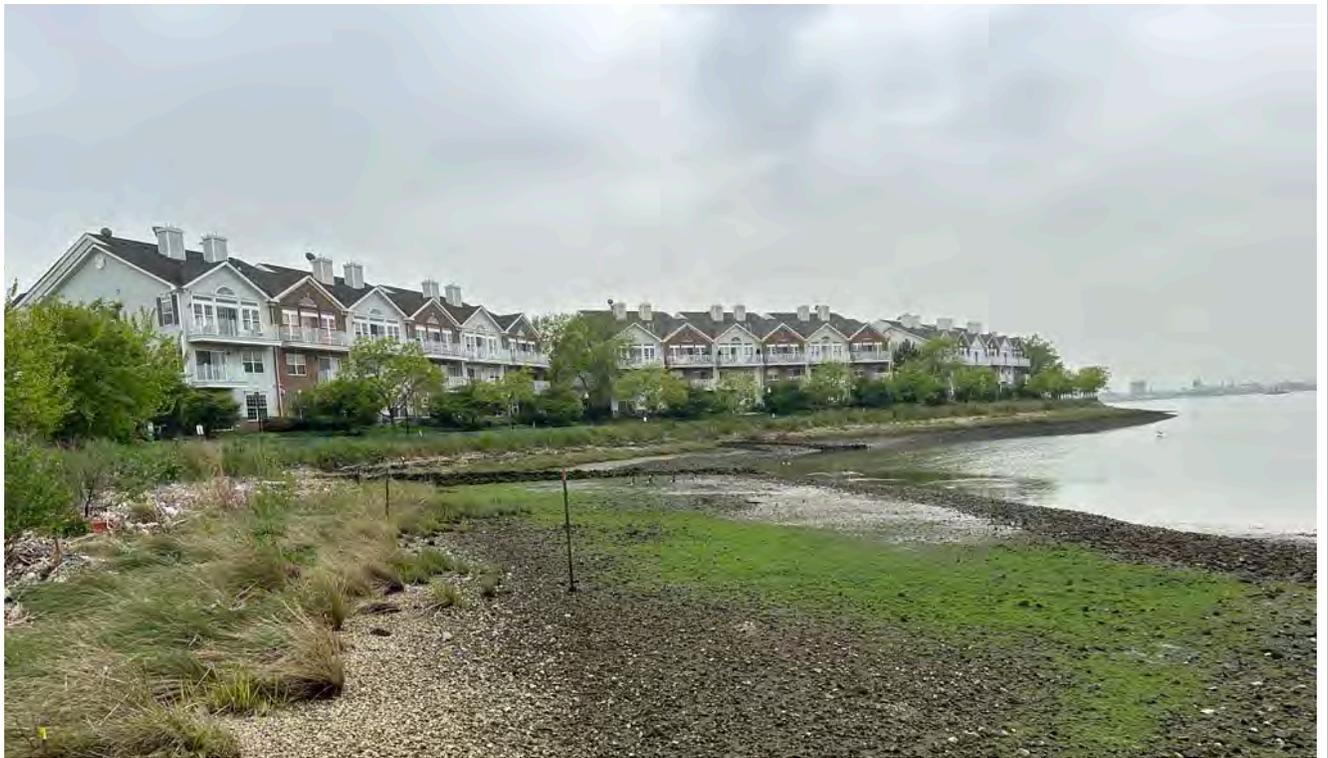
**Photo 2:** Central portion of Cap Area 16 (facing west). Note reference posts used to assess sediment surface changes.

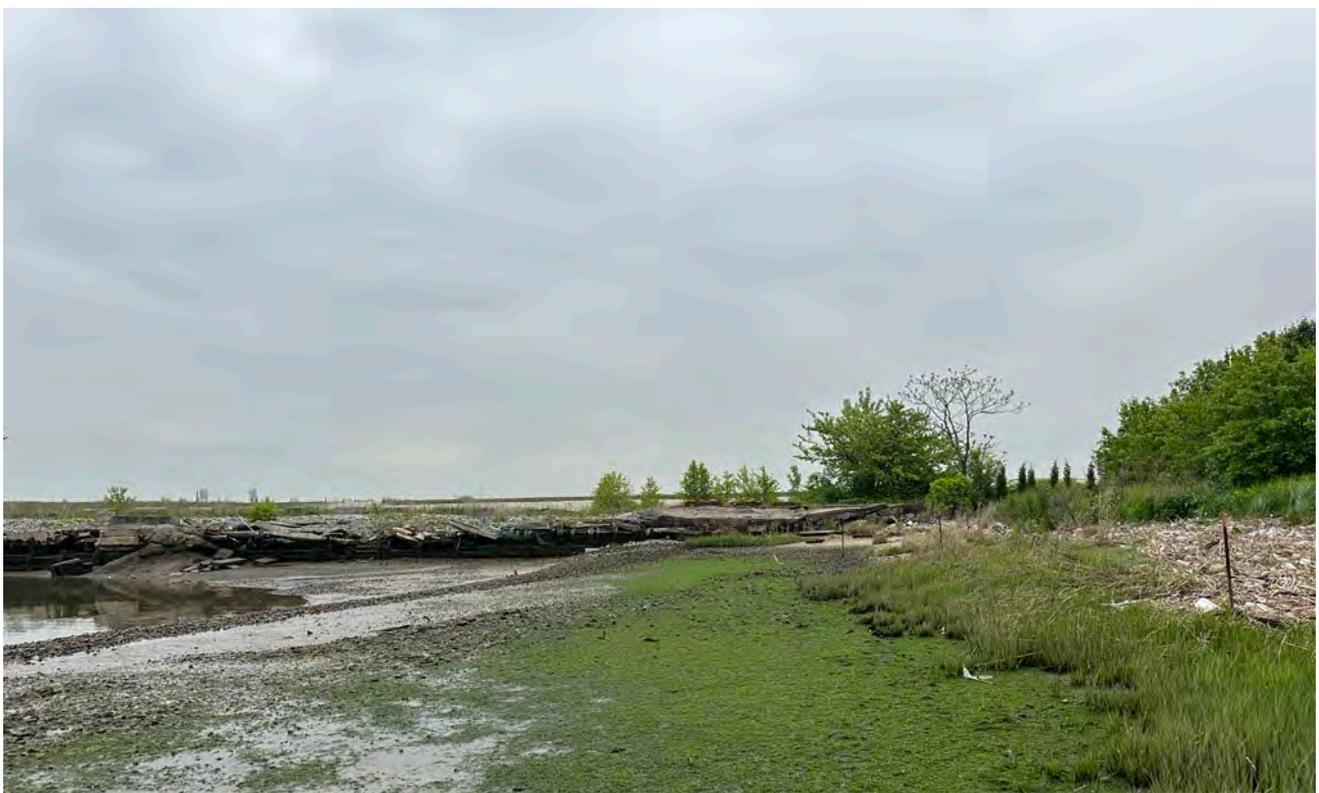
**Photo 3:** Western end of Cap Area 16 (facing east). Note the vibrant and healthy vegetation in the low marsh planting zone and presence of algae in the mudflat area.

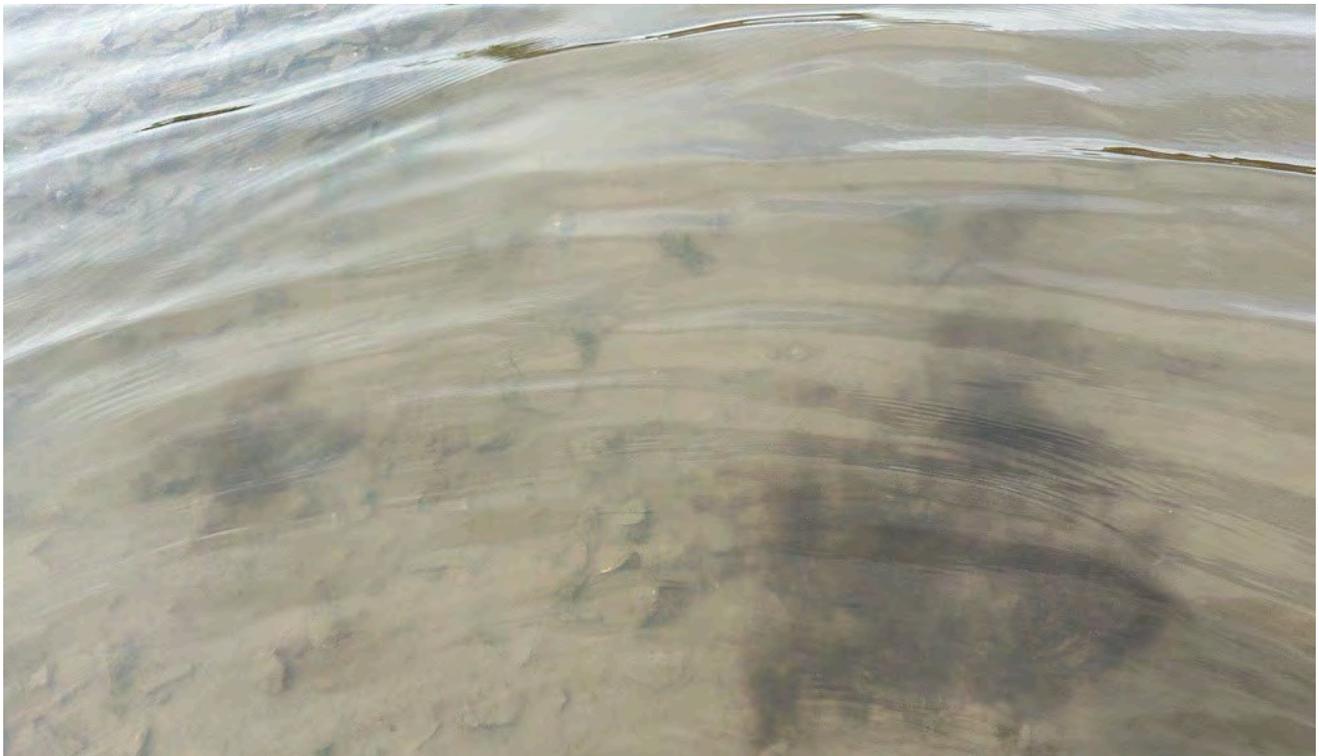
**Photo 4:** Subaquatic vegetation observed within Cap Area 22 (facing west).

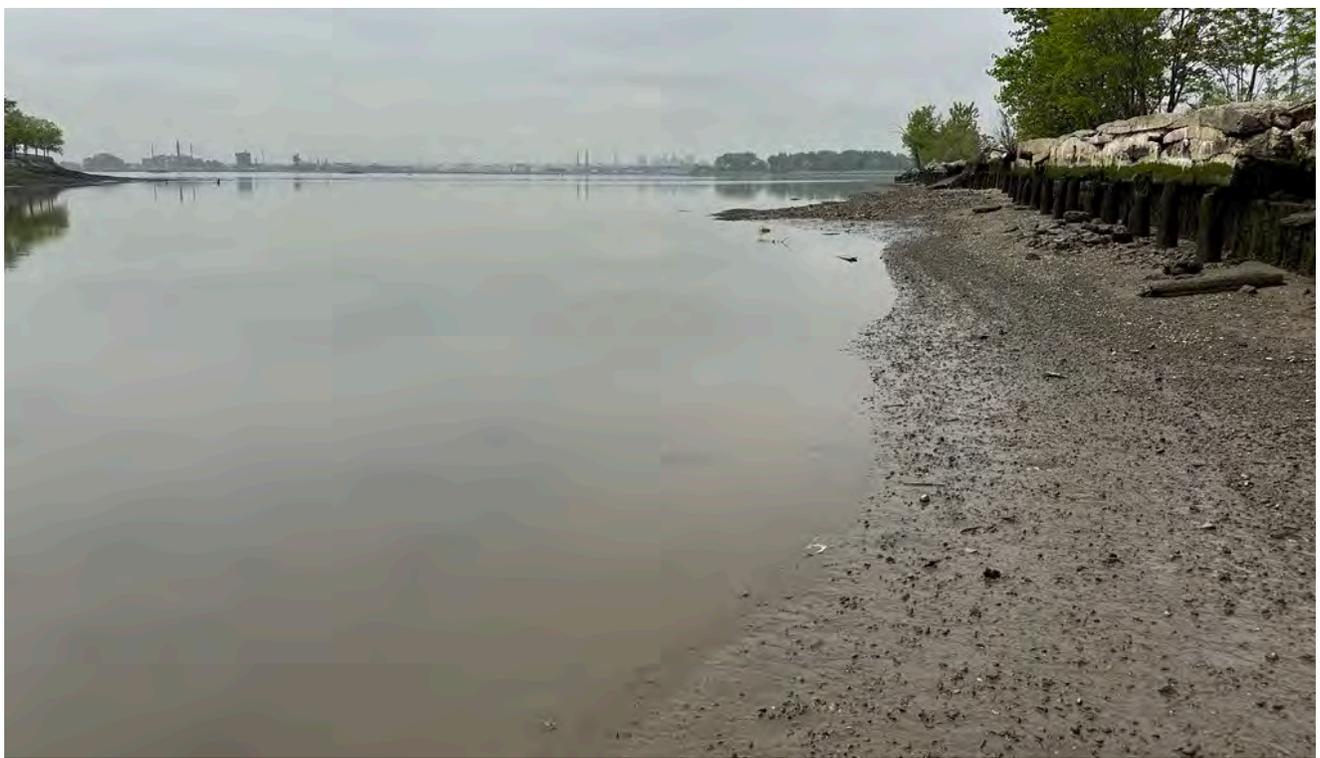
**Photo 5:** Partially exposed Cap Area 22 during low tide (facing west).

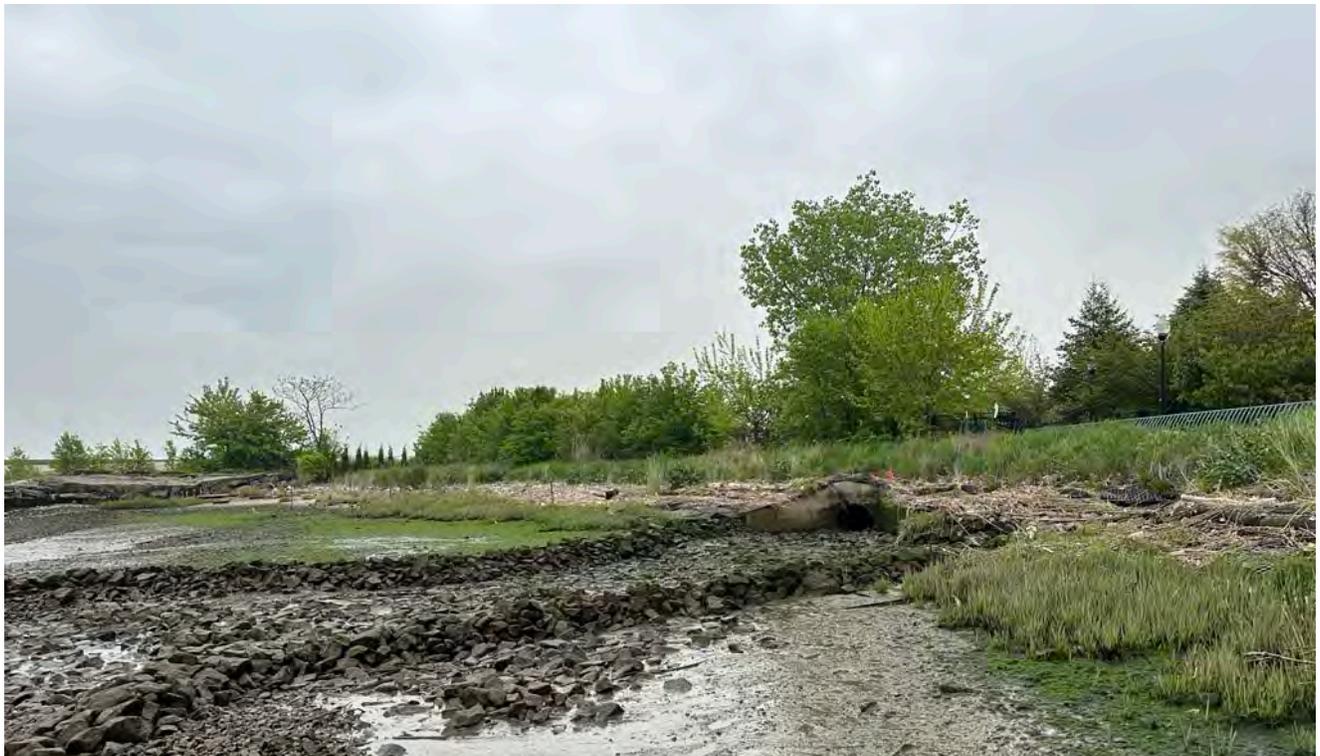
**Photo 6:** Central portion of the BEP, between Outfalls A and B (facing southeast). Note presence of algae and early stages of growing season in the low marsh planting zone.

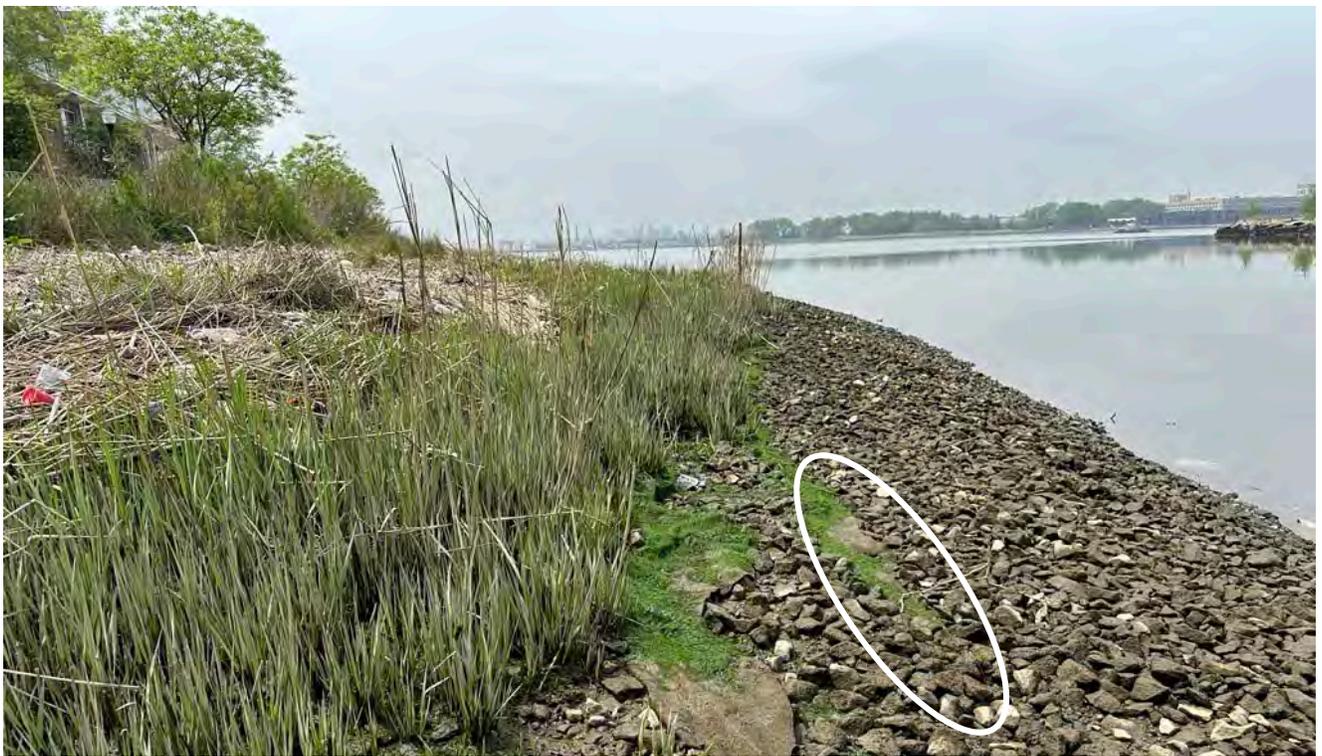
**Photo 7:** Exposed geotextile fabric between the shoreline stabilization berm and the BEP fill material west of Outfall A (facing west).

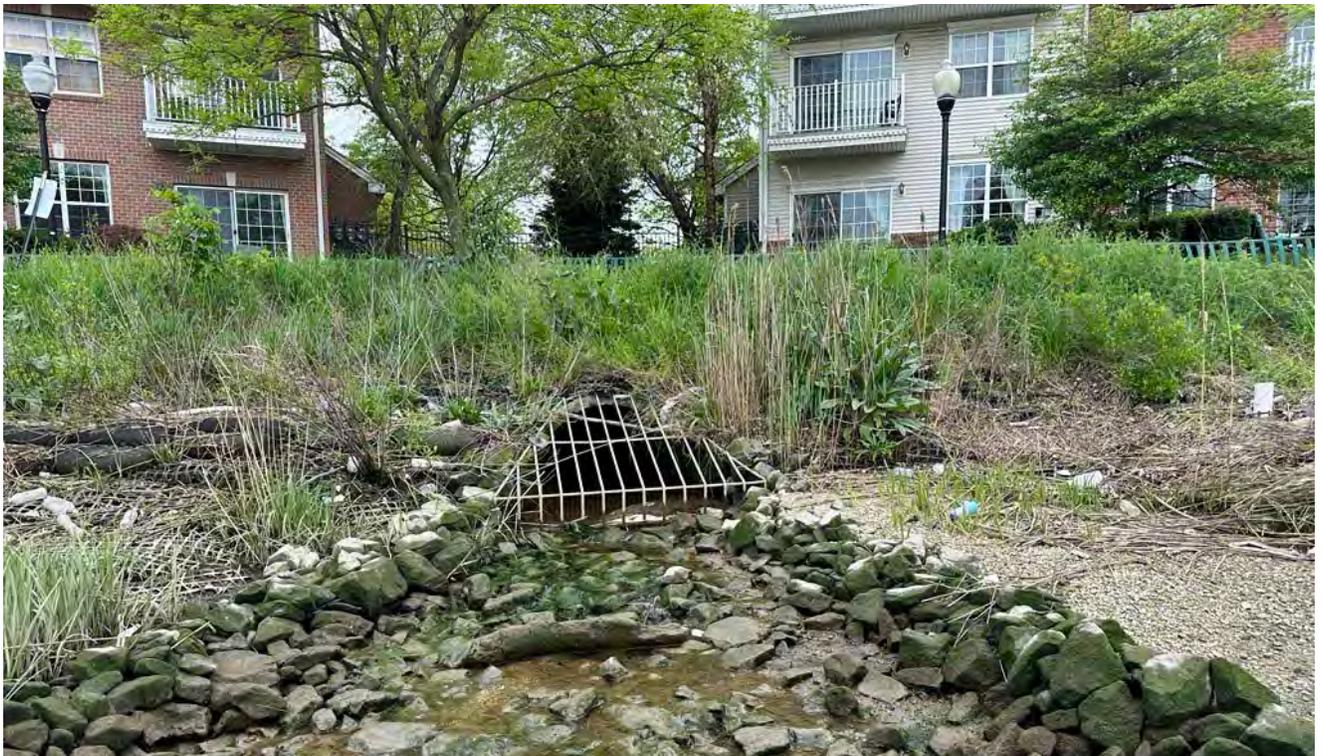
**Photo 8:** Outfall A and surrounding armor stone (facing southwest). Note areas of exposed geogrid and GroSoxx in the high marsh planting zone.

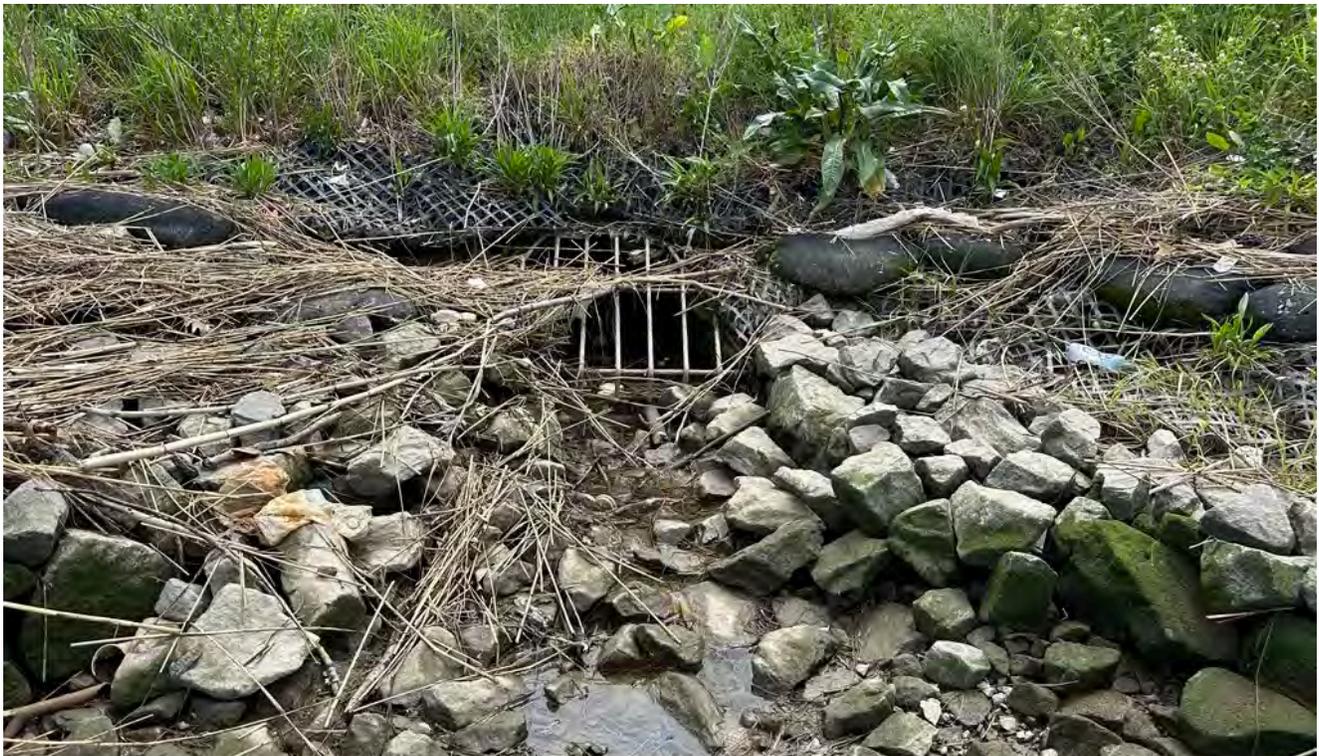
**Photo 9:** Outfall B and surrounding armor stone (facing southwest). Note the tidal drift deposits and debris in front of the outlet.

TABLE 2. BENEFICIAL ENVIRONMENTAL PROJECT AREA INSPECTION LOG			
BEP AREA ELEMENT	OBSERVATIONS	PHOTO(S) TAKEN	CORRECTIVE ACTION(S) REQUIRED
<b>SHORELINE STABILIZATION</b>	<ul style="list-style-type: none"> <li>Shoreline stabilization appeared to be in good condition.</li> <li>Several areas of exposed geofabric were observed between the BEP fill material and the shoreline stabilization berm west of Outfall A.</li> </ul>	6 to 7	<ul style="list-style-type: none"> <li>Cut exposed geofabric or cover it with stone.</li> </ul>
<b>OUTFALL RIPRAP APRONS</b>	<ul style="list-style-type: none"> <li>Outfall A: Appeared in good condition. Siltation within the rip rap apron ranged from approximately 1 to 3 inches.</li> <li>Outfalls B and C: Appeared in good condition. Consistent with prior observations, approximately 1 to 3 inches of siltation was observed throughout the rip rap apron.</li> <li>Outfall D: Appeared in good condition. The previously observed minor flow channel at the discharge of Outfall D continues to be partially filled with displaced stone.</li> </ul>	8 to 12	<ul style="list-style-type: none"> <li>Monitor drift deposits and debris at the Outfalls; if persistent, arrange for removal.</li> </ul>

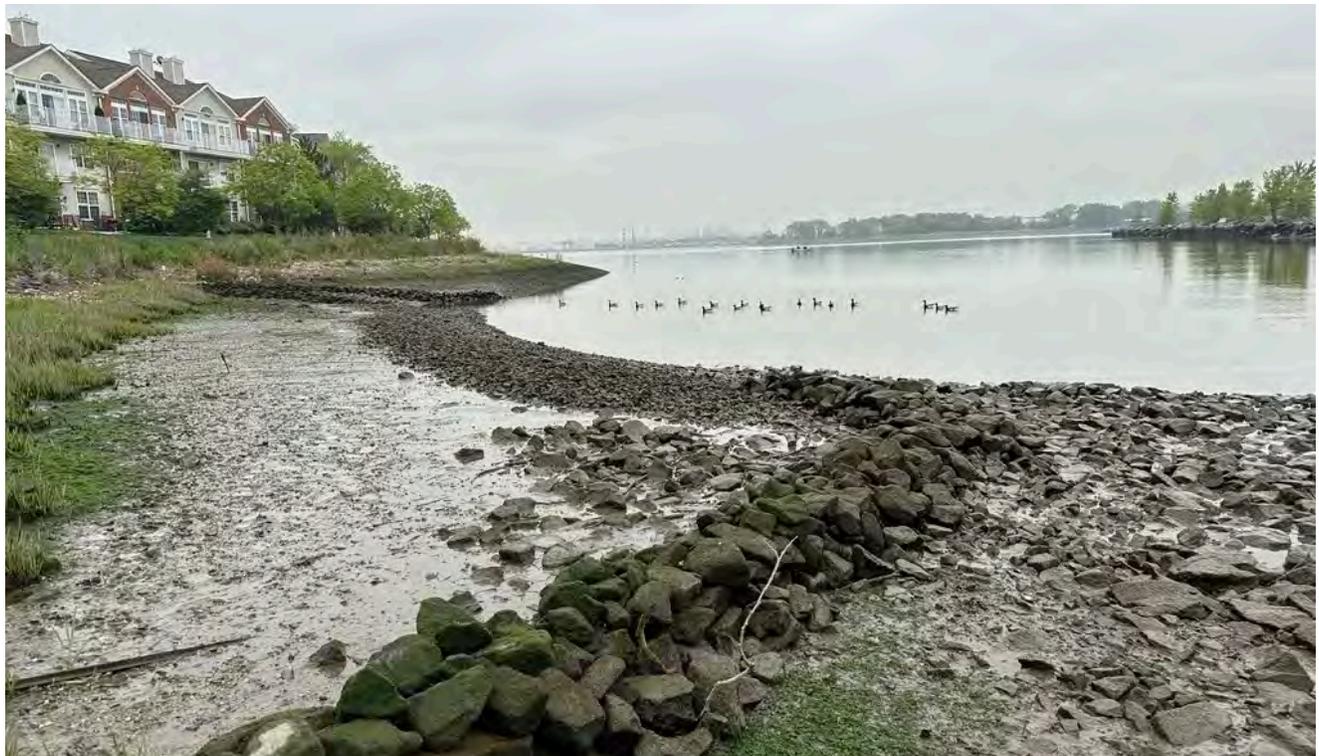
**Photo 10:** Armor stone along the western edge of the apron for Outfalls B and C (facing west). Note the algae present on and behind the apron stone.

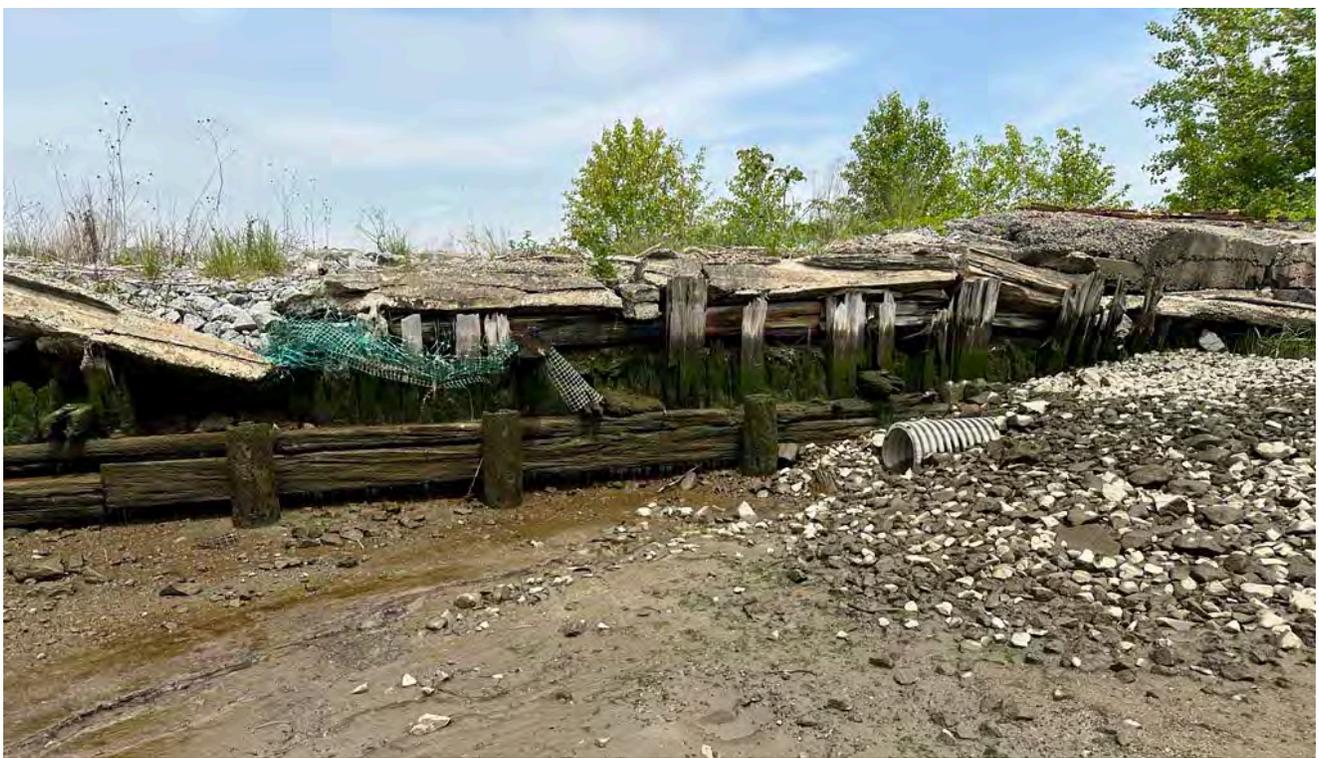
**Photo 11:** Outfall D discharge area where previously observed minor flow channel is overlain by displaced stone (facing east).

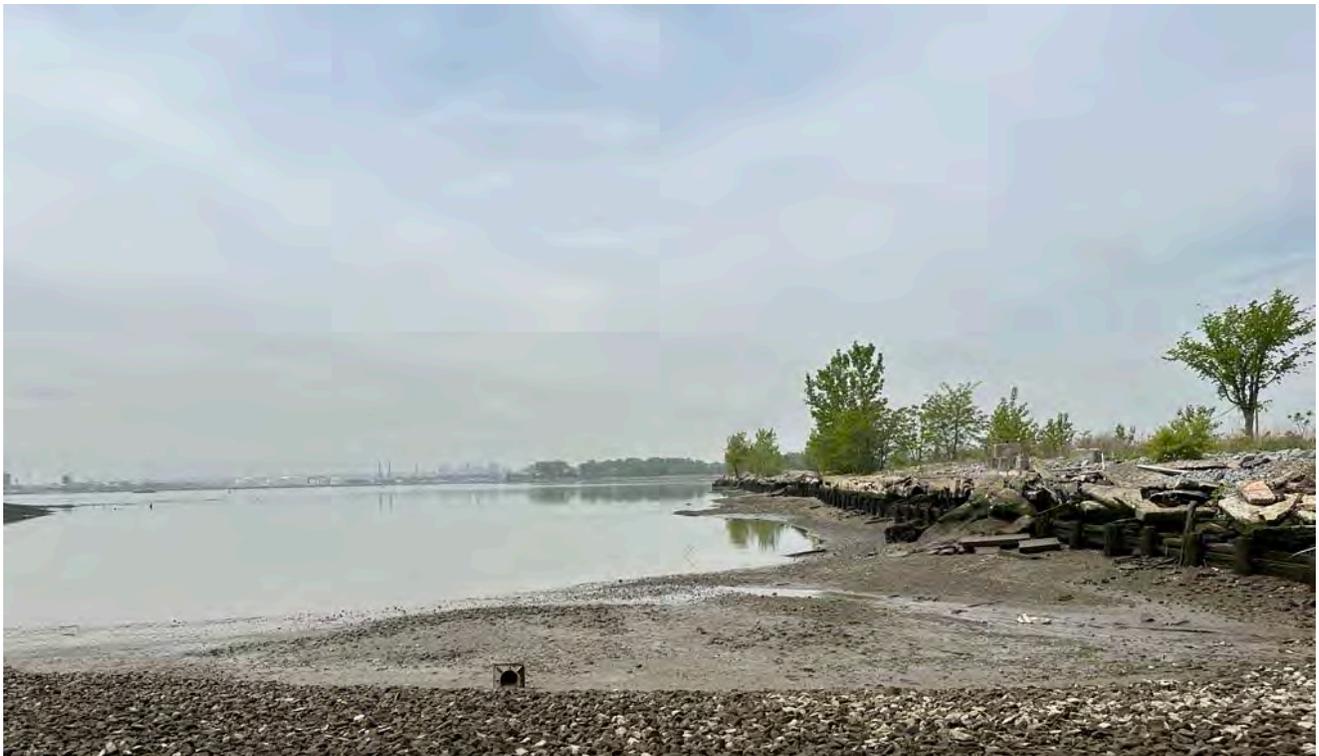
**Photo 12:** Area beyond the shoreline stabilization berm near Outfall D with Cap Area 22 partially exposed in the background (facing north).

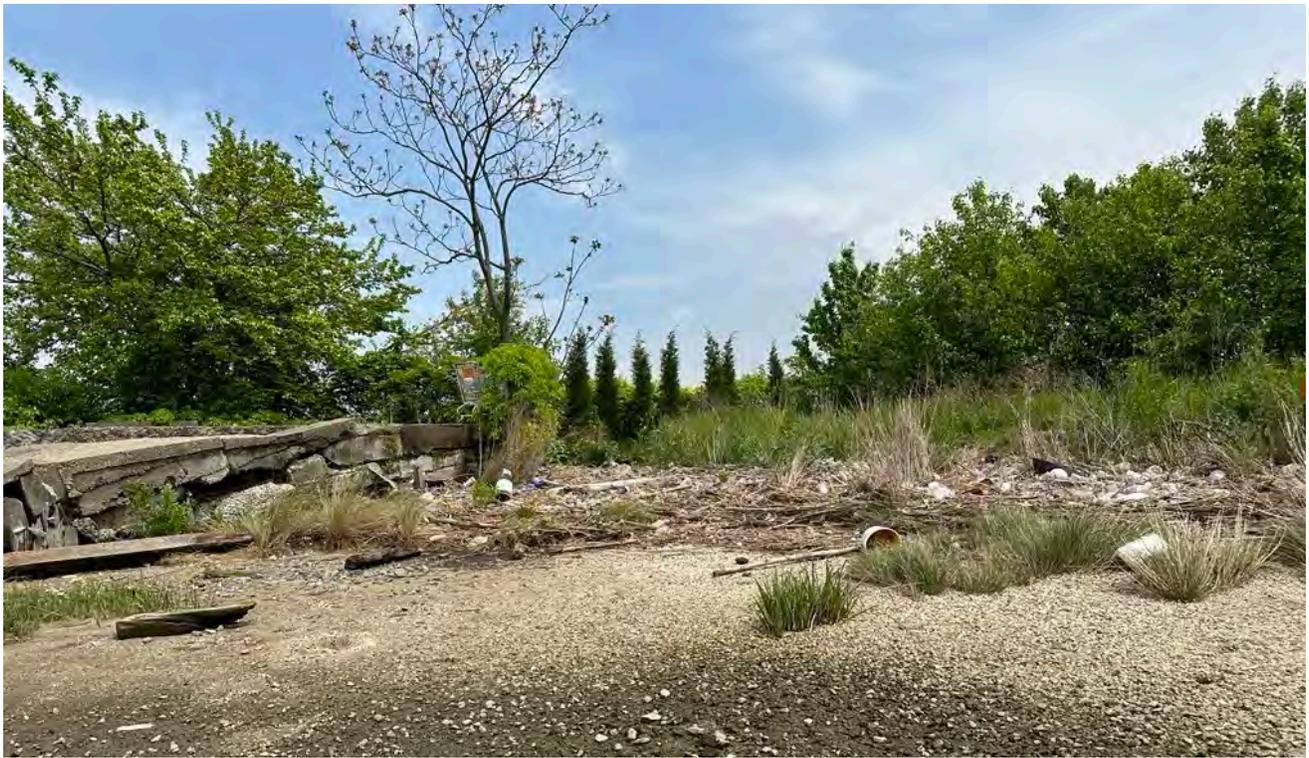
**Photo 13:** Low marsh zone in the eastern corner of the BEP near Outfall D (facing southeast). Note increased presence of tidal drift deposits and debris.

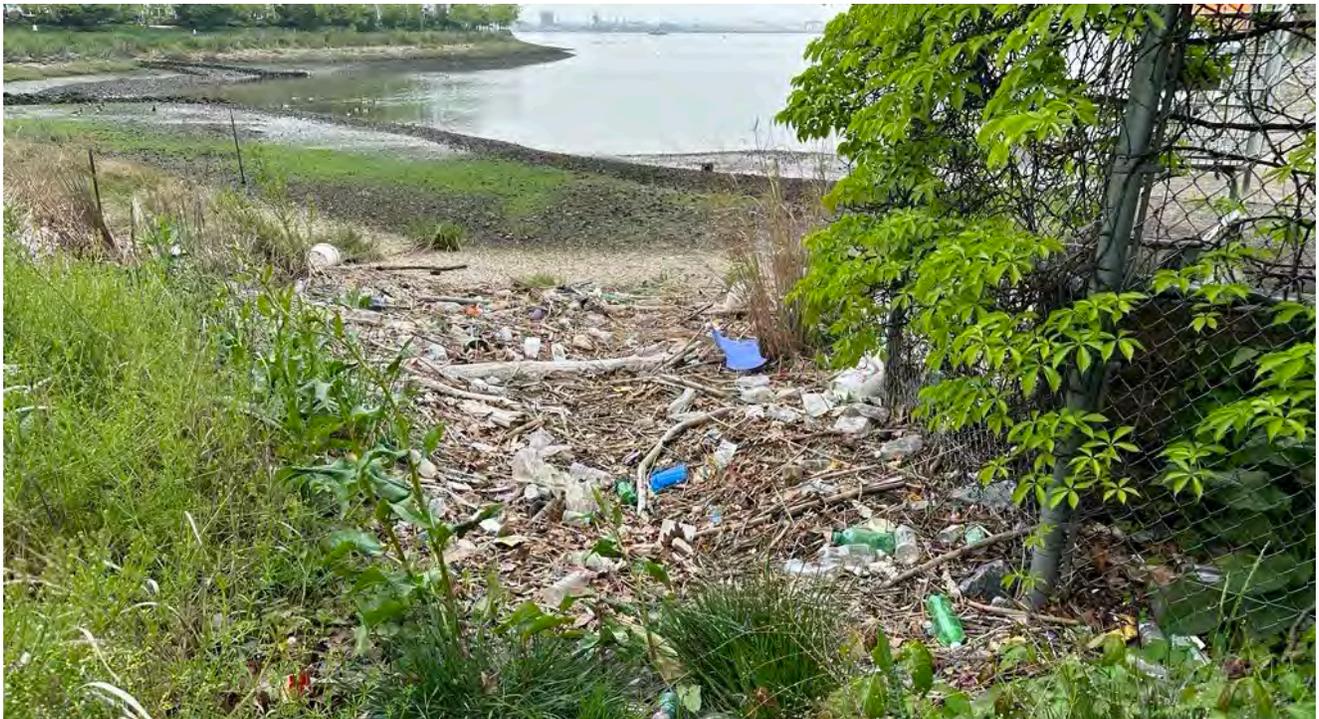
**Photo 14:** Transition from upland to low marsh zone in the easternmost corner of the BEP area (facing west). Note tidal drift deposits and debris covering the area.

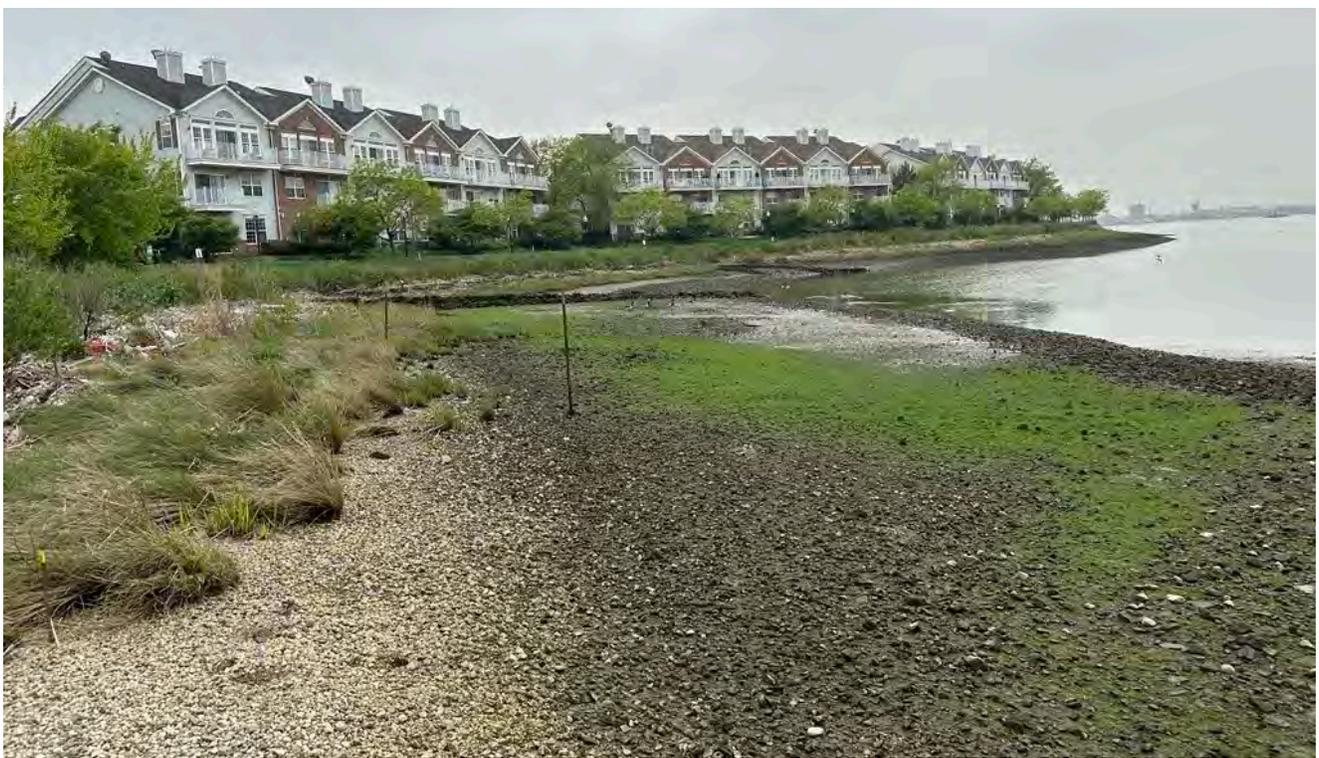
**Photo 15:** Low marsh planting zone on the eastern side of the BEP (facing west). Note presence of algae in portions of the low marsh planting zone.

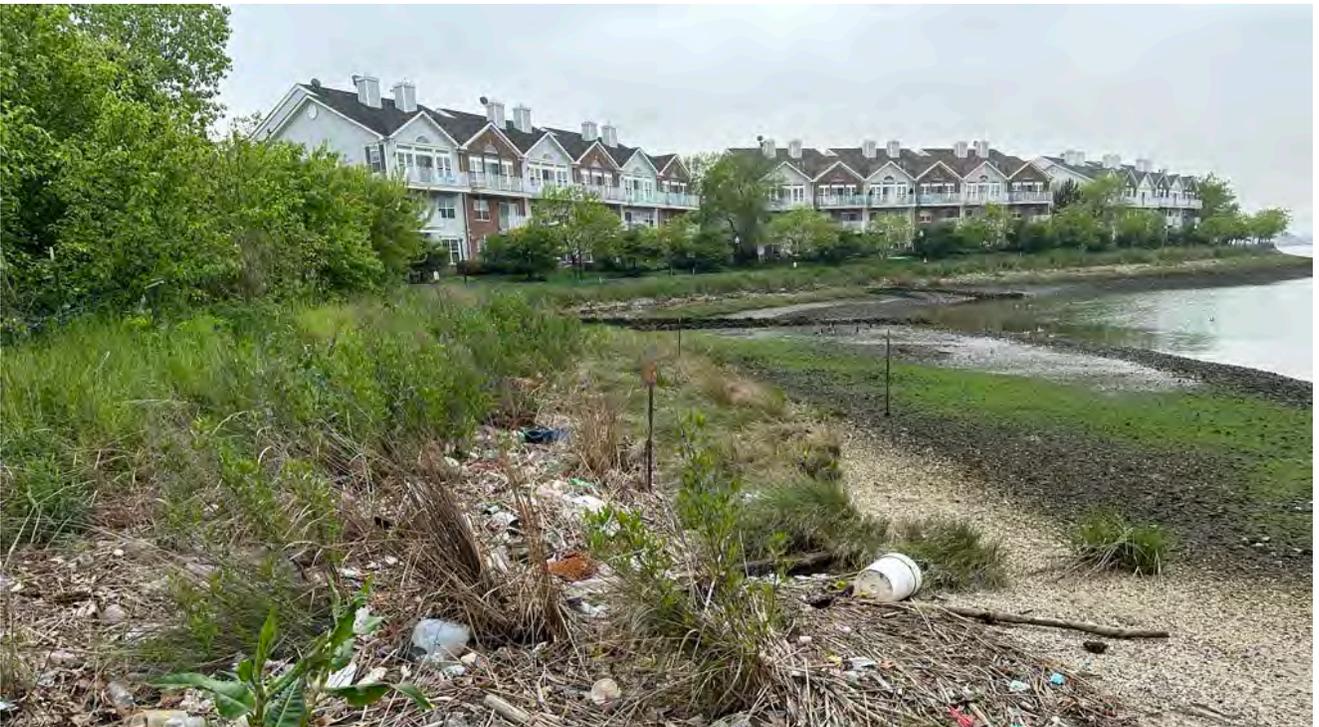
**Photo 16:** Transition area between low marsh planting zone and high marsh planting zone within the eastern side of the BEP (facing southeast). Note the vibrant and healthy vegetation in upper portion of low marsh planting zone, and the presence of tidal drift deposits and debris within high marsh planting zone.

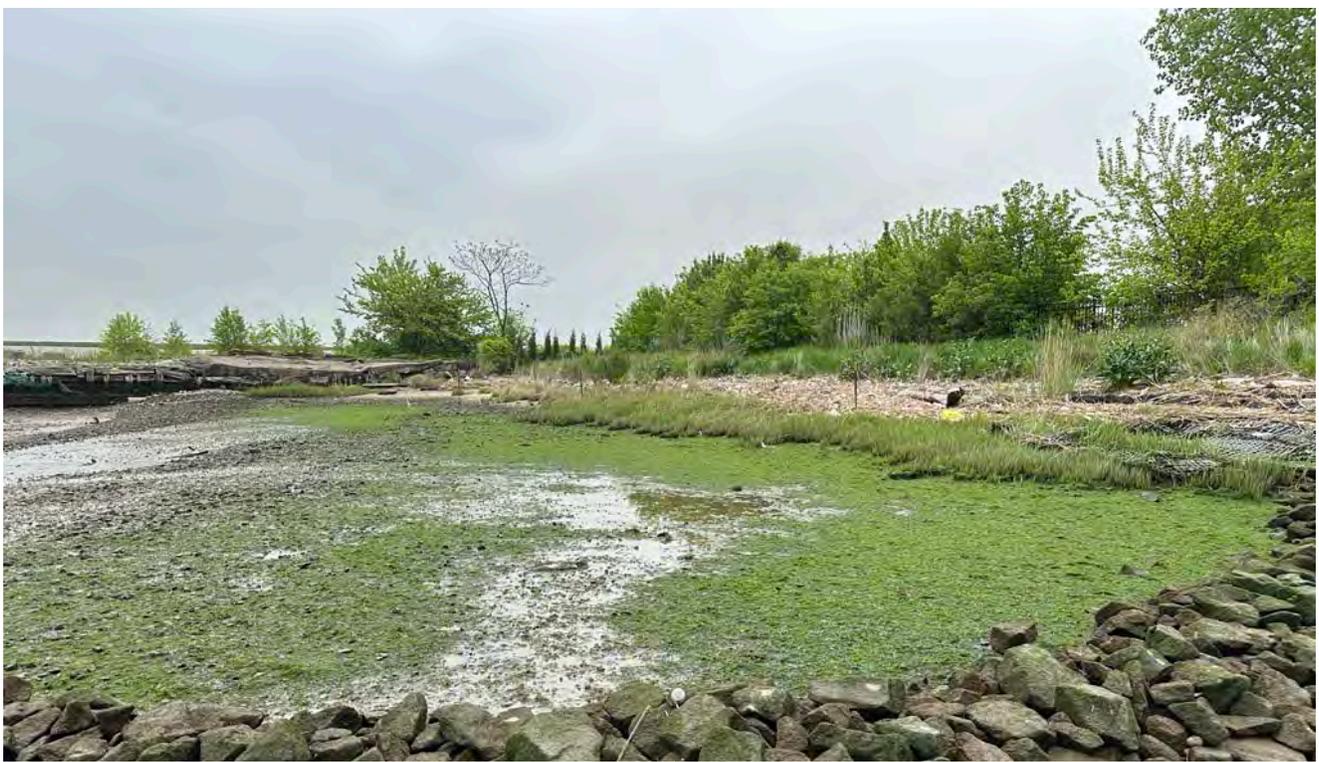
**Photo 17:** Low marsh planting zone within eastern portion of the BEP (facing northeast). Note the vibrant and healthy vegetation as well as algae present throughout the low marsh area.

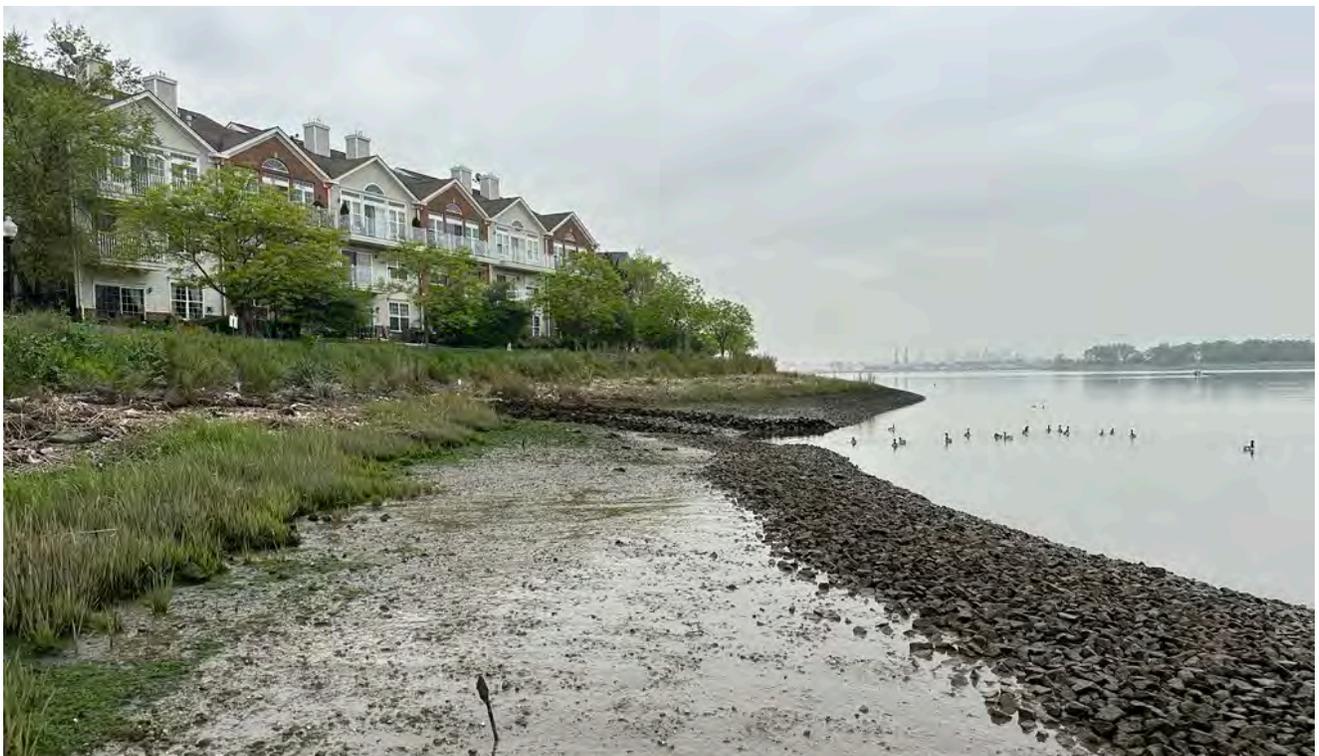
**Photo 18:** Low marsh planting zone between Outfalls A and B (facing west). Note the vibrant and healthy vegetation in the higher elevations of the low marsh area.

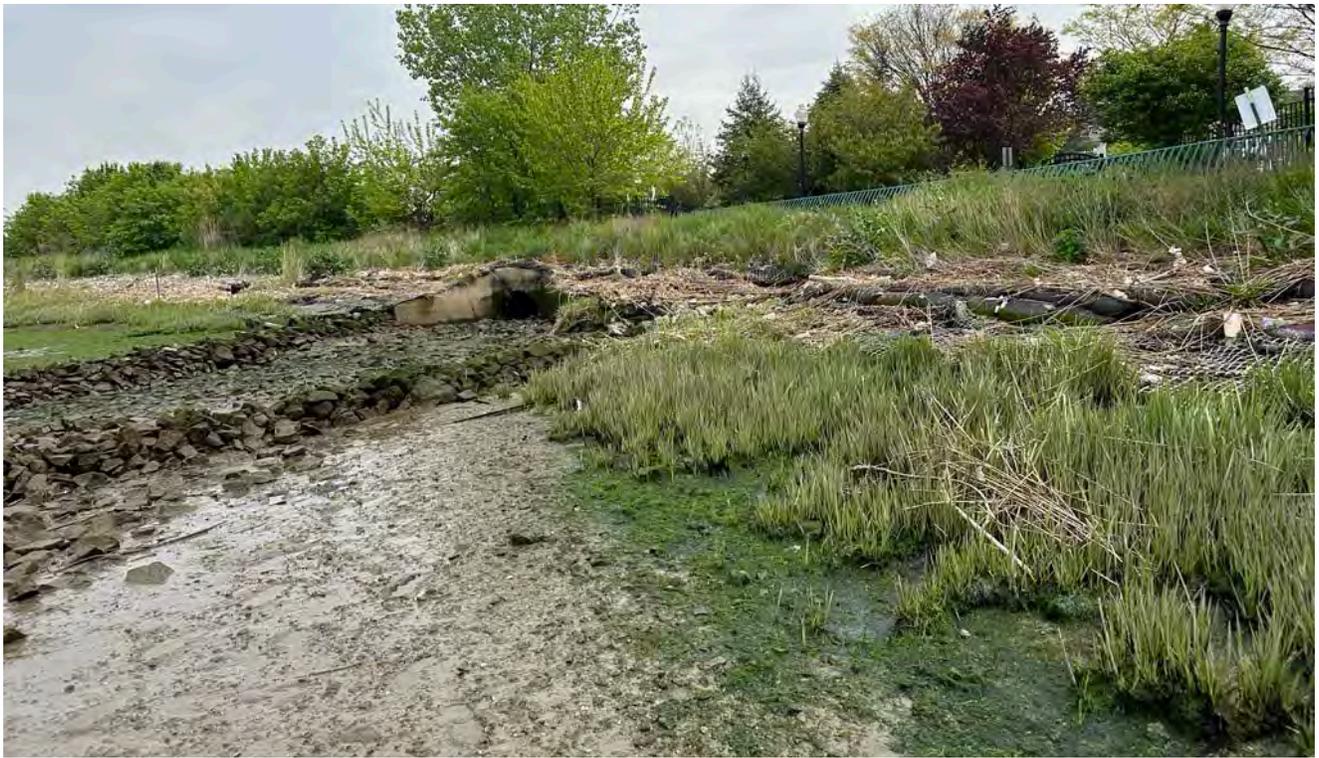
**Photo 19:** Vibrant and healthy vegetation in the higher elevations of the low marsh zone and high marsh zones in the eastern BEP area (facing southeast).

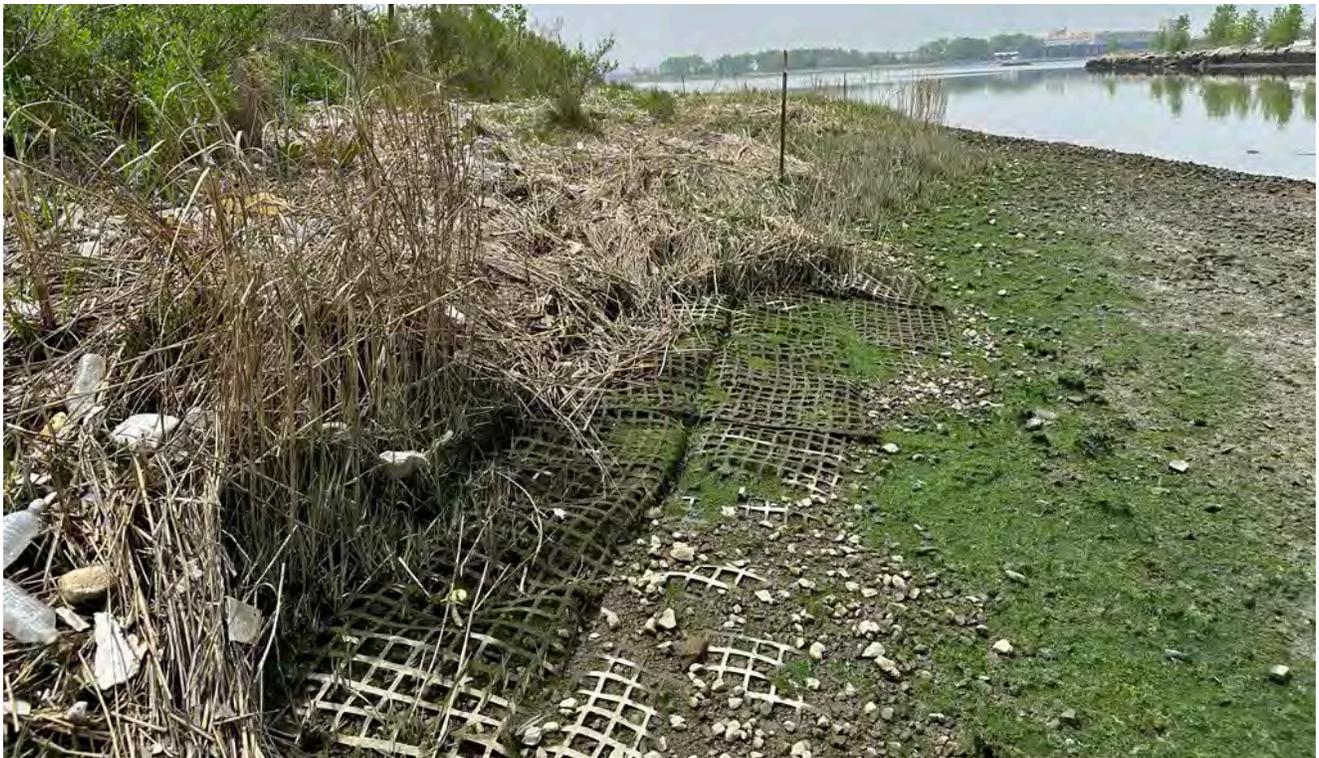
**Photo 20:** Tidal drift deposits and debris within the low and high marsh zones west of Outfall A (facing southwest). Note the exposed geogrid and absence of GroSoxx at the bottom of the low marsh zone.

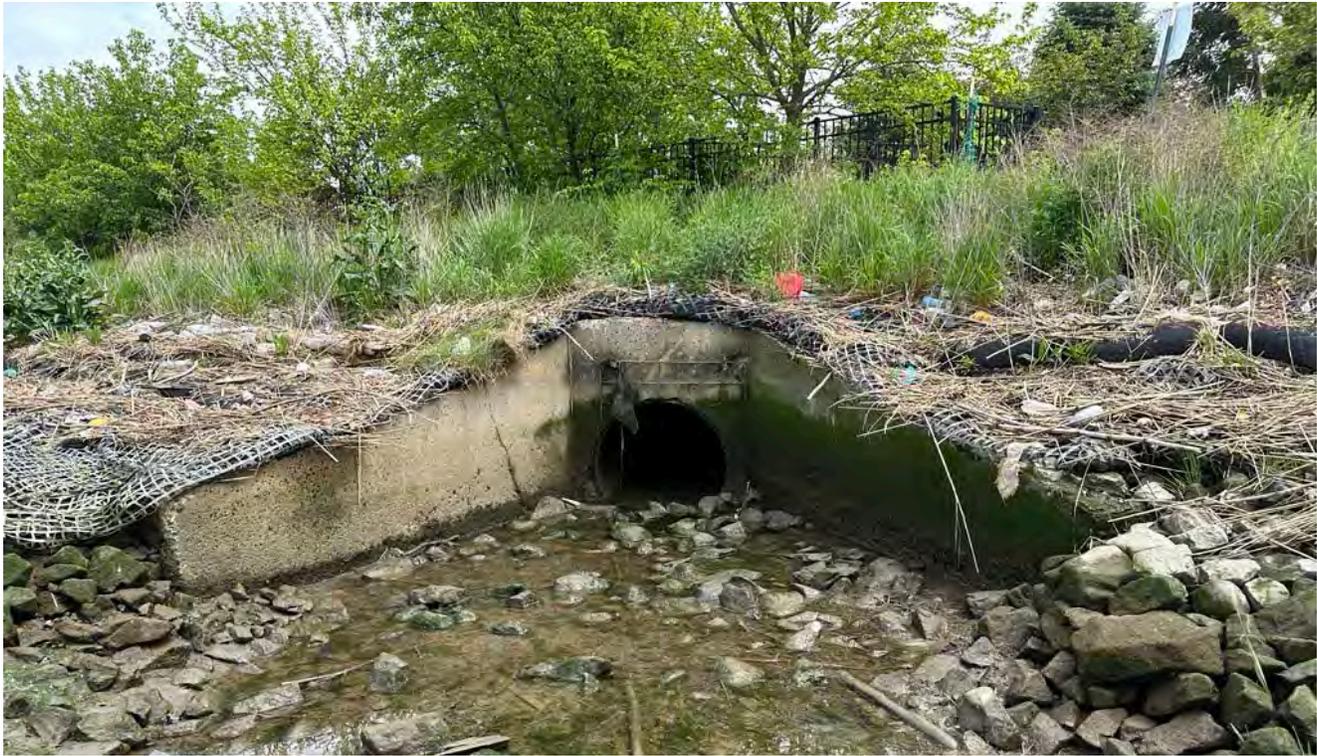
**Photo 21:** Exposed geogrid over and around the Outfall C structure and within the high marsh planting zone (facing south).

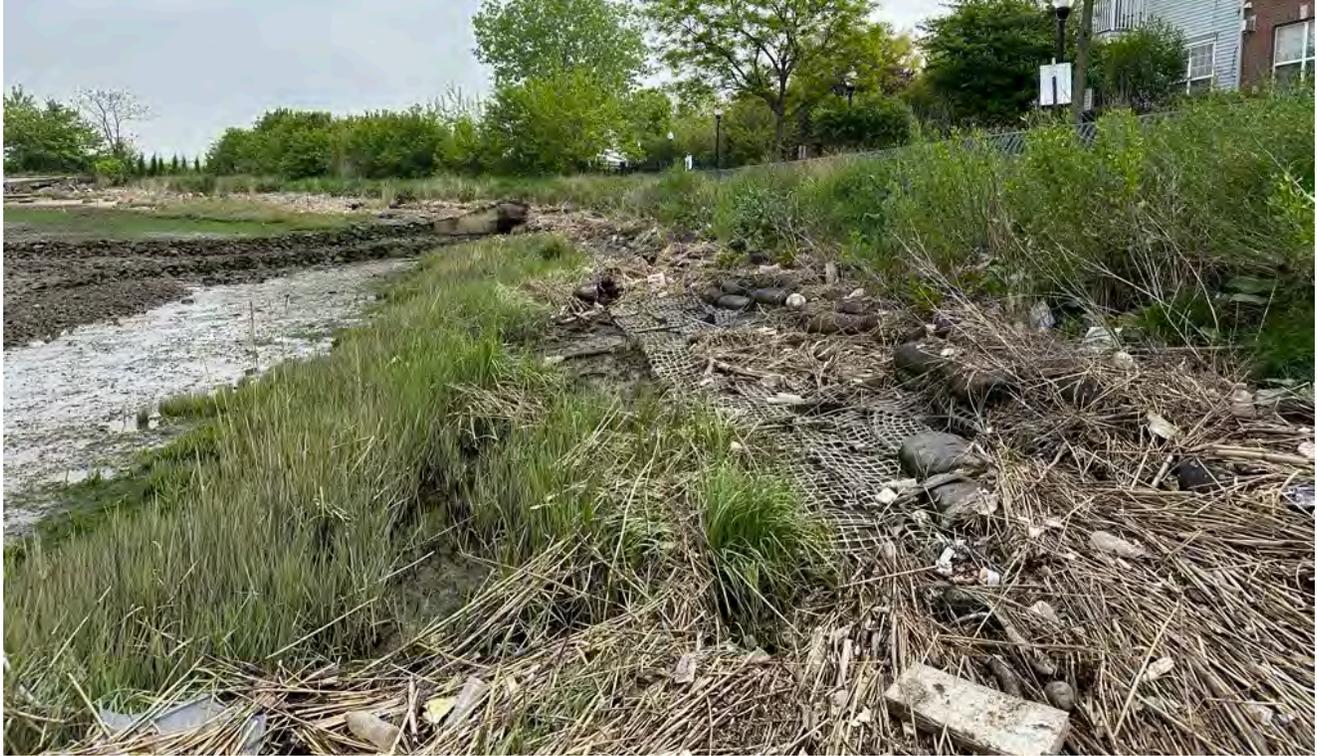
**Photo 22:** Healthy vegetation in the upland transition and low marsh planting zones east of Outfall A (facing east). Note the presence of tidal drift deposits and debris within the high marsh planting zone.
