# MEMORANDUM

Subject: **SA-7 Sediment Remedy Long-Term Monitoring**  
**Summary of Year 11 Monitoring & Proposed Year 12**  
**Program**

**ATTACHMENT A  
YEAR 11 INSPECTION LOGS**

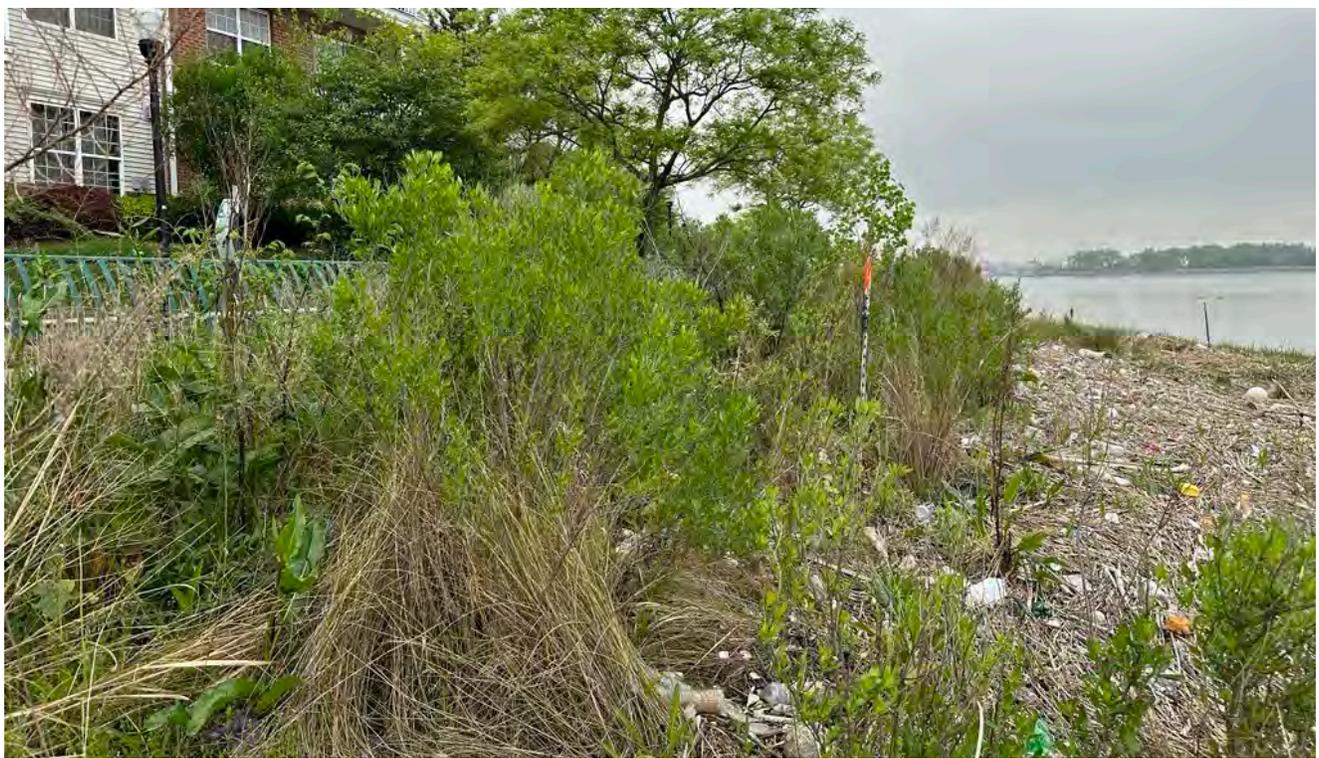
**Photo 23:** Healthy vegetation in the upland transition area between Outfalls A and B. Note presence of tidal drift deposits and debris covering the interface between the low and high marsh zones (facing southeast).

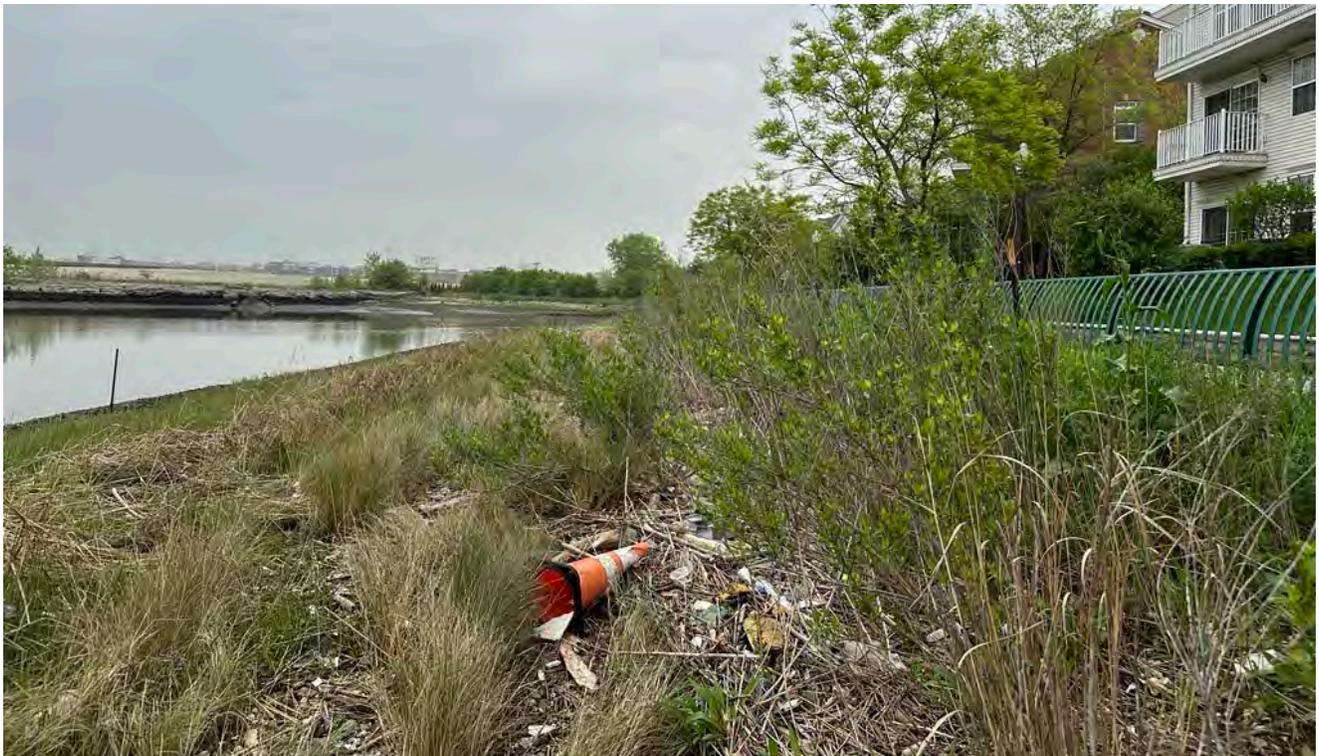
**Photo 24:** Healthy vegetation in the upland transitional area and interface between the low and high marsh west of Outfall A (facing southeast). Note the presence of tidal drift deposits and debris within the high marsh areas.

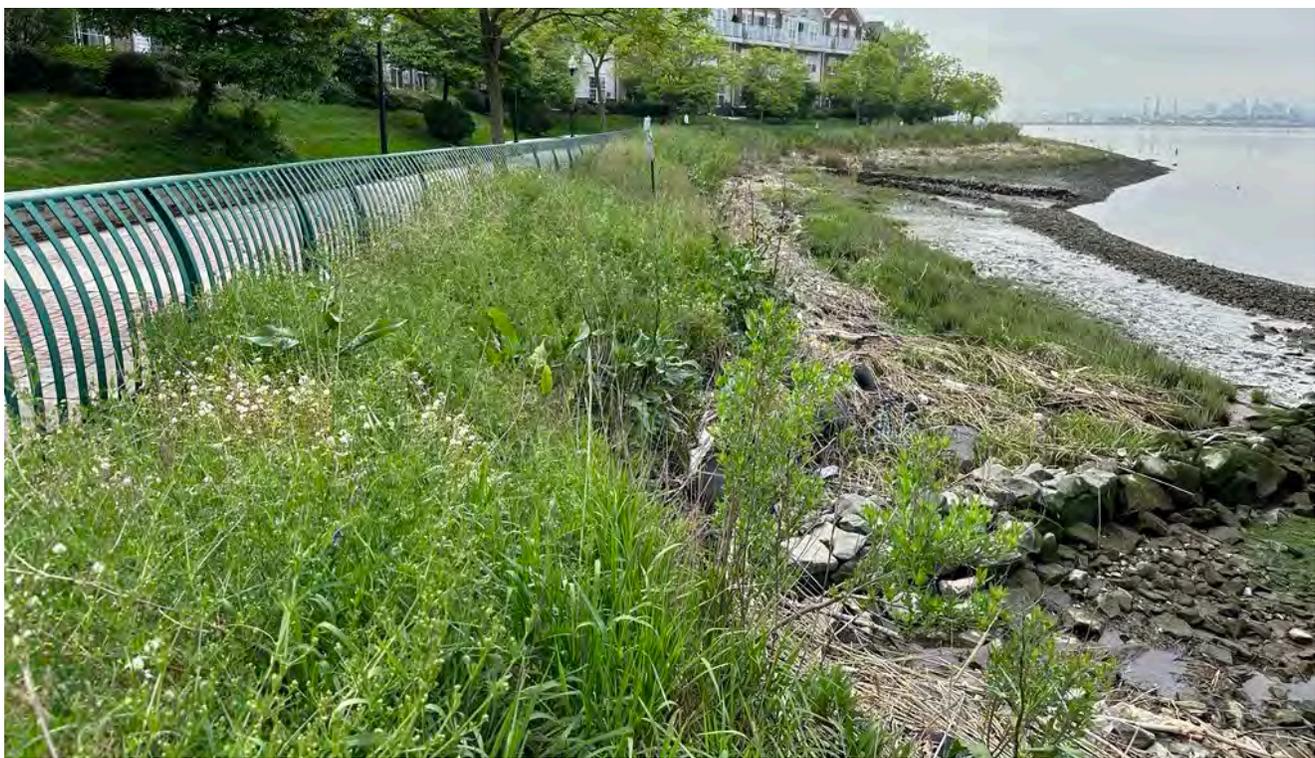
Photo 25: Healthy and vibrant vegetation in the upland transition zone in the western portion of the BEP (facing west).

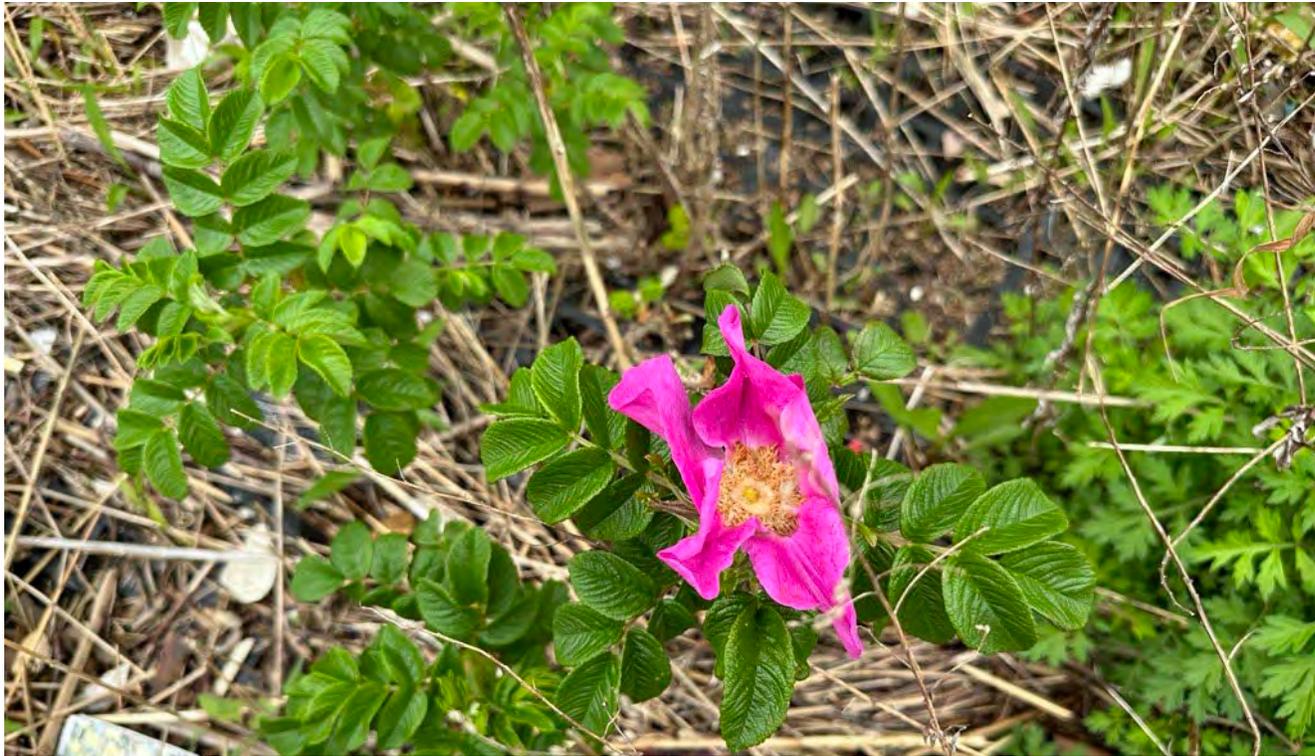
Photo 26: Invasive species beach rose located within the upland transitional planting zone of the BEP.

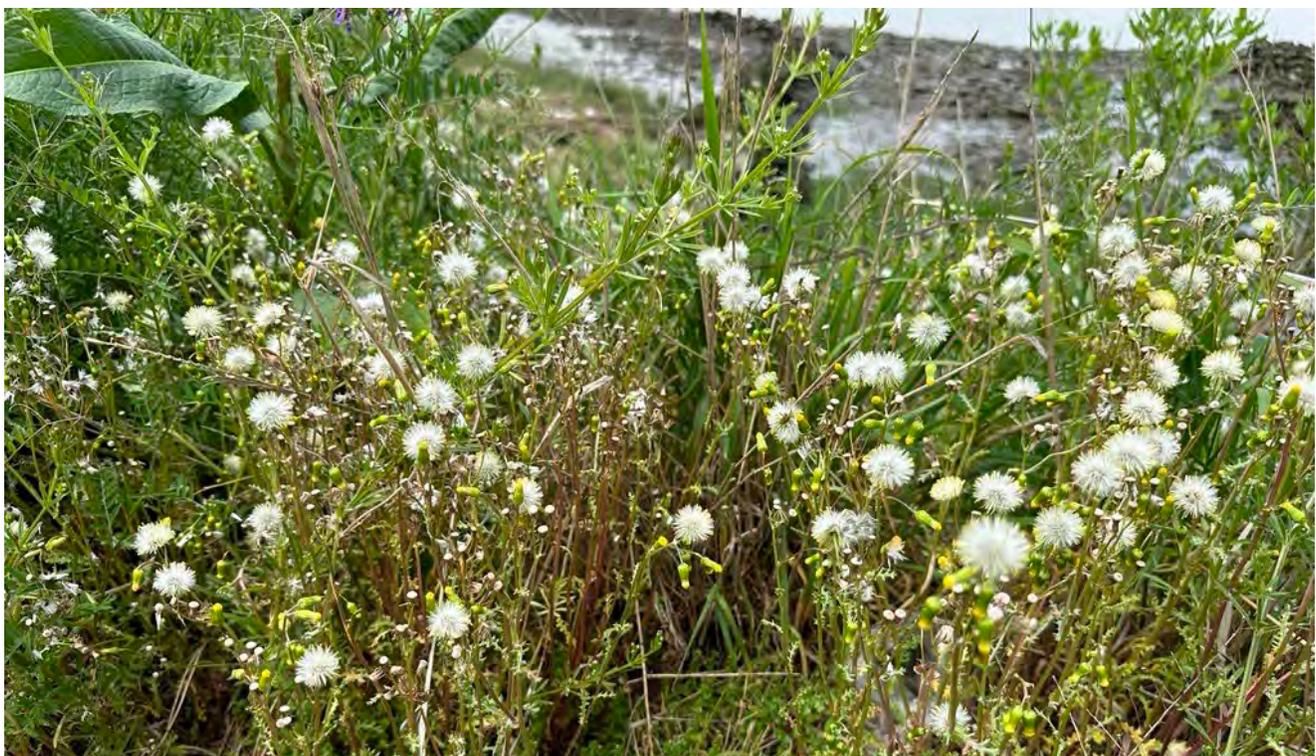
**Photo 27:** Invasive species common groundsel within the upland transition planting zone of the BEP.

TABLE 2. BENEFICIAL ENVIRONMENTAL PROJECT AREA INSPECTION LOG			
BEP AREA ELEMENT	OBSERVATIONS	PHOTO(S) TAKEN	CORRECTIVE ACTION(S) REQUIRED
<b>PLANTING ZONE C – UPLANDS TRANSITION AREA</b>	<ul style="list-style-type: none"> <li>• Total vegetative cover within the upland portion of the BEP was greater than 95% (greater than the 70 to 80% vegetative cover observed during the May 2023 inspection and consistent with the vegetative cover observed during the November 2023 inspection). GroSoxx, geogrid, and anchors, and the ¾-inch stone strip along the fence line appeared to be in good condition.</li> <li>• Invasive species cover throughout the upland zone ranged from 15 to 20%, which is a significant decrease from the 50 to 60% observed in the May 2023 inspection and lower than observed during the November 2023 inspection (40 to 50%). The highest density of invasive species was observed in the central and western areas of the BEP. The dominant species included common mugwort (<i>Artemisia vulgaris</i>), curly dock (<i>Rumex crispus</i>), Japanese siltgrass (<i>Microstegium vimineum</i>), and hairy vetch (<i>Vicia villosa</i>). Additional observed invasive species included beach rose (<i>Rosa rugosa</i>) and common groundsel (<i>Senecio vulgaris</i>).</li> <li>• With the decrease in invasive species cover, native species make up the predominant vegetative cover within the uplands area. The following notable native species were observed:                         <ul style="list-style-type: none"> <li>○ Switchgrass (<i>Panicum virgatum</i>)</li> <li>○ Black locust (<i>Robinia pseudoacacia</i>)</li> <li>○ Clasping coneflower (<i>Dracopis amplexicaulis</i>)</li> <li>○ Sage brush (<i>Artemisia tridentata</i>)</li> </ul> </li> </ul>	23 to 28	<ul style="list-style-type: none"> <li>• Continue to monitor non-native plant density.</li> </ul>

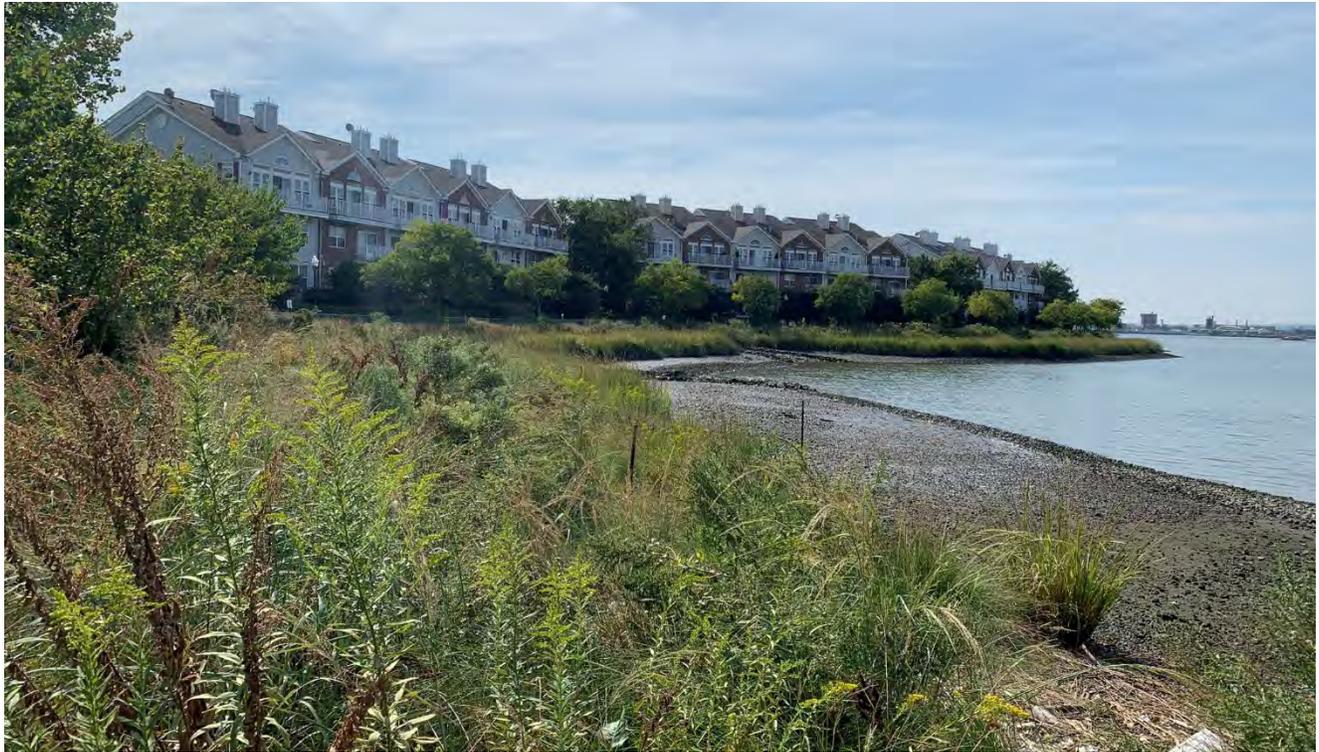
**Photo 1:** Northern end of Cap Area 16 (facing west). Note vibrant and healthy vegetation present in high marsh planting and upland zones.

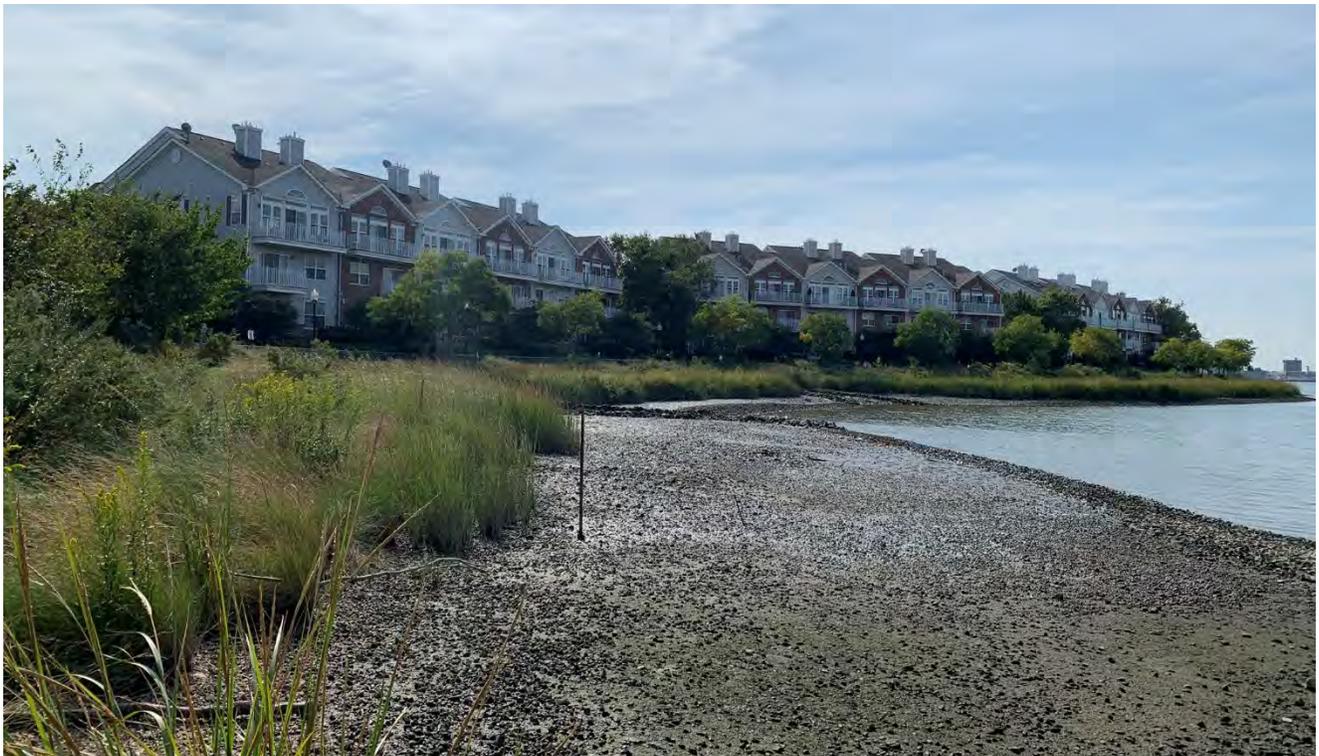
**Photo 2:** Central portion of Cap Area 16 (facing west). Note reference posts used to assess sediment surface changes.

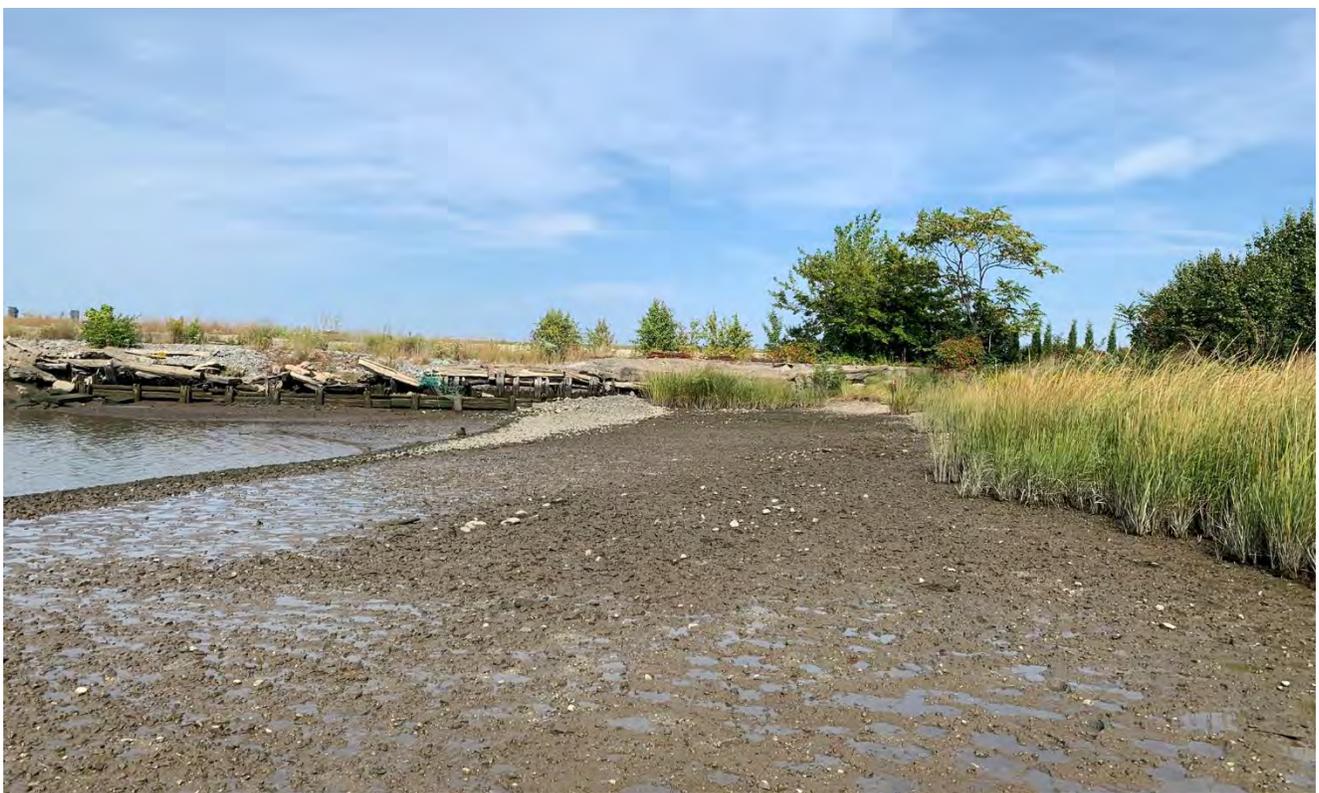
**Photo 3:** Western end of Cap Area 16 (facing east). Note the vibrant and healthy vegetation in the low marsh planting zones.

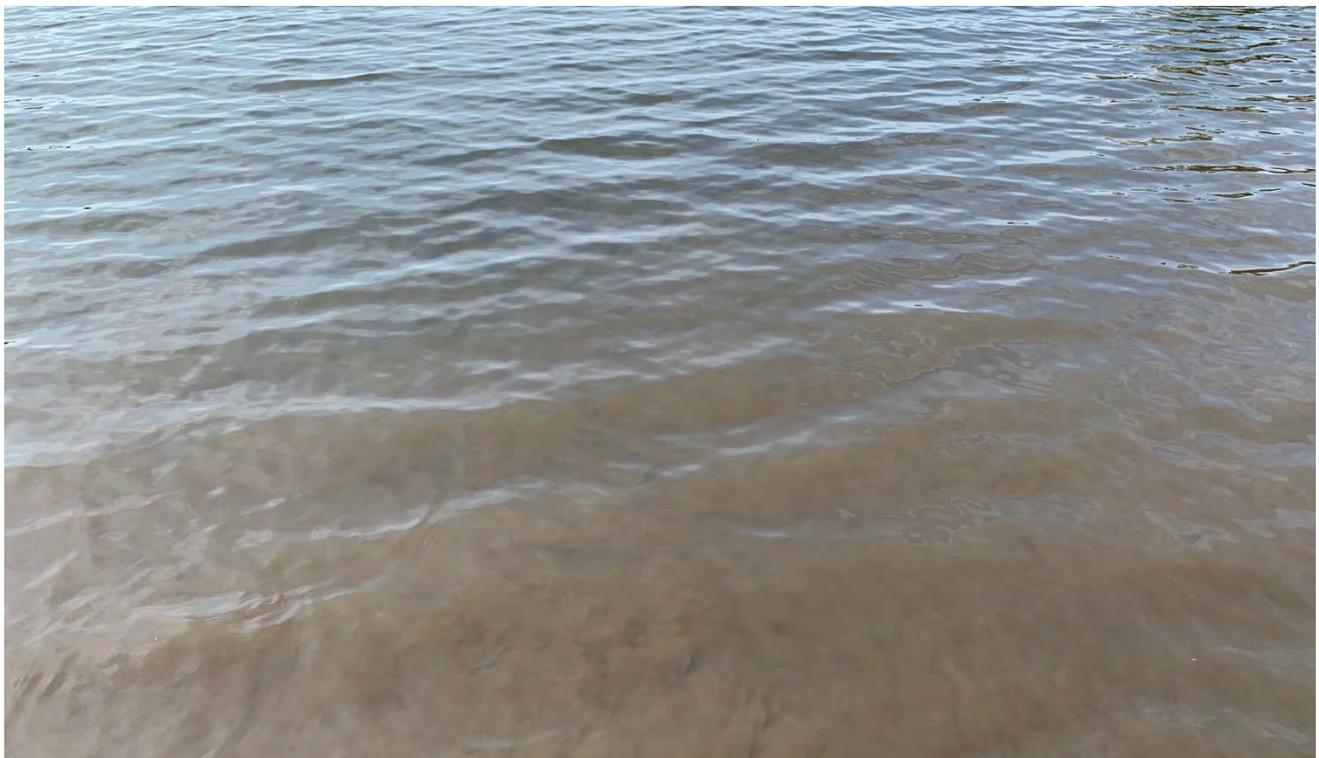
**Photo 4:** Subaquatic vegetation not observed within Cap Area 22 (facing west).

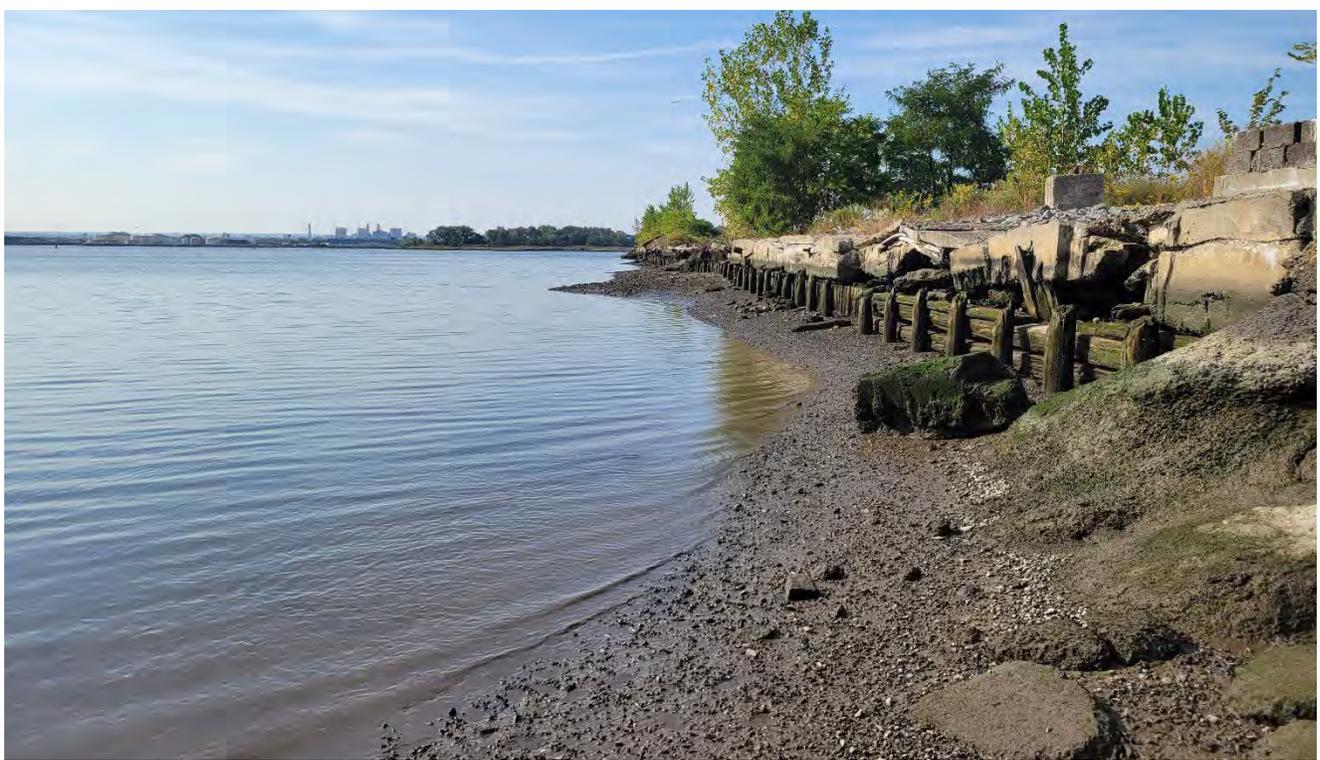
**Photo 5:** Partially exposed Cap Area 22 during low tide (facing west).

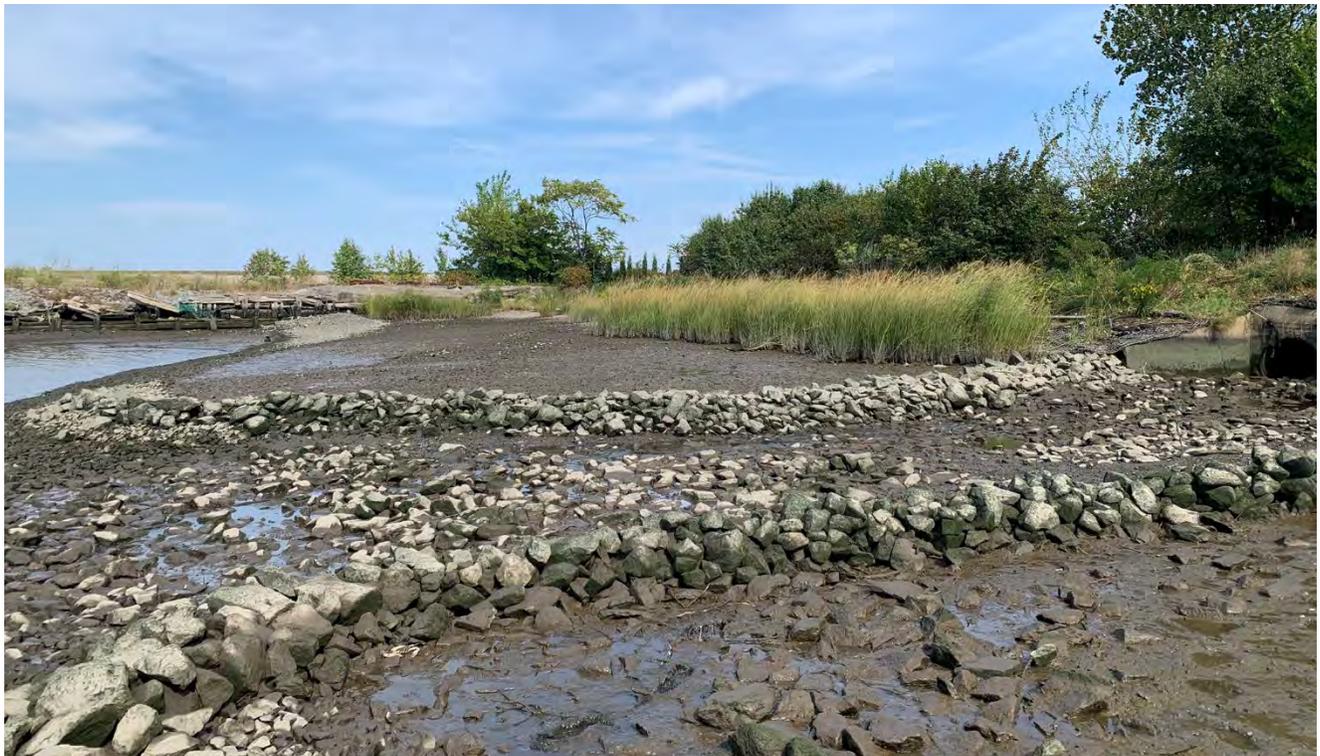
**Photo 6:** Central portion of the BEP, between Outfalls A and B (facing southeast). Note healthy and vibrant vegetation in the low marsh planting zone.

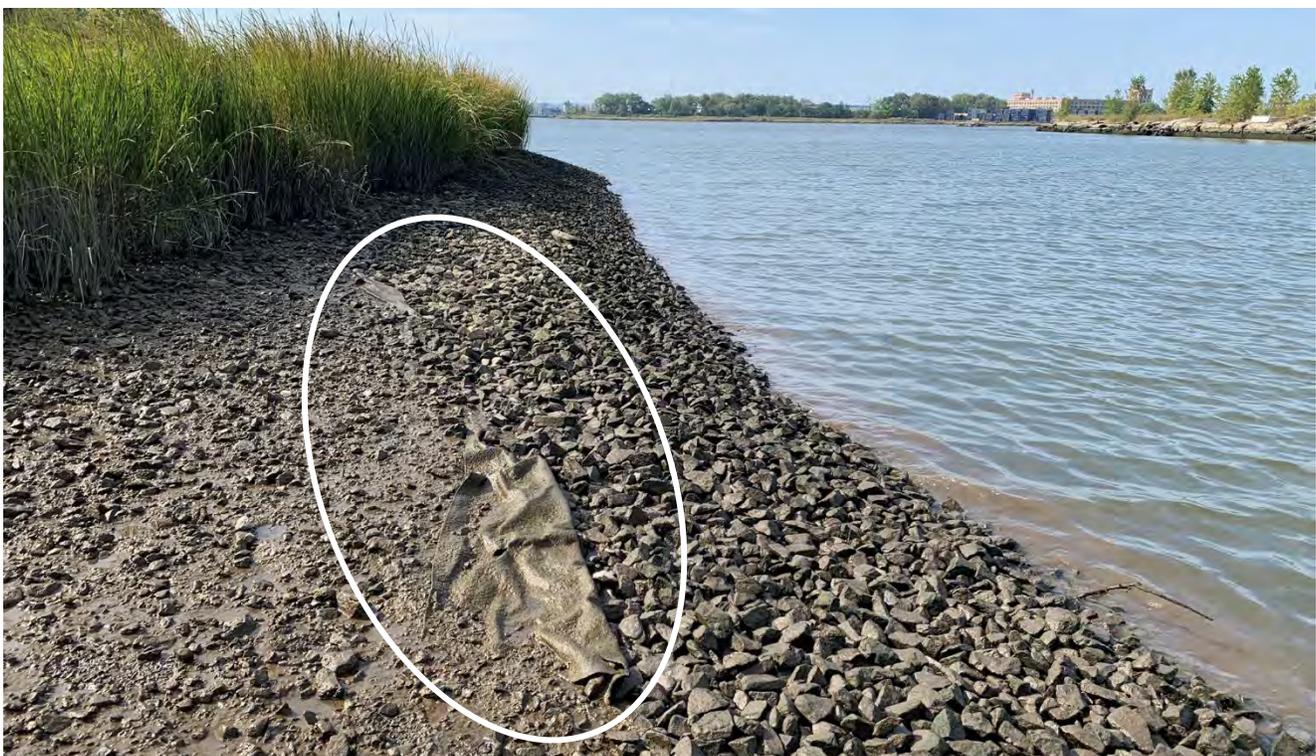
**Photo 7:** Exposed geotextile fabric between the shoreline stabilization berm and the BEP fill material west of Outfall A (facing west).

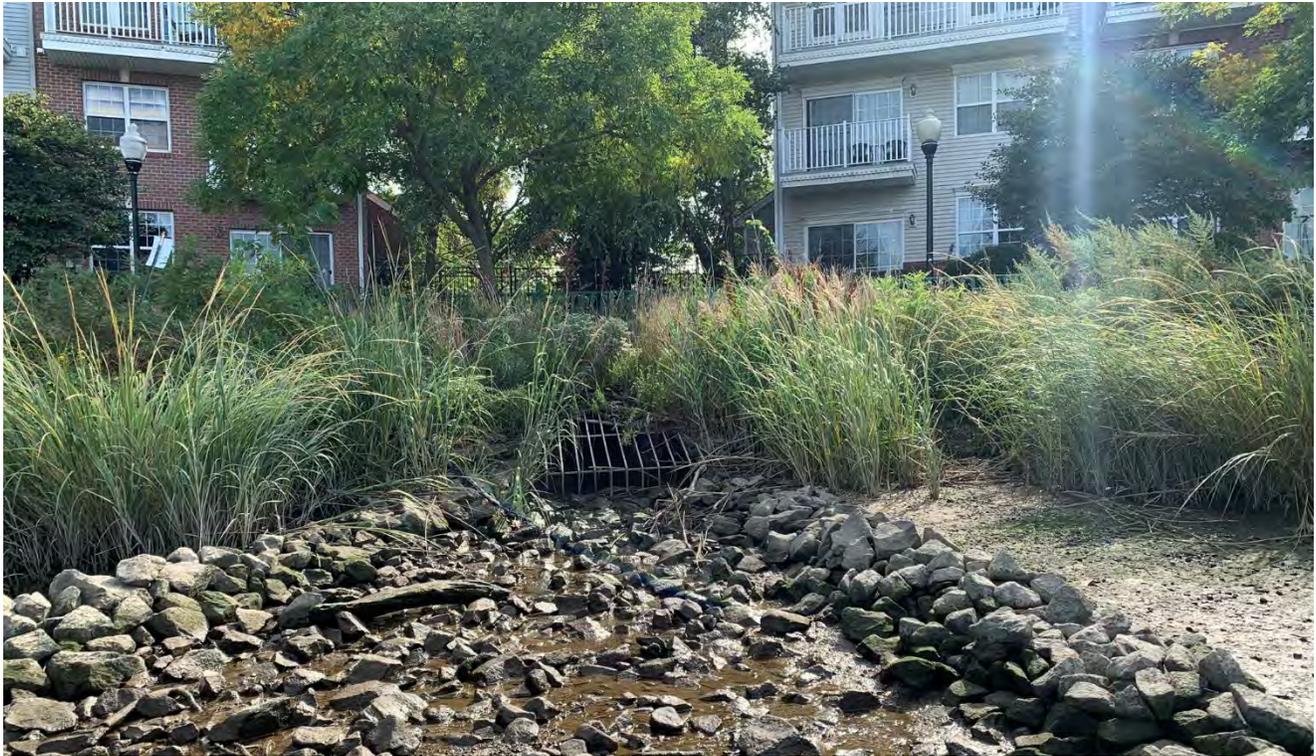
**Photo 8:** Outfall A and surrounding armor stone (facing southwest). Note vibrant and healthy vegetation in the high marsh planting zones and areas of exposed geogrid and GroSoxx in the high marsh planting zone.

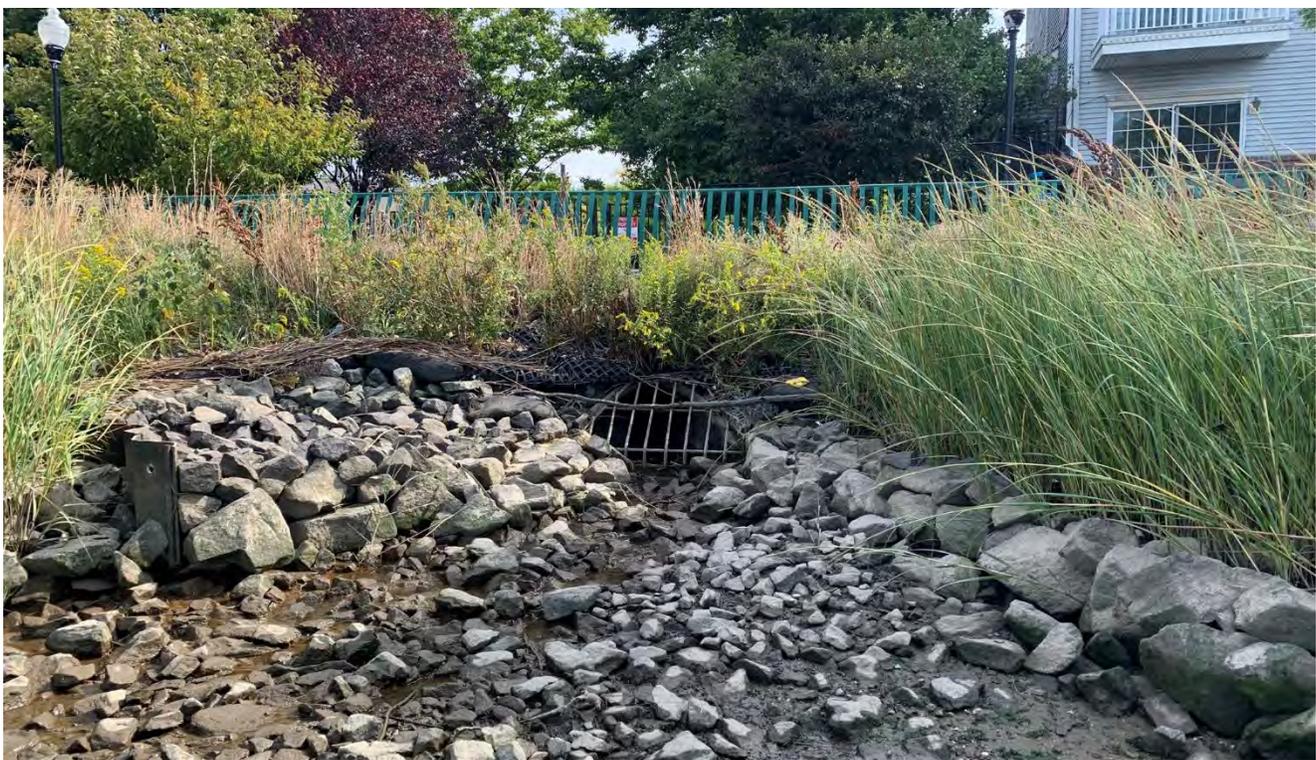
**Photo 9:** Outfall B and surrounding armor stone (facing southwest). Note the exposed geogrid and tidal drift deposits near the front of the outlet.

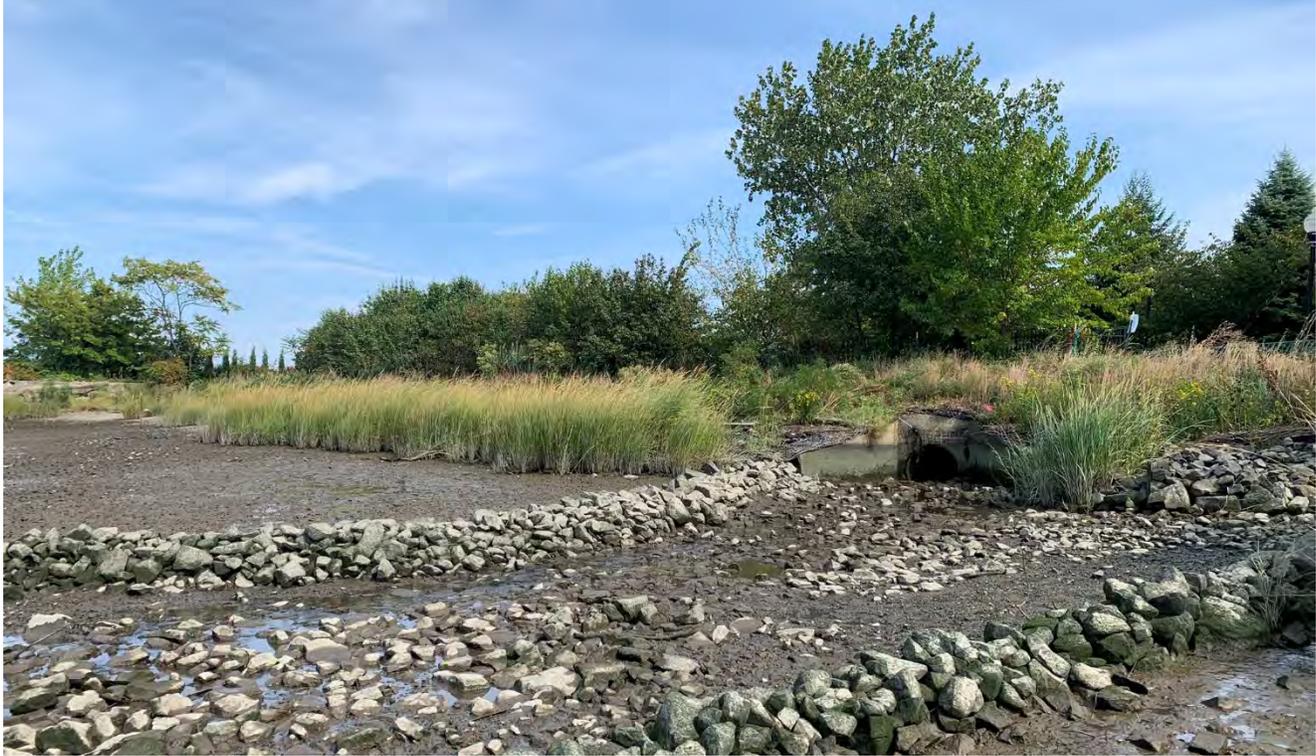
**Photo 10:** Armor stone along the western edge of the apron for Outfalls B and C (facing southeast).

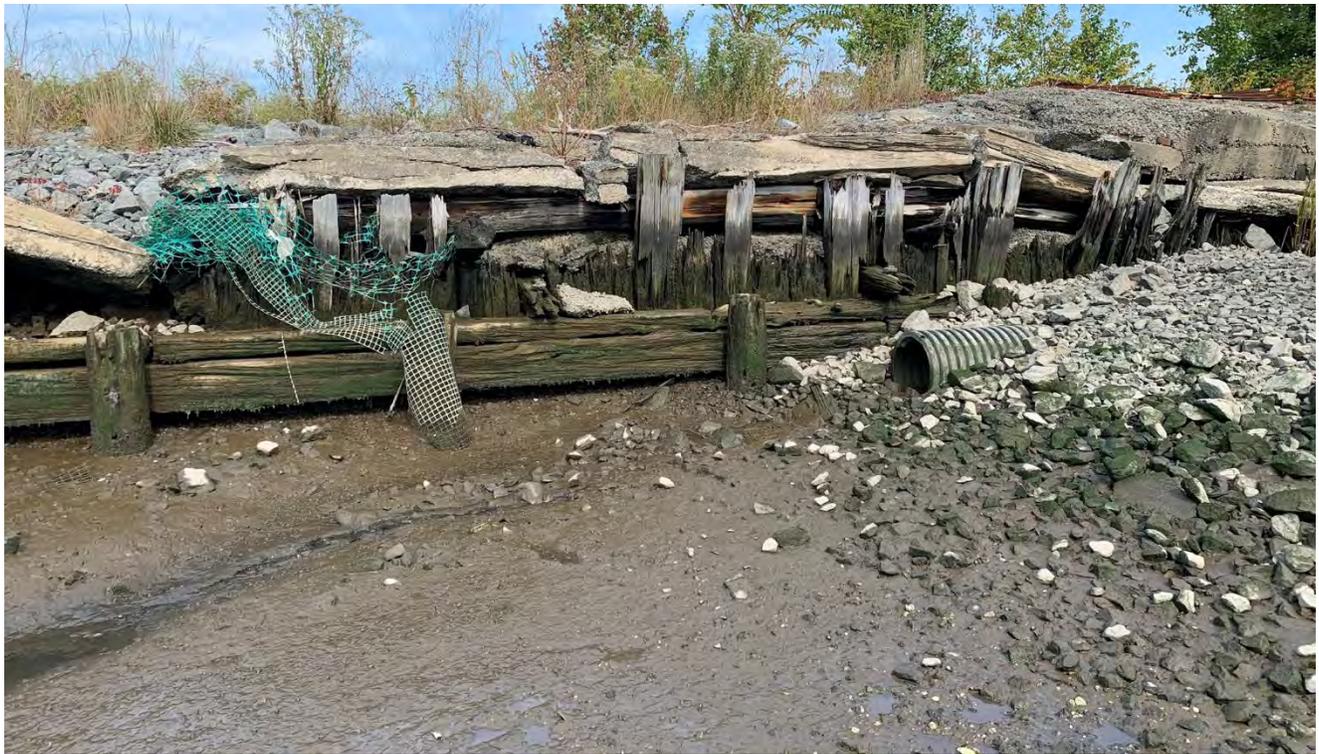
**Photo 11:** Outfall D discharge area where previously observed minor flow channel is overlain by displaced stone (facing east).

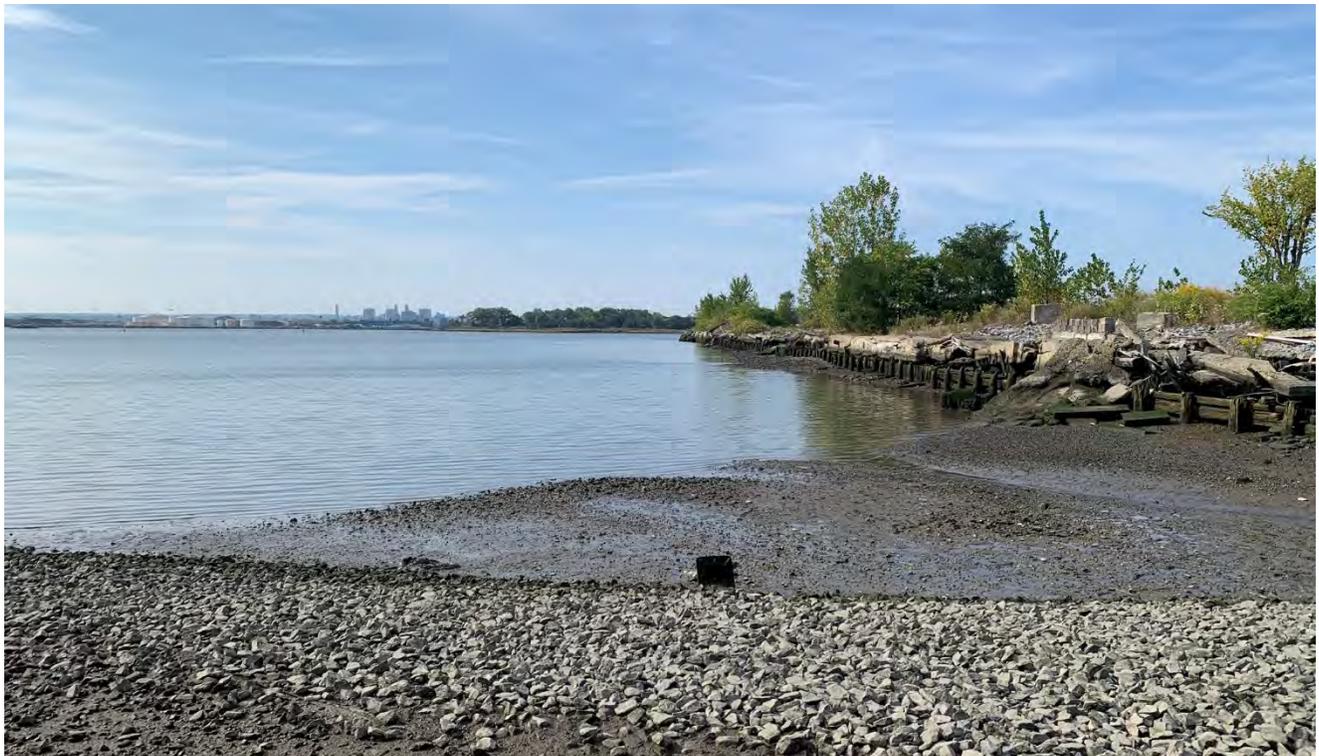
**Photo 12:** Area beyond the shoreline stabilization berm near Outfall D with Cap Area 22 partially exposed in the background (facing north).

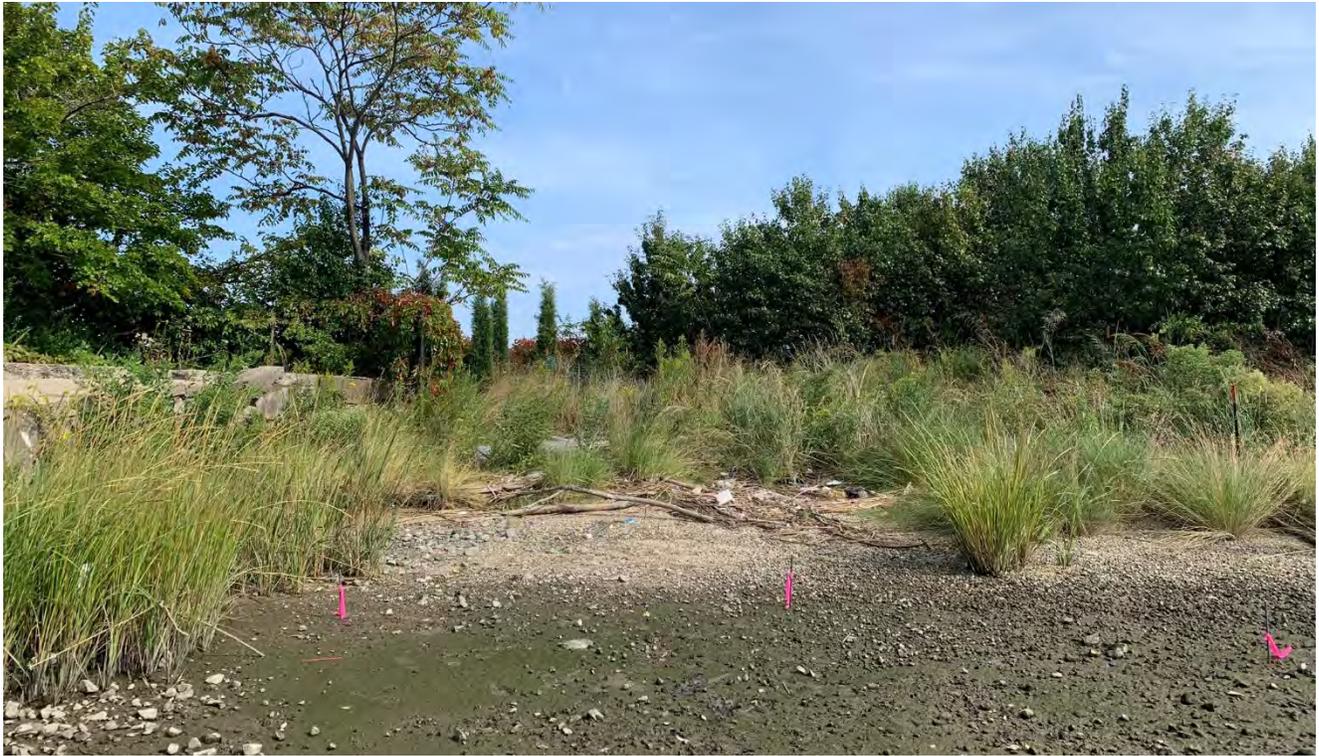
**Photo 13:** Low marsh zone in the eastern corner of the BEP near Outfall D (facing southeast). Note stakes demarcating extent of proposed areas BEP enhancement activities.

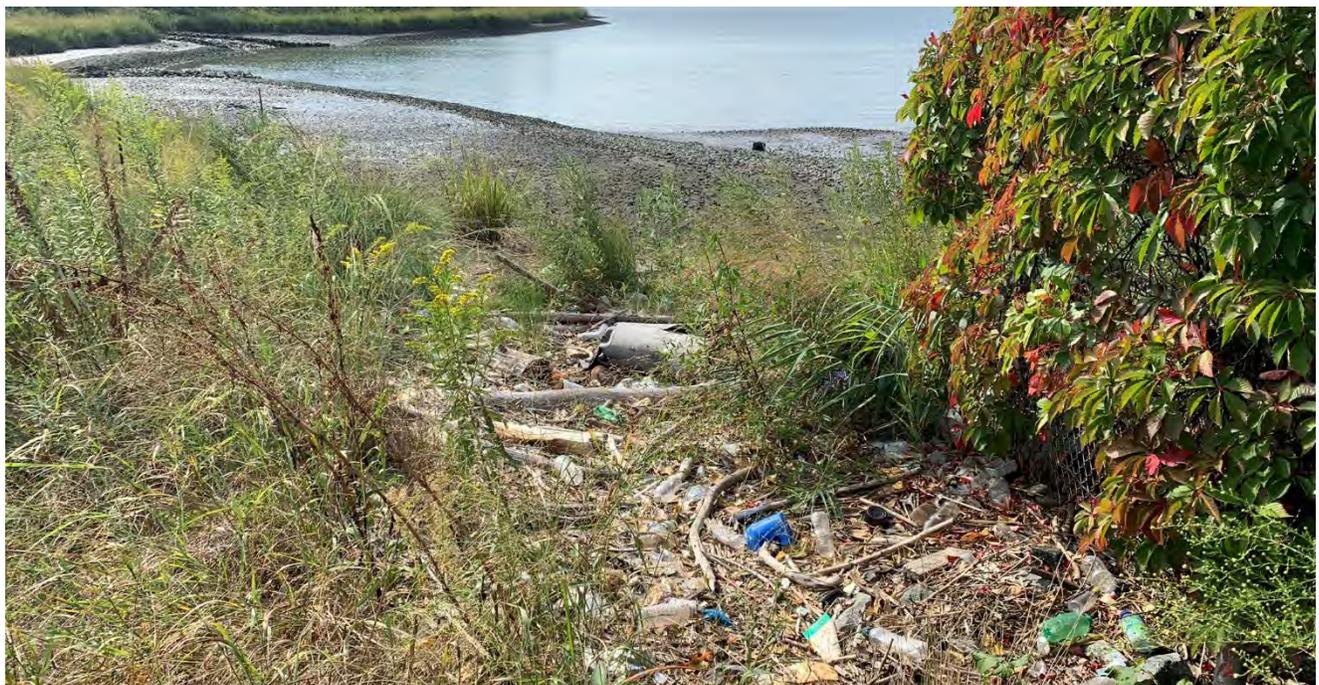
**Photo 14:** Transition from upland to low marsh zone in the easternmost corner of the BEP area (facing west). Note tidal drift deposits and debris covering the area.

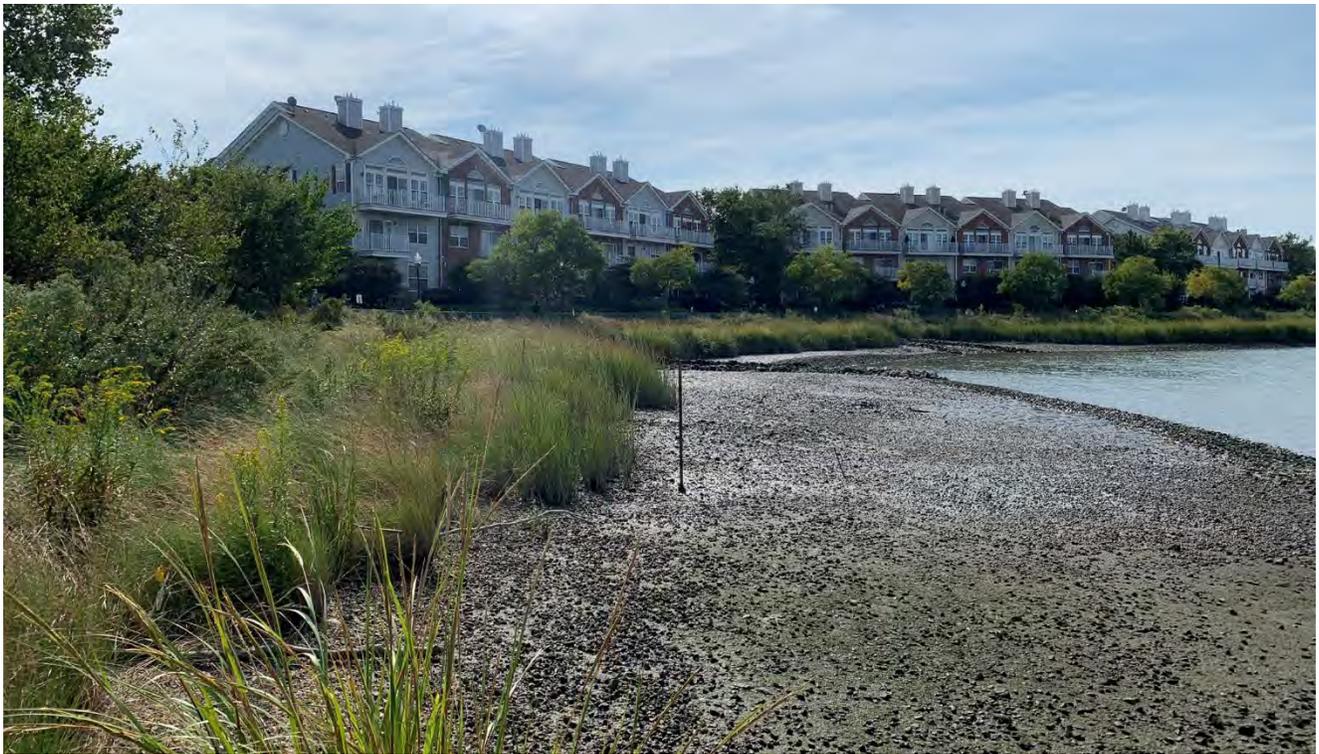
**Photo 15:** Low marsh planting zone on the eastern side of the BEP (facing west). Note presence of vibrant and healthy vegetation in upper portion of low marsh planting zone.

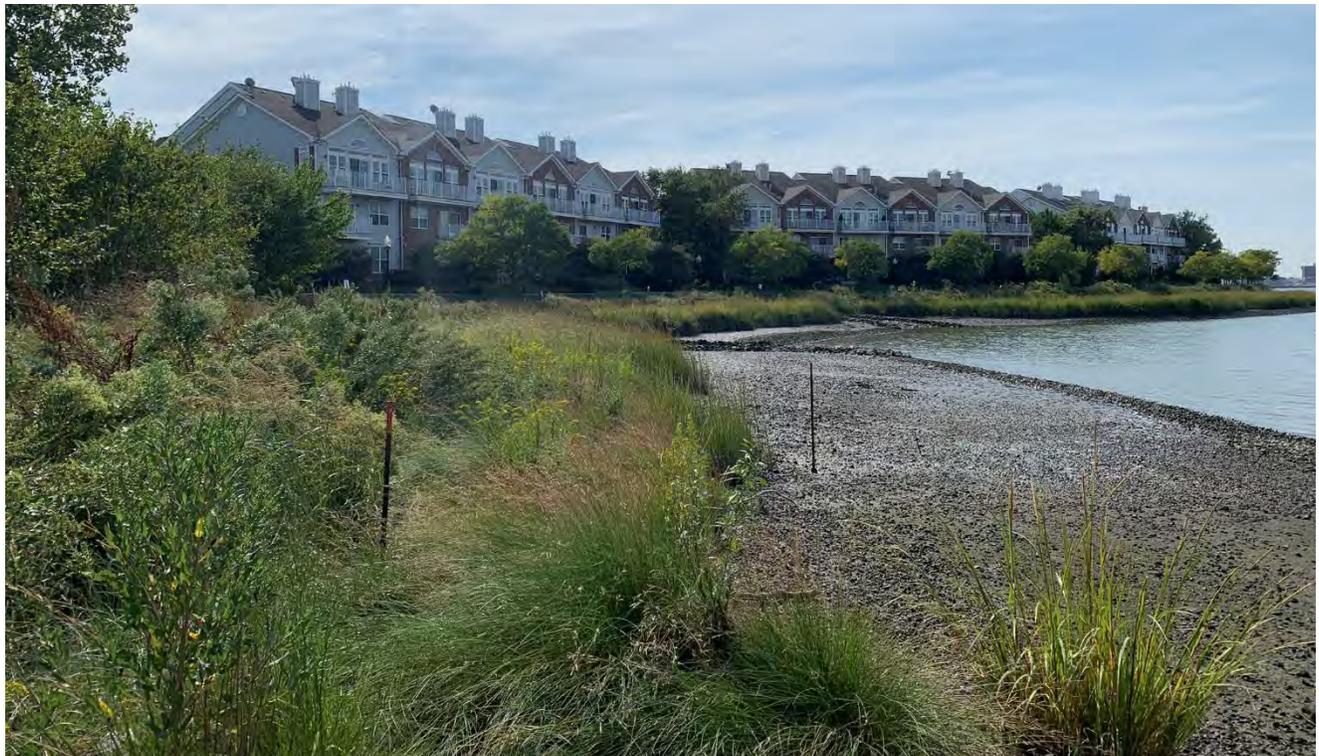
**Photo 16:** Transition area between low marsh planting zone and high marsh planting zone within the eastern side of the BEP (facing southeast). Note the vibrant and healthy vegetation in upper portion of low marsh planting zone.
