# MEMORANDUM

Subject: **SA-7 Sediment Remedy Long-Term Monitoring**  
**Summary of Year 11 Monitoring & Proposed Year 12**  
**Program**

**ATTACHMENT A  
YEAR 11 INSPECTION LOGS**

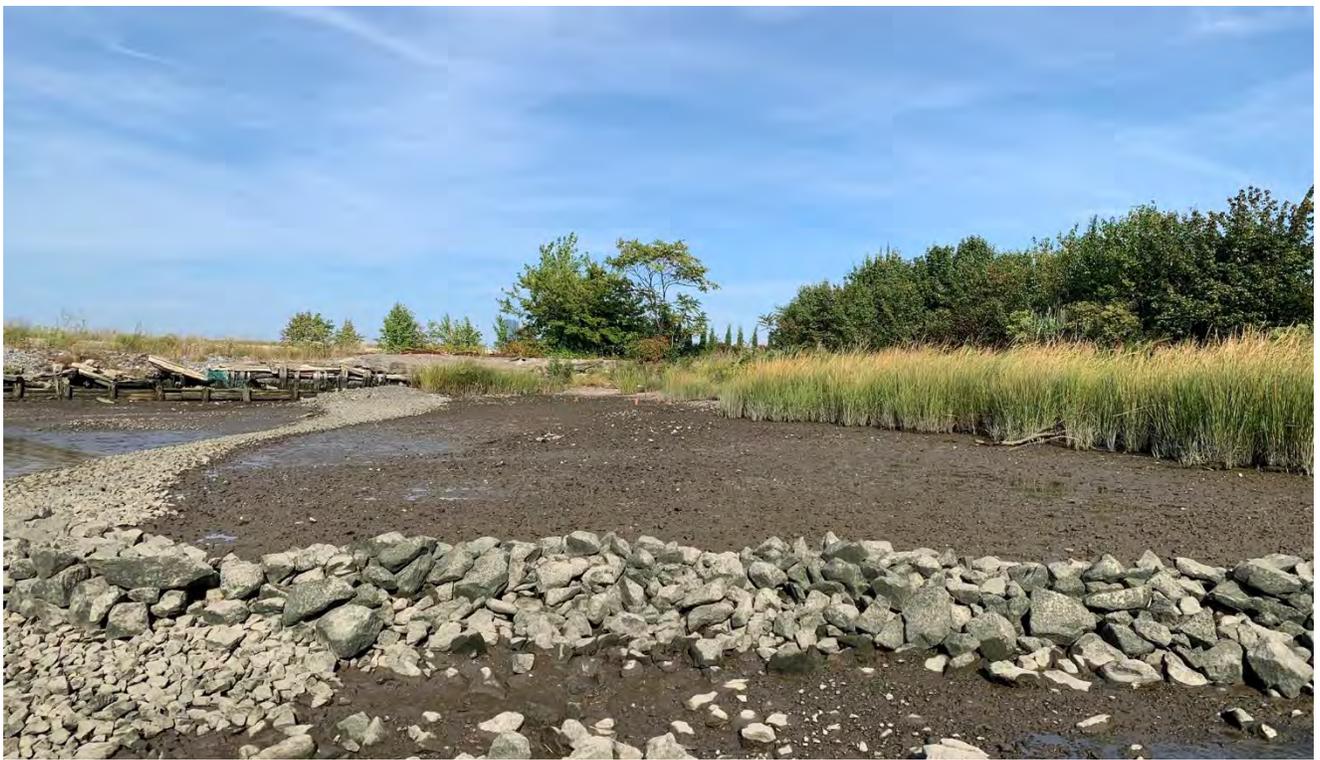
**Photo 17:** Low marsh planting zone within eastern portion of the BEP (facing northeast). Note the tall, vibrant, and healthy vegetation.

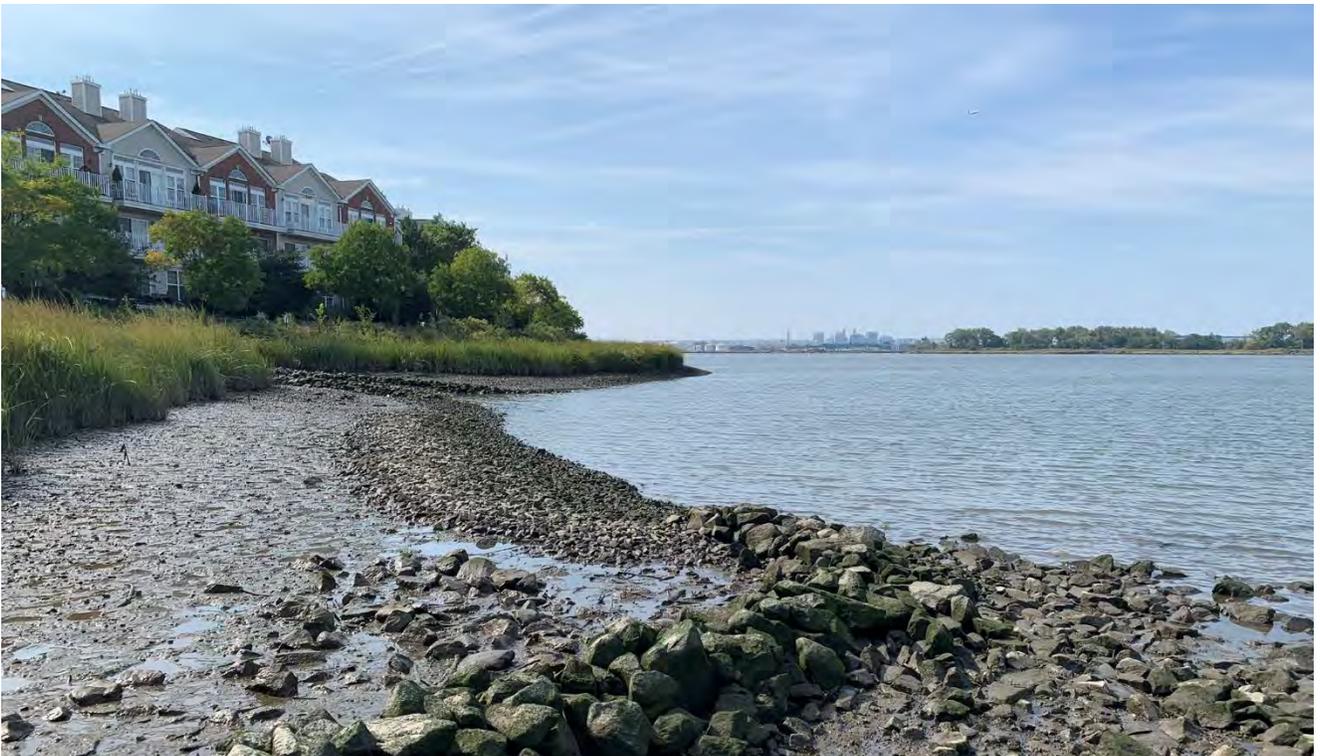
**Photo 18:** Low marsh planting zone between Outfalls A and B (facing west). Note the vibrant and healthy vegetation in the higher elevations of the low marsh area.

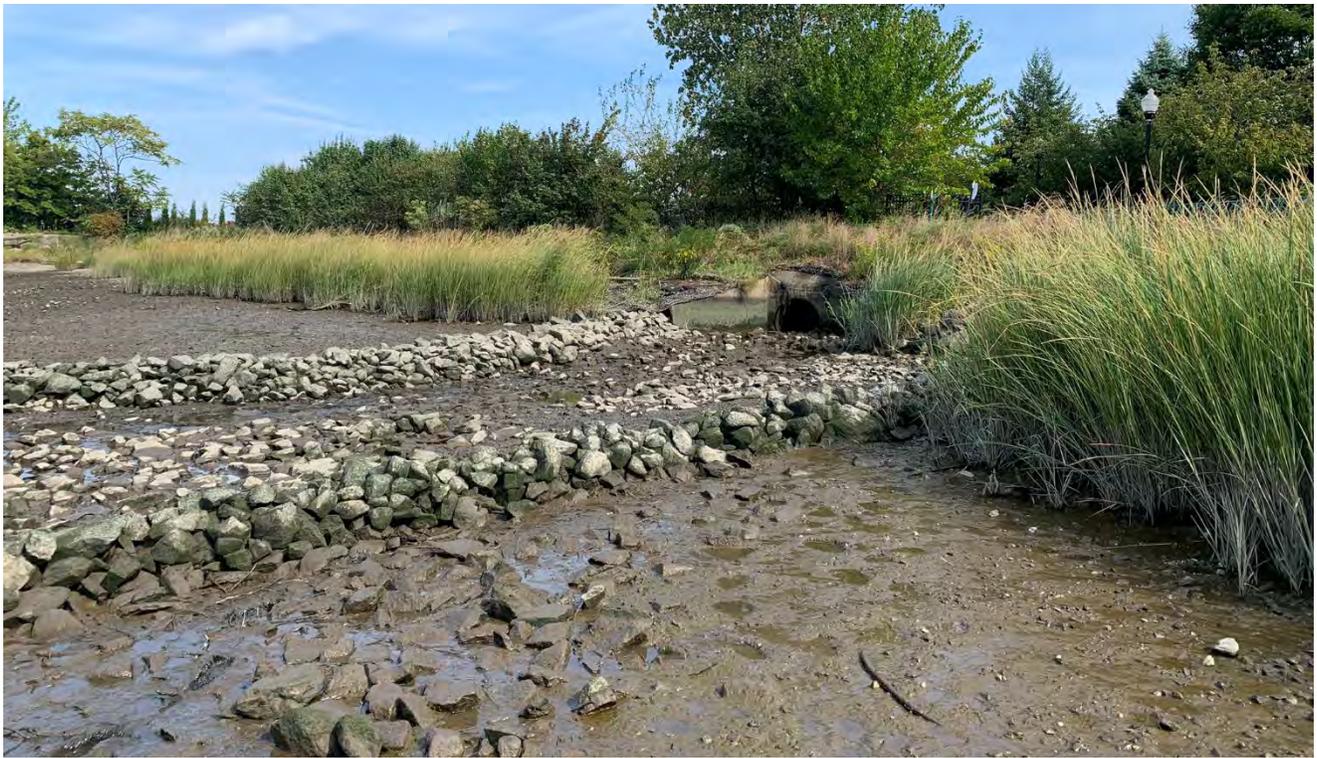
**Photo 19:** Vibrant and healthy vegetation in the higher elevations of the low marsh zone and high marsh zones in the eastern BEP area (facing southeast).

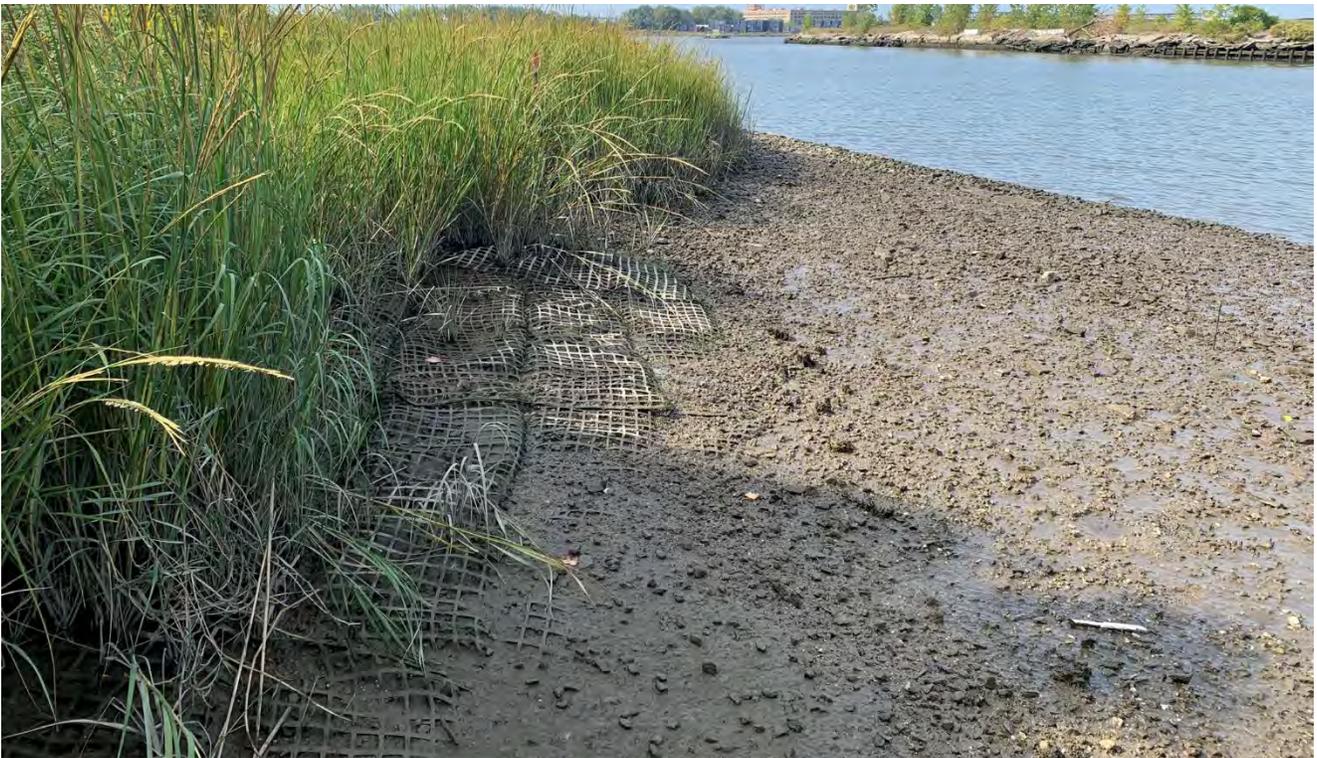
**Photo 20:** Vibrant and healthy vegetation within the low marsh zones west of Outfall A (facing southwest). Note the exposed geogrid and absence of GroSoxx at the bottom of the low marsh zone.

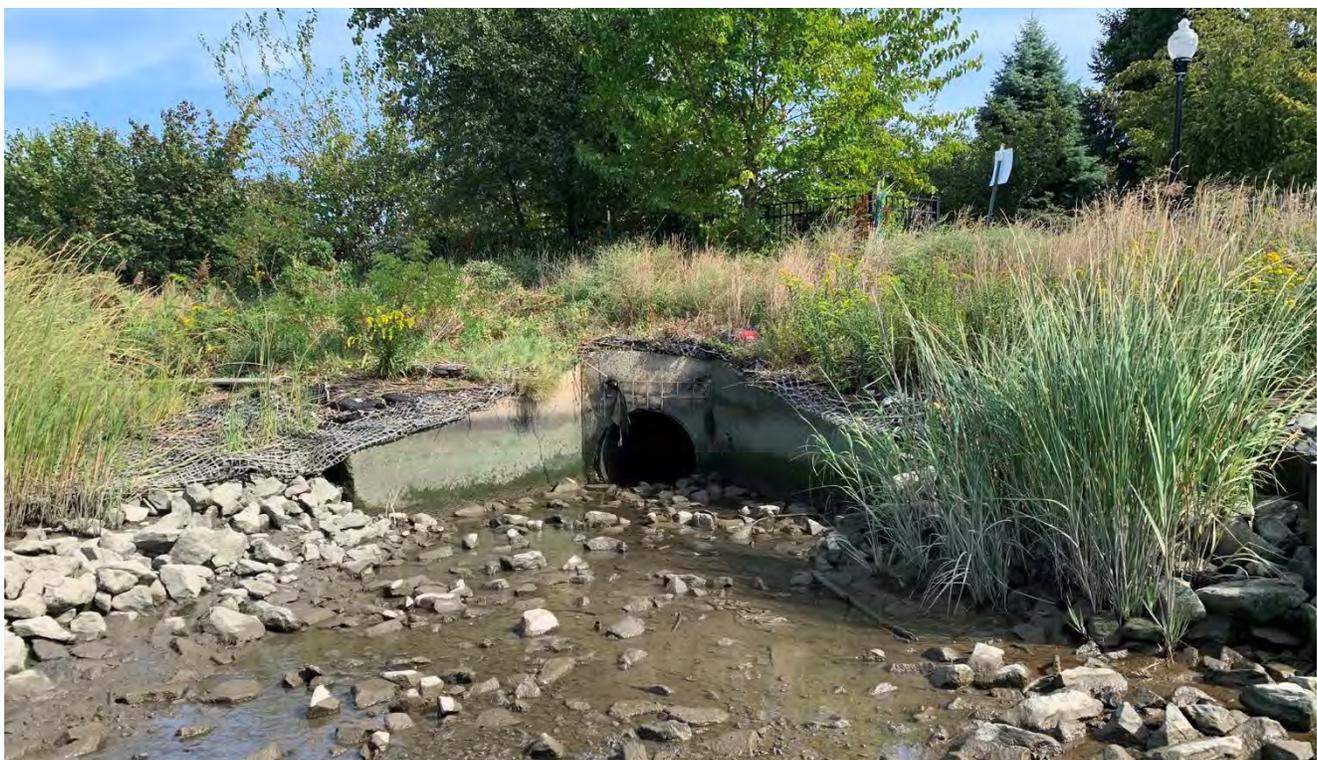
**Photo 21:** Exposed geogrid over and around the Outfall C structure and within the high marsh planting zone (facing south).

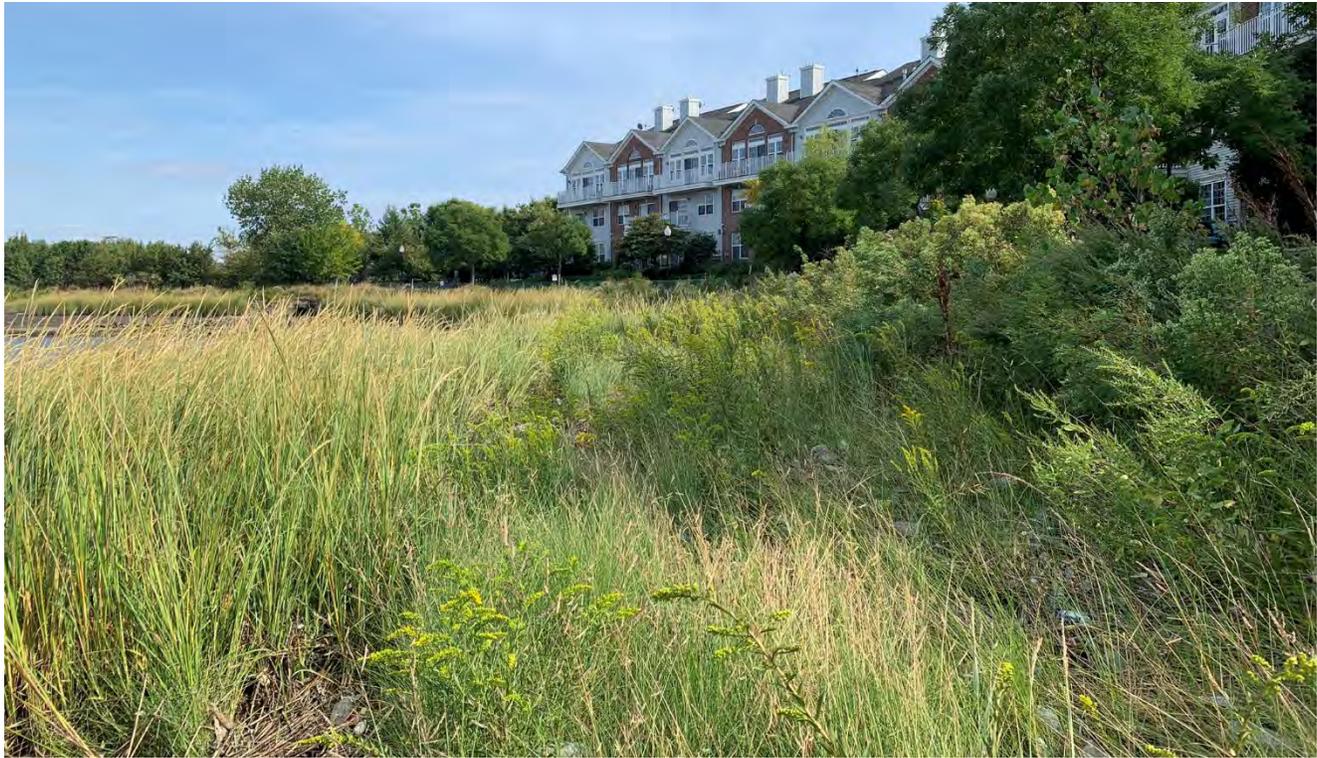
**Photo 22:** Healthy vegetation in the upland transition, high marsh, and low marsh planting zones east of Outfall A (facing east).

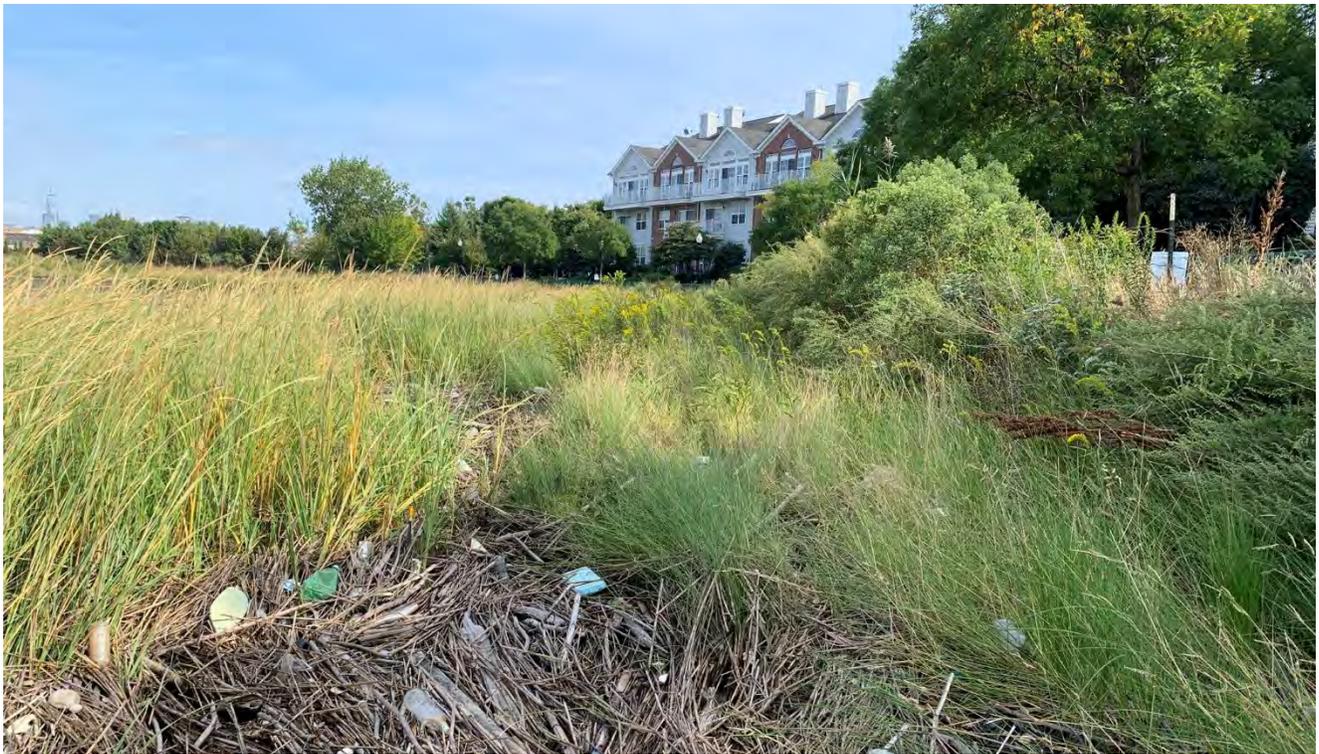
**Photo 23:** Healthy vegetation in the upland transition area east of Outfall A. Note presence of tidal drift and debris covering the interface between the low and high marsh zones (facing southeast).

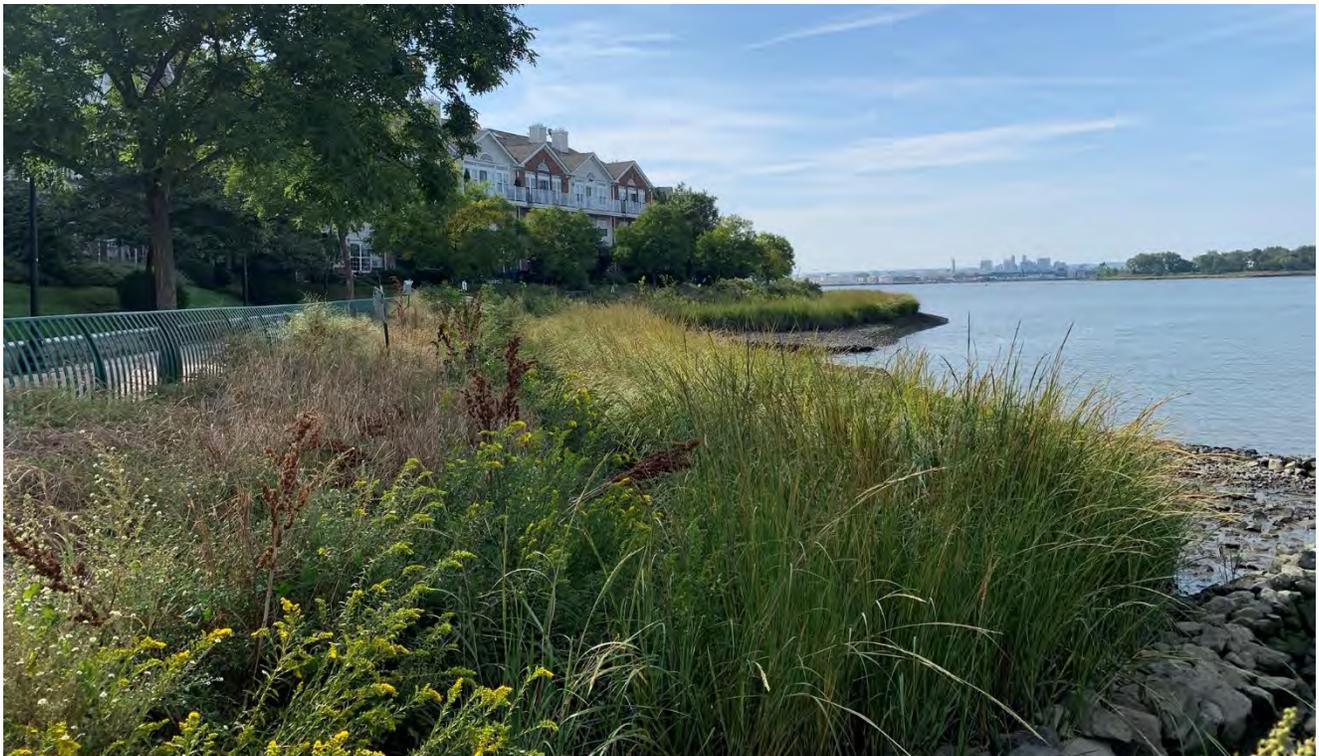
**Photo 24:** Healthy and vibrant vegetation in the upland transition zone in the western portion of the BEP (facing west).

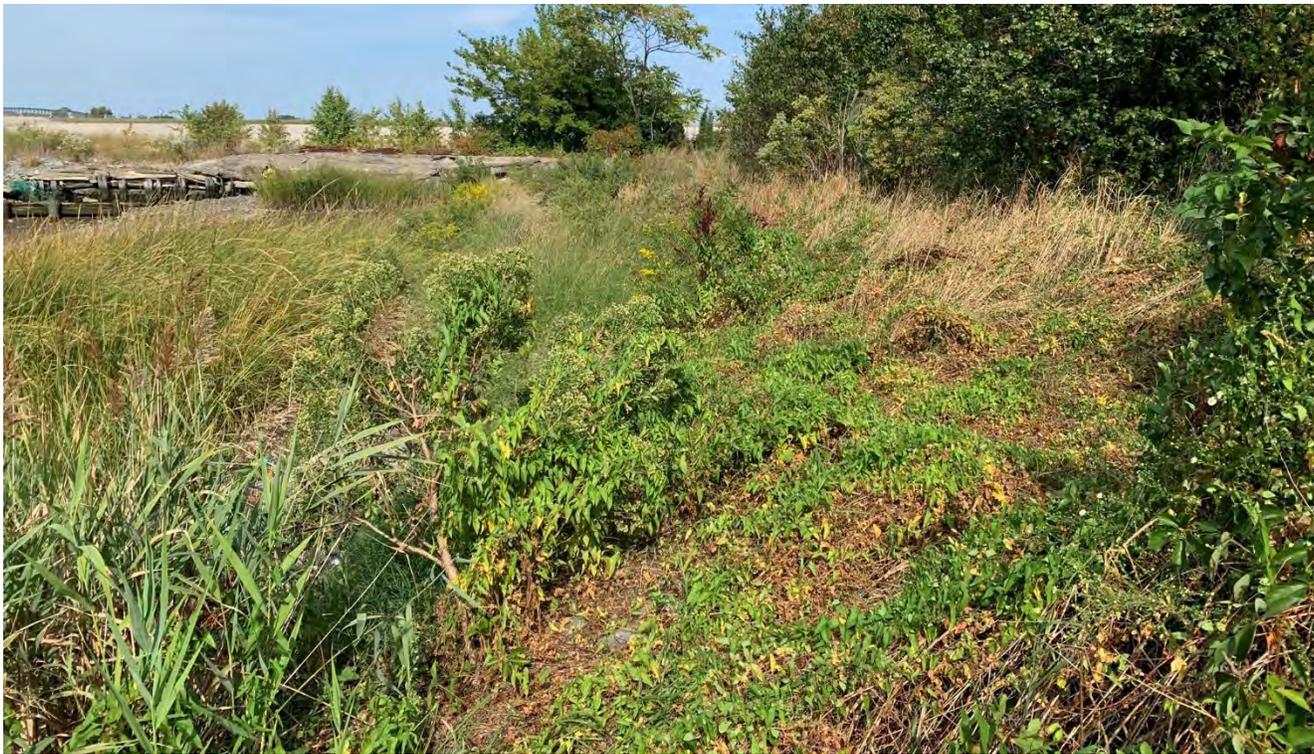
**Photo 25:** Healthy and vibrant vegetation in the upland transition zone in the eastern portion of the BEP (facing east).

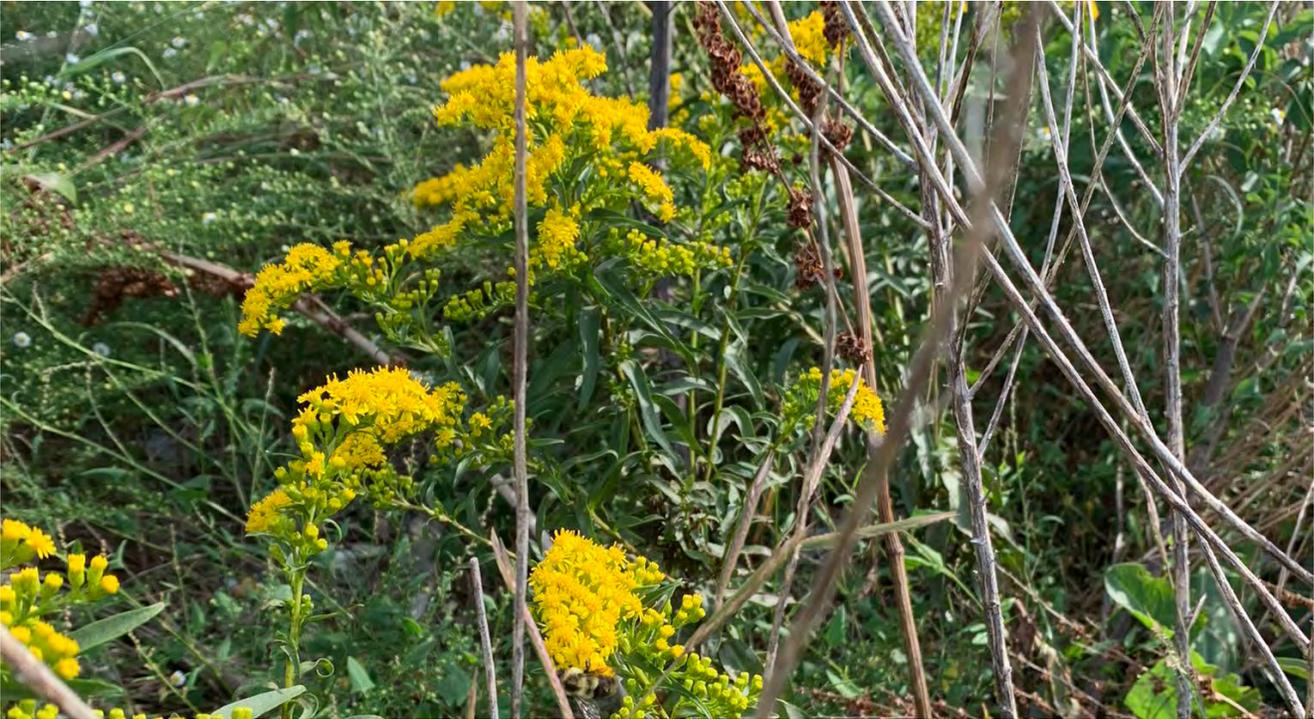
**Photo 26:** Native species northern seaside goldenrod located within the upland transitional planting zone of the BEP.

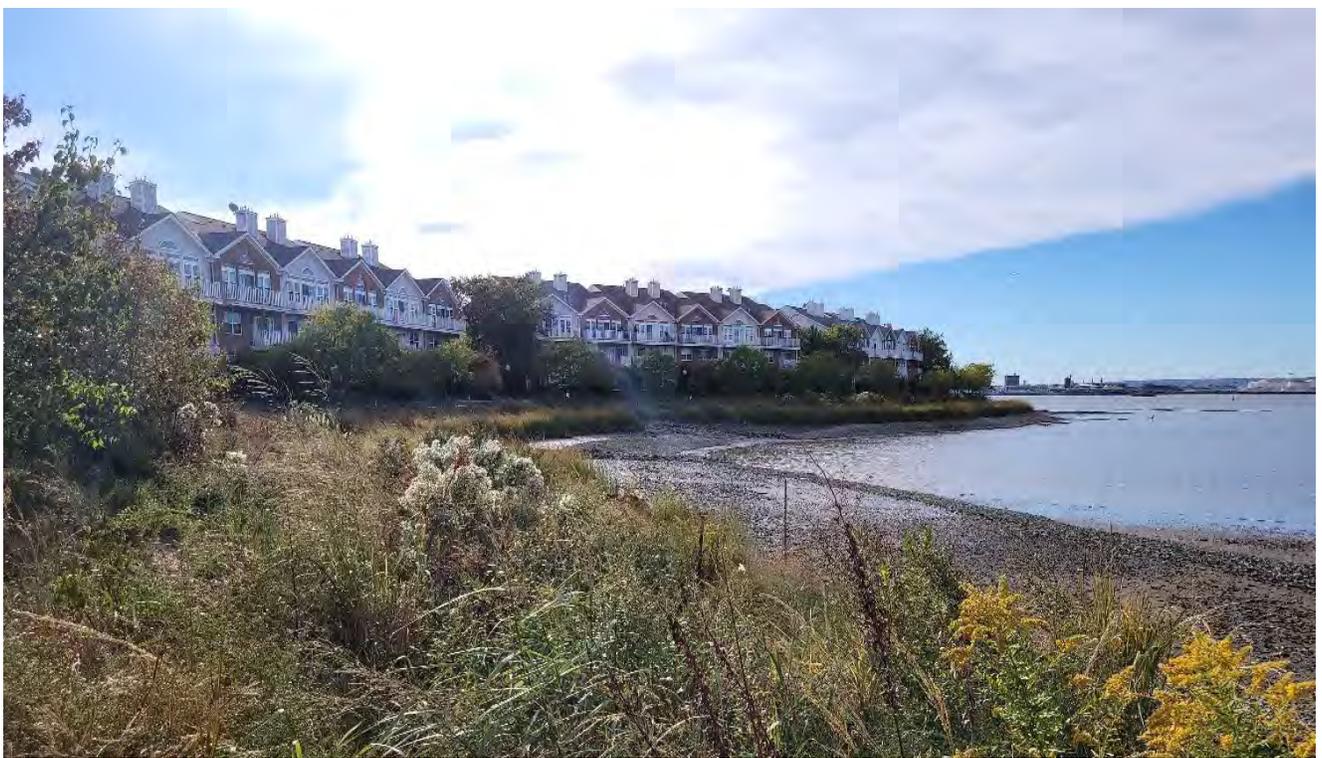
**Photo 1:** Northern end of Cap Area 16 (facing west). Note vibrant and healthy vegetation present in high marsh planting and upland zones.

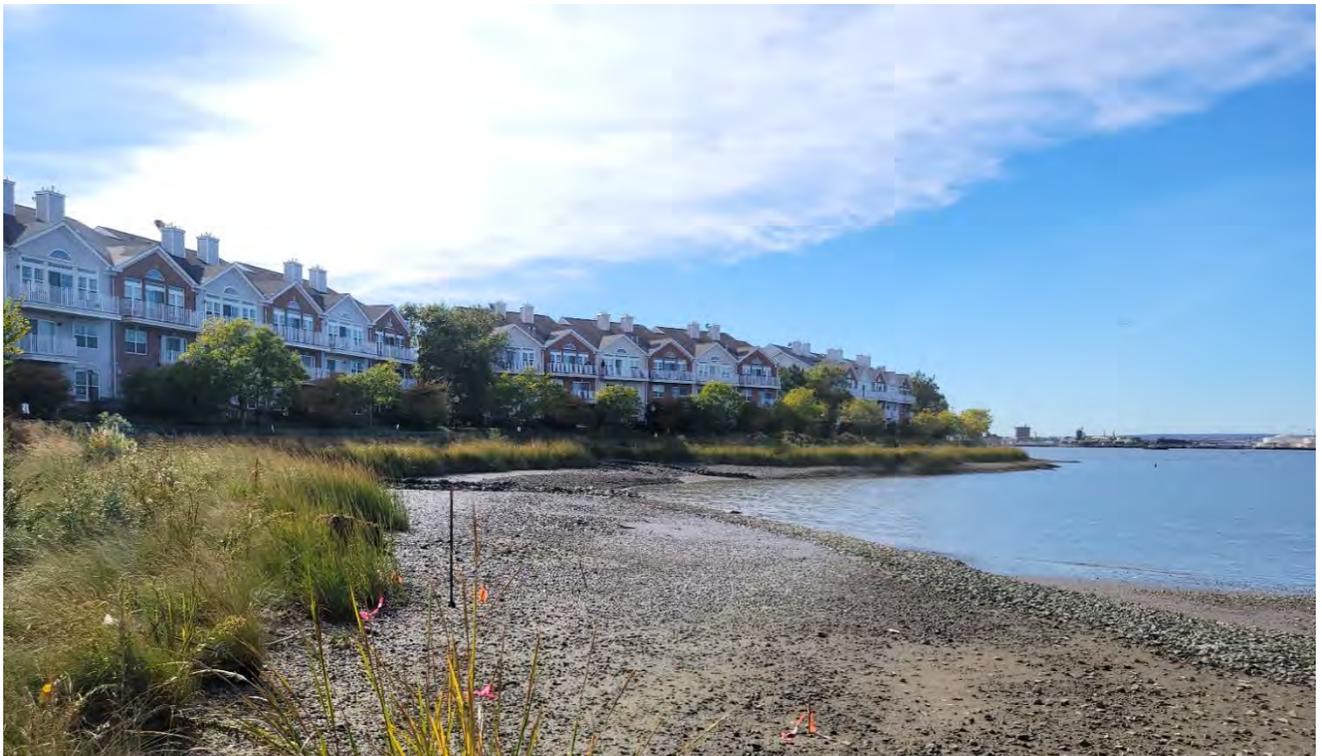
**Photo 2:** Central portion of Cap Area 16 (facing west). Note reference posts used to assess sediment surface changes.

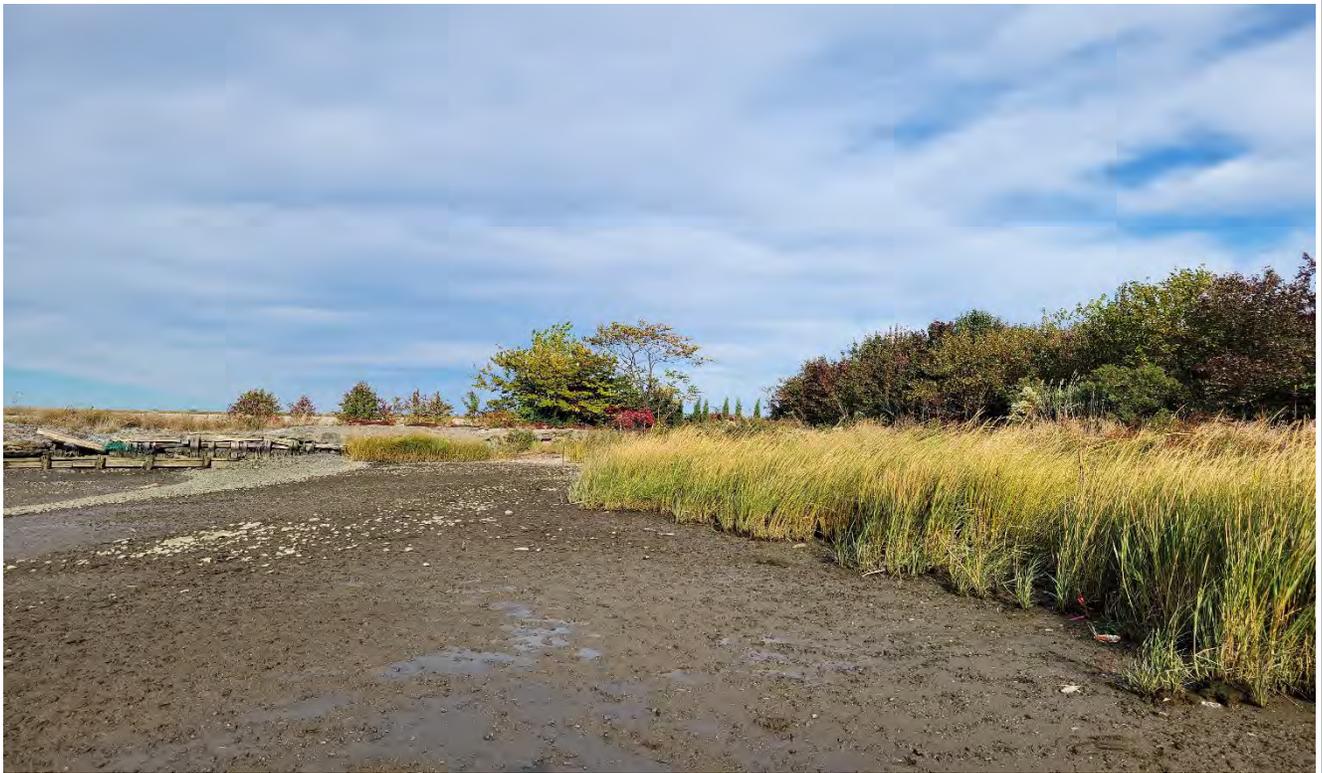
**Photo 3:** Western end of Cap Area 16 (facing east). Note the vibrant and healthy vegetation in the low and high marsh planting zones.

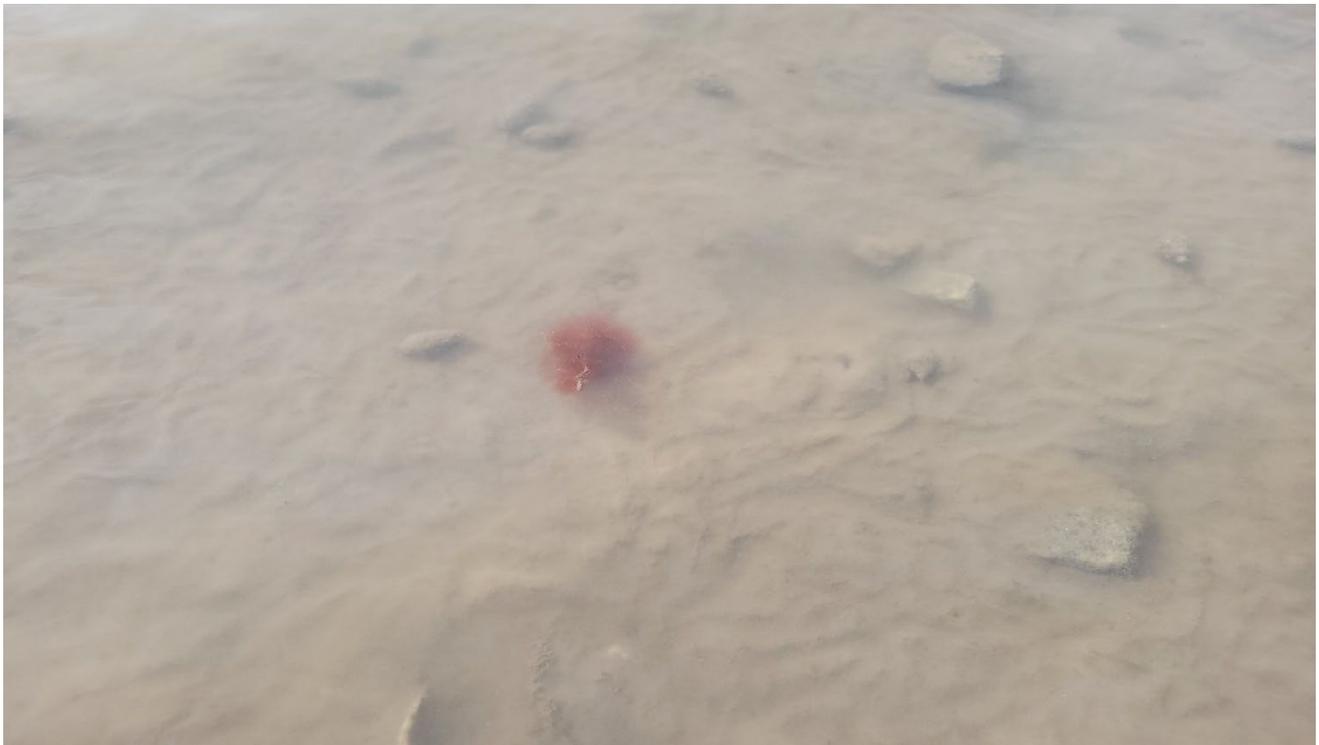
**Photo 4:** Subaquatic vegetation and sediment accumulation observed within Cap Area 22 (facing northwest).

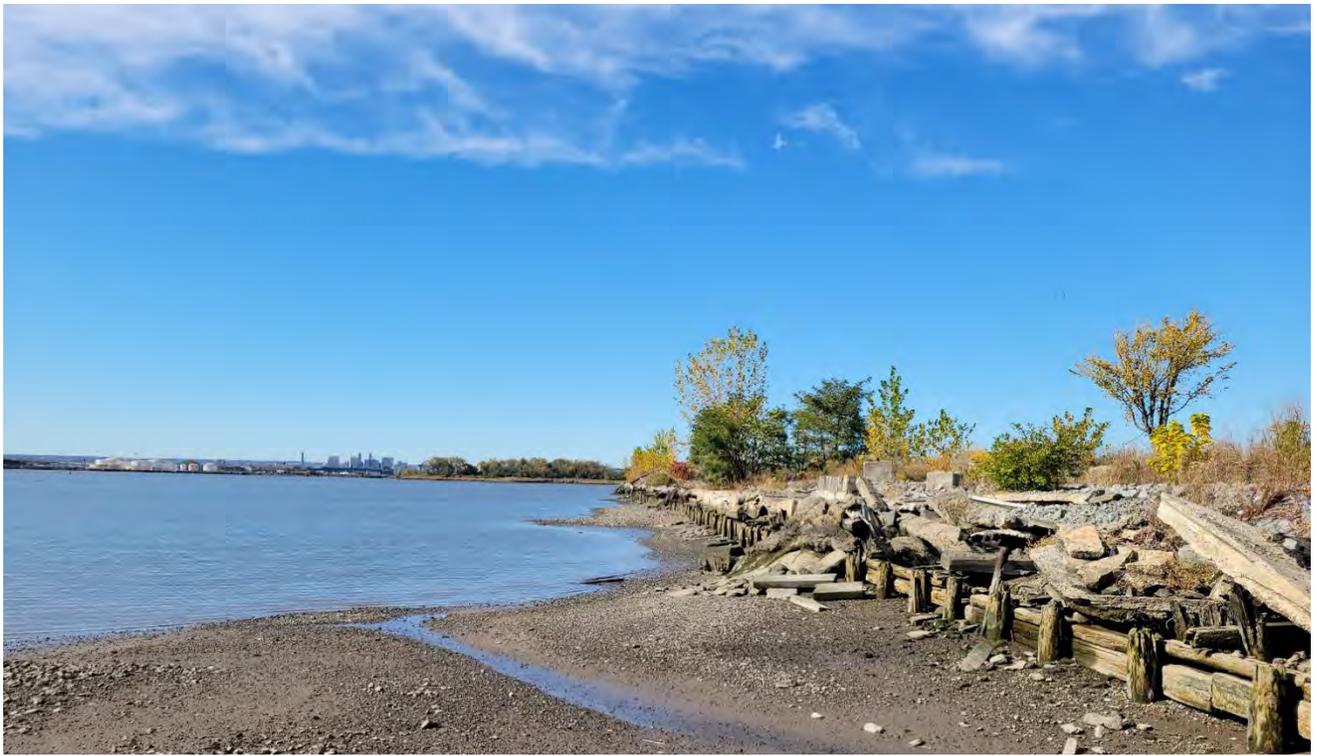
**Photo 5:** Cap Area 22 partially exposed during low tide (facing west).

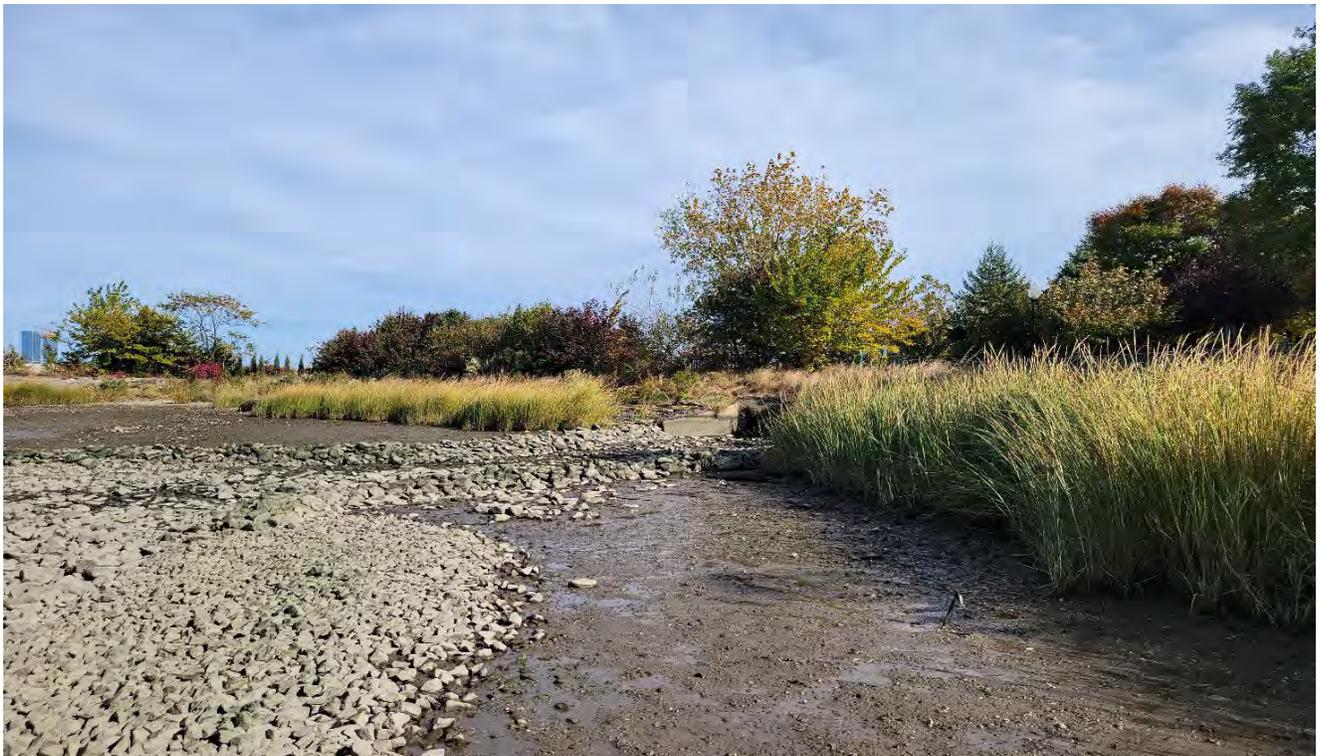
**Photo 6:** Central portion of the BEP, between Outfalls A and B (facing east). Note vibrant and healthy vegetation in the low marsh planting zone.

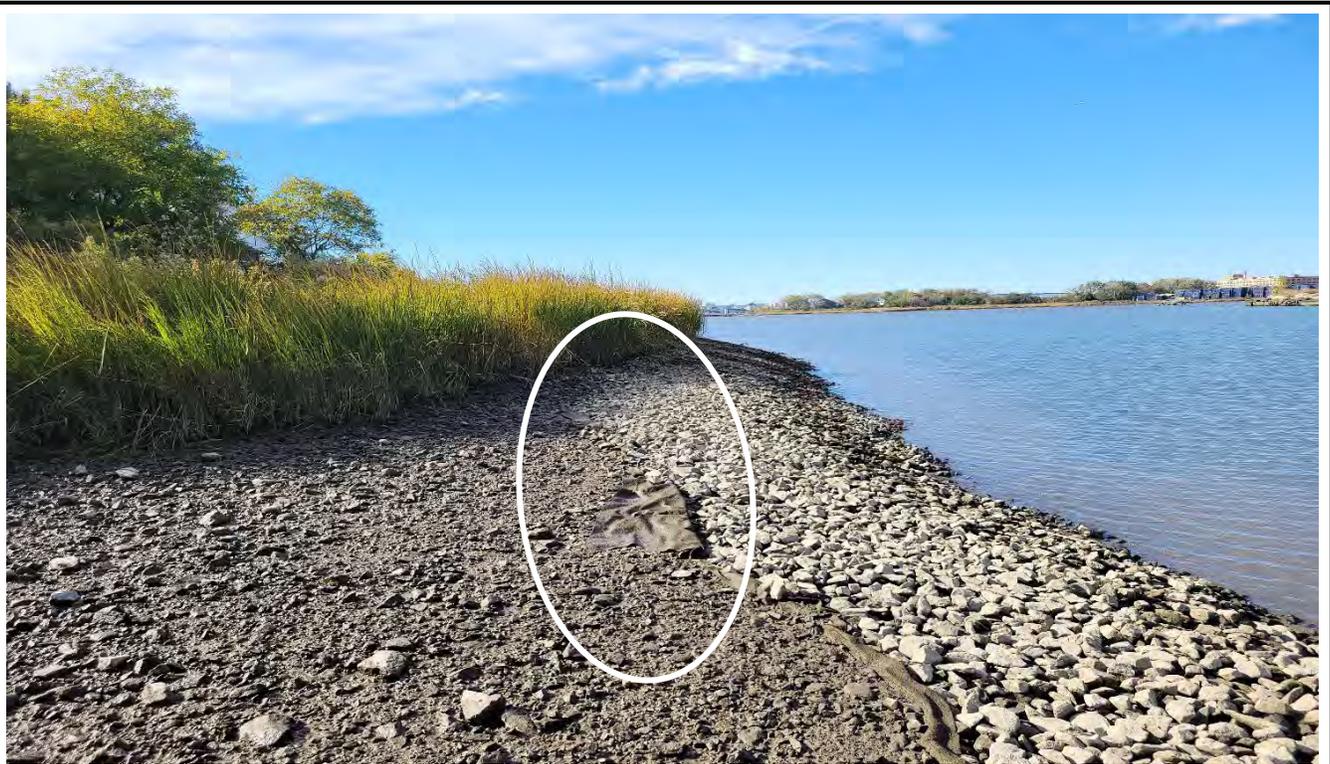
**Photo 7:** Exposed geotextile fabric between the shoreline stabilization berm and the BEP fill material west of Outfall A (facing west).

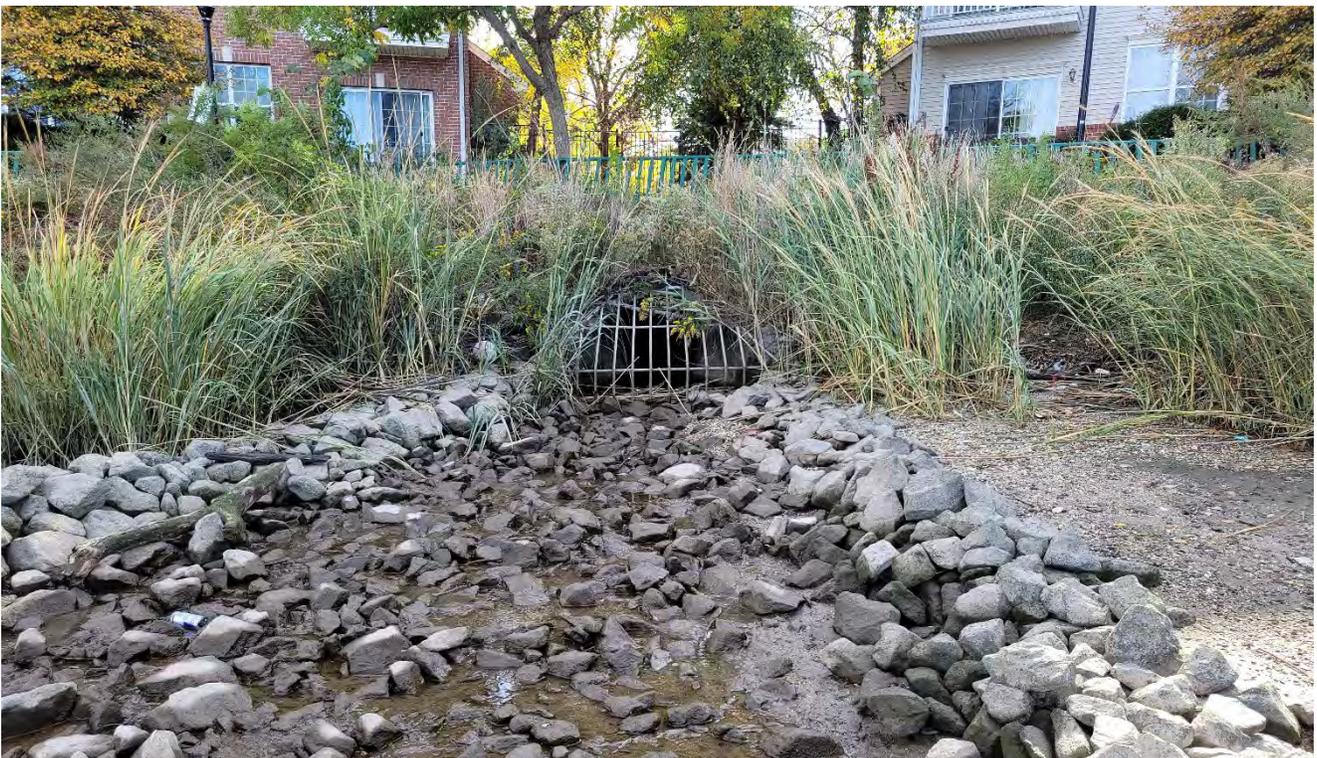
**Photo 8:** Outfall A and surrounding armor stone (facing southwest). Note vibrant and healthy vegetation in the low marsh and high marsh planting zones.

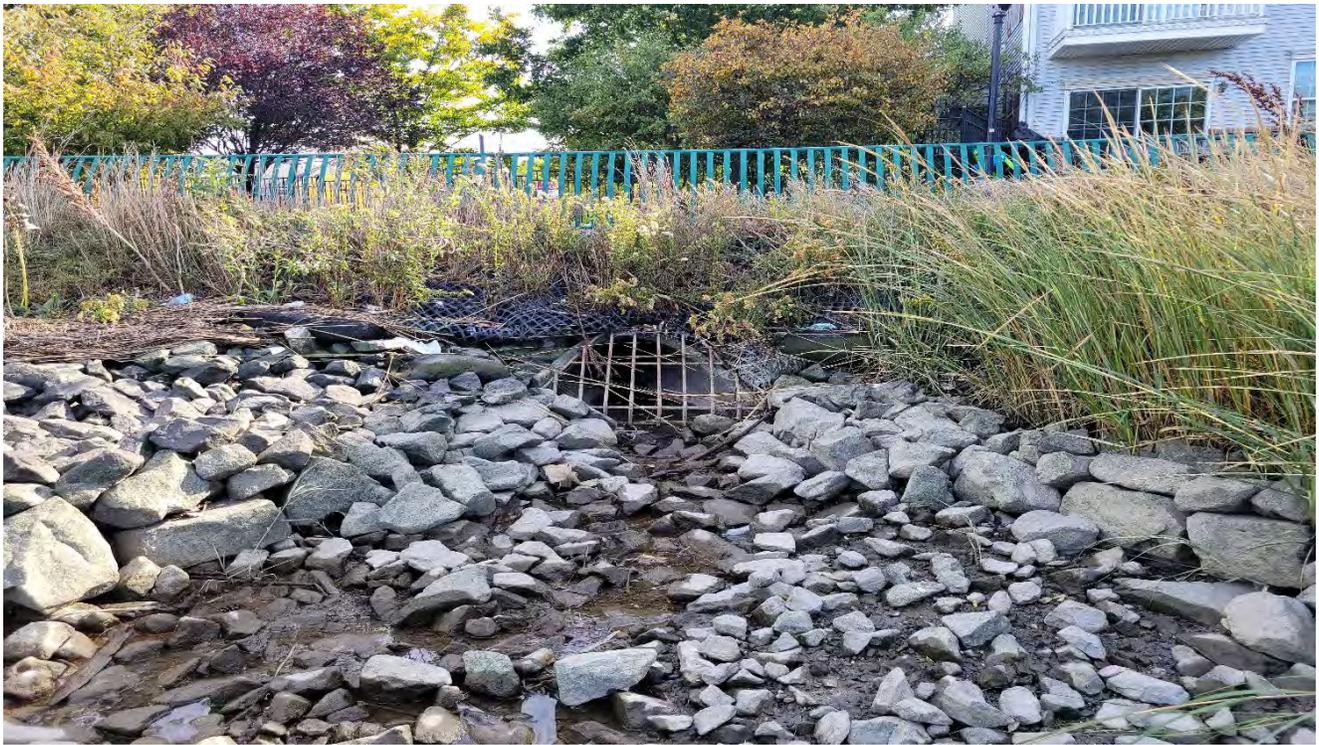
**Photo 9:** Outfall B and surrounding armor stone (facing south).

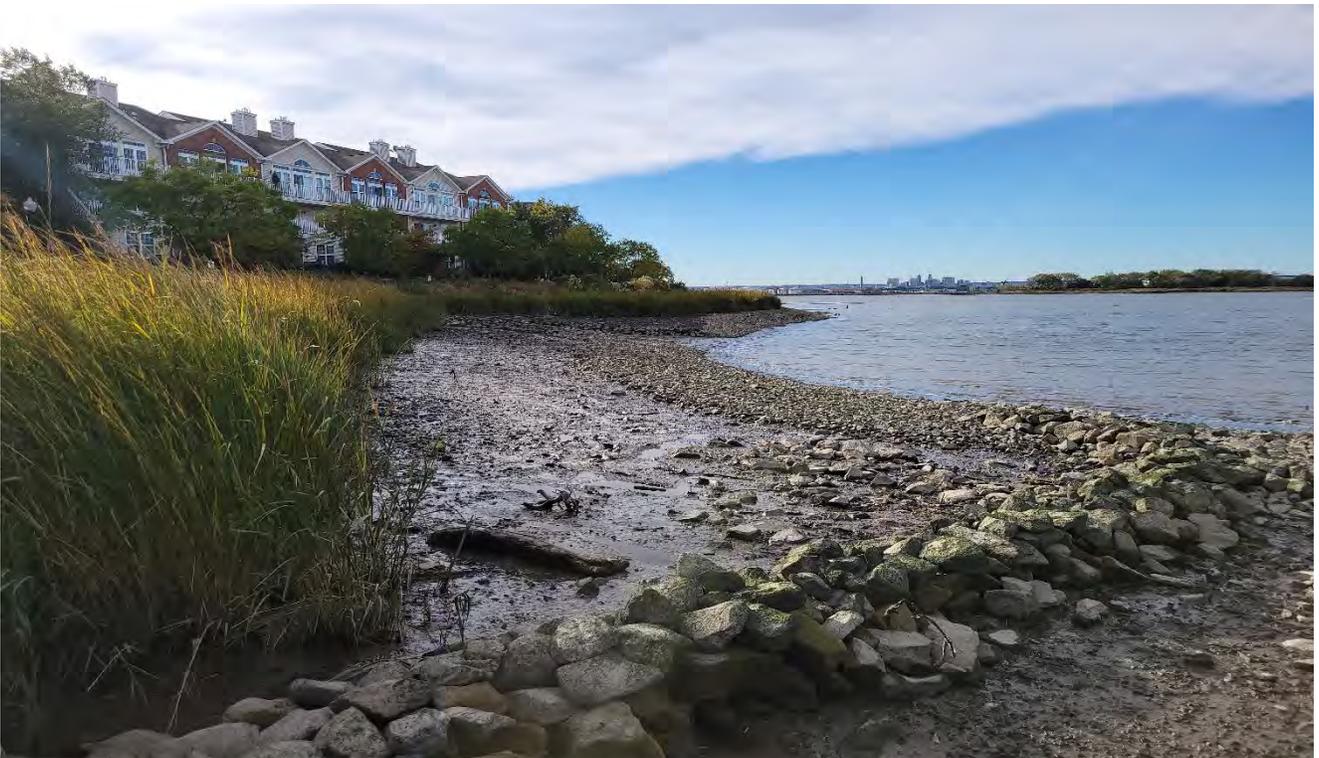
**Photo 10:** Armor stone along the western edge of the apron for Outfalls B and C (facing west). Note the siltation present on the apron stone.

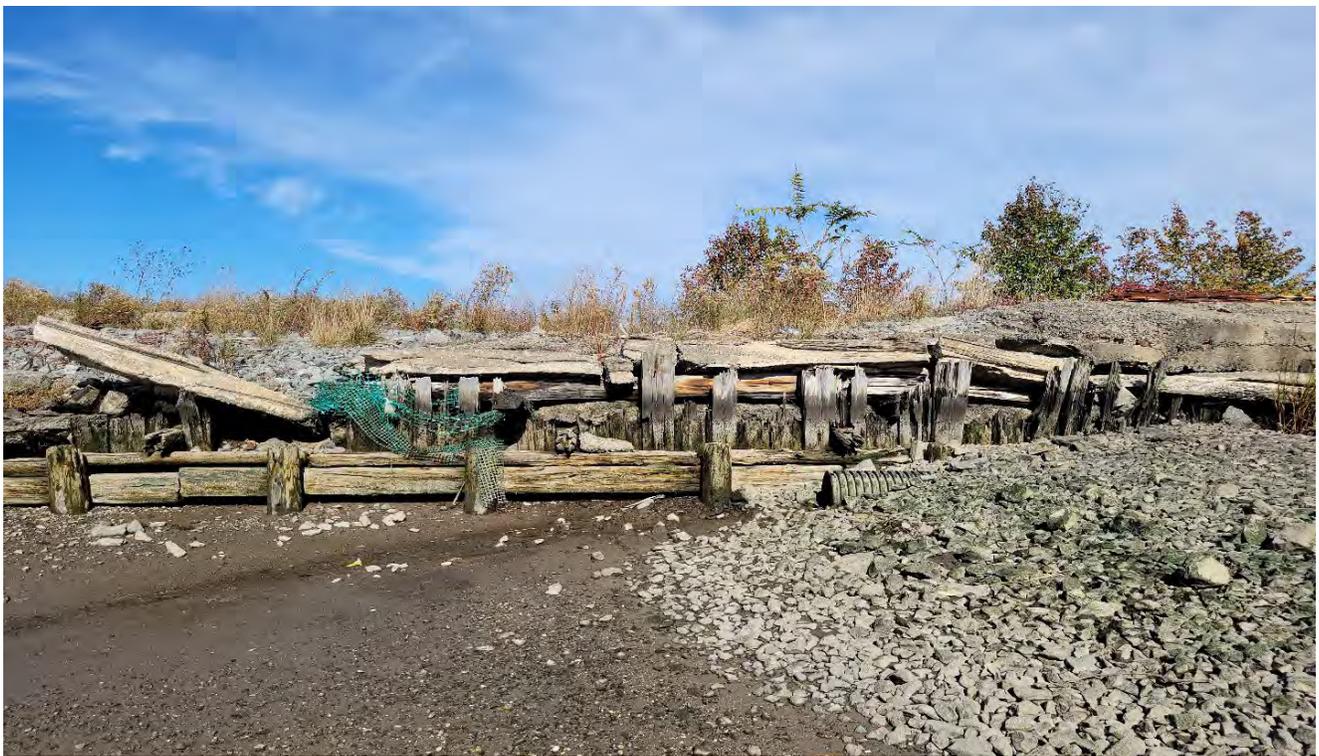
**Photo 11:** Outfall D discharge area where previously observed minor flow channel is overlain by displaced stone (facing east).

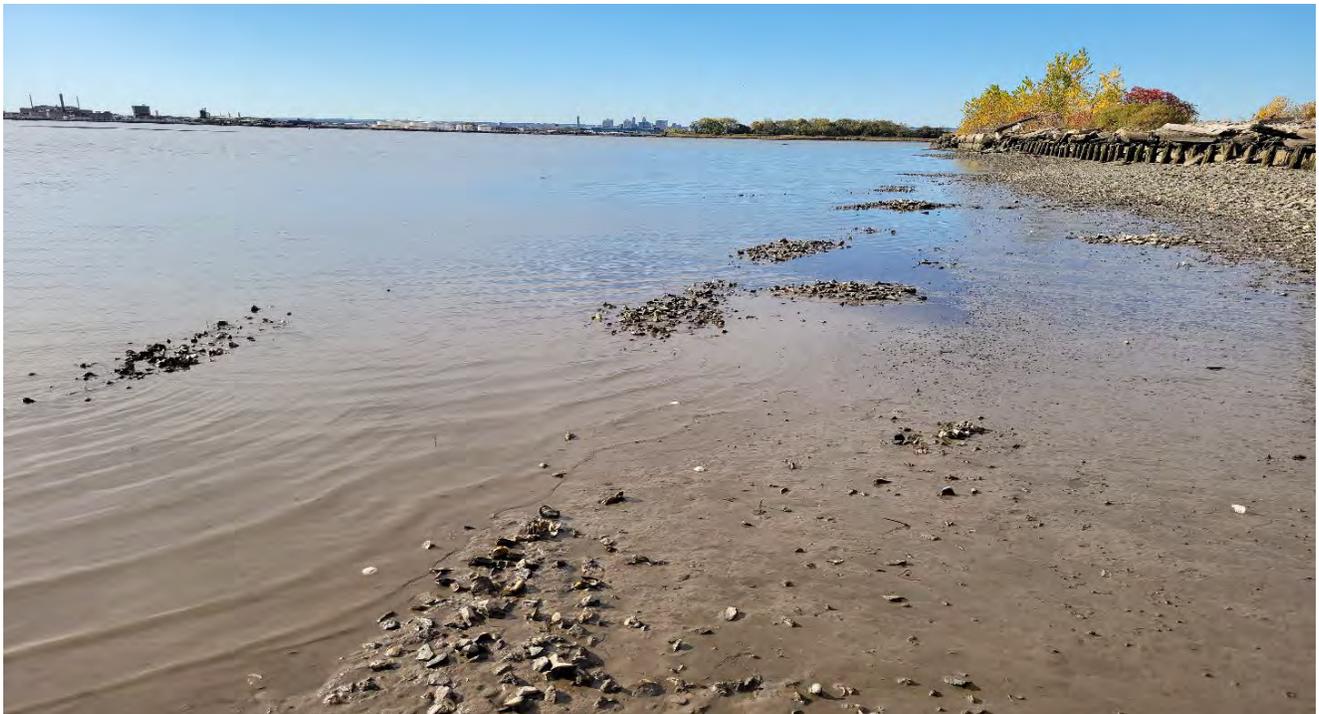
**Photo 12:** Cap Area 22 partially exposed during low tide (facing north). Note sediment accumulation on armoring.
