# MEMORANDUM

Subject: **SA-7 Sediment Remedy Long-Term Monitoring**  
**Summary of Year 11 Monitoring & Proposed Year 12**  
**Program**

**ATTACHMENT A  
YEAR 11 INSPECTION LOGS**

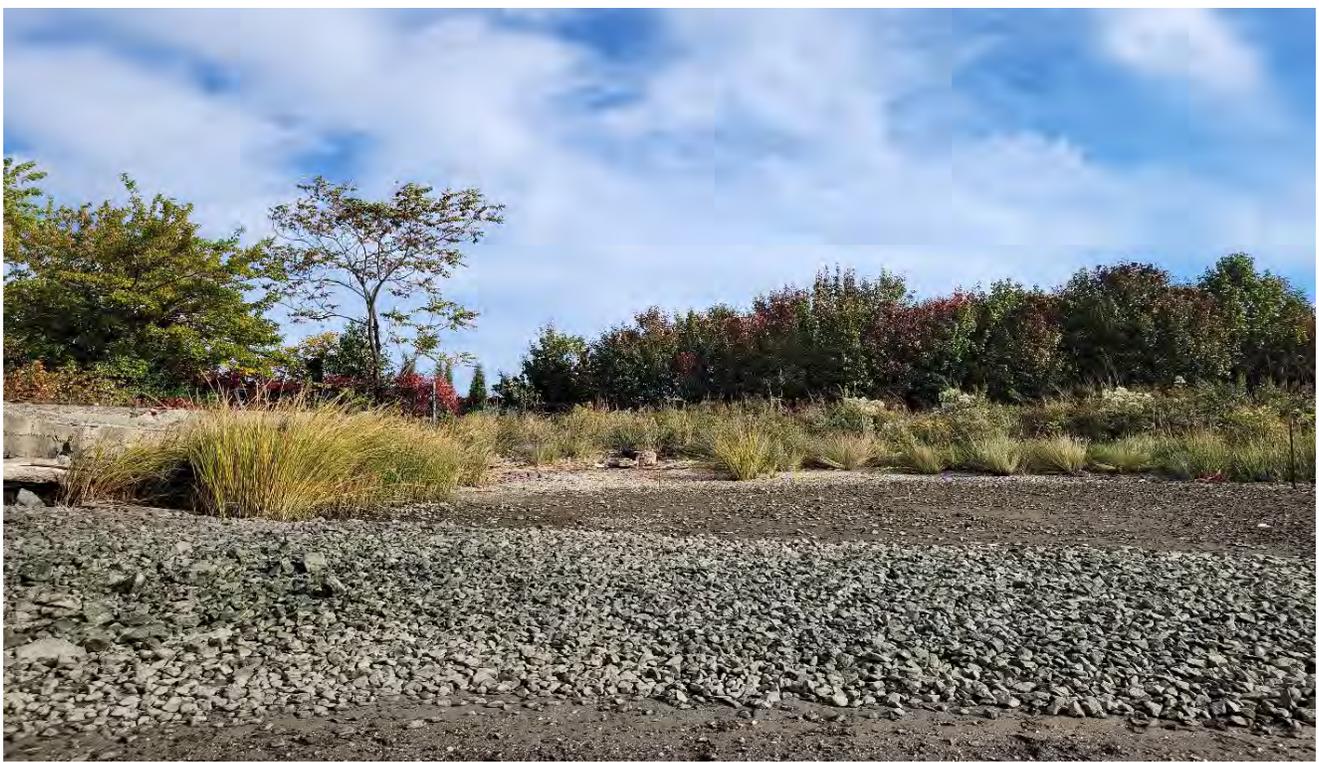
**Photo 13:** Low marsh zone in the eastern corner of the BEP near Outfall D (facing southeast). Note vibrant and healthy vegetation throughout the low marsh planting zone.

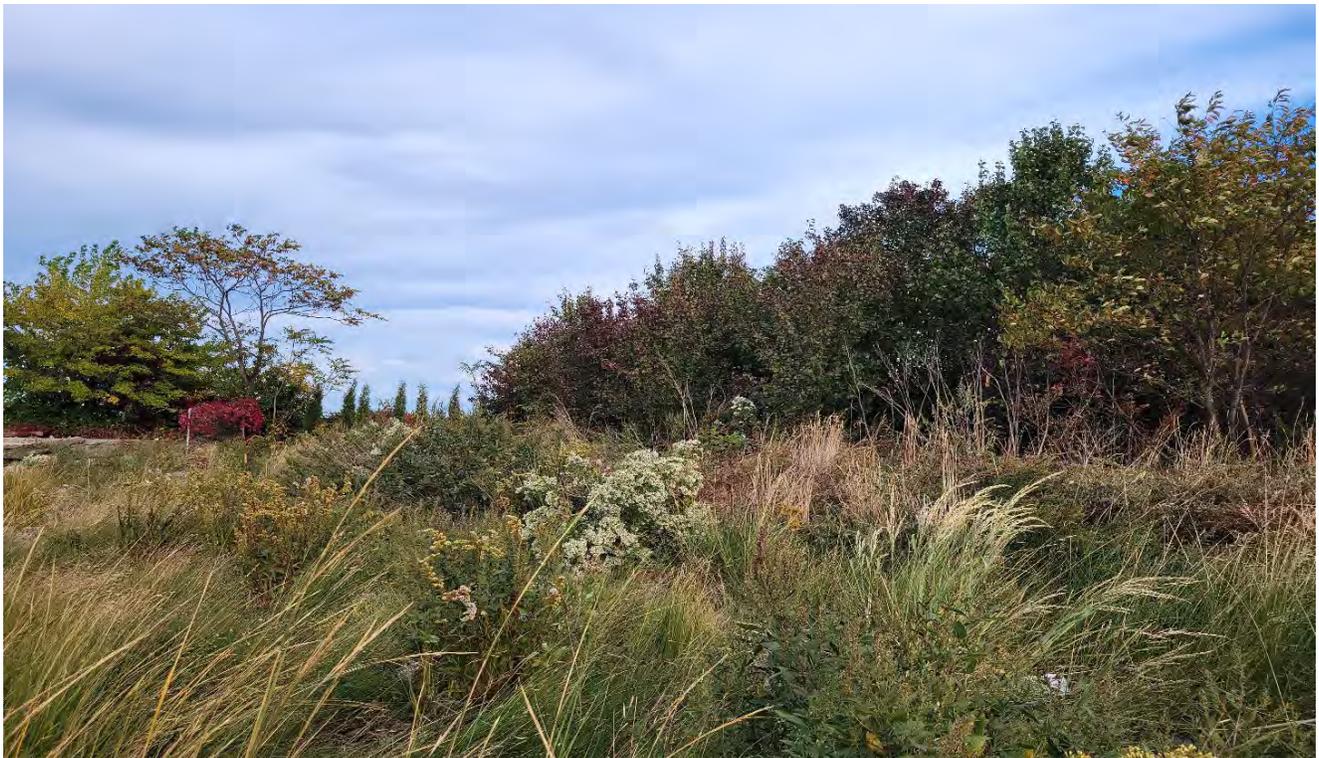
**Photo 14:** Transition from upland to low marsh zone in the easternmost corner of the BEP area (facing northeast).

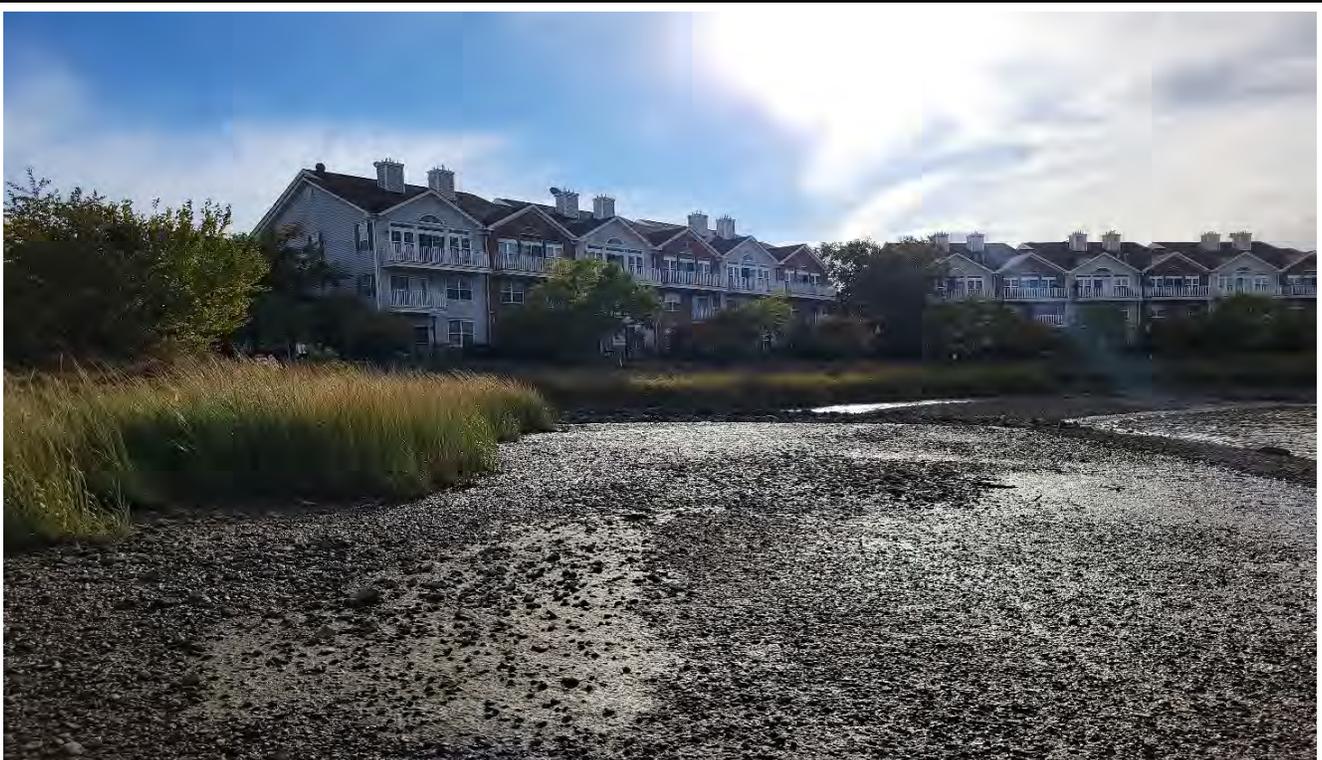
**Photo 15:** Low marsh planting zone on the eastern side of the BEP (facing west).

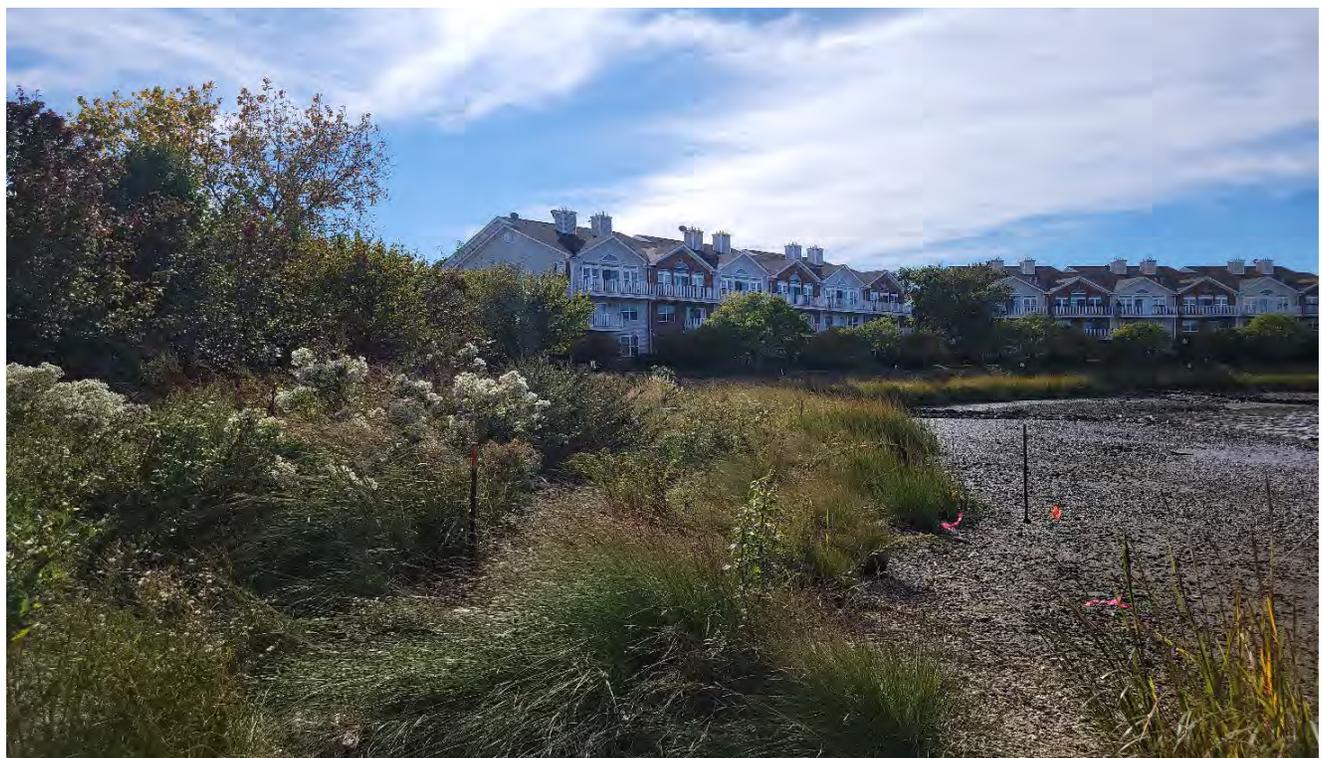
**Photo 16:** Transition area between low marsh planting zone and high marsh planting zone within the eastern side of the BEP (facing southeast). Note the vibrant and healthy low marsh and high marsh vegetation.

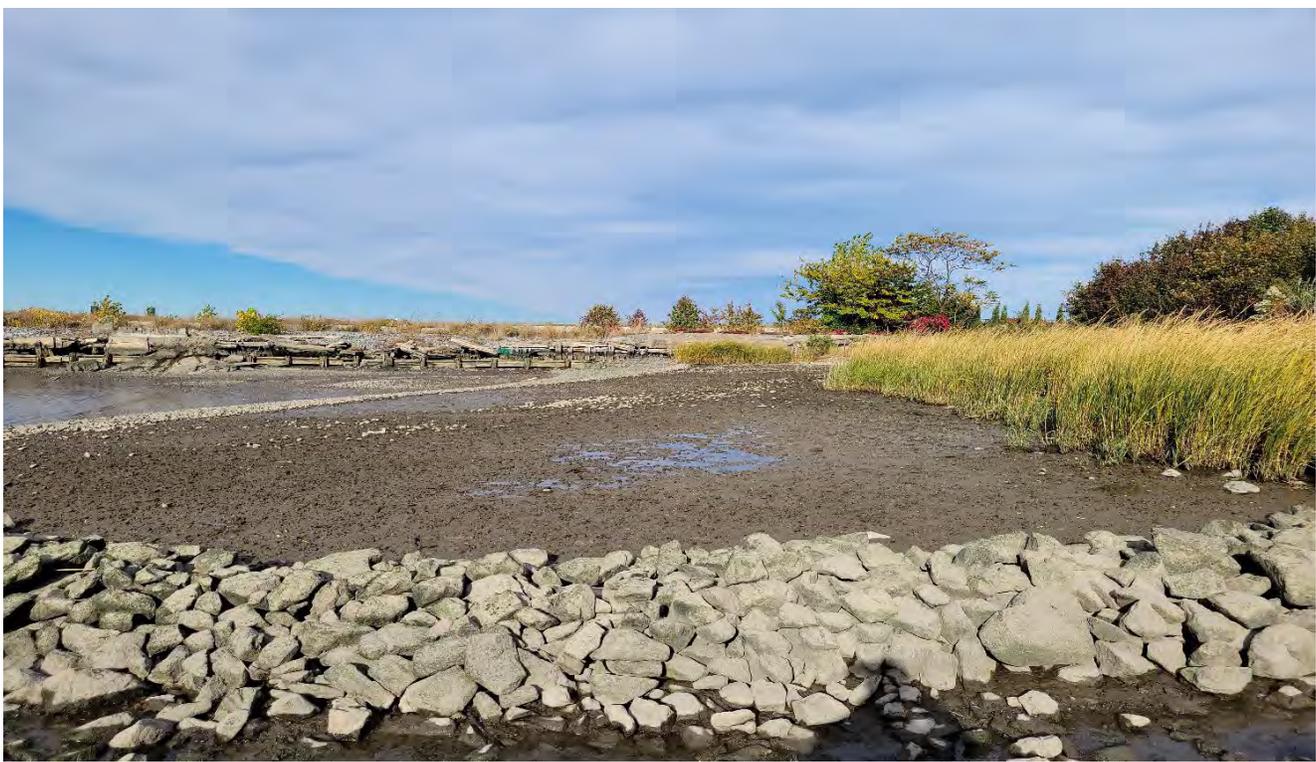
Photo 17: Low marsh planting zone within eastern portion of the BEP (facing northeast).

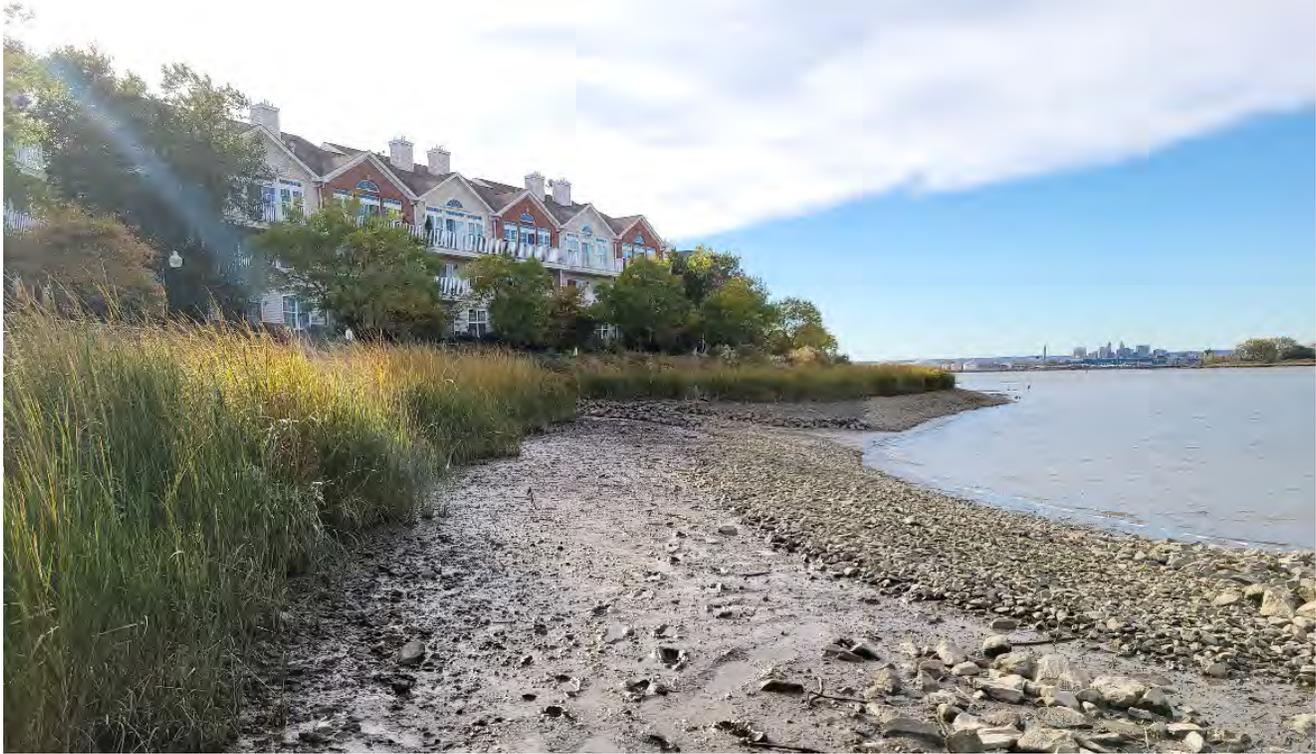
Photo 18: Low marsh planting zone between Outfalls A and B (facing west). Note the vibrant and healthy vegetation in the higher elevations of the low marsh area.

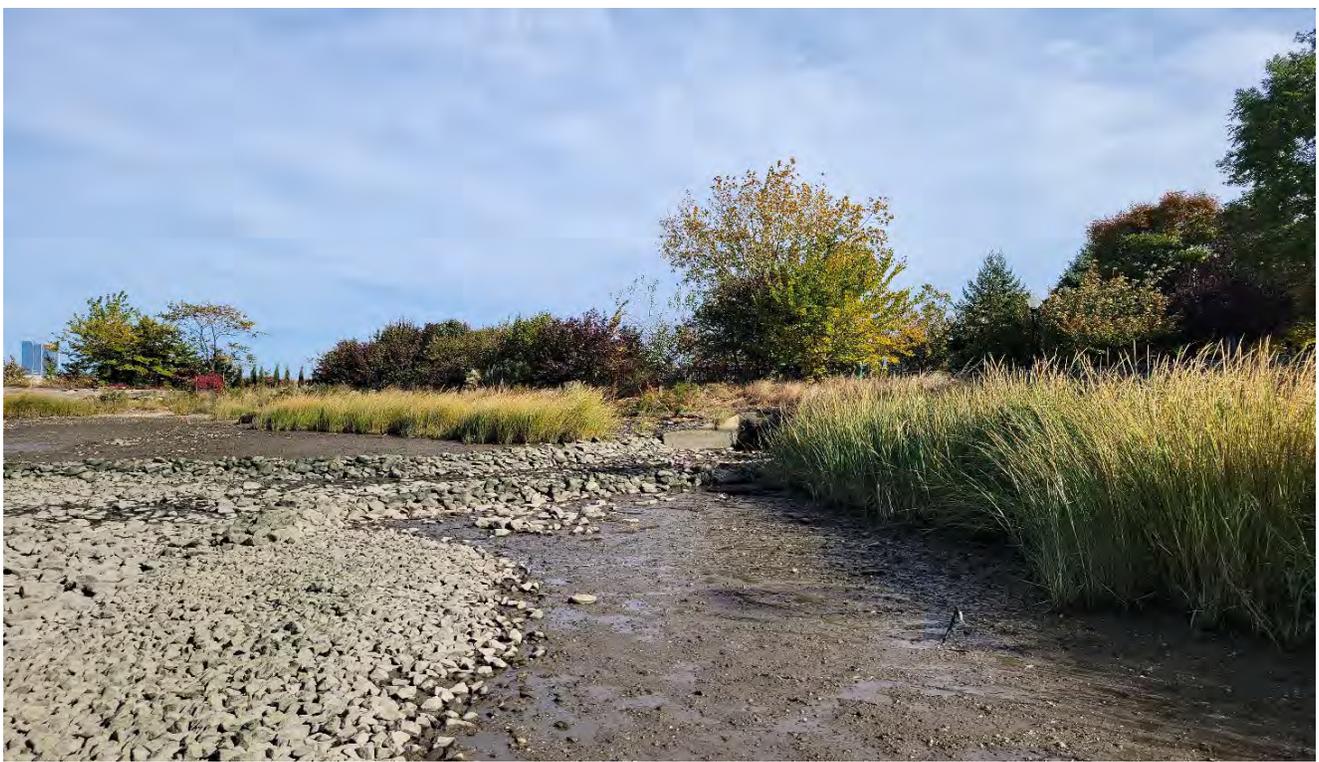
**Photo 19:** Vibrant and healthy vegetation in the higher elevations of the low marsh zone and high marsh zones in the eastern BEP area (facing southeast).

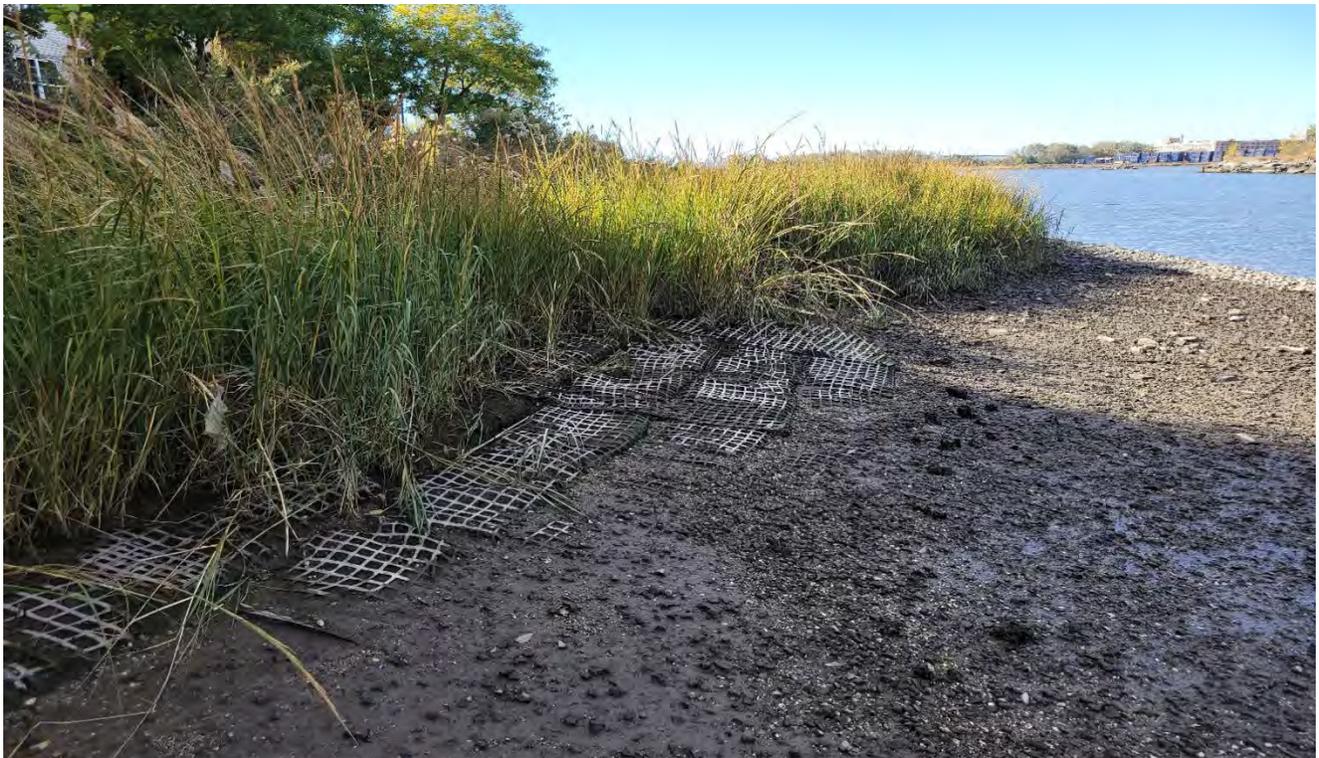
**Photo 20:** Vibrant and healthy low and high marsh zones west of Outfall A (facing southwest). Note the exposed geogrid and absence of GroSoxx at the bottom of the low marsh zone.

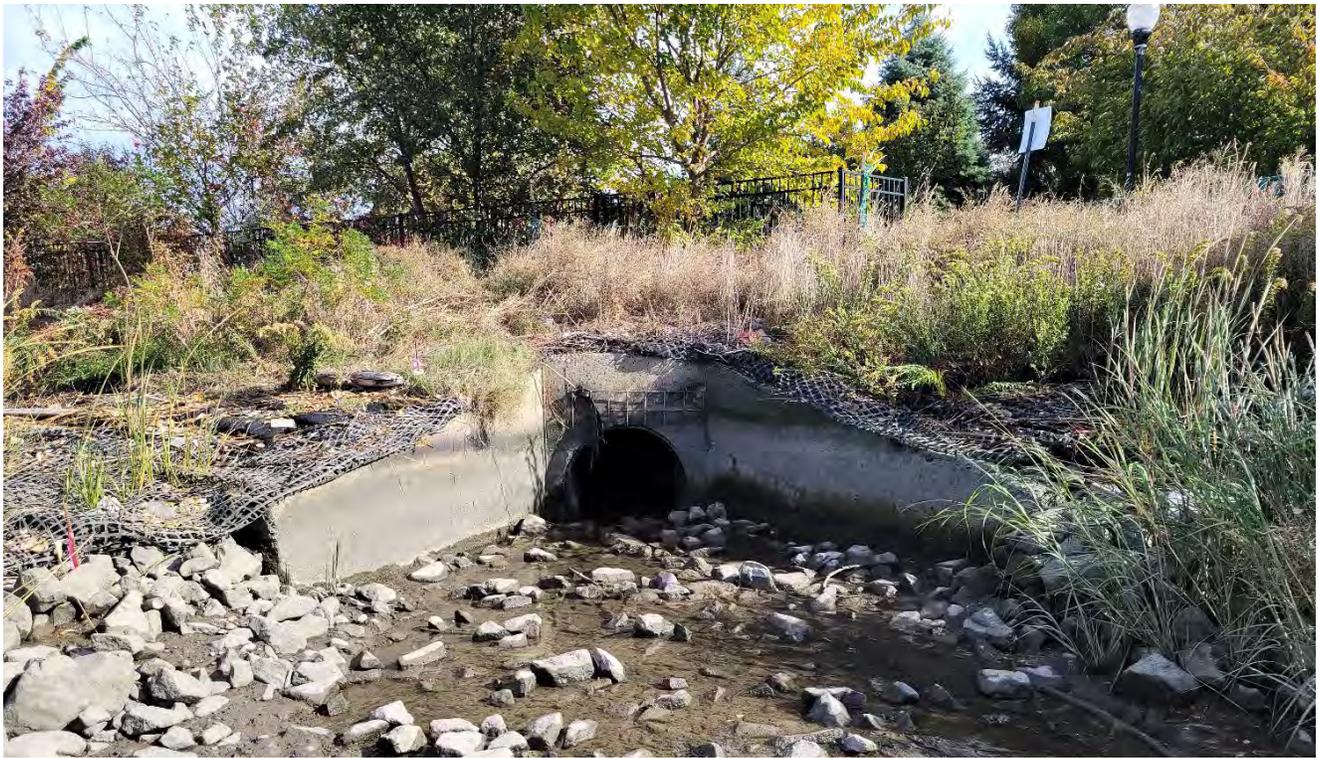
**Photo 21:** Exposed geogrid over and around the Outfall C structure and within the high marsh planting zone (facing south).

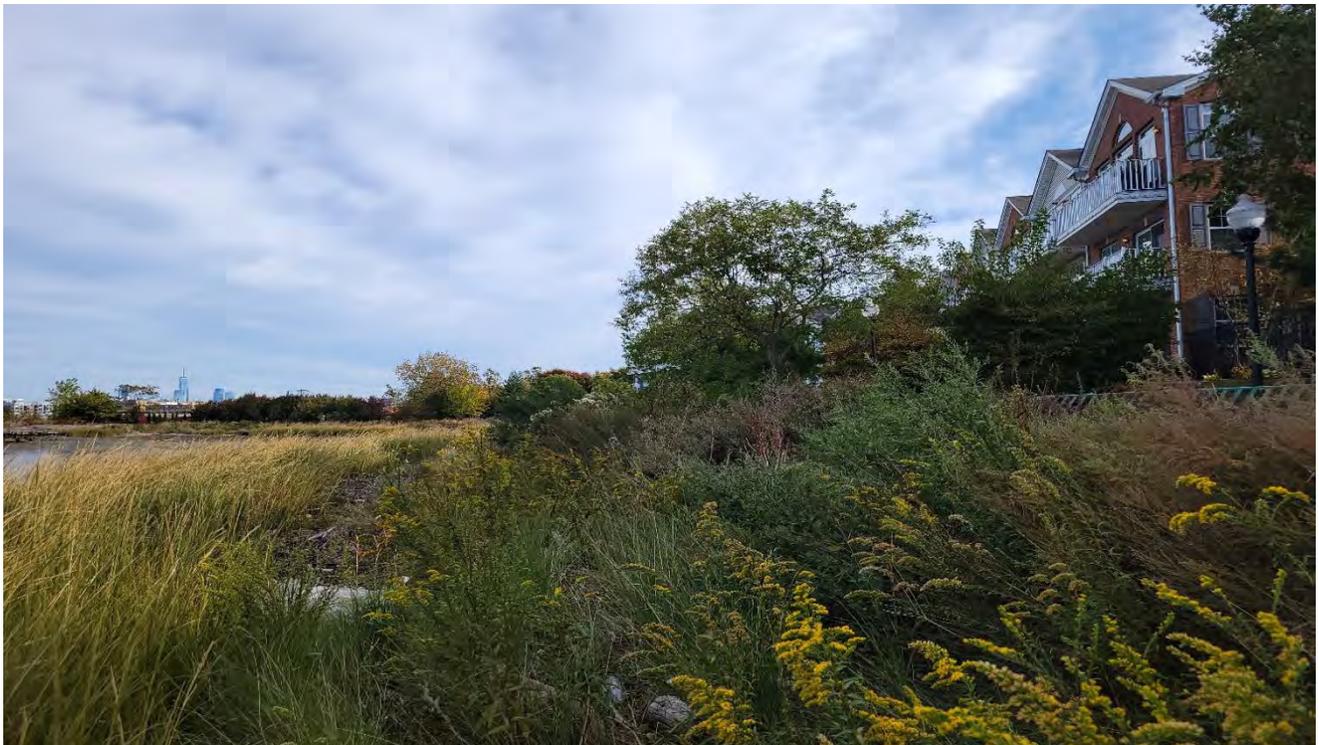
**Photo 22:** Healthy low and high marsh vegetation west of Outfall A (facing east). Note the presence of tidal drift deposits and debris within the high marsh areas.

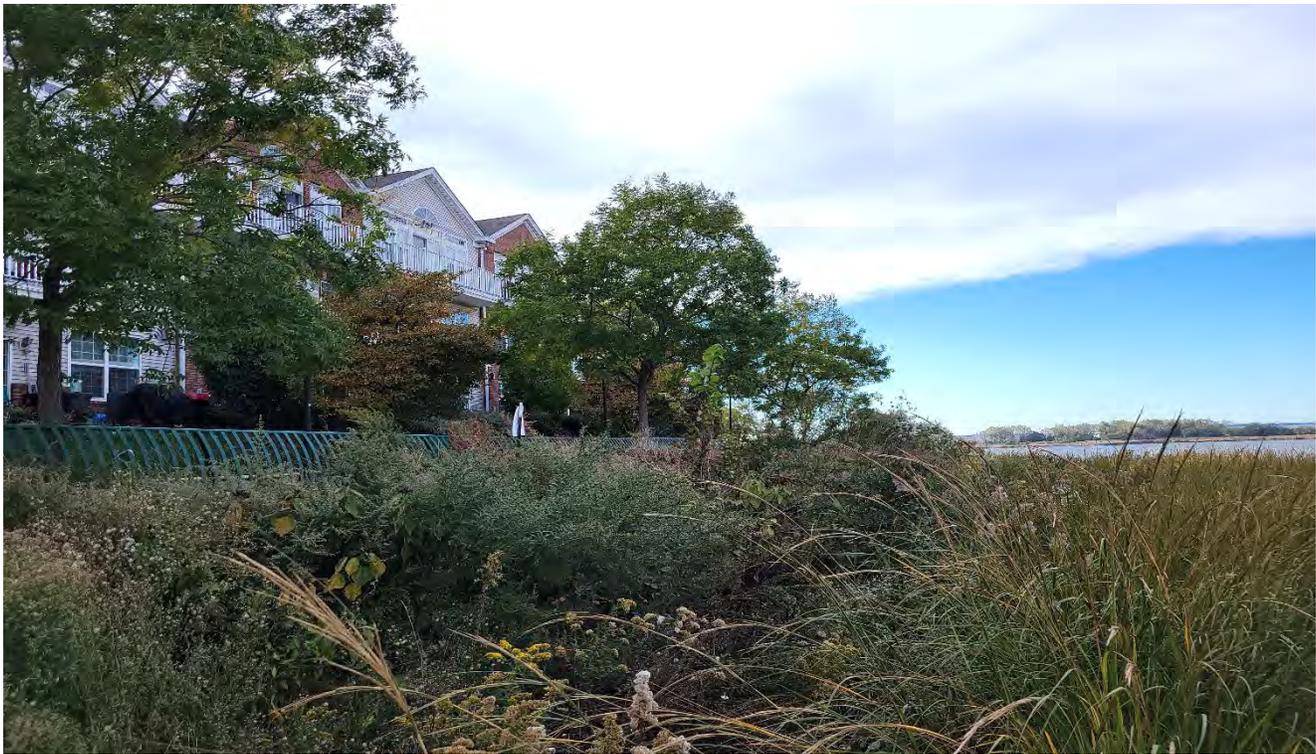
**Photo 23:** Healthy vegetation in the upland transition area and interface between the low and high marsh between Outfalls A and B (facing west).

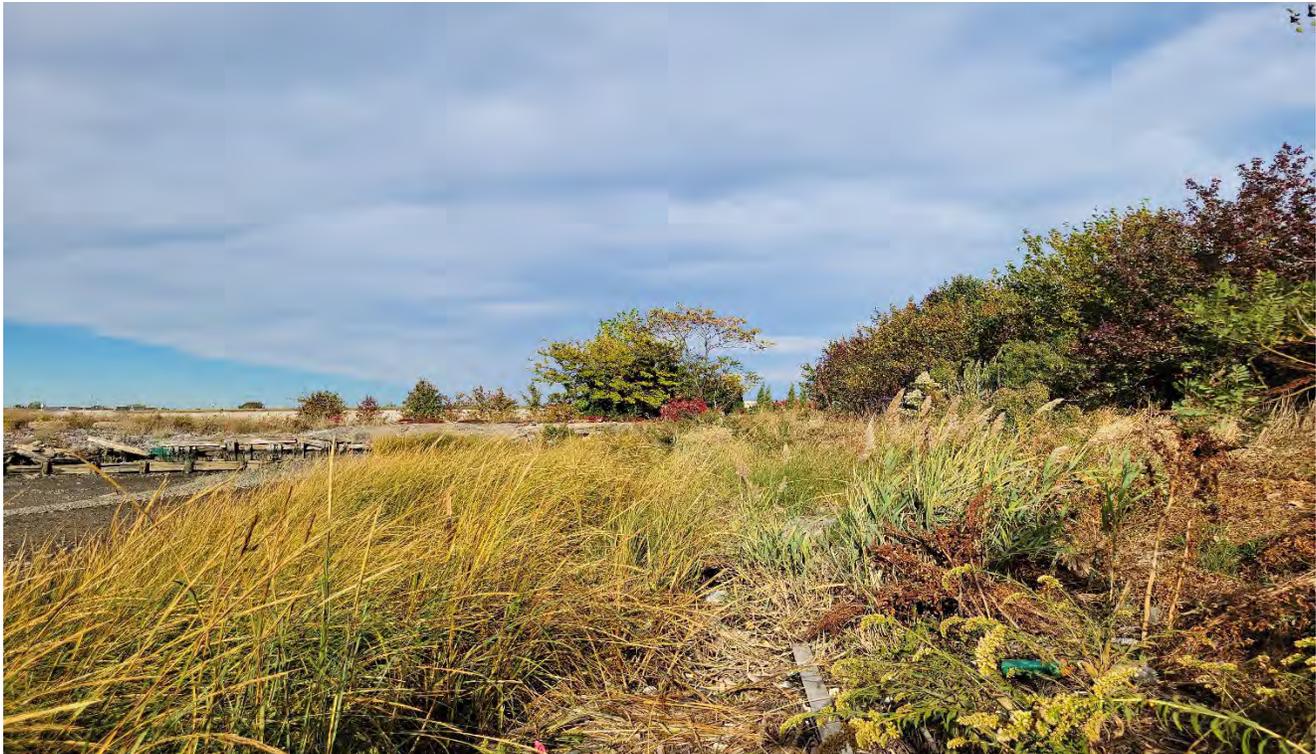
**Photo 24:** Healthy vegetation in the upland transitional area and interface between the low and high marsh west of Outfall A (facing east).

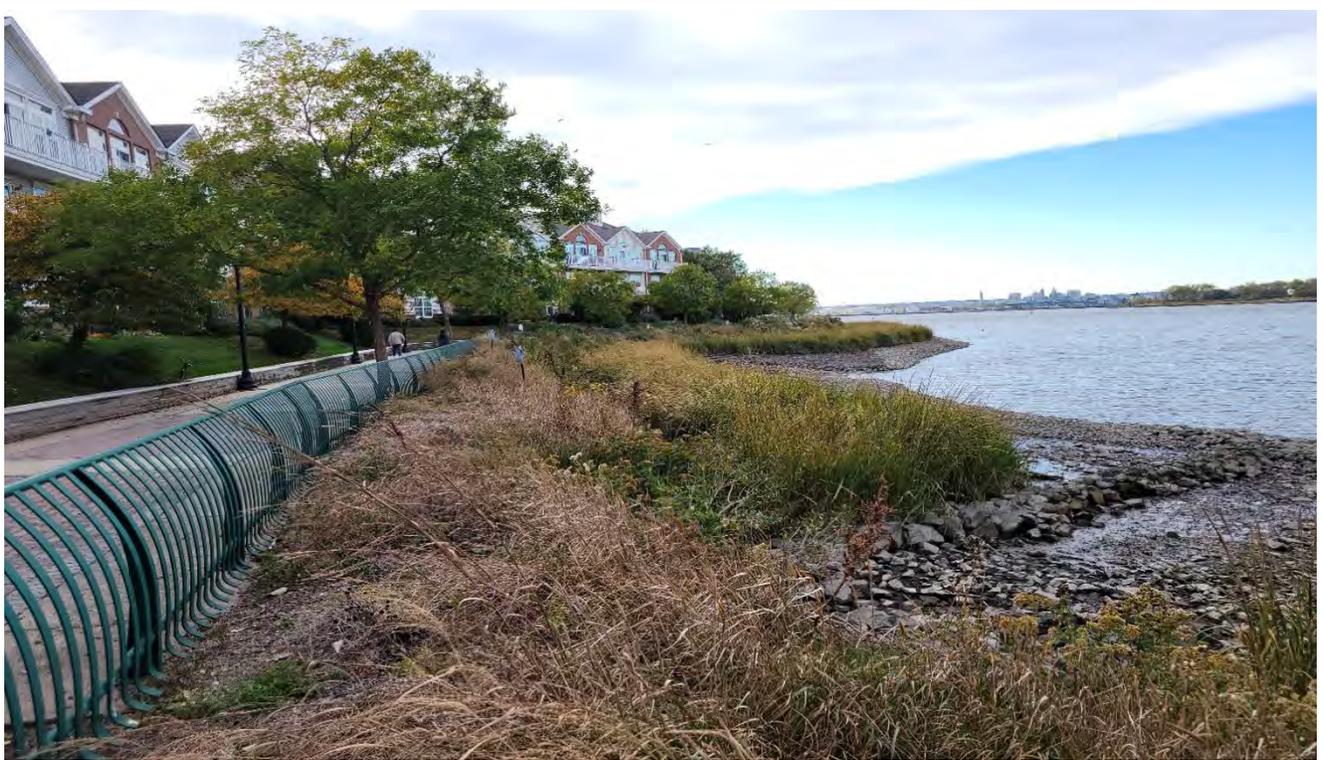
**Photo 25:** Previously mowed section of the upland planting area in the western portion of the BEP (facing west).

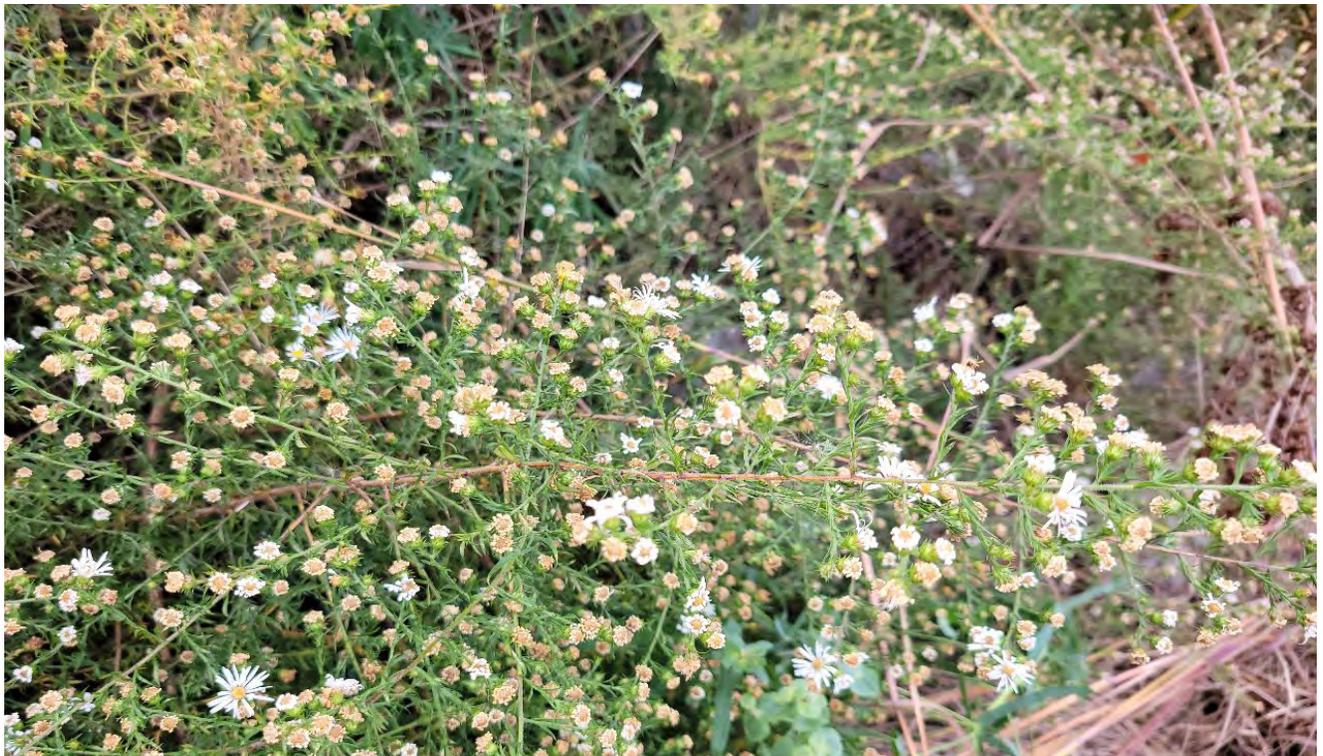
**Photo 26:** Native hairy white oldfield aster species located within the upland transitional planting zone of the BEP.

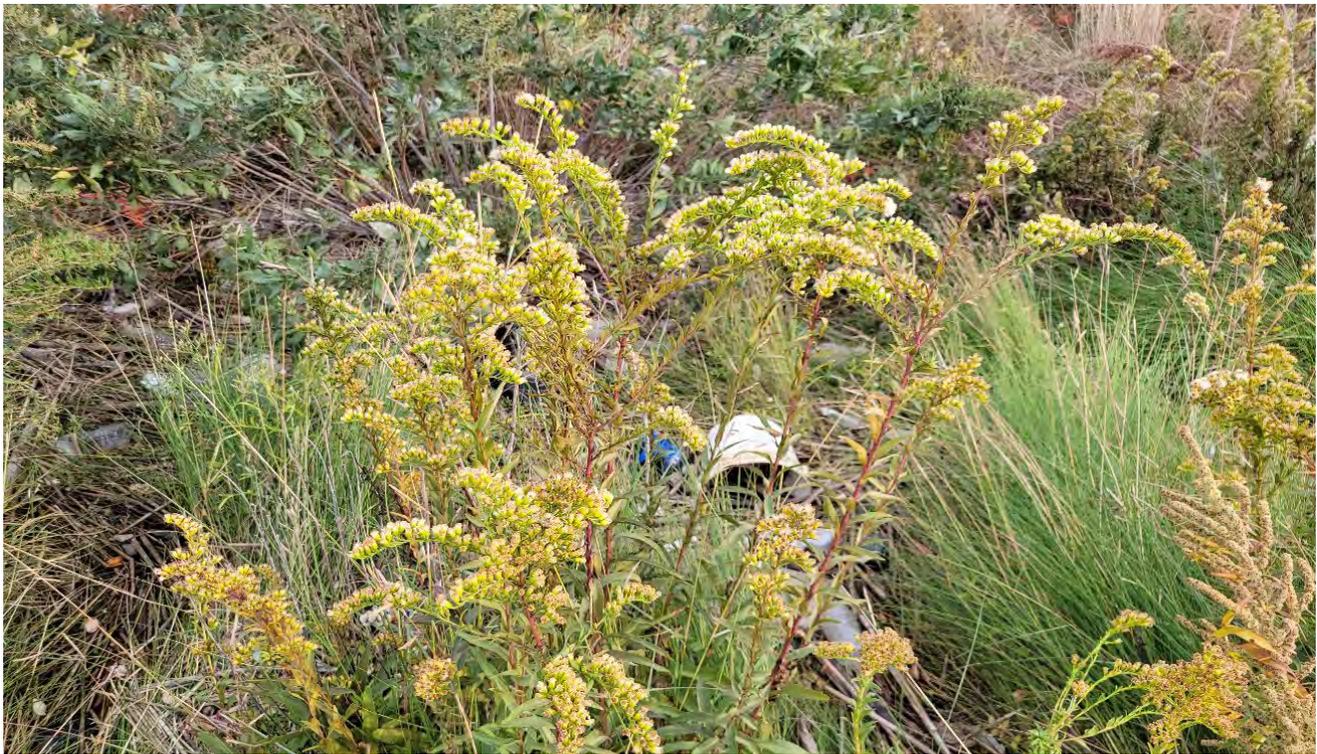
**Photo 27:** Planted species seaside goldenrod located within the upland transitional planting zone of the BEP.
