**LONG TERM MONITORING PROGRAM
YEAR 2 IMPLEMENTATION REPORT
STUDY AREA 7 SEDIMENT REMEDY
JERSEY CITY, NEW JERSEY**

Honeywell
Morristown, New Jersey

**RAMBOLL** ENVIRON
Ramboll Environ US Corporation
Princeton, New Jersey

July 2016

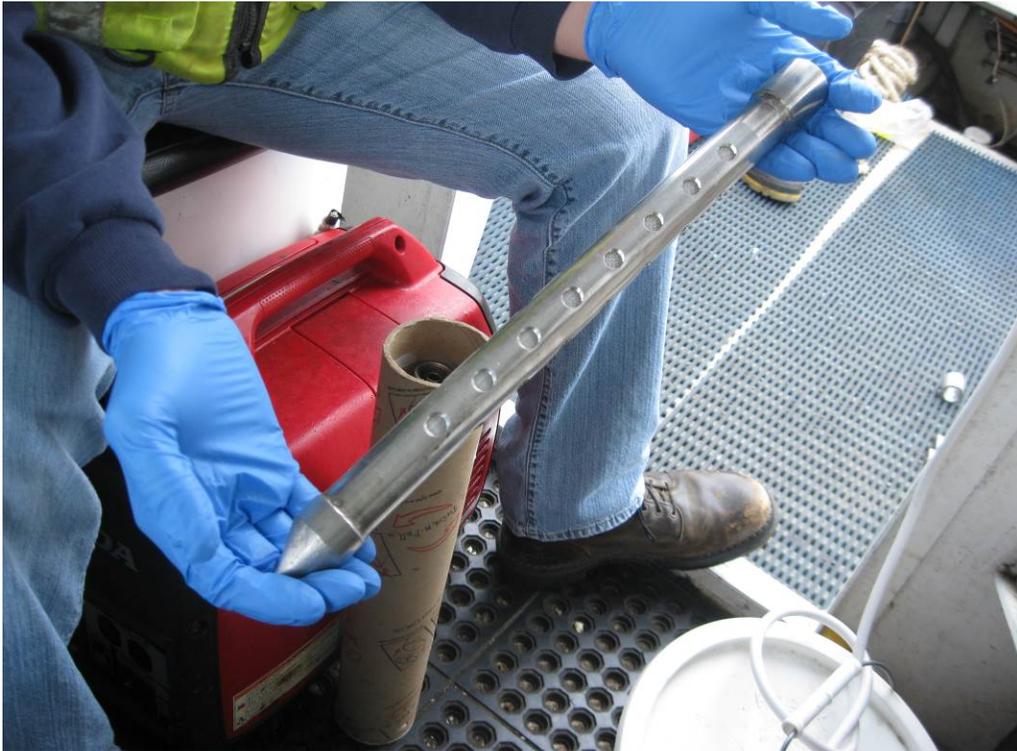
Photo 1: Pore water sampling device used at subtidal sampling locations

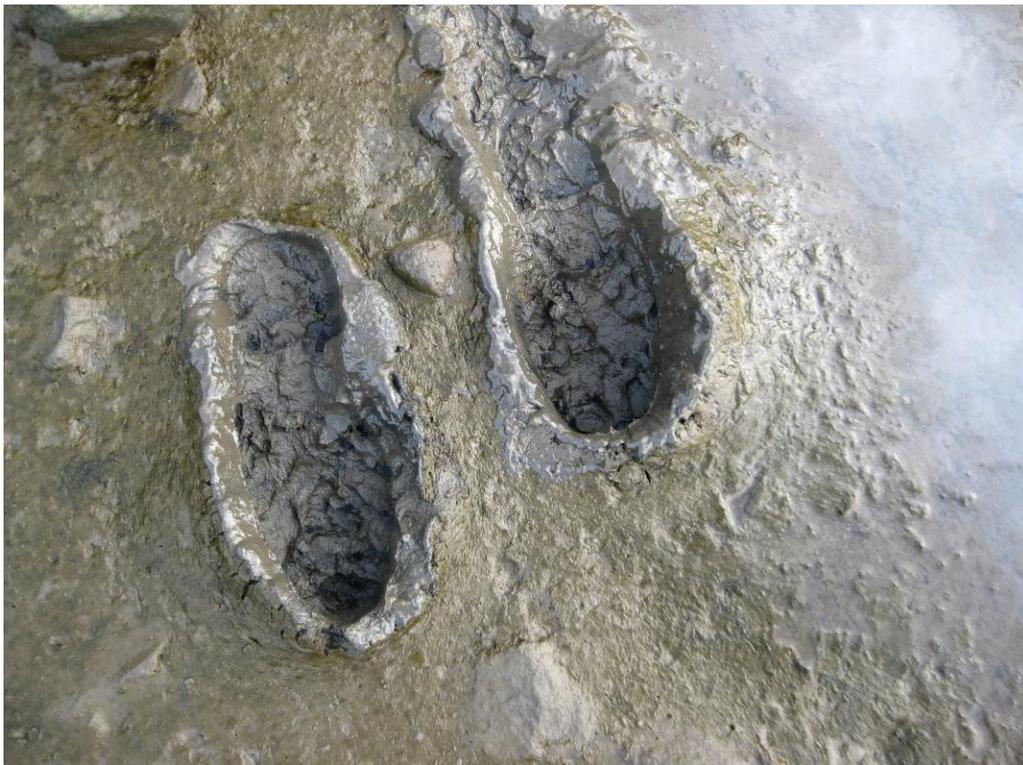
Photo 6: Sediment deposition over sediment cap armor layer in intertidal area

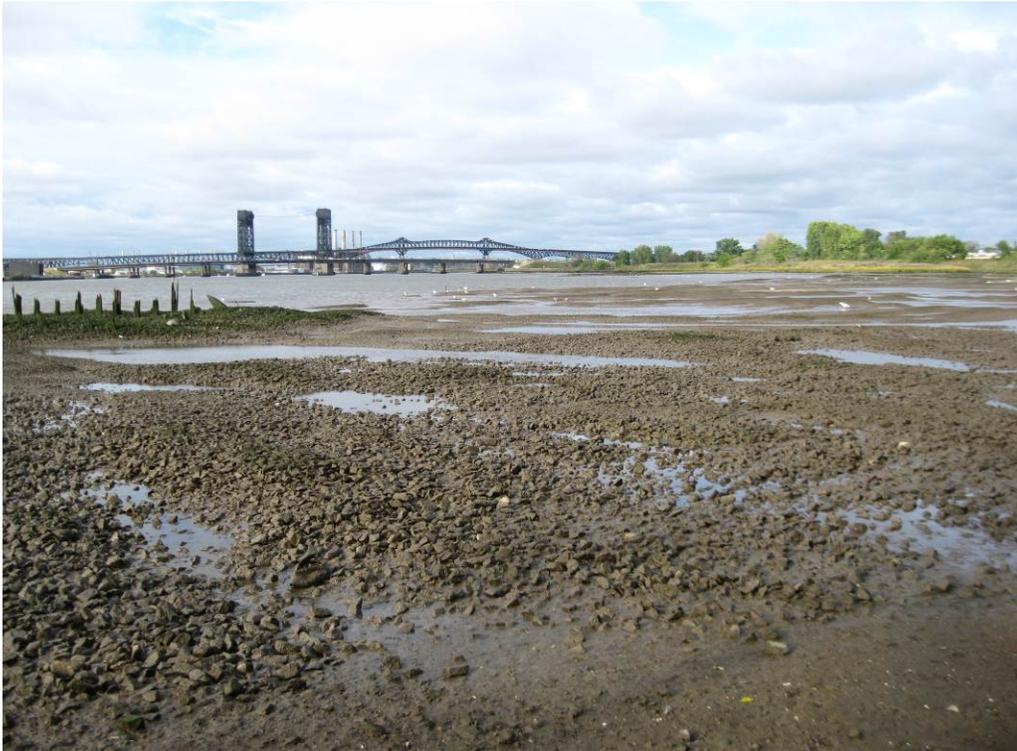
Photo 7: Intertidal cap area 13 at low tide

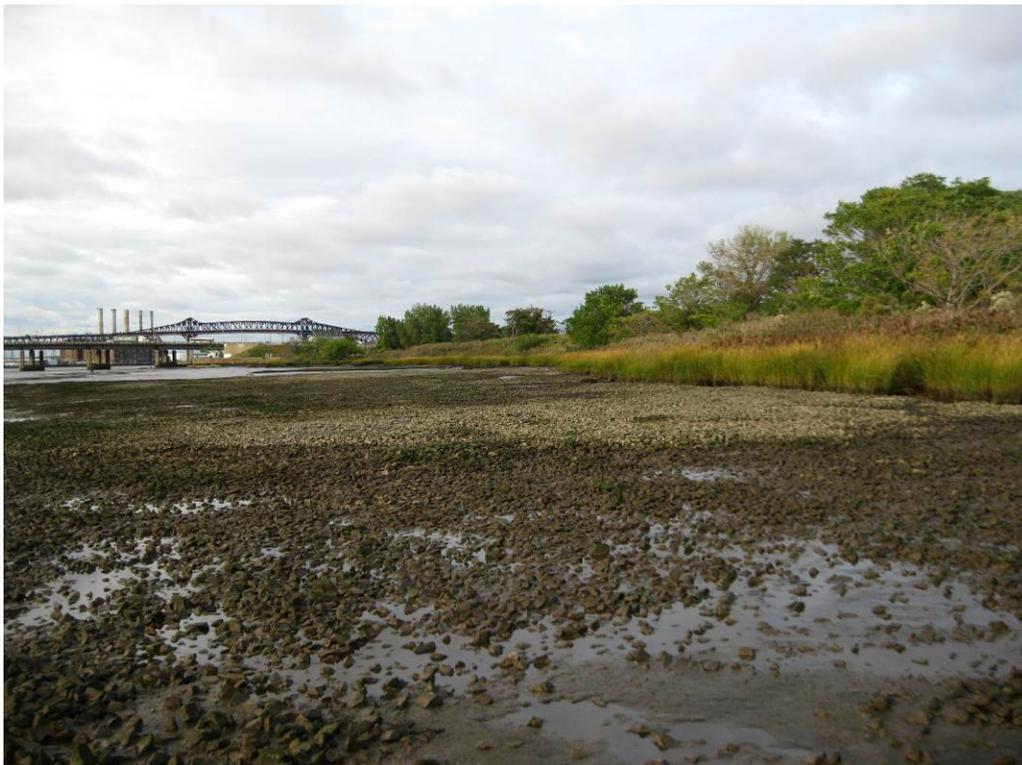
Photo 10: Intertidal cap area 11 at low tide

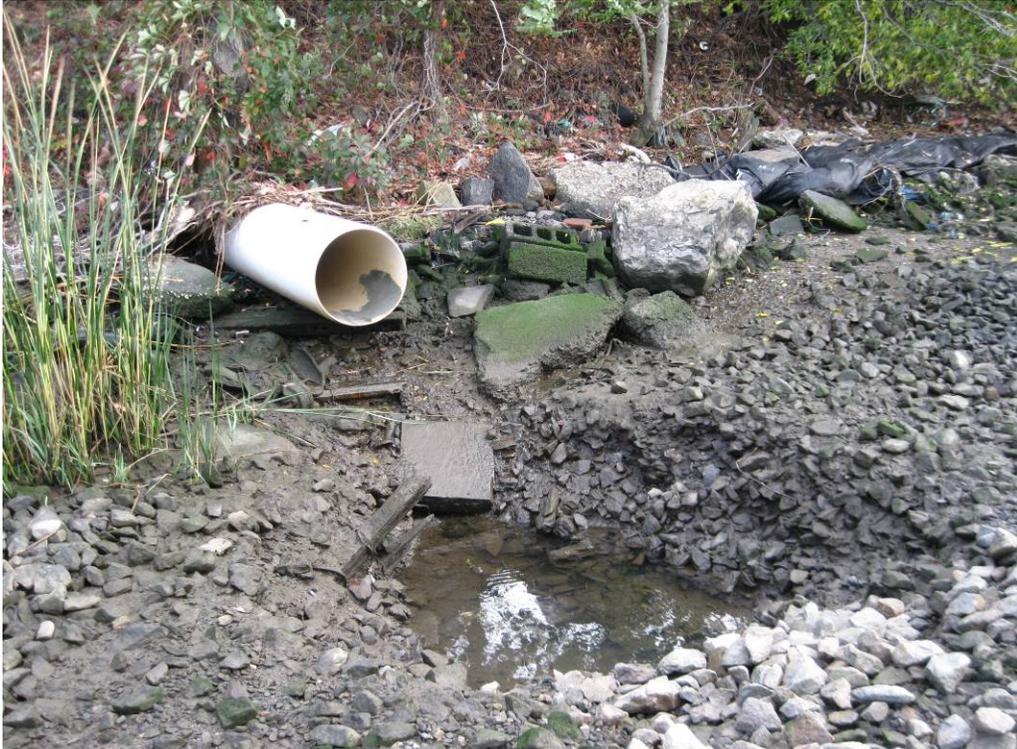
One small area (approximately 3 by 5 feet) showing signs of material loss was observed along the shoreline of Cap Area 13, at the discharge point for an 18-inch stormwater PVC pipe from the adjacent DeFeo property. As shown in the photographs included in **Appendix A**, the area exhibited a scour hole-like depression, approximately 2 feet deep. No signs of material displacement were observed. On October 23, 2015, Ramboll Environ completed repairs at this location, which consisted of the following:

Photo 11: Scour hole at discharge point of 18-inch PVC pipe from the DeFeo property prior to repair

- Lining the depression with a woven geotextile fabric.
- Placing a large boulder (approximately 2 by 2 by 1.5 feet) and loose 3.5 to 6 inch rocks from the adjacent shoreline within the depression and over the geotextile.
- Placing ¼-inch stone in the depression.
- Covering the filled area with surplus 2.5-inch armor stone obtained from surrounding areas.

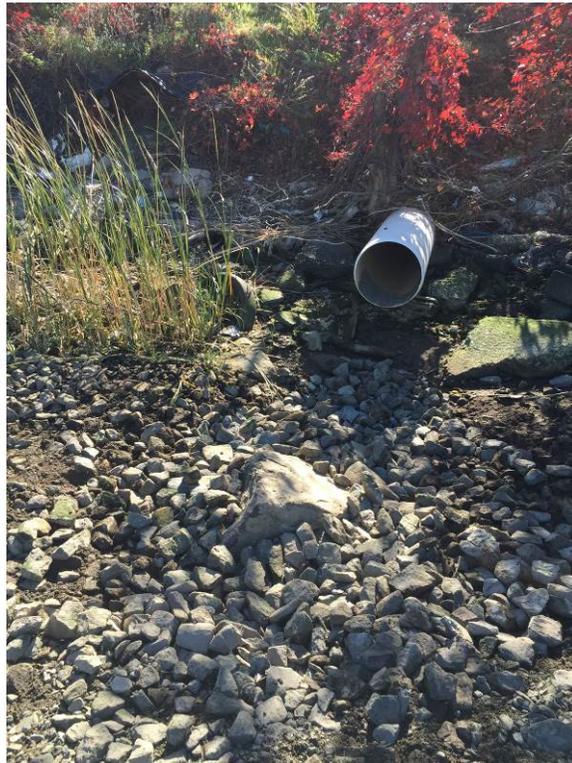
Photo 12: Scour hole at discharge point of 18-inch PVC pipe from the DeFeo property following repair

Photos of the completed repairs are included in **Appendix A**.

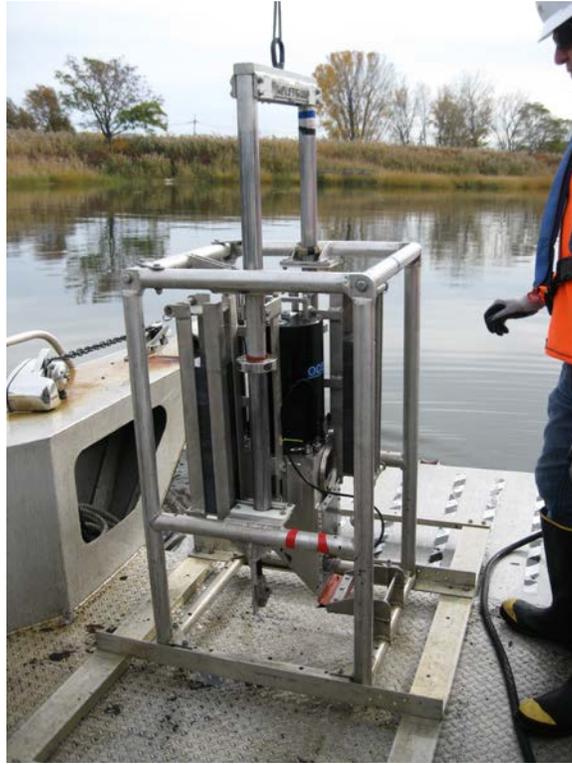
Photo 13: SPI Camera staged on deck of ASI vessel

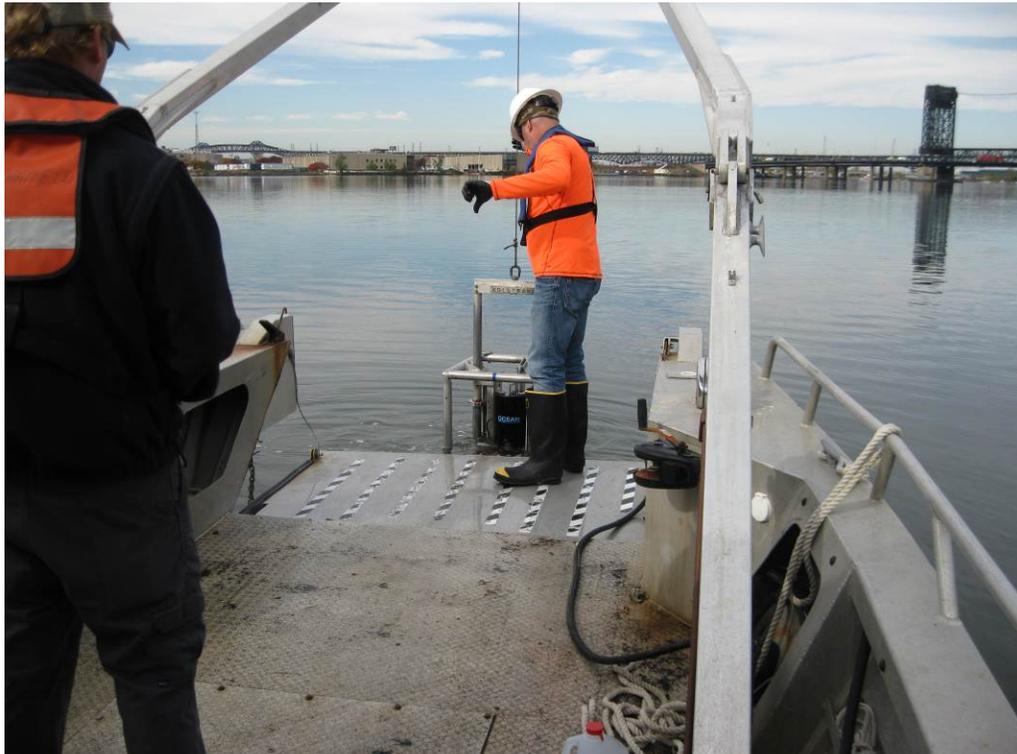
Photo 14: Deploying the SPI Camera in subtidal MNR area

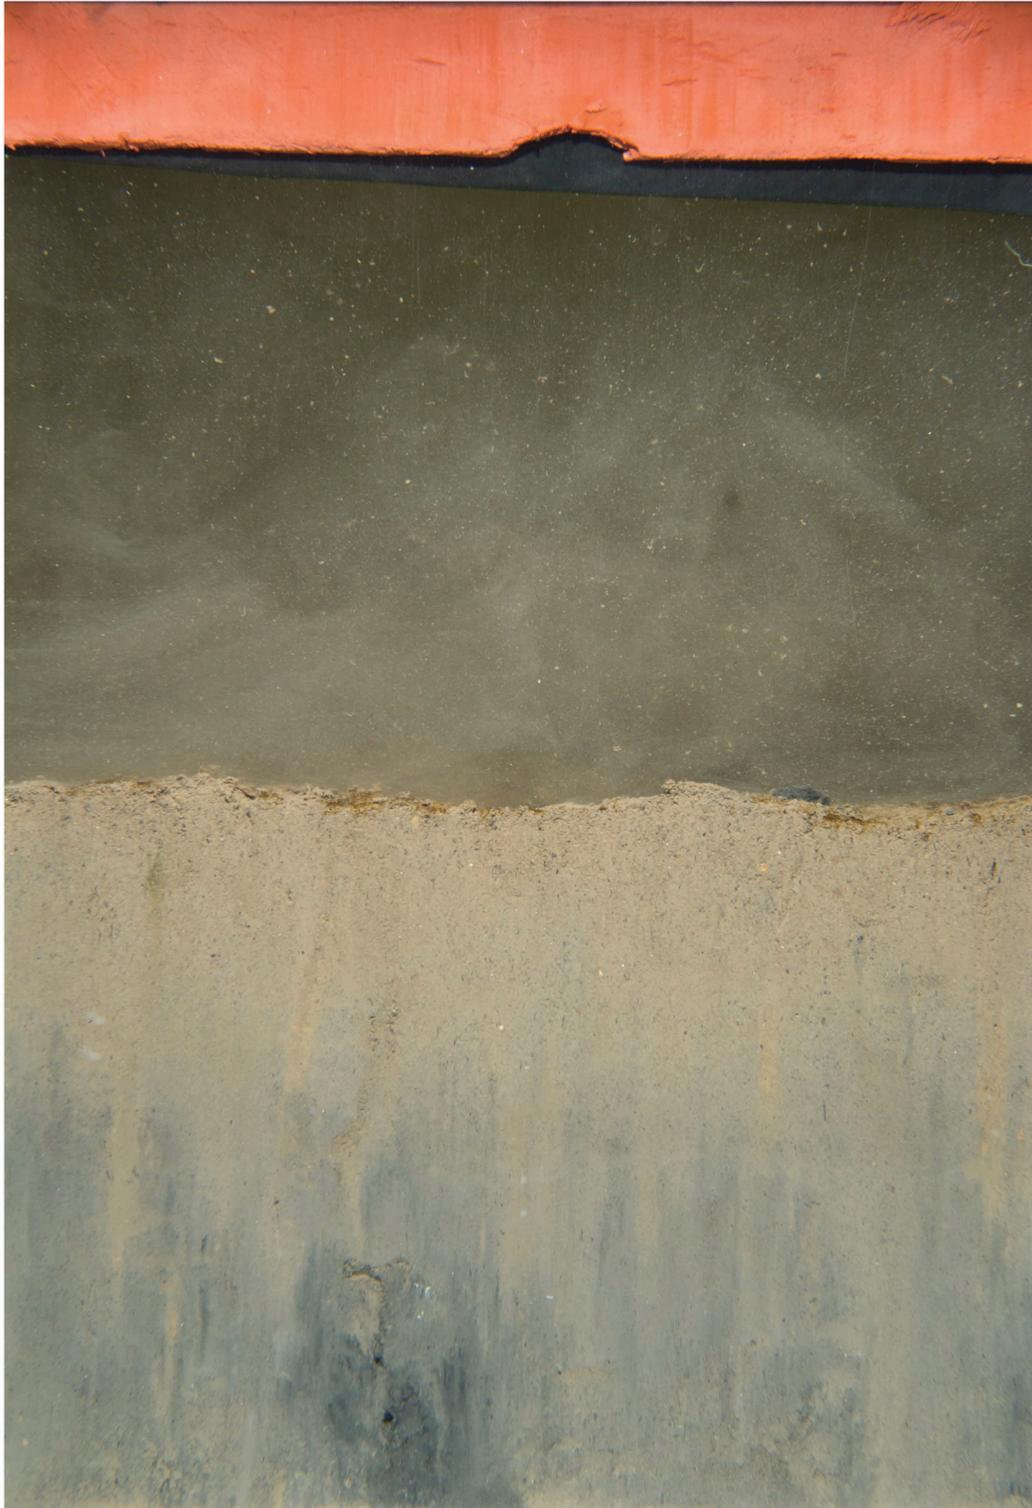
Figure 5: This profile image from Station 10 shows the silt-clay sediments with a minor fraction of very fine sand in the surface 1-2 cm that was typically encountered at most of the stations surveyed. Scale: width of profile image = 14.7 cm.

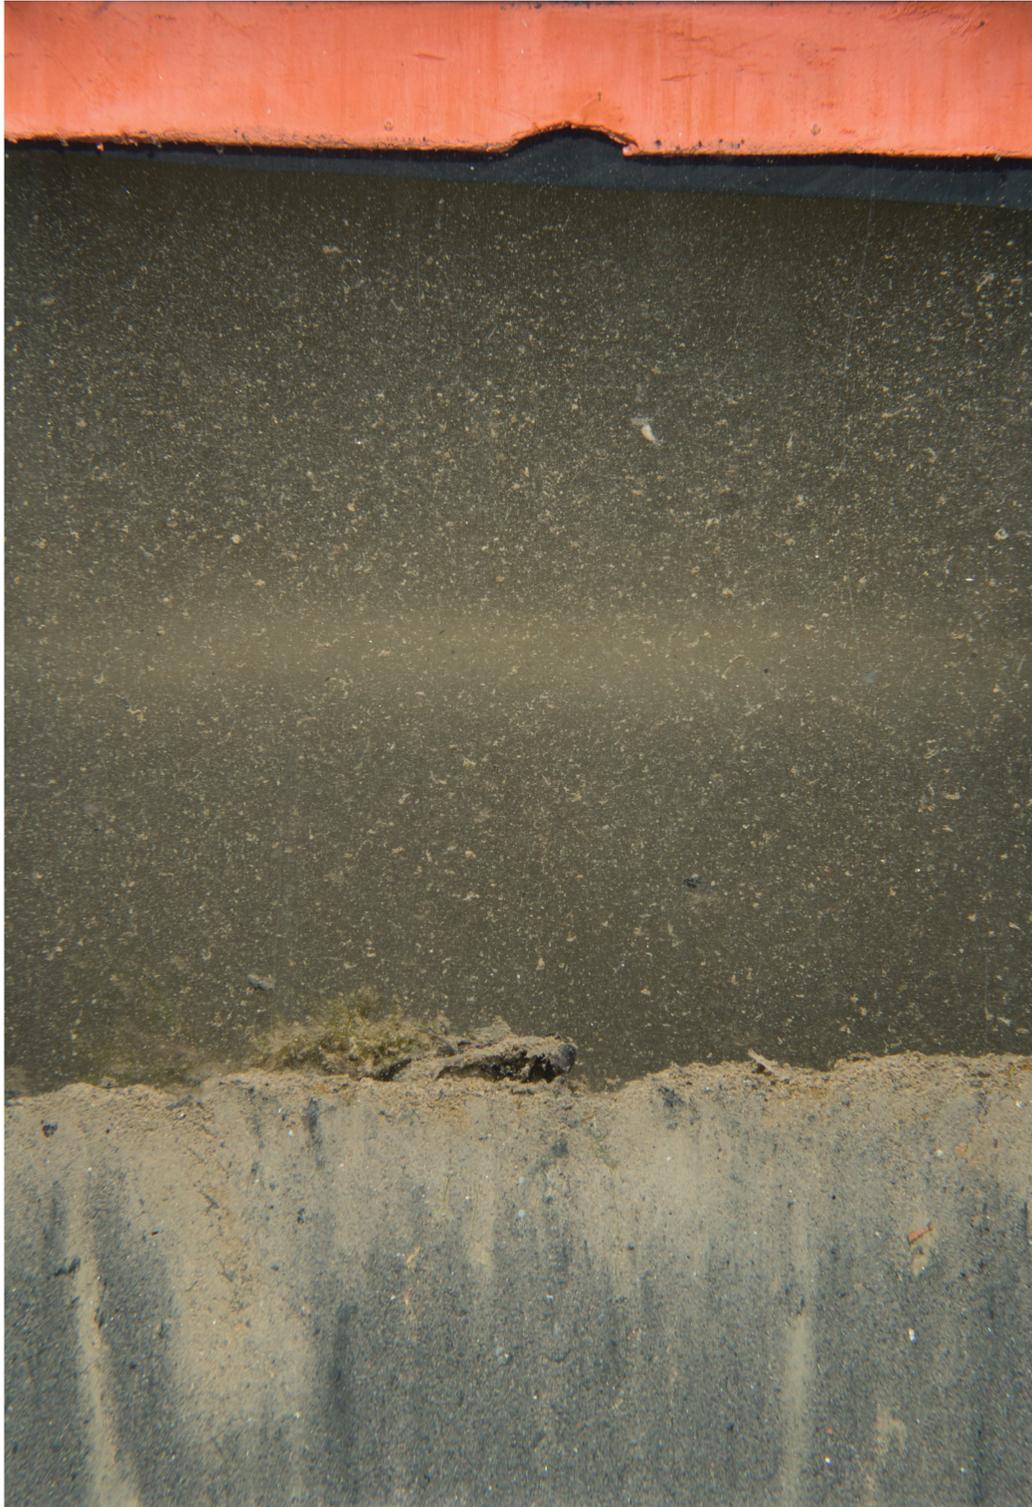
Figure 6: This profile image from Station 7 shows the higher percentage of sand that was found at this location and also at Station 2. Scale: width of profile image = 14.7 cm.

- Figure 6** This profile image from Station 7 shows the higher percentage of sand that was found at this location and also at Station 2.
- Figure 7** This profile image from Station 2 had the lowest prism penetration values found at the site because of the armoring of small rocks and pebbles on the sediment surface.

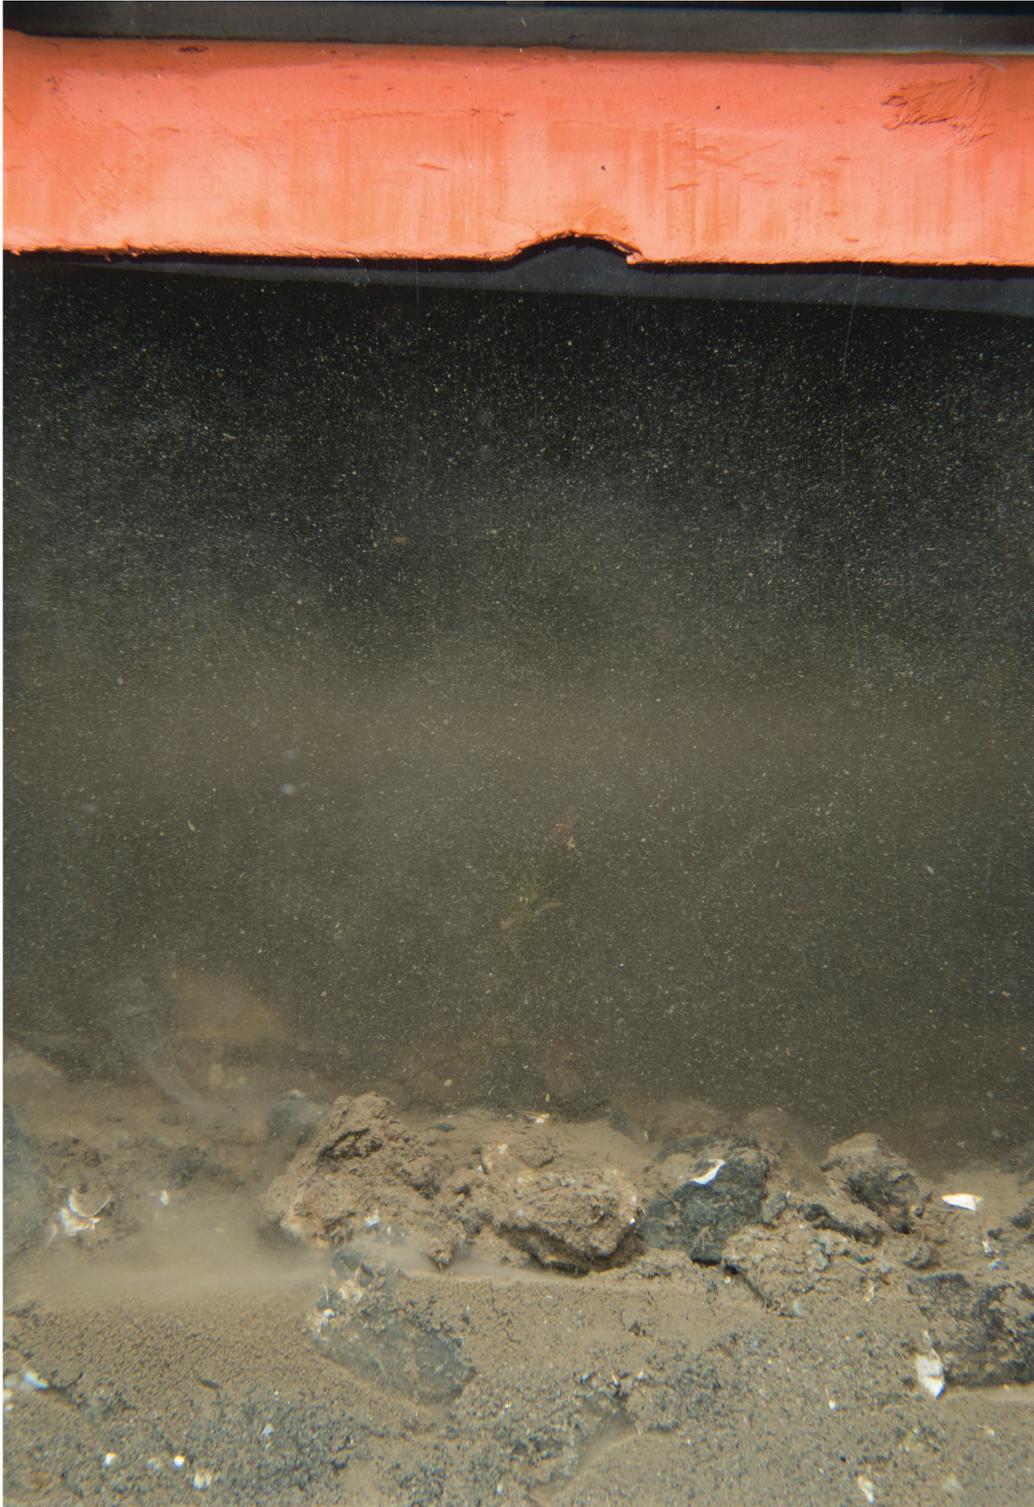
Figure 7: This profile image from Station 2 had the lowest prism penetration values found at the site because of the armoring of small rocks and pebbles on the sediment surface. Scale: width of profile image = 14.7 cm.

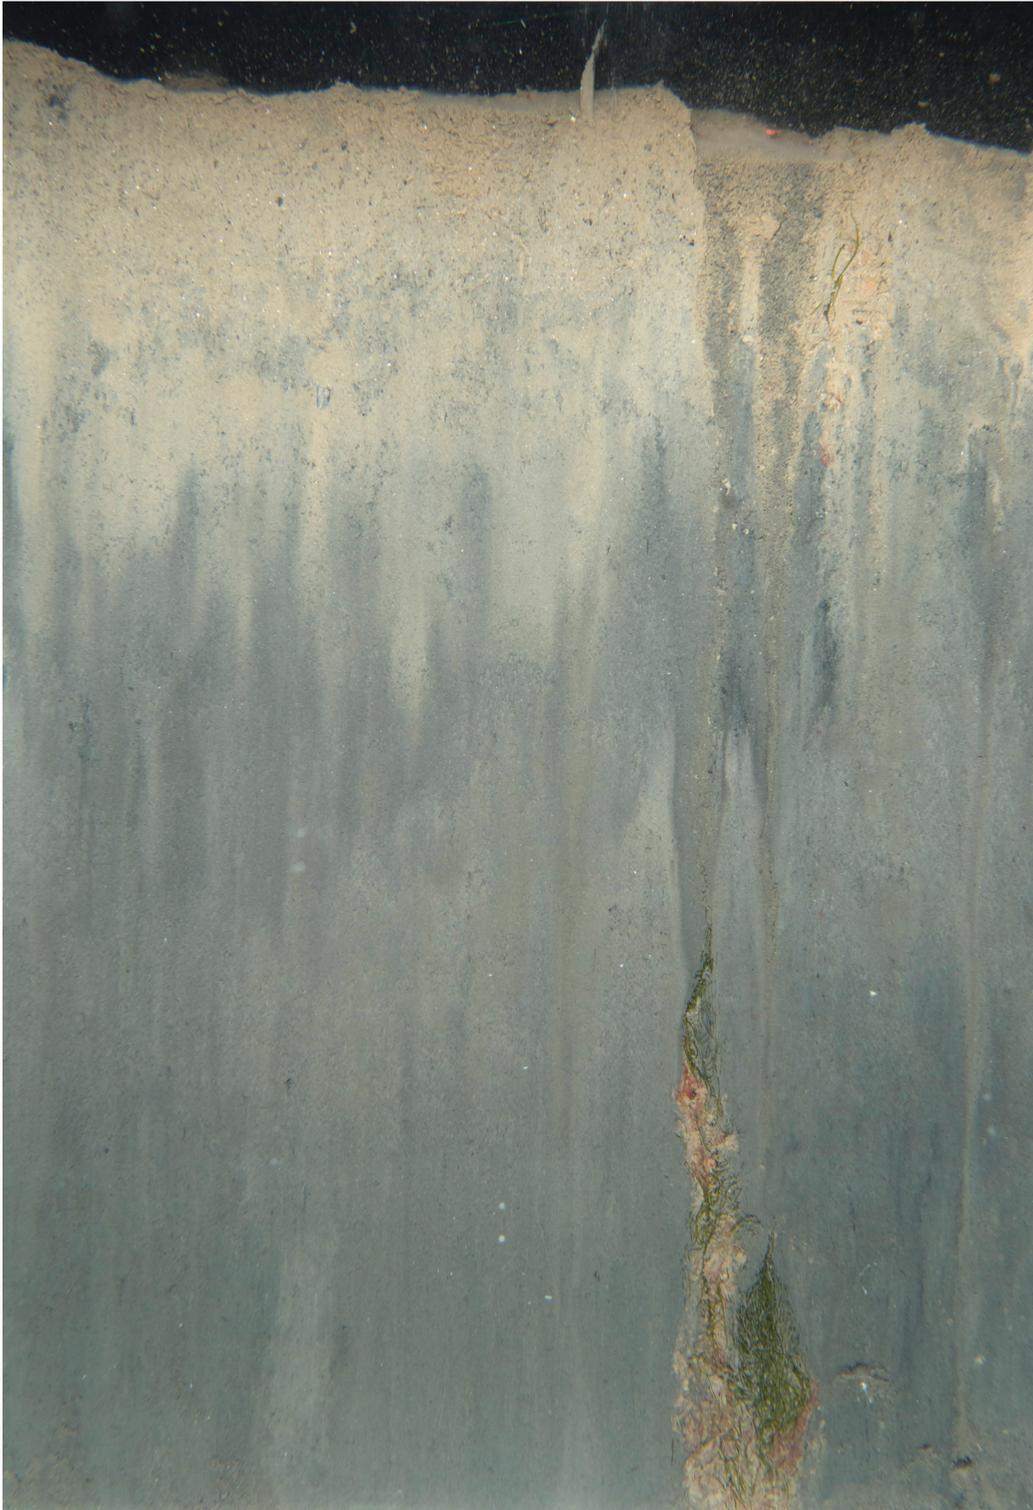
Figure 10: This profile image from Station 3 shows biogenic surface topography caused by a fecal mound (left) and a burrow opening (right) on the sediment surface. Scale: width of profile image = 14.7 cm.

- Figure 10** This profile image from Station 3 shows biogenic surface topography caused by a fecal mound (left) and a burrow opening (right) on the sediment surface.

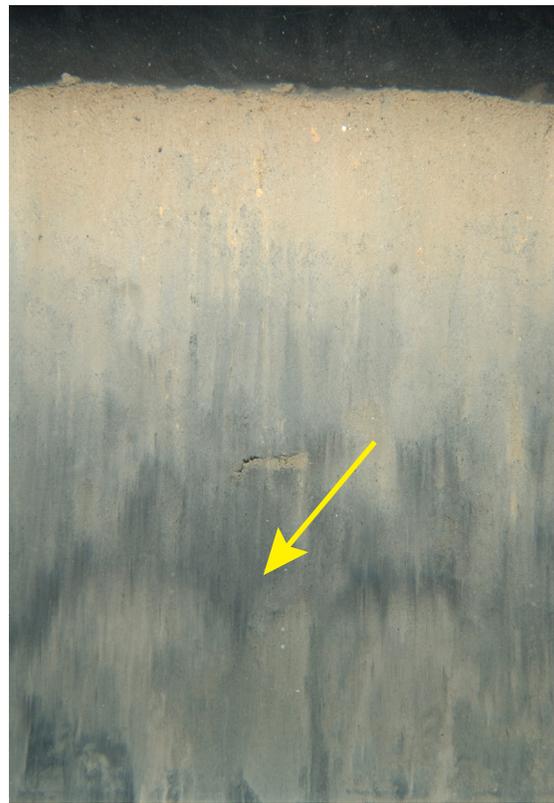
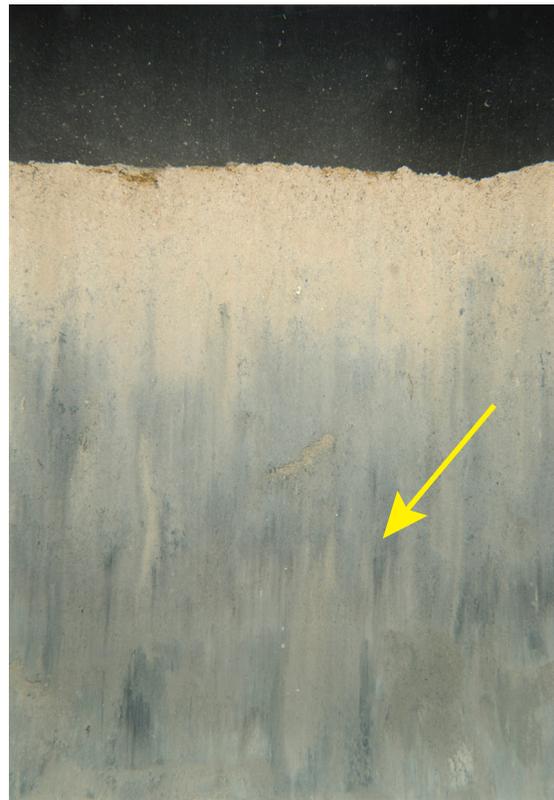
Figure 11: These profile images from Stations 4, 5, 6 and 10 show buried contact horizons (arrows) of the former sediment-water interface, indicating a quantum deposition of sediment at some point in the past year. Scale: width of each profile image = 14.7 cm.

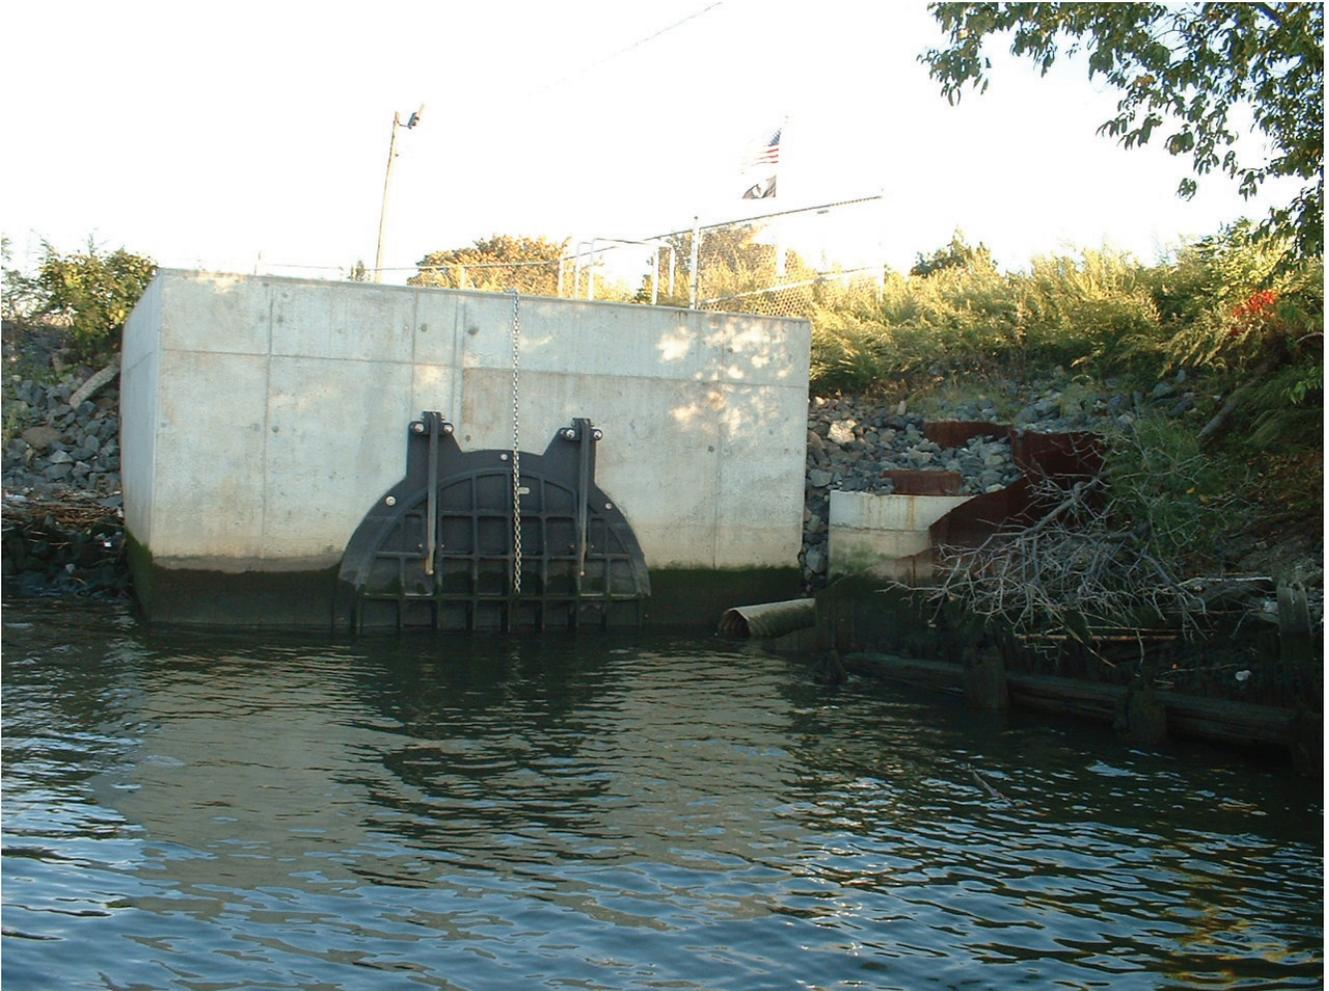
Figure 20: This combined sewage/storm water outlet near Station 7 continues to be a source of organic loading and disturbance to sediments in the immediate vicinity of this structure.
