MEMORANDUM

Subject: **SA-7 Sediment Remedy Long-Term Monitoring
Summary of Year 8 Monitoring & Proposed Year 8 Program**

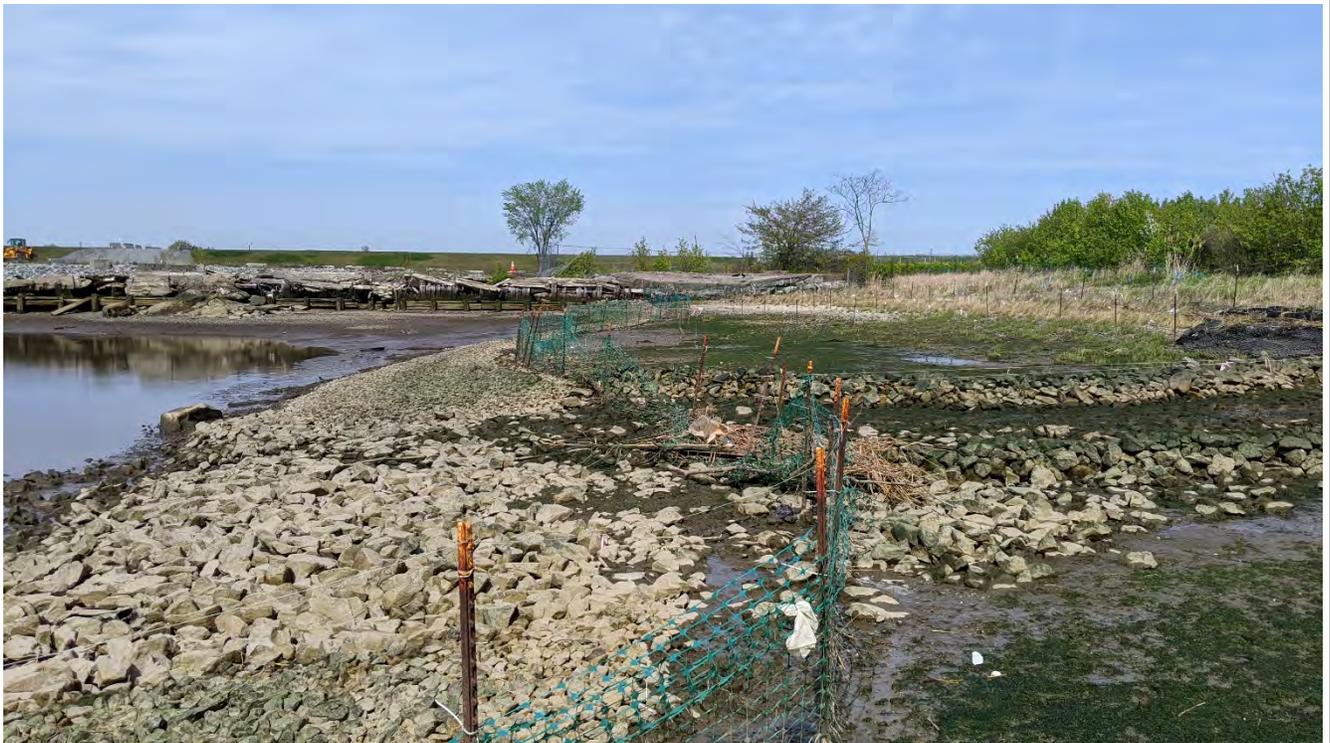
Photo 2: Western end of Cap Area 16. Note limited vegetative growth in low marsh zone (facing northeast).

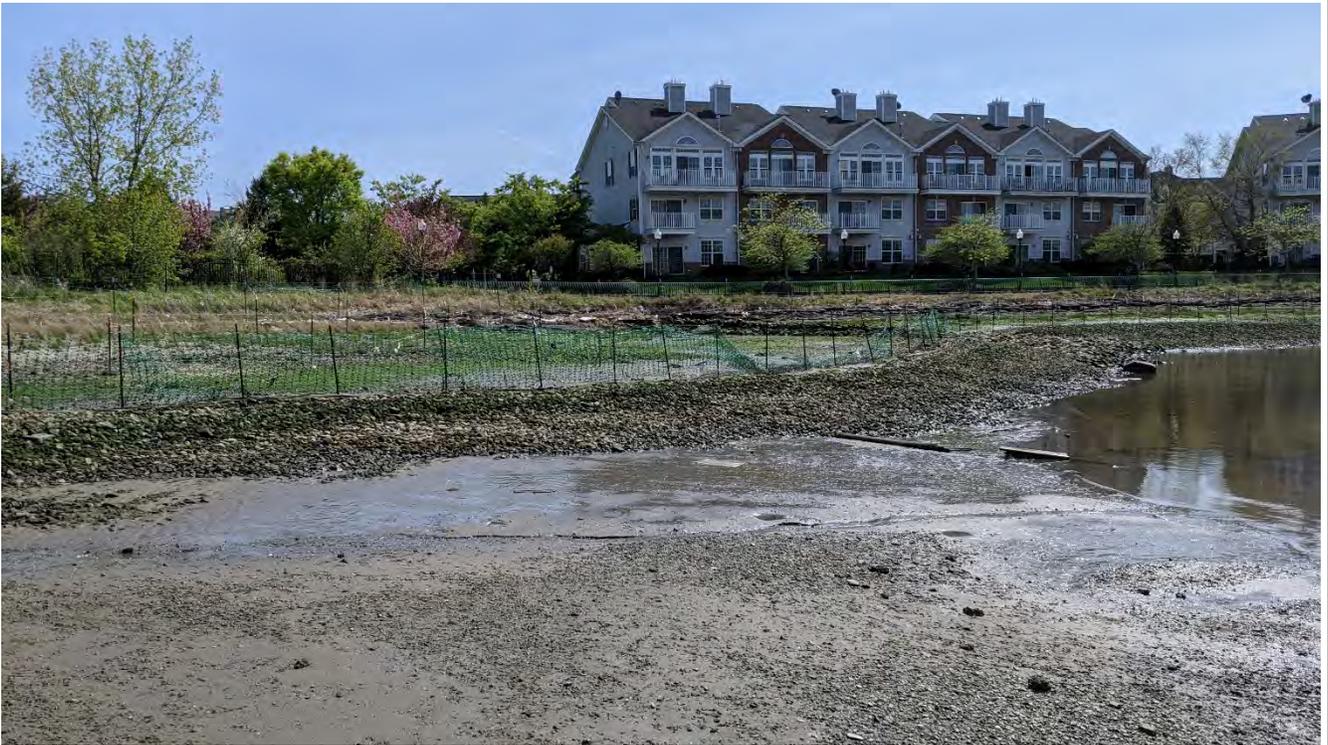
Photo 3: Cap Area 16 and shoreline stabilization berm viewed from SA-6S bulkhead (facing southwest).

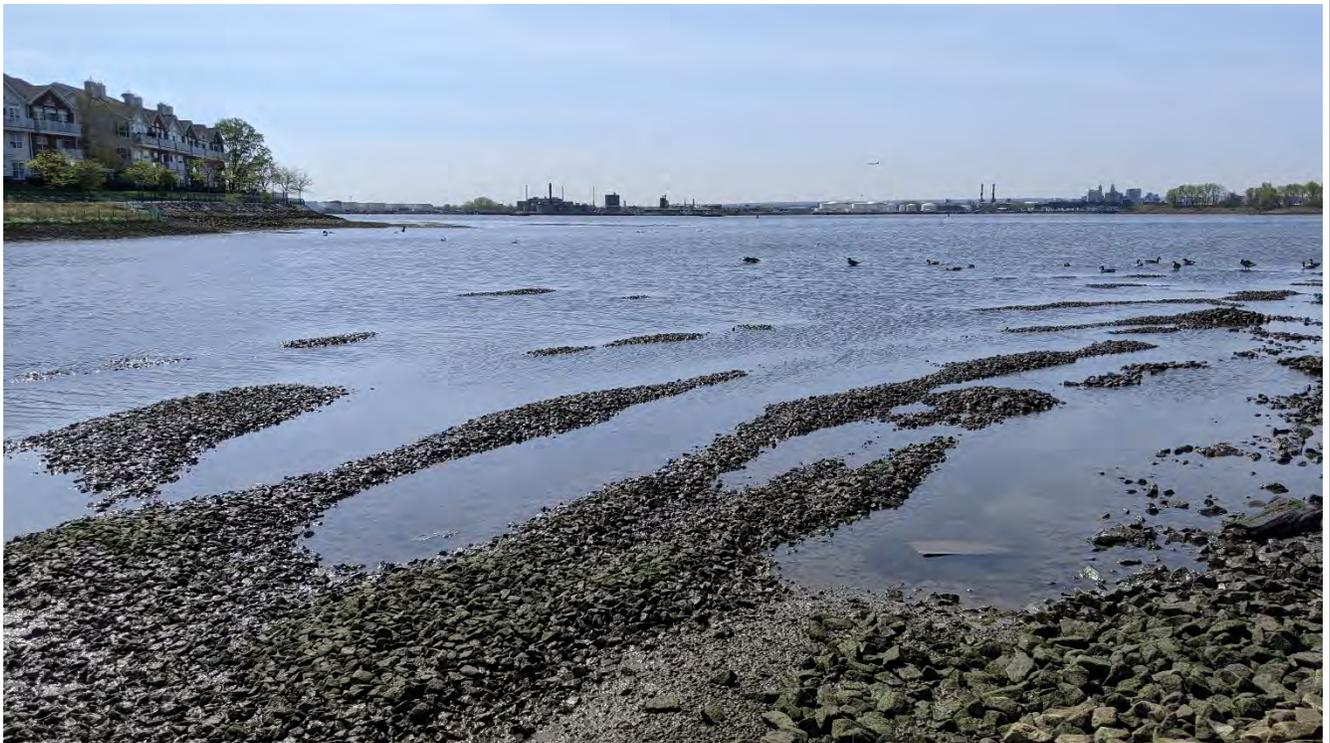
Photo 6: Cap Area 22. Note depressional areas in the armor stone (facing northwest).

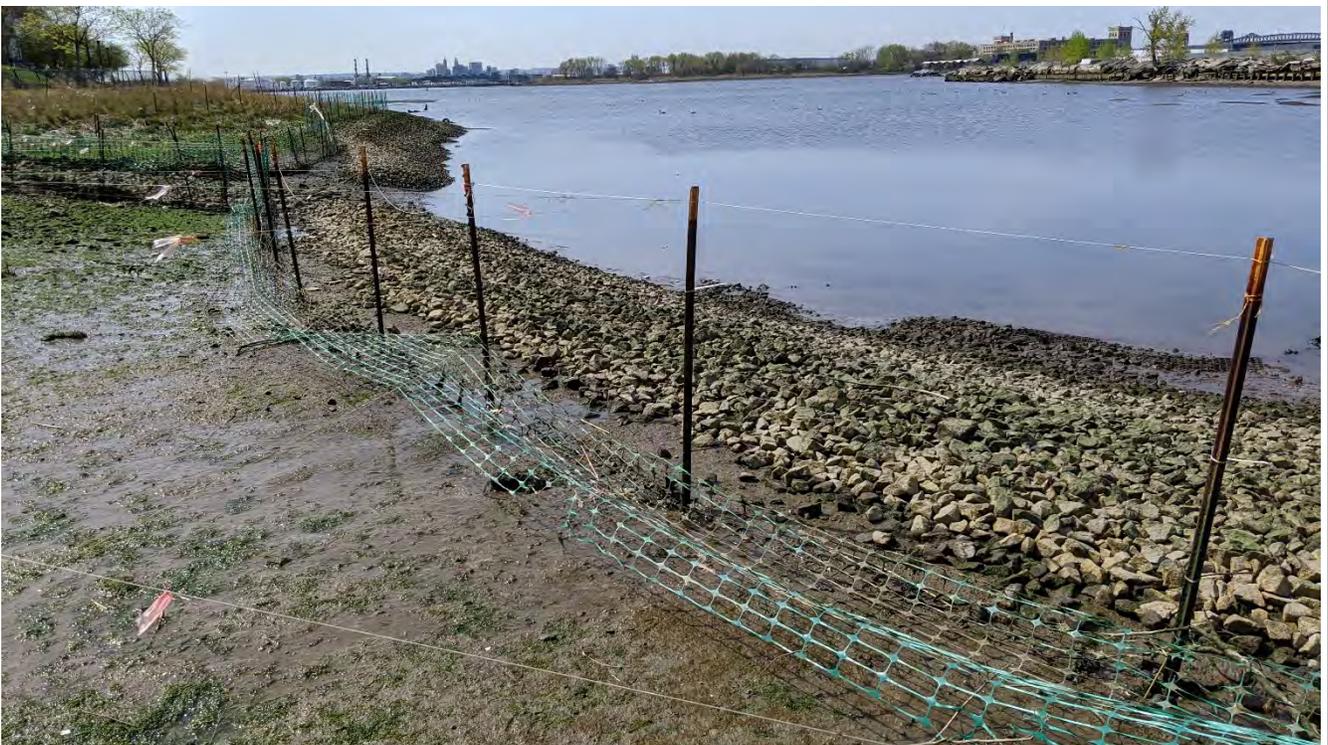
Photo 8: Shoreline stabilization along the central portion of the BEP area. Note the compromised snow fence (facing northwest).

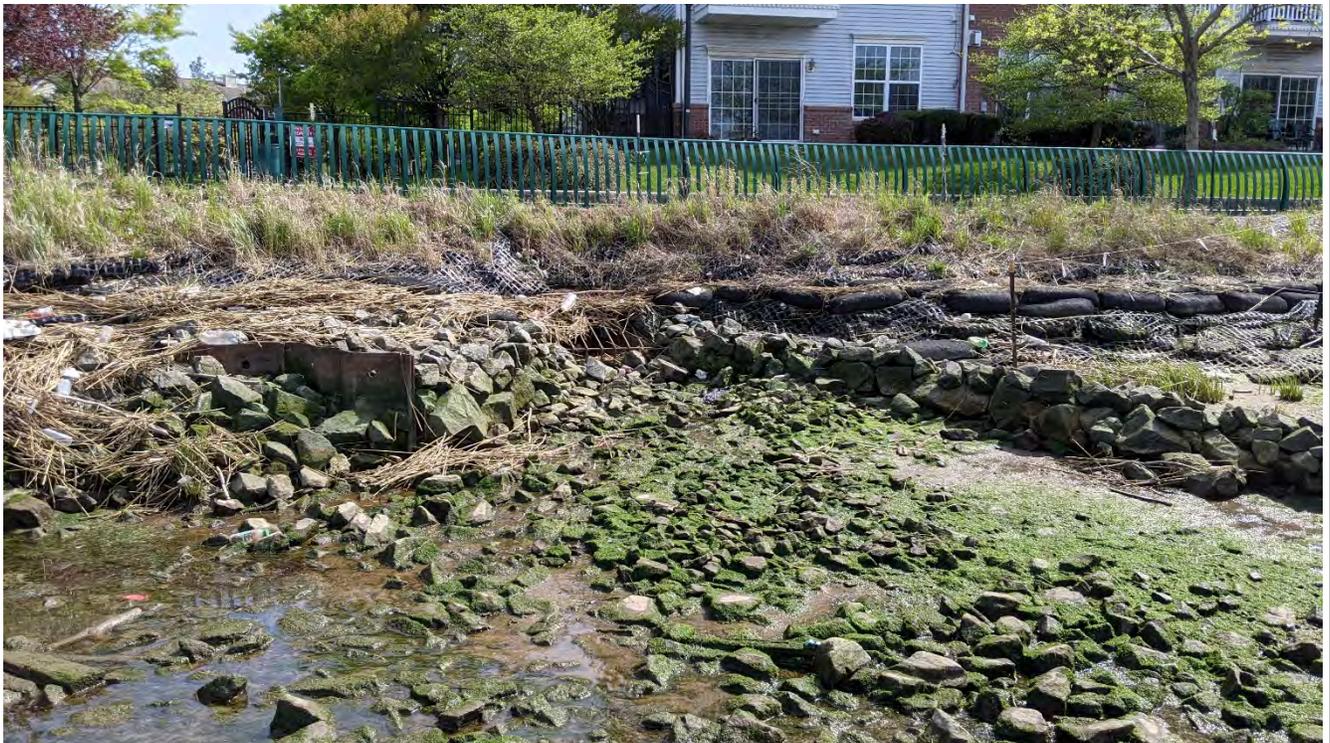
Photo 10: Outfalls C and B located in the central portion of the BEP area (facing south).

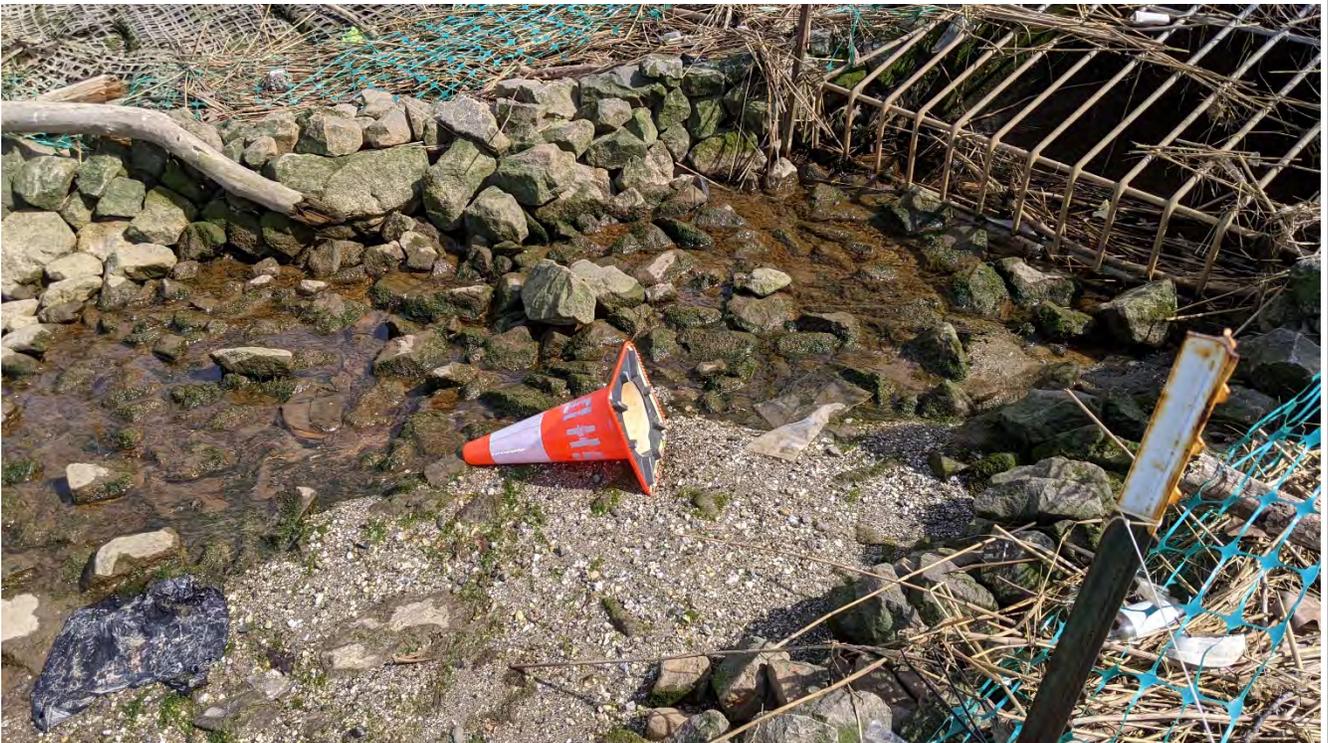
Photo 12: Outfall A and the debris screen. Note the accumulation of sediment in the foreground (facing southeast).

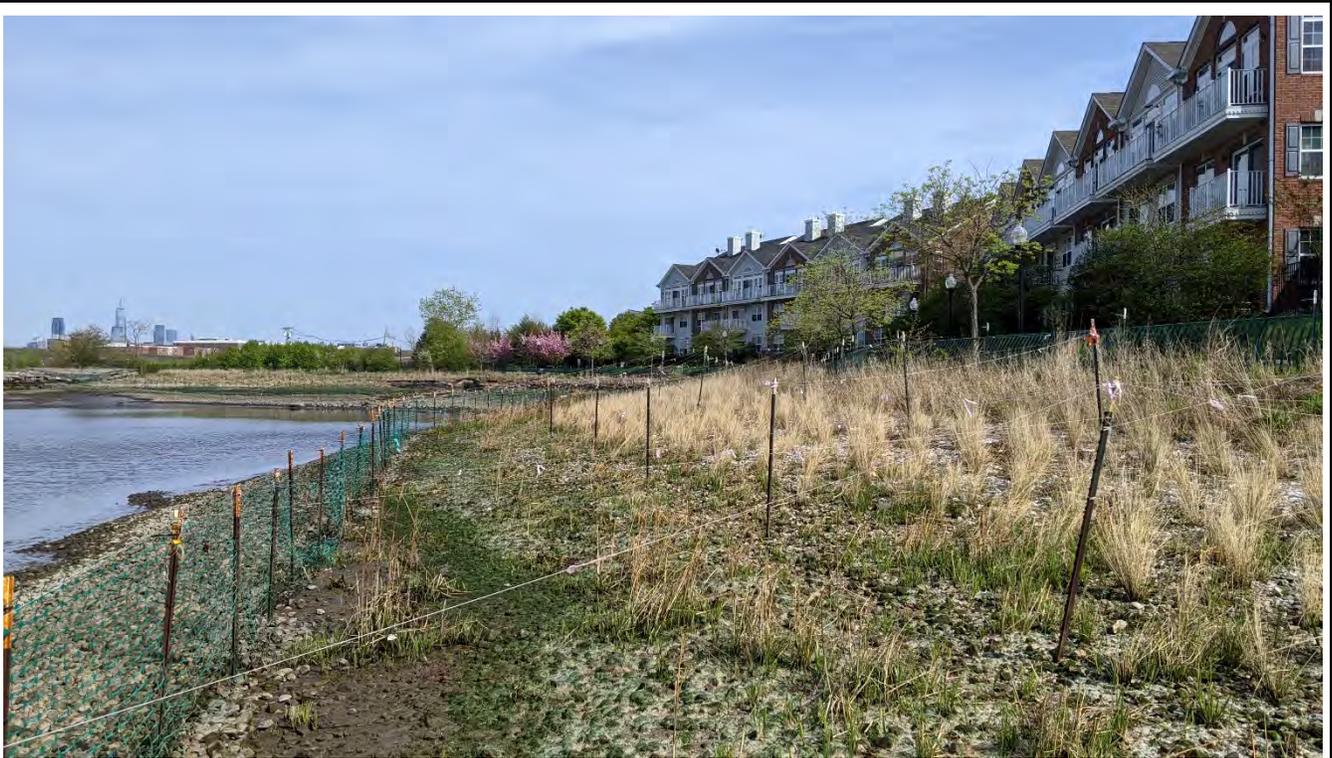
Photo 17: Vegetative growth present in the low marsh zone from the western side of the BEP area (facing southeast).

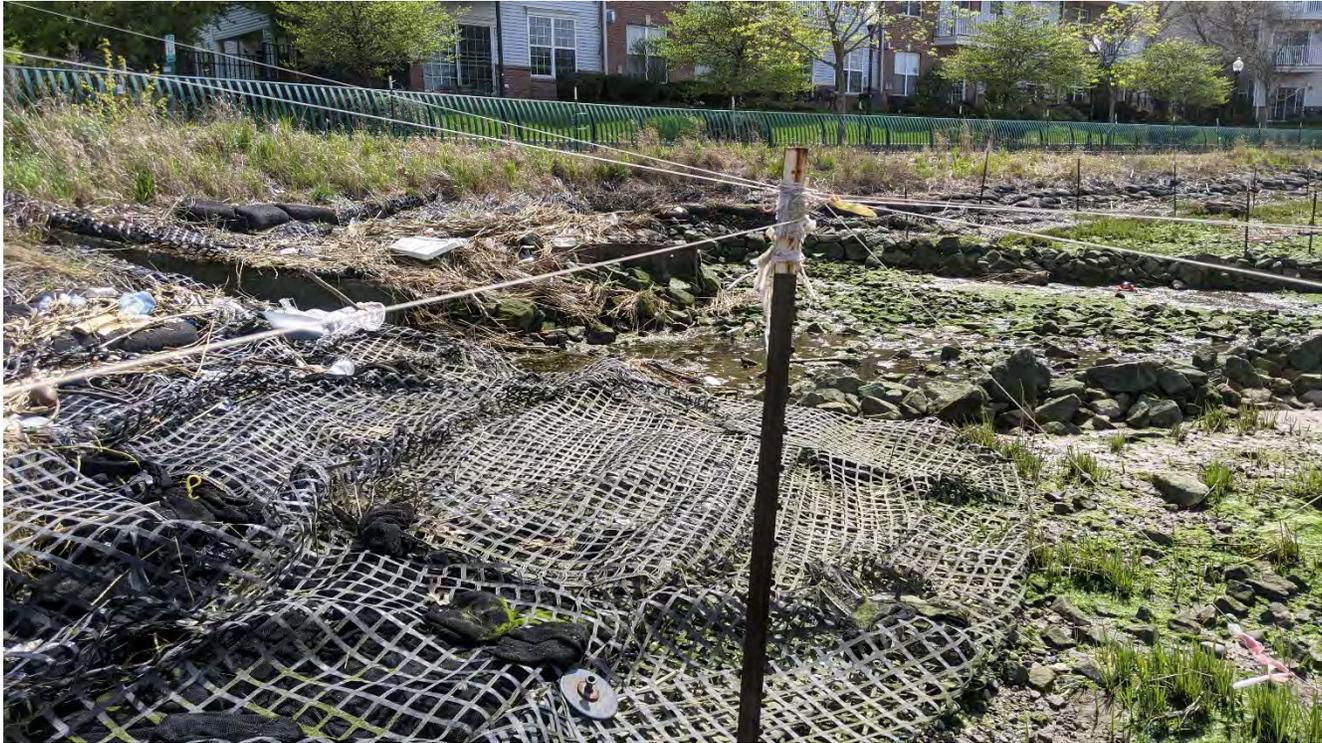
Photo 20: Exposed geogrid and sparse vegetation in the high marsh zone of the northern portion of the BEP area adjacent to Outfall C (facing southwest).

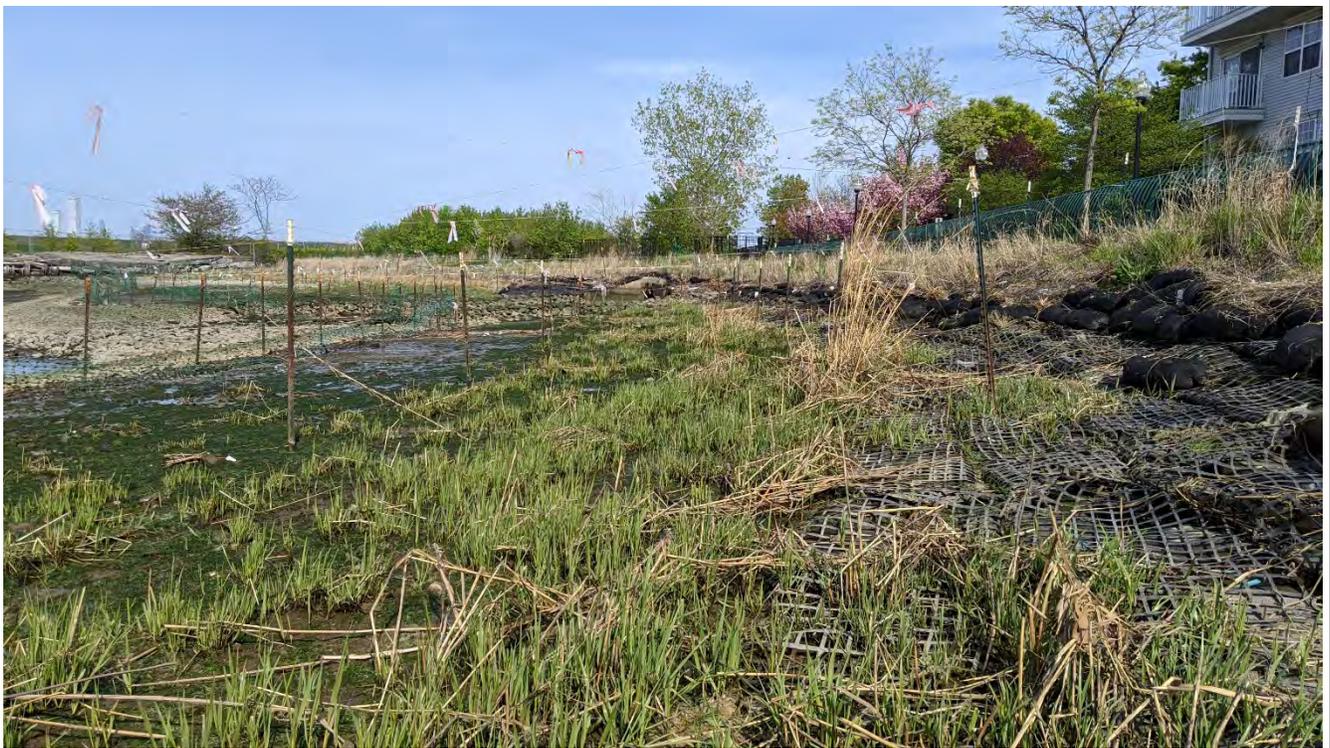
Photo 25: Vegetation present on the high marsh zone and the limited vegetative growth in the lower portion of the GroSoxx located near Outfall A. Note the fresh shoots and increased levels of colonization (facing southeast).

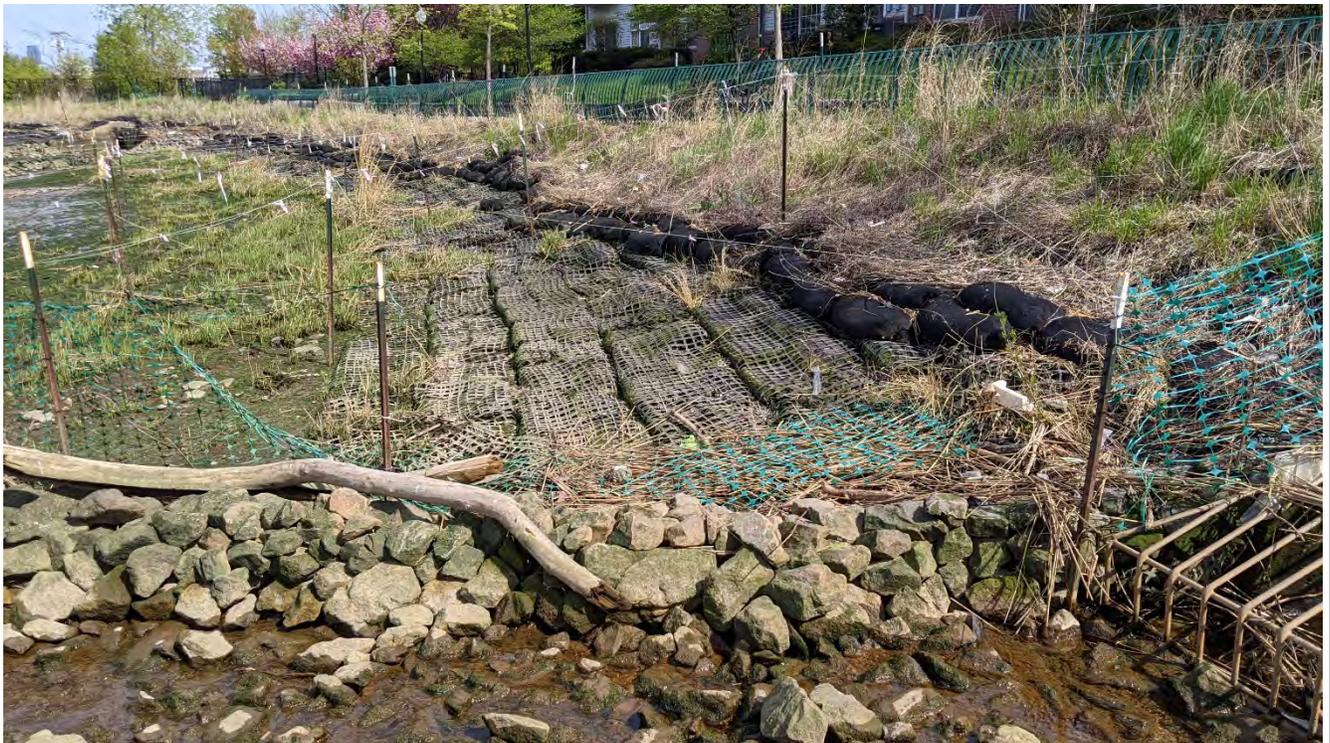
Photo 26: Sparse vegetation present near the exposed geogrid and RockSoxx located adjacent to Outfall A (facing east).

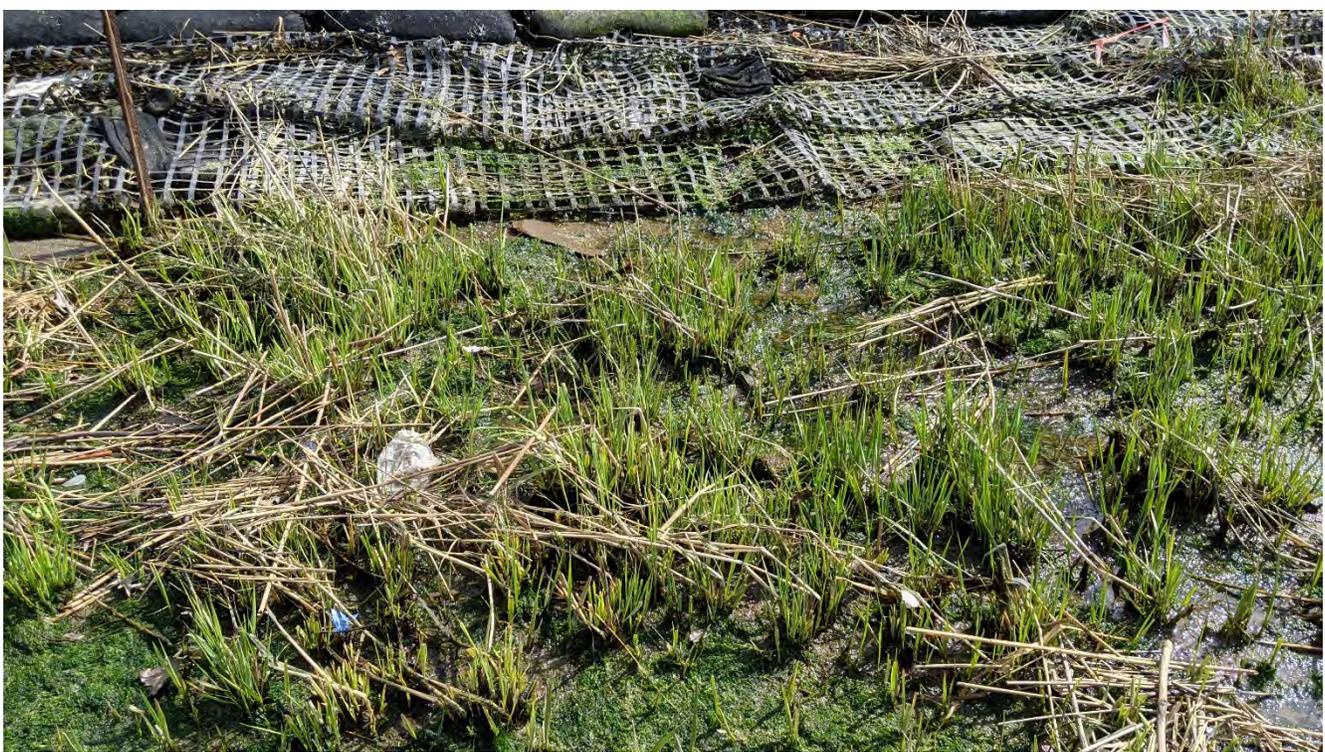
Photo 27: Emergent growth of vegetation observed throughout the high marsh zone. Note: the new shoots appeared to be healthy and in good condition and exposed geogrid below it.

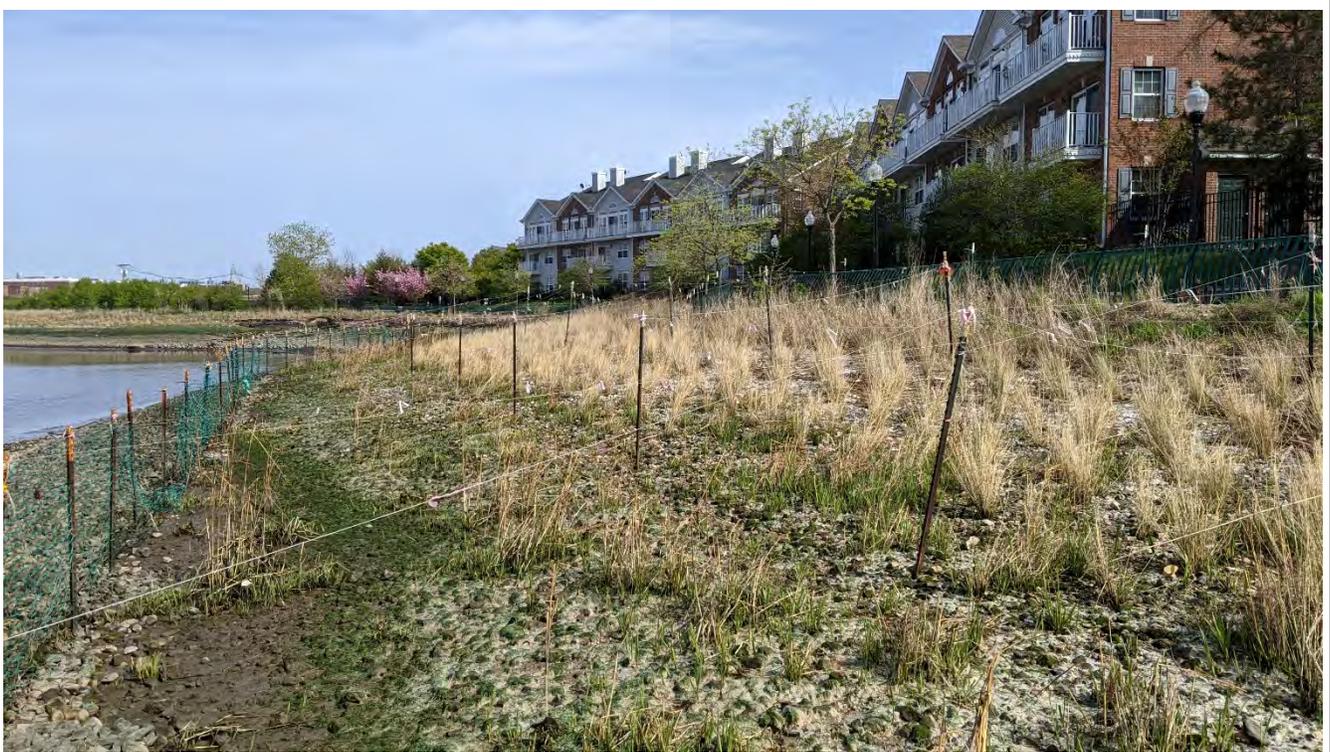
Photo 31: Vegetation present on the western side of the BEP area. Note the dormant, healthy, and vibrant vegetation in the high marsh and upland areas (facing southeast).

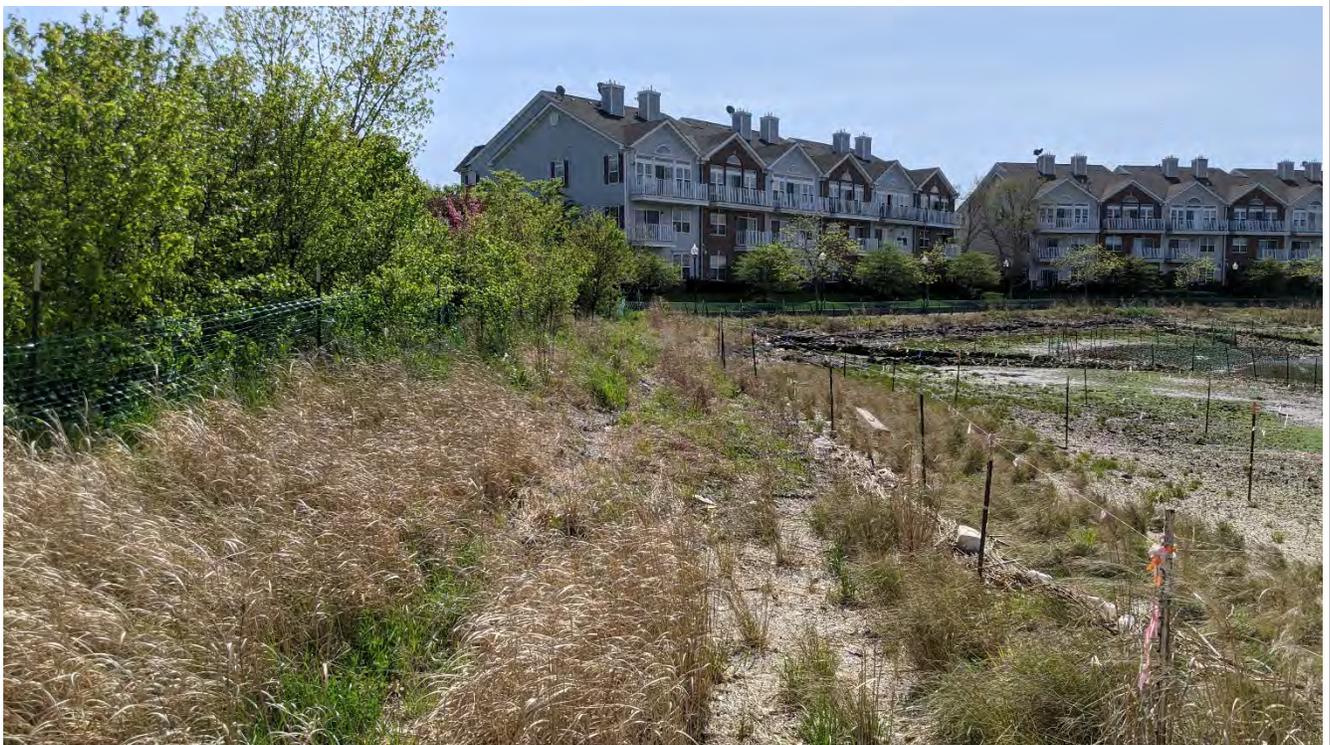
Photo 32: Upland vegetation present on the eastern side of the BEP area (facing southwest). Note the dormant, healthy, and vibrant vegetation in the high marsh and upland areas.

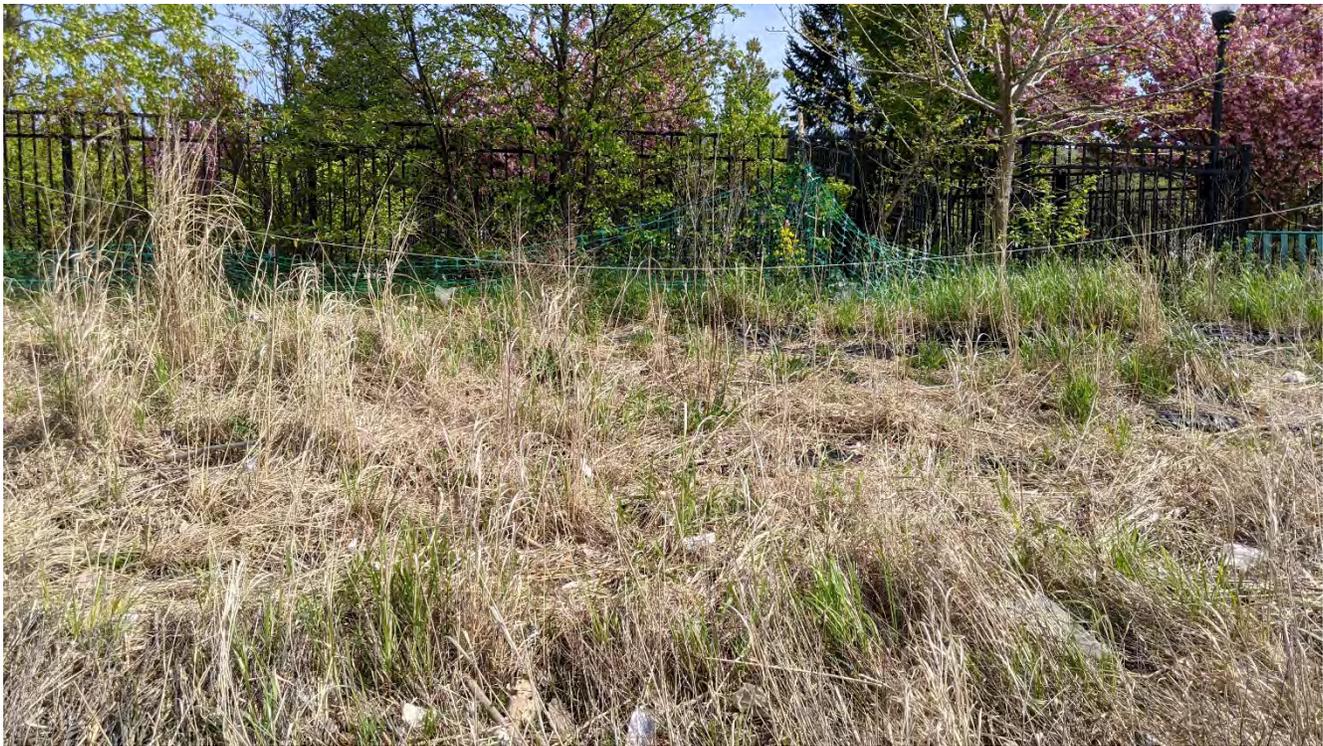
Photo 33: Upland vegetation present on the eastern side of the BEP area (facing southeast). Note the dormant, healthy, and vibrant vegetation in the upland areas.

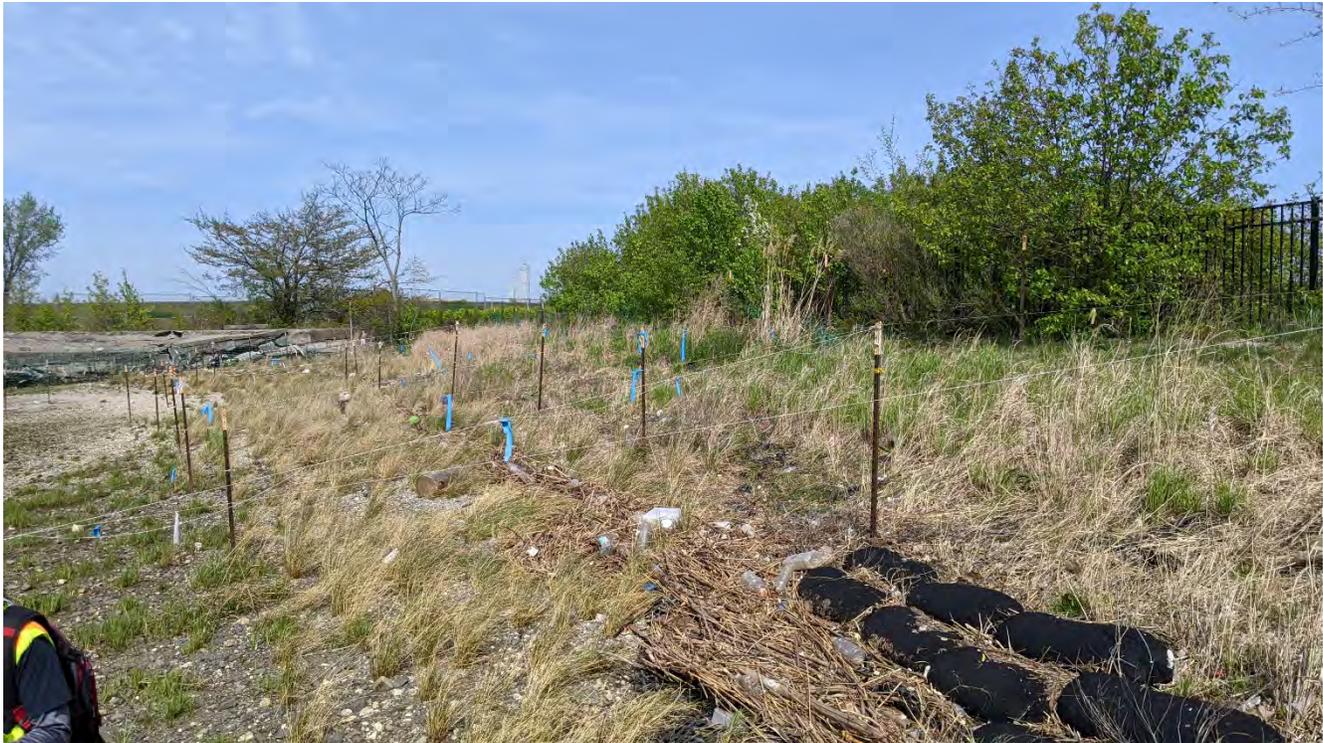
Photo 34: Upland vegetation present on the eastern side of the BEP area (facing northeast). Note the dormant, healthy, and vibrant vegetation in the high marsh and upland areas.

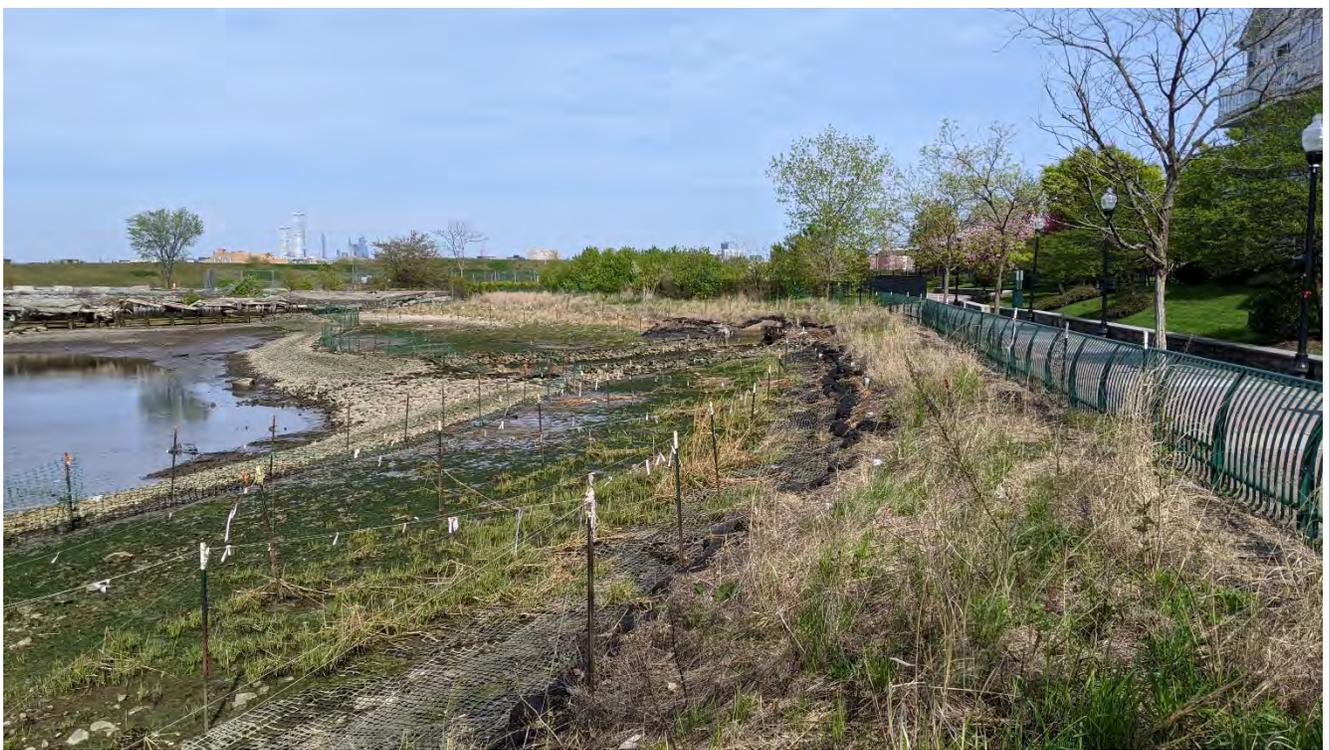
Photo 35: Upland vegetation present in the central portion of the BEP area (facing east). Note the dormant, healthy, and vibrant vegetation in the high marsh and upland areas.

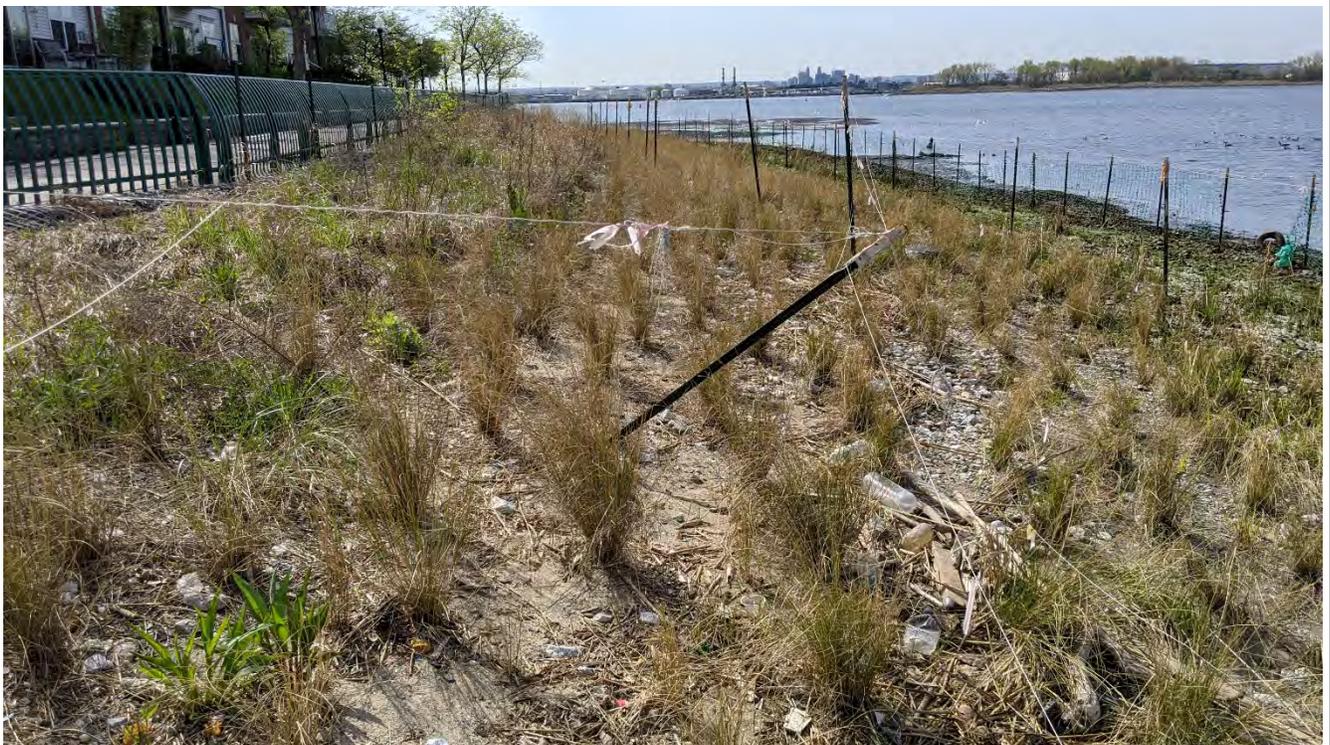
Photo 36: Upland vegetation present on the western side of the BEP area (facing northwest). Note the dormant, healthy, and vibrant vegetation in the high marsh and upland areas.

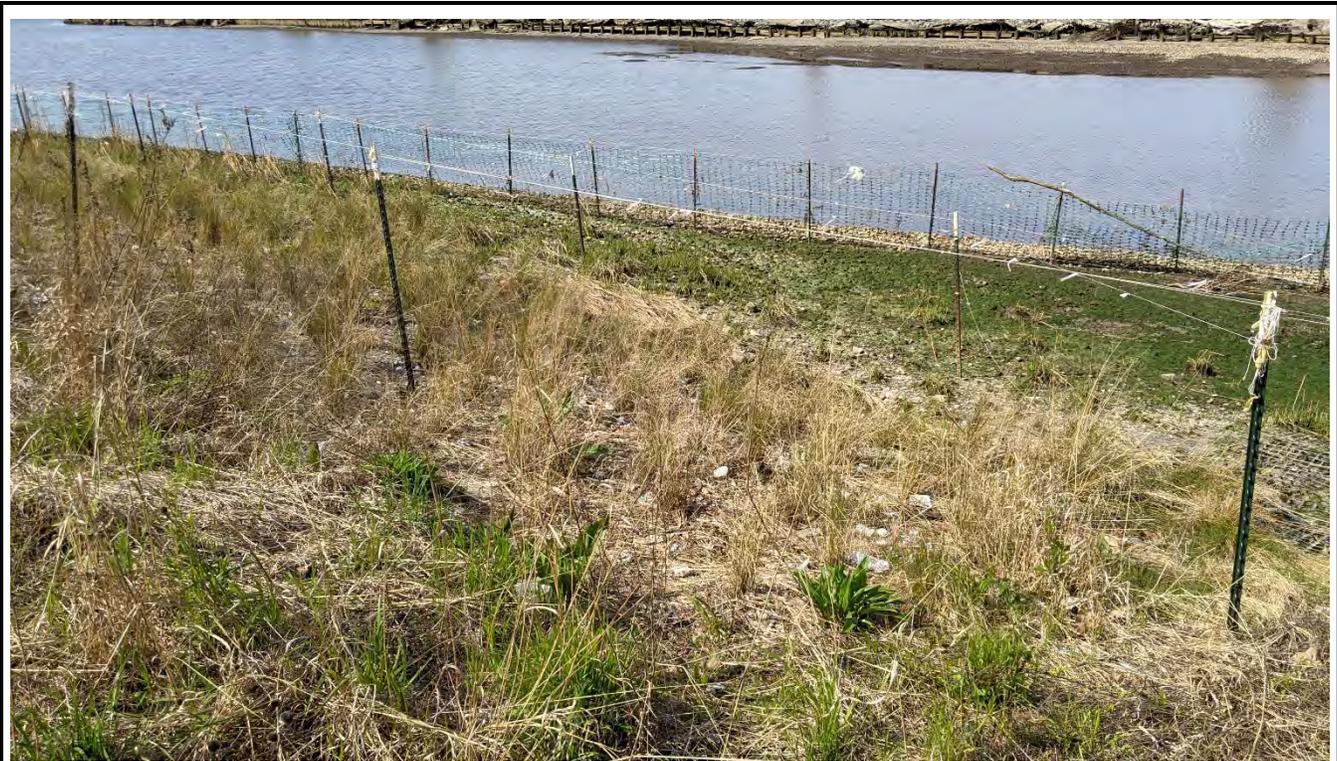
Photo 37: Upland vegetation present on the eastern side of the BEP area (facing north). Note the dormant, healthy, and vibrant vegetation in the high marsh and upland areas, but sparse vegetation in the low marsh zone.

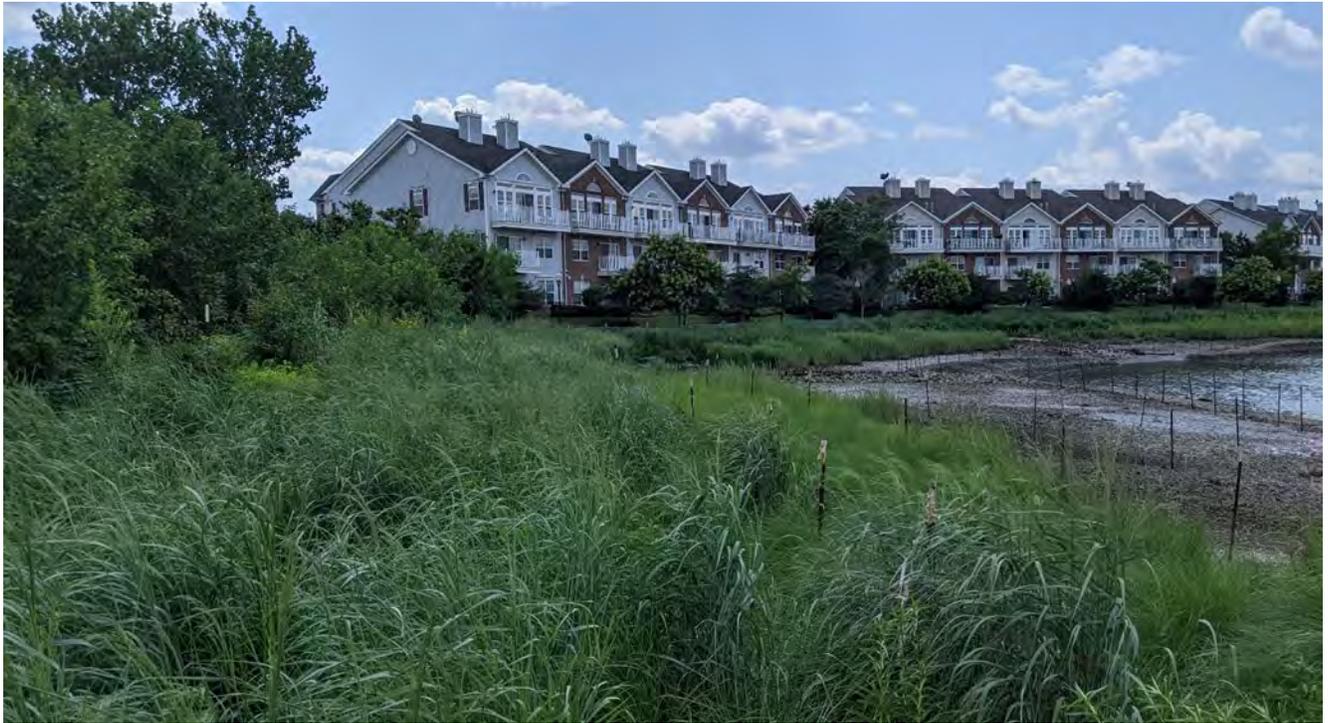
Photo 1: Northern end of Cap Area 16. Note vibrance of vegetation present in upland and high marsh planting zones (facing southwest). All snow fencing and waterfowl exclusion measures have been removed but posts remain.

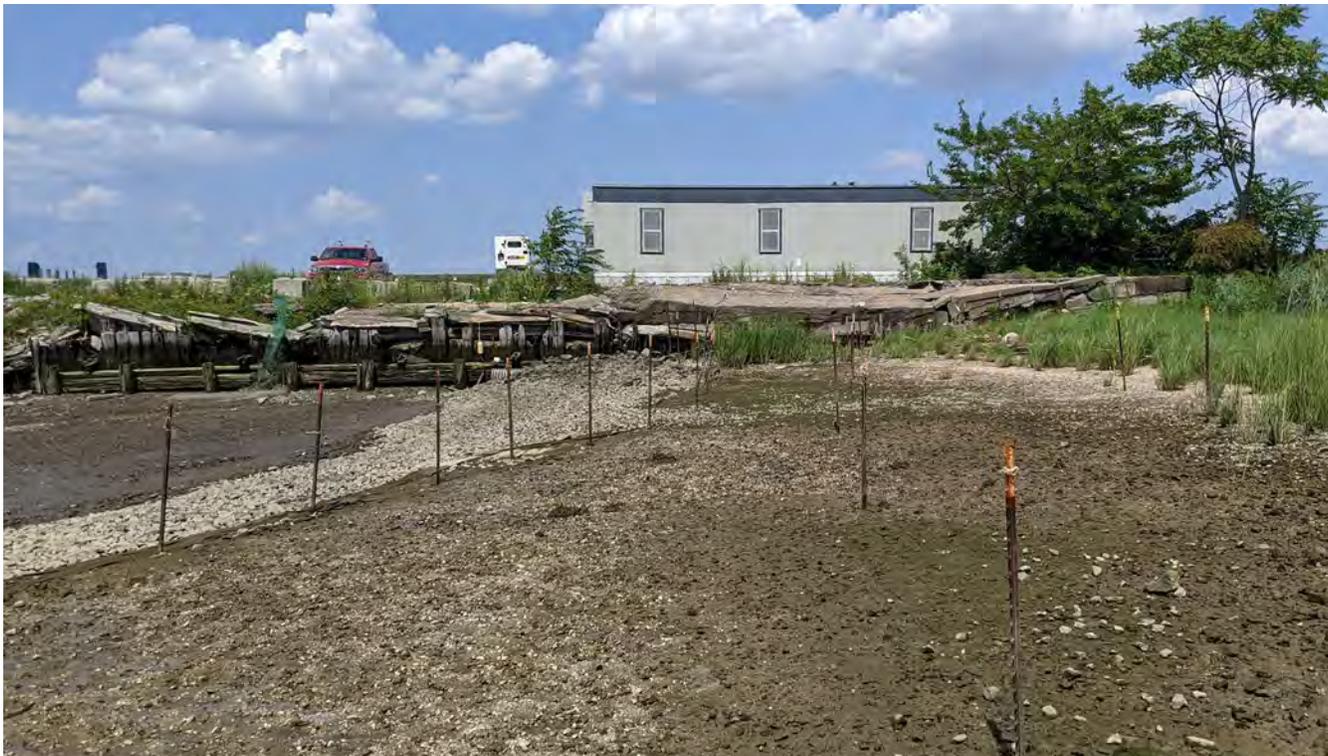
Photo 2: Western end of Cap Area 16. Note limited vegetative growth in low marsh zone and that all snow fencing and waterfowl exclusion measures have been removed but posts remained (facing northeast).

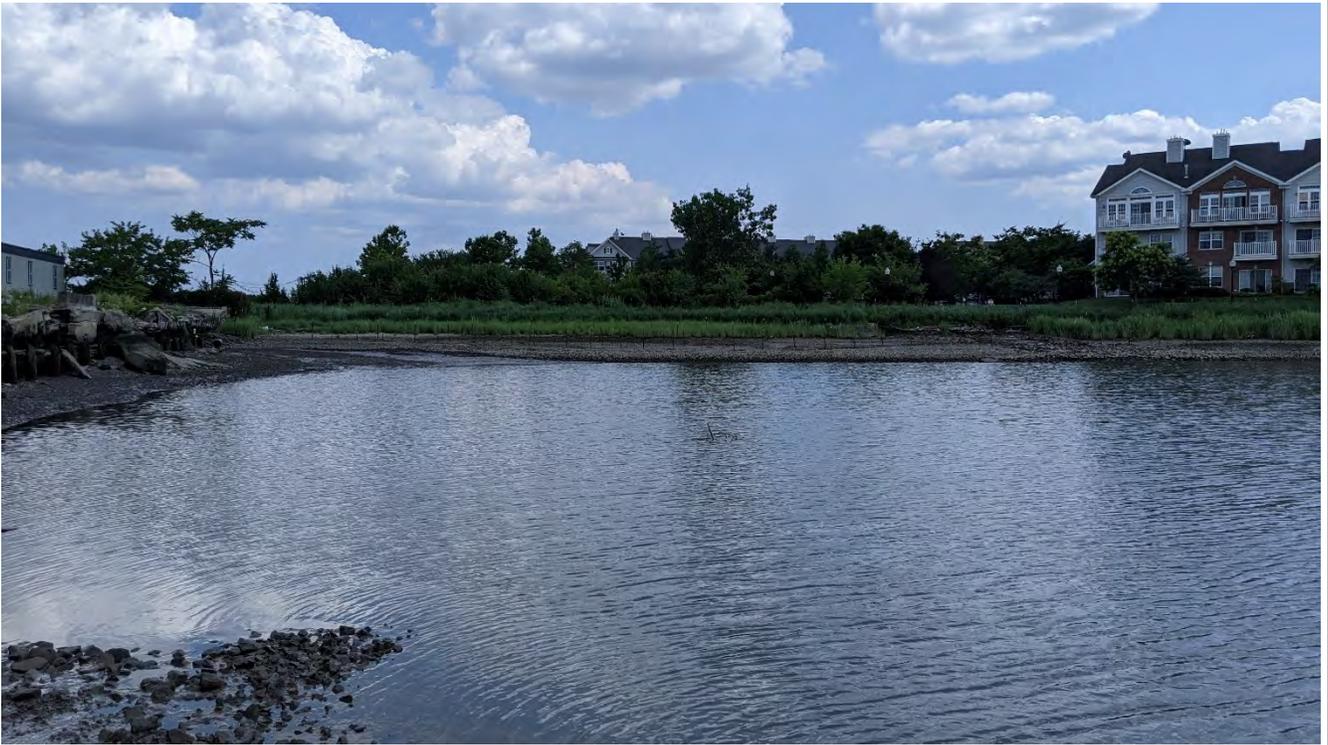
Photo 3: Cap Area 16 viewed from SA-6S bulkhead (facing south).

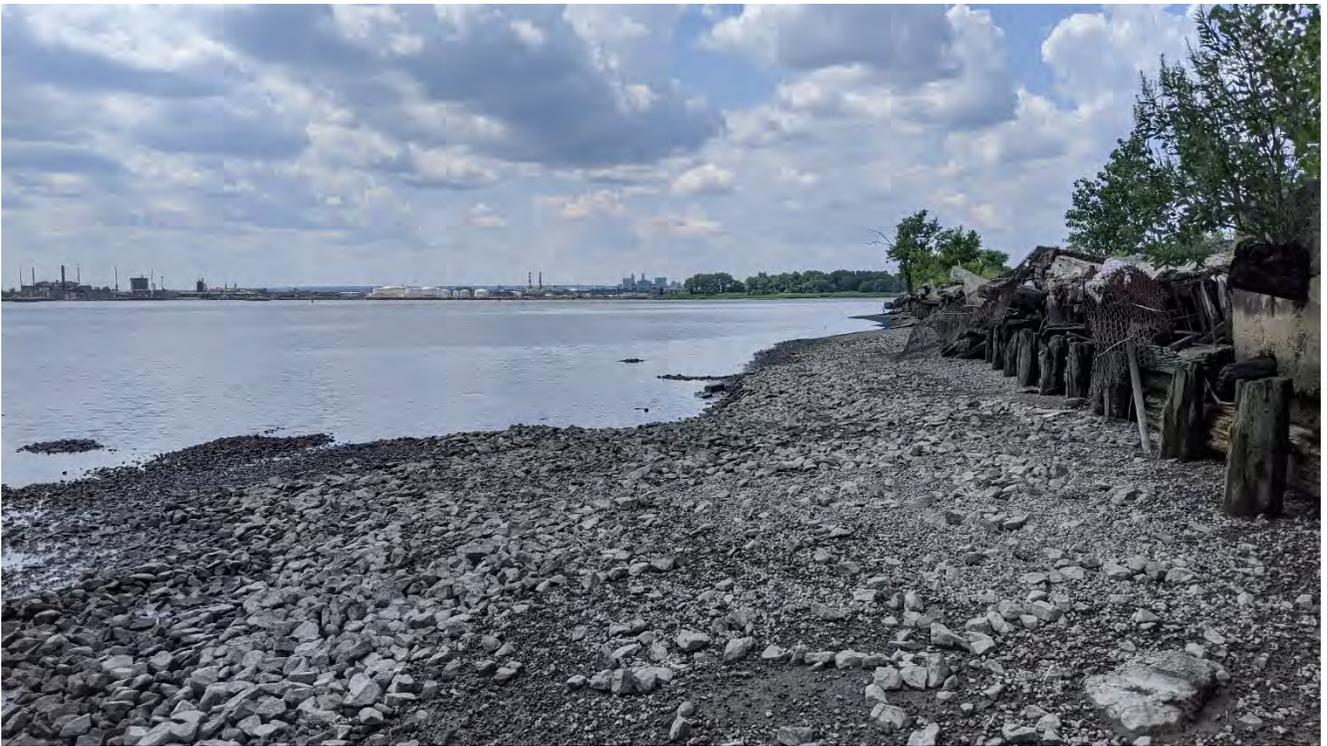
Photo 4: Cap Area 22 (facing northwest).
