MEMORANDUM

Subject: **SA-7 Sediment Remedy Long-Term Monitoring
Summary of Year 8 Monitoring & Proposed Year 8 Program**

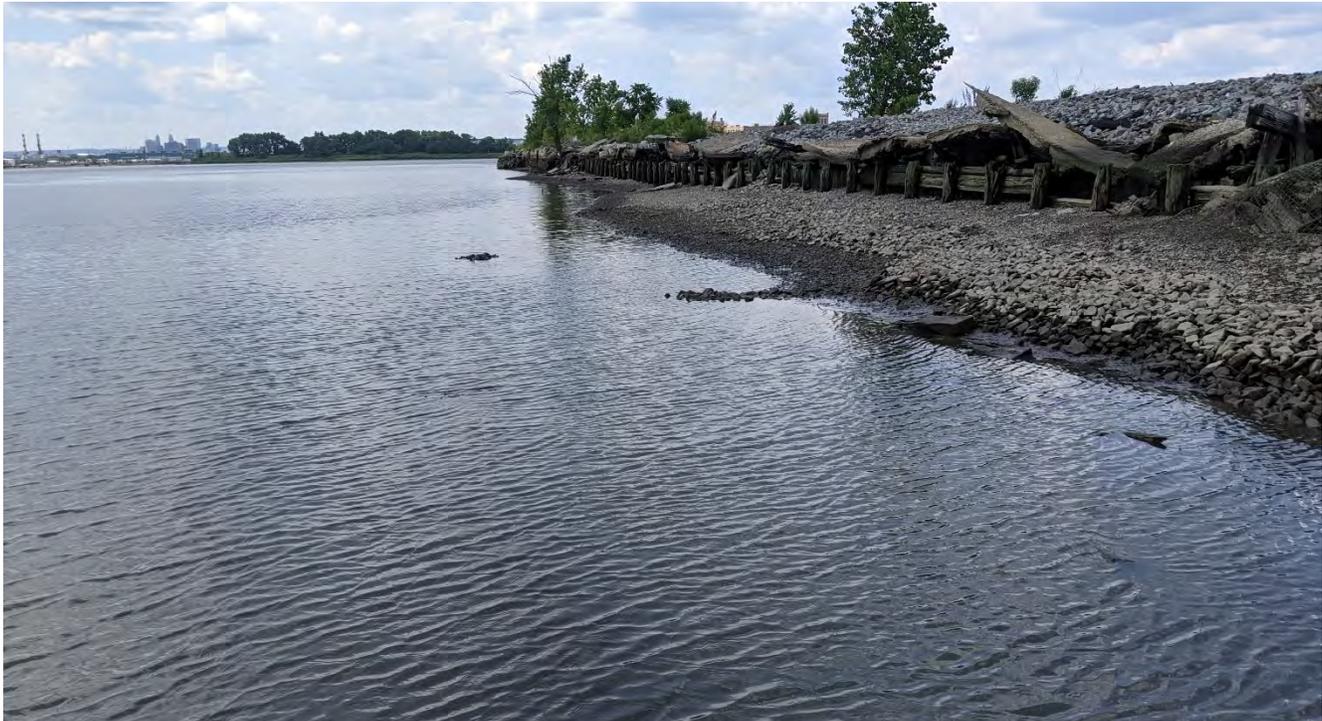
Photo 5: Cap Area 22 (facing northeast).

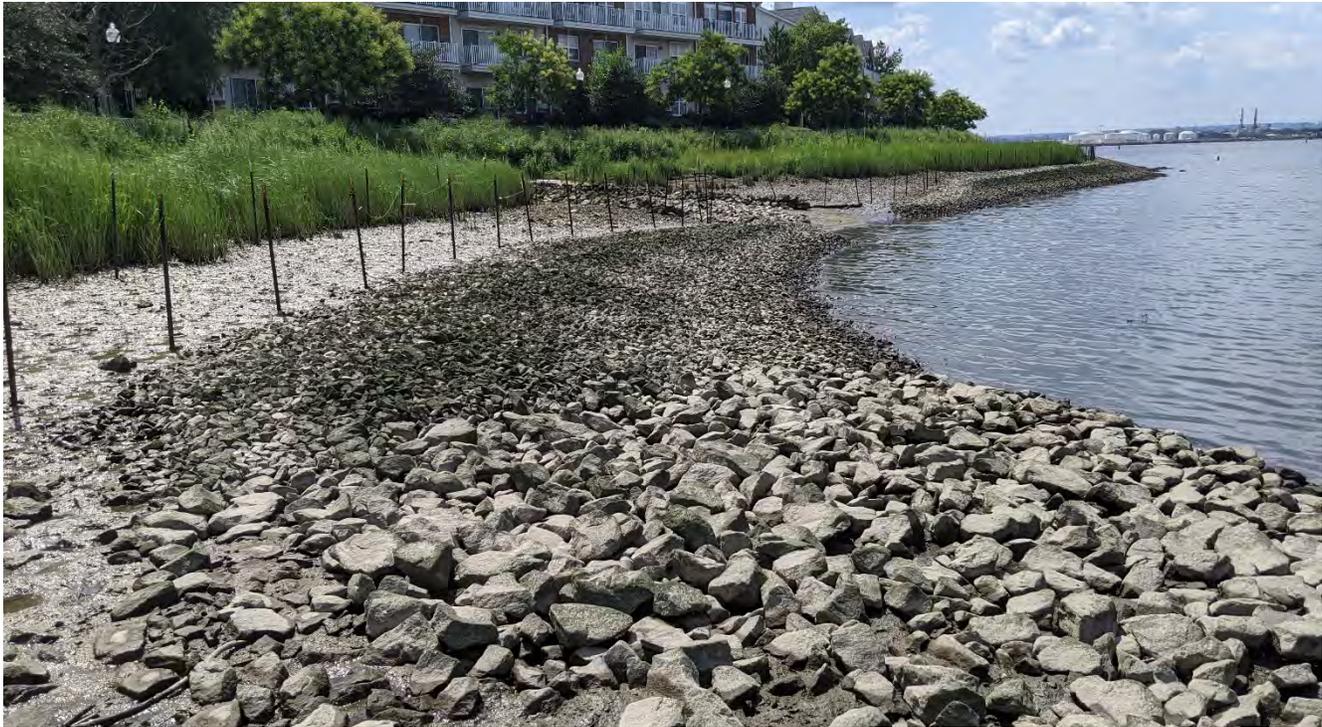
Photo 6: Shoreline stabilization along the central portion of the BEP area (facing northwest). Note that all snow fencing and waterfowl exclusion measures have been removed but posts remained at the time of the inspection.

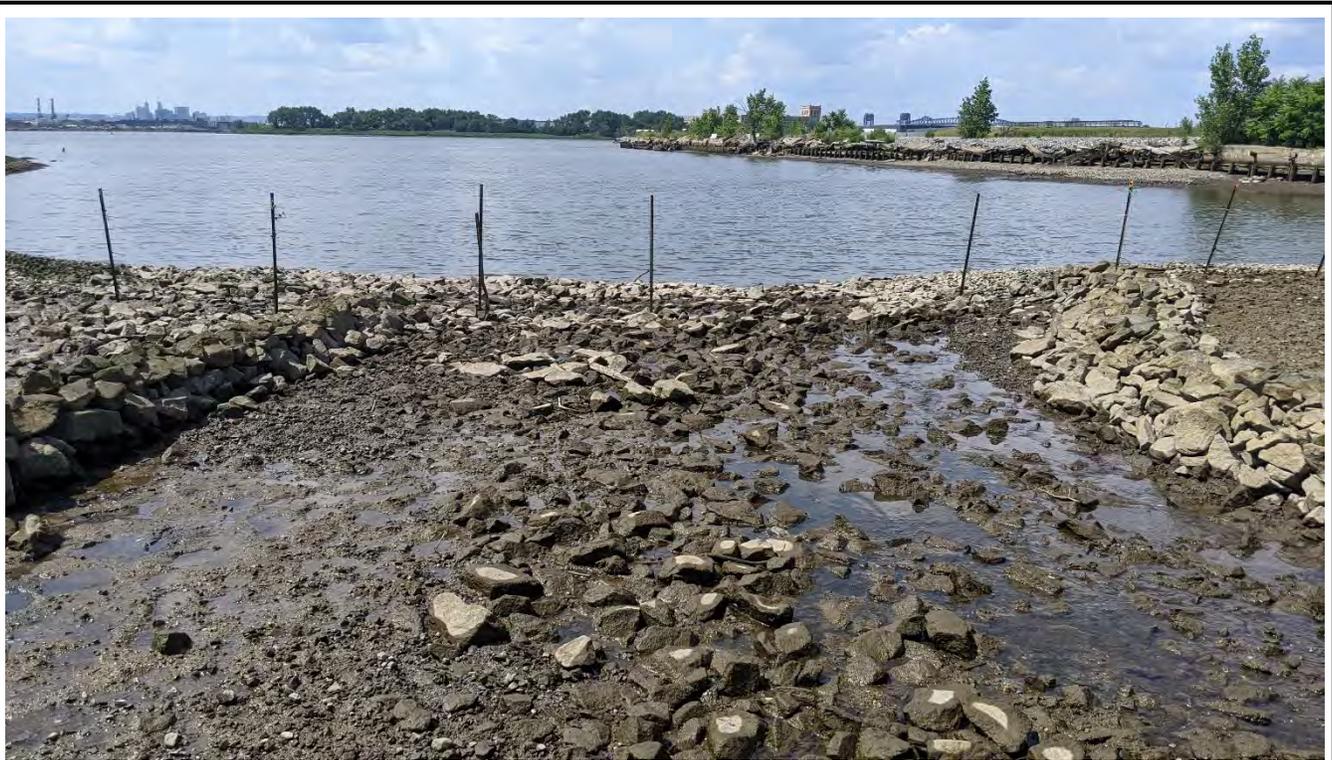
Photo 7: Discharge area of Outfalls B and C (facing northwest). Note that all snow fencing had been removed, but posts remained in place at the time of the inspection.

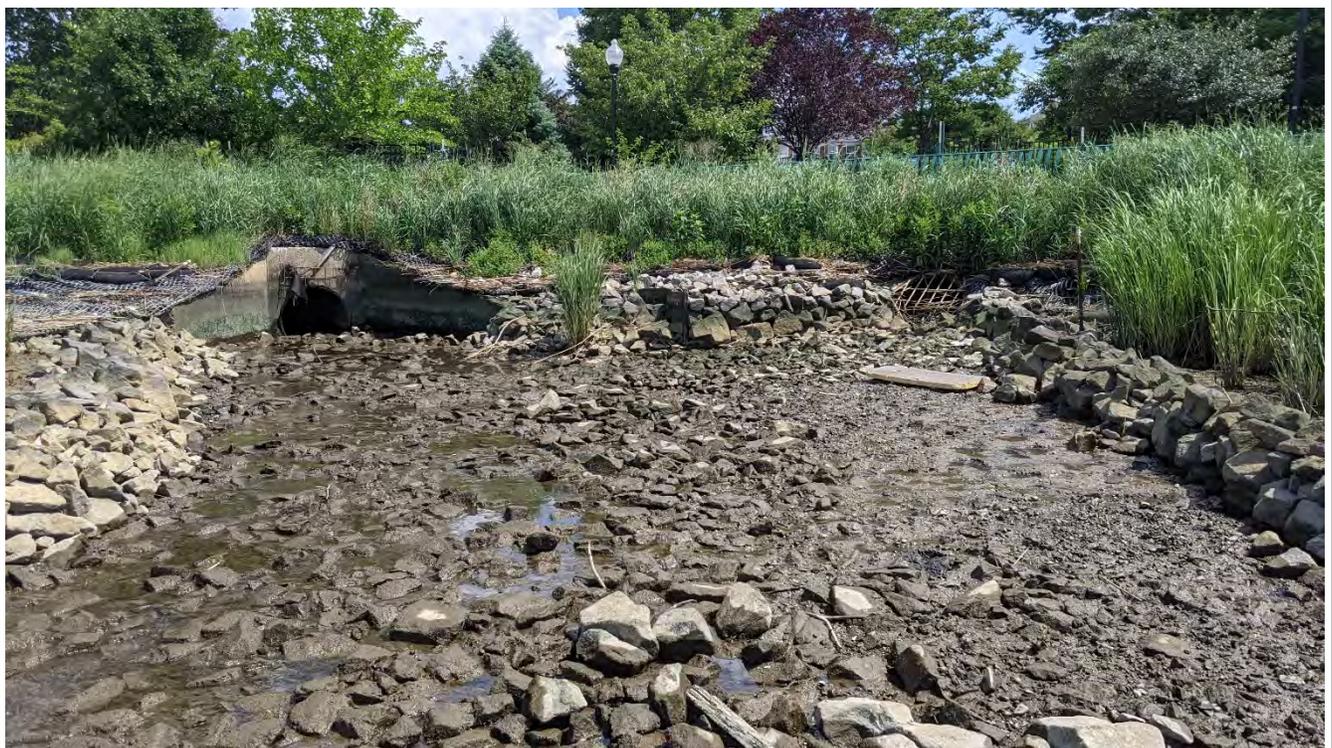
Photo 8: Outfalls B and C located in the central portion of the BEP area (facing southeast).

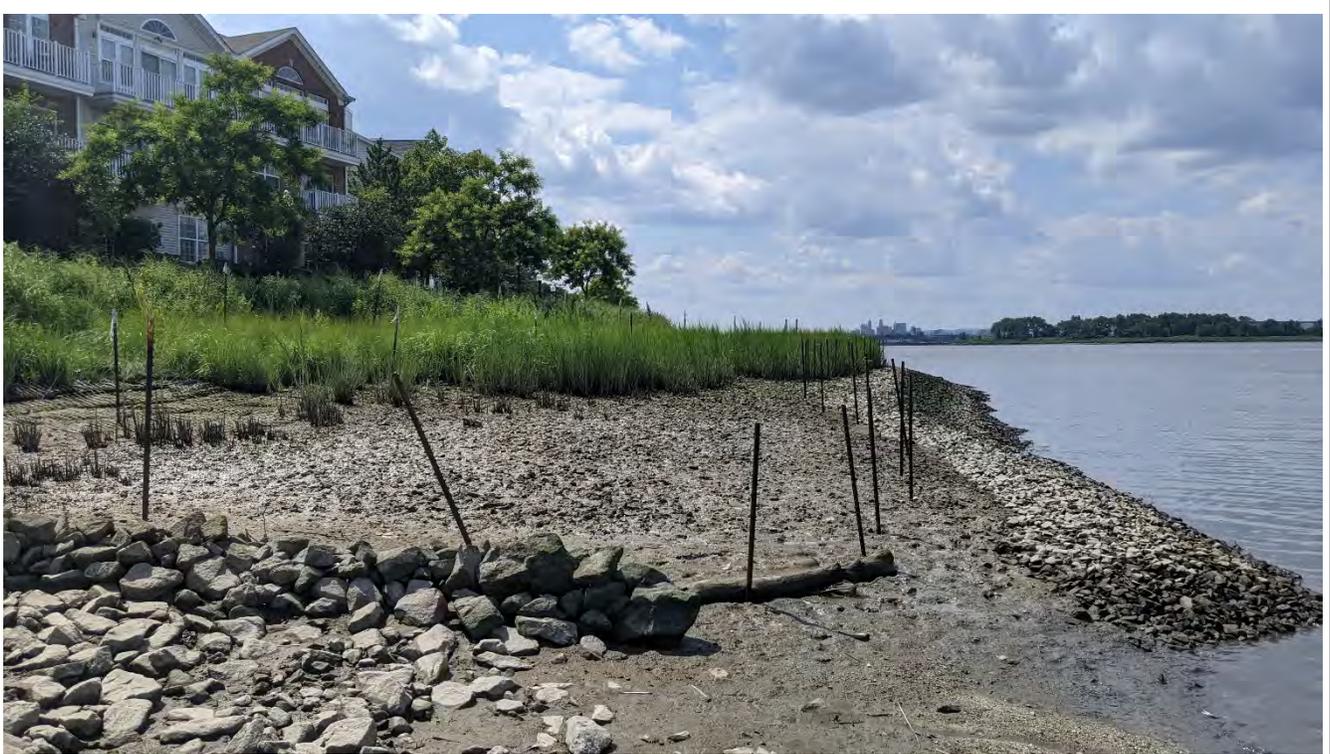
Photo 9: View of the western side of the BEP area from the Outfall A discharge area (facing northwest). Note that all snow fencing and waterfowl exclusion measures have been removed but posts remained.

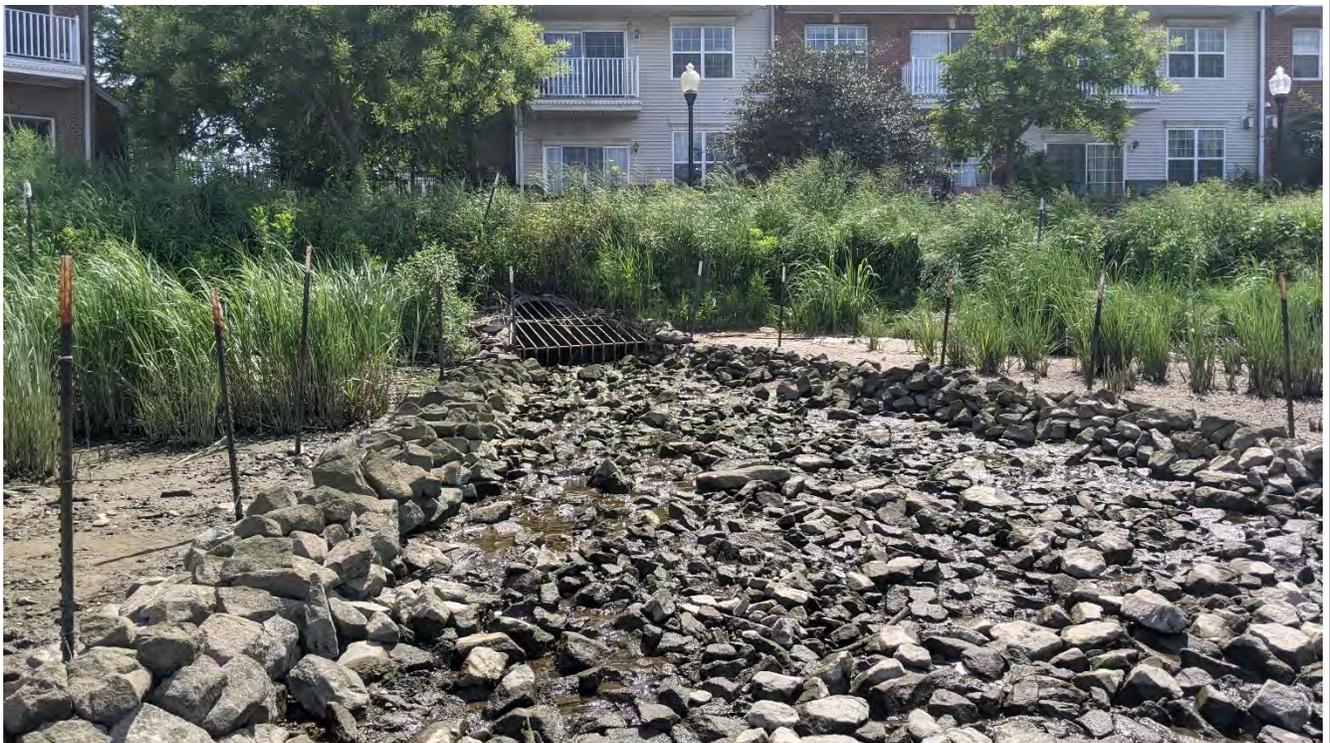
Photo 10: Outfall A and the debris screen (facing south).

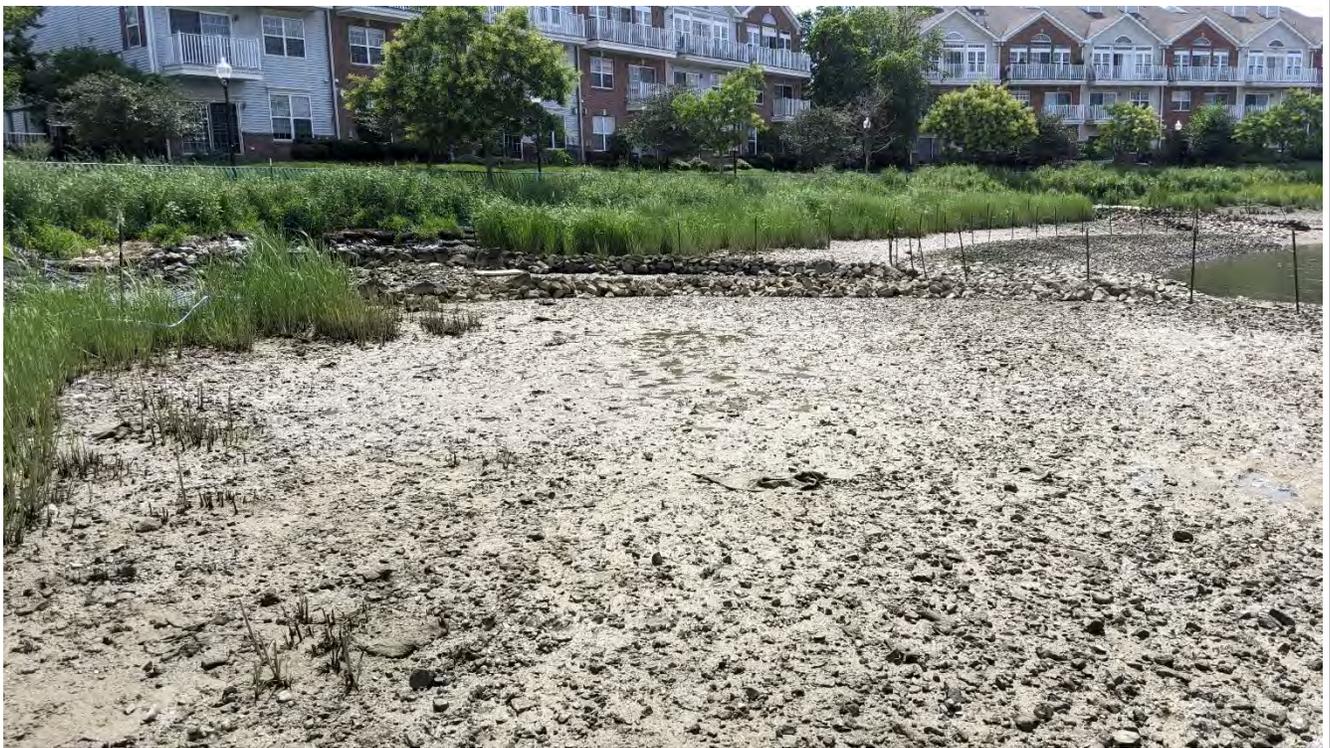
Photo 11: Limited vegetation present throughout the low marsh zone (facing southwest). Note that all snow fencing and waterfowl exclusion measures have been removed but posts remained.

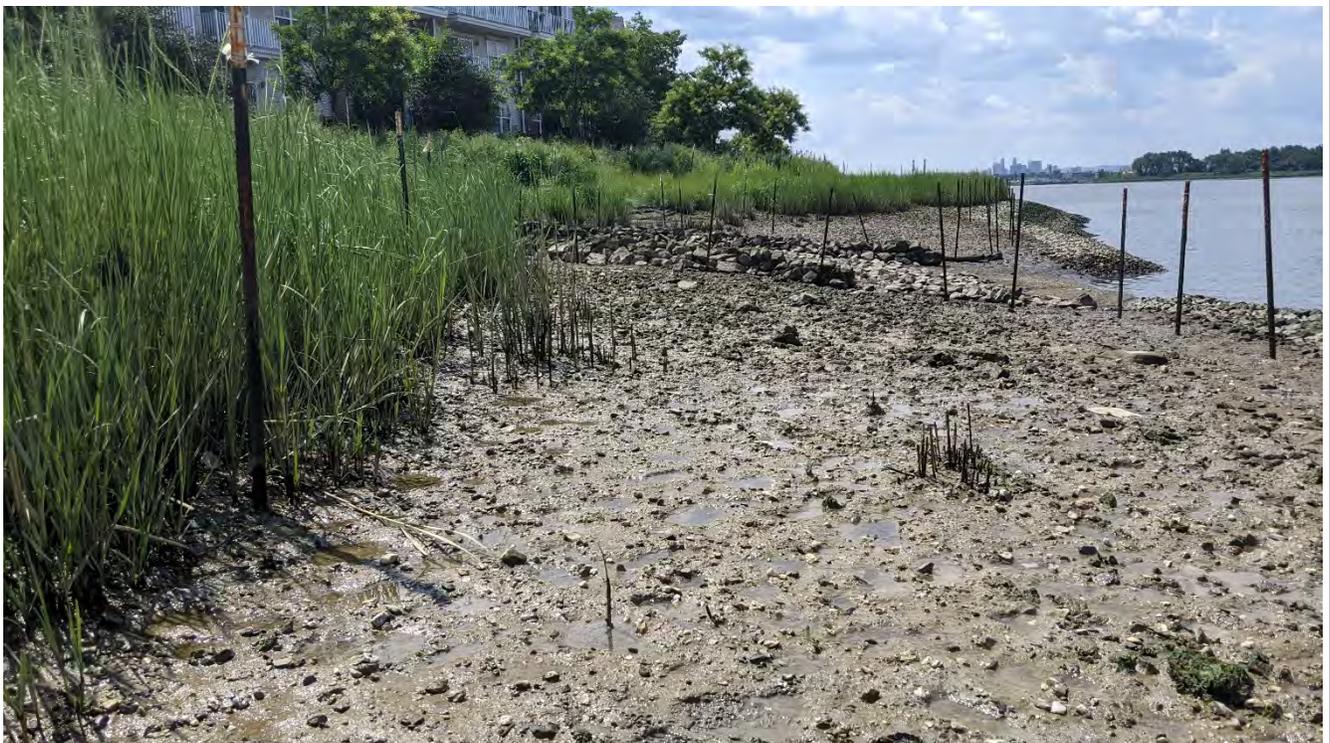
Photo 12: Limited vegetation present throughout the low marsh zone (facing northwest). Note that all snow fencing and waterfowl exclusion measures have been removed but posts remained.

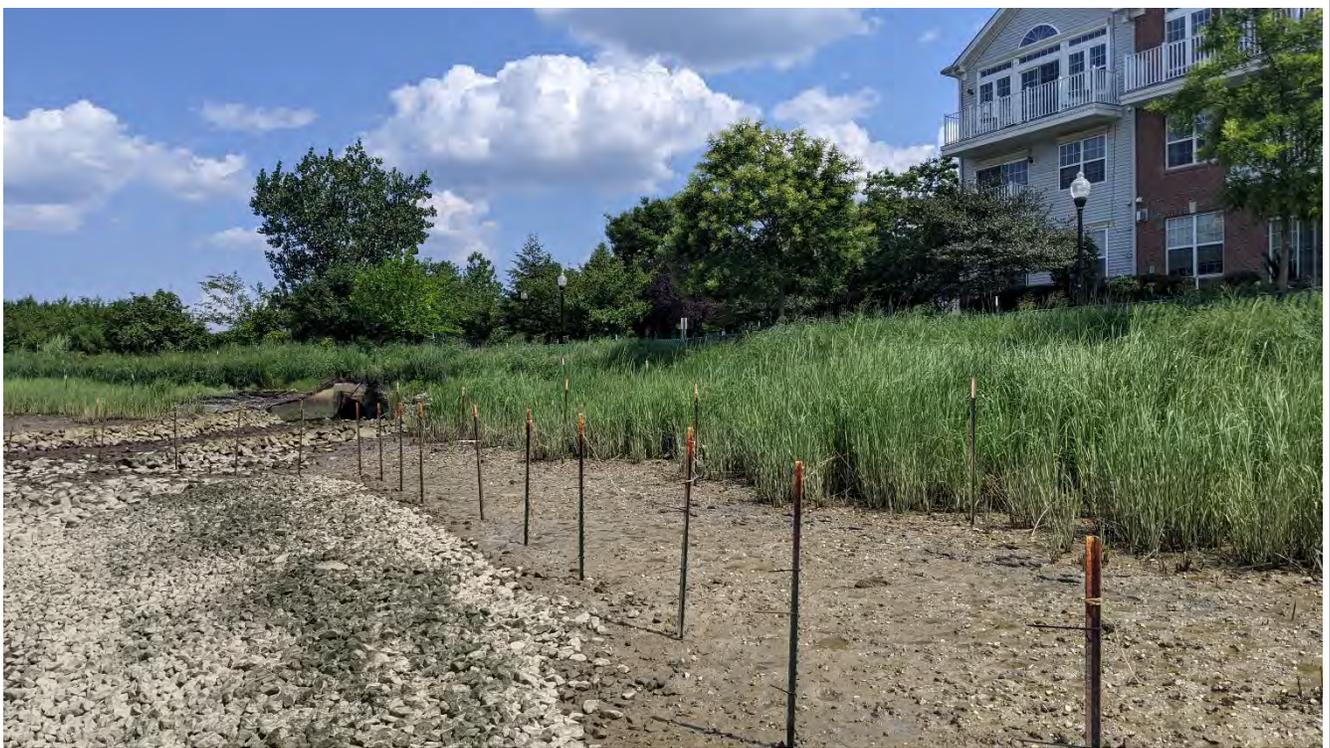
Photo 13: Limited vegetation present in the low marsh zone located between Outfalls A and B (facing southeast). Note that all snow fencing and waterfowl exclusion measures have been removed but posts remained.

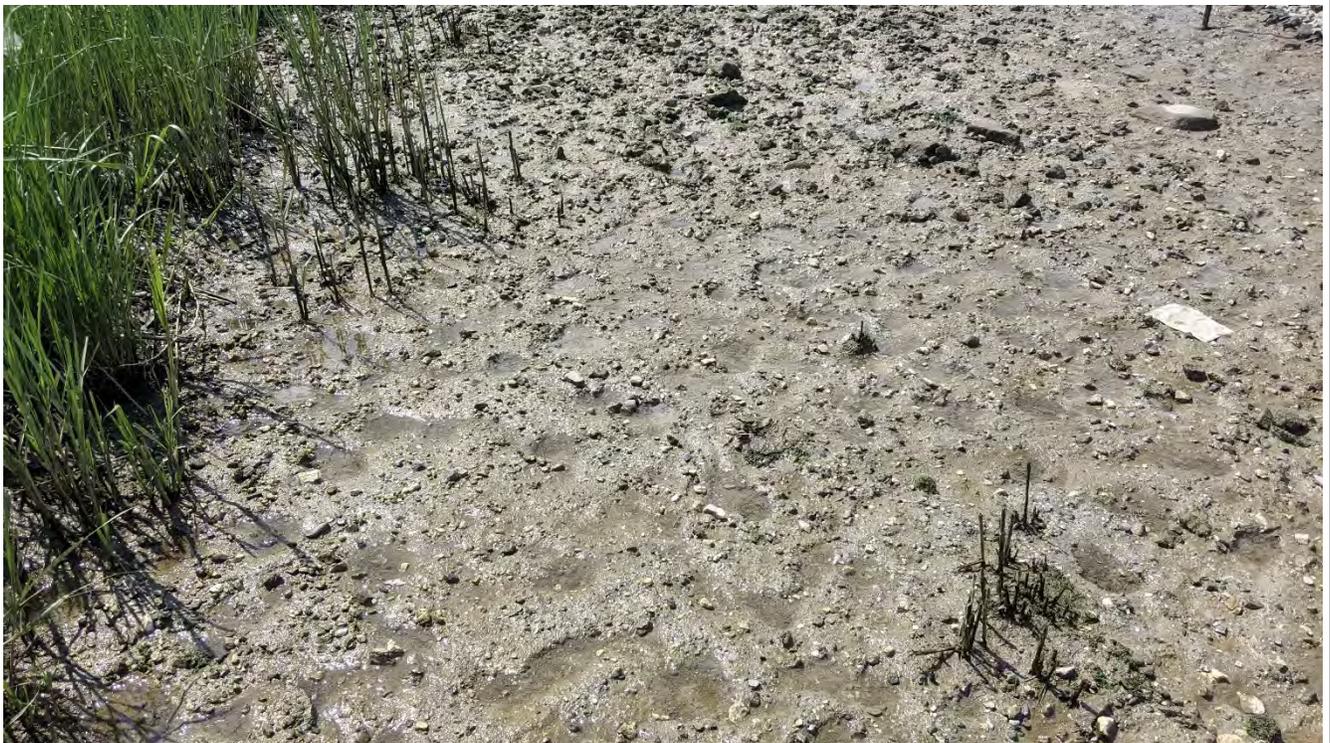
Photo 14: Example of the limited vegetation present in the low marsh zone located between Outfalls A and B.

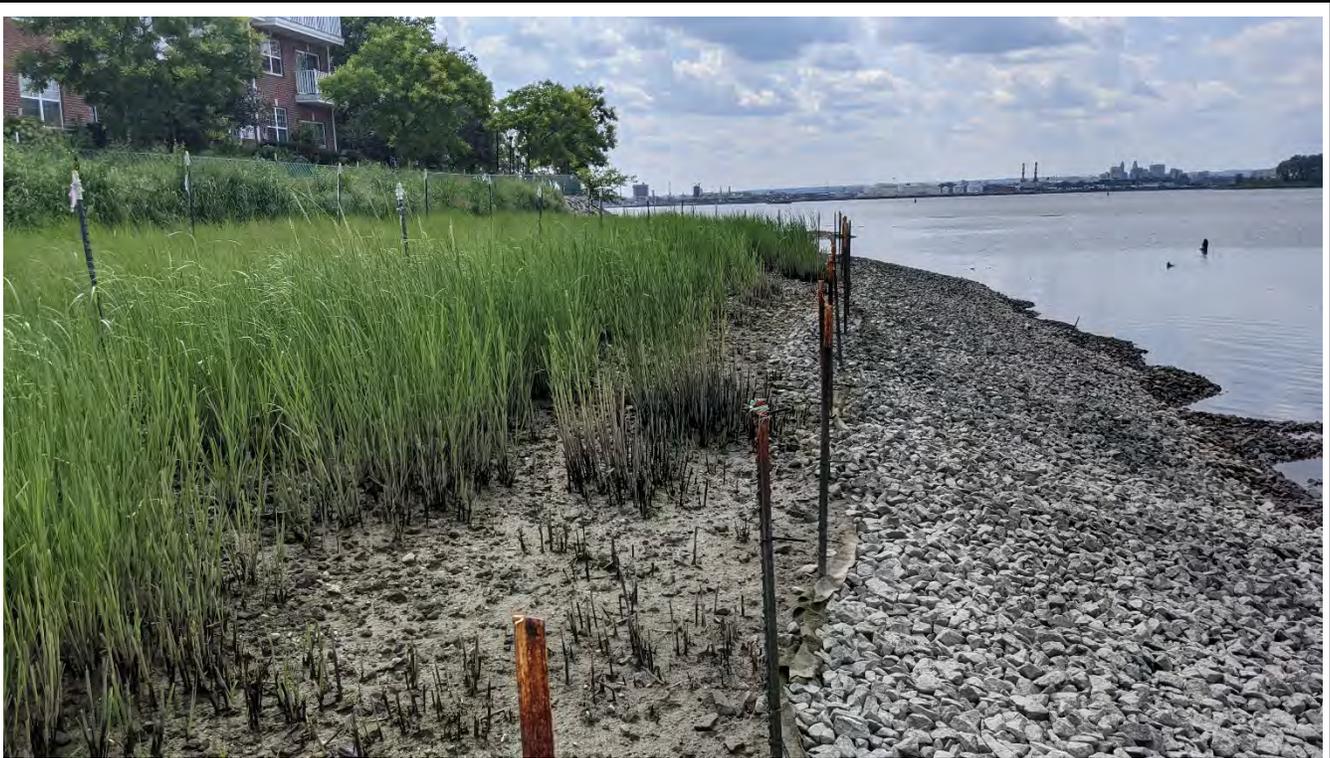
Photo 15: Vegetation present in the low marsh zone from the western side of the BEP area (facing northwest). Note that all snow fencing and waterfowl exclusion measures have been removed but posts remained.

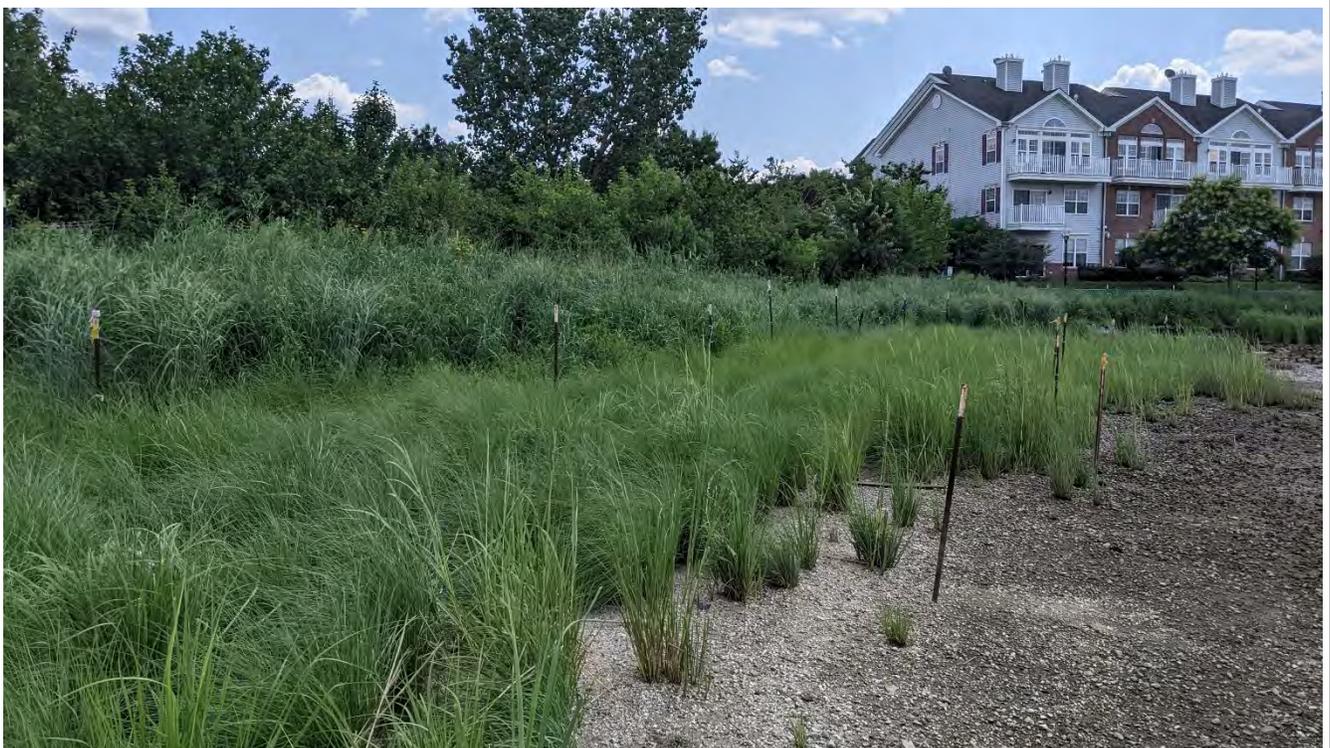
Photo 16: Vegetation on the eastern side of the BEP area. Note the healthy and vibrant vegetation in the uplands and high marsh zones, but limited growth in the low marsh zone (facing southwest).

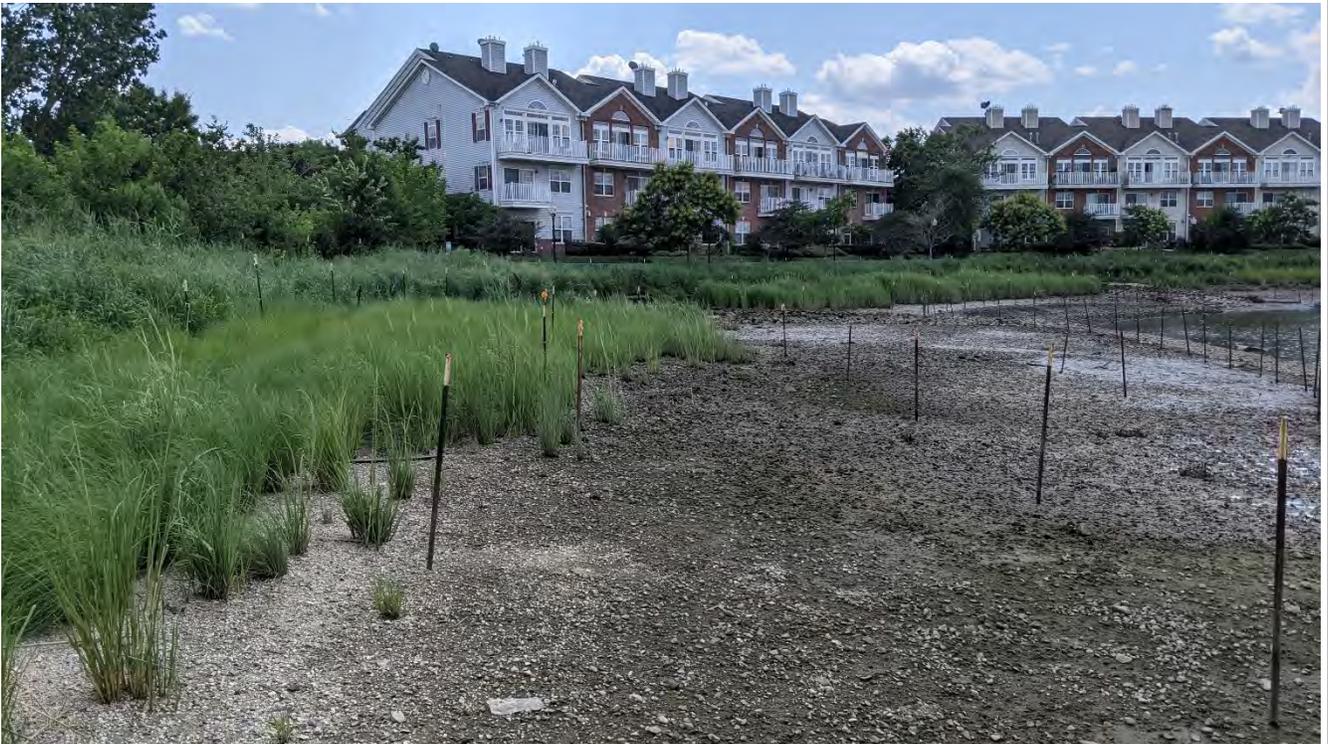
Photo 17: Vegetation on the eastern side of the BEP area. Note the healthy and vibrant vegetation in the uplands and high marsh zones, but limited growth in the low marsh zone and that all snow fencing and waterfowl exclusion measures have been removed but posts remained (facing southwest).

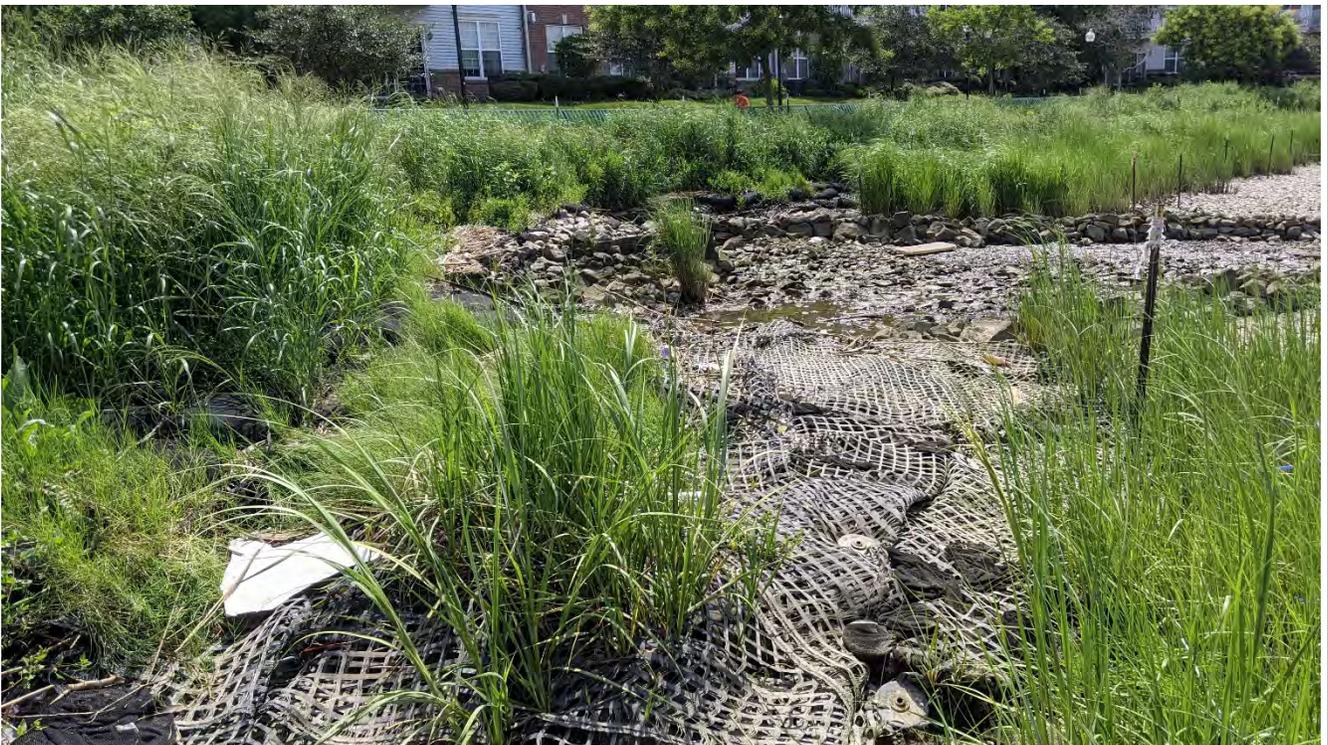
Photo 18: Sparse vegetation present near the exposed geogrid located in the eastern portion of the BEP area near Outfall C (facing southwest).

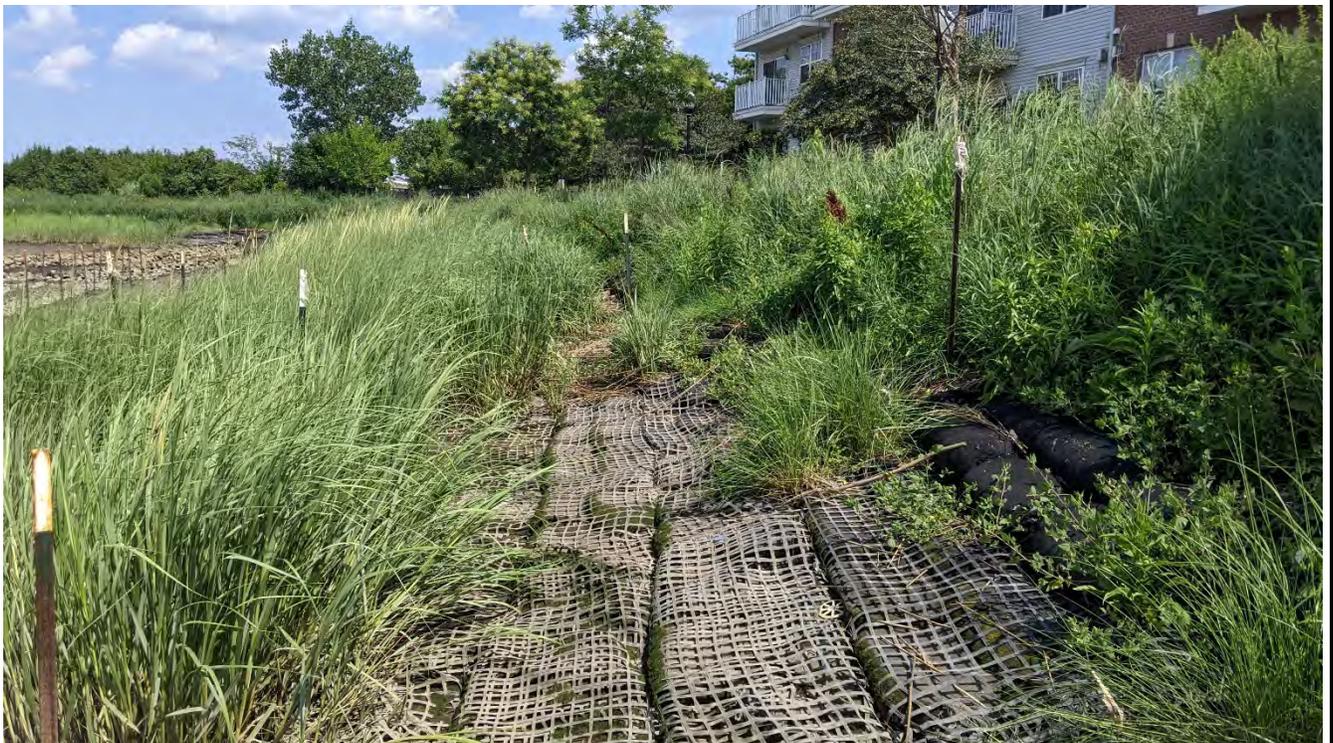
Photo 22: Improved vegetative growth in lower portion of GroSoxx near Outfall A and exposed geogrid/RockSoxx. Note that all waterfowl exclusion measures have been removed but posts remain in place (facing east).

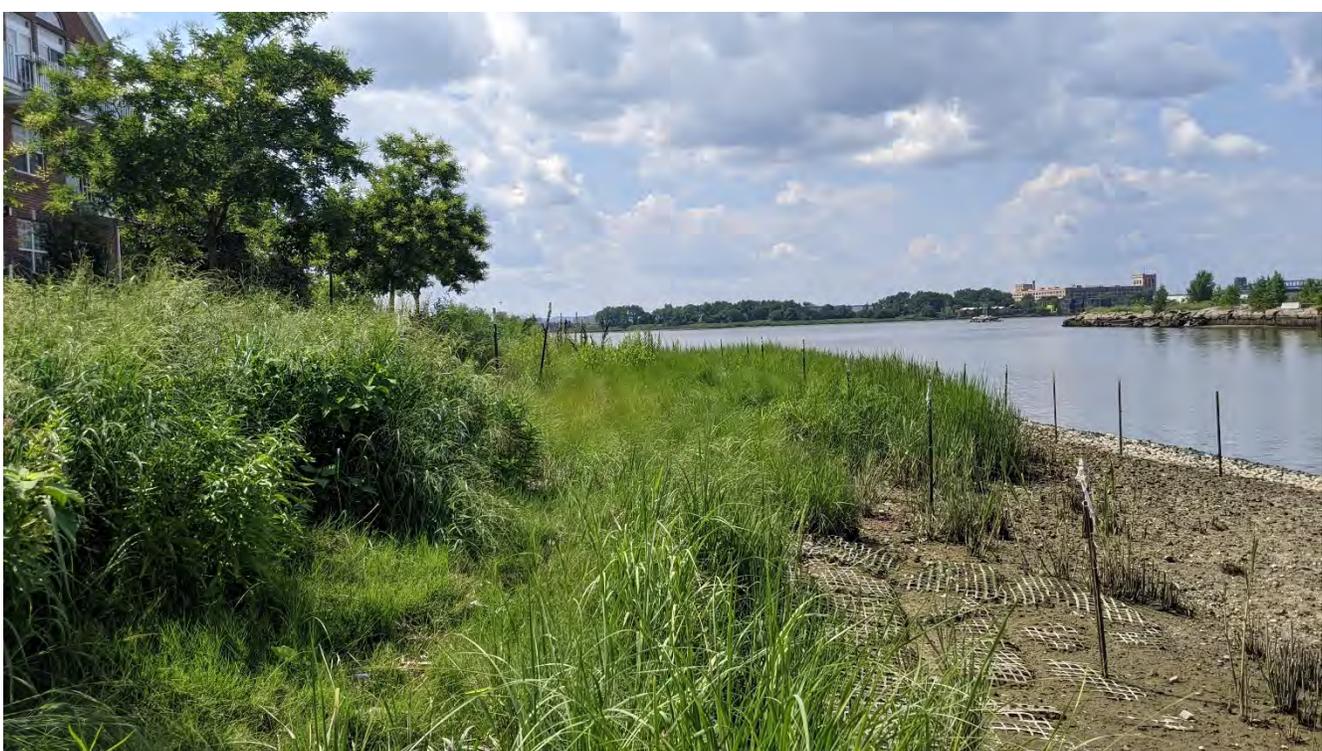
Photo 23: Partially buried and sparsely vegetated GroSoxx near Outfall A to the right, healthy and vibrant upland vegetation pictured left (facing northwest).

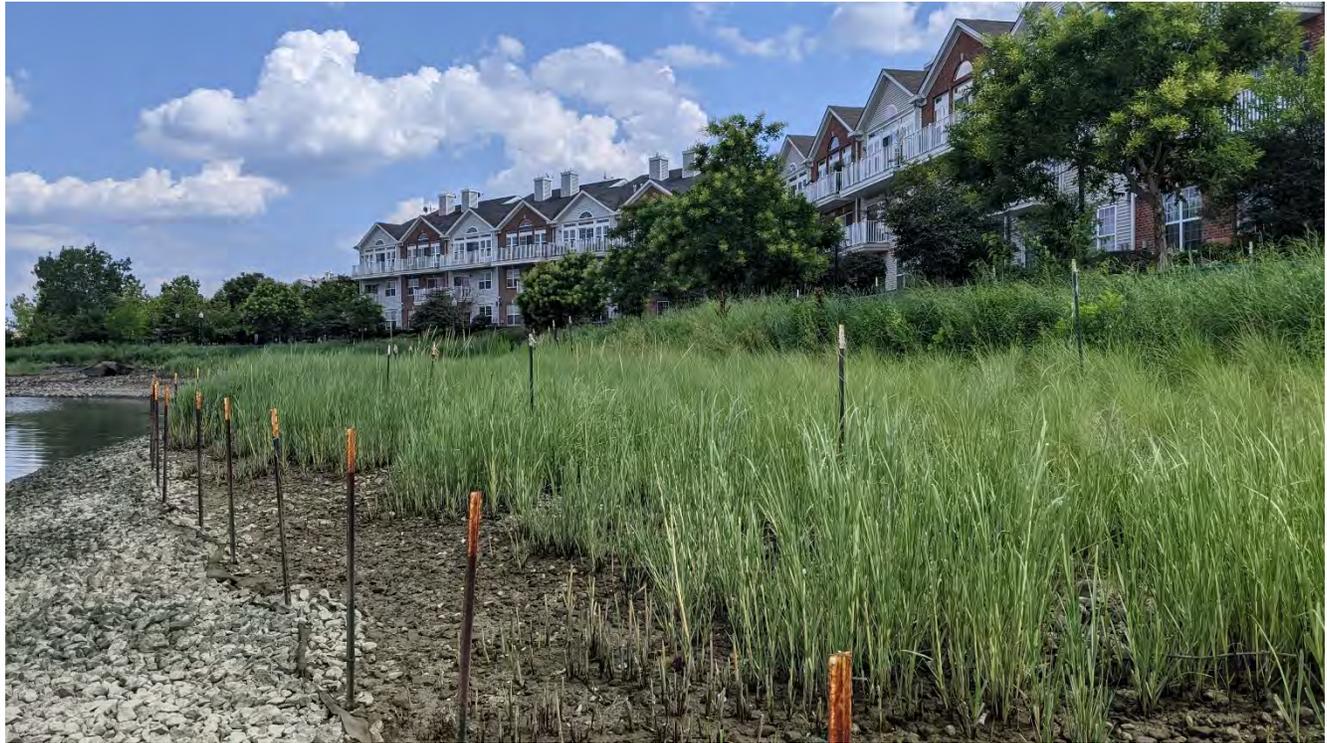
Photo 26: Vegetation present on the western side of the BEP area (facing southeast). Note the healthy and vibrant vegetation in the high marsh and upland zones and removed snow fencing and waterfowl exclusion measures.

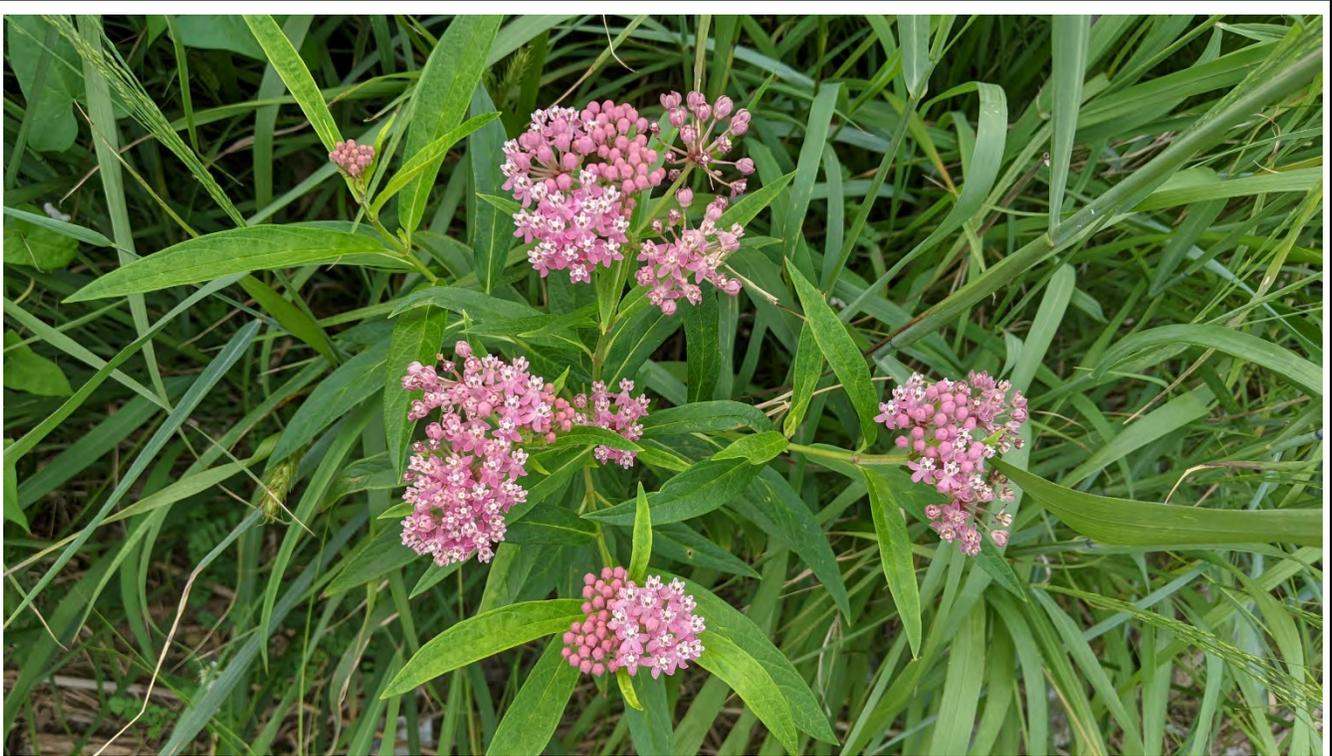
Photo 27: Swamp Milkweed present in the upland transition zone on the western side of the BEP area.

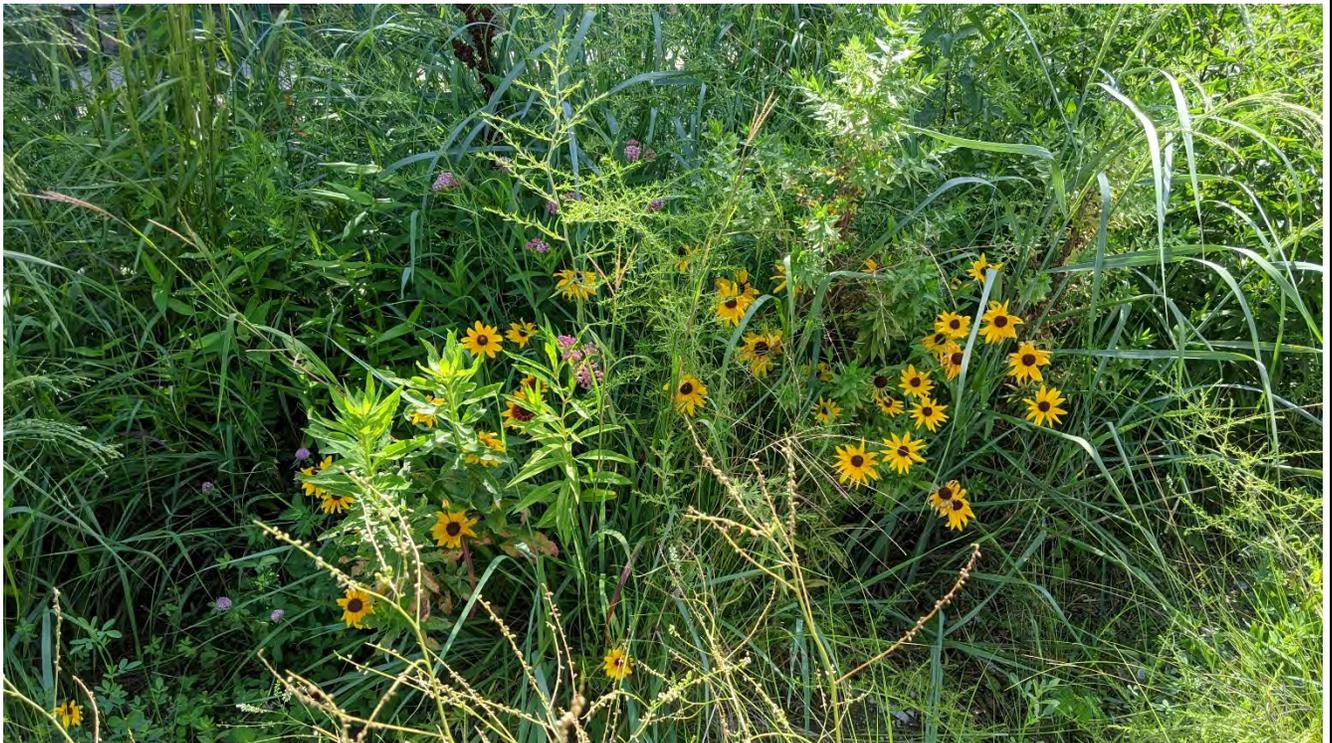
Photo 28: Black-eyed Susan present in the upland transition zone in the central portion of the BEP area.

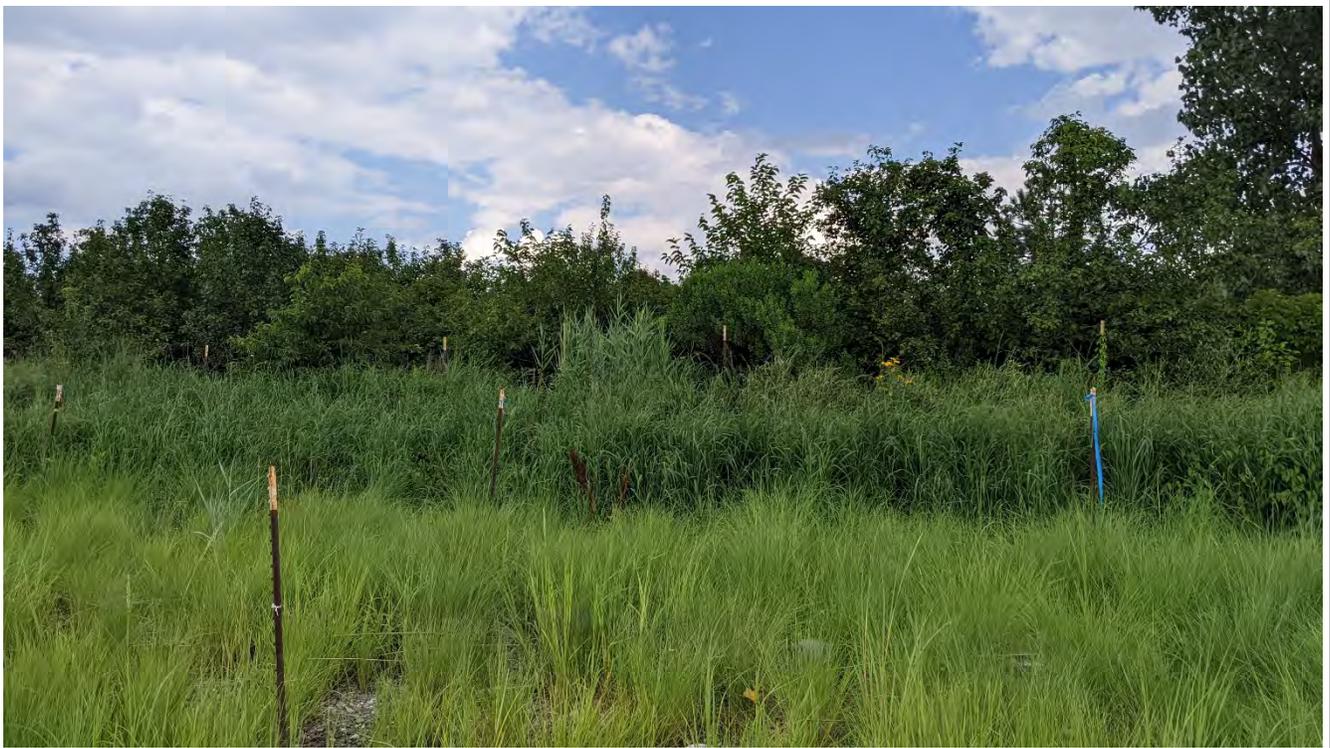
Photo 29: Upland vegetation present on the eastern side of the BEP area (facing northeast). Note the healthy and vibrant vegetation in the high marsh and upland zones and removed waterfowl exclusion measures.

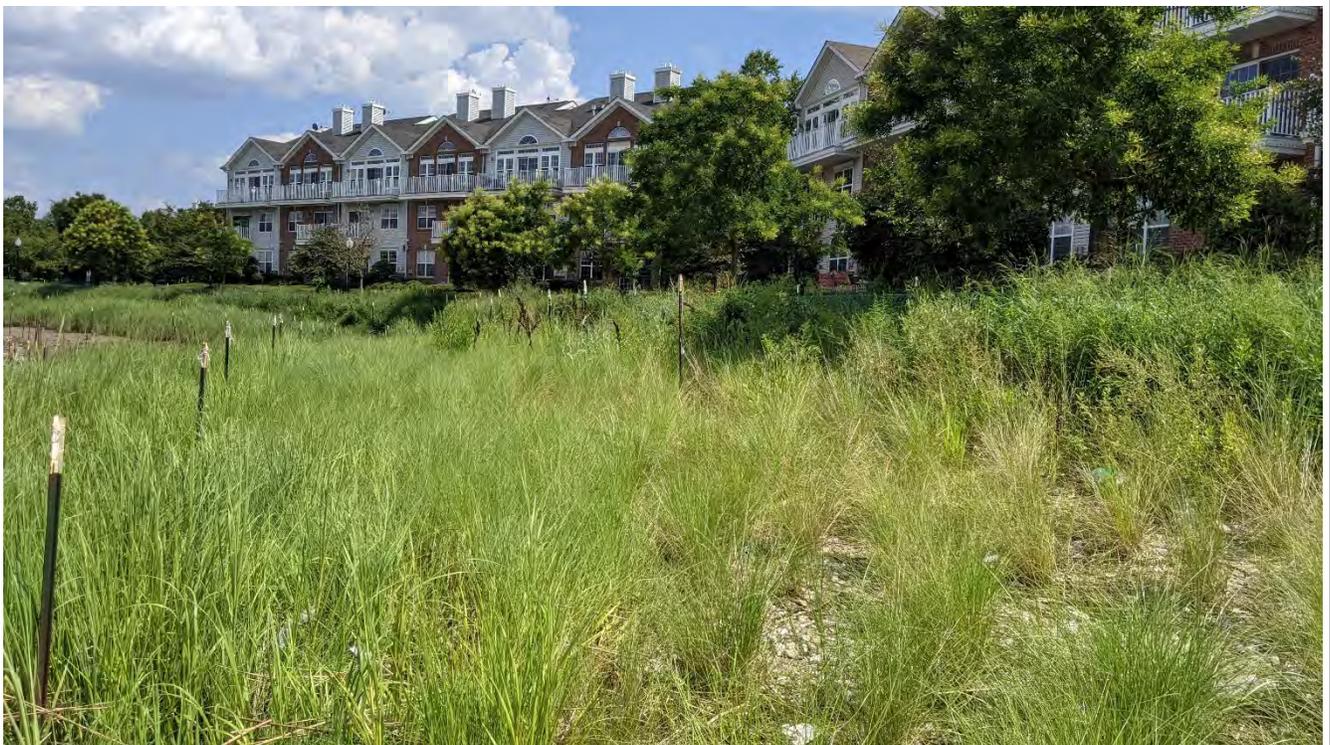
Photo 30: Upland (right) and high marsh vegetation in the central portion of the BEP area (facing east). Note the healthy and vibrant vegetation in the high marsh / upland zones and removed waterfowl exclusion measures.

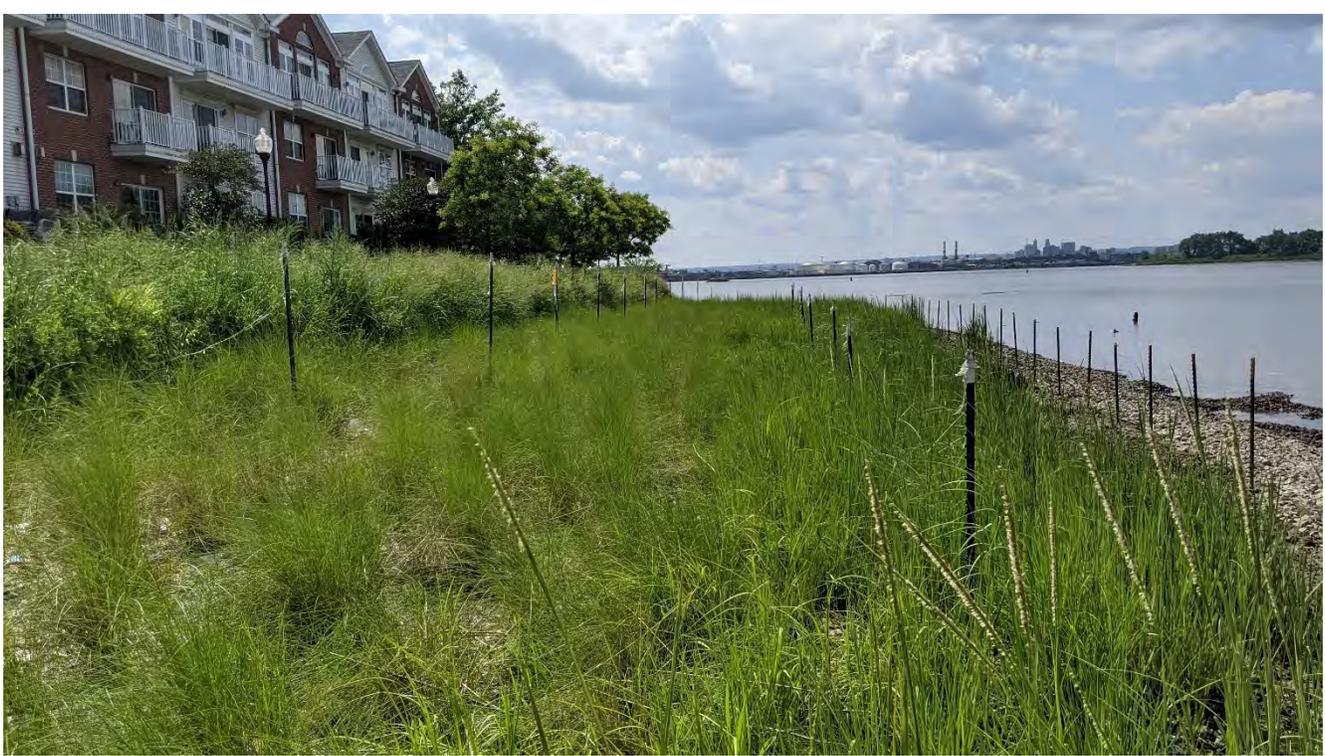
Photo 31: Upland (left) and high marsh vegetation on the western side of the BEP area (facing west). Note the healthy and vibrant vegetation in the high marsh / upland zones and removed waterfowl exclusion measures.
