MEMORANDUM

Subject: **SA-7 Sediment Remedy Long-Term Monitoring
Summary of Year 8 Monitoring & Proposed Year 8 Program**

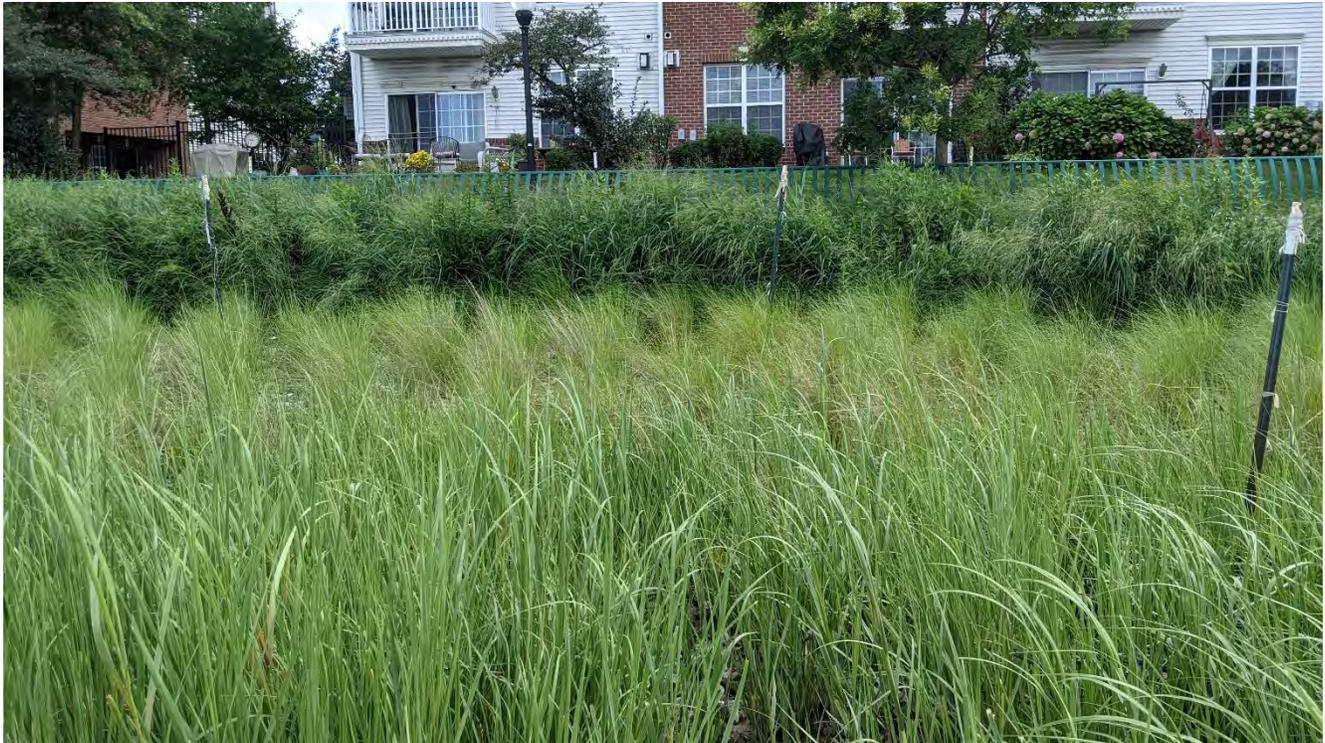
Photo 32: Upland vegetation (background) present on the eastern side of the BEP area (facing south). Note the healthy and vibrant vegetation in the high marsh and upland zones.

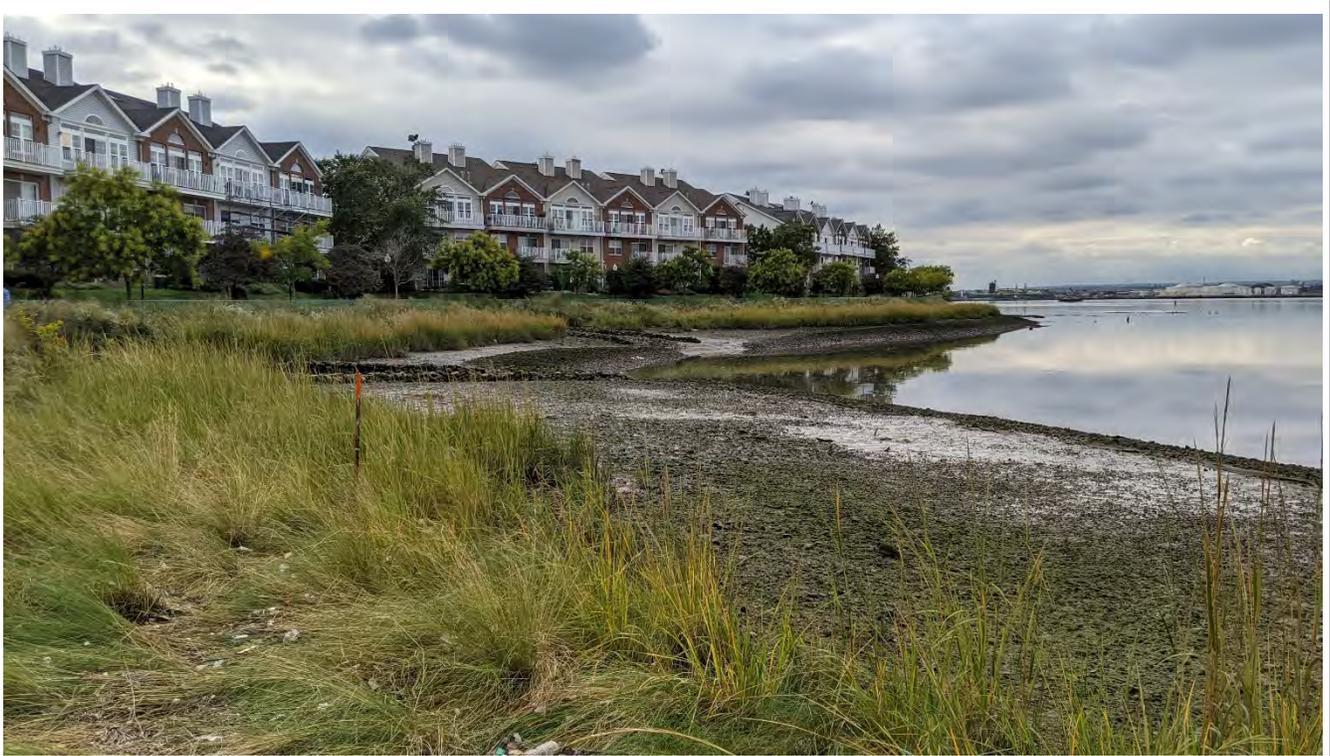
Photo 1: Northern end of Cap Area 16. Note vibrant vegetation present in high marsh planting zone (facing west).

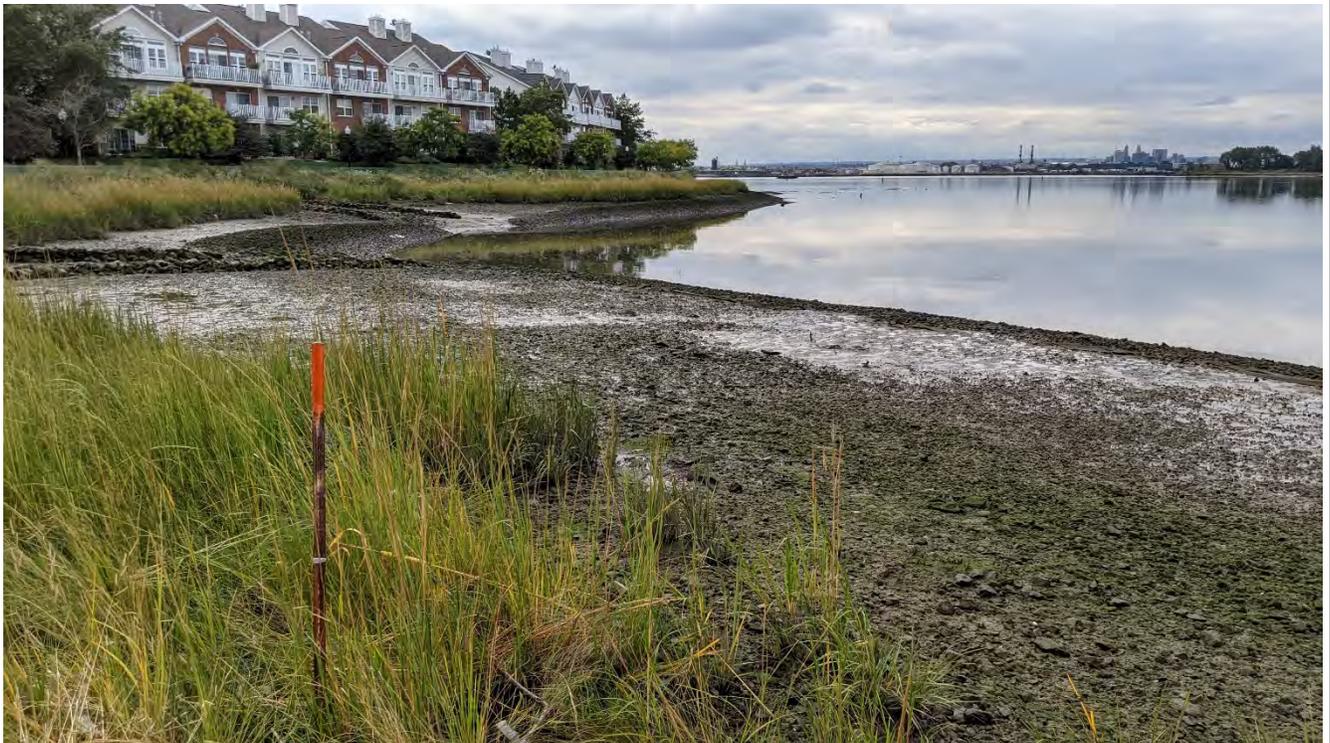
Photo 2: Central portion of Cap Area 16. Note limited vegetation present in low marsh zone (facing northwest).

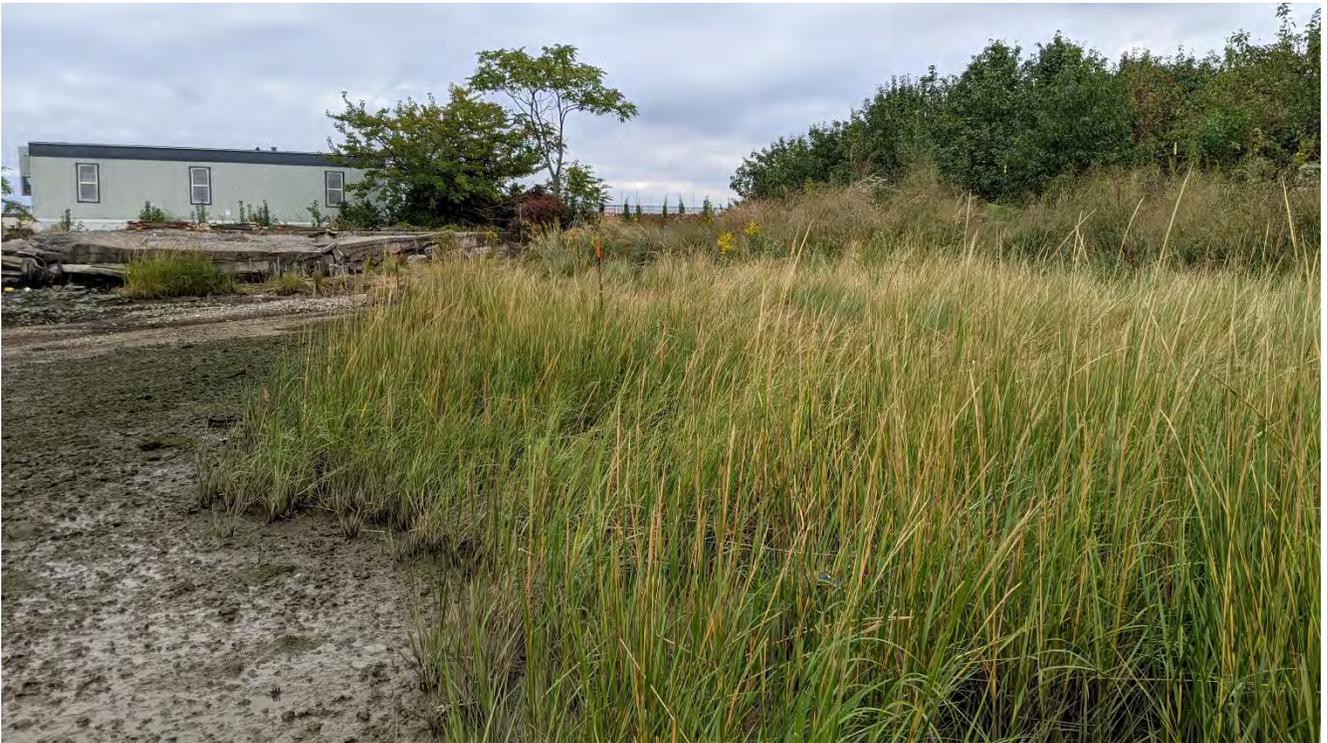
Photo 3: Western end of Cap Area 16. Note vibrant vegetation present in high marsh planting zone (facing northeast).

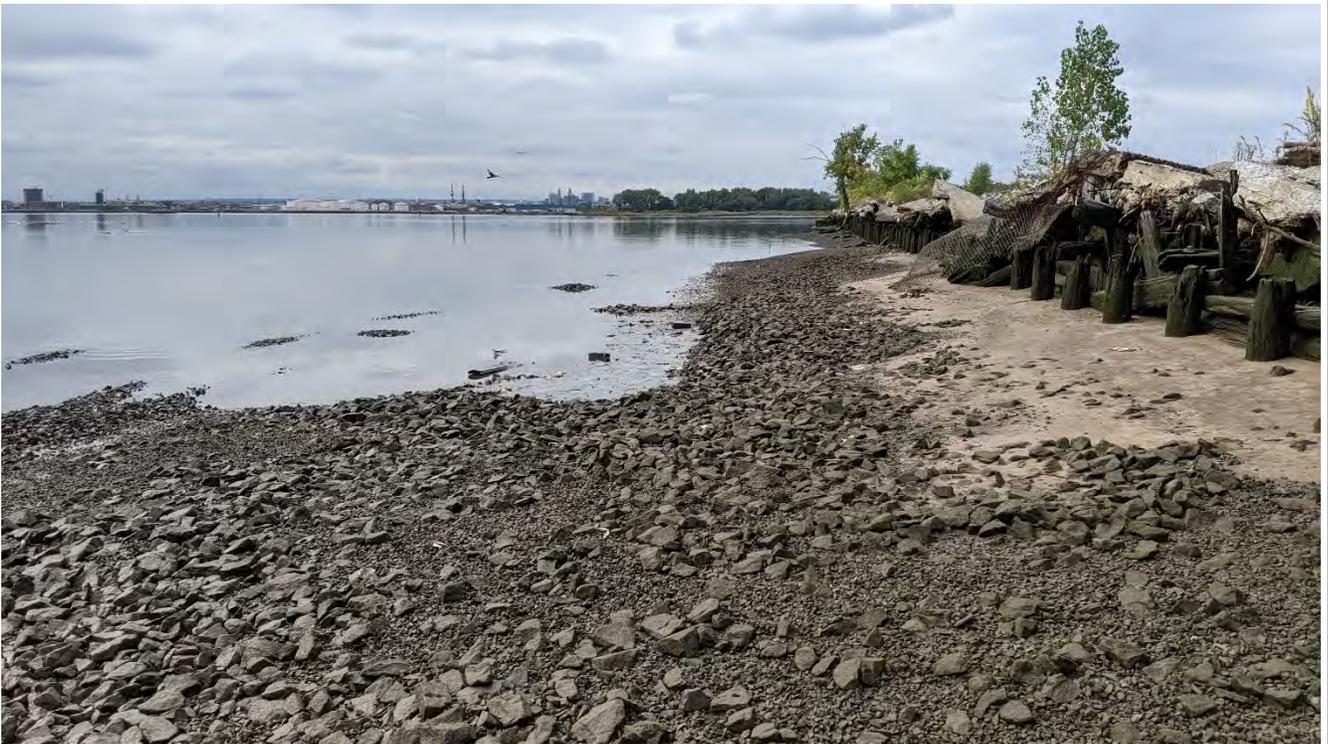
Photo 4: Cap Area 22 (facing northwest).

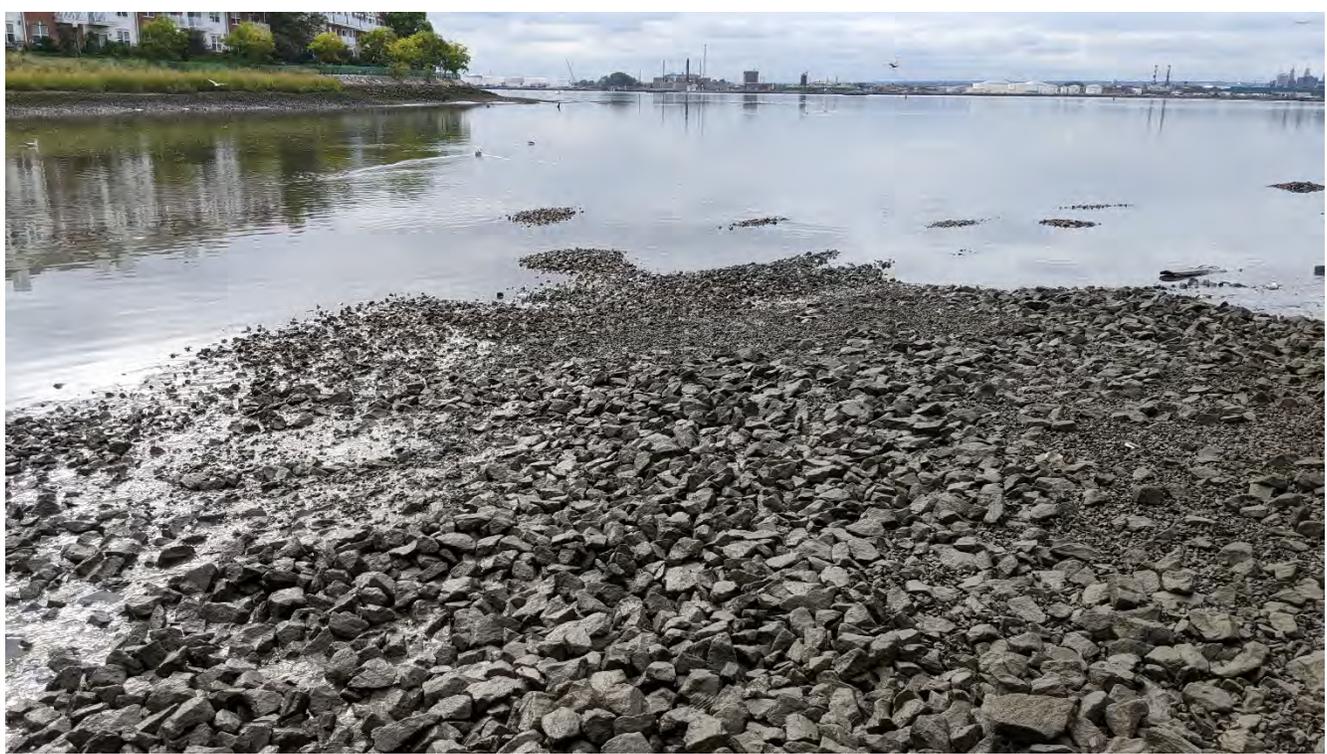
Photo 5: Cap Area 22 (facing west).

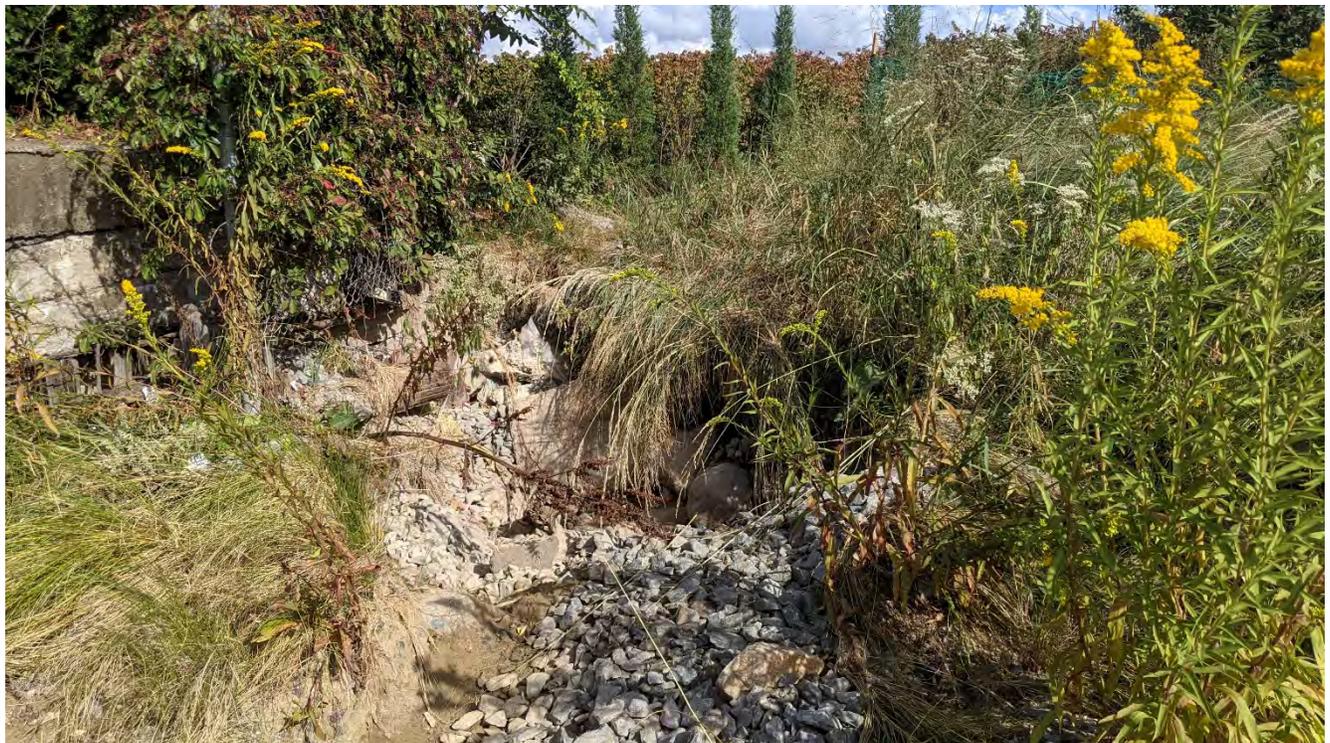
Photo 14: Large area of erosion located in the easternmost corner of the BEP area (facing southeast). Note the area of erosion is approximately 4-ft deep.

TABLE 2. BENEFICIAL ENVIRONMENTAL PROJECT AREA INSPECTION LOG			
BEP AREA ELEMENT	OBSERVATIONS	PHOTO(S) TAKEN	CORRECTIVE ACTION(S) REQUIRED
SHORELINE STABILIZATION	<ul style="list-style-type: none"> • Shoreline stabilization was damaged by the September 2020 storm event. Specifically, <ul style="list-style-type: none"> – Approximately 65 linear feet of shoreline stabilization stone, located on the eastern side of the BEP near Outfall D, washed out. – Several areas of exposed geofabric were observed between the BEP fill material and the shoreline stabilization stone. 	7 to 8	<ul style="list-style-type: none"> • Repair shoreline stabilization stone on the eastern side of the BEP (near Outfall D) . • Cut or cover exposed geofabric located between the BEP fill material and the shoreline stabilization stone.
OUTFALL RIPRAP APRONS	<ul style="list-style-type: none"> • The outfalls were damaged by the September 2020 storm event. Specifically, <ul style="list-style-type: none"> – Outfall A: Approximately 8 linear feet of the stone edge on the southwest side of the outfall's apron was displaced. – Outfalls B and C: Consistent with prior observations, approximately 1 to 3 inches of siltation (likely displaced shoreline fill) were observed throughout the riprap apron, especially in the vicinity of both outfalls. Approximately 3 to 4 inches of siltation was observed along the western edge of the Outfall B riprap apron. However, approximately 15 linear feet of the stone edge along the northwest corner of the apron was displaced. – Outfall D: The outfall makes a 90-degree turn near the southernmost corner of the bulkhead at the terminus of Kellogg Street. A significant area of erosion approximately 20 square feet and 4 feet deep was observed at this location, exposing the pipe. The stone around the pipe in this area was washed out and scatted in the low marsh planting zone on the eastern side of the BEP. <p>Although outside of the BEP area, an approximately 65 ft long, 1 to 1.5 feet deep and 1 to 2 feet wide scour channel was observed in sediments at the discharge of the outfall.</p>	9 to 15	<ul style="list-style-type: none"> • Repair the damages to outfall areas and fill scour hole at the elbow of Outfall D.

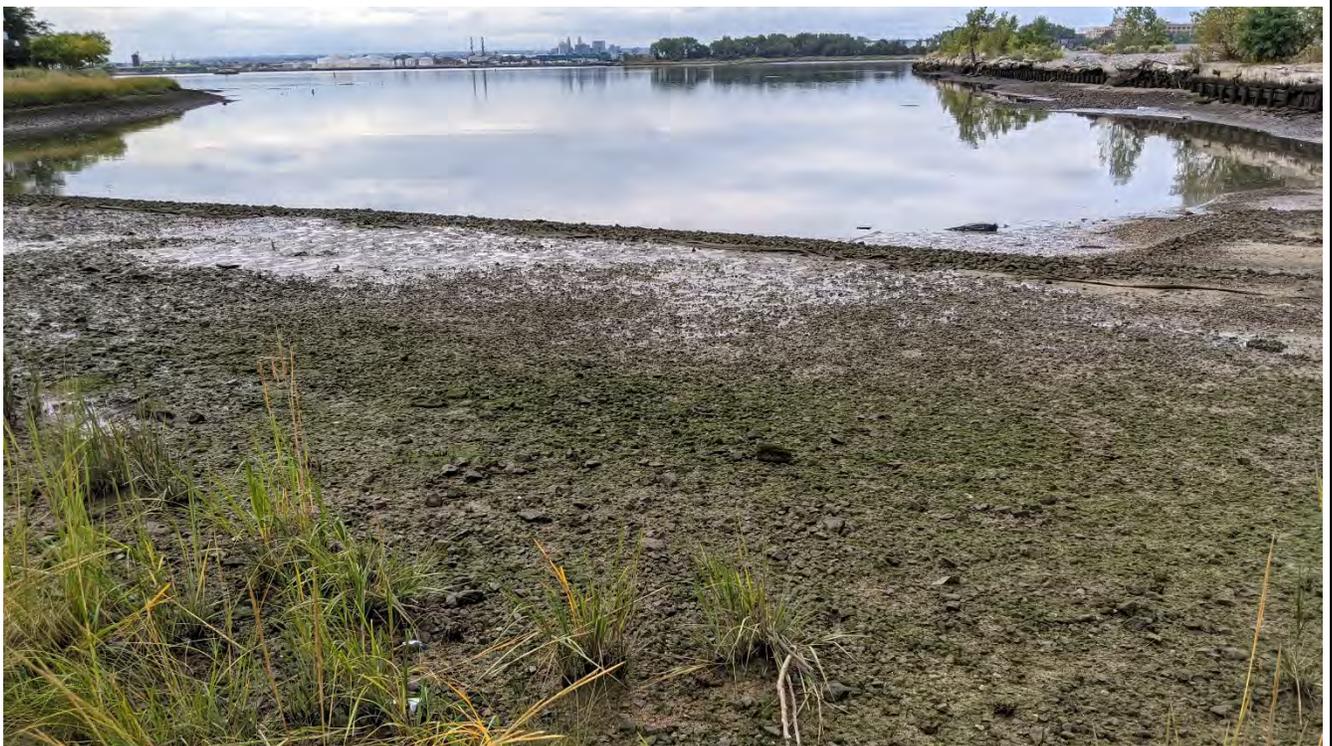
Photo 16: Vegetation present in the low marsh planting zone within Cap Area 16 (facing northwest).

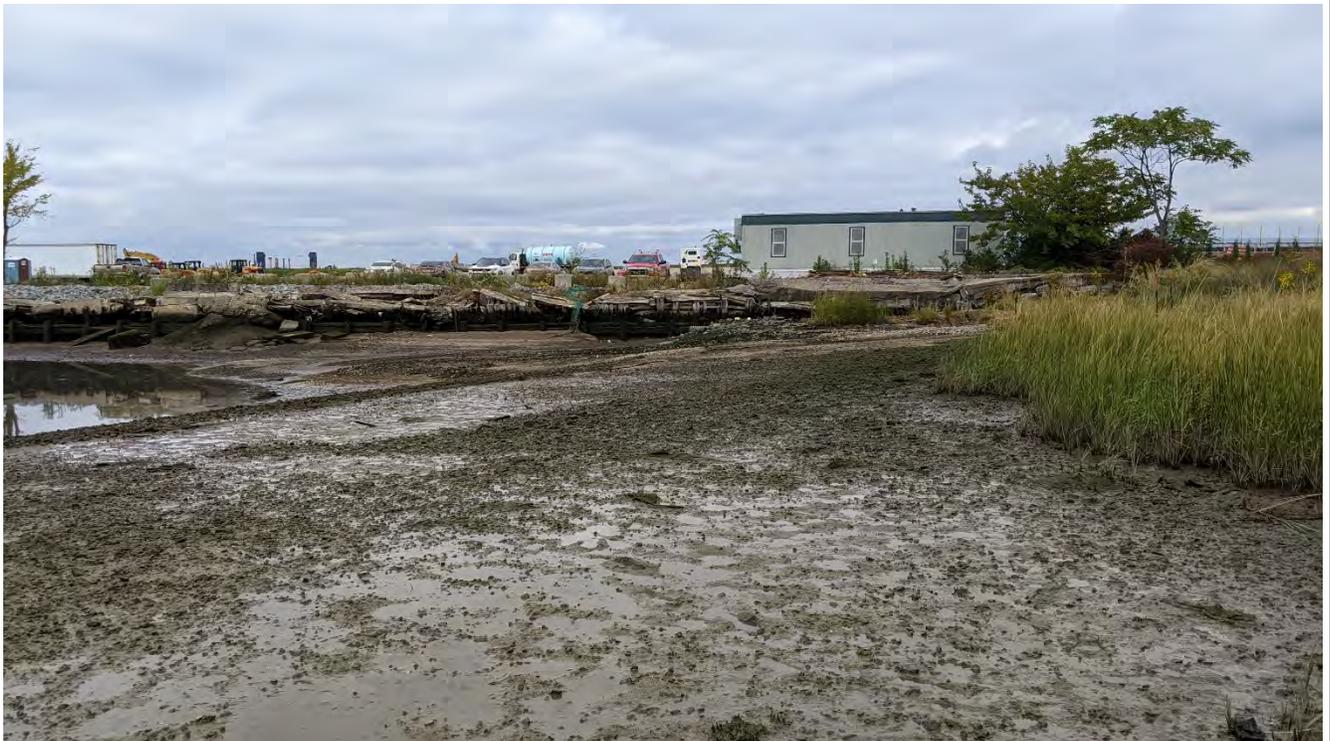
Photo 18: Low marsh planting zone within Cap Area 16 (facing northeast).

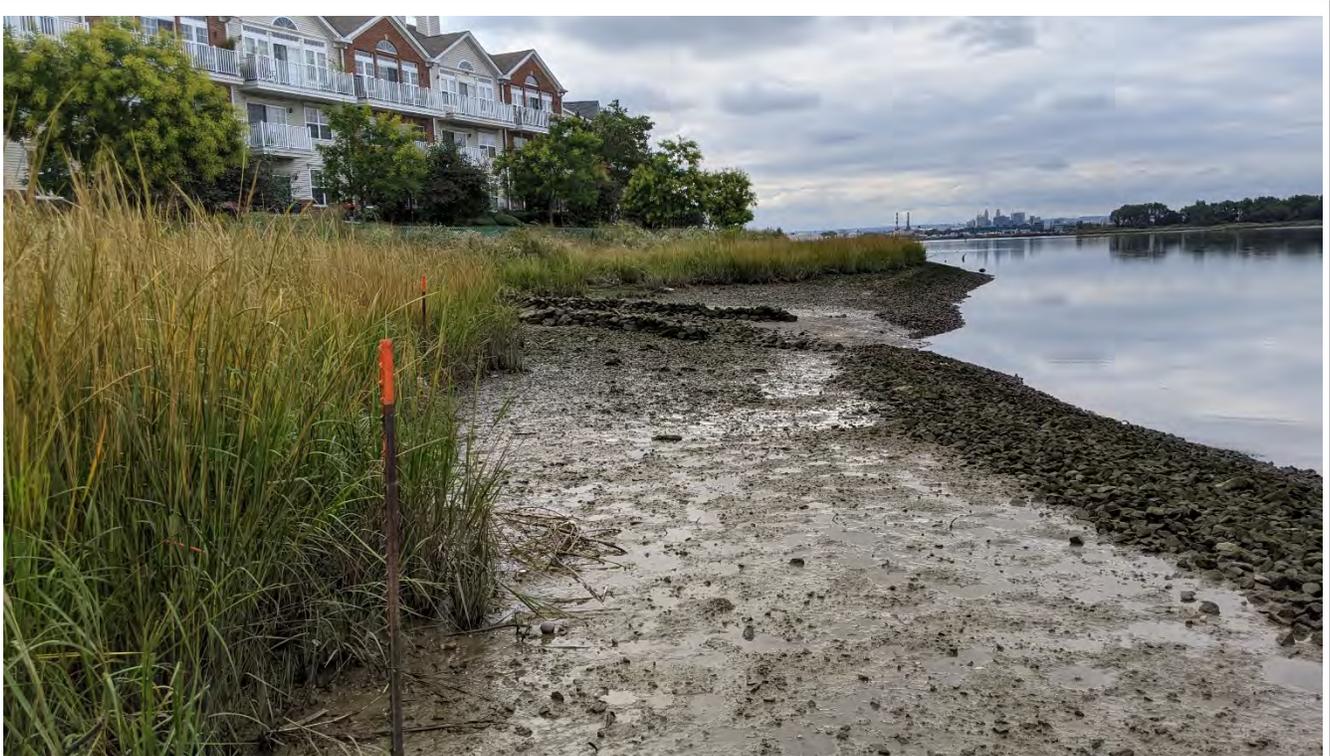
Photo 19: Low marsh planting zone between Outfalls A and C (facing west). Note the vibrant and healthy vegetation within the adjacent high marsh planting zone.

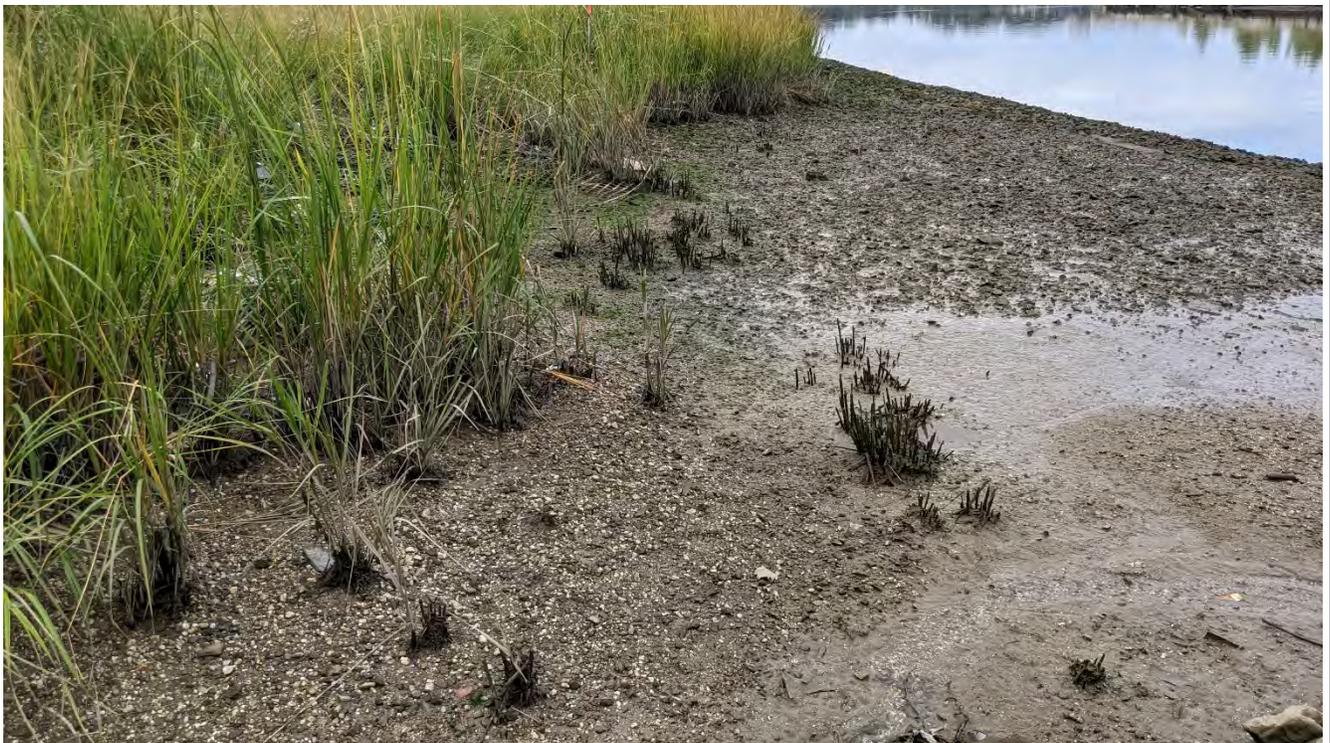
Photo 20: Stunted low marsh vegetation near Outfall A (facing north). Note the vibrant and healthy vegetation within the adjacent high marsh planting zone.

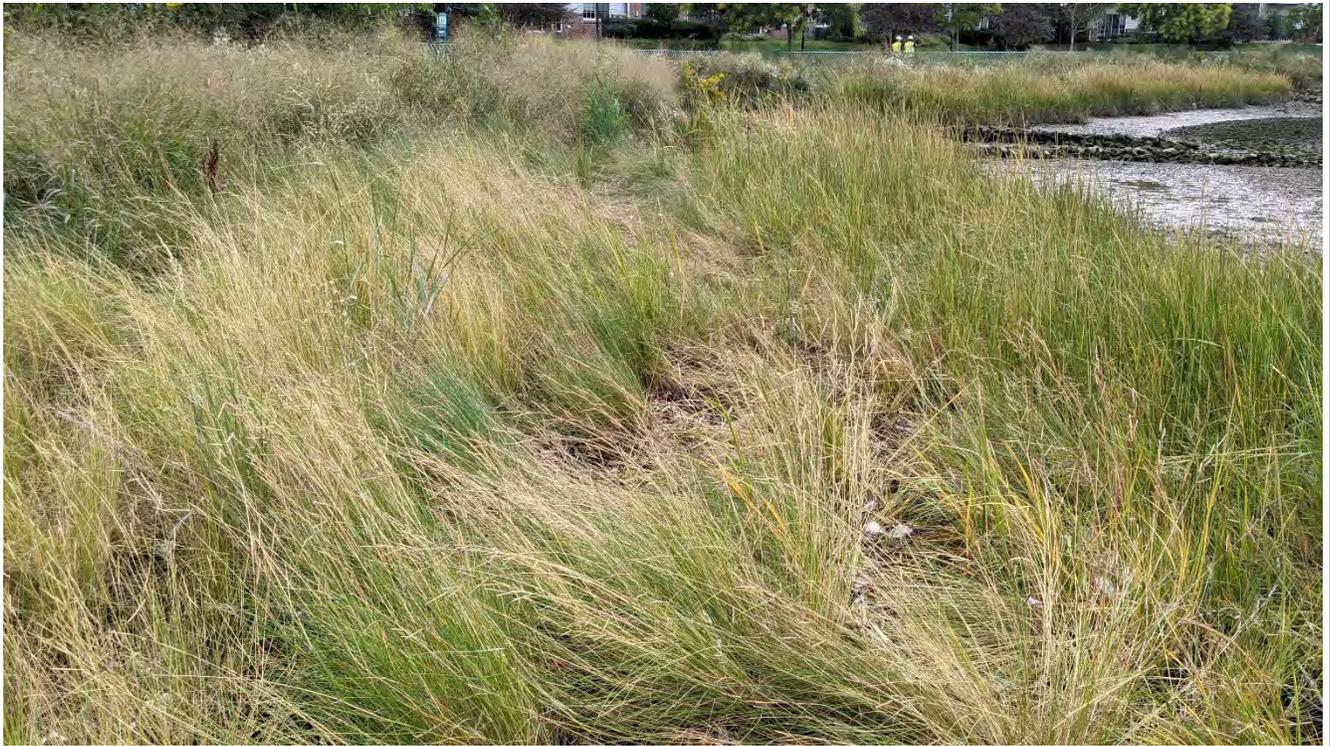
Photo 21: Vibrant and healthy vegetation within the high marsh and the upland transition area (featured left) within Cap Area 16 (facing southwest).

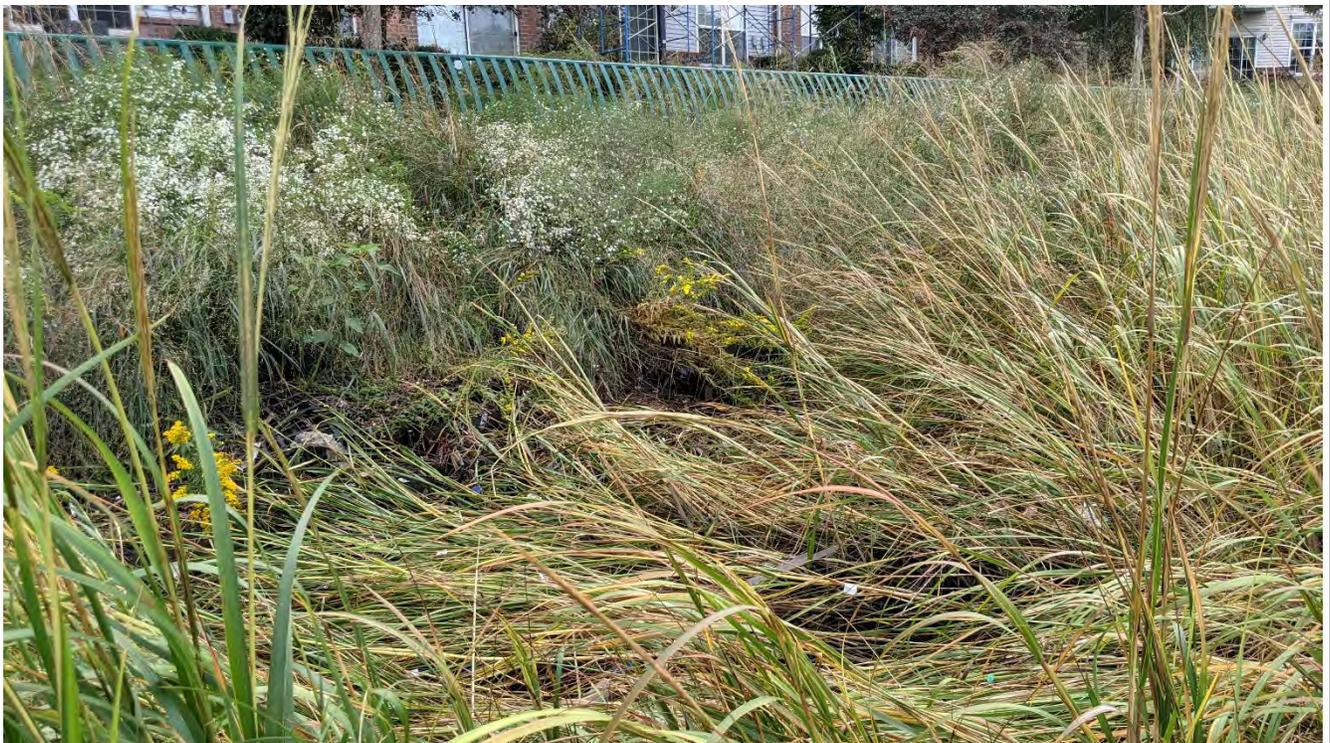
Photo 22: Vibrant and healthy vegetation within the high marsh and the upland transition area between Outfalls A and B (facing south).

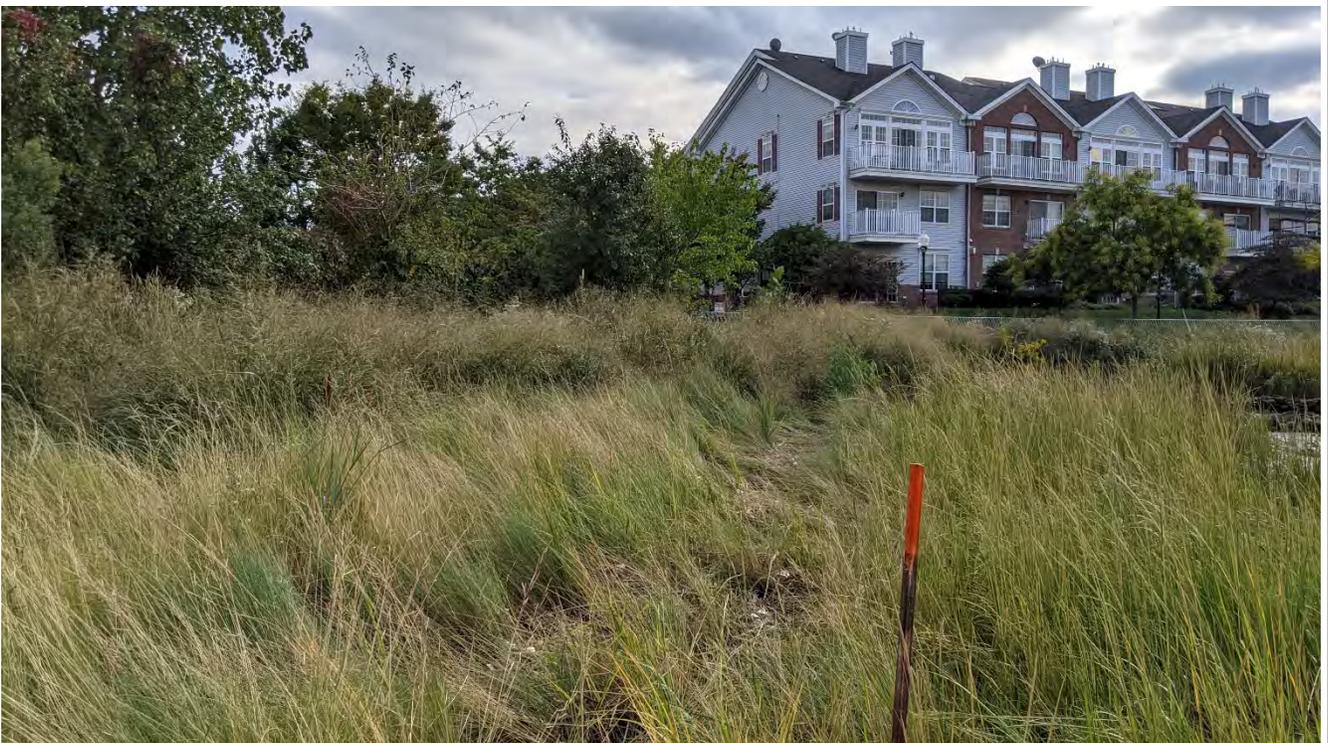
Photo 24: Vibrant and healthy vegetation within the high marsh and the upland transition area (featured left) within Cap Area 16 (facing southwest). Note the debris present along the drift line in the high marsh planting zone.

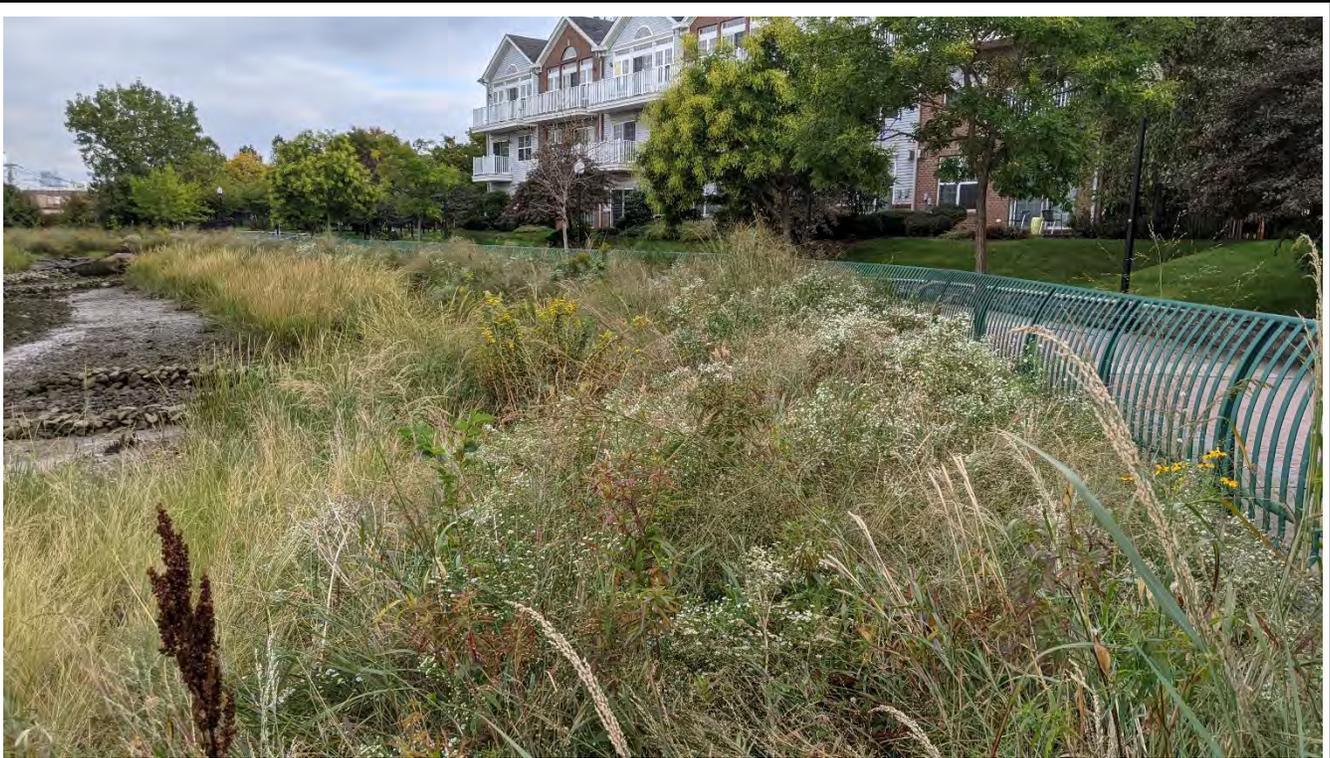
Photo 27: Vibrant and healthy upland transitional and high marsh (featured left) vegetation between Outfalls A and B (facing east).

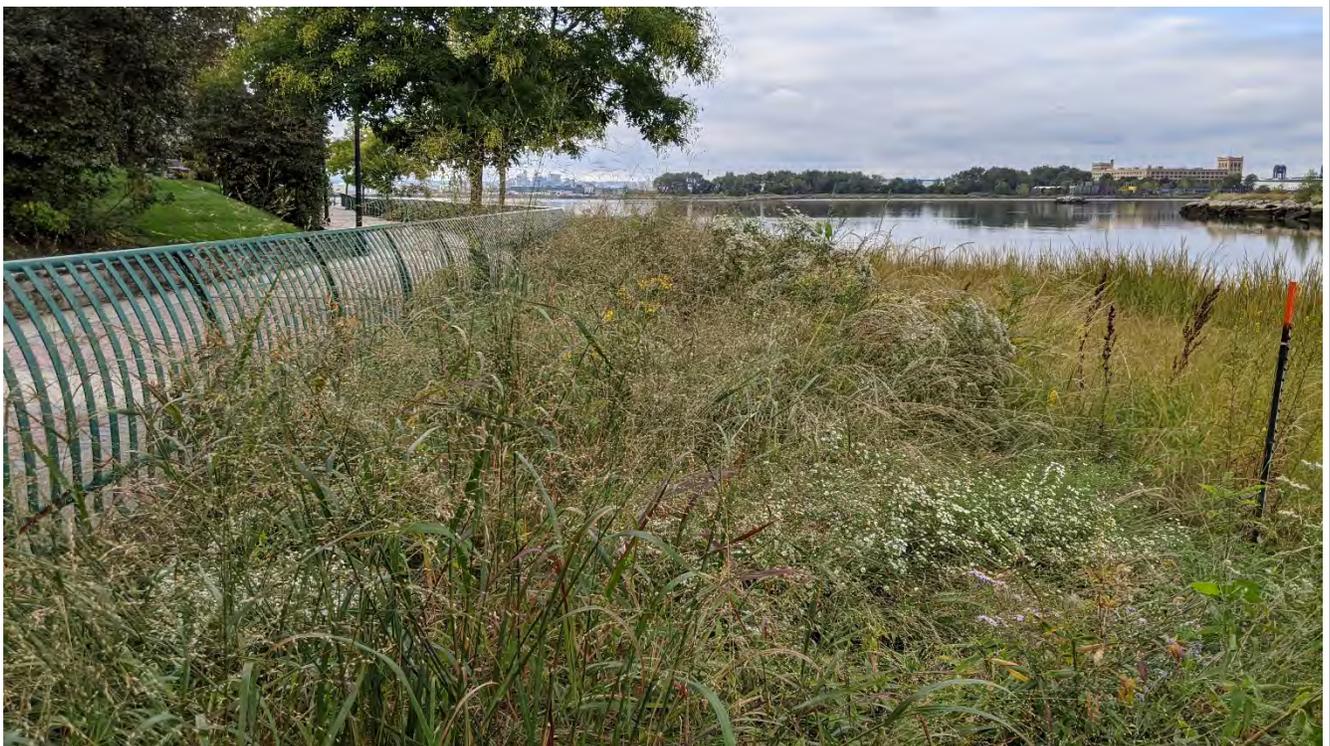
Photo 28: Vibrant and healthy upland transitional and high marsh (featured right) vegetation near Outfall A (facing northwest).

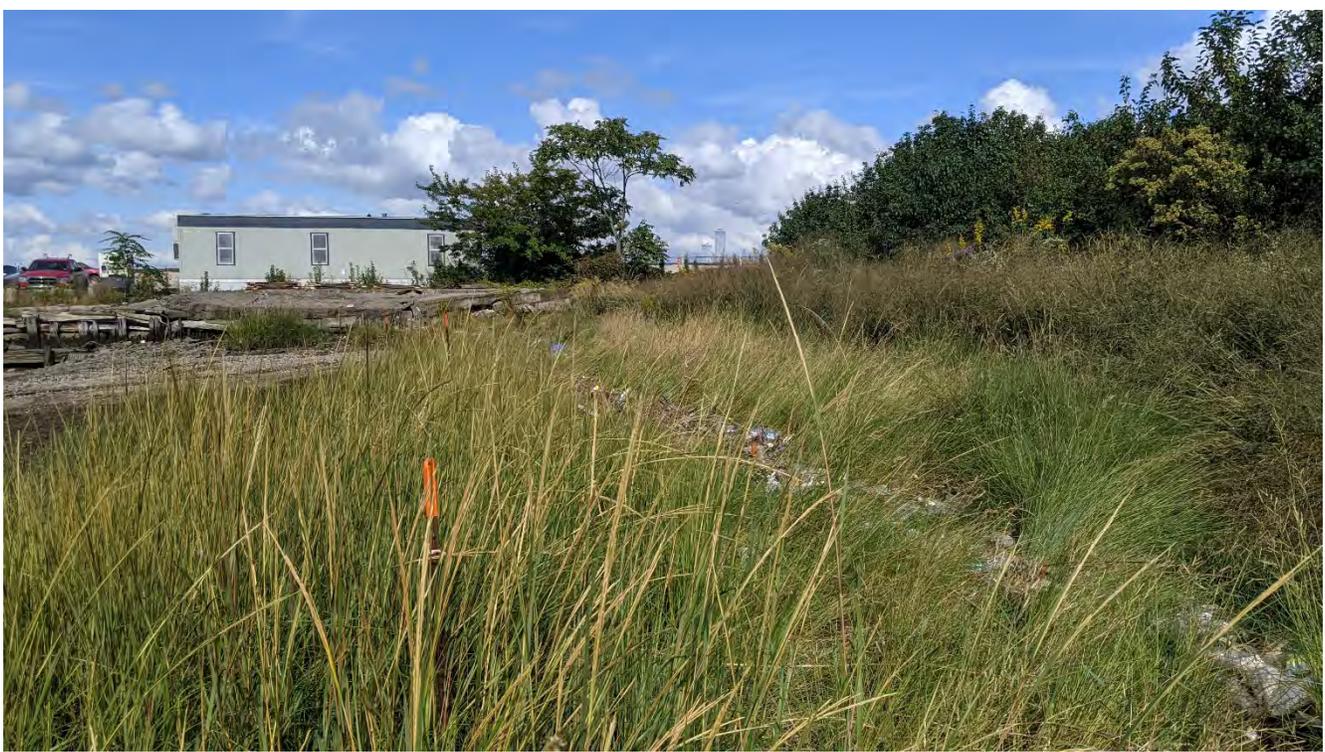
Photo 29: Vibrant and healthy high marsh and upland transitional (featured right) vegetation located east of Outfall C (facing northeast).

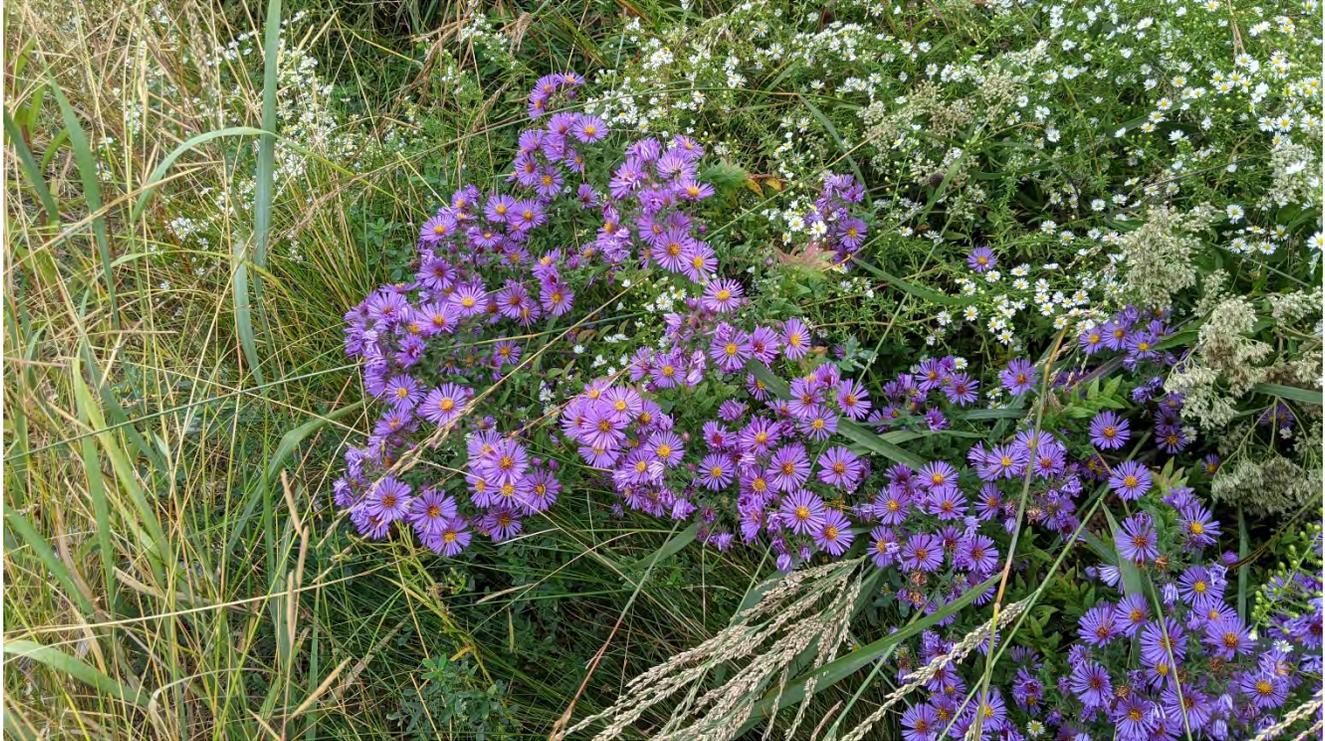
Photo 30: Native aster located within the upland transitional planting zone within the BEP.

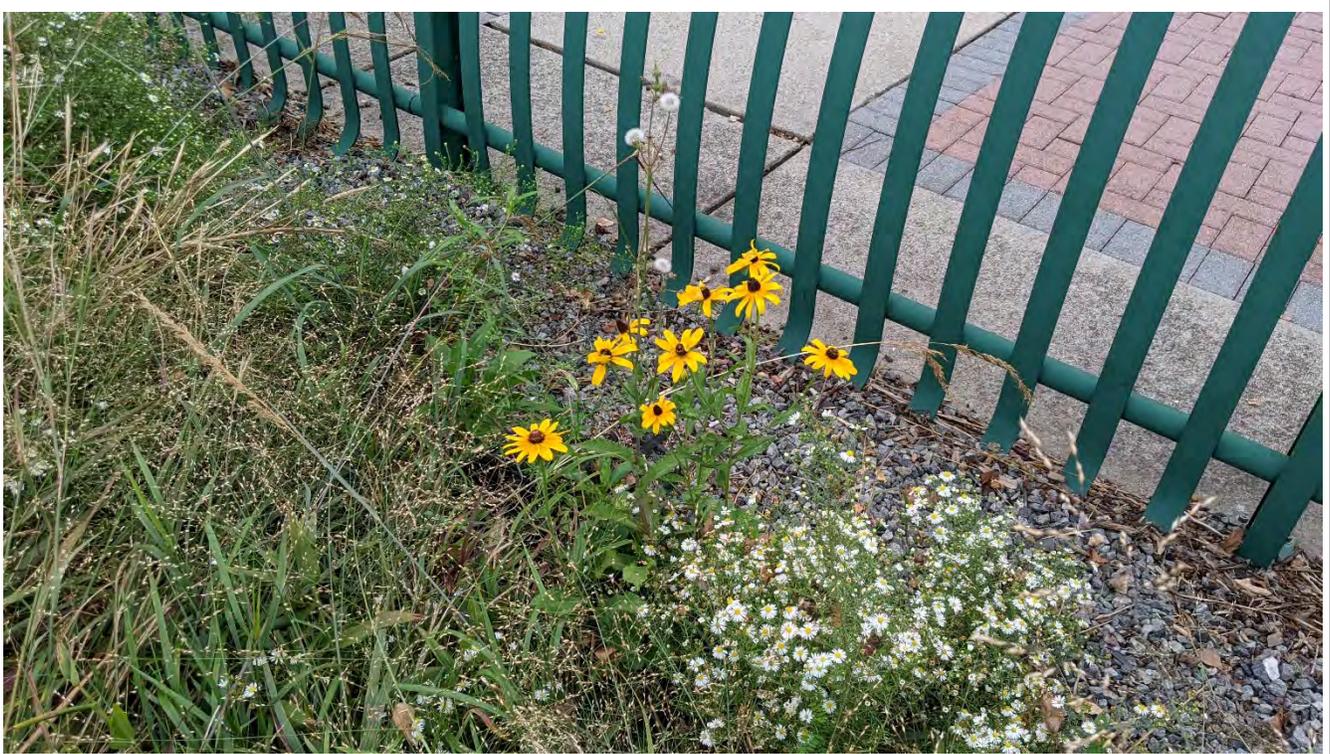
Photo 31: Black-eyed Susan located within the upland transitional planting zone of the BEP.
