# MEMORANDUM

Subject: **SA-7 Sediment Remedy Long-Term Monitoring**  
**Summary of Year 9 Monitoring & Proposed Year 10 Program**

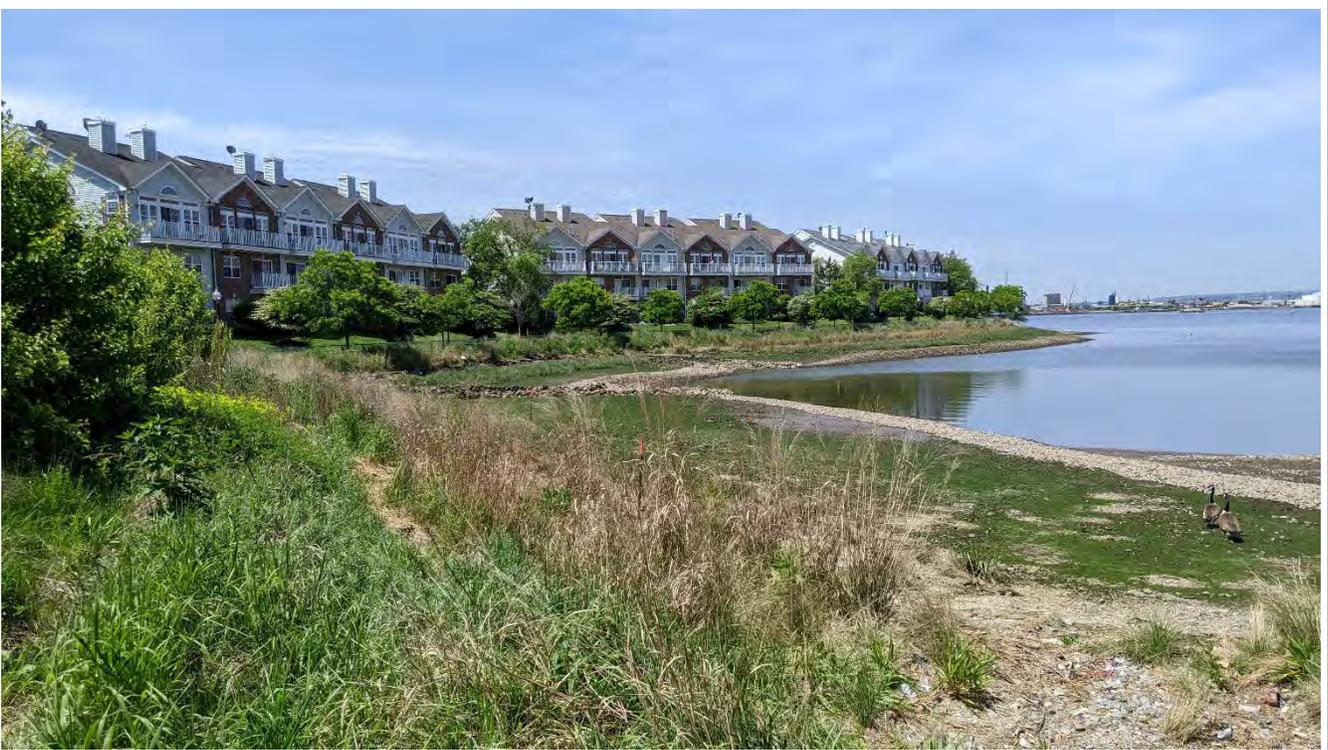
**Photo 1:** Northern end of Cap Area 16. Note vibrant vegetation present in high marsh planting zone (facing west).

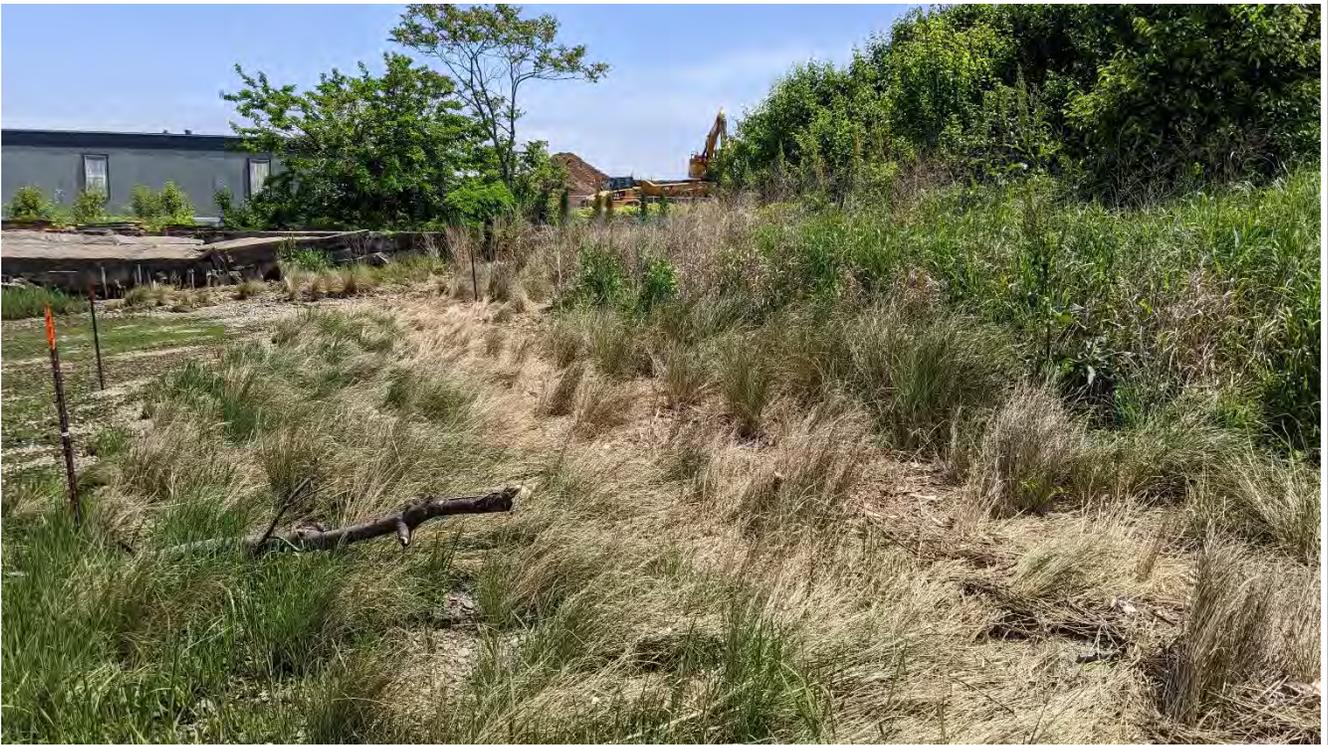
**Photo 3:** Western end of Cap Area 16. Note the mix of vibrant and dormant vegetation growth in the high marsh planting zone (facing northeast).

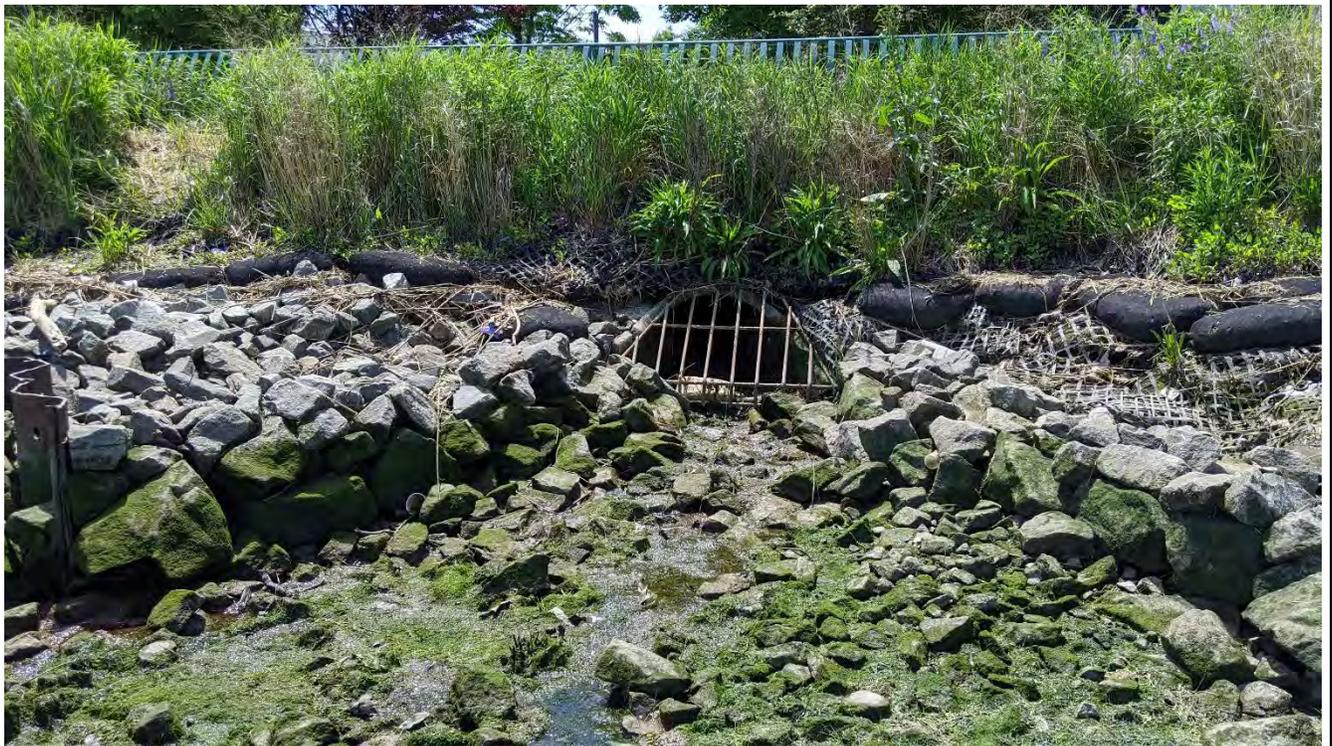
**Photo 8:** Outfall B and surrounding armor stone (facing south). Note the healthy and vibrant vegetation within the uplands.

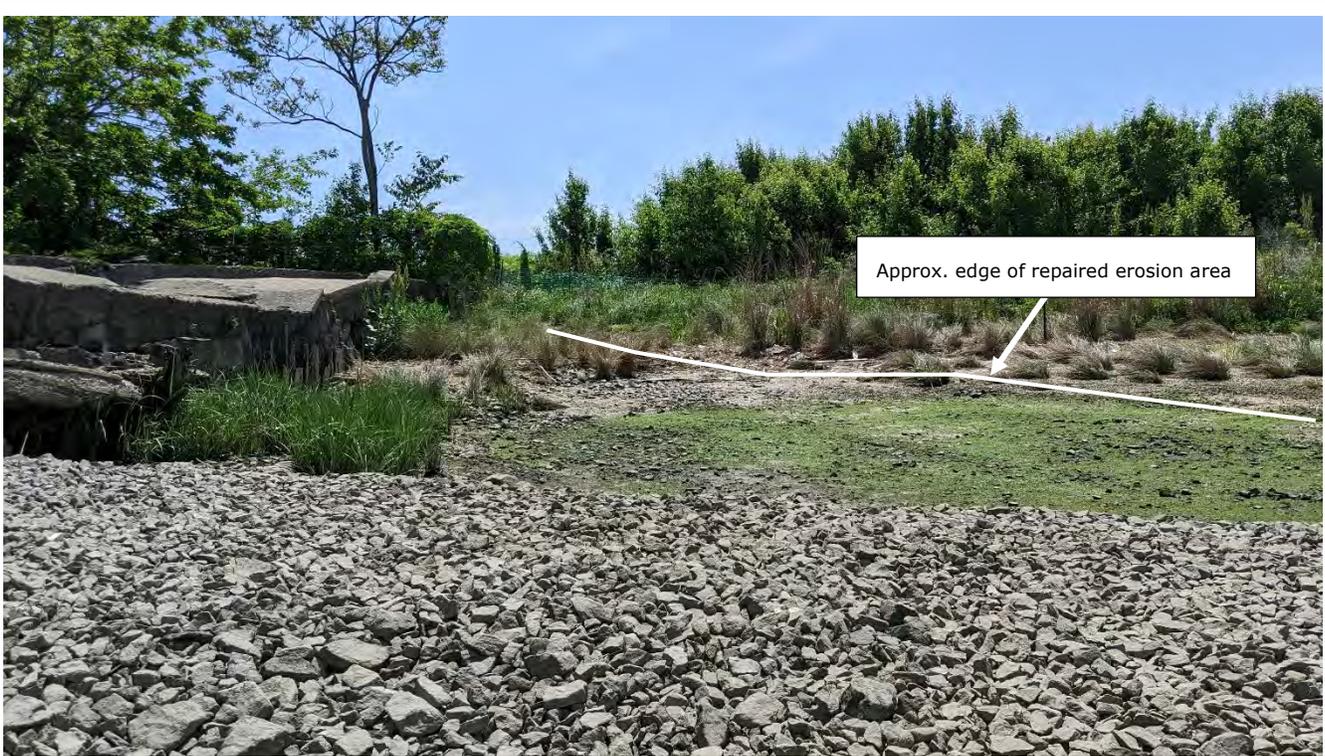
Photo 13: Easternmost side of the BEP at Outfall D following March 2022 repairs (facing southeast).

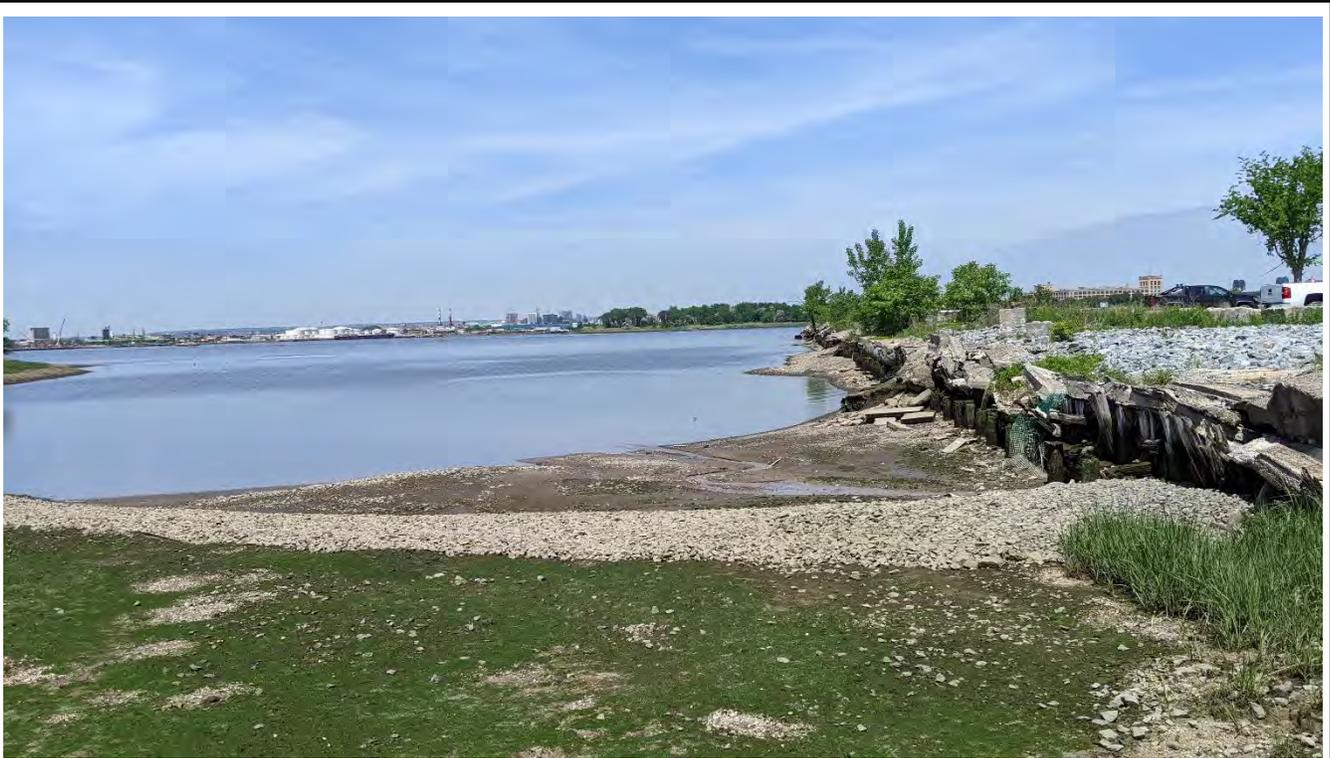
**Photo 15:** Low marsh planting zone on the eastern side of the BEP (facing northwest). Note the algae cover on the mudflats area.

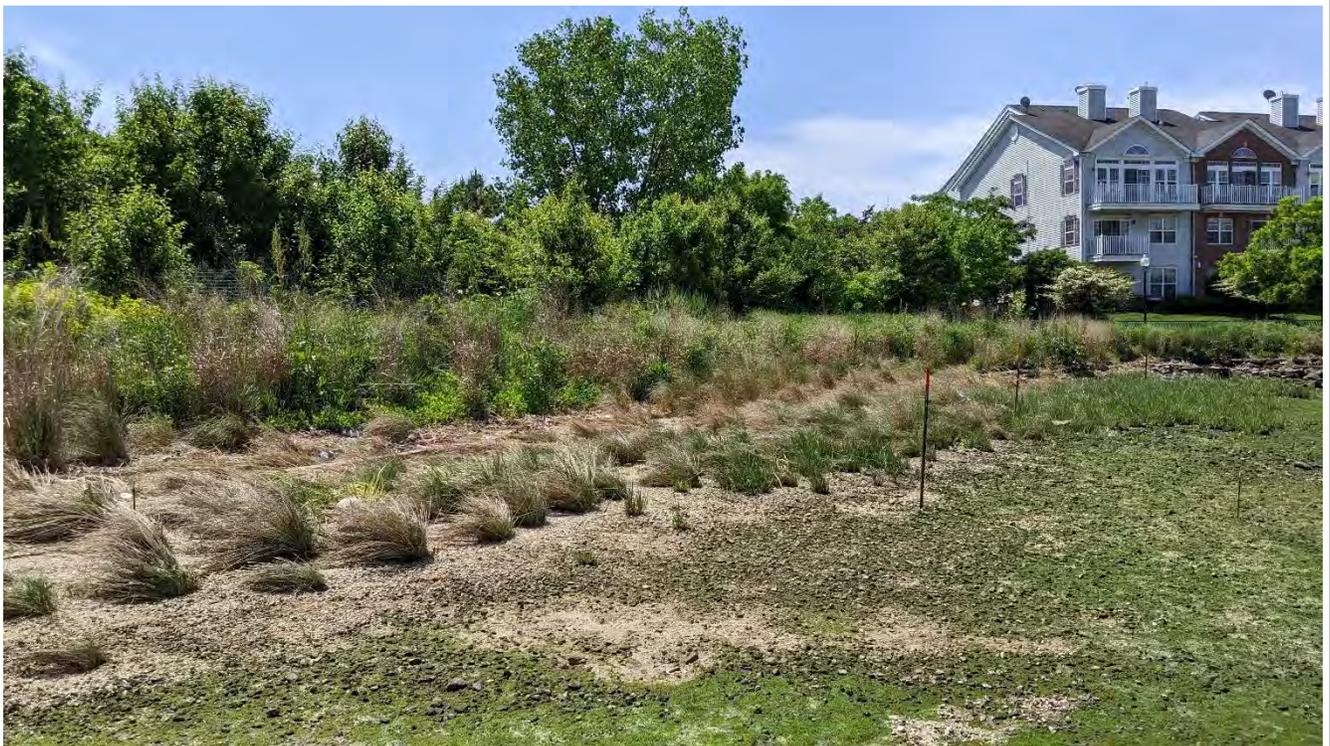
**Photo 16:** Area where the low marsh planting zone meets the high marsh planting zone within the eastern side of the BEP (facing southwest). Note where present, the low marsh vegetation appears vibrant and healthy.

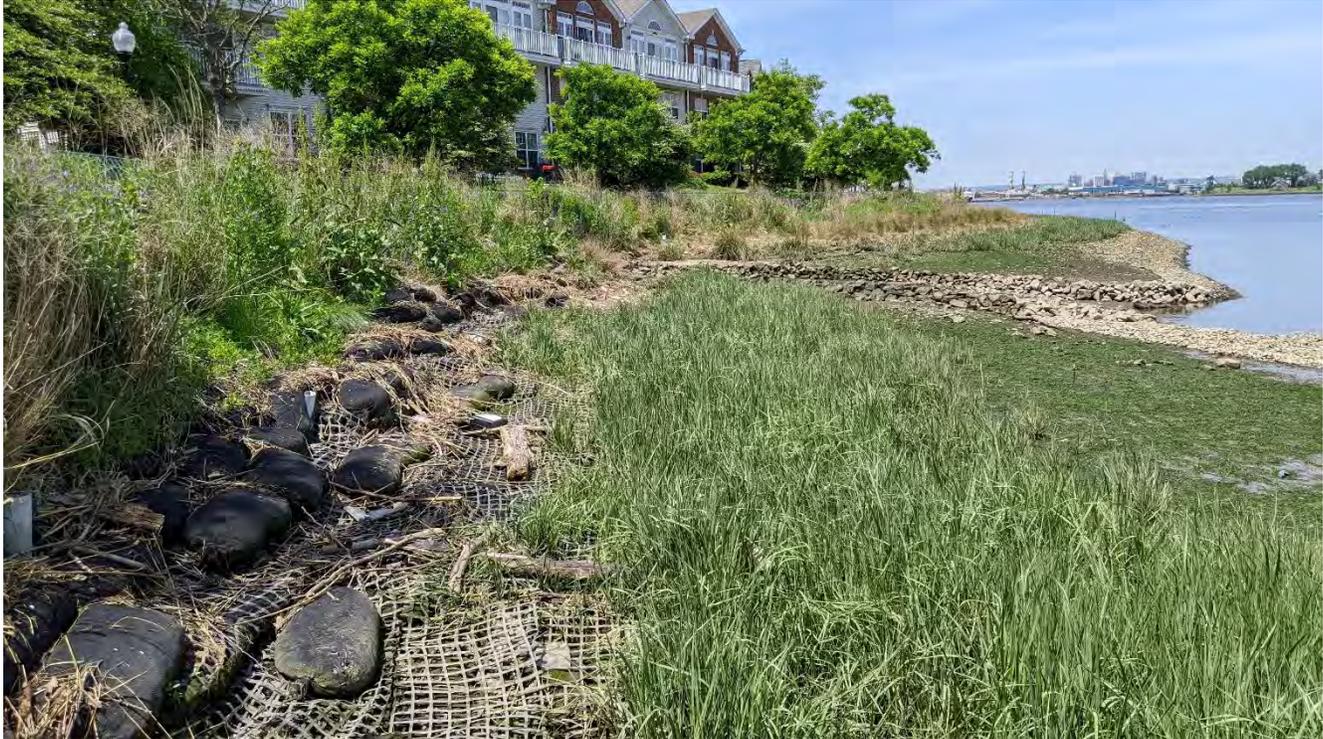
**Photo 18:** Low marsh planting zone between Outfalls A and B (facing west). Note the vibrant and healthy vegetation within the upper portion of the low marsh planting zone and exposed geogrid and Rocksoxx.

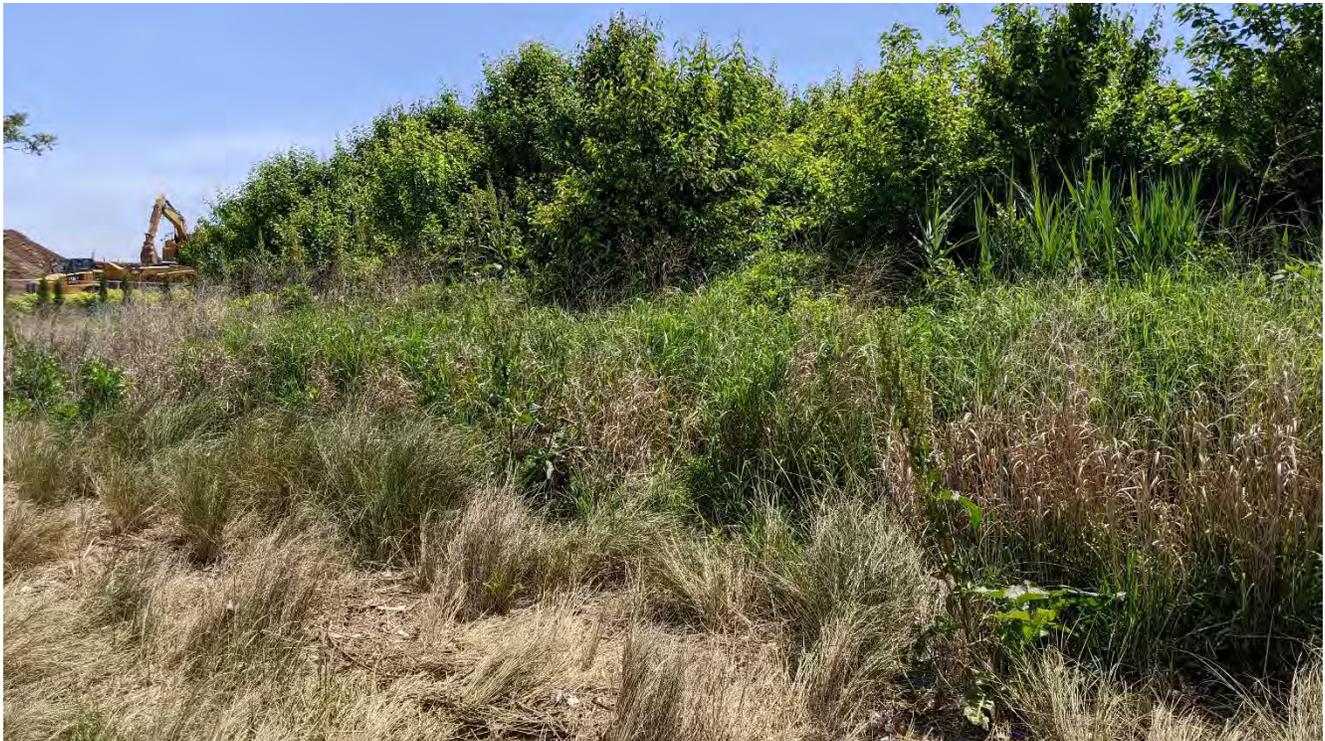
**Photo 20:** Partially dormant vegetation within the high marsh and vibrant and healthy vegetation in the upland transition area within Cap Area 16 (facing southeast).

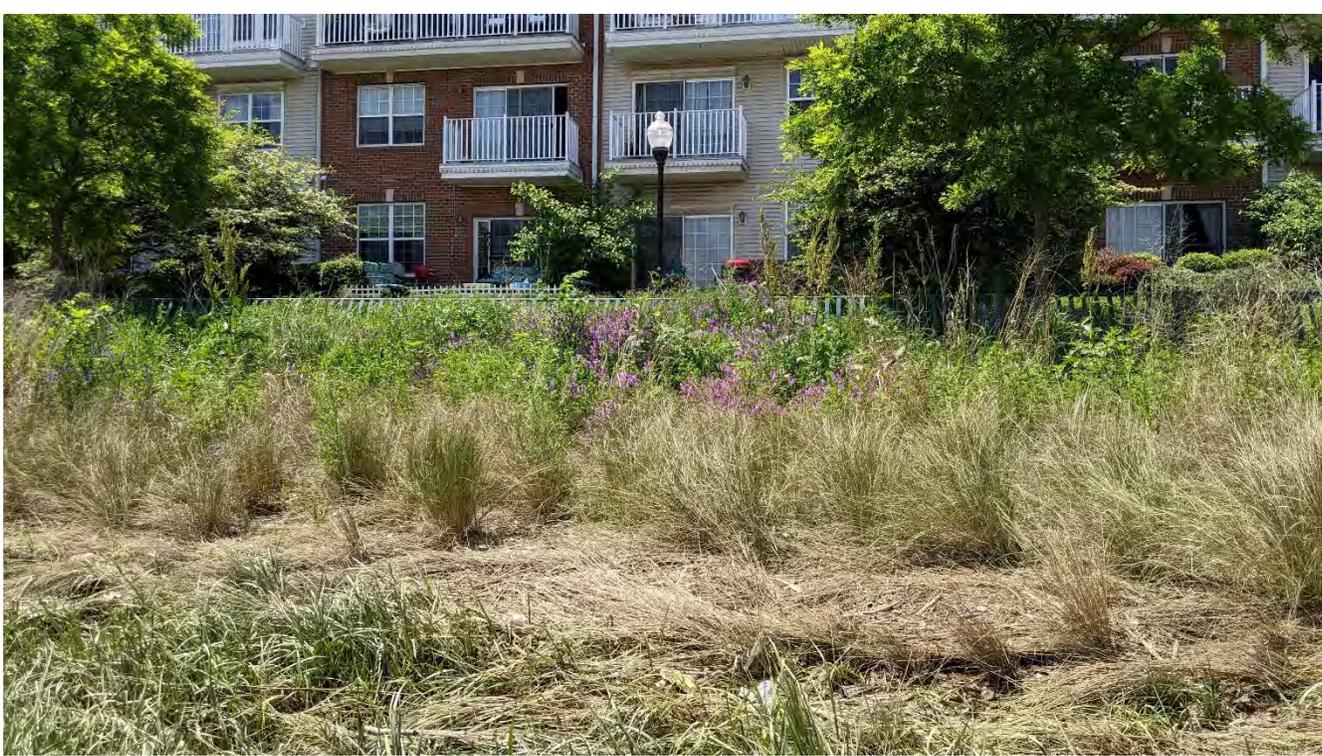
**Photo 21:** Partially dormant vegetation within the high marsh and vibrant and healthy vegetation in the upland transition area west of Outfalls A (facing southwest).

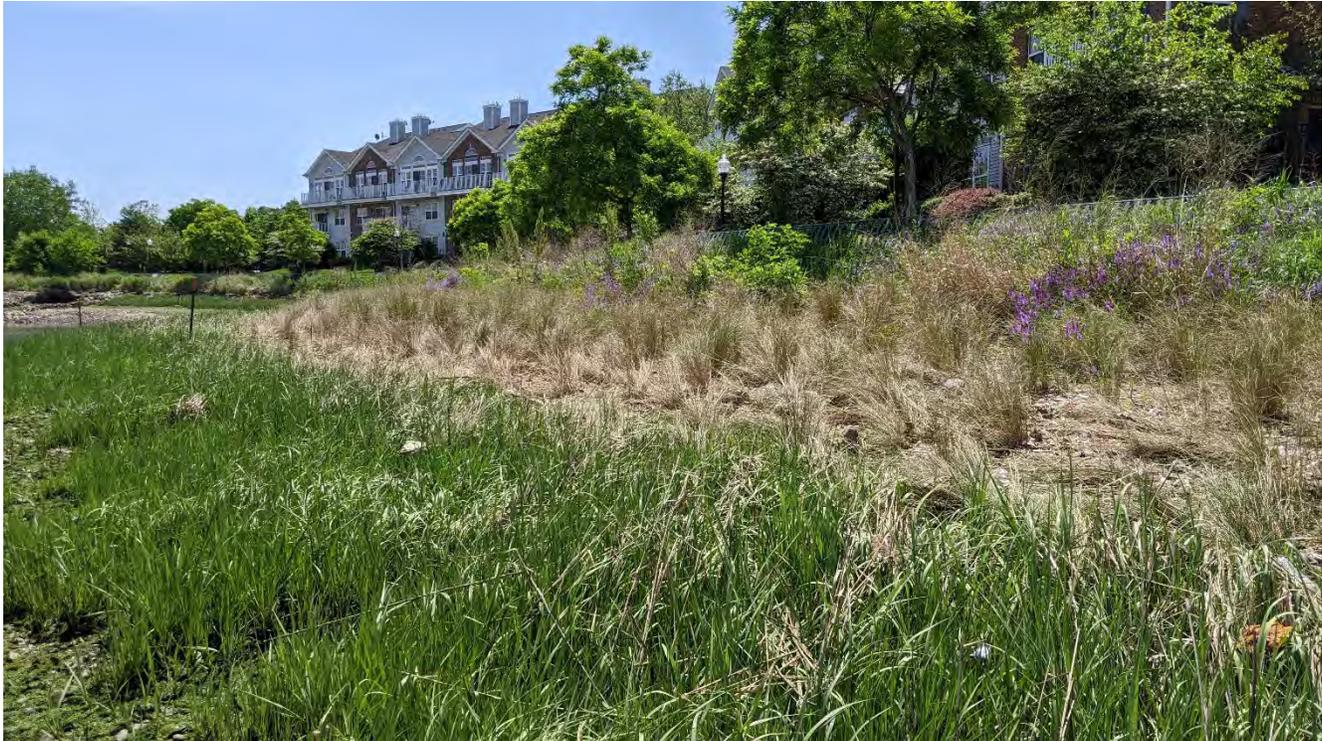
**Photo 22:** Healthy and vibrant low marsh, high marsh, and uplands located on the western side of the BEP (facing southeast).

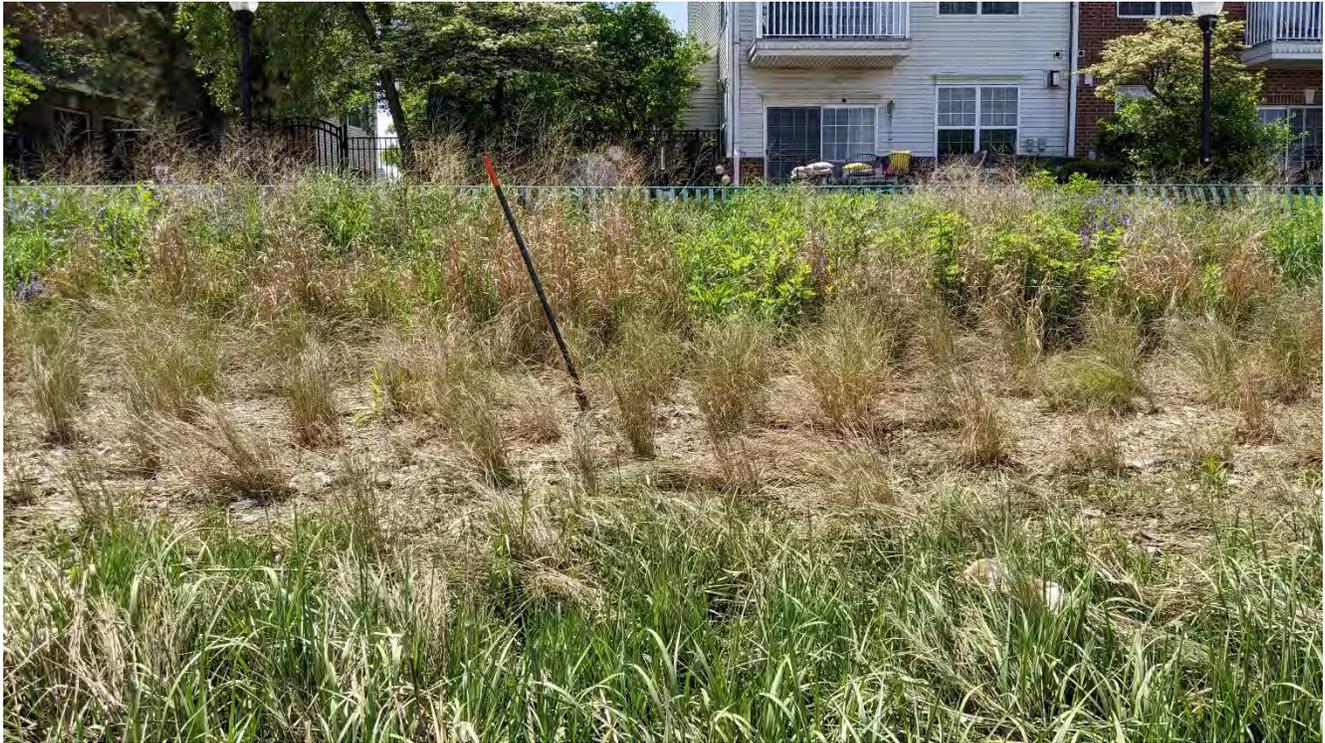
**Photo 28:** Vibrant and healthy low marsh, high marsh, and uplands west of Outfall A (facing south).

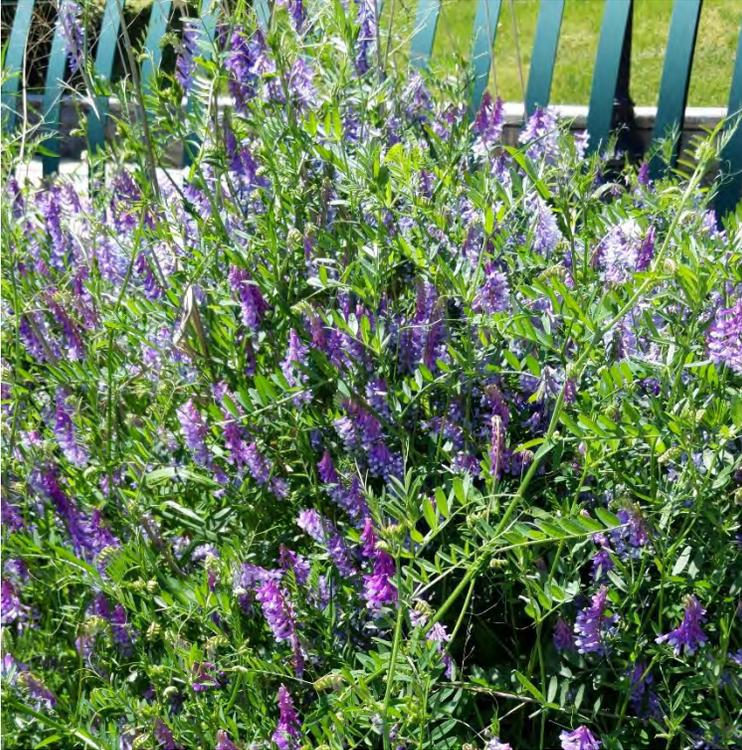
**Photo 29:** Invasive species Hairy Vetch located within the upland transitional planting zone within the BEP.

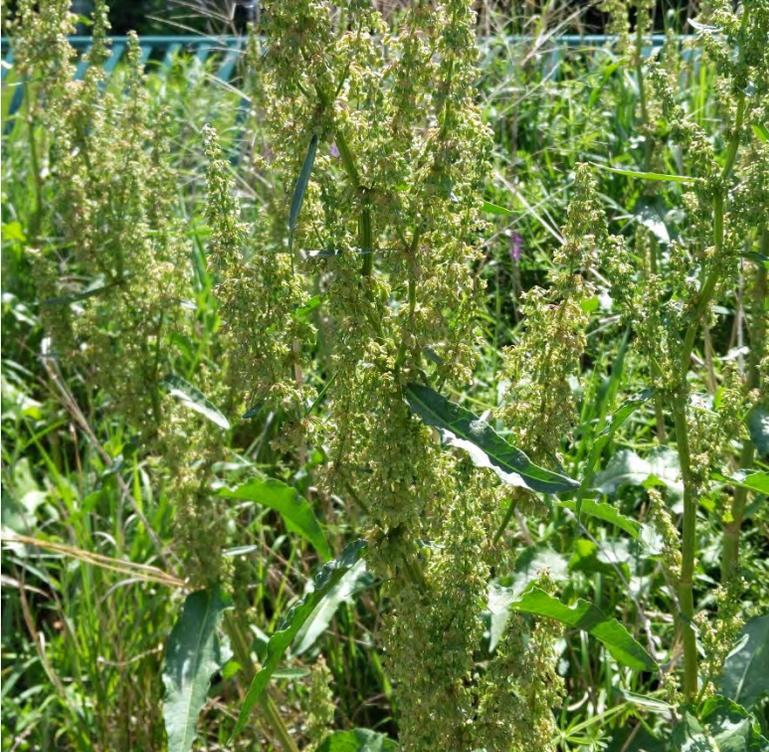
**Photo 30:** Invasive species Curly Dock located within the upland transitional planting zone of the BEP.

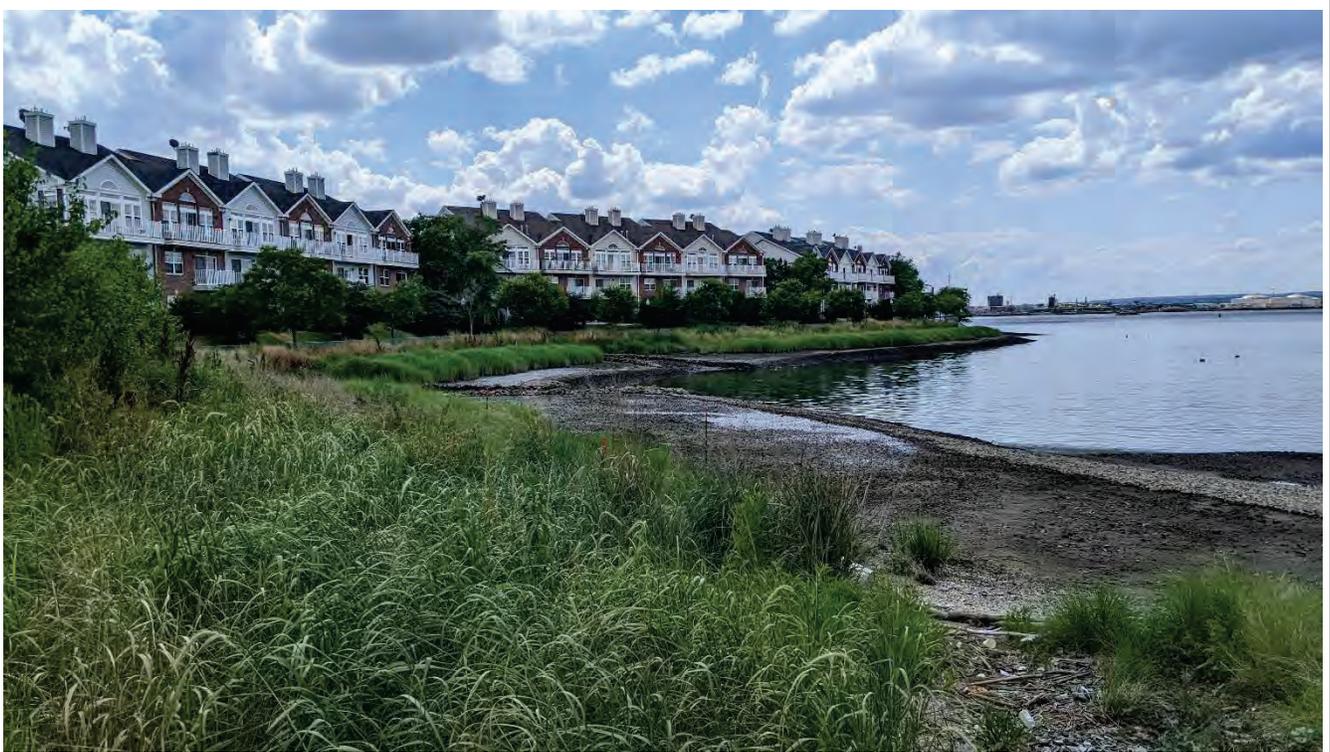
**Photo 1:** Northern end of Cap Area 16. Note vibrant and healthy vegetation present in high marsh planting zone (facing west).

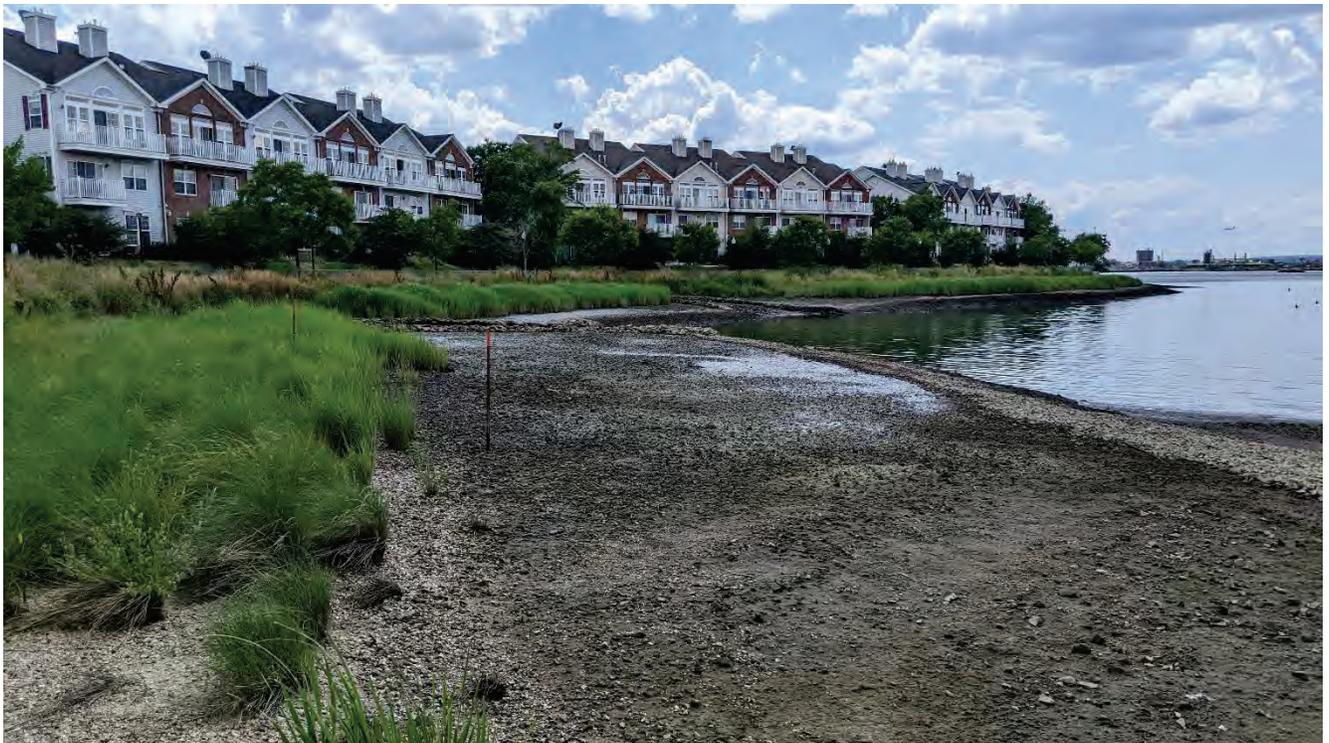
**Photo 2:** Central portion of Cap Area 16. Note significant die back of algae over the low marsh zone (facing southwest).

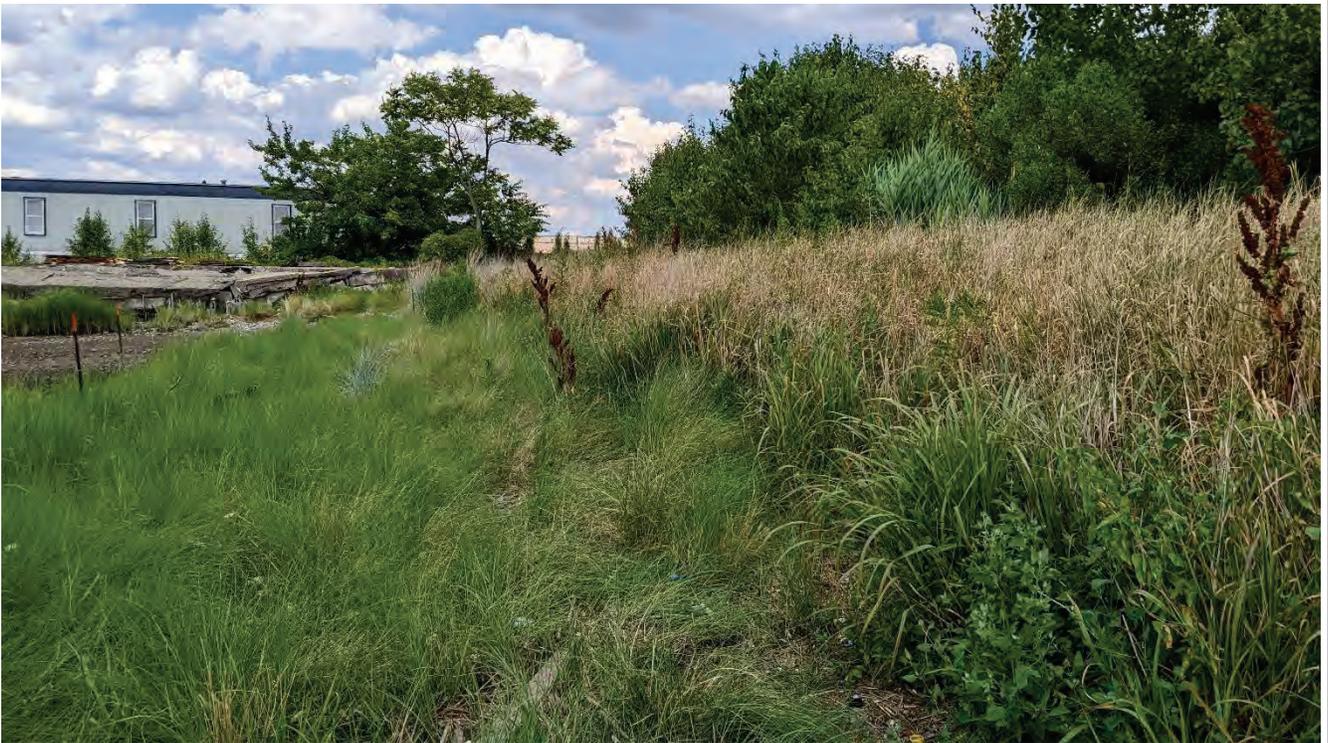
**Photo 3:** Western end of Cap Area 16. Note the vibrant and healthy vegetation in the high marsh planting zone (facing northeast).

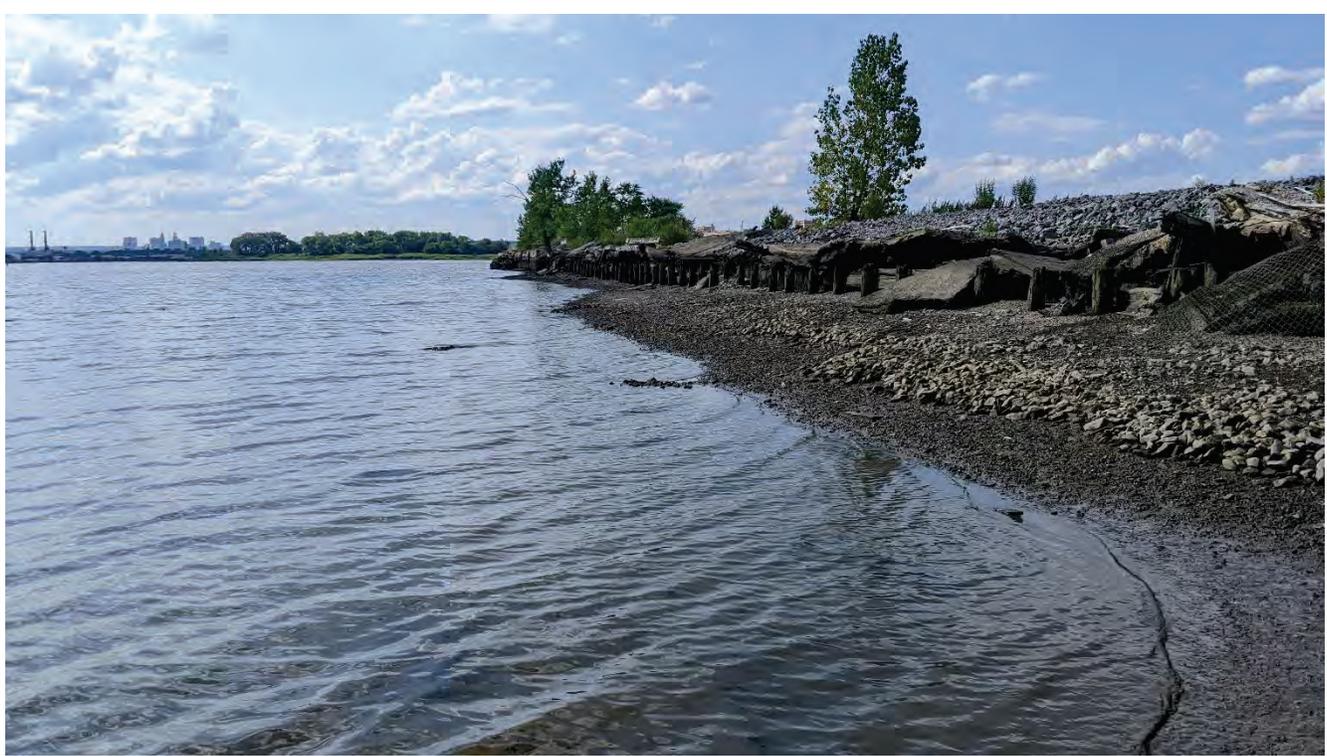
**Photo 5:** Cap Area 22 partially exposed during low tide (facing north).

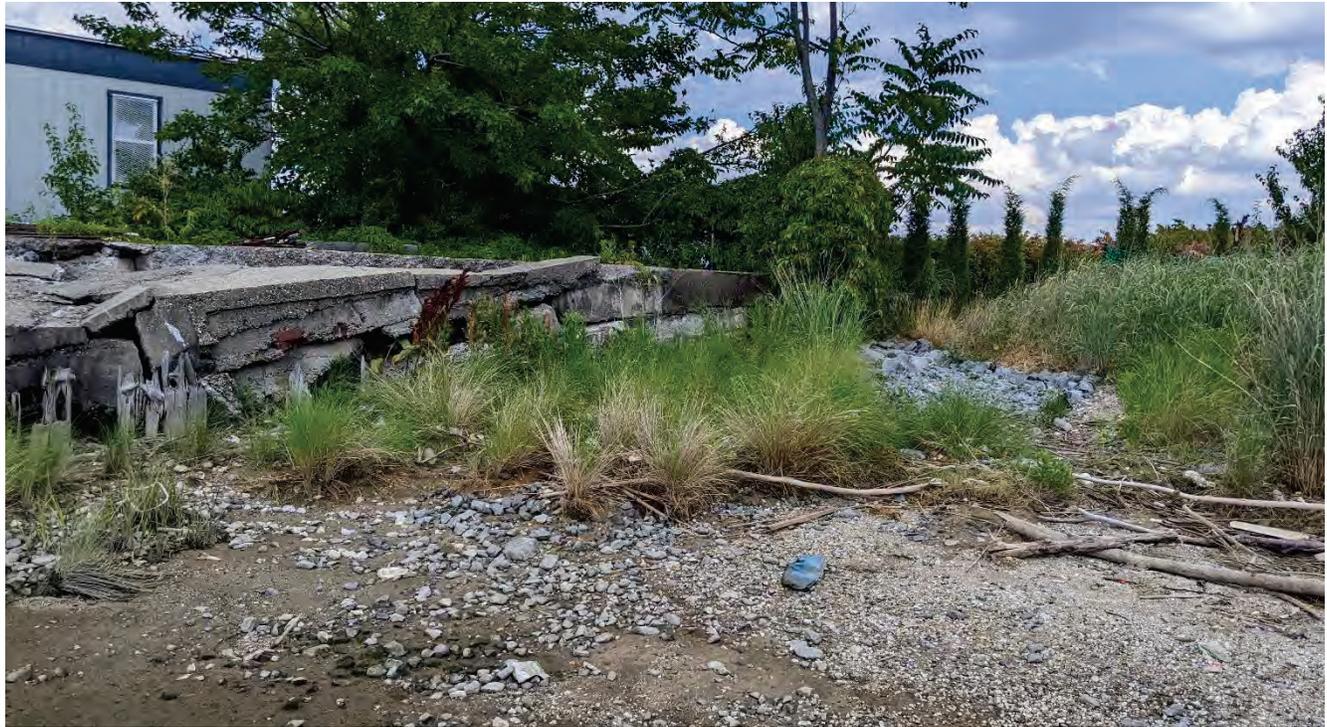
**Photo 6:** Repairs remain stable and in good condition on the eastern side of the BEP, near Outfall D (facing southeast).

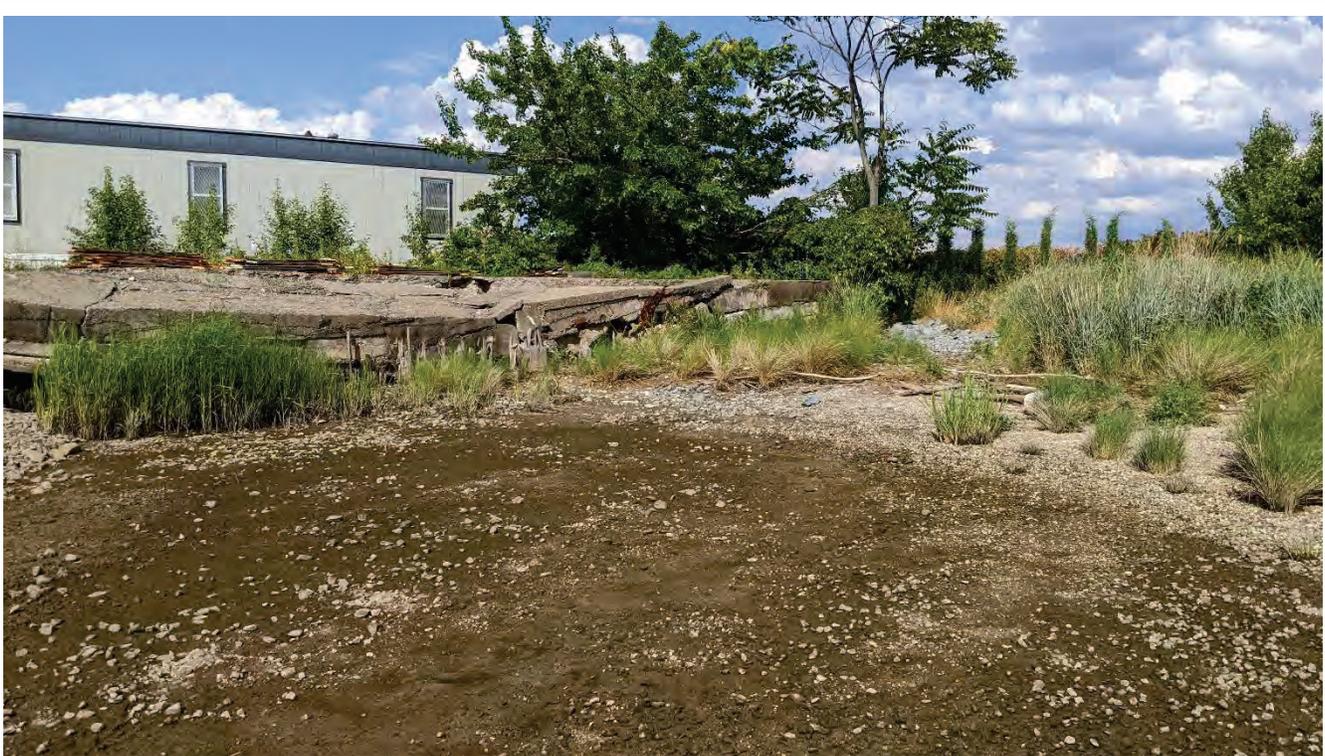
Photo 13: Low marsh zone in the eastern corner of the BEP at Outfall D (facing southeast).

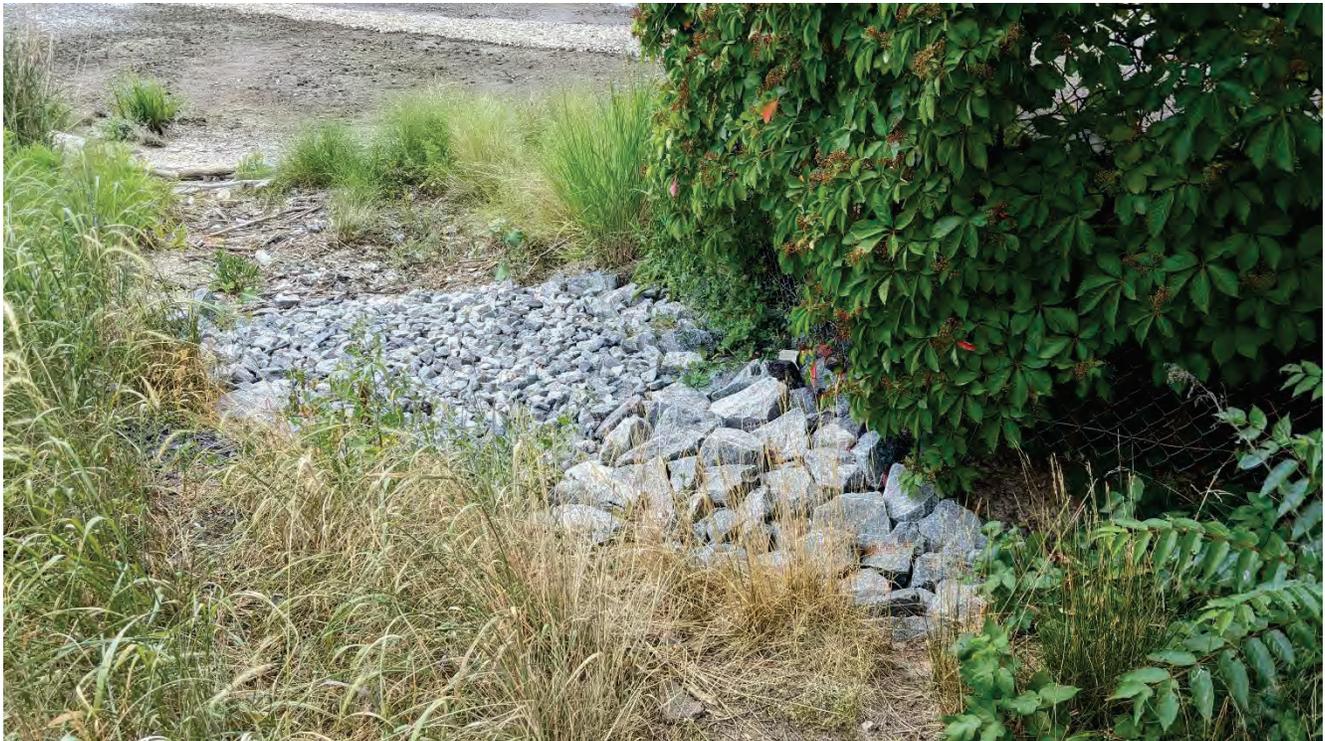
Photo 14: Repaired area located in the easternmost corner of the BEP area remains stable and in good condition (facing northwest).

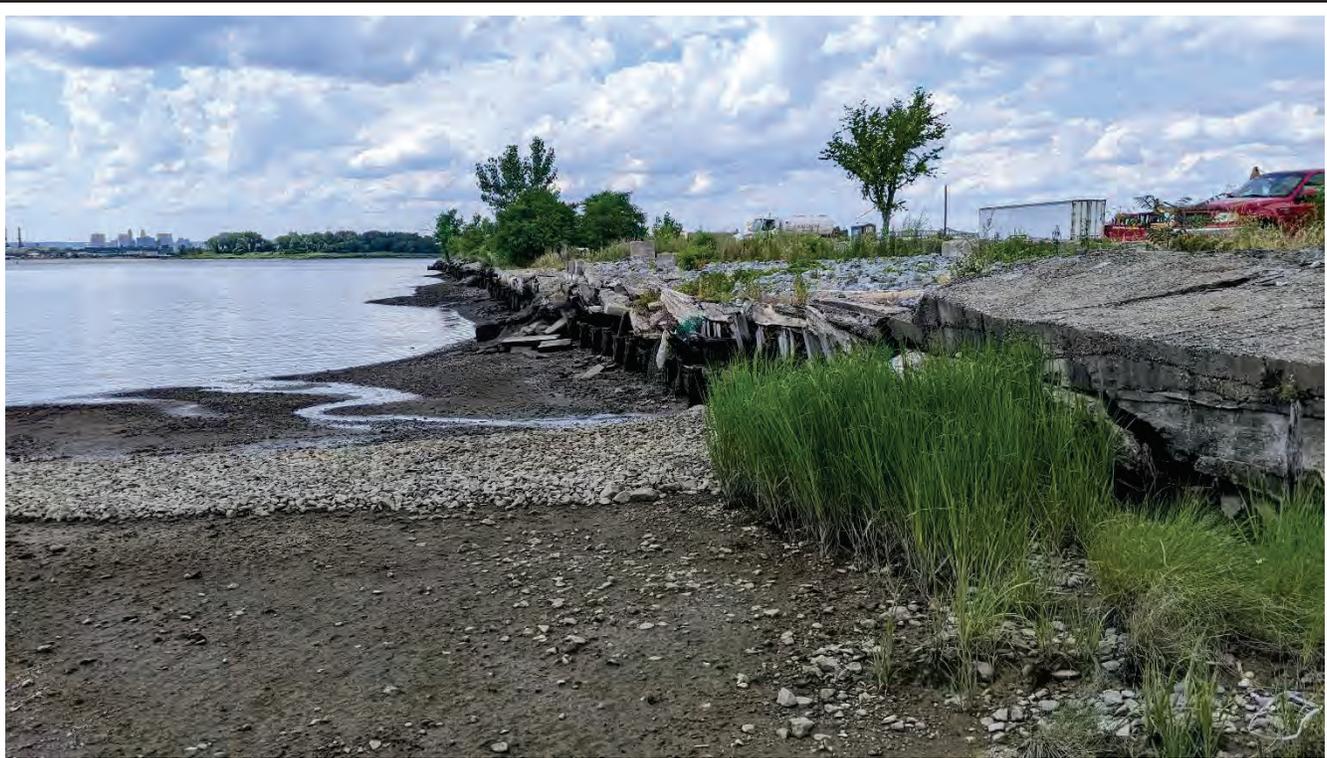
**Photo 15:** Low marsh planting zone on the eastern side of the BEP (facing north).

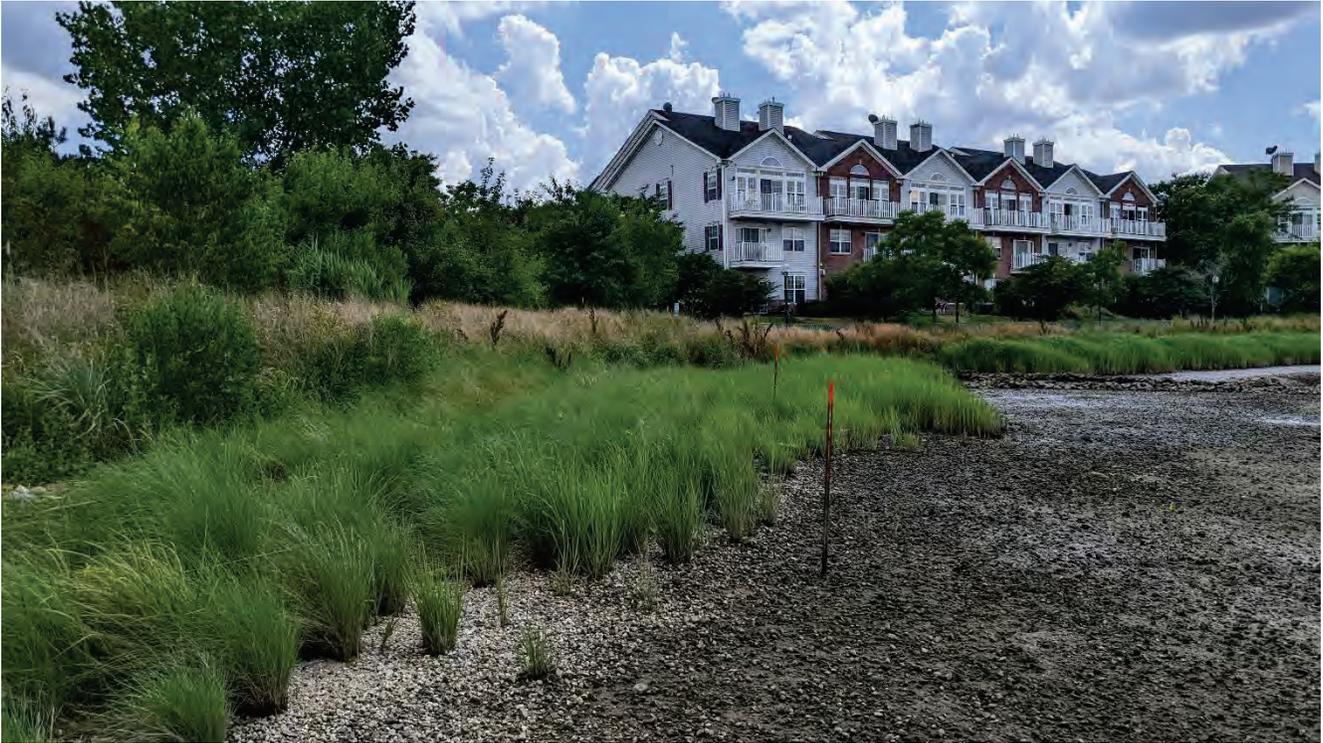
**Photo 16:** Area where the low marsh planting zone meets the high marsh planting zone within the eastern side of the BEP (facing southwest). Note the low marsh vegetation appears vibrant and healthy.

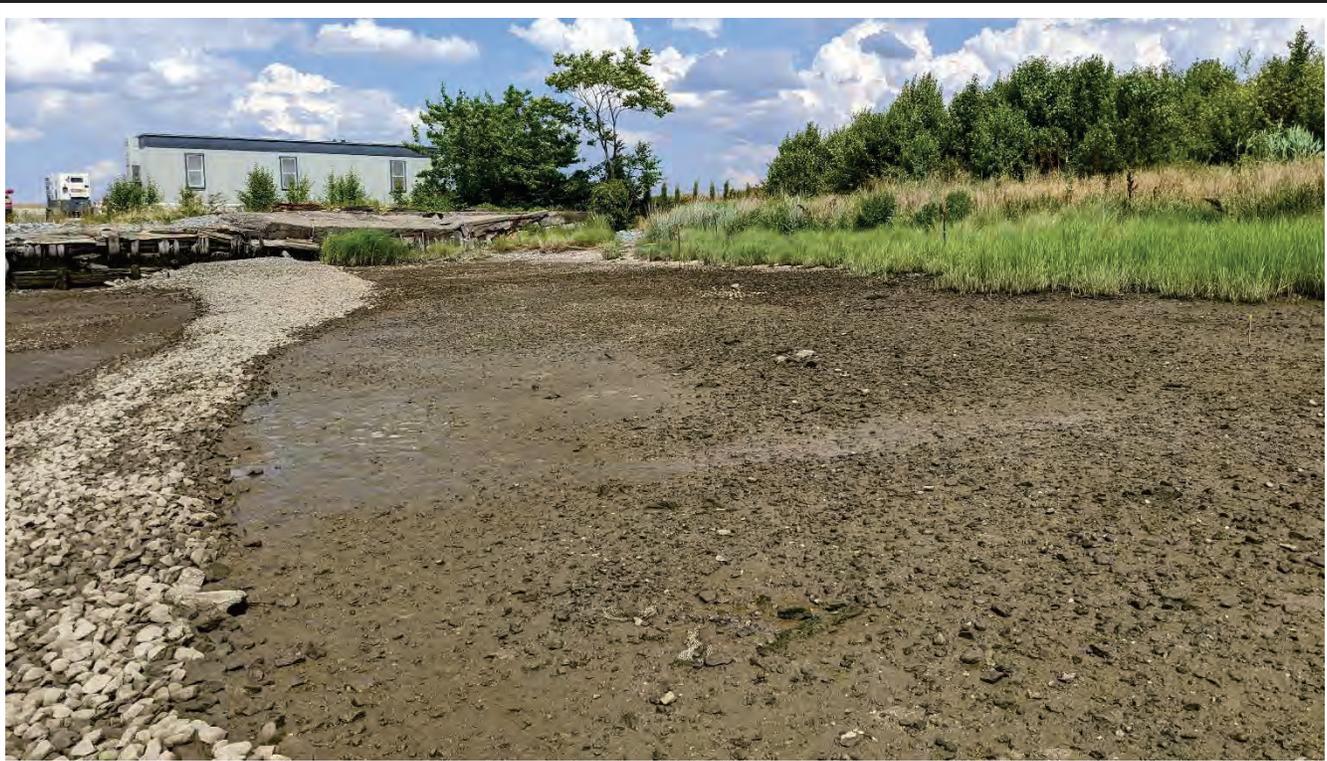
**Photo 17:** Low marsh planting zone within Cap Area 16 (facing northeast). Note the limited algae cover throughout the lower elevations of the low marsh area, as compared to the May 2022 inspection.
