# MEMORANDUM

Subject: **SA-7 Sediment Remedy Long-Term Monitoring**  
**Summary of Year 9 Monitoring & Proposed Year 10 Program**

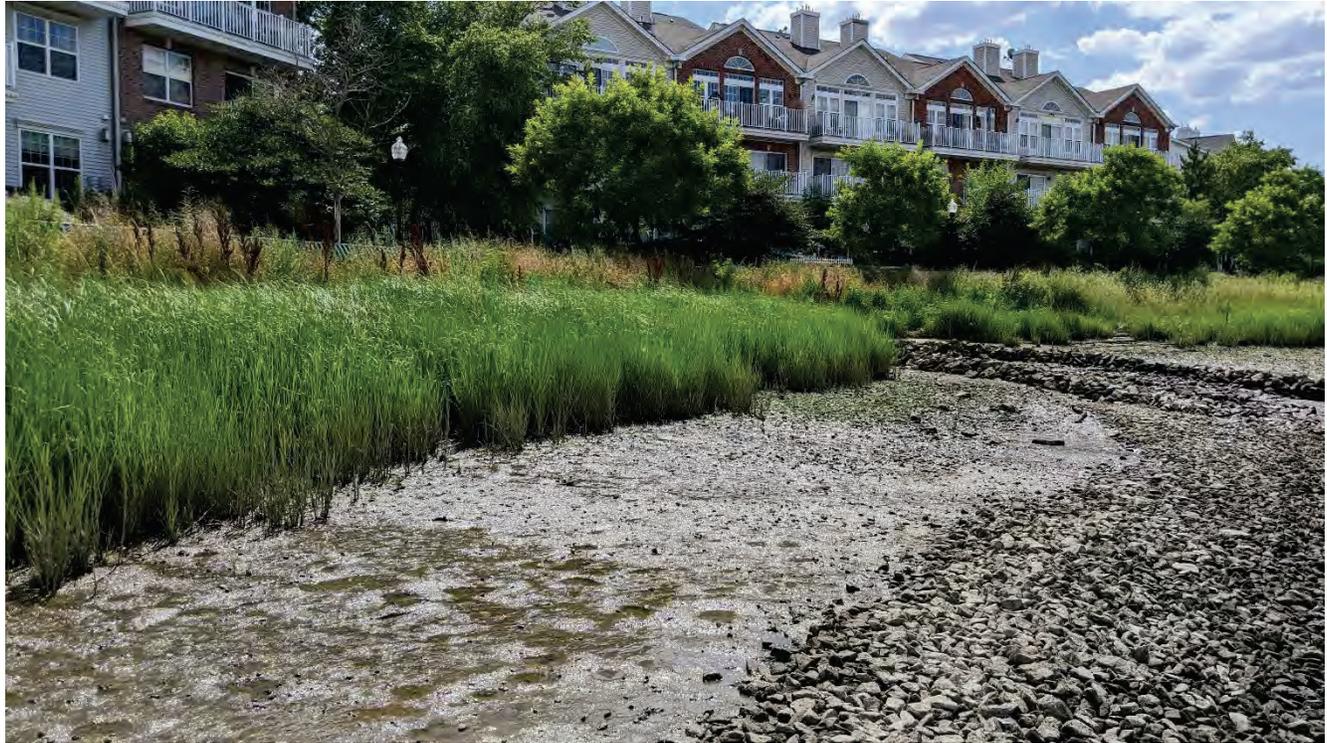
**Photo 18:** Low marsh planting zone between Outfalls A and B (facing west). Note the vibrant and healthy vegetation.

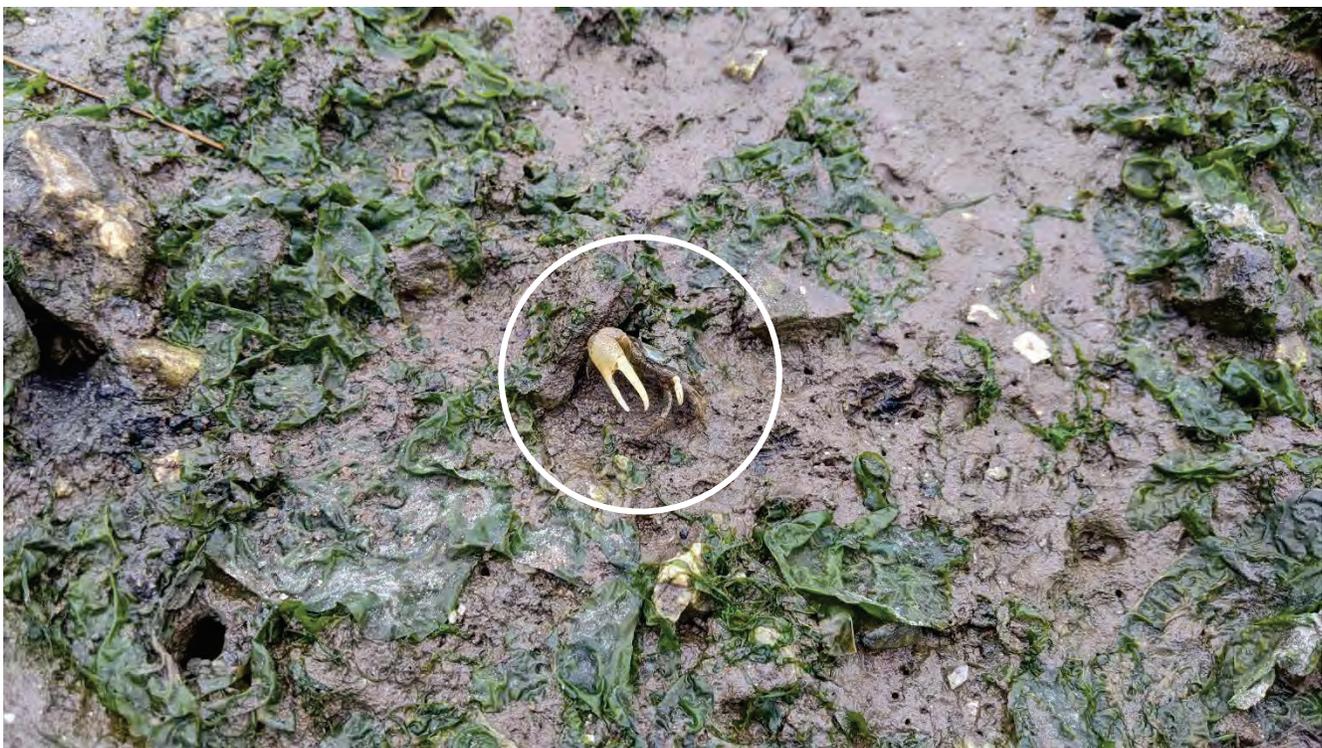
Photo 19: Fiddler crab using the mudflat within Cap Area 16 west of Outfall A.

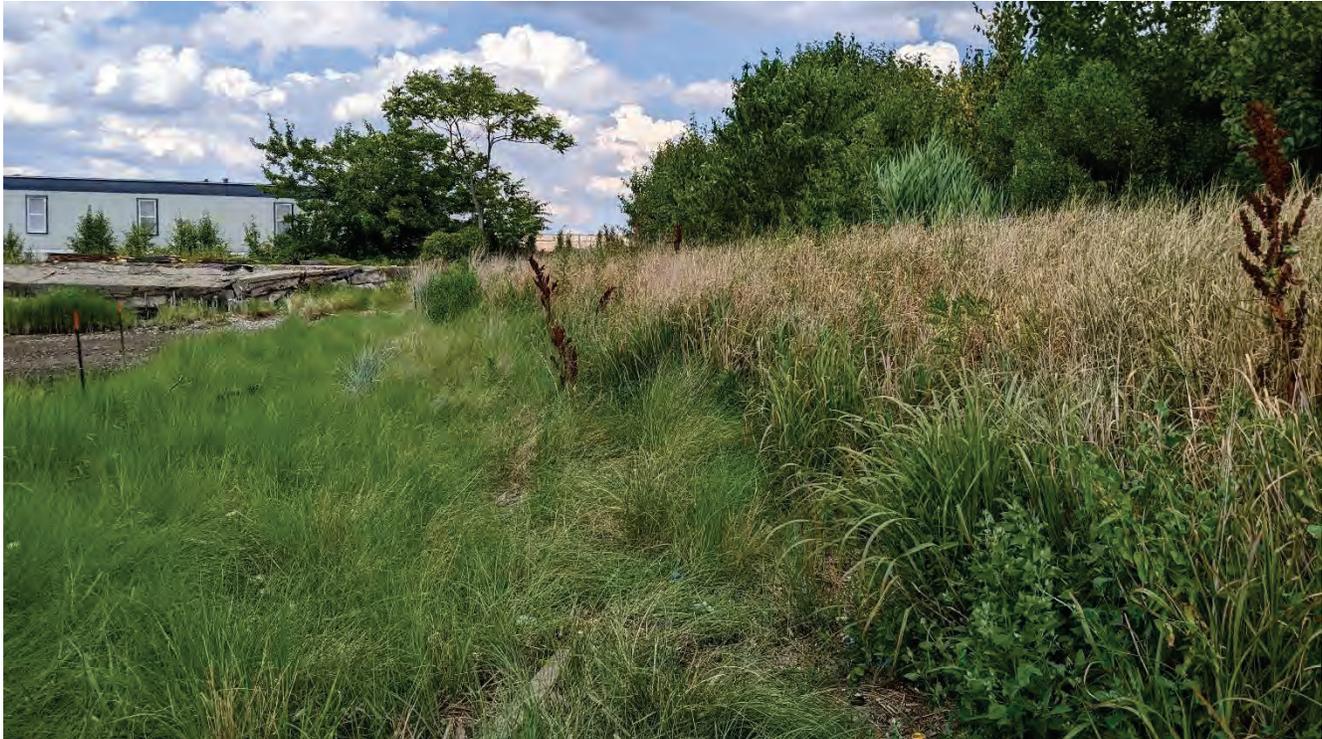
Photo 20: Vibrant and healthy vegetation in the low and high marsh zones in the eastern BEP area (facing southeast).

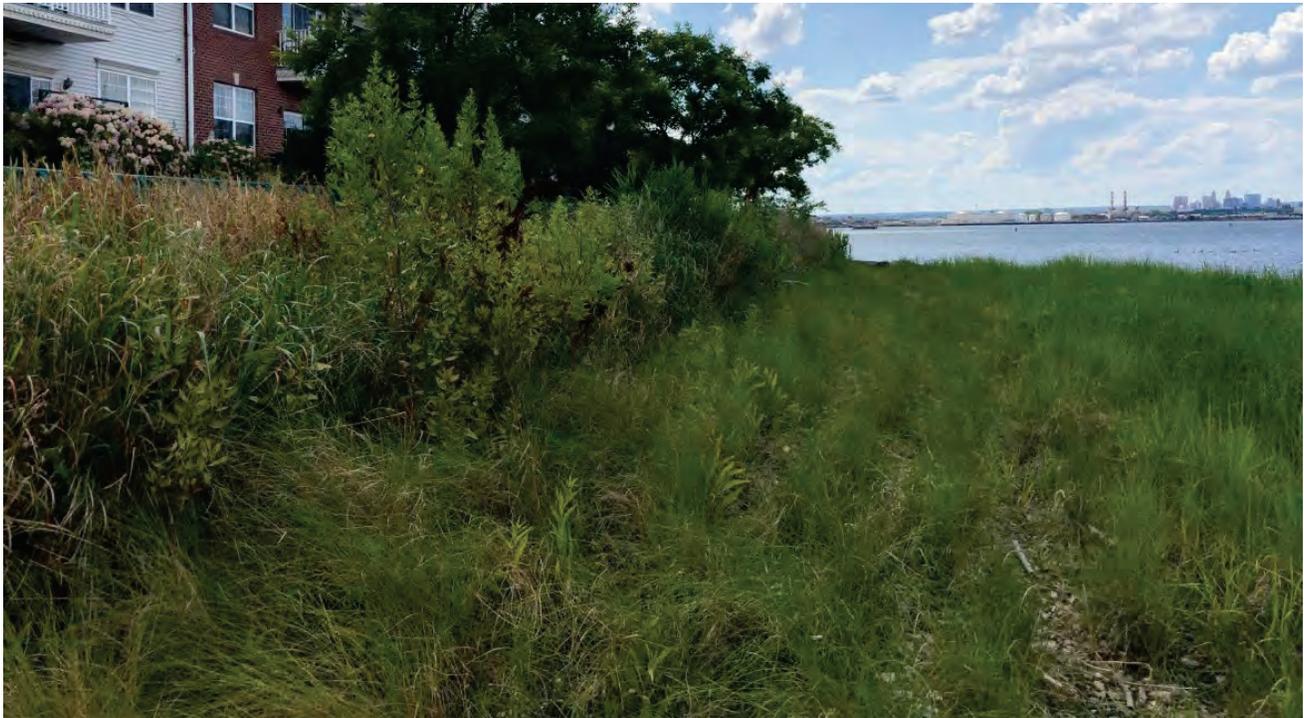
**Photo 21:** Vibrant and healthy vegetation in the high marsh zone in the area west of Outfall A (facing west).

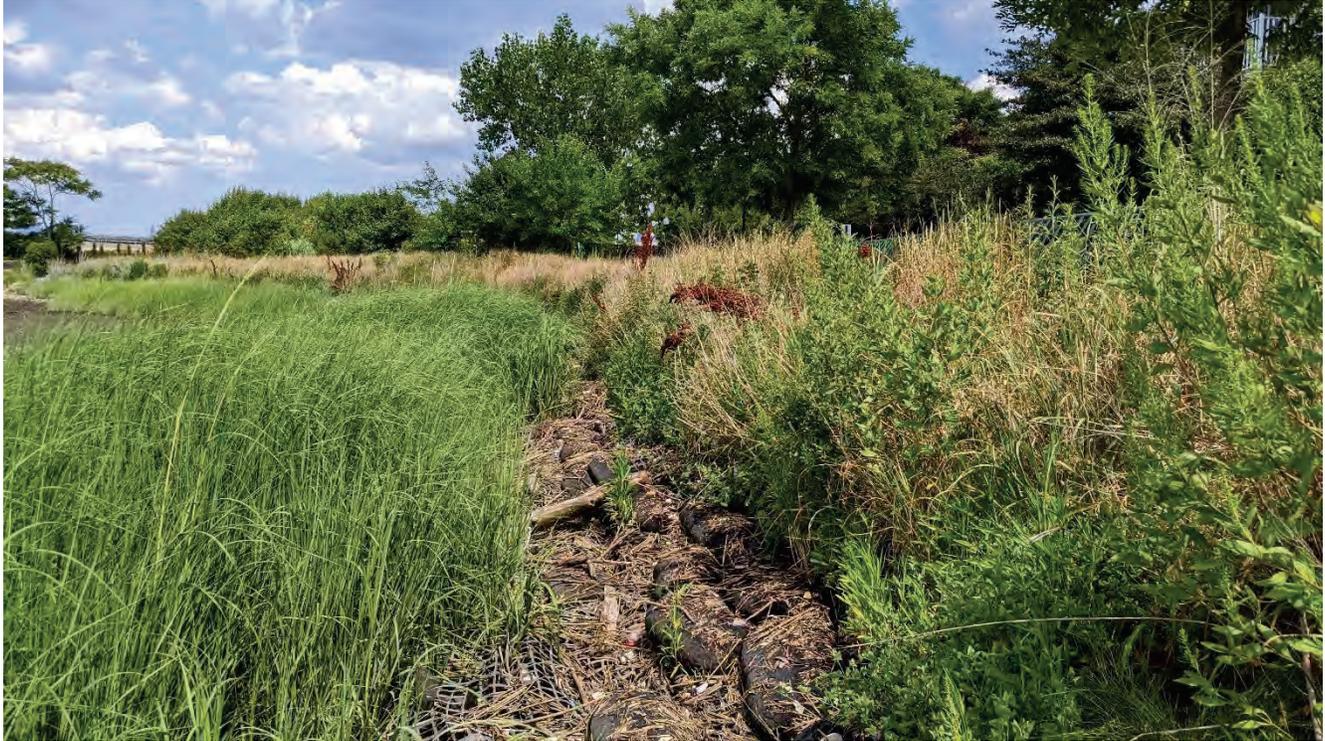
**Photo 24:** Area of exposed GroSoxx and geogrid with some debris, located east of Outfall A (facing southeast). Note the presence of healthy and vibrant vegetation around the GroSoxx area.

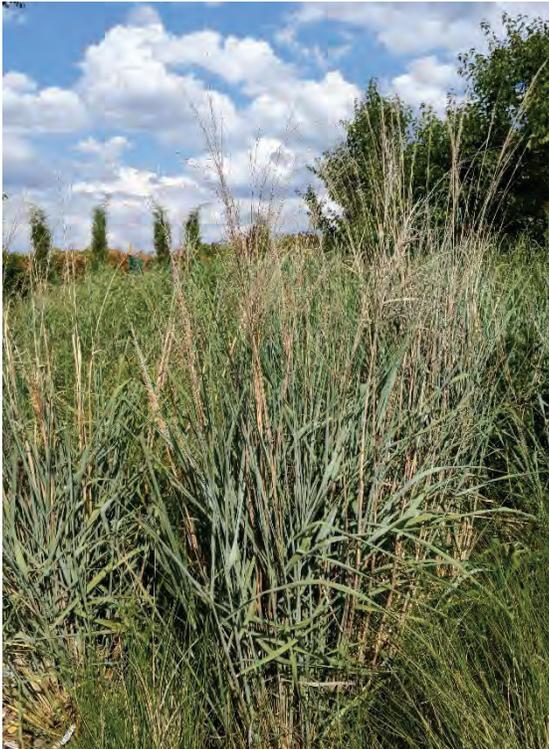
**Photo 25:** Small presence of bitter panicgrass observed in the eastern BEP area (facing south).

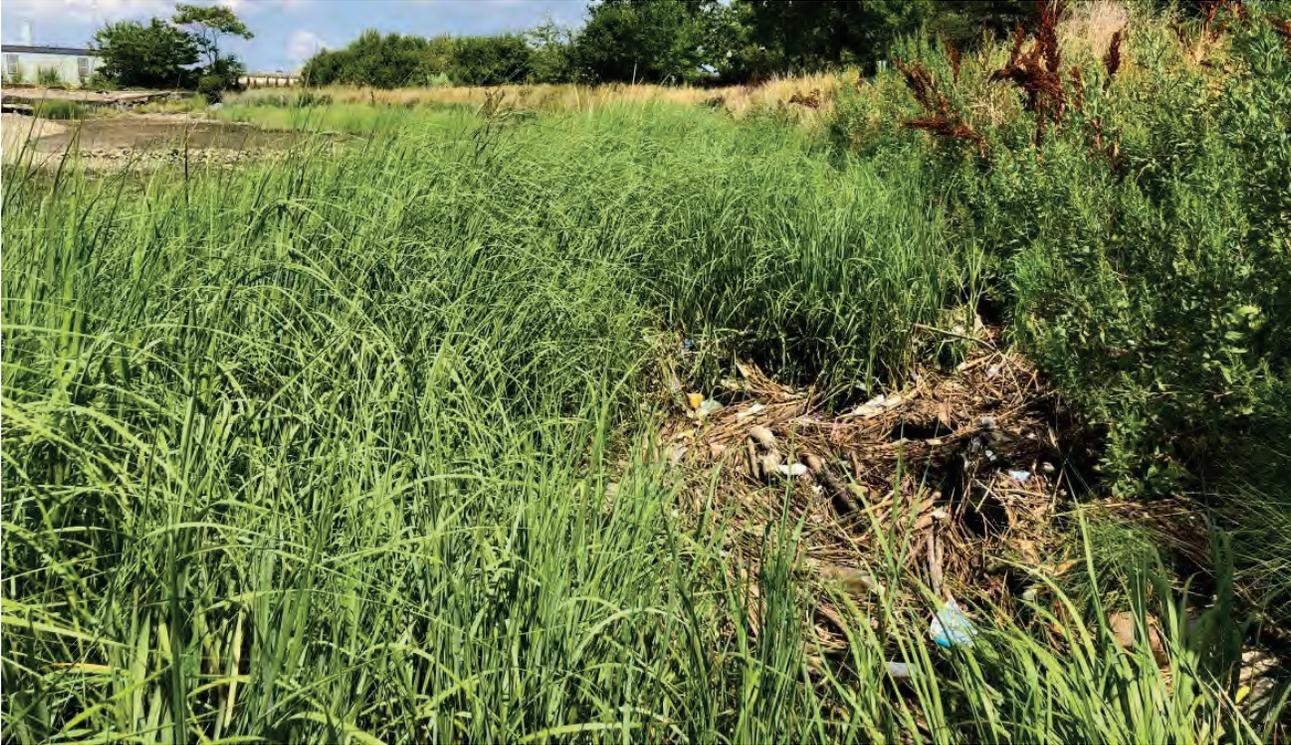
**Photo 26:** Vibrant and healthy upper low marsh, lower high marsh, and upland vegetation between Outfalls A and B (facing east). Note the presence of drift deposits from the tidal action in the foreground.

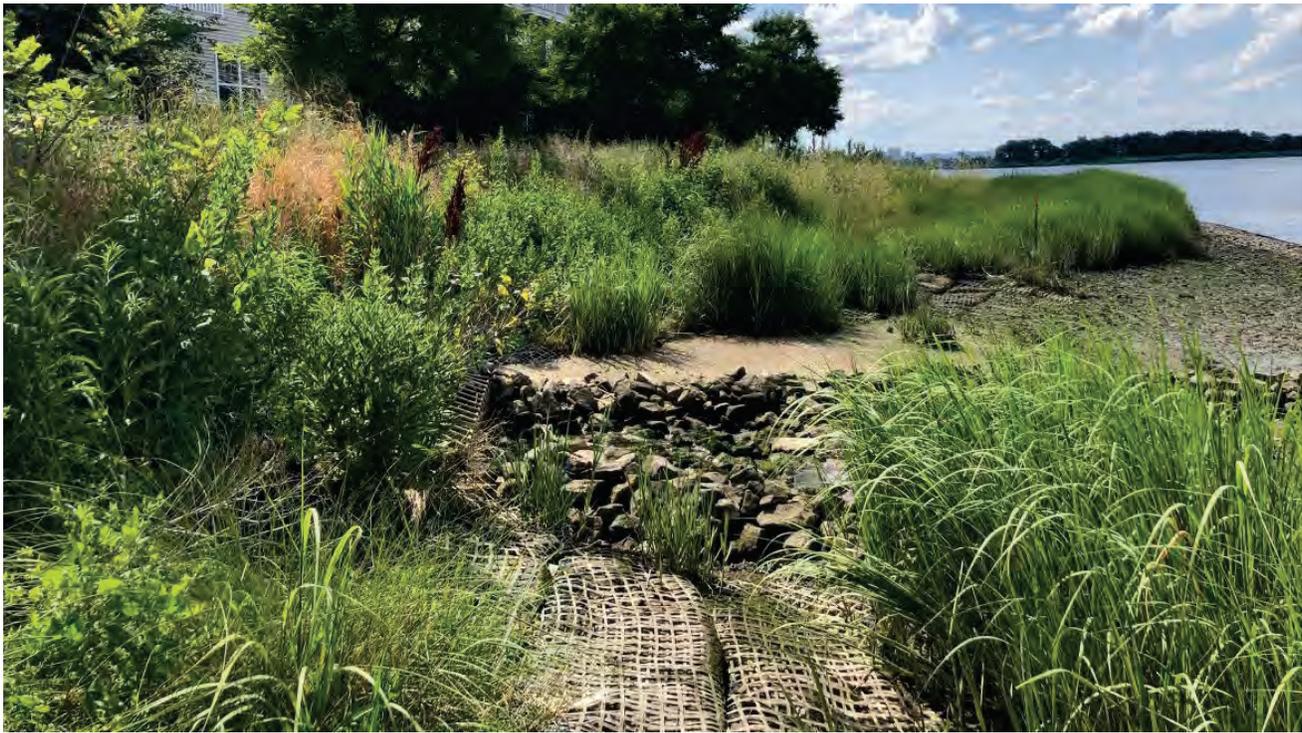
**Photo 27:** Vibrant and healthy upland transitional and high marsh vegetation near Outfall A (facing west). Note the exposed geogrid.

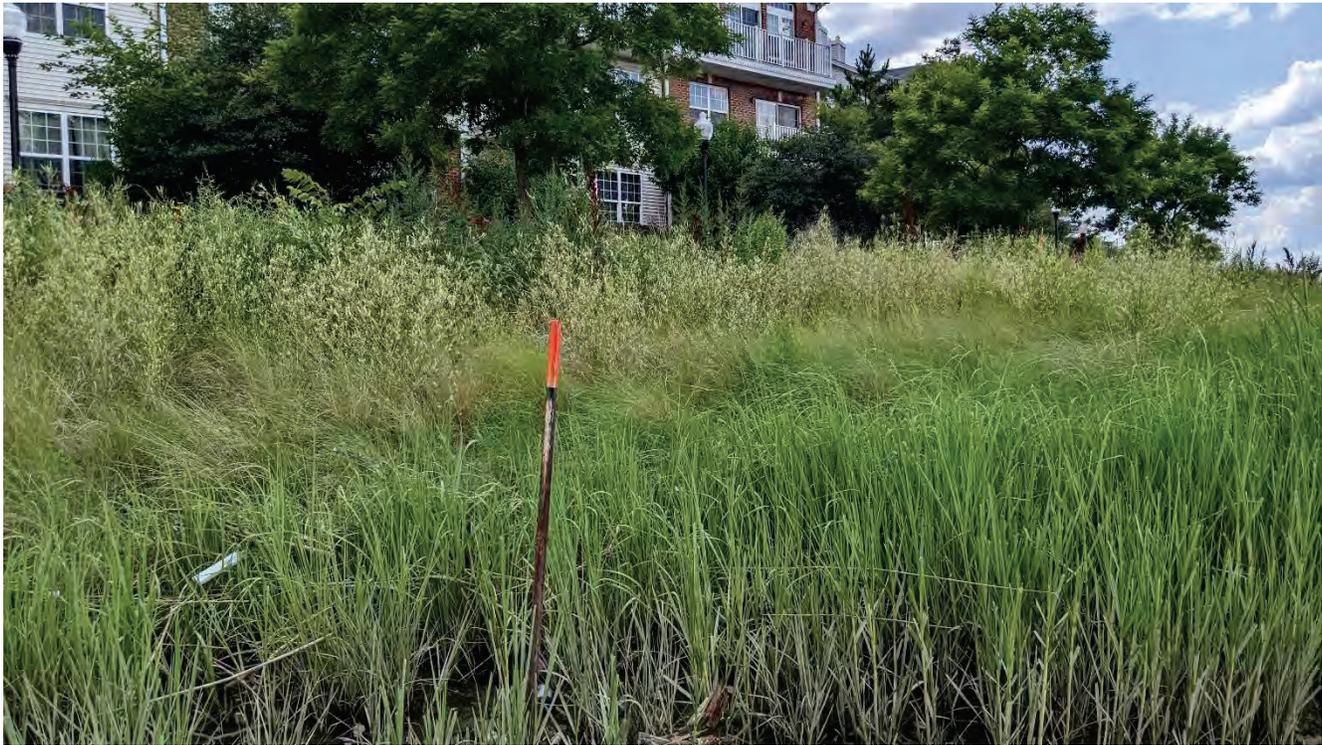
**Photo 28:** Vibrant and healthy low marsh, high marsh, and uplands east of Outfall A (facing southwest).

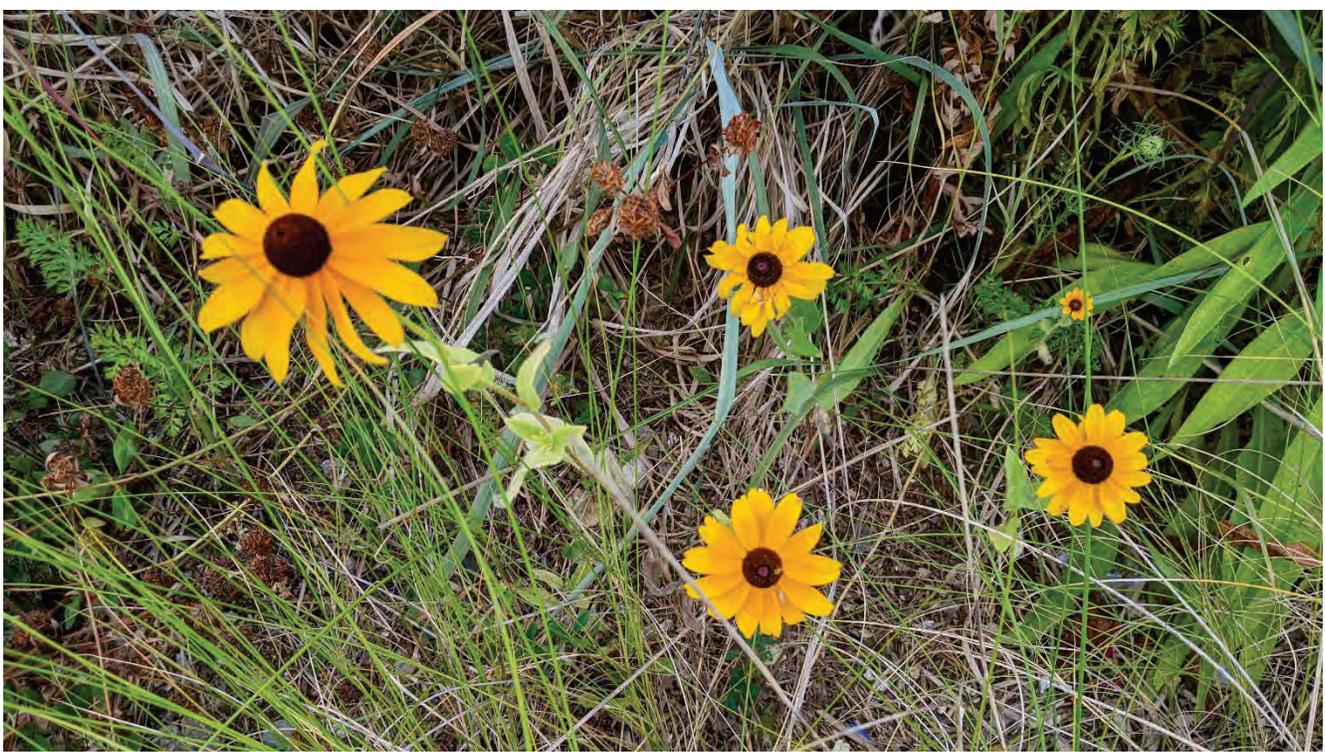
Photo 29: Native species Black-eyed Susan located within the upland transitional planting zone within the BEP.

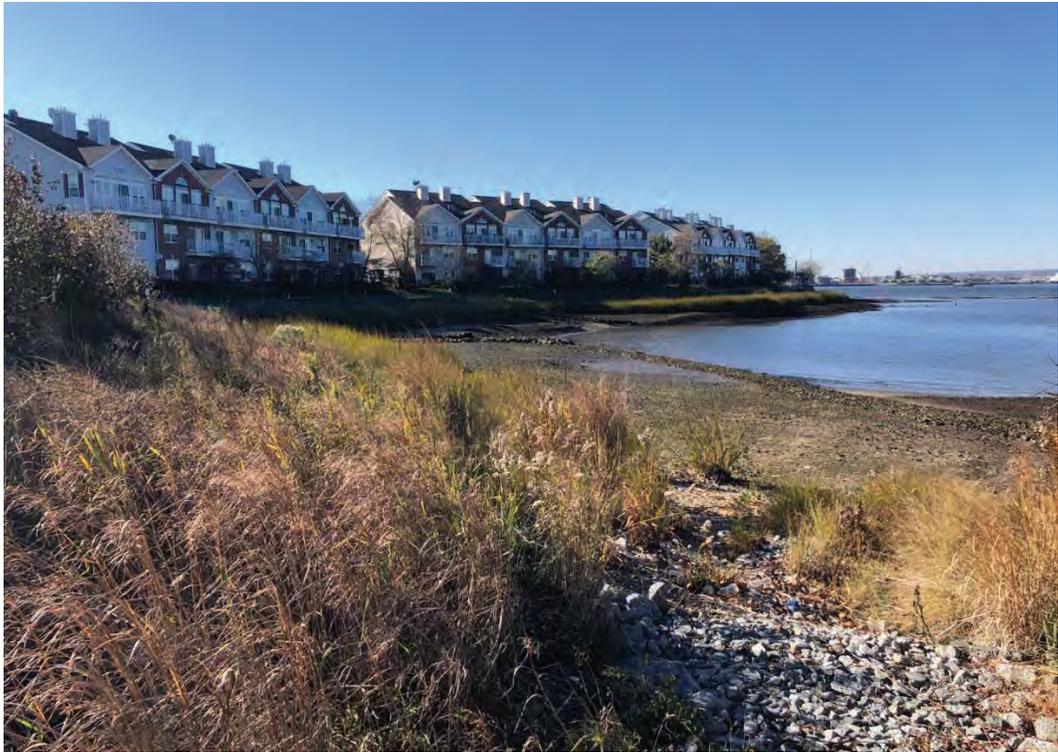
**Photo 1:** Northern end of Cap Area 16. Note vibrant and healthy vegetation present in high marsh planting zone (facing west).

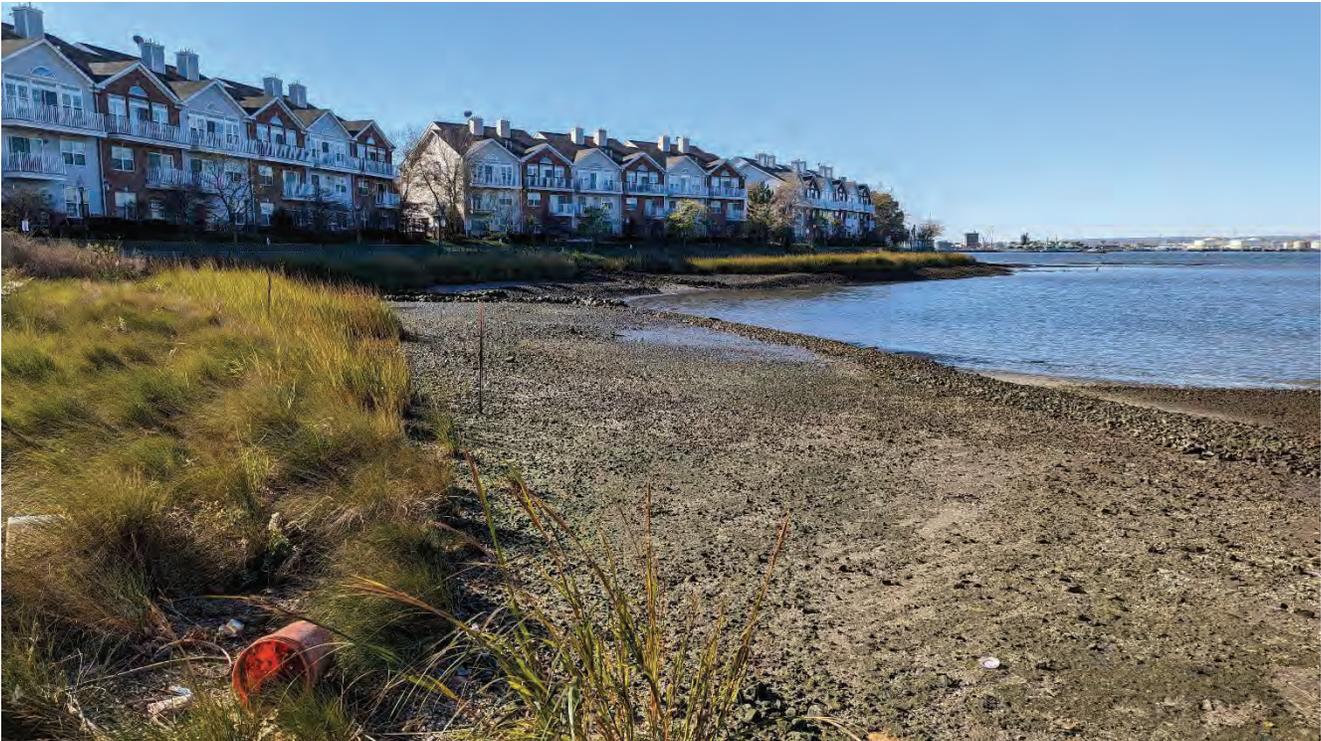
**Photo 2:** Central portion of Cap Area 16 (facing west).

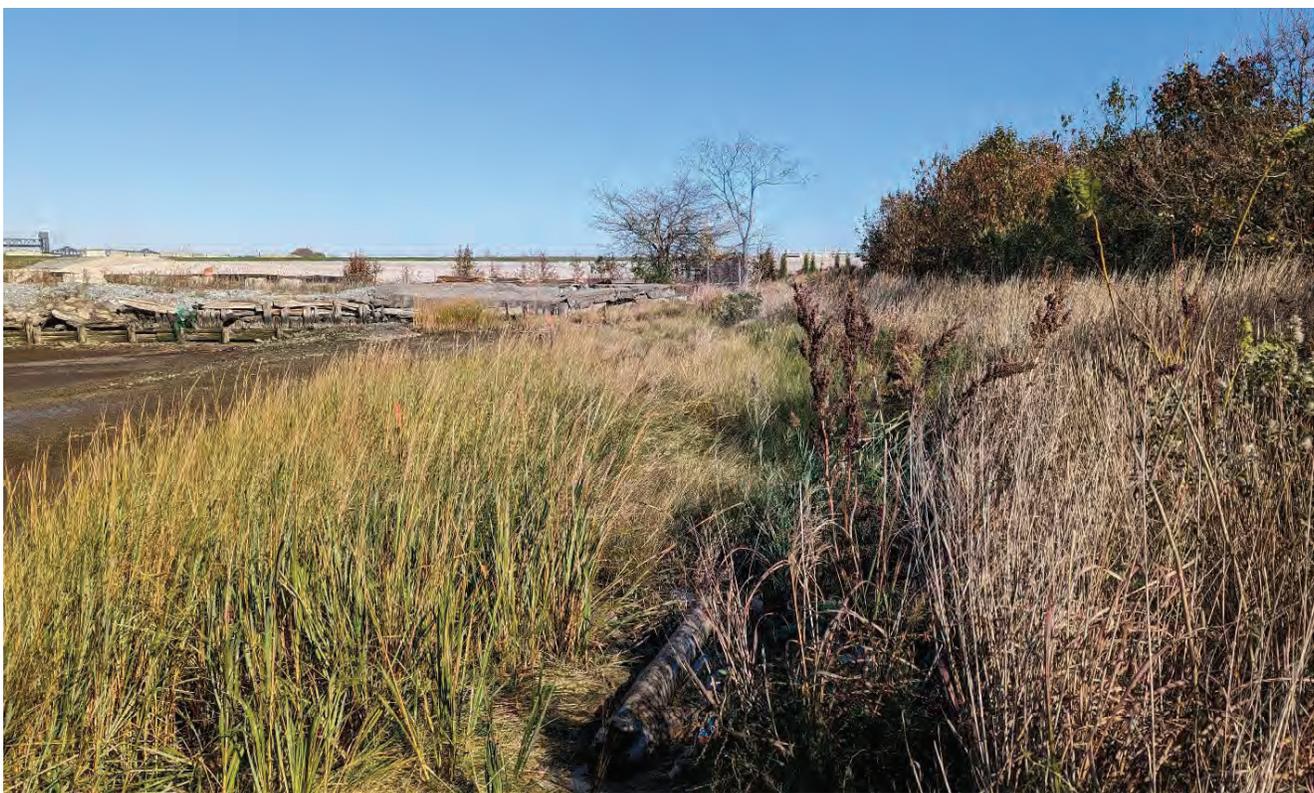
**Photo 3:** Western end of Cap Area 16. Note the vibrant and healthy vegetation in the high marsh planting zone (facing northeast).

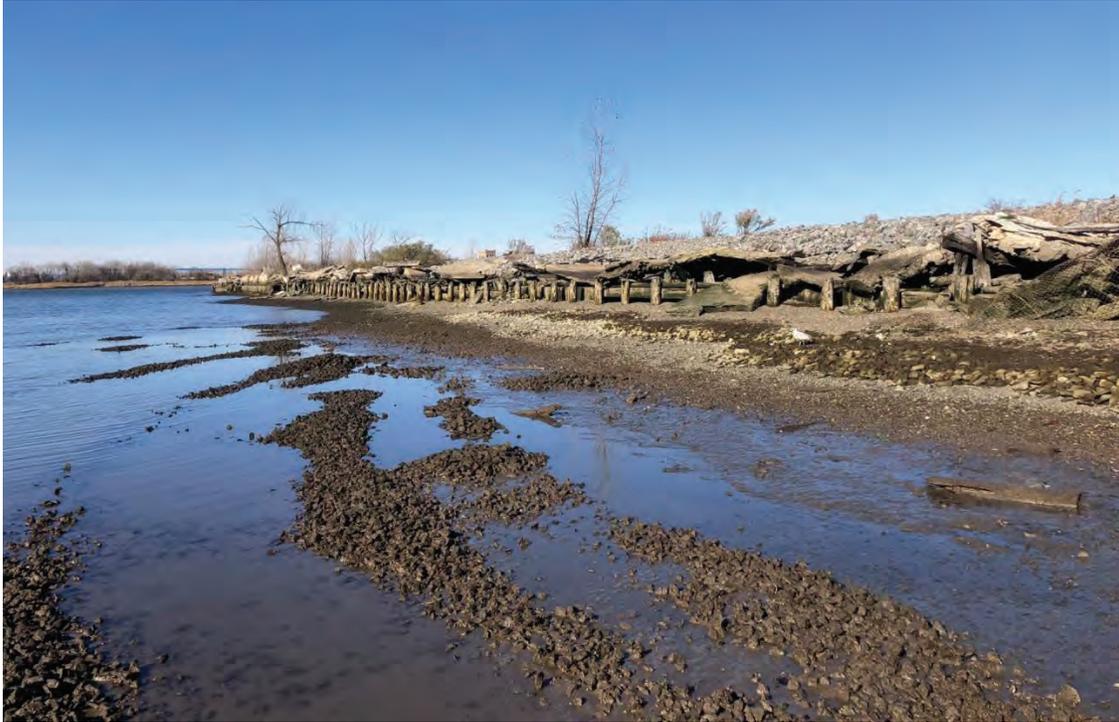
**Photo 5:** Partially exposed Cap Area 22 during low tide (facing north).

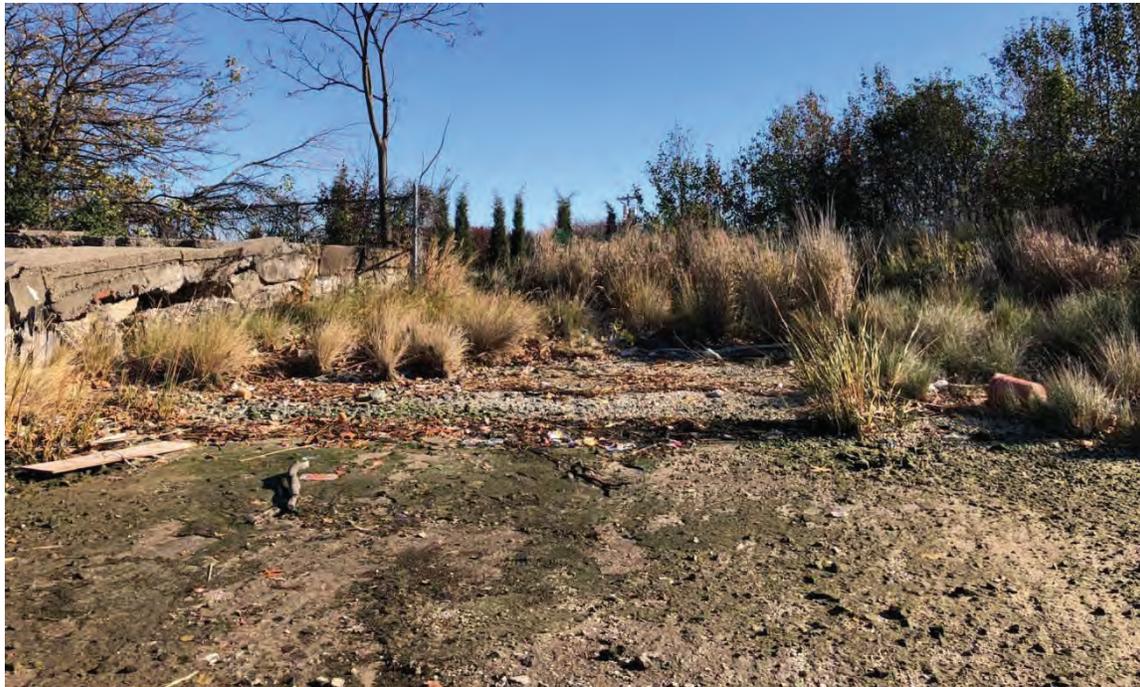
**Photo 6:** Eastern side of the BEP, near Outfall D (facing southeast).

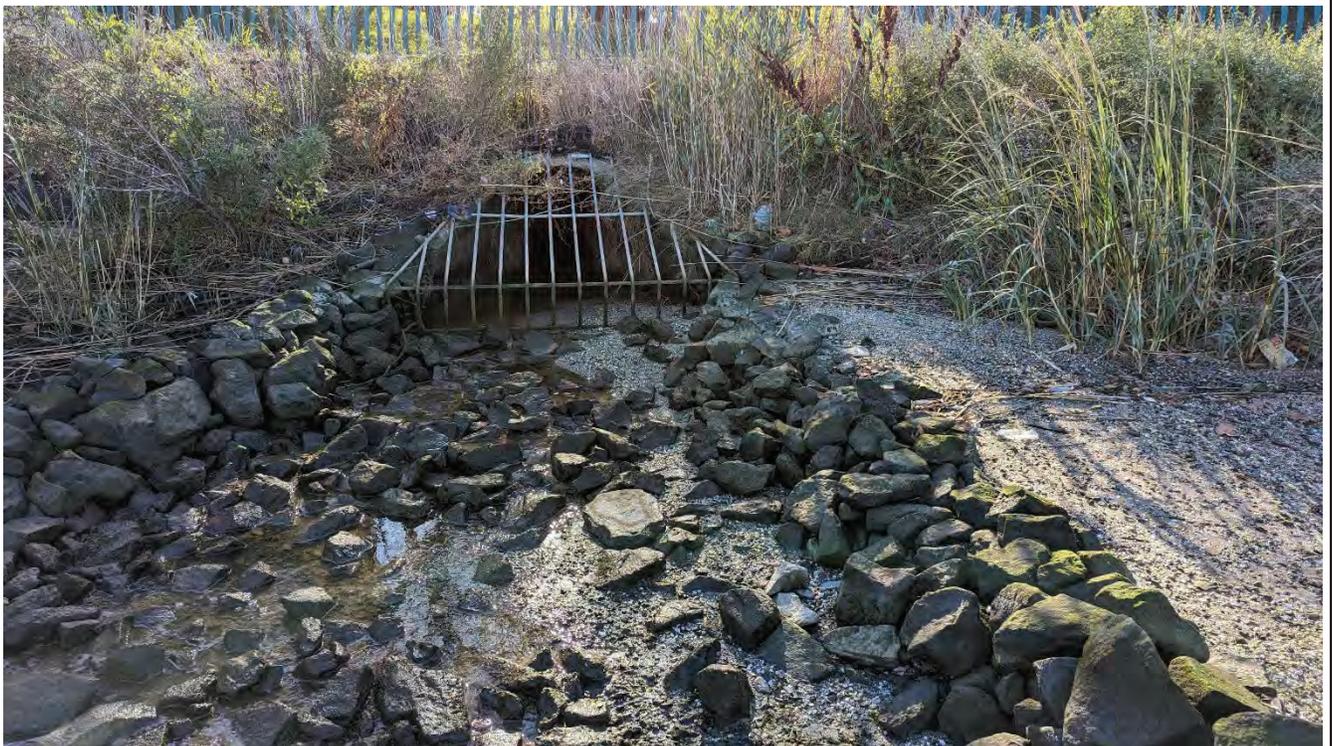
**Photo 8:** Outfall B and surrounding armor stone (facing south).

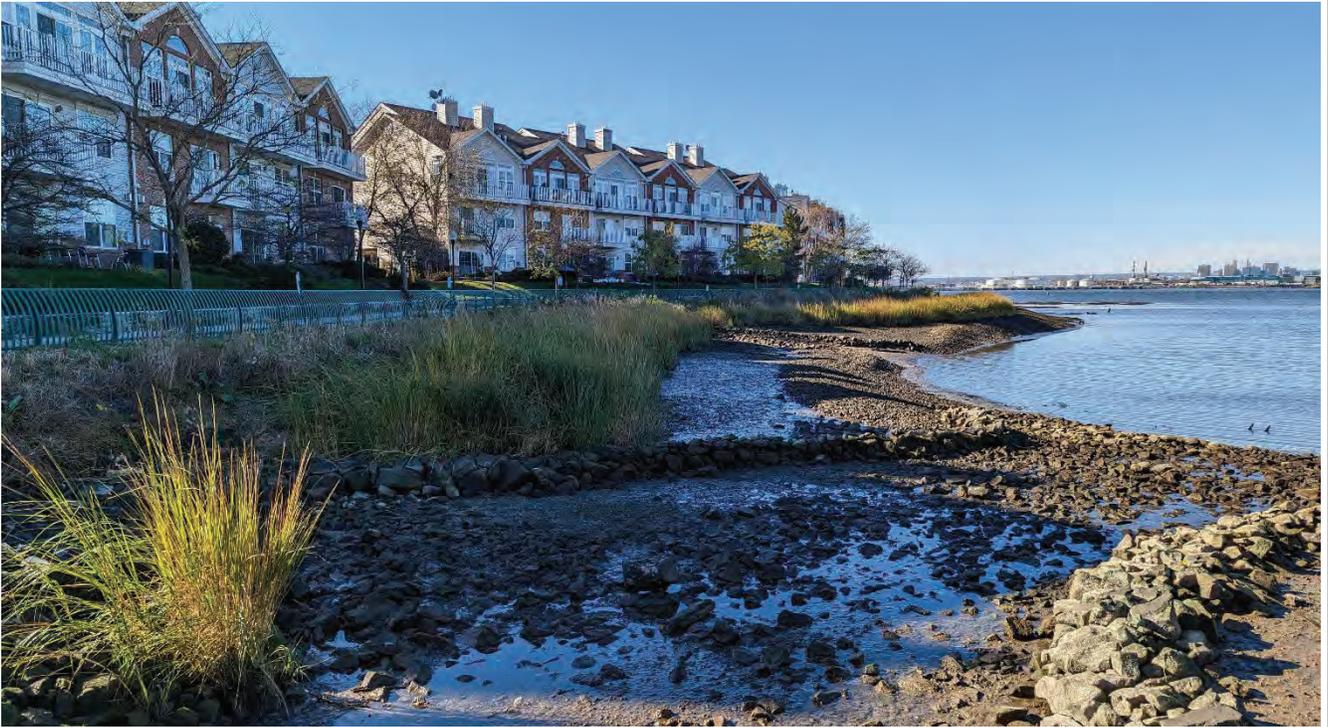
**Photo 9:** Armor stone along the western edge of the apron for Outfalls B and C (facing west). Note the siltation present on the apron stone.

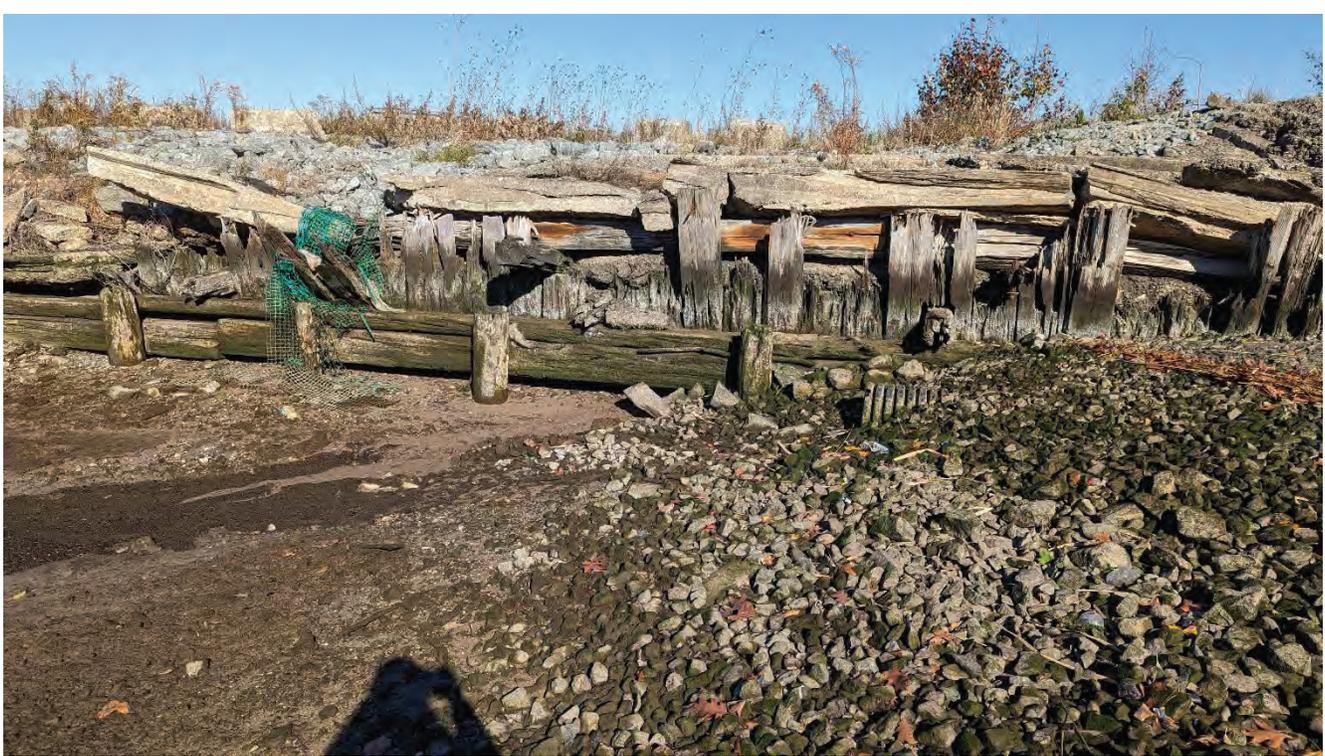
**Photo 11:** Discharge area of the Outfall D, where minor flow channel observed in the July 2022 inspection is no longer visible (facing northeast).

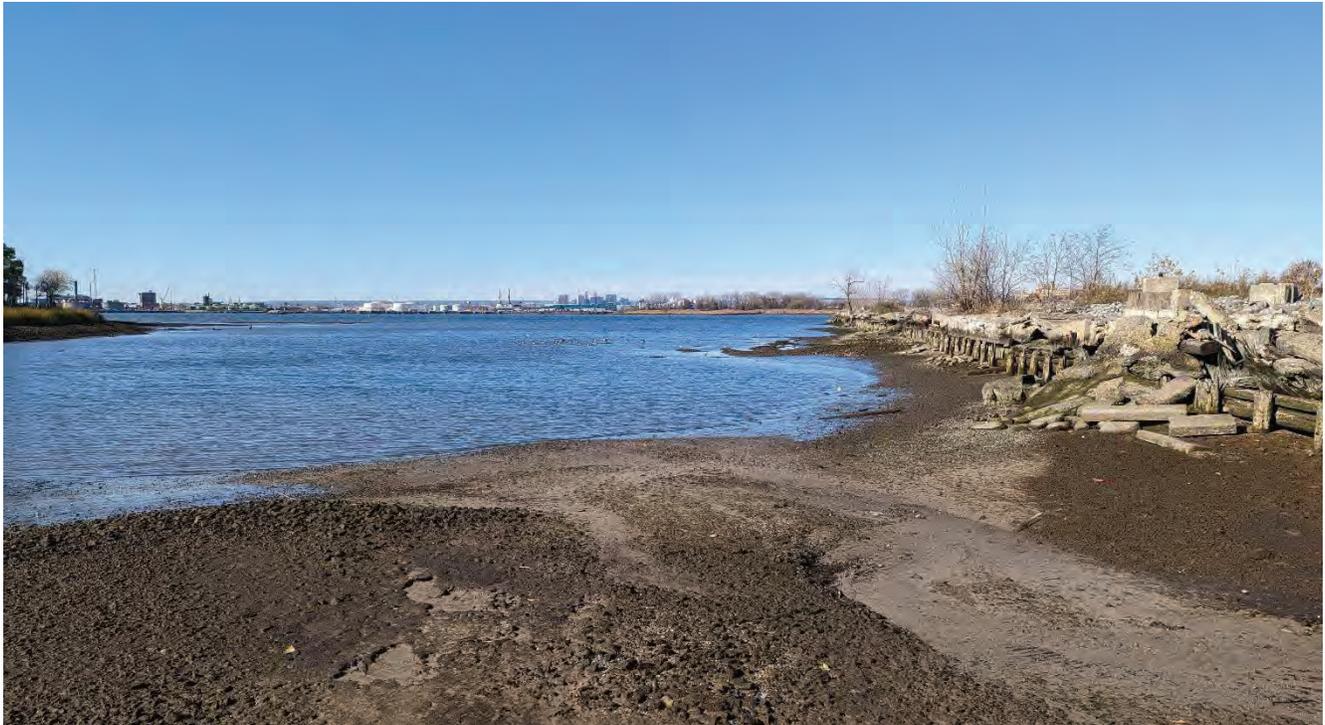
**Photo 12:** Area of former minor flow channel previously observed in the July 2022 inspection. Cap Area 22 in the background (facing northwest).

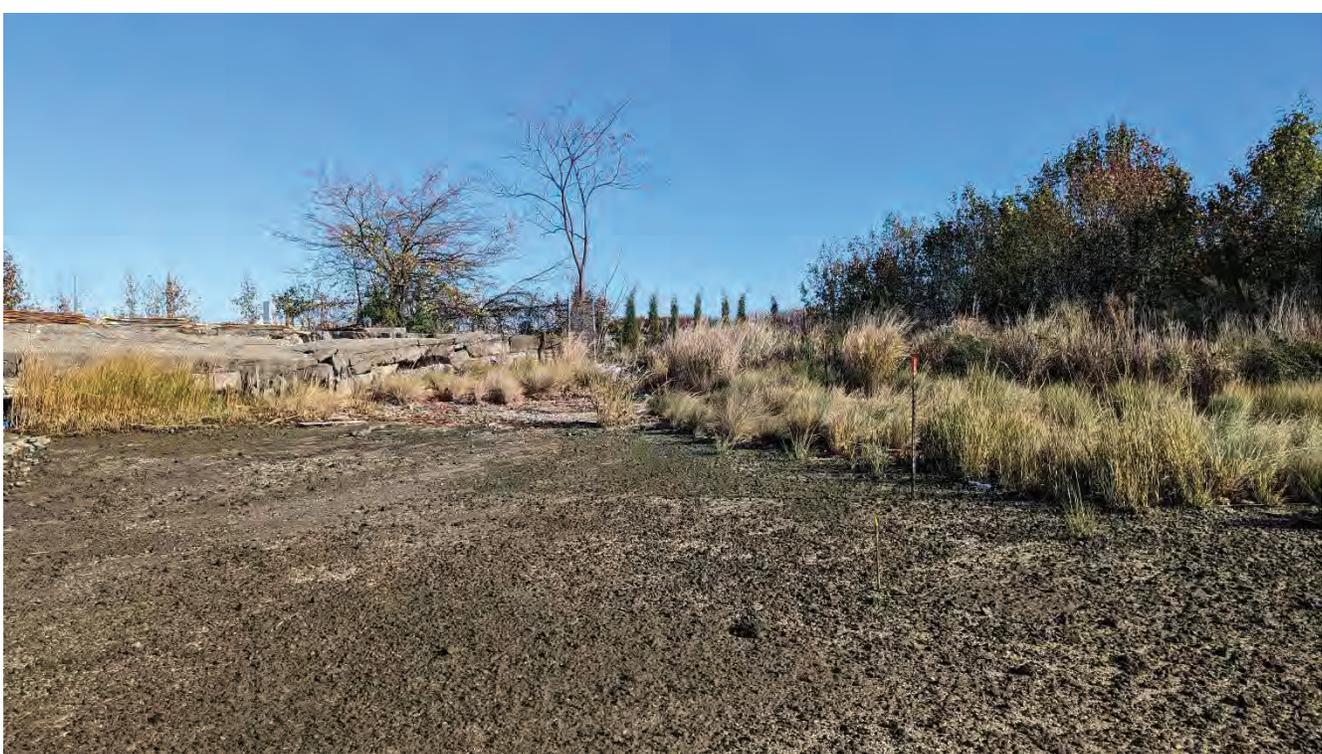
**Photo 13:** Low marsh zone in the eastern corner of the BEP at Outfall D (facing southeast).

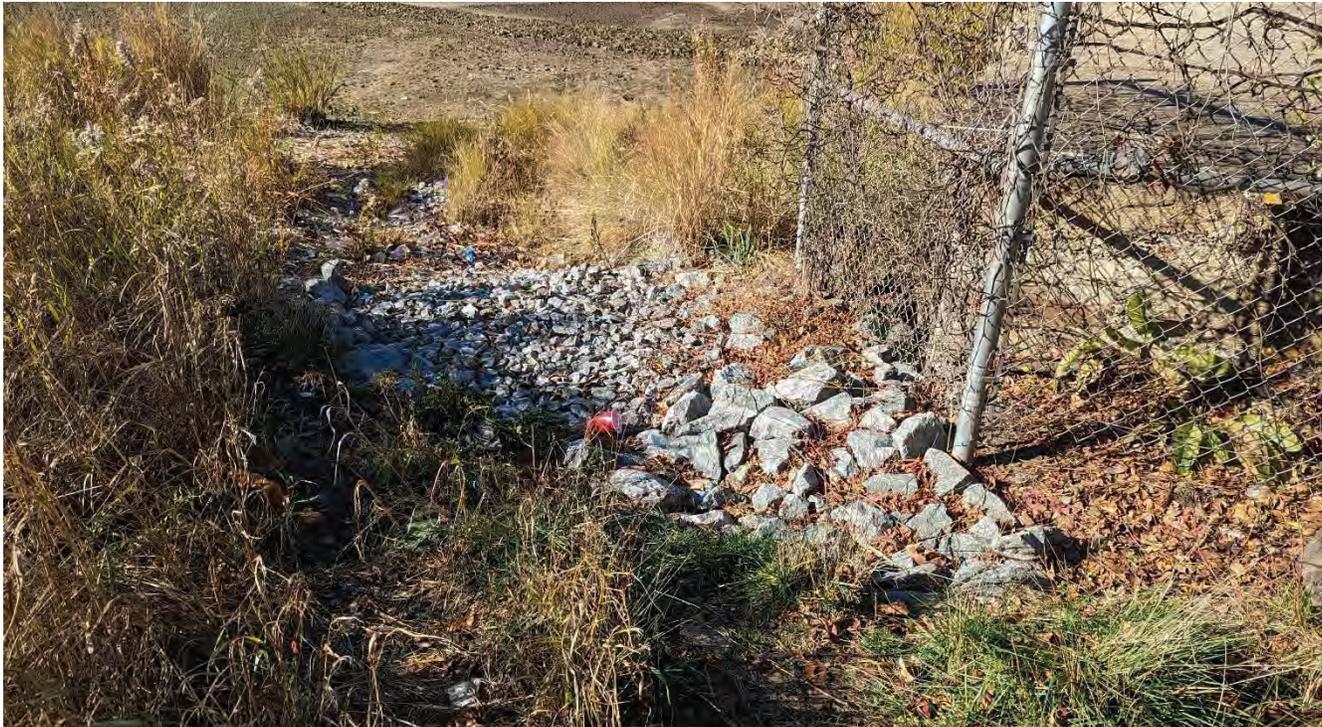
**Photo 14:** Transition from upland to low marsh zone in the easternmost corner of the BEP area (facing northwest).

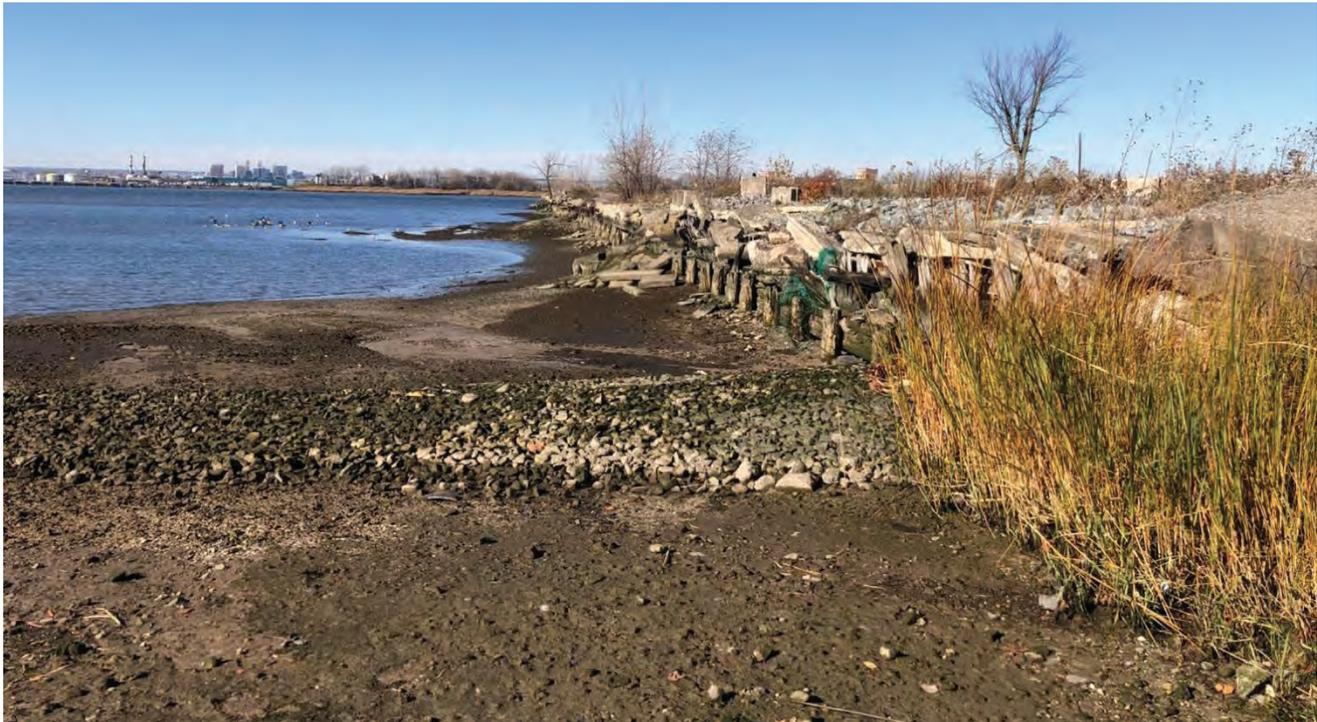
Photo 15: Low marsh planting zone on the eastern side of the BEP (facing north).

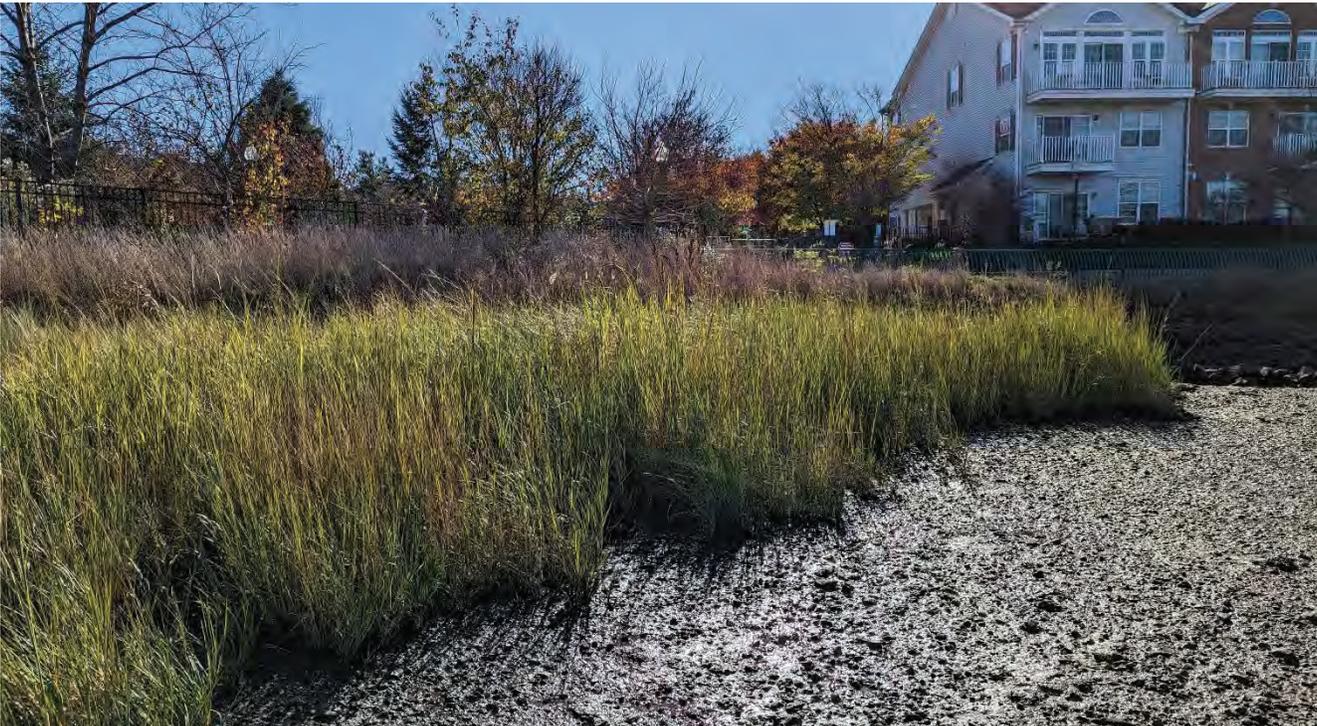
Photo 16: Area where the low marsh planting zone meets the high marsh planting zone within the eastern side of the BEP (facing southwest). Note the low marsh vegetation appears vibrant and healthy.

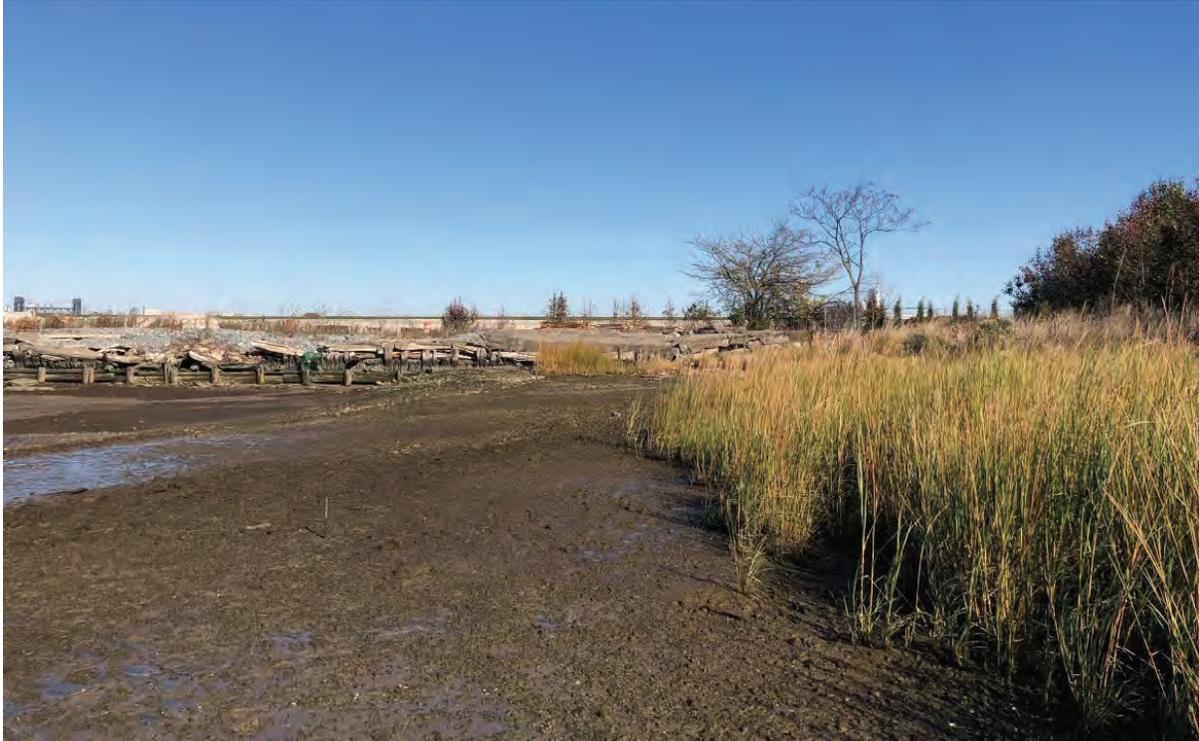
**Photo 17:** Low marsh planting zone within Cap Area 16 (facing northeast). Note the limited algae cover throughout the lower elevations of the low marsh area compared to the May 2022 inspection.
