# MEMORANDUM

Subject: **SA-7 Sediment Remedy Long-Term Monitoring**  
**Summary of Year 9 Monitoring & Proposed Year 10 Program**

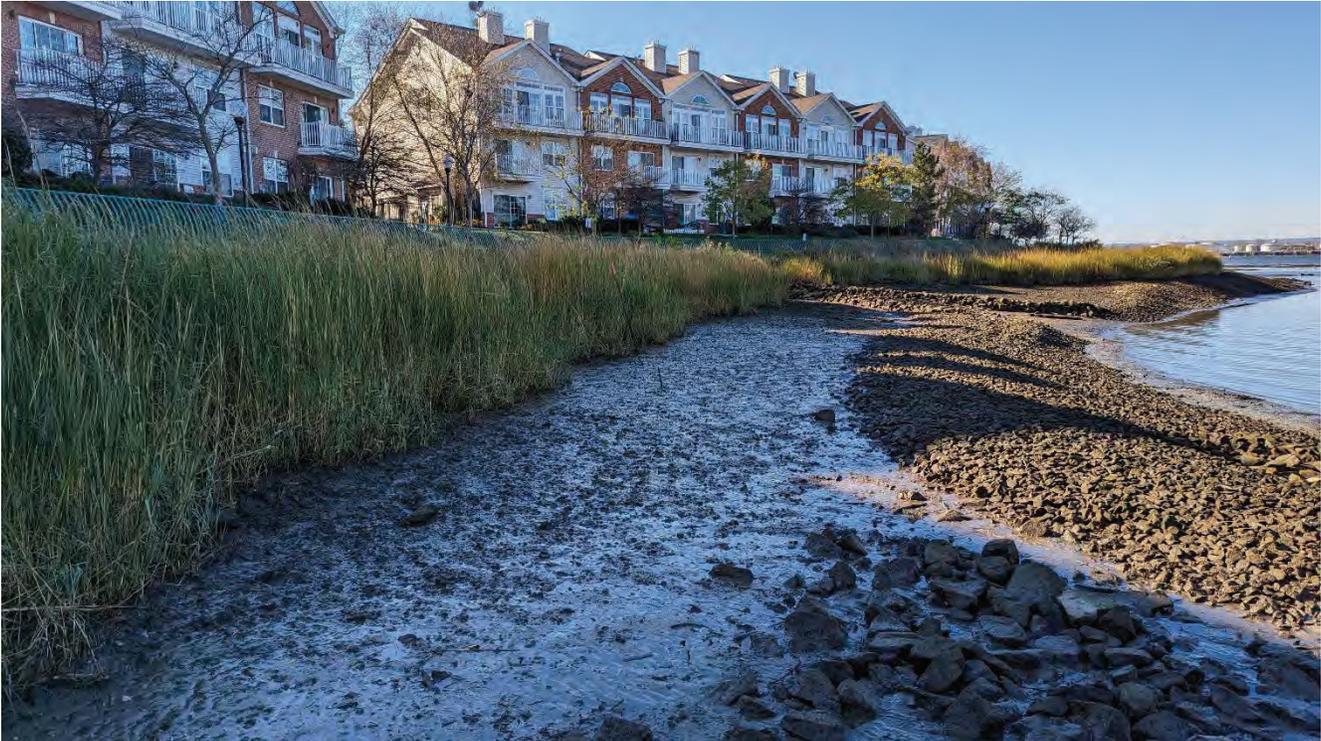
**Photo 18:** Low marsh planting zone between Outfalls A and B (facing west). Note the vibrant and healthy vegetation.

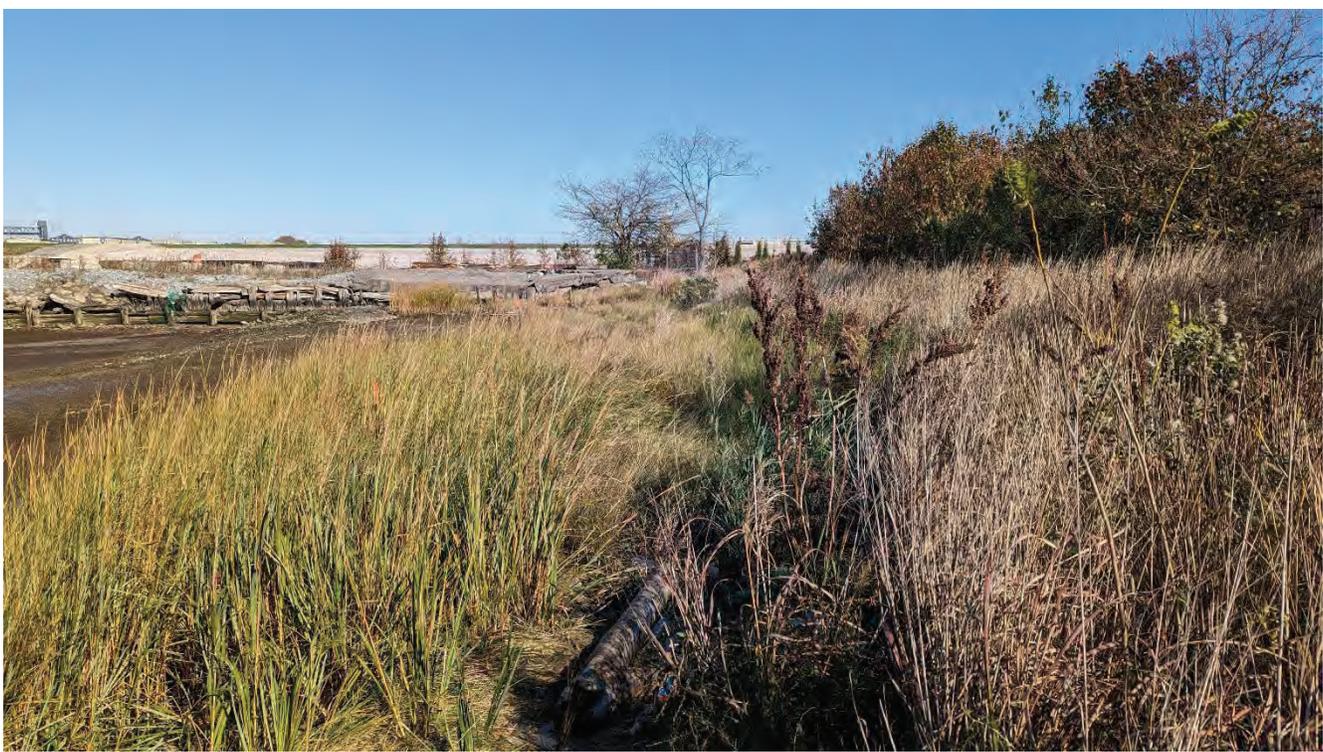
**Photo 19:** Vibrant and healthy vegetation in the low and high marsh zones in the eastern BEP area (facing southeast).

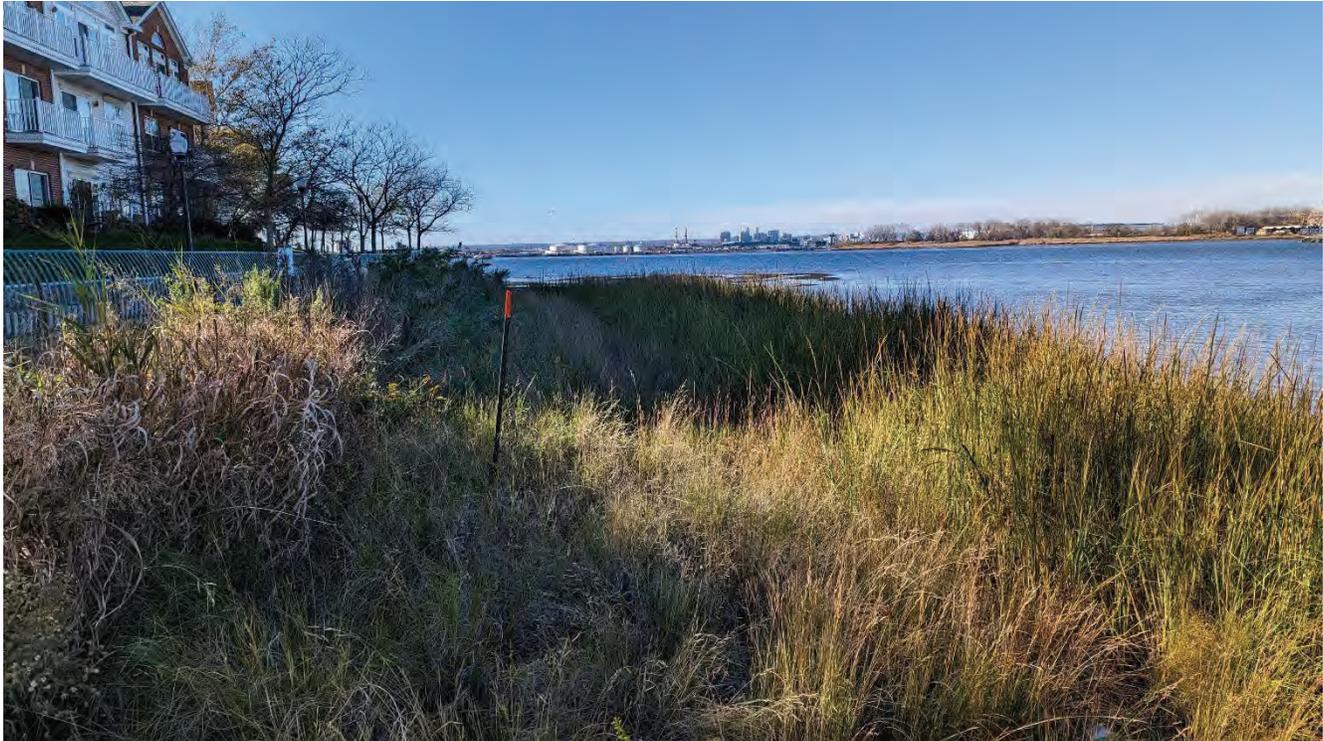
**Photo 20:** Vibrant and healthy vegetation in the high marsh zone in the area west of Outfall A (facing west).

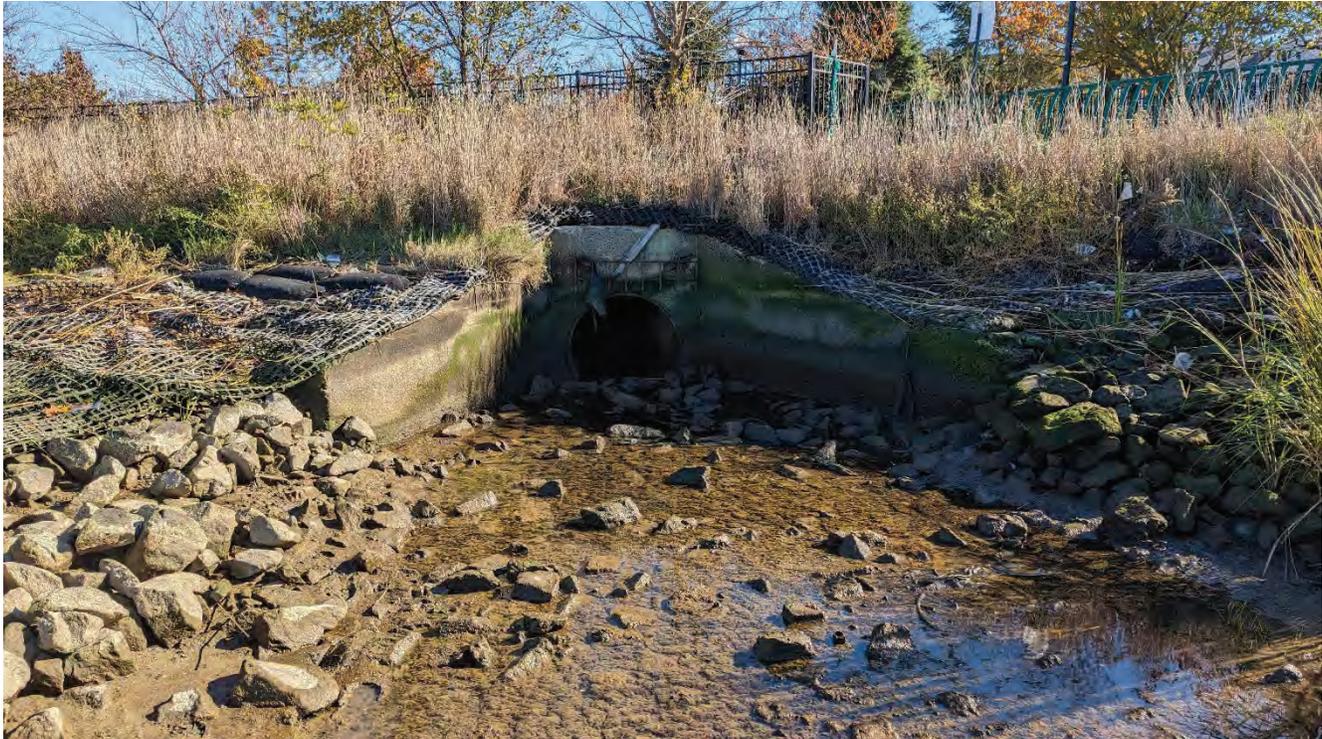
**Photo 22:** Exposed geogrid over the ledge of the Outfall B structure (facing south).

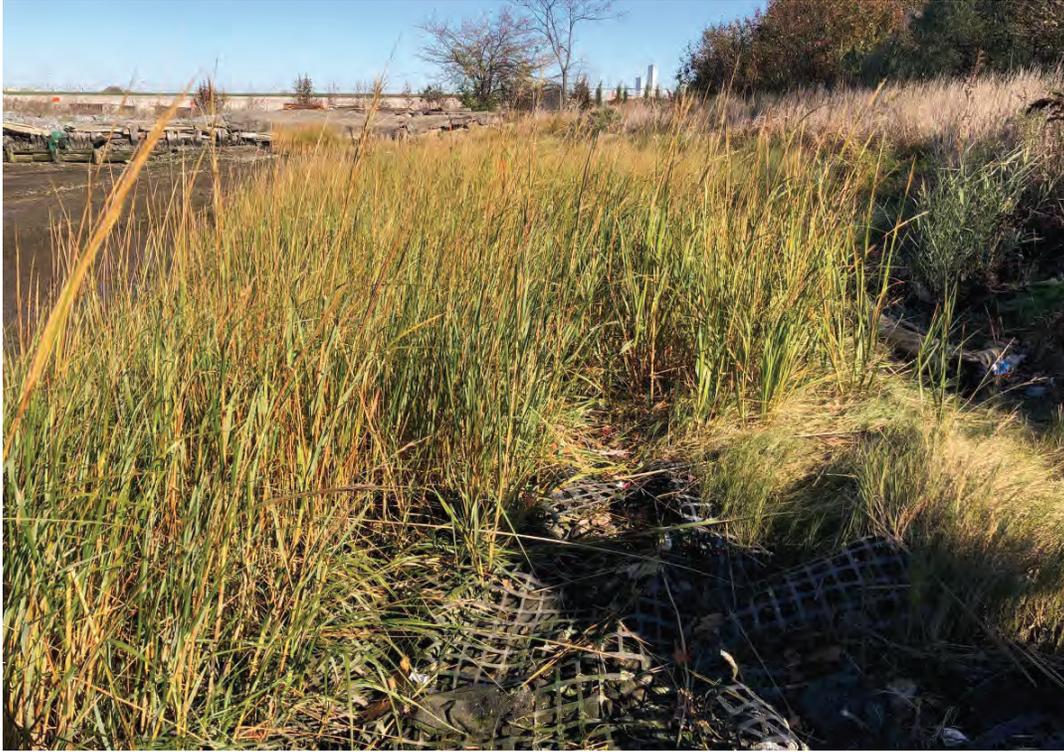
**Photo 23:** Area of exposed GroSoxx and geogrid with some debris, located east of Outfall A (facing southeast). Note the presence of healthy and vibrant vegetation around the GroSoxx area.

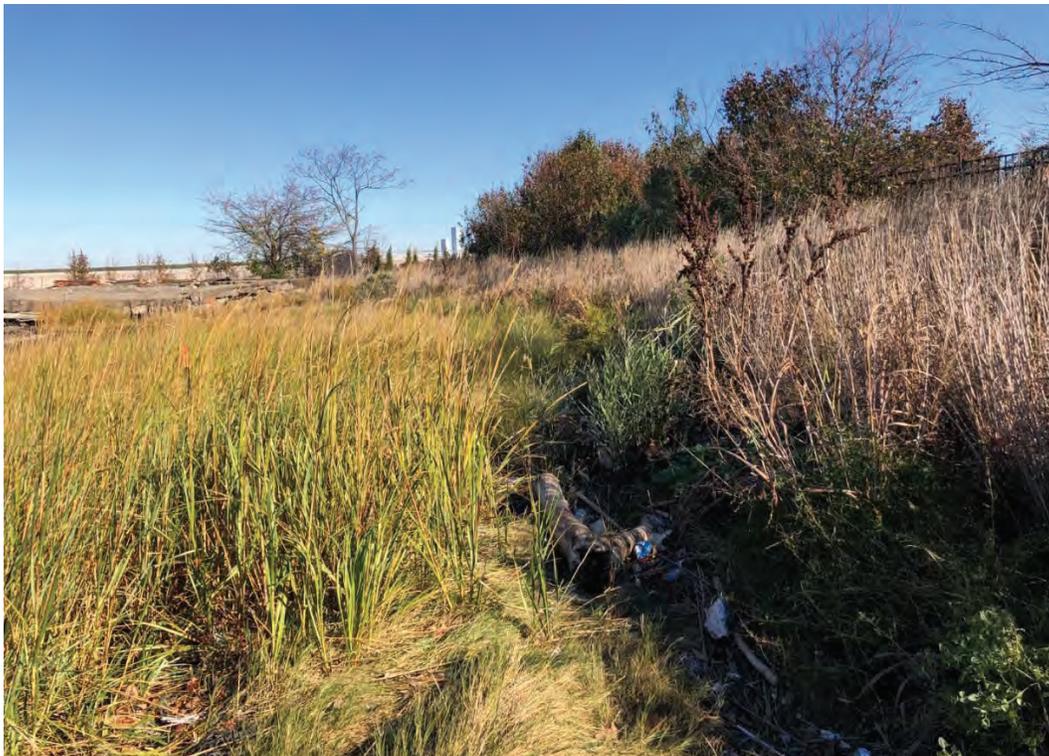
**Photo 24:** Vibrant and healthy upper low marsh, lower high marsh, and upland vegetation between Outfalls A and B (facing east). Note the presence of drift deposits from the tidal action in the foreground.

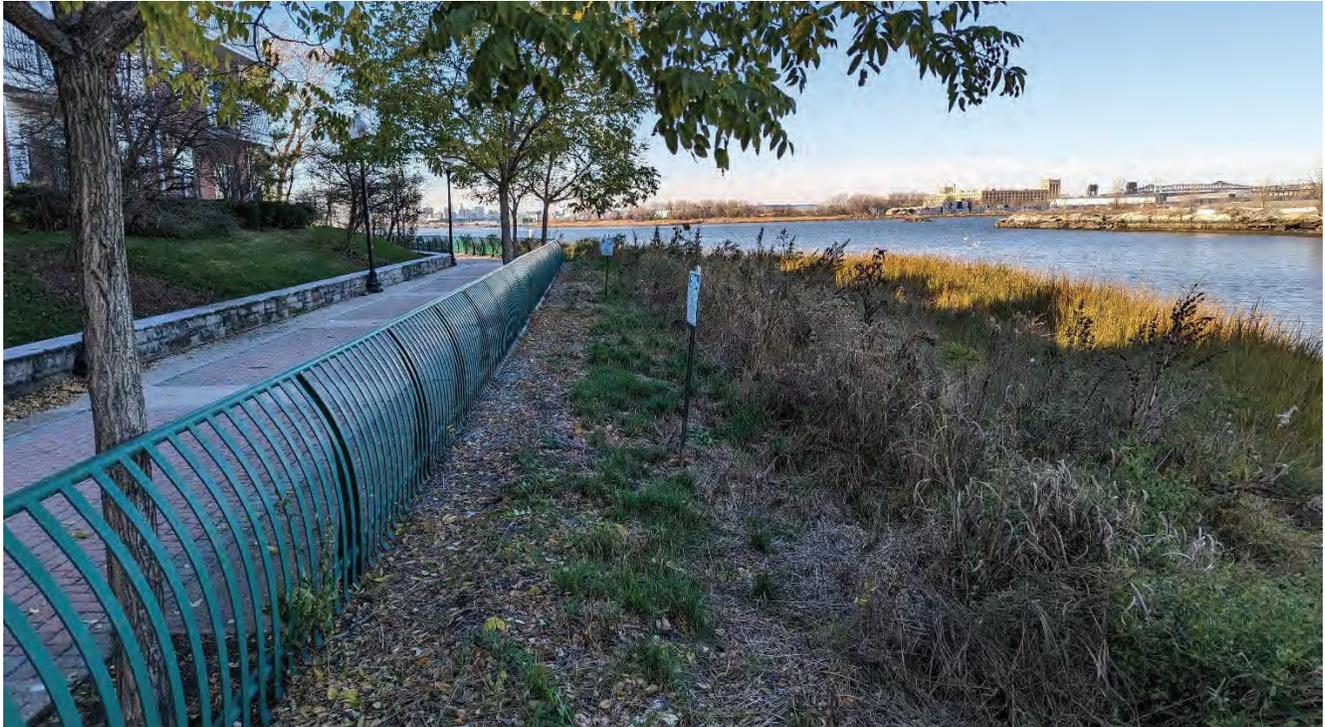
**Photo 26:** Mowed section of the uplands transition area in the western area of the BEP (facing west).

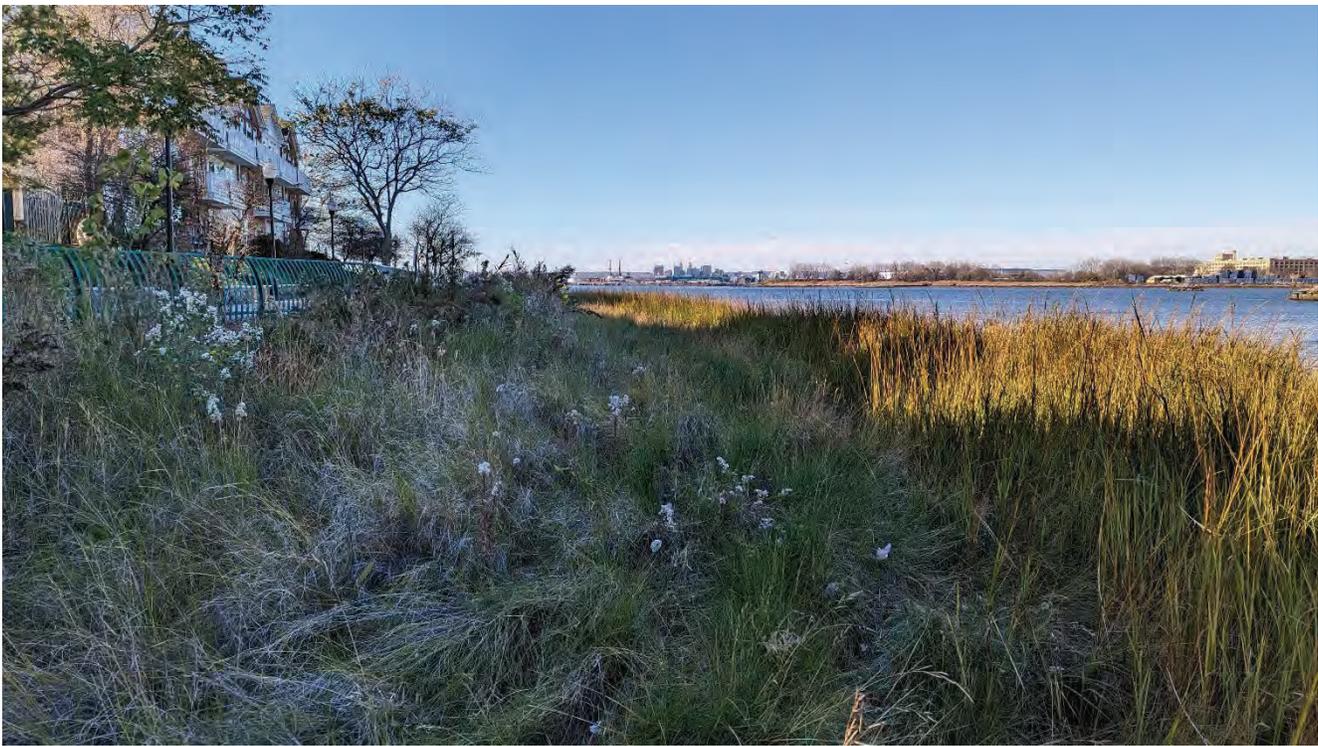
**Photo 27:** Vibrant and healthy low marsh, high marsh, and uplands transition area west of Outfall A (facing west). Note the presence of native species boneset in the uplands transition area.

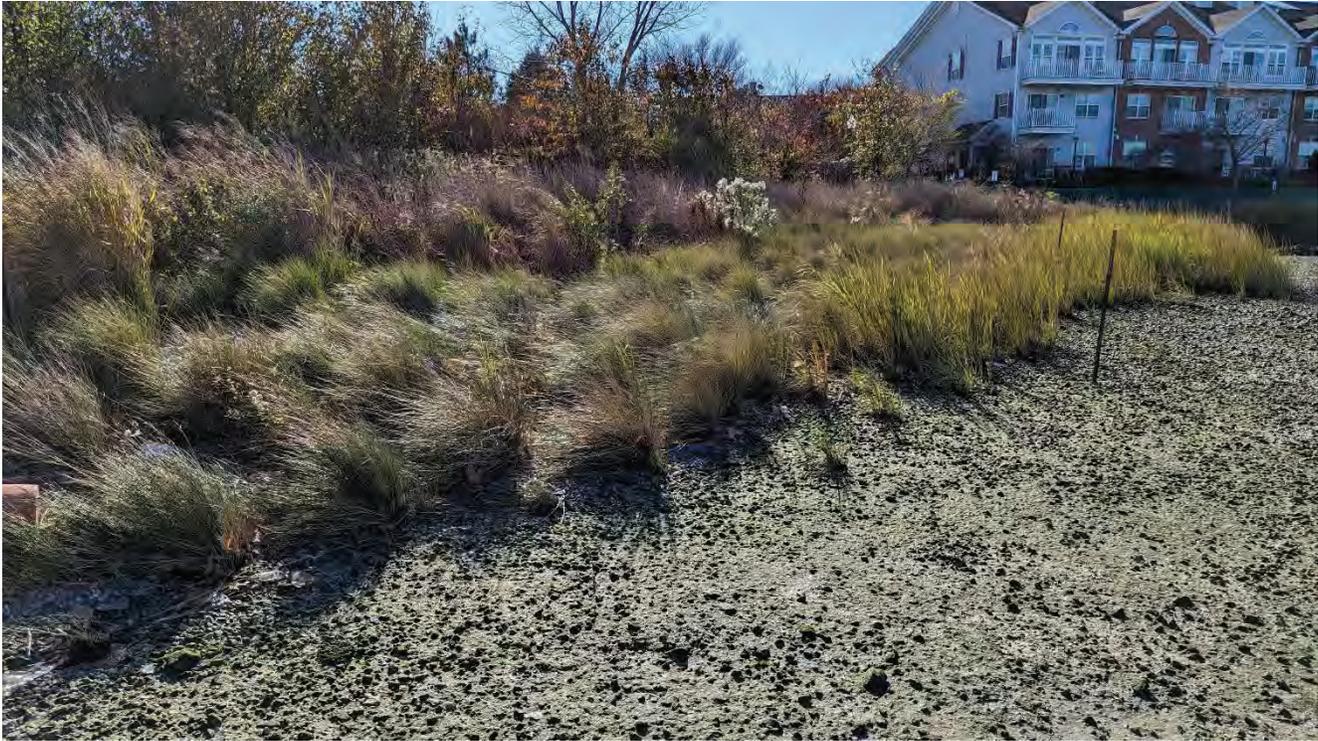
**Photo 28:** Vibrant and health low marsh, high marsh, and uplands transition area east of Outfall C (facing southwest).
